**Flood Control Project Maintenance
Levee Inspections**

Fall 2018 Levee Maintenance Deficiency Summary Report

**Flood Control Project Maintenance
Levee Inspections****LMA District Cover Sheet****Fall 2018 Levee Inspection Results****Reclamation District No. 2098 Cache and Haas Slough**

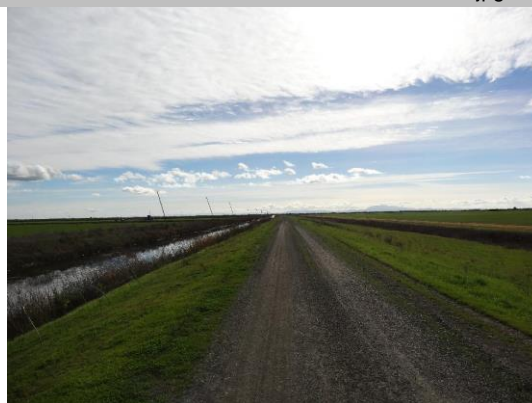
Photo 1 of 1 : UCIP_FA_2018_53380_76889.jpg

Comment Code					
Inspector Comment					
FS_ID:53380 DS_ID:20995 EP_NO: 17842 Repair Type: Non-Urgent Crossing Status: Found UCIP Comments: 10/2/2018 Crossing downgraded to Non-Urgent due to reclassification of gas lines. Need to contact owner to determine current status of crossing (D. Sanoski - DWR UCIP).12/22/2016 same as previous inspection crossing remains Urgent due to unknown status of gas line--no markers present. According to LMA representative, RD 2068 issued a permit for a gas line however, the current status of this line is unknown. Permit issued by RD 2068 is 20040903. Need to contact owner to determine status of crossing. Markers will need to be installed per Title 23. (O. Magana - DWR UCIP)03/19/2014 No markers found. Need to contact owner to determine status and location. (W. Wylie - DWR UCIP) FIELD_STRUCT_DESC: 3-inch gas line of an unknown material bored under the levee and the channel, approximately 37 feet below the crown. (3-inch natural gas line authorized under Permit No. 17842, 2004 - Castle Minerals, Inc.). FS Date: 10/2/2018 4:32:00 PM

View of levee crown and slopes through this section of the levee.

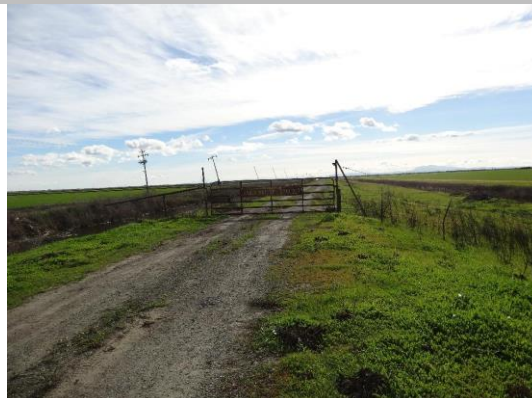
Photo 1 of 3 : UCIP_FA_2018_53381_76867.jpg

Comment Code					
Inspector Comment					
FS_ID:53381 DS_ID:20989 EP_NO: 11564 Repair Type: Urgent Crossing Status: Found UCIP Comments: 10/2/2018 Same as last inspection; remaining as Urgent and recommend internal pipe inspection (D. Sanoski - DWR UCIP).12/06/2016 Crossing has been upgraded from Non-Urgent to Urgent due to sections of the wall missing on the LS. Crossing is also opened on both WS and LS. According to Mr. Mike Hardesty, this crossing is not abandoned the crossing is out of service for now. Recommend internal integrity inspection and coordinating with CVFPB to comply with Title 23. (O. Magana - DWR UCIP)03/19/2014 Pipe appears abandoned and if so should be done so properly. Pipe rusted through at outlet in canal. This may indicate further degradation of pipe within the levee. Good candidate for video inspection. (W. Wylie - DWR UCIP) FIELD_STRUCT_DESC: 18-inch steel drainage pipe through the levee, 2 feet below the crown. Steel cutoff wall around the pipe at the center of the levee. Siphon breaker on the apex of the pipe located on the landside (LS) shoulder. Pump missing from steel pump pad over a 4-foot by 4-foot concrete sump located on the waterside (WS) toe. (18-inch pipe authorized under Permit No. 11564, 1976 - Reclamation District No. 2068). [Additional Reference(s): DWR Levee Log, 2003]. FS Date: 10/2/2018 4:33:00 PM

Overview of levee crown at multiple pipe crossings.

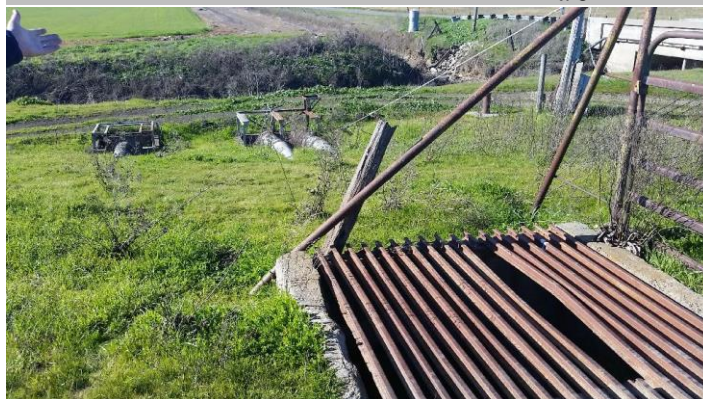
Photo 2 of 3 : UCIP_FA_2018_53381_76872.jpg

View of WS photo taken from levee crown.

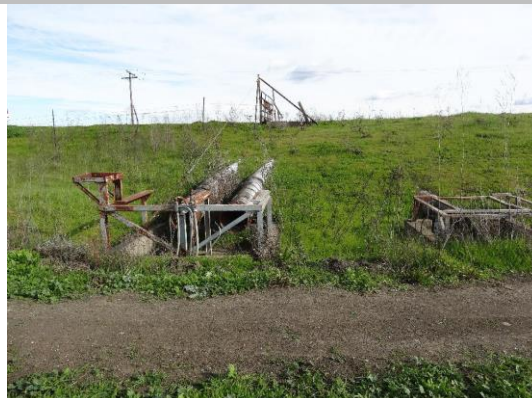
Photo 3 of 3 : UCIP_FA_2018_53381_76868.jpg

Comment Code						
Inspector Comment						
FS_ID:53381 DS_ID:20989 EP_NO: 11564 Repair Type: Urgent Crossing Status: Found UCIP Comments: 10/2/2018 Same as last inspection; remaining as Urgent and recommend internal pipe inspection (D. Sanoski - DWR UCIP).12/06/2016 Crossing has been upgraded from Non-Urgent to Urgent due to sections of the wall missing on the LS. Crossing is also opened on both WS and LS. According to Mr. Mike Hardesty, this crossing is not abandoned the crossing is out of service for now. Recommend internal integrity inspection and coordinating with CVFPB to comply with Title 23. (O. Magana - DWR UCIP)03/19/2014 Pipe appears abandoned and if so should be done so properly. Pipe rusted through at outlet in canal. This may indicate further degradation of pipe within the levee. Good candidate for video inspection. (W. Wylie - DWR UCIP) FIELD_STRUCT_DESC: 18-inch steel drainage pipe through the levee, 2 feet below the crown. Steel cutoff wall around the pipe at the center of the levee. Siphon breaker on the apex of the pipe located on the landside (LS) shoulder. Pump missing from steel pump pad over a 4-foot by 4-foot concrete sump located on the waterside (WS) toe. (18-inch pipe authorized under Permit No. 11564, 1976 - Reclamation District No. 2068). [Additional Reference(s): DWR Levee Log, 2003]. FS Date: 10/2/2018 4:33:00 PM

View of WS--pipe crossing is located on the right.

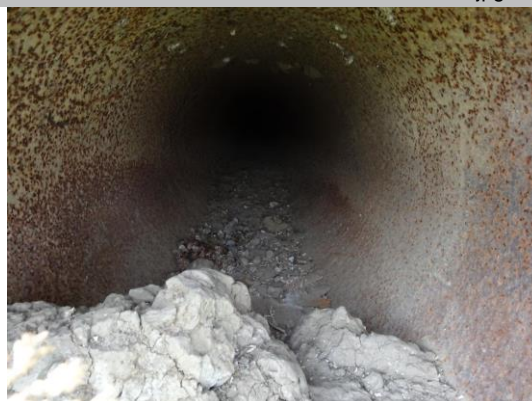
Photo 3 of 3 : UCIP_FA_2018_53383_76885.jpg

Comment Code						
Inspector Comment						
FS_ID:53383 DS_ID:21013 EP_NO: 5426-A Repair Type: Urgent Crossing Status: Found UCIP Comments: 10/2/2018 Same as last inspection; remaining as Urgent and recommend internal pipe inspection (D. Sanoski - DWR UCIP).12/06/2016 Crossing is opened on both WS and LS. Concrete box located on the LS has been removed. According to Mr. Mike Hardesty, this crossing is not abandoned the crossing is out of service for now. Recommend internal integrity inspection and coordinating with CVFPB to comply with Title 23. (O. Magana - DWR UCIP)03/19/2014 Pipe appears abandoned and if so should be done so properly. Foundation for concrete distribution box on LS toe at canal has failed. Box has fallen into canal and LS slope has erosion at same location. Pipe open on both ends. (W. Wylie - DWR UCIP) FIELD_STRUCT_DESC: 2 of 2: 18-inch coated steel drainage pipe through the levee, 3 feet below the crown. Vertical pumps missing from steel pad over a 7-foot by 4-foot concrete sump located on the waterside (WS) toe. Concrete cattle guard structure, 7 feet long, 15 feet wide, and 4 feet deep, located on the crown around the pipes. Discharge structure is located on the landside (LS) slope. (Permit No. 5426, 1966, and 5426-A, 1967 - Reclamation District No. 2068. Permit recordation indicates one 14-inch pipe and one 18-inch pipe to be installed). [Additional Reference(s): DWR Levee Log, 2003]. FS Date: 10/2/2018 4:54:00 PM

Inside view of pipe from LS.

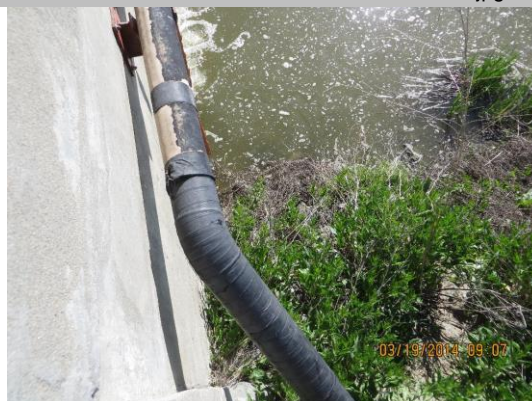
Photo 1 of 3 : UCIP_FA_2018_32566_59110.jpg

LM Start	12.07	Rating **	M	Issue No.	24
LM End	12.07	Issue Type +	En	Location *	
Category	Supplemental			GPS Latitude/Longitude	
				Start	End
Item	DWR UCIP Field Study			38.358110 °	38.358110 °
				-121.740381 °	-121.740381 °
DWR ID	24845				
Comment Code					
Inspector Comment					
FS_ID:32566 DS_ID:24845 EP_NO: N/A Repair Type: Non-Urgent Crossing Status: Found UCIP Comments: 03/19/2014 Need to verify status with gas company and install signs. No permit identified for crossing, though it may be connected to a permitted line installed in RD 2068 under Permit No. 13490. (W. Wylie - DWR UCIP) FIELD_STRUCT_DESC: 6-inch coated steel gas line through the levee, 3 feet below the crown. Signs on the east side of the levee. Pipe visible on the downstream side of the roadway bridge. FS Date: 3/19/2014

Pipe visible on South side of Bridge at Swan Road.

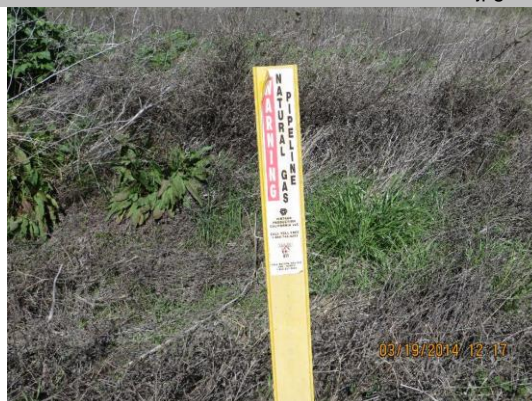
Photo 3 of 3 : UCIP_FA_2018_32566_59108.jpg

LM Start	12.07	Rating **	M	Issue No.	24 (cont)	
LM End	12.07	Issue Type +	En	Location *		
Category	Supplemental			GPS Latitude/Longitude		
				Start	End	
Item	DWR UCIP Field Study			38.358110 °	38.358110 °	
				-121.740381 °	-121.740381 °	
DWR ID	24845					
Comment Code						
Inspector Comment						
FS_ID:32566						
DS_ID:24845						
EP_NO: N/A						
Repair Type: Non-Urgent						
Crossing Status: Found						
UCIP Comments: 03/19/2014 Need to verify status with gas company and install signs. No permit identified for crossing, though it may be connected to a permitted line installed in RD 2068 under Permit No. 13490. (W. Wylie - DWR UCIP)						
FIELD_STRUCT_DESC: 6-inch coated steel gas line through the levee, 3 feet below the crown. Signs on the east side of the levee. Pipe visible on the downstream side of the roadway bridge.						
FS Date: 3/19/2014

Sign off LS toe on East side of canal.
