**Flood Control Project Maintenance
Levee Inspections**

Fall 2019 Levee Maintenance Deficiency Summary Report

**Flood Control Project Maintenance
Levee Inspections**
LMA District Cover Sheet
Fall 2019 Levee Inspection Results

Reclamation District No. 2098 Cache and Haas Slough

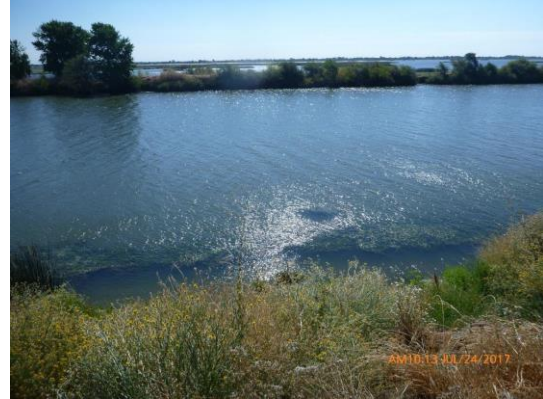
Photo 1 of 3 : LEVAL_FA_2019_416_2726.jpg

LM Start	2.21	Rating **	A/W	Issue No.	21
LM End	2.22	Issue Type +	Ma	Location *	WS
Category	Supplemental			GPS Latitude/Longitude	
				Start	End
Item	2017 Storm Damage			38.297100 °	38.297000 °
				-121.693300 °	-121.693300 °
DWR ID	LMA-243				
Comment Code					
Inspector Comment					
Levee Evaluation Comments					
Description:The damage consists of erosion, cracking, and sloughing of the waterside levee slope.					
Site ID No:416					
Site Designation:LMA-243					
Repair Type: Erosion					
Rating:Serious					
Field Date:7/24/2017					
Notes: Erosion with sloughing. About 2' vertical cut at top of erosion.

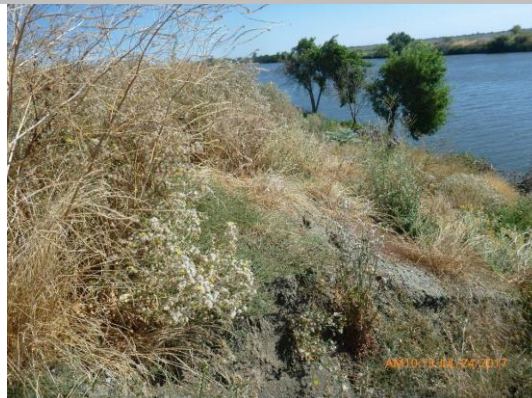
Photo 3 of 3 : LEVAL_FA_2019_416_2728.jpg

LM Start	2.21	Rating **	A/W	Issue No.	21 (cont)
LM End	2.22	Issue Type +	Ma	Location *	WS
Category	Supplemental			GPS Latitude/Longitude	
				Start	End
Item	2017 Storm Damage			38.297100 °	38.297000 °
				-121.693300 °	-121.693300 °
DWR ID	LMA-243				
Comment Code					
Inspector Comment					
Levee Evaluation Comments					
Description:The damage consists of erosion, cracking, and sloughing of the waterside levee slope.					
Site ID No:416					
Site Designation:LMA-243					
Repair Type: Erosion					
Rating:Serious					
Field Date:7/24/2017					
Notes: Erosion with sloughing. About 2' vertical cut at top of erosion.

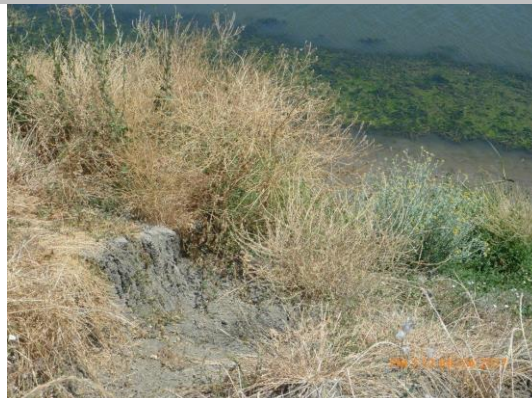
Photo 2 of 3 : FA_2019_RD2098_244_28_20190826_00016.jpg

LM Start	2.35	Rating **	A/W	Issue No.	28 (cont)	
LM End	2.39	Issue Type +	Ma	Location *	WS	
Category	Supplemental			GPS Latitude/Longitude		
				Start		End
Item	2017 Storm Damage			38.295100 °		38.294500 °
				-121.693400 °		-121.693400 °
DWR ID	LMA-250					
Comment Code						
Inspector Comment						
Levee Evaluation Comments						
Description:The damage consists of scour, sloughing, and cracking of the lower and mid waterside levee slope.						
Site ID No:423						
Site Designation:LMA-250						
Repair Type: Erosion						
Rating:Area of Concern						
Field Date:7/24/2017						
Notes: 2' of sloughing about half way up the slope.

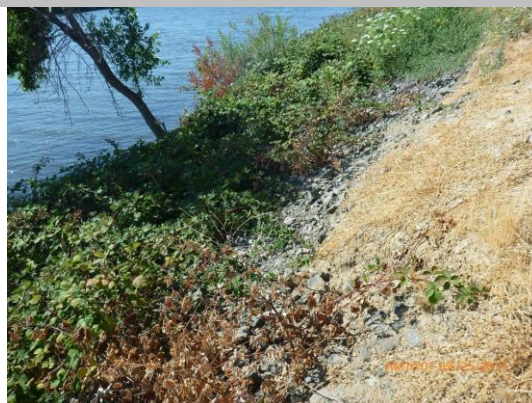
Photo 1 of 3 : FA_2019_RD2098_244_36_20190826_00024.jpg

LM Start	2.91	Rating **	A/W	Issue No.	36
LM End	2.93	Issue Type +	Ma	Location *	WS
Category	Supplemental			GPS Latitude/Longitude	
				Start	End
Item	2017 Storm Damage			38.286900 °	38.286700 °
				-121.693500 °	-121.693500 °
DWR ID	LMA-258				
Comment Code					
Inspector Comment					
Levee Evaluation Comments					
Description:The damage consists of scour and sloughing of the waterside levee slope.					
Site ID No:431					
Site Designation:LMA-258					
Repair Type: Erosion					
Rating:Serious					
Field Date:7/25/2017					
Notes: Erosion of WS toe, resulting in 8' verticle wall.

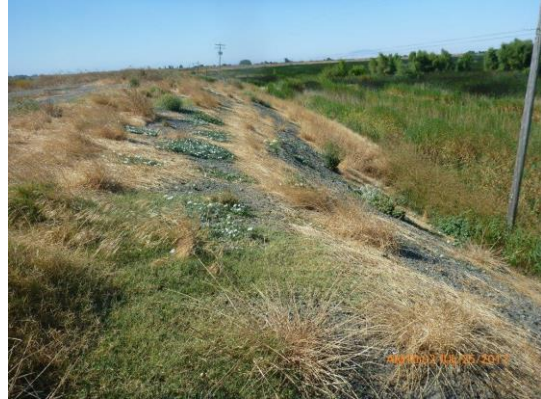
Photo 2 of 3 : FA_2019_RD2098_244_36_20190826_00025.jpg

LM Start	2.91	Rating **	A/W	Issue No.	36 (cont)
LM End	2.93	Issue Type +	Ma	Location *	WS
Category	Supplemental			GPS Latitude/Longitude	
				Start	End
Item	2017 Storm Damage			38.286900 °	38.286700 °
				-121.693500 °	-121.693500 °
DWR ID	LMA-258				
Comment Code					
Inspector Comment					
Levee Evaluation Comments					
Description:The damage consists of scour and sloughing of the waterside levee slope.					
Site ID No:431					
Site Designation:LMA-258					
Repair Type: Erosion					
Rating:Serious					
Field Date:7/25/2017					
Notes: Erosion of WS toe, resulting in 8' verticle wall.

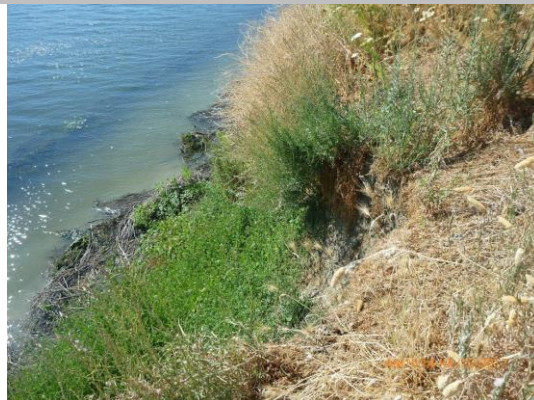
Photo 1 of 3 : FA_2019_RD2098_244_37_20191210_00050.jpg

LM Start	2.99	Rating **	A/W	Issue No.	37
LM End	3.29	Issue Type +	Ma	Location *	
Category	Supplemental			GPS Latitude/Longitude	
				Start	End
Item	2017 Storm Damage			38.285700 °	38.281500 °
				-121.693500 °	-121.694300 °
DWR ID	LMA-259				
Comment Code					
Inspector Comment					
Levee Evaluation Comments					
Description:The damage consists of scour and sloughing of the waterside levee slope.					
Site ID No:432					
Site Designation:LMA-259					
Repair Type: Erosion					
Rating:Serious					
Field Date:7/25/2017					
Notes: Varying erosion and sloughing at WS toe. Revetment at end of levee section.

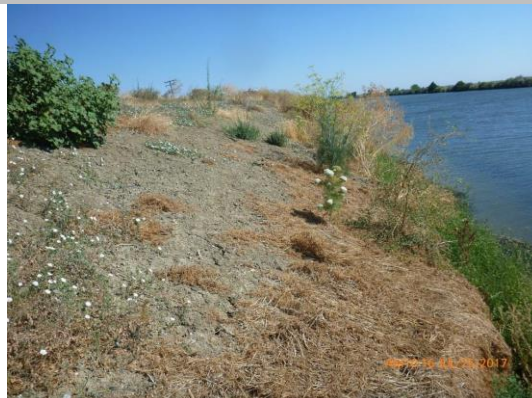
Photo 3 of 3 : FA_2019_RD2098_244_37_20191210_00052.jpg

LM Start	2.99	Rating **	A/W	Issue No.	37 (cont)
LM End	3.29	Issue Type +	Ma	Location *	
Category	Supplemental			GPS Latitude/Longitude	
				Start	End
Item	2017 Storm Damage			38.285700 °	38.281500 °
				-121.693500 °	-121.694300 °
DWR ID	LMA-259				
Comment Code					
Inspector Comment					
Levee Evaluation Comments					
Description:The damage consists of scour and sloughing of the waterside levee slope.					
Site ID No:432					
Site Designation:LMA-259					
Repair Type: Erosion					
Rating:Serious					
Field Date:7/25/2017					
Notes: Varying erosion and sloughing at WS toe. Revetment at end of levee section.

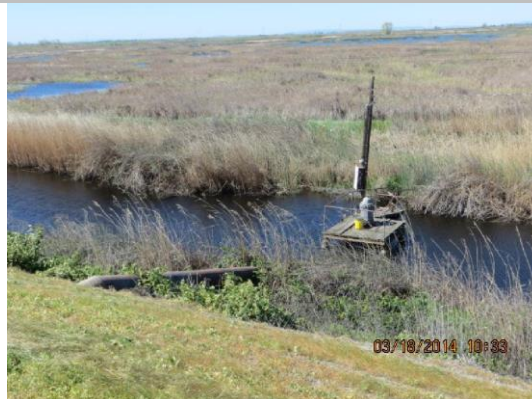
Photo 1 of 3 : UCIP_FA_2019_32227_58692.jpg

Comment Code						
Inspector Comment						
DS_ID:20969 FS_ID:32227 EP_NO: 13222 Repair Type: Non-Urgent Crossing Status: Found UCIP Comments: 03/18/2014 Pipe rusted through at outlet on WS slope, may indicate further degradation of pipe within levee. Good candidate for video inspection. (W. Wylie - DWR UCIP) FIELD_STRUCT_DESC: 20-inch steel drainage pipe through the levee, 7.5 feet below the crown. Siphon breaker on the waterside (WS) shoulder. Pump on pile structure in drainage ditch on the landside (LS). (This pipe was retained under Automatic Board Order (ABO) issued as Permit No. 10168, 1974 - Moresco Brothers. Pipe removed and replaced with a 19-inch steel pipe under the crown and along the LS slope under Permit No. 13222, 1981 - Prudential Insurance Company of America). [Additional Reference(s): DWR Levee Log, 2003. USACE Sacramento O&M Manual 109, April 1962, (HLM 2.98)]. FS Date: 3/18/2014

Pump on pile structure in drainage channel on LS toe.

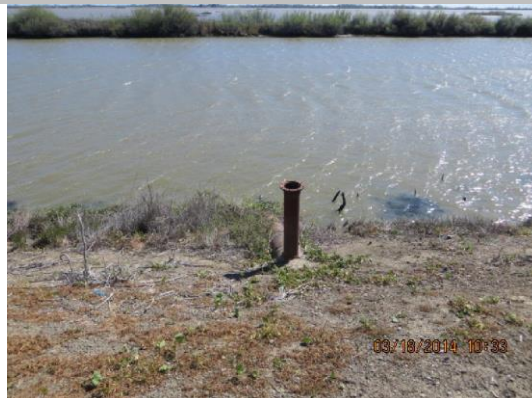
Photo 2 of 3 : UCIP_FA_2019_32227_58691.jpg

Comment Code						
Inspector Comment						
DS_ID:20969 FS_ID:32227 EP_NO: 13222 Repair Type: Non-Urgent Crossing Status: Found UCIP Comments: 03/18/2014 Pipe rusted through at outlet on WS slope, may indicate further degradation of pipe within levee. Good candidate for video inspection. (W. Wylie - DWR UCIP) FIELD_STRUCT_DESC: 20-inch steel drainage pipe through the levee, 7.5 feet below the crown. Siphon breaker on the waterside (WS) shoulder. Pump on pile structure in drainage ditch on the landside (LS). (This pipe was retained under Automatic Board Order (ABO) issued as Permit No. 10168, 1974 - Moresco Brothers. Pipe removed and replaced with a 19-inch steel pipe under the crown and along the LS slope under Permit No. 13222, 1981 - Prudential Insurance Company of America). [Additional Reference(s): DWR Levee Log, 2003. USACE Sacramento O&M Manual 109, April 1962, (HLM 2.98)]. FS Date: 3/18/2014

Siphon breaker in steel riser on WS slope.

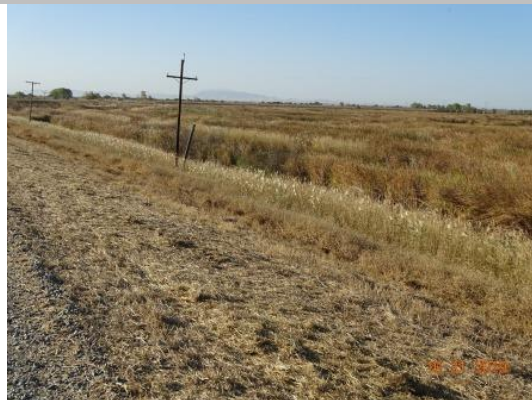
Photo 1 of 1 : FA_2019_RD2098_244_12_20191031_00049.jpg

LM Start	3.04	Rating **	M	Issue No.	12
LM End	3.60	Issue Type +	Ma	Location *	LS
Category	Earthen Levee			GPS Latitude/Longitude	
				Start	End
Item	Vegetation			38.285075 °	38.277458 °
				-121.693647 °	-121.696303 °
DWR ID	DWR_RD2098_01_f_2017_12				
Comment Code					
V1 : Control annual grass and weeds on the levee slopes and easements.					
Inspector Comment					
Vegetation at the bottom of the slope and toe needs to be maintained.

View looking upstream at vegetation on the landside slope (Fall 2019).

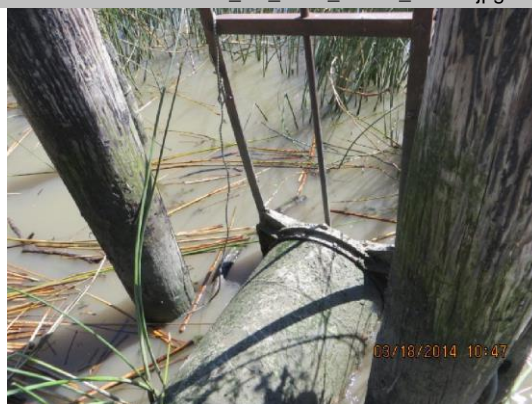
Photo 3 of 3 : UCIP_FA_2019_32243_58700.jpg

Comment Code						
Inspector Comment						
DS_ID:20970 FS_ID:32243 EP_NO: 10168 Repair Type: Non-Urgent Crossing Status: Found UCIP Comments: 03/18/2014 Walkway to slidegate on WS toe is in poor structural condition and may not be safe for accessing the slide gate actuator. Pipe appears abandoned and if so should be done so properly. Outlet on LS toe may be buried. (W. Wylie - DWR UCIP) FIELD_STRUCT_DESC: 24-inch steel irrigation pipe through the levee, 22.3 feet below the crown. Slide gate on the waterside (WS) end. Walkway from the WS shoulder to the slide gate control. Flap gate on the landside (LS) end. (This pipe was retained under Automatic Board Order (ABO) issued as Permit No. 10168, 1974 - Moresco Brothers). [Additional Reference(s): DWR Levee Log, 2003]. FS Date: 3/18/2014

Slidegate on WS toe at pipe.

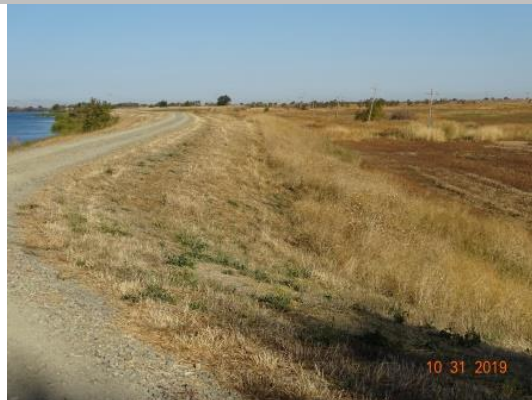
Photo 1 of 1 : FA_2019_RD2098_246_6_20191031_00034.jpg

LM Start	5.29	Rating **	M	Issue No.	6
LM End	6.77	Issue Type +	Ma	Location *	LS
Category	Earthen Levee			GPS Latitude/Longitude	
				Start	End
Item	Vegetation			38.275732°	38.292812°
				-121.705768°	-121.716600°
DWR ID	DWR_RD2098_02_f_2019_6				
Comment Code					
V1 : Control annual grass and weeds on the levee slopes and easements.					
Inspector Comment

View looking upstream at vegetation on the landside slope (Fall 2019).

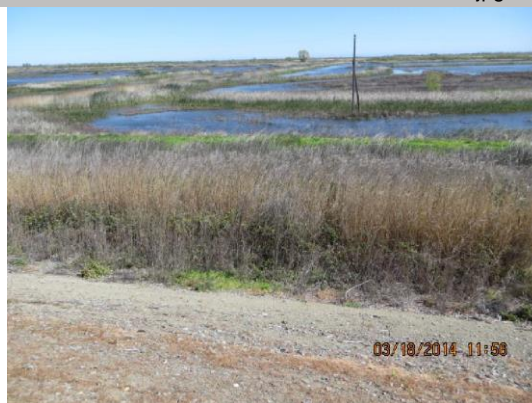
Photo 1 of 3 : UCIP_FA_2019_32287_58755.jpg

Comment Code						
Inspector Comment						
DS_ID:20973 FS_ID:32287 EP_NO: 10172 Repair Type: Non-Urgent Crossing Status: Found UCIP Comments: 12/22/2016 Met with Mike Hadesty, LMA Superintendent, and Brian Bush, LMA General Manager, to go over the list of pipes in RD2098. Per LMA, pipe is a drainage pipe. (O. Magana - DWR UCIP) 03/18/2014 Pipe appears abandoned and if so should be done so properly. Slide gate appears to be open and should be closed for the season. (W. Wylie - DWR UCIP) FIELD_STRUCT_DESC: 24-inch corrugated metal drainage pipe through the levee, 22.8 feet below the crown. Two cutoff walls around the pipe at the levee shoulders. Slide gate in 36-inch corrugated metal pipe (CMP) riser on the waterside (WS) slope. Flap gate and concrete U-shaped headwall on the landside (LS) end. (This pipe was retained under Automatic Board Order (ABO) issued as Permit No. 10172, 1974 - Moresco Brothers). [Additional Reference(s): DWR Levee Log, 2003]. FS Date: 3/18/2014

LS - no pipe visible.

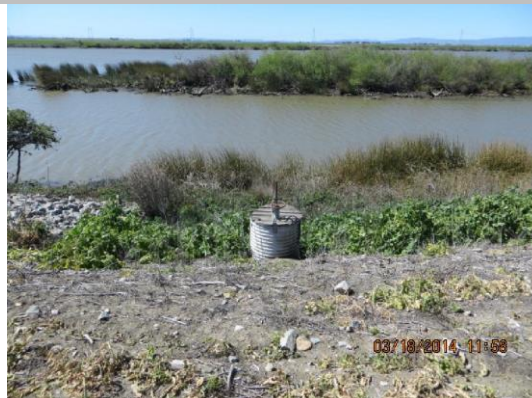
Photo 2 of 3 : UCIP_FA_2019_32287_58754.jpg

DS_ID:20973
FS_ID:32287
EP_NO: 10172
Repair Type: Non-Urgent
Crossing Status: Found
UCIP Comments: 12/22/2016 Met with Mike Hadesty, LMA Superintendent, and Brian Bush, LMA General Manager, to go over the list of pipes in RD2098. Per LMA, pipe is a drainage pipe. (O. Magana - DWR UCIP)
03/18/2014 Pipe appears abandoned and if so should be done so properly. Slide gate appears to be open and should be closed for the season. (W. Wylie - DWR UCIP)
FIELD_STRUCT_DESC: 24-inch corrugated metal drainage pipe through the levee, 22.8 feet below the crown. Two cutoff walls around the pipe at the levee shoulders. Slide gate in 36-inch corrugated metal pipe (CMP) riser on the waterside (WS) slope. Flap gate and concrete U-shaped headwall on the landside (LS) end. (This pipe was retained under Automatic Board Order (ABO) issued as Permit No. 10172, 1974 - Moresco Brothers). [Additional Reference(s): DWR Levee Log, 2003].

Slide gate in 36-inch standpipe on WS slope.

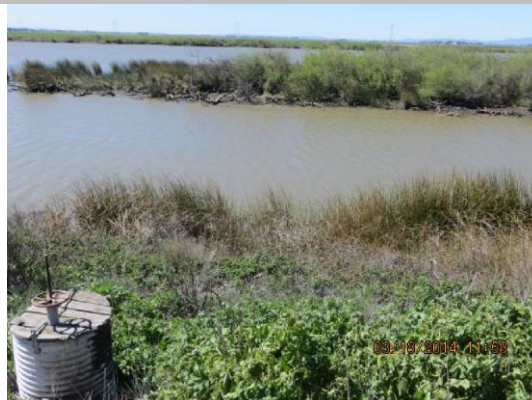
Photo 3 of 3 : UCIP_FA_2019_32287_58753.jpg

Slide gate in 36-inch standpipe on WS slope.

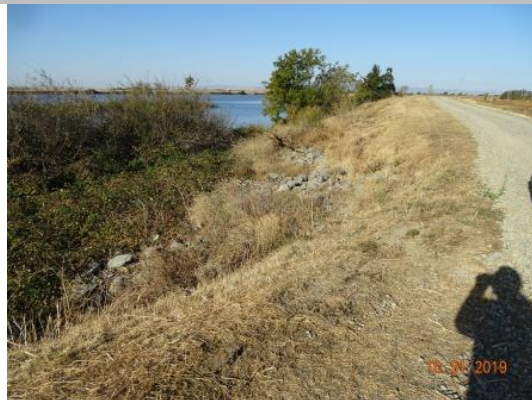
Photo 1 of 1 : FA_2019_RD2098_246_11_20191031_00035.jpg

LM Start	5.88	Rating **	M	Issue No.	11
LM End	5.88	Issue Type +	Ma	Location *	WS
Category	Earthen Levee			GPS Latitude/Longitude	
				Start	End
Item	Erosion / Bank Caving			38.282946 °	38.282946 °
				-121.710902 °	-121.710902 °
DWR ID	DWR_RD2098_02_s_2018_11				
Comment Code					
E1 : Note and monitor erosion site.					
Inspector Comment					
This waterside slump site is not new, and is somewhat protected by riprap and thick brushy vegetation, but it has the potential to erode into crown during high water with a strong south wind. It currently has a two-foot vertical scarp at the levee shoulder.

View looking upstream at erosion site on the waterside slope (Fall 2019).

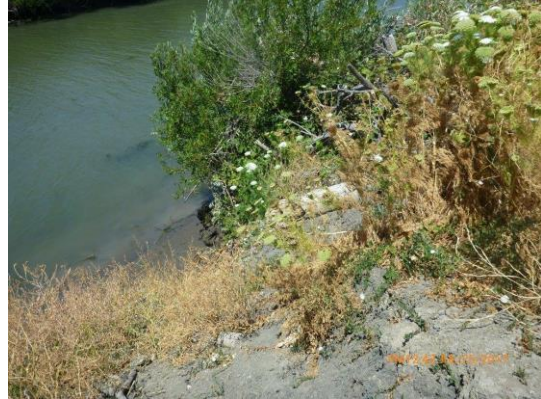
Photo 3 of 3 : FA_2019_RD2098_246_15_20190826_00005.jpg

LM Start	6.46	Rating **	A/W	Issue No.	15 (cont)	
LM End	6.46	Issue Type +	Ma	Location *	WS	
Category	Supplemental			GPS Latitude/Longitude		
				Start	End	
Item	2017 Storm Damage			38.288700 °	38.288800 °	
				-121.717000 °	-121.717000 °	
DWR ID	LMA-267					
Comment Code						
Inspector Comment						
Levee Evaluation Comments						
Description:The damage consists of scour of the lower and mid waterside levee slope.						
Site ID No:440						
Site Designation:LMA-267						
Repair Type: Erosion						
Rating:Area of Concern						
Field Date:7/25/2017						
Notes: Sloughing on waterside slope due to toe erosion.

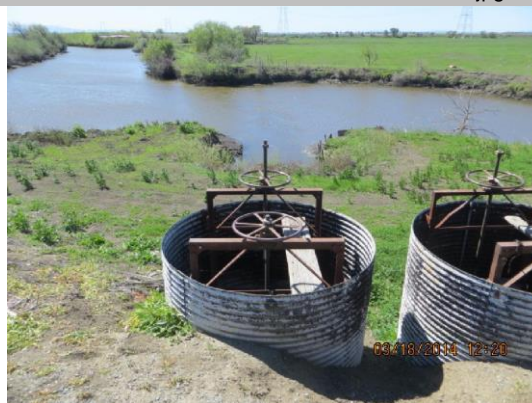
Photo 1 of 3 : UCIP_FA_2019_33784_61162.jpg

Comment Code					
Inspector Comment					
DS_ID:20976					
FS_ID:33784					
EP_NO: 10172					
Repair Type: Non-Urgent					
Crossing Status: Found					
UCIP Comments: 03/18/2014 Headwalls on WS toe failing at outlet. It is unclear if these were permanent installations or something that was installed as a temporary fix. (W. Wylie - DWR UCIP)					
FIELD_STRUCT_DESC: 1 of 2: 48-inch corrugated metal drainage pipe through the levee, 29 feet below the crown. Two slide gates in a 7-foot-diameter corrugated metal pipe (CMP) riser on the waterside (WS) slope. (two 48-inch [HLM 6.75] authorized under Automatic Board Order (ABO) issued as Permit No. 10172, 1974 - Moresco Brothers).					
[Additional Reference(s): DWR Levee Log, 2003. USACE Sacramento O&M Manual 109, April 1962, (HLM 6.75)].					
FS Date: 3/18/2014

Two slide gates in 7-foot diameter CMP riser on waterward slope.

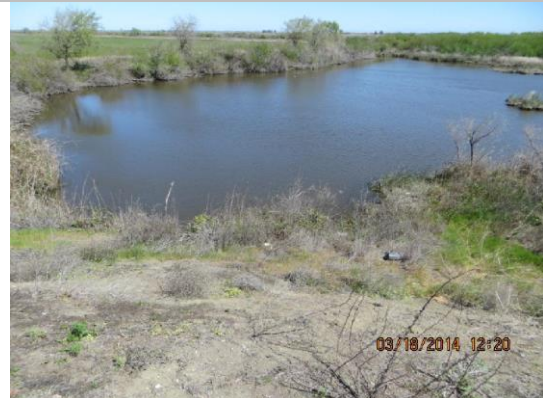
Photo 2 of 3 : UCIP_FA_2019_33784_61161.jpg

Comment Code						
Inspector Comment						
DS_ID:20976 FS_ID:33784 EP_NO: 10172 Repair Type: Non-Urgent Crossing Status: Found UCIP Comments: 03/18/2014 Headwalls on WS toe failing at outlet. It is unclear if these were permanent installations or something that was installed as a temporary fix. (W. Wylie - DWR UCIP) FIELD_STRUCT_DESC: 1 of 2: 48-inch corrugated metal drainage pipe through the levee, 29 feet below the crown. Two slide gates in a 7-foot-diameter corrugated metal pipe (CMP) riser on the waterside (WS) slope. (two 48-inch [HLM 6.75] authorized under Automatic Board Order (ABO) issued as Permit No. 10172, 1974 - Moresco Brothers). [Additional Reference(s): DWR Levee Log, 2003. USACE Sacramento O&M Manual 109, April 1962, (HLM 6.75)]. FS Date: 3/18/2014

Inlet not visible on LS toe.

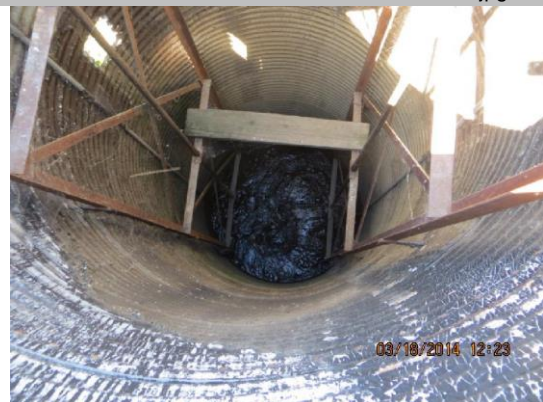
Photo 3 of 3 : UCIP_FA_2019_33784_61160.jpg

View inside CMP riser on WS shoulder.

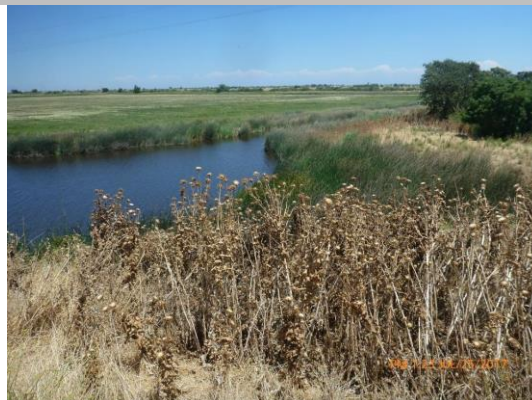
LM Start	6.74	Rating **	A/W	Issue No.	19 (cont)
LM End	6.75	Issue Type +	Ma	Location *	LS
Category	Supplemental			GPS Latitude/Longitude	
				Start	End
Item	2017 Storm Damage			38.292500°	38.292600°
				-121.716100°	-121.716200°
DWR ID	LMA-270				
Comment Code					
Inspector Comment					
Levee Evaluation Comments					
Description:The damage consists of scour and sloughing of the landside levee slope.					
Site ID No:443					
Site Designation:LMA-270					
Repair Type: Stability					
Rating:Area of Concern					
Field Date:7/25/2017					
Notes: Sloughing on crown into upper portion of landside levee slope.

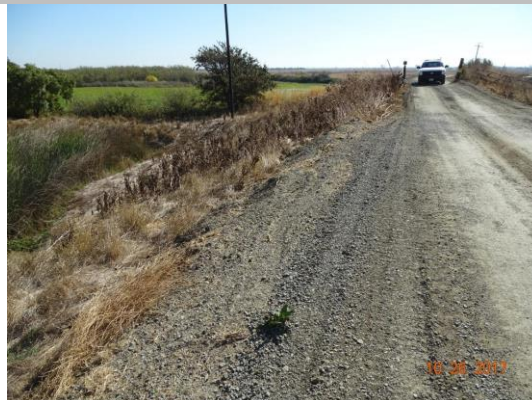
LM Start	6.77	Rating **	A/W	Issue No.	20 (cont)
LM End	6.80	Issue Type +	Ma	Location *	LS
Category	Supplemental			GPS Latitude/Longitude	
				Start	End
Item	2017 Storm Damage			38.292900 °	38.293000 °
				-121.716600 °	-121.717000 °
DWR ID	LMA-271				
Comment Code					
Inspector Comment					
Levee Evaluation Comments					
Description:The damage consists of cracking of the levee crest.					
Site ID No:444					
Site Designation:LMA-271					
Repair Type: Erosion					
Rating:Area of Concern					
Field Date:7/25/2017					
Notes: Two combined sloughing locations (271 and 272) within levee crown into waterside and landside slopes. Sloughing on landside slope bulges into ditch at toe.

10/26/17: Notice depression in crown road and slumping toward the left/landside (bulge at toe of levee).

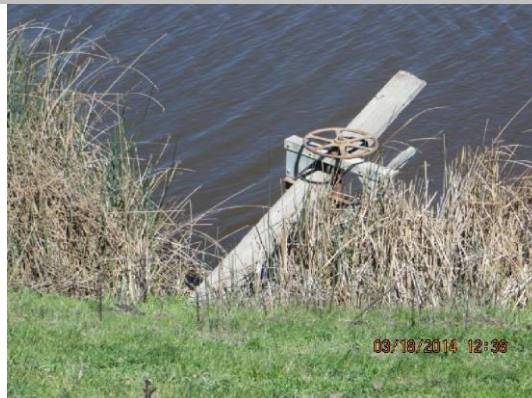
Photo 1 of 3 : UCIP_FA_2019_32290_58764.jpg

Comment Code						
Inspector Comment						
DS_ID:20977 FS_ID:32290 EP_NO: 10171 Repair Type: Non-Urgent Crossing Status: Found UCIP Comments: 12/22/2016 Met with Mike Hadesty, LMA Superintendent, and Brian Bush, LMA General Manager, to go over the list of pipes in RD2098. Per LMA, pipe is a drainage pipe.(O. Magana - DWR UCIP) 03/18/2014 Pipe appears to be abandoned and if so it should be done so properly. Walkway to gate valve actuator on WS slope is in disrepair and does not appear to be safe for use. (W. Wylie - DWR UCIP) FIELD_STRUCT_DESC: 36-inch corrugated metal drainage pipe through the levee, 23 feet below the crown. Walkway to slide gate on the waterside (WS) end. Slide gate at the landside (LS) toe. (This pipe was retained under Automatic Board Order (ABO) issued as Permit No. 10171, 1974 - Glenn A. Bowlsbey). [Additional Reference(s): DWR Levee Log, 2003. USACE Sacramento O&M Manual 109, April 1962, (HLM 7.23)]. FS Date: 3/18/2014

Slide gate at LS toe.

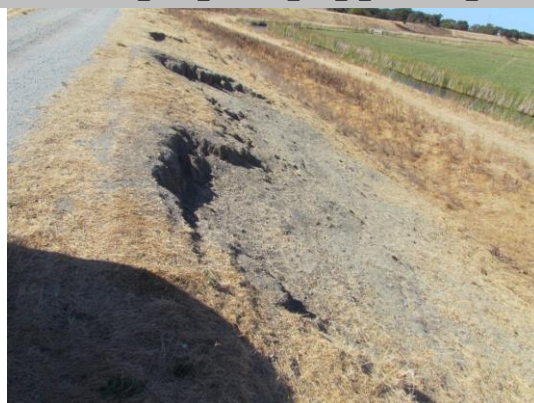
Photo 2 of 4 : FA_2019_RD2098_247_1_20190311_00001.jpg

LM Start	7.51	Rating **	M	Issue No.	1
LM End	7.51	Issue Type +	Ma	Location *	LS
Category	Earthen Levee			GPS Latitude/Longitude	
				Start	End
Item	Slope Stability			38.296846°	38.296846°
				-121.727546°	-121.727546°
DWR ID	DWR_RD2098_03_f_2016_1				
Comment Code					
S2 : Repair the levee slope damaged by foot traffic and prevent access where possible.					
Inspector Comment					
Livestock activity causing erosion of levee slope.

Close up. Looking upstream.

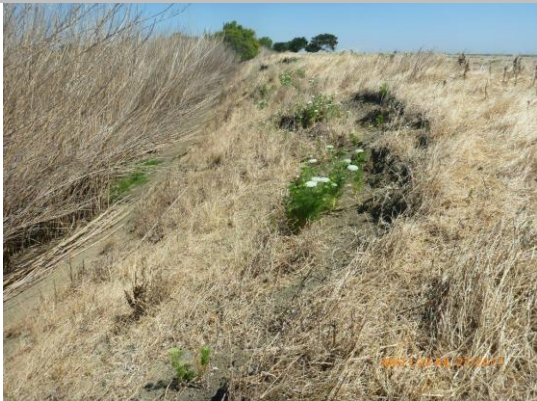
Photo 1 of 3 : FA_2019_RD2098_247_10_20190826_000006.jpg

LM Start	7.61	Rating **	A/W	Issue No.	10 (cont)	
LM End	7.62	Issue Type +	Ma	Location *	WS	
Category	Supplemental			GPS Latitude/Longitude		
				Start		End
Item	2017 Storm Damage			38.297900 °		38.298100 °
				-121.728900 °		-121.728900 °
DWR ID	LMA-276					
Comment Code						
Inspector Comment						
Levee Evaluation Comments						
Description:The damage consists of sloughing of the lower and mid waterside levee slope.						
Site ID No:449						
Site Designation:LMA-276						
Repair Type: Erosion						
Rating:Area of Concern						
Field Date:7/27/2017						
Notes: Sloughing on waterside slope due to erosion at waterside toe.

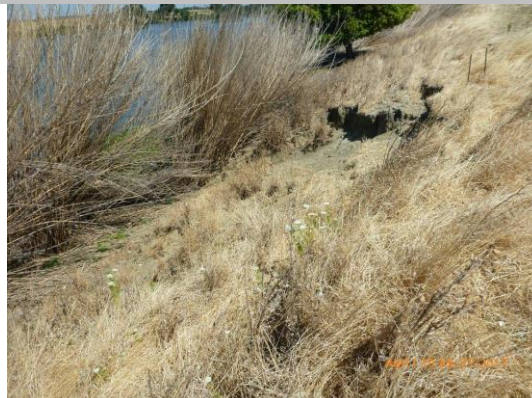
Photo 1 of 3 : FA_2019_RD2098_247_13_20190826_00009.jpg

LM Start	7.63	Rating **	A/W	Issue No.	13
LM End	7.64	Issue Type +	Ma	Location *	WS
Category	Supplemental			GPS Latitude/Longitude	
				Start	End
Item	2017 Storm Damage			38.298300 °	38.298400 °
				-121.728800 °	-121.728800 °
DWR ID	LMA-277				
Comment Code					
Inspector Comment					
Levee Evaluation Comments					
Description:The damage consists of scour and sloughing of the waterside levee slope.					
Site ID No:450					
Site Designation:LMA-277					
Repair Type: Erosion					
Rating:Area of Concern					
Field Date:7/27/2017					
Notes: Sloughing on waterside due to waterside toe erosion.

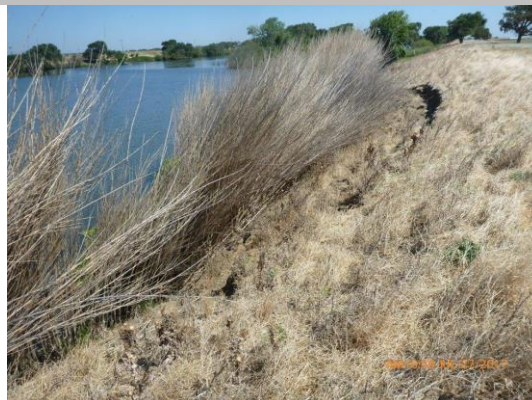
Photo 3 of 5 : FA_2019_RD2098_247_15_20190826_00013.jpg

LM Start	7.66	Rating **	A/W	Issue No.	15 (cont)	
LM End	7.68	Issue Type +	Ma	Location *	WS	
Category	Supplemental			GPS Latitude/Longitude		
				Start	End	
Item	2017 Storm Damage			38.298700 °	38.299000 °	
				-121.728700 °	-121.728600 °	
DWR ID	LMA-278					
Comment Code						
Inspector Comment						
Levee Evaluation Comments						
Description:The damage consists of scour and sloughing of the lower and mid waterside levee slope.						
Site ID No:451						
Site Designation:LMA-278						
Repair Type: Erosion						
Rating:Area of Concern						
Field Date:7/27/2017						
Notes: Sloughing on waterside slope due to waterside toe erosion.						
Additional erosion seen on the Fall 2019 inspection. Mitigate erosion then monitor site.

View looking upstream at erosion at the storm damage site that has worsened over January and February of 2019 (Spring 2019).

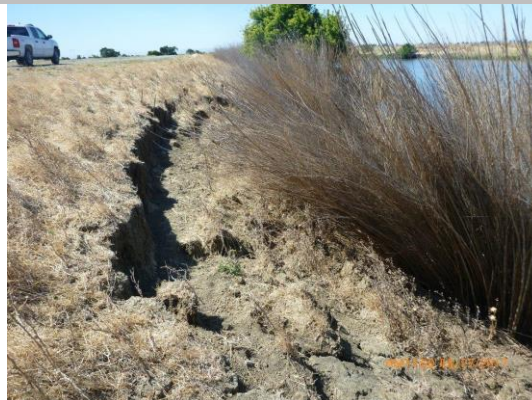
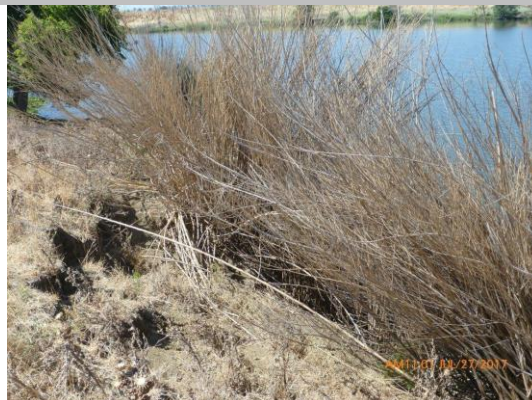
LM Start	7.66	Rating **	A/W	Issue No.	15 (cont)	
LM End	7.68	Issue Type +	Ma	Location *	WS	
Category	Supplemental			GPS Latitude/Longitude		
				Start	End	
Item	2017 Storm Damage			38.298700 °	38.299000 °	
				-121.728700 °	-121.728600 °	
DWR ID	LMA-278					
Comment Code						
Inspector Comment						
Levee Evaluation Comments						
Description:The damage consists of scour and sloughing of the lower and mid waterside levee slope.						
Site ID No:451						
Site Designation:LMA-278						
Repair Type: Erosion						
Rating:Area of Concern						
Field Date:7/27/2017						
Notes: Sloughing on waterside slope due to waterside toe erosion.						
Additional erosion seen on the Fall 2019 inspection. Mitigate erosion then monitor site.

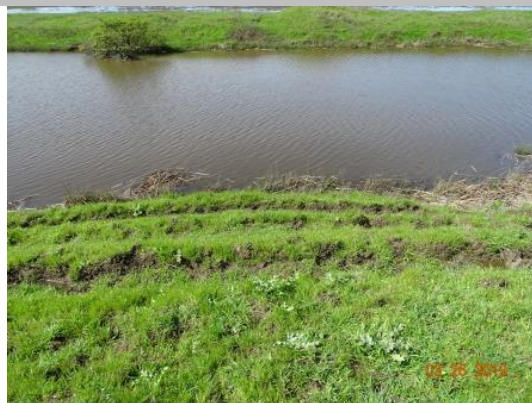
Photo 1 of 3 : FA_2019_RD2098_248_9_20190826_00001.jpg

LM Start	9.44	Rating **	U	Issue No.	9
LM End	9.74	Issue Type +	Ma	Location *	WS
Category	Supplemental			GPS Latitude/Longitude	
				Start	End
Item	2017 USACE Erosion Survey			38.320240 °	38.324587 °
				-121.740183 °	-121.740254 °
DWR ID	DWR_RD2098_04_f_2018_9				
Comment Code					
Inspector Comment					
2017 Site ID: HAS 9.7 L					
Status: Critical					
2017 Field Notes: Upgraded to CRITICAL. Multiple slump on top of old slumping ; slump is into levee prism.					
Site History: 2011 - Several scallops of erosion. Erosion primarily due to the weight of cattle on the slope. 2016 - Two new large scallop pockets in the middle of the site.

View looking downslope at deep ruts in the waterside slope made by cows (Spring 2019).

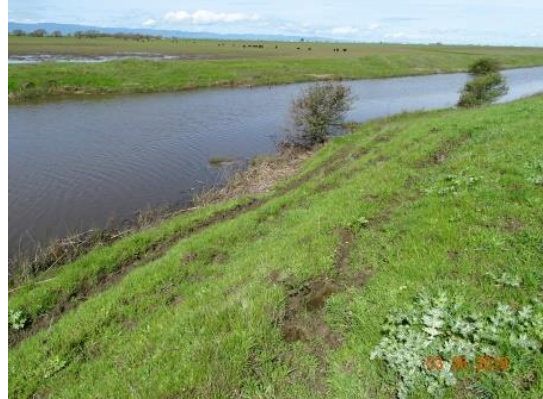
Photo 2 of 3 : FA_2019_RD2098_248_9_20190826_00002.jpg

View looking upstream at deep ruts in the waterside slope made by cows (Spring 2019).

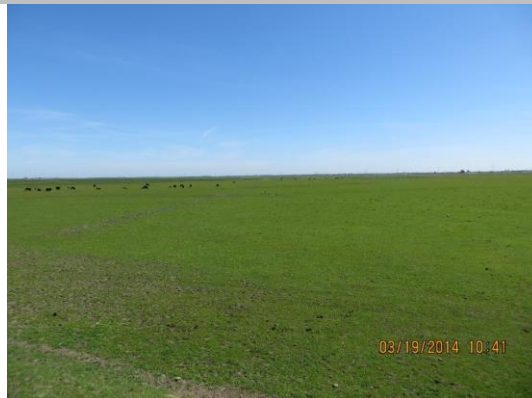
Photo 1 of 2 : UCIP_FA_2019_32383_58881.jpg

LM Start	9.49	Rating **	M	Issue No.	18	
LM End	9.49	Issue Type +	En	Location *		
Category	Supplemental			GPS Latitude/Longitude		
				Start	End	
Item	DRAFT DWR UCIP Field Study			38.321032 °	38.321032 °	
				-121.740154 °	-121.740154 °	
DWR ID	20983					
Comment Code						
Inspector Comment						
DS_ID:20983 FS_ID:32383 EP_NO: N/A Repair Type: Non-Urgent Crossing Status: Indicator Found UCIP Comments: 03/19/2014 need to verify status of gaslines in region with PG&E (888) 743-7431 Email: PipelineRequests@pge.com. (W. Wylie - DWR UCIP) FIELD_STRUCT_DESC: 4-inch gas line of an unknown material through the levee, 2 feet below the crown. Shutoff valve located 370 feet east of the levee crown. [Additional Reference(s): DWR Levee Log, 2003]. FS Date: 3/19/2014

Shutoff valve visible 370-feet off LS toe.

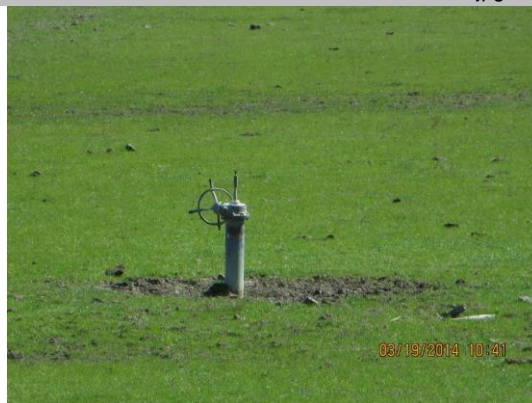
Photo 2 of 2 : UCIP_FA_2019_32383_58880.jpg

Shutoff valve visible 370-feet off LS toe.

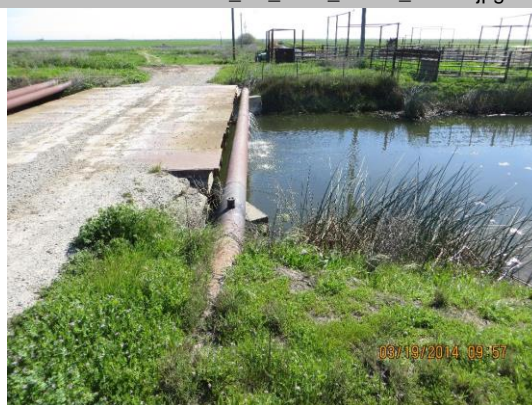
Photo 1 of 3 : UCIP_FA_2019_32403_58905.jpg

Comment Code						
Inspector Comment						
DS_ID:20991 FS_ID:32403 EP_NO: 12851 Repair Type: Non-Urgent Crossing Status: Found UCIP Comments: 12/22/2016 Met with Mike Hadesty, LMA Superintendent, and Brian Bush, LMA General Manager, to go over the list of pipes in RD2098. Per LMA, suspended pipe with leaks was repaired in the summer of 2016. (O. Magana - DWR UCIP) 03/19/2014 Holes in pipe next to rail car bridge may indicate further deterioration of pipe through levee. Good candidate for video inspection. (W. Wylie - DWR UCIP) FIELD_STRUCT_DESC: 12-inch steel irrigation pipe through the levee, 2 feet below the crown. Cutoff wall around the pipe at the center of the levee. Siphon breaker on the landside (LS) toe at the canal. 1-inch polyvinyl chloride (PVC) electrical conduit at the same location (Permit No. 12851, 1980 - Bunker Ranch). [Additional Reference(s): DWR Levee Log, 2003]. FS Date: 3/19/2014

Pipe and siphon breaker visible on LS at canal crossing.

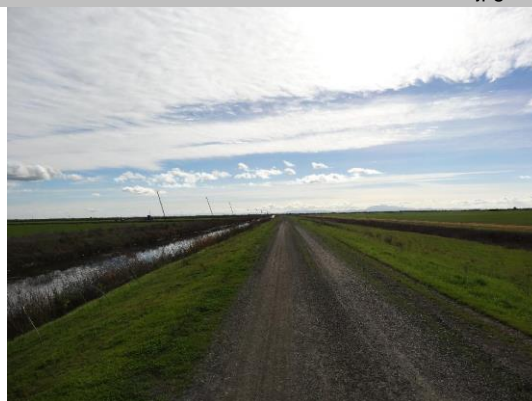
Photo 1 of 1 : UCIP_FA_2019_53380_76889.jpg

Item	DRAFT DWR UCIP Field Study		38.344349°	38.344349°						
			-121.740794°	-121.740794°						
DWR ID	20995									
Comment Code										
Inspector Comment										
DS_ID:20995 FS_ID:53380 EP_NO: 17842 Repair Type: Non-Urgent Crossing Status: Found UCIP Comments: 10/2/2018 Crossing downgraded to Non-Urgent due to reclassification of gas lines. Need to contact owner to determine current status of crossing (D. Sanoski - DWR UCIP).12/22/2016 same as previous inspection crossing remains Urgent due to unknown status of gas line--no markers present. According to LMA representative, RD 2068 issued a permit for a gas line however, the current status of this line is unknown. Permit issued by RD 2068 is 20040903. Need to contact owner to determine status of crossing. Markers will need to be installed per Title 23. (O. Magana - DWR UCIP)03/19/2014 No markers found. Need to contact owner to determine status and location. (W. Wylie - DWR UCIP) FIELD_STRUCT_DESC: 3-inch gas line of an unknown material bored under the levee and the channel, approximately 37 feet below the crown. (3-inch natural gas line authorized under Permit No. 17842, 2004 - Castle Minerals, Inc.). FS Date: 10/2/2018 4:32:00 PM

View of levee crown and slopes through this section of the levee.

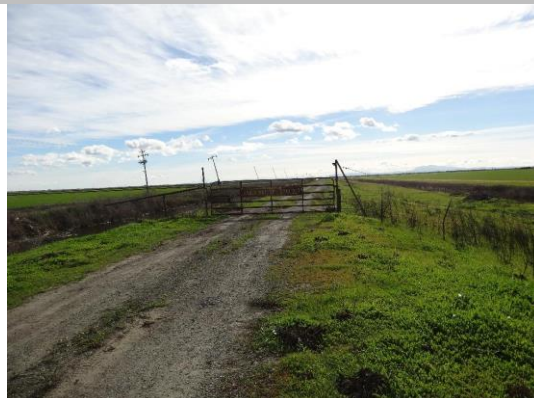
Photo 1 of 3 : UCIP_FA_2019_53381_76867.jpg

Comment Code						
Inspector Comment						
DS_ID:20989 FS_ID:53381 EP_NO: 11564 Repair Type: Urgent Crossing Status: Found UCIP Comments: 10/2/2018 Same as last inspection; remaining as Urgent and recommend internal pipe inspection (D. Sanoski - DWR UCIP).12/06/2016 Crossing has been upgraded from Non-Urgent to Urgent due to sections of the wall missing on the LS. Crossing is also opened on both WS and LS. According to Mr. Mike Hardesty, this crossing is not abandoned the crossing is out of service for now. Recommend internal integrity inspection and coordinating with CVFPB to comply with Title 23. (O. Magana - DWR UCIP)03/19/2014 Pipe appears abandoned and if so should be done so properly. Pipe rusted through at outlet in canal. This may indicate further degradation of pipe within the levee. Good candidate for video inspection. (W. Wylie - DWR UCIP) FIELD_STRUCT_DESC: 18-inch steel drainage pipe through the levee, 2 feet below the crown. Steel cutoff wall around the pipe at the center of the levee. Siphon breaker on the apex of the pipe located on the landside (LS) shoulder. Pump missing from steel pump pad over a 4-foot by 4-foot concrete sump located on the waterside (WS) toe. (18-inch pipe authorized under Permit No. 11564, 1976 - Reclamation District No. 2068). [Additional Reference(s): DWR Levee Log, 2003]. FS Date: 10/2/2018 4:33:00 PM

Overview of levee crown at multiple pipe crossings.

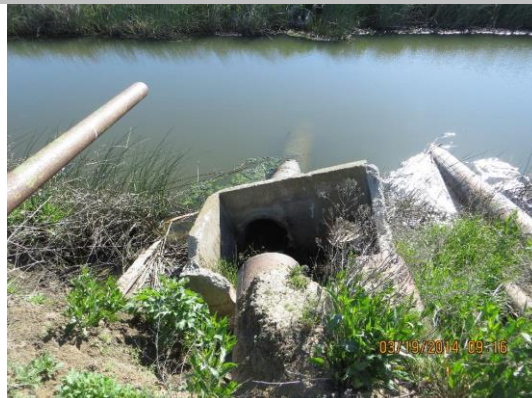
Photo 3 of 3 : UCIP_FA_2019_53382_58817.jpg

Comment Code						
Inspector Comment						
DS_ID:20990 FS_ID:53382 EP_NO: 5426-A Repair Type: Urgent Crossing Status: Found UCIP Comments: 10/2/2018 Same as last inspection; remaining as Urgent and recommend internal pipe inspection (D. Sanoski - DWR UCIP).12/06/2016 Crossing is opened on both WS and LS. Concrete box located on the LS has been removed. According to Mr. Mike Hardesty, this crossing is not abandoned the crossing is out of service for now. Recommend internal integrity inspection and coordinating with CVFPB to comply with Title 23. (O. Magana - DWR UCIP)03/19/2014 Pipe appears abandoned and if so should be done so properly. Foundation for concrete distribution box on LS toe at canal has failed. Box has fallen into canal and LS slope has erosion at same location. Pipe open on both ends. (W. Wylie - DWR UCIP) FIELD_STRUCT_DESC: 1 of 2: 18-inch coated steel drainage pipe through the levee, 3 feet below the crown. Vertical pump missing from steel platform over a 7-foot by 4-foot concrete box located on the waterside (WS) toe. Concrete cattle guard structure, 7 feet long, 15 feet wide, and 4 feet deep, located on the crown around the pipes. Discharge structure is located on the landside (LS) slope. (Permit No. 5426, 1966, and 5426-A, 1967 - Reclamation District No. 2068. Permit recordation indicates one 14-inch pipe and one 18-inch pipe to be installed). [Additional Reference(s): DWR Levee Log, 2003]. FS Date: 10/2/2018 4:51:00 PM

Concrete distribution box on LS slope has slipped into canal.

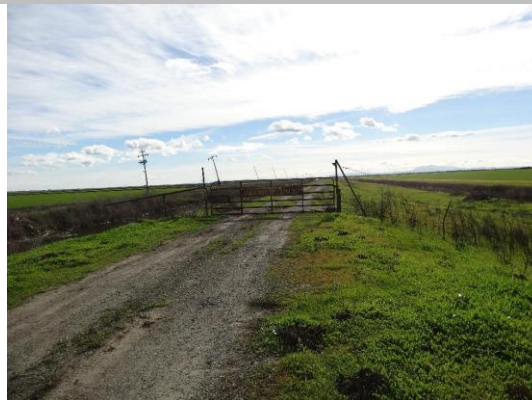
Photo 1 of 3 : UCIP_FA_2019_53383_76883.jpg

DS_ID:21013
FS_ID:53383
EP_NO: 5426-A
Repair Type: Urgent
Crossing Status: Found
UCIP Comments: 10/2/2018 Same as last inspection; remaining as Urgent and recommend internal pipe inspection (D. Sanoski - DWR UCIP). 12/06/2016 Crossing is opened on both WS and LS. Concrete box located on the LS has been removed. According to Mr. Mike Hardesty, this crossing is not abandoned the crossing is out of service for now. Recommend internal integrity inspection and coordinating with CVFPB to comply with Title 23. (O. Magana - DWR UCIP) 03/19/2014 Pipe appears abandoned and if so should be done so properly. Foundation for concrete distribution box on LS toe at canal has failed. Box has fallen into canal and LS slope has erosion at same location. Pipe open on both ends. (W. Wylie - DWR UCIP)
FIELD_STRUCT_DESC: 2 of 2: 18-inch coated steel drainage pipe through the levee, 3 feet below the crown. Vertical pumps missing from steel pad over a 7-foot by 4-foot concrete sump located on the waterside (WS) toe. Concrete cattle guard structure, 7 feet long, 15 feet wide, and 4 feet deep, located on the crown around the pipes. Discharge structure is located on the landside (LS) slope. (Permit No. 5426, 1966, and 5426-A, 1967 - Reclamation District No. 2068. Permit recordation indicates one 14-inch pipe and one 18-inch pipe to be installed). [Additional Reference(s): DWR Levee Log, 2003].

Overview of levee crown at multiple crossings.
