Flood Control Project Maintenance Levee Inspections

Fall 2023 Levee Maintenance Deficiency Summary Report

Sacramento River Basin

Reclamation District No. 2098 Cache and Haas Slough

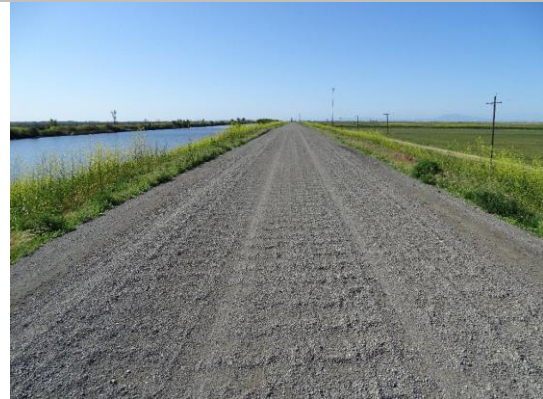
Photo 1 of 3 : UCIP_FA_2023_74264_111252.jpg

Comment Code						
Inspector Comment						
DS_ID:20997 FS_ID:74264 EP_NO: N/A Repair Type: Non-Urgent EVAL Issue: Crossing Status: Not Found UCIP Comments: 04/12/2022 Record remains Non-Urgent. Geophysical results did not confirm presence of pipe through levee. Record will remain in UCIP's inspection records until future Levee Improvement Project can confirm no crossing was found through the levee. System Feature. (D.Sanoski - DWR UCIP) FIELD_STRUCT_DESC: 42-inch drainage pipe of an unknown material through the levee, 21 feet below the crown. [Additional Reference(s): USACE Sacramento O&M Manual 109, April 1962, (HLM 0.69)]. FS Date: 4/12/2022 10:30:41 AM

View of levee crown.

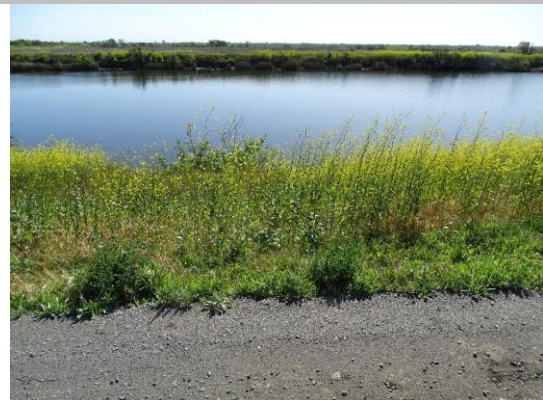
Photo 2 of 3 : UCIP_FA_2023_74264_111251.jpg

View of WS slope.

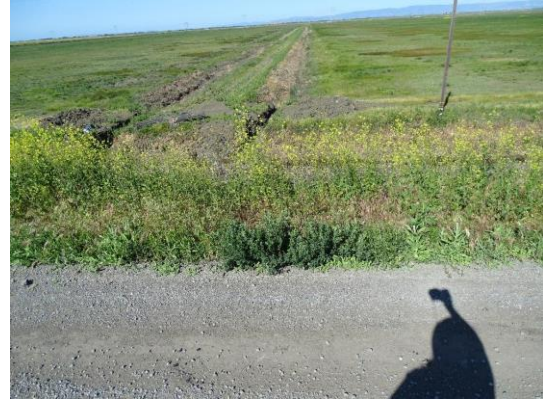
Photo 3 of 3 : UCIP_FA_2023_74264_111253.jpg

View of LS slope.

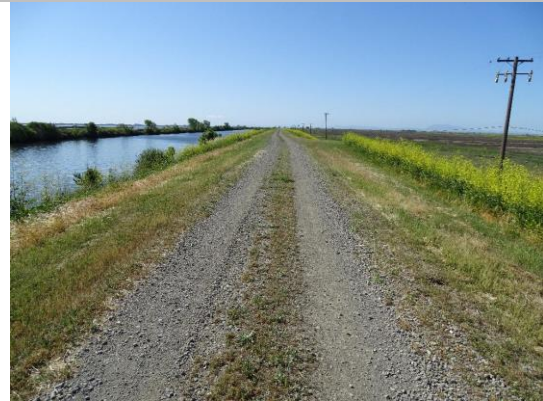
Photo 1 of 3 : UCIP_FA_2023_74544_111287.jpg

Comment Code						
Inspector Comment						
DS_ID:20965 FS_ID:74544 EP_NO: 10168 Repair Type: Non-Urgent EVAL Issue: 6, Levee Damage or Threat for Levee Damage Crossing Status: Found UCIP Comments: 04/12/2022 Record remains Non-Urgent. Threat for levee damage with same erosion under pipe at WS toe. System Feature. (D.Sanoski - DWR UCIP) 12/22/2016 Met with Mike Hadesty, LMA Superintendent, and Brian Bush, LMA General Manager, to go over the list of pipes in RD2098. Per LMA records, this pipe has a different owner. (O. Magana - DWR UCIP) 03/18/2014 Erosion under pipe at WS toe. (W. Wylie - DWR UCIP) FIELD_STRUCT_DESC: 10-inch steel drainage pipe through the levee, 2.8 feet below the crown. Pump in pump house off the landside (LS). (This pipe was retained under Automatic Board Order (ABO) issued as Permit No. 10168, 1974 - Moresco Brothers). [Additional Reference(s): DWR Levee Log, 2003. USACE Sacramento O&M Manual 109, April 1962, (HLM 1.80)]. FS Date: 4/12/2022 12:51:06 PM

View of levee crown.

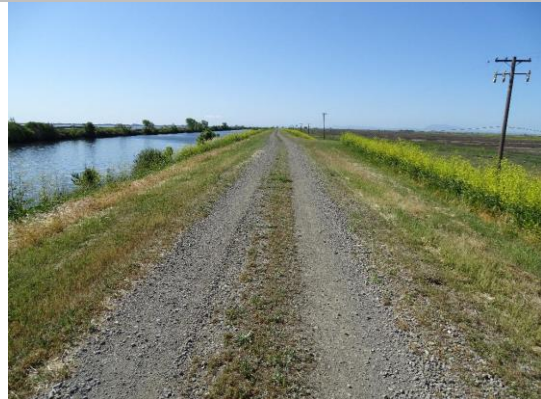
Photo 1 of 3 : UCIP_FA_2023_74545_111292.jpg

Comment Code						
Inspector Comment						
DS_ID:20998 FS_ID:74545 EP_NO: N/A Repair Type: Non-Urgent EVAL Issue: Crossing Status: Not Found UCIP Comments: 04/12/2022 Record remains Non-Urgent. Geophysical results did not confirm presence of pipe through levee. Record will remain in UCIP's inspection records until future Levee Improvement Project can confirm no crossing was found through the levee. System Feature. (D.Sanoski - DWR UCIP) FIELD_STRUCT_DESC: 18-inch drainage pipe of an unknown material through the levee, 24.5 feet below the crown. Slide gate on the waterside (WS). [Additional Reference(s): USACE Sacramento O&M Manual 109, April 1962, (HLM 1.81)]. FS Date: 4/12/2022 12:51:27 PM

View of levee crown.

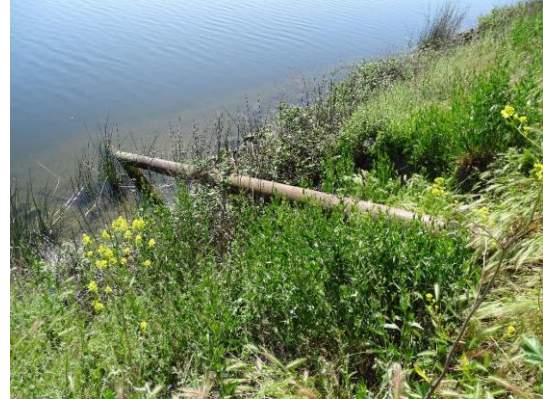
Photo 3 of 3 : UCIP_FA_2023_74545_111295.jpg

View of WS slope.

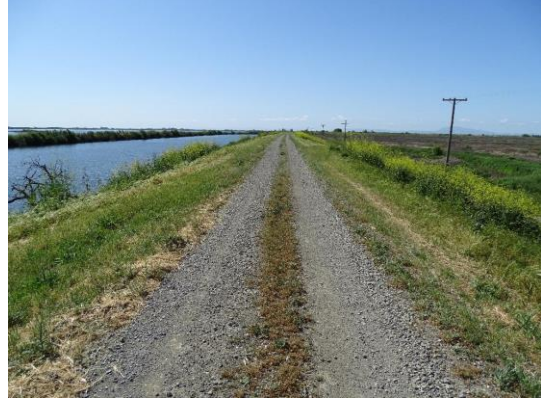
Photo 1 of 3 : UCIP_FA_2023_74561_111323.jpg

Comment Code					
Inspector Comment					
DS_ID:20999					
FS_ID:74561					
EP_NO: N/A					
Repair Type: Non-Urgent					
EVAL Issue:					
Crossing Status: Not Found					
UCIP Comments: 04/12/2022 Record remains Non-Urgent. Geophysical results did not confirm presence of pipe through levee. Record will remain in UCIP's inspection records until future Levee Improvement Project can confirm no crossing was found through the levee. System Feature. (D.Sanoski - DWR UCIP)					
FIELD_STRUCT_DESC: 42-inch drainage pipe of an unknown material through the levee, 19.3 feet below the crown. Flap gate on the waterside (WS). [Additional Reference(s): USACE Sacramento O&M Manual 109, April 1962, (HLM 2.75)].					
FS Date: 4/12/2022 12:52:52 PM

View of levee crown.

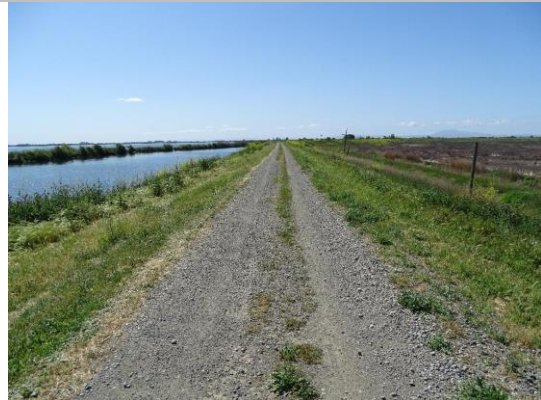
Photo 1 of 3 : UCIP_FA_2023_74562_111326.jpg

Comment Code					
Inspector Comment					
DS_ID:20969 FS_ID:74562 EP_NO: 13222 Repair Type: Non-Urgent EVAL Issue: 5, Pipe Damage Crossing Status: Found UCIP Comments: 04/12/2022 Record remains Non-Urgent. Pipe rusted out on WS slope at toe. (D.Sanoski - DWR UCIP) 03/18/2014 Pipe rusted through at outlet on WS slope, may indicate further degradation of pipe within levee. Good candidate for video inspection. (W. Wylie - DWR UCIP) FIELD_STRUCT_DESC: 20-inch steel drainage pipe through the levee, 7.5 feet below the crown. Siphon breaker on the waterside (WS) shoulder. Pump on pile structure in drainage ditch on the landside (LS). (This pipe was retained under Automatic Board Order (ABO) issued as Permit No. 10168, 1974 - Moresco Brothers. Pipe removed and replaced with a 19-inch steel pipe under the crown and along the LS slope under Permit No. 13222, 1981 - Prudential Insurance Company of America). [Additional Reference(s): DWR Levee Log, 2003. USACE Sacramento O&M Manual 109, April 1962, (HLM 2.98)]. FS Date: 4/12/2022 12:53:15 PM

View of levee crown.

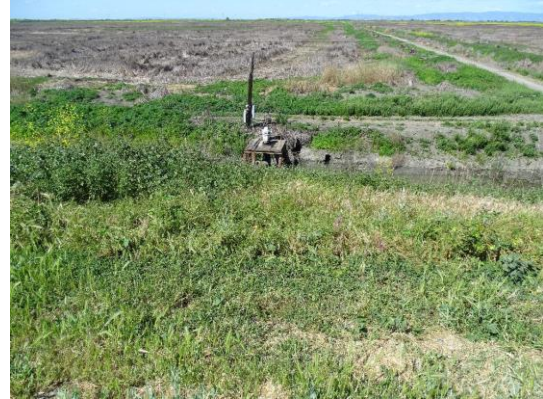
Photo 2 of 3 : UCIP_FA_2023_74562_111327.jpg

View of LS slope and pump on toe.

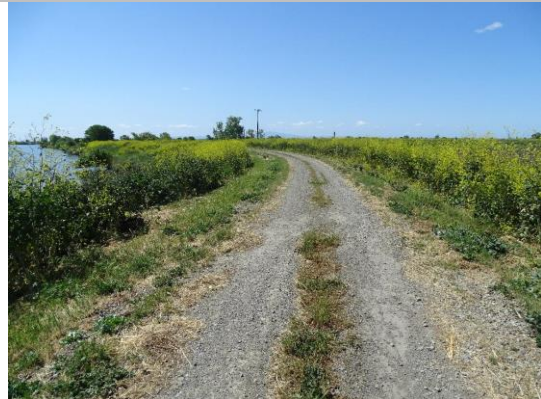
Photo 1 of 3 : UCIP_FA_2023_74573_111373.jpg

Comment Code					
Inspector Comment					
DS_ID:20959 FS_ID:74573 EP_NO: 15169 Repair Type: Non-Urgent EVAL Issue: 11, Maintenance Compliance Issue Crossing Status: Found UCIP Comments: 04/12/2022 Record remains Non-Urgent. Maintenance compliant issue with siphon breaker riser broken on WS shoulder. Otherwise, all good besides the overgrown vegetation, but looks like same conditions as last inspection. (D.Sanoski - DWR UCIP) 12/22/2016 Met with Mike Hadesty, LMA Superintendent, and Brian Bush, LMA General Manager, to go over the list of pipes in RD2098. Per LMA, pipe is a drainage pipe. New property owner is John Anderson. (O. Magana - DWR UCIP) 03/18/2014 Soil and debris buildup in steel riser on WS shoulder may prevent proper function of siphon breaker. (W. Wylie - DWR UCIP) FIELD_STRUCT_DESC: 2 of 2: 24-inch coated steel drainage pipe through the levee, 5.6 feet below the crown. Cutoff wall around the pipe at the center of the levee. Siphon breaker on the waterside (WS) shoulder. Flap gate on the WS end. Pump in pump house on piling structure on the landside (LS). (Permit No. 15169, 1989 - Maxim Development). [Additional Reference(s): DWR Levee Log, 2003]. FS Date: 4/12/2022 12:54:15 PM

View of levee crown.

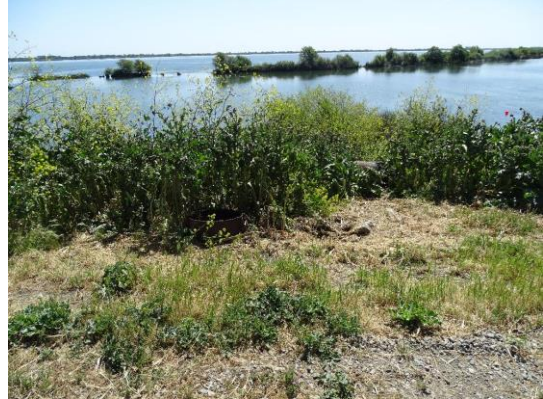
Photo 3 of 3 : UCIP_FA_2023_74573_111374.jpg

View of WS shoulder with siphon breaker.

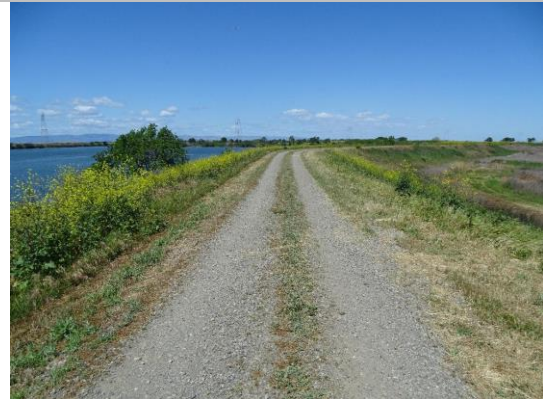
Photo 1 of 3 : UCIP_FA_2023_74580_111390.jpg

Comment Code					
Inspector Comment					
DS_ID:20974 FS_ID:74580 EP_NO: 10172 Repair Type: No Action Needed EVAL Issue: Crossing Status: Found UCIP Comments: 04/12/2022 Record remains No Action Needed. No issues observed during inspection except minor issue of half broken lid on riser. System Feature. (D.Sanoski - DWR UCIP) 12/22/2016 Met with Mike Hadesty, LMA Superintendent, and Brian Bush, LMA General Manager, to go over the list of pipes in RD2098. Per LMA, pipe is a drainage pipe. (O. Magana - DWR UCIP) FIELD_STRUCT_DESC: 24-inch corrugated metal drainage pipe through the levee, 21.5 feet below the crown. Two cutoff walls around the pipe at the levee shoulders. Slide gate in corrugated metal pipe (CMP) riser on the waterside (WS) slope. Flap gate and concrete U-shaped headwall on the landside (LS) end. (This pipe was retained under Automatic Board Order (ABO) issued as Permit No. 10172, 1974 - Moresco Brothers). [Additional Reference(s): DWR Levee Log, 2003. USACE Sacramento O&M Manual 109, April 1962, (HLM 6.21)]. FS Date: 4/12/2022 12:55:23 PM

View of levee crown.

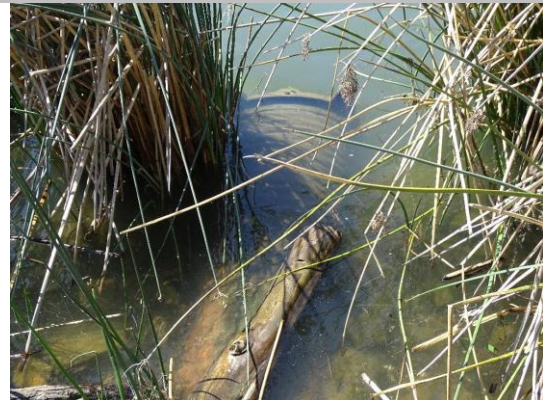
Photo 2 of 3 : UCIP_FA_2023_74580_111389.jpg

View of pipe with flap gate out of WS toe.

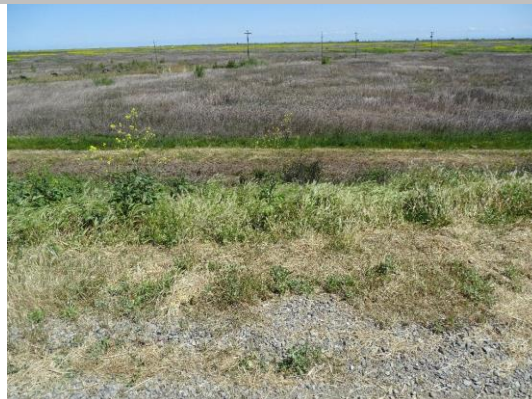
Photo 3 of 3 : UCIP_FA_2023_74580_111392.jpg

View of LS shoulder and slope.

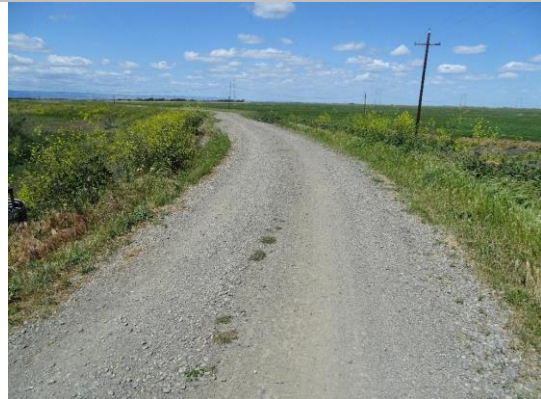
Photo 1 of 3 : UCIP_FA_2023_74585_111408.jpg

Comment Code					
Inspector Comment					
DS_ID:20976 FS_ID:74585 EP_NO: 10172 Repair Type: No Action Needed EVAL Issue: Crossing Status: Found UCIP Comments: 04/12/2022 Record updated from Non-Urgent to No Action Needed. No issues observed during inspection. WS toe too overgrown to see inlet, but appears same conditions as last inspection. System Feature. (D.Sanoski - DWR UCIP) 03/18/2014 Headwalls on WS toe failing at outlet. It is unclear if these were permanent installations or something that was installed as a temporary fix. (W. Wylie - DWR UCIP) FIELD_STRUCT_DESC: 1 of 2: 48-inch corrugated metal drainage pipe through the levee, 29 feet below the crown. Two slide gates in a 7-foot-diameter corrugated metal pipe (CMP) riser on the waterside (WS) slope. (two 48-inch [HLM 6.75] authorized under Automatic Board Order (ABO) issued as Permit No. 10172, 1974 - Moresco Brothers). [Additional Reference(s): DWR Levee Log, 2003. USACE Sacramento O&M Manual 109, April 1962, (HLM 6.75)]. FS Date: 4/12/2022 12:55:59 PM

View of levee crown.

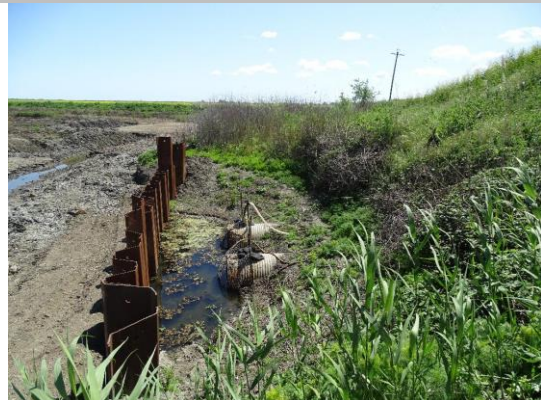
Photo 2 of 3 : UCIP_FA_2023_74585_111406.jpg

View of pipe out of LS slope with metal retaining wall.

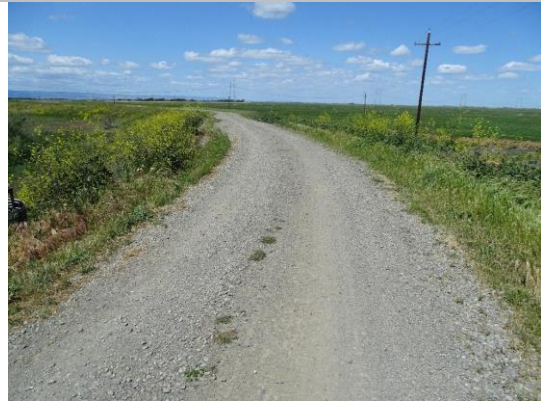
Photo 1 of 3 : UCIP_FA_2023_74586_111417.jpg

DS_ID:20961
 FS_ID:74586
 EP_NO: 10172
 Repair Type: No Action Needed
 EVAL Issue:
 Crossing Status: Found
 UCIP Comments: 04/12/2022 Record updated from Non-Urgent to No Action Needed. No issues observed during inspection. WS too overgrown to see WS toe completely, but appears same as last inspection. System Feature. (D.Sanoski - DWR UCIP)
 03/18/2014 Headwalls at WS toe failing. It is uncertain if these retaining walls were a permanent fixture or a temporary fix that failed. (W. Wylie - DWR UCIP)
 FIELD_STRUCT_DESC: 2 of 2: 48-inch corrugated metal drainage pipe through the levee, 29 feet below the crown. Two slide gates in a 7-foot-diameter corrugated metal pipe (CMP) riser on the waterside (WS) slope. (two 48-inch pipes [HLM 6.75] authorized under Automatic Board Order (ABO) issued as Permit No. 10172, 1974 - Moresco Brothers).
 [Additional Reference(s): DWR Levee Log, 2003. USACE Sacramento O&M Manual 109, April 1962, (HLM 6.75)].

View of levee crown.

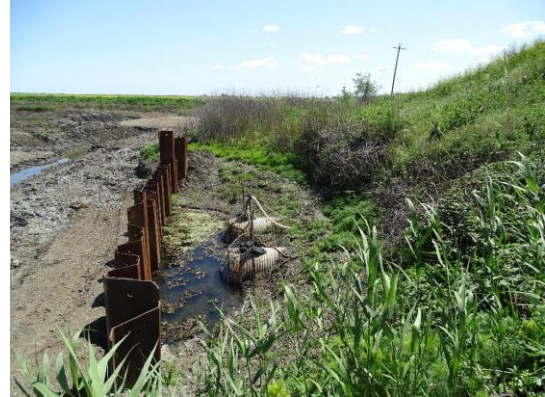
Photo 2 of 3 : UCIP_FA_2023_74586_111420.jpg

View of pipe out of LS slope with metal retaining wall.

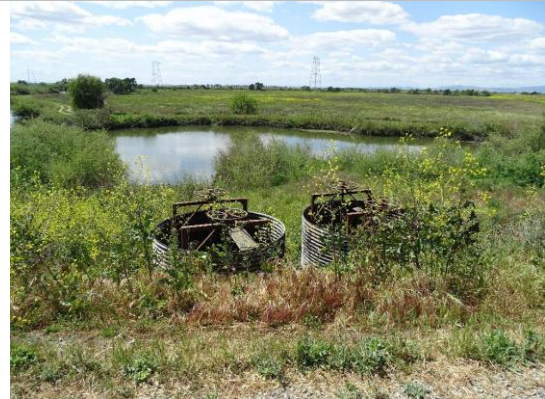
Photo 3 of 3 : UCIP_FA_2023_74586_111418.jpg

View of WS shoulder with CMP riser on slope.

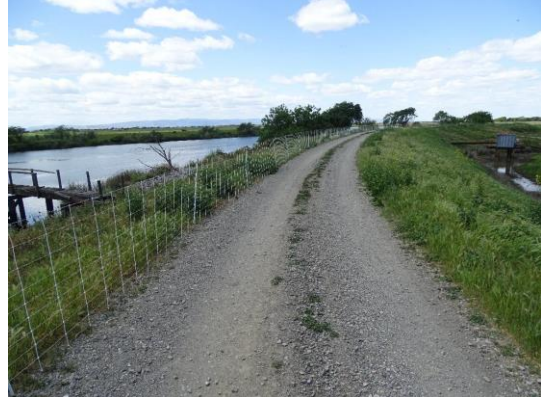
Photo 1 of 3 : UCIP_FA_2023_74588_111422.jpg

Comment Code					
Inspector Comment					
DS_ID:20977 FS_ID:74588 EP_NO: 10171 Repair Type: Non-Urgent EVAL Issue: Crossing Status: Found UCIP Comments: 04/12/2022 Record remains Non-Urgent. Crossing appears abandoned. System Feature. (D.Sanoski - DWR UCIP) (D.Sanoski - DWR UCIP) 12/22/2016 Met with Mike Hadesty, LMA Superintendent, and Brian Bush, LMA General Manager, to go over the list of pipes in RD2098. Per LMA, pipe is a drainage pipe.(O. Magana - DWR UCIP) 03/18/2014 Pipe appears to be abandoned and if so it should be done so properly. Walkway to gate valve actuator on WS slope is in disrepair and does not appear to be safe for use. (W. Wylie - DWR UCIP) FIELD_STRUCT_DESC: 36-inch corrugated metal drainage pipe through the levee, 23 feet below the crown. Walkway to slide gate on the waterside (WS) end. Slide gate at the landside (LS) toe. (This pipe was retained under Automatic Board Order (ABO) issued as Permit No. 10171, 1974 - Glenn A. Bowlsbey). [Additional Reference(s): DWR Levee Log, 2003. USACE Sacramento O&M Manual 109, April 1962, (HLM 7.23)]. FS Date: 4/12/2022 12:56:49 PM

View of levee crown.

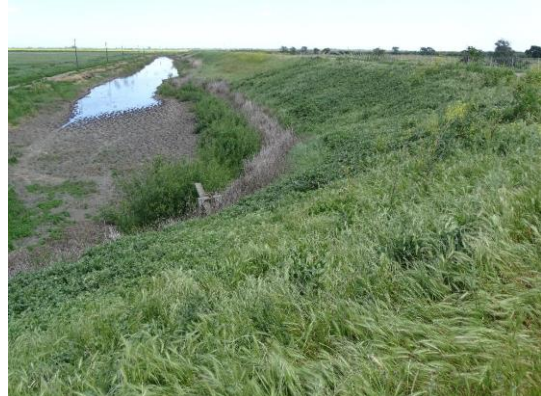
Photo 2 of 3 : UCIP_FA_2023_74588_111425.jpg

View of LS slope and slide gate on toe.

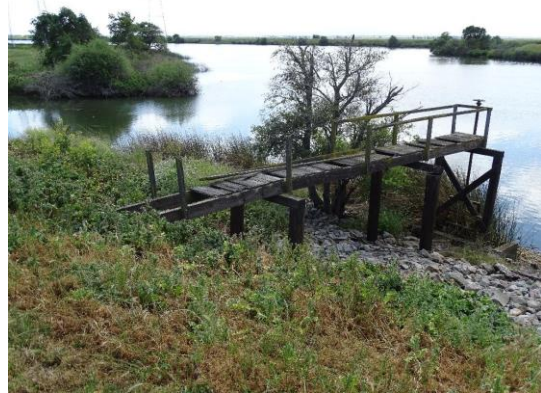
Photo 3 of 3 : UCIP_FA_2023_74588_111424.jpg

View of WS slope and abandoned walkway.

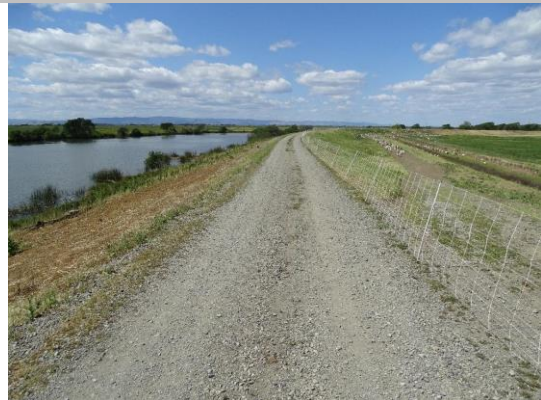
Photo 1 of 3 : UCIP_FA_2023_74595_111444.jpg

Comment Code						
Inspector Comment						
DS_ID:21000 FS_ID:74595 EP_NO: N/A Repair Type: Non-Urgent EVAL Issue: Crossing Status: Not Found UCIP Comments: 04/12/2022 Record updated from No Action Needed to Non-Urgent. Geophysical results did not confirm presence of pipe through levee. Record will remain in UCIP's inspection records until future Levee Improvement Project can confirm no crossing was found through the levee. System Feature. (D.Sanoski - DWR UCIP) FIELD_STRUCT_DESC: 36-inch drainage pipe of an unknown material through the levee, 23 feet below the crown. Slide gate on the waterside (WS). [Additional Reference(s): USACE Sacramento O&M Manual 109, April 1962, (HLM 7.43)]. FS Date: 4/12/2022 12:58:18 PM

View of levee crown.

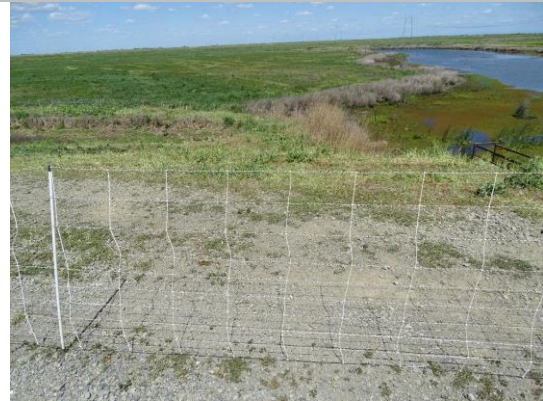
Photo 2 of 3 : UCIP_FA_2023_74595_111443.jpg

LM Start	7.40	Rating **	M	Issue No.	14 (cont)
LM End	7.40	Issue Type +	Ma	Location *	
Category	Supplemental		GPS Latitude/Longitude		
			Start	End	
Item	DWR UCIP LMA Responsibility		38.295755°	38.295755°	
			-121.726123°	-121.726123°	
DWR ID	21000

View of LS slope.

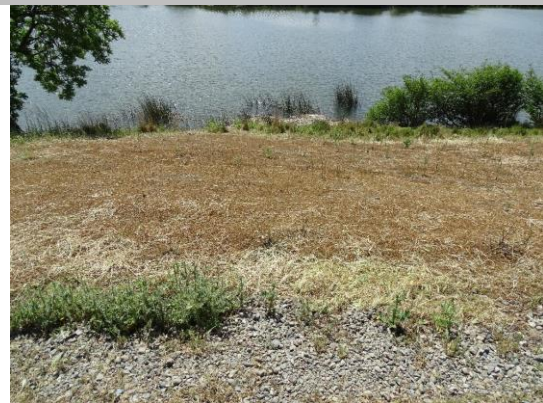
Photo 3 of 3 : UCIP_FA_2023_74595_111442.jpg

LM Start	7.40	Rating **	M	Issue No.	14 (cont)
LM End	7.40	Issue Type +	Ma	Location *

View of WS slope.

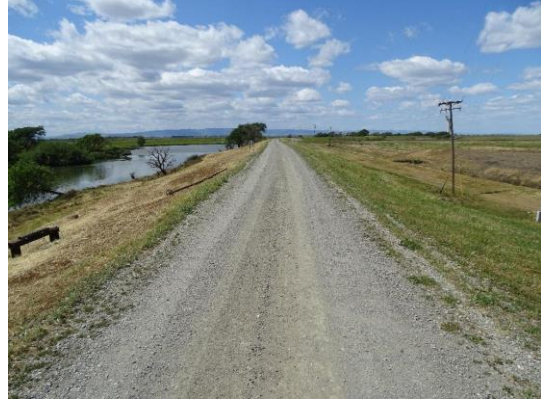
Photo 1 of 3 : UCIP_FA_2023_74598_111454.jpg

Comment Code						
Inspector Comment						
<p>DS_ID:20981 FS_ID:74598 EP_NO: 10174 Repair Type: Non-Urgent EVAL Issue: Crossing Status: Found UCIP Comments: 04/12/2022 Record updated from No Action Needed to Non-Urgent. Crossing appears abandoned per Superintendent Bryce Hall per Lookout Slough Rehabilitation Project. System Feature. (D.Sanoski - DWR UCIP) 12/22/2016 Crossing has been downgraded from Urgent to No Action Needed walkways on both WS and LS have been rebuilt and the WS gate has been upgraded to stainless steel where previous corrodable material was present. (O. Magana - DWR UCIP)03/19/2014 Current walkway to slidegate on WS toe does not provide safe access to operate slidegate. (W. Wylie - DWR UCIP) FIELD_STRUCT_DESC: 36-inch steel dual-purpose irrigation and drainage pipe through the levee, 26 feet below the crown. Two corrugated metal cutoff walls around the pipe. Walkway to the slide gate on the waterside (WS) end. Combination slide and flap gate on the landside (LS) end. 48-inch corrugated metal pipe (CMP) riser and an adjoining pump on a metal pier at the LS toe. (36-inch pipe [HLM 8.20] authorized under Automatic Board Order (ABO) issued as Permit No. 10174, 1974 - Glen A. Bowsbey). [Additional Reference(s): DWR Levee Log, 2003. USACE Sacramento O&M Manual 109, April 1962, (HLM 8.20)]. FS Date: 4/12/2022 1:01:14 PM</p>

View of levee crown.

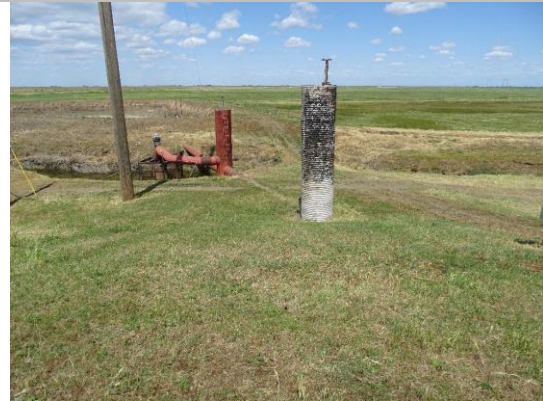
Photo 3 of 3 : UCIP_FA_2023_74598_111456.jpg

LM Start	8.16	Rating **	M	Issue No.	15 (cont)
LM End	8.16	Issue Type +	Ma	Location *	
Category	Supplemental		GPS Latitude/Longitude		
			Start	End	
Item	DWR UCIP LMA Responsibility		38.305462°	38.305462°	
			-121.728881°	-121.728881°	
DWR ID	20981

View of LS slope and toe.

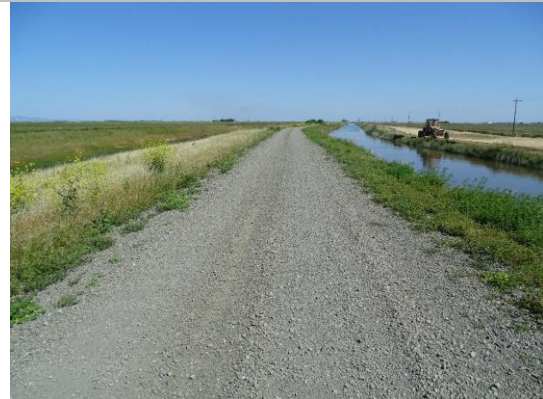
Photo 1 of 3 : UCIP_FA_2023_74679_111675.jpg

Comment Code						
Inspector Comment						
DS_ID:20996						
FS_ID:74679						
EP_NO: 13126						
Repair Type: Non-Urgent						
EVAL Issue: 6, Levee Damage or Threat for Levee Damage						
Crossing Status: Found						
UCIP Comments: 04/28/2022 Record updated from No Action Needed						
to Non-Urgent. Threat for levee damage- developing significant						
scour/erosion on LS slope around pipe exit from slope. (D.Sanoski -						
DWR UCIP)						
FIELD_STRUCT_DESC: 8-inch steel dual-purpose irrigation and						
drainage pipe through the levee, 4 feet below the crown. Steel cutoff						
wall around the pipe at the center of the levee. Pump and siphon						
breaker on the landside (LS) of the Reclamation District No. 2068 canal.						
Pipe exposed across canal. Pipe encased in 5 inches of cement slurry						
under the crown. (Permit No. 13126, 1981 - Edward S. Wineman).						
FS Date: 4/28/2022 1:24:25 PM

View of levee crown.

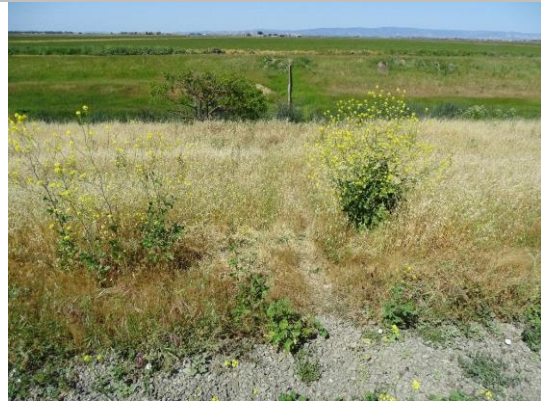
Photo 3 of 3 : UCIP_FA_2023_74679_111677.jpg

LM Start	10.56	Rating **	M	Issue No.	16 (cont)
LM End	10.56	Issue Type +	En	Location *	
Category	Supplemental			GPS Latitude/Longitude	
				Start	End
Item	DWR UCIP Field Study			38.336199°	38.336199°
				-121.740705°	-121.740705°
DWR ID	20996

View of WS slope with pipe in distance.

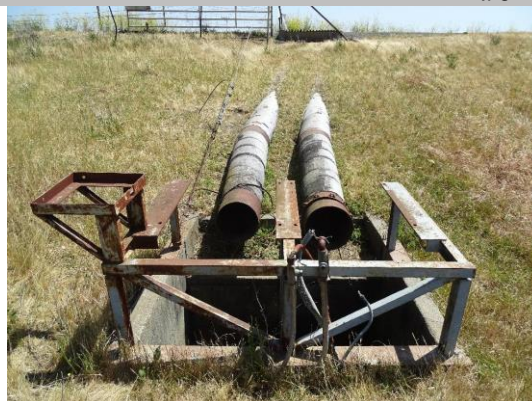
Photo 2 of 3 : UCIP_FA_2023_74695_111743.jpg

LM Start	12.05	Rating **	U	Issue No.	18 (cont)
LM End	12.05	Issue Type +	En	Location *	
Category	Supplemental		GPS Latitude/Longitude		
			Start	End	
Item	DWR UCIP Field Study		38.357863 °	38.357863 °	
			-121.740394 °	-121.740394 °	
DWR ID	20990

View of pipe out of WS slope into distribution box.

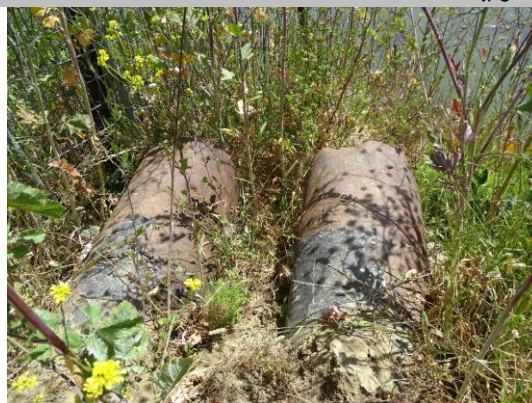
Photo 3 of 3 : UCIP_FA_2023_74695_111747.jpg

LM Start	12.05	Rating **	U	Issue No.	18 (cont)
LM End	12.05	Issue Type +	En	Location *

View of pipe out of LS slope.
