**Flood Control Project Maintenance
Levee Inspections****LMA District Cover Sheet
Spring 2016 Levee Inspection Results****Reclamation District No. 2098 Cache and Haas Slough**

Spring 2016 Levee Inspection Results

Reclamation District No. 2098 Cache and Haas Slough

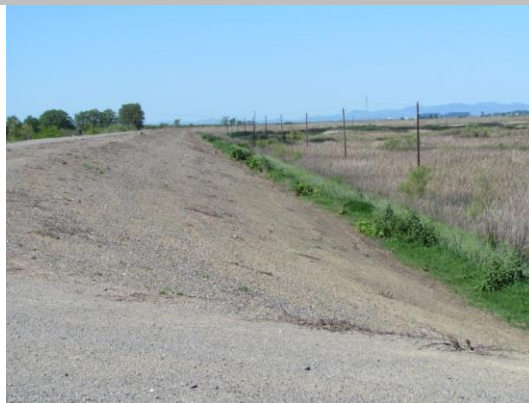
Photo 1 of 1 : SP_2016_RD2098_245_2_20160511_00003.jpg

LM Start	0.00	Rating **	A/W	Issue No.	2
LM End	0.52	Issue Type +	Ma	Location *	LS
Category	Earthen Levee			GPS Latitude/Longitude	
				Start	End
Item	Vegetation			38.277392 °	38.275692 °
				-121.696303 °	-121.705667 °
DWR ID	DWR_RD2098_01A_f_2015_2				
Comment Code					
V1 : Control annual grass and weeds on the levee slopes and easements.					
Inspector Comment					
Slopes are maintained.

RD 2098 Unit 1A looking downstream of the landside slope levee mile 0.52.

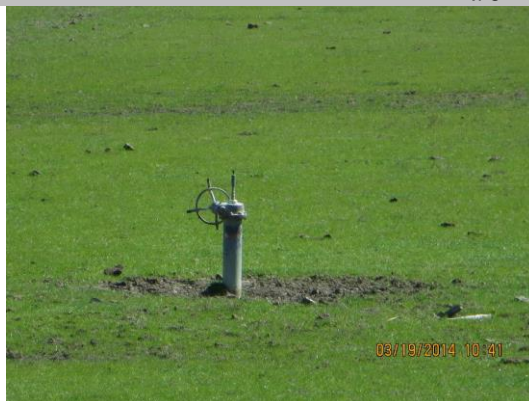
Photo 2 of 2 : UCIP_SP_2016_32383_58880.jpg

LM Start	9.49	Rating **	M	Issue No.	23 (cont)
LM End	9.49	Issue Type +	En	Location *	WS

Shutoff valve visible 370-feet off LS toe.

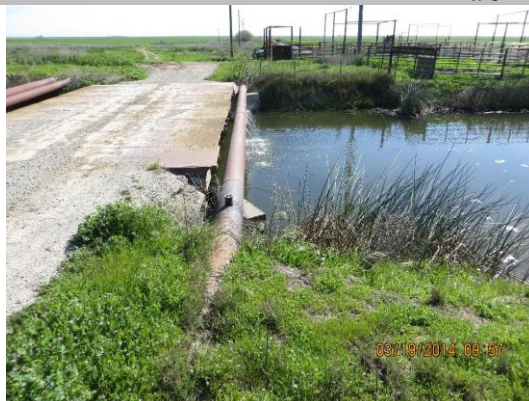
Photo 1 of 2 : UCIP_SP_2016_32403_58905.jpg

LM Start	11.07	Rating **	M	Issue No.	24
LM End	11.07	Issue Type +	En	Location *	WS
Category	Supplemental			GPS Latitude/Longitude	
				Start	End
Item	DWR UCIP Field Study			38.343608 °	38.343608 °
				-121.740836 °	-121.740836 °
DWR ID					
Comment Code					
Inspector Comment					
FS_ID:32403					
DS_ID:20991					
EP_NO: 12851					
Repair Type: Non-Urgent					
Crossing Status: Found					
UCIP Comments: Holes in pipe next to rail car bridge may indicate further deterioration of pipe through levee. Good candidate for video inspection.					
FIELD_STRUCT_DESC: 12-inch steel irrigation pipe through the levee, 2-feet below the crown. Cutoff wall around pipe at center of levee.					
Siphon breaker on Landside toe at canal. 1-inch PVC electrical conduit at same location (Permit No. 12851-1980)					
FS Date: 3/19/2014

Pipe and siphon breaker visible on LS at canal crossing.

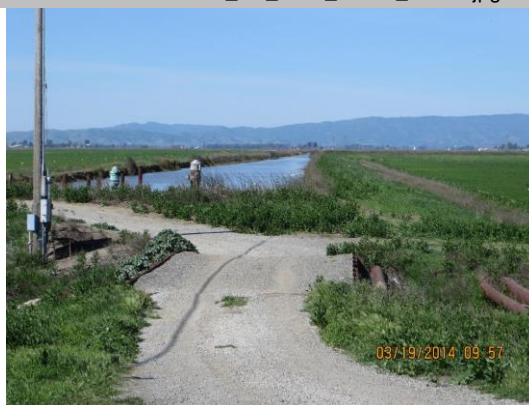
Photo 2 of 2 : UCIP_SP_2016_32403_58904.jpg

LM Start	11.07	Rating **	M	Issue No.	24 (cont)
LM End	11.07	Issue Type +	En	Location *	WS

Pump on pier in irrigation canal off WS toe.

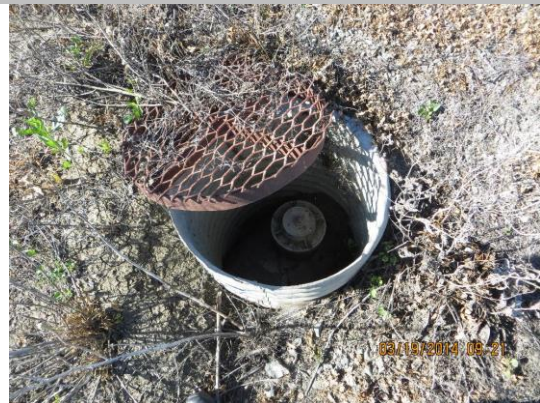
Photo 1 of 2 : UCIP_SP_2016_32327_58822.jpg

LM Start	12.05	Rating **	M	Issue No.	21	
LM End	12.05	Issue Type +	En	Location *	WS	
Category	Supplemental			GPS Latitude/Longitude		
				Start		End
Item	DWR UCIP Field Study			38.357841 °		38.357841 °
				-121.740396 °		-121.740396 °
DWR ID						
Comment Code						
Inspector Comment						
FS_ID:32327 DS_ID:20989 EP_NO: 11564 Repair Type: Non-Urgent Crossing Status: Found UCIP Comments: Pipe appears abandoned and if so should be done so properly. Pipe rusted through at outlet in canal. This may indicate further degradation of pipe within the levee. Good candidate for video inspection. FIELD_STRUCT_DESC: 18-inch steel drain pipe through the levee, 2.0 feet below the crown. Steel cutoff wall around pipe at center of levee. Siphon breaker on apex of pipe at LS shoulder. Pump missing from steel pump pad over 4'X4' concrete sump at WS toe (Permit No. 11564-1976). FS Date: 3/19/2014

Siphon breaker in CMP riser on LS shoulder.

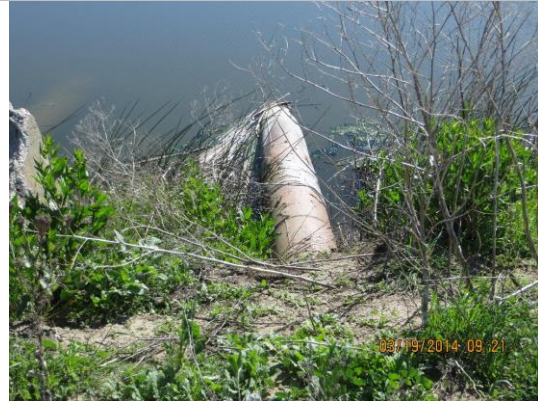
Photo 2 of 2 : UCIP_SP_2016_32327_58821.jpg

LM Start	12.05	Rating **	M	Issue No.	21 (cont)
LM End	12.05	Issue Type +	En	Location *	WS
Category	Supplemental			GPS Latitude/Longitude	
				Start	End
Item	DWR UCIP Field Study			38.357841 °	38.357841 °
				-121.740396 °	-121.740396 °
DWR ID					
Comment Code					
Inspector Comment					
FS_ID:32327 DS_ID:20989 EP_NO: 11564 Repair Type: Non-Urgent Crossing Status: Found UCIP Comments: Pipe appears abandoned and if so should be done so properly. Pipe rusted through at outlet in canal. This may indicate further degradation of pipe within the levee. Good candidate for video inspection. FIELD_STRUCT_DESC: 18-inch steel drain pipe through the levee, 2.0 feet below the crown. Steel cutoff wall around pipe at center of levee. Siphon breaker on apex of pipe at LS shoulder. Pump missing from steel pump pad over 4'X4' concrete sump at WS toe (Permit No. 11564-1976). FS Date: 3/19/2014

Pipe at canal on LS toe.

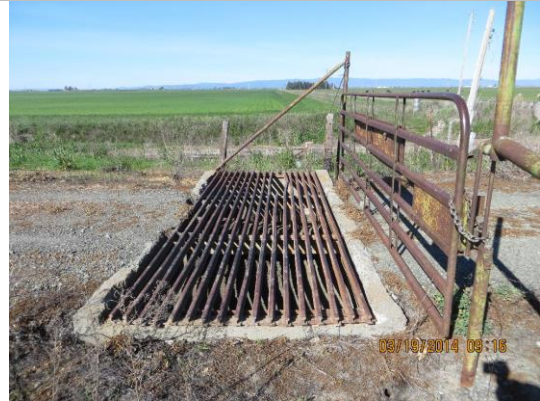
Photo 2 of 2 : UCIP_SP_2016_32326_58816.jpg

Item	DWR UCIP Field Study			38.357863 °		38.357863 °
				-121.740394 °		-121.740394 °
DWR ID						
Comment Code						
Inspector Comment						
FS_ID:32326						
DS_ID:20990						
EP_NO: 5426-A						
Repair Type: Urgent						
Crossing Status: Found						
UCIP Comments: Pipe appears abandoned and if so should be done so properly. Foundation for concrete distribution box on LS toe at canal has failed. Box has fallen into canal and LS slope has erosion at same location. Pipe open on both ends.						
FIELD_STRUCT_DESC: 1 of 2: 18-inch steel drainpipe through the levee, 3.0 feet below the crown. Vertical pump missing from steel platform over 7'X4' concrete box on WS toe. Concrete cattle guard structure (7x15x4 foot) on crown around pipes. Discharge structure on landward slope. (Permit No. 5426A-1967)						
FS Date: 3/19/2014

Concrete cattle guard box over pipes at crown.

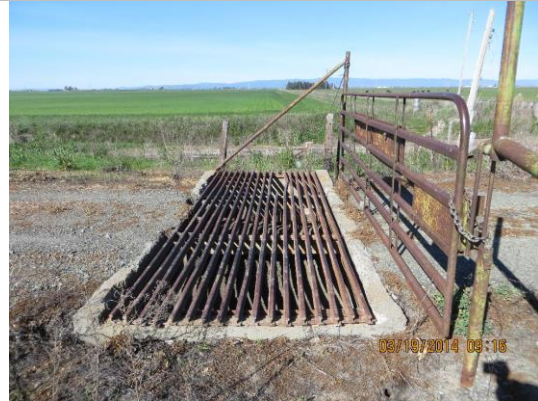
Photo 2 of 2 : UCIP_SP_2016_32325_58811.jpg

Item	DWR UCIP Field Study			38.357870 °		38.357870 °
				-121.740396 °		-121.740396 °
DWR ID						
Comment Code						
Inspector Comment						
FS_ID:32325 DS_ID:21013 EP_NO: 5426-A Repair Type: Urgent Crossing Status: Found UCIP Comments: Pipe appears abandoned and if so should be done so properly. Foundation for concrete distribution box on LS toe at canal has failed. Box has fallen into canal and LS slope has erosion at same location. Pipe open on both ends. FIELD_STRUCT_DESC: 2 of 2: 18-inch steel drainpipe through the levee, 3.0 feet below the crown. Vertical pumps missing from steel pad over 7'X4' concrete sump on WS toe. Concrete cattle guard structure (7x15x4 foot) on crown around pipes. Discharge structure on landward slope. (Permit No. 5426A-1967) FS Date: 3/19/2014

Concrete cattle guard over pipe on crown.

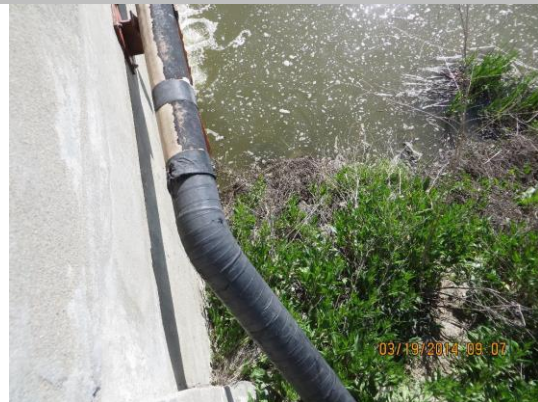
Photo 1 of 2 : UCIP_SP_2016_32566_59110.jpg

LM Start	12.07	Rating **	M	Issue No.	22
LM End	12.07	Issue Type +	En	Location *	WS
Category	Supplemental			GPS Latitude/Longitude	
				Start	End
Item	DWR UCIP Field Study			38.358110 °	38.358110 °
				-121.740381 °	-121.740381 °
DWR ID					
Comment Code					
Inspector Comment					
FS_ID:32566 DS_ID:24845 EP_NO: N/A Repair Type: Non-Urgent Crossing Status: Found UCIP Comments: Need to verify status with gas company and install signs. No permit identified for crossing, though it may be connected to a permitted line installed in RD 2068 under Permit No. 13490. FIELD_STRUCT_DESC: 6-inch steel gasoline through the levee 3-feet below the crown. Signs on East side of levee. Pipe visible on downstream side of roadway bridge. FS Date: 3/19/2014

Pipe visible on South side of Bridge at Swan Road.

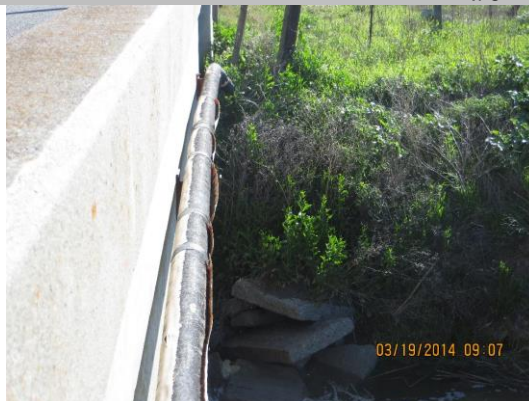
Photo 2 of 2 : UCIP_SP_2016_32566_59109.jpg

LM Start	12.07	Rating **	M	Issue No.	22 (cont)
LM End	12.07	Issue Type +	En	Location *	WS
Category	Supplemental			GPS Latitude/Longitude	
				Start	End
Item	DWR UCIP Field Study			38.358110 °	38.358110 °
				-121.740381 °	-121.740381 °
DWR ID					
Comment Code					
Inspector Comment					
FS_ID:32566					
DS_ID:24845					
EP_NO: N/A					
Repair Type: Non-Urgent					
Crossing Status: Found					
UCIP Comments: Need to verify status with gas company and install signs. No permit identified for crossing, though it may be connected to a permitted line installed in RD 2068 under Permit No. 13490.					
FIELD_STRUCT_DESC: 6-inch steel gasoline through the levee 3-feet below the crown. Signs on East side of levee. Pipe visible on downstream side of roadway bridge.					
FS Date: 3/19/2014

Pipe visible on South side of Bridge at Swan Road.
