**Flood Control Project Maintenance
Levee Inspections**
LMA District Cover Sheet
Spring 2017 Levee Inspection Results

Reclamation District No. 2098 Cache and Haas Slough

Spring 2017 Levee Inspection Results

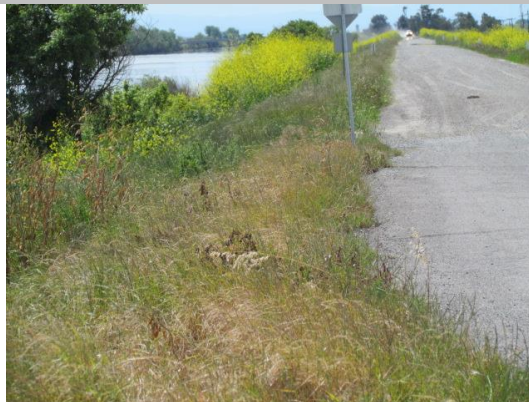
Photo 1 of 1 : SP_2017_RD2098_244_12_20170523_00023.jpg

LM Start	0.03	Rating **	U	Issue No.	12
LM End	3.58	Issue Type +	Ma	Location *	WS
Category	Earthen Levee			GPS Latitude/Longitude	
				Start	End
Item	Vegetation			38.328715 °	38.277708 °
				-121.694037 °	-121.696232 °
DWR ID	DWR_RD2098_01_s_2017_12				
Comment Code					
V2 : Remove the wild growth other than native grasses from the levee slopes.					
Inspector Comment

RD 2098 Unit 1 looking upstream from the waterside levee slope levee mile 0.03-3.58, tall unwanted mustard and weeds growth covering the levee slope.

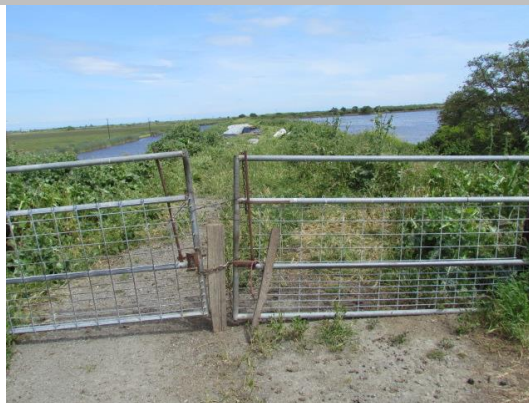
Photo 1 of 1 : SP_2017_RD2098_246_5_20170523_00034.jpg

LM Start	7.14	Rating **	U	Issue No.	5
LM End	7.14	Issue Type +	Ma	Location *	CR
Category	Earthen Levee			GPS Latitude/Longitude	
				Start	End
Item	Repair Gates			38.292962 °	38.292962 °
				-121.723312 °	-121.723312 °
DWR ID	DWR_RD2098_02_f_2013_5				
Comment Code					
Inspector Comment					
Gate damage, make repairs to this gate. This gate could cause injury to someone.

RD 2098 Levee mile 7.14.

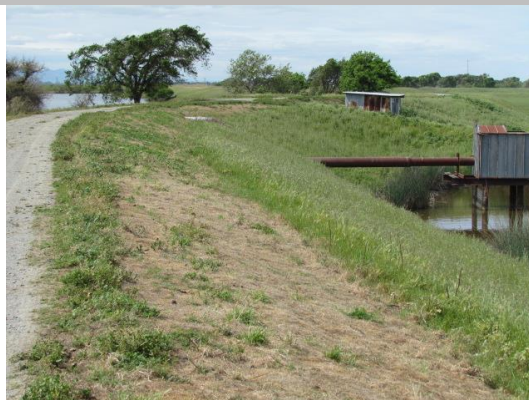
Photo 1 of 2 : SP_2017_RD2098_247_2_20170523_00011.jpg

LM Start	7.19	Rating **	U	Issue No.	2
LM End	7.31	Issue Type +	Ma	Location *	LS
Category	Earthen Levee			GPS Latitude/Longitude	
				Start	End
Item	Vegetation			38.293178 °	38.294705 °
				-121.724220 °	-121.725130 °
DWR ID	DWR_RD2098_03_f_2016_2				
Comment Code					
V2 : Remove the wild growth other than native grasses from the levee slopes.					
Inspector Comment					
Remove the tall vegetation from the landside slope.

RD 2098 Looking downstream from levee mile 7.19-7.31

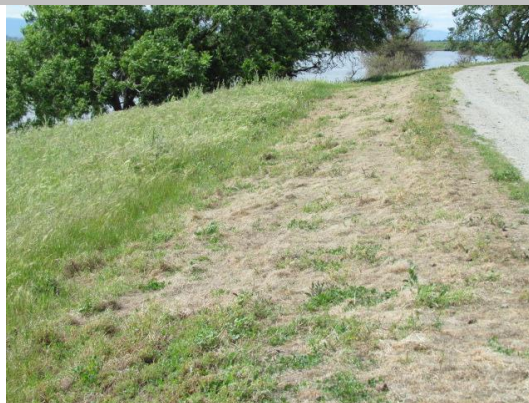
Photo 1 of 1 : SP_2017_RD2098_247_8_20170523_00012.jpg

LM Start	7.19	Rating **	U	Issue No.	8
LM End	7.31	Issue Type +	Ma	Location *	WS
Category	Earthen Levee			GPS Latitude/Longitude	
				Start	End
Item	Vegetation			38.293178 °	38.294705 °
				-121.724215 °	-121.725133 °
DWR ID	DWR_RD2098_03_f_2016_8				
Comment Code					
V2 : Remove the wild growth other than native grasses from the levee slopes.					
Inspector Comment					
Remove the tall vegetation from the water side slope.

RD 2098 Unit 3 levee mile 7.19-7.31 waterside slope.

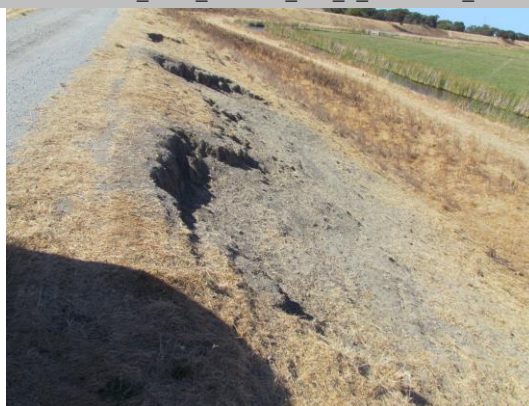
Photo 1 of 2 : SP_2017_RD2098_247_1_20170404_00002.jpg

LM Start	7.51	Rating **	U	Issue No.	1	
LM End	7.51	Issue Type +	Ma	Location *	LS	
Category	Earthen Levee			GPS Latitude/Longitude		
				Start		End
Item	Slope Stability			38.296846 °		38.296846 °
				-121.727546 °		-121.727546 °
DWR ID	DWR_RD2098_03_f_2016_1					
Comment Code						
S2 : Repair the levee slope damaged by foot traffic and prevent access where possible.						
Inspector Comment						
Make the repairs to the erosion site listed.

Close up. Looking downstream.

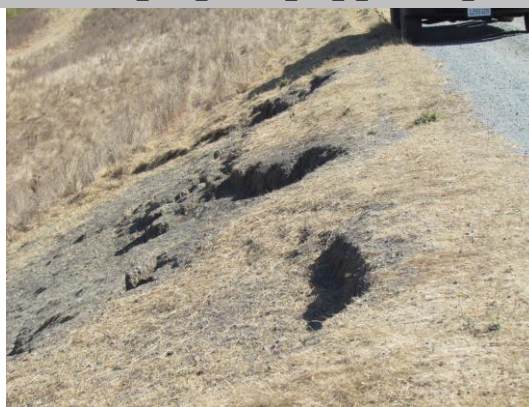
Photo 2 of 2 : SP_2017_RD2098_247_1_20170404_00003.jpg

LM Start	7.51	Rating **	U	Issue No.	1 (cont)
LM End	7.51	Issue Type +	Ma	Location *	LS

Looking upstream.

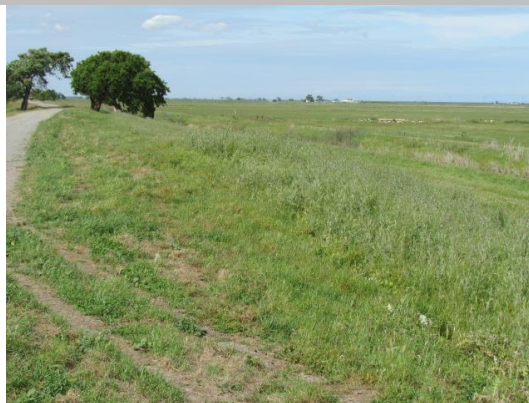
Photo 1 of 1 : SP_2017_RD2098_247_13_20170523_00013.jpg

LM Start	7.77	Rating **	U	Issue No.	13
LM End	8.66	Issue Type +	Ma	Location *	LS
Category	Earthen Levee			GPS Latitude/Longitude	
				Start	End
Item	Vegetation			38.300250 °	38.310588 °
				-121.728330 °	-121.734603 °
DWR ID	DWR_RD2098_03_s_2017_13				
Comment Code					
V1 : Control annual grass and weeds on the levee slopes and easements.					
Inspector Comment					
Control annual grasses and weeds from the slope and berm.

RD 2098 Unit 3 levee mile 7.77-8.66 landside slope.

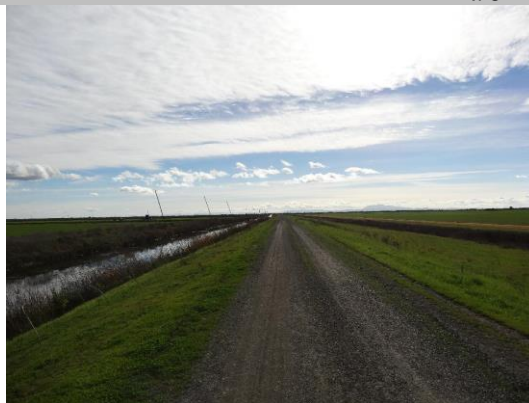
Photo 1 of 1 : UCIP_SP_2017_51457_76889.jpg

Comment Code					
Inspector Comment					
FS_ID:51457 DS_ID:20995 EP_NO: 17842 Repair Type: Urgent Crossing Status: Found UCIP Comments: 12/22/2016 same as previous inspection crossing remains Urgent due to unknown status of gas line--no markers present. According to LMA representative, RD 2068 issued a permit for a gas line however, the current status of this line is unknown. Permit issued by RD 2068 is 20040903. Need to contact owner to determine status of crossing. Markers will need to be installed per Title 23. (O. Magana - DWR UCIP)03/19/2014 No markers found. Need to contact owner to determine status and location. (W. Wylie - DWR UCIP) FIELD_STRUCT_DESC: 3-inch gas pipe bored under channel and levee, approximately 37 feet below the crown. (3-inch natural gas line authorized under Permit No. 17842, 2004 - Castle Minerals, Inc.) FS Date: 12/22/2016

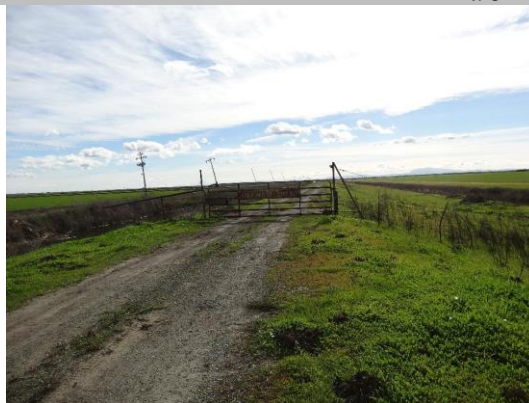
Photo 1 of 3 : UCIP_SP_2017_51454_76867.jpg

LM Start	12.05	Rating **	U	Issue No.	21 (cont)
LM End	12.05	Issue Type +	En	Location *	LS

Overview of levee crown at multiple pipe crossings.

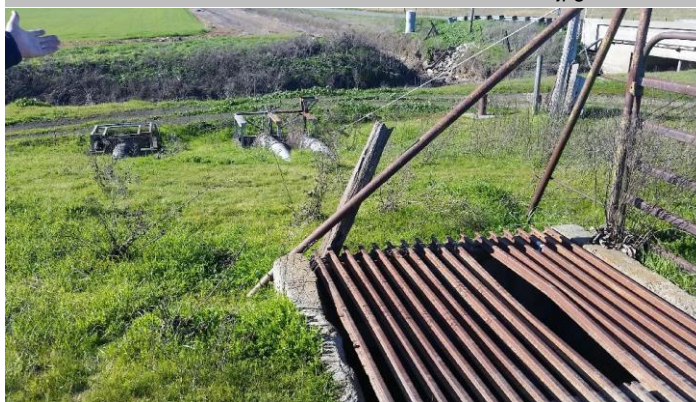
Photo 2 of 3 : UCIP_SP_2017_51454_76872.jpg

View of WS photo taken from levee crown.

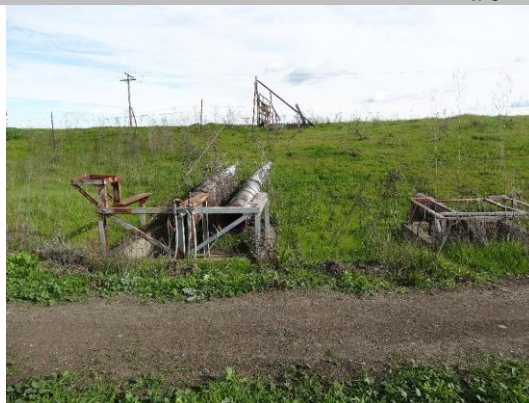
Photo 3 of 3 : UCIP_SP_2017_51454_76868.jpg

Comment Code					
Inspector Comment					
FS_ID:51454 DS_ID:20989 EP_NO: 11564 Repair Type: Urgent Crossing Status: Found UCIP Comments: 12/06/2016 Crossing has been upgraded from Non-Urgent to Urgent due to sections of the wall missing on the LS. Crossing is also opened on both WS and LS. According to Mr. Mike Hardesty, this crossing is not abandoned the crossing is out of service for now. Recommend internal integrity inspection and coordinating with CVFPB to comply with Title 23. (O. Magana - DWR UCIP)03/19/2014 Pipe appears abandoned and if so should be done so properly. Pipe rusted through at outlet in canal. This may indicate further degradation of pipe within the levee. Good candidate for video inspection. (W. Wylie - DWR UCIP) FIELD_STRUCT_DESC: 18-inch steel drainage pipe through the levee, 2 feet below the crown. Steel cutoff wall around pipe at center of levee. Siphon breaker on apex of pipe located on the landside (LS) shoulder. Pump missing from steel pump pad over 4-foot by 4-foot concrete sump located on the waterside (WS) toe. (18-inch authorized under Permit No. 11564, 1976 - Reclamation District No. 2068). [Additional Reference(s): DWR Levee Log, 2003]. FS Date: 12/6/2016

View of WS--pipe crossing is located on the right.

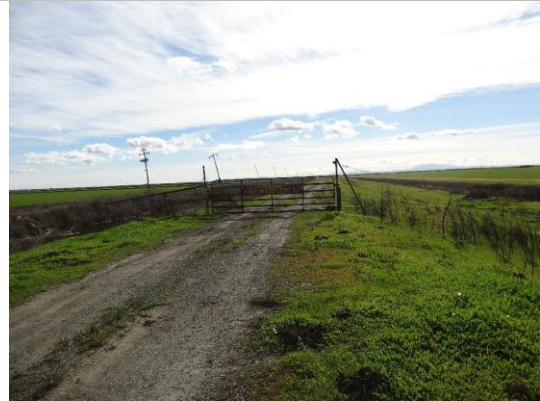
Photo 1 of 3 : UCIP_SP_2017_51455_76875.jpg

LM Start	12.05	Rating **	U	Issue No.	22 (cont)
LM End	12.05	Issue Type +	En	Location *	LS

Overview of levee crown at multiple pipe crossings.

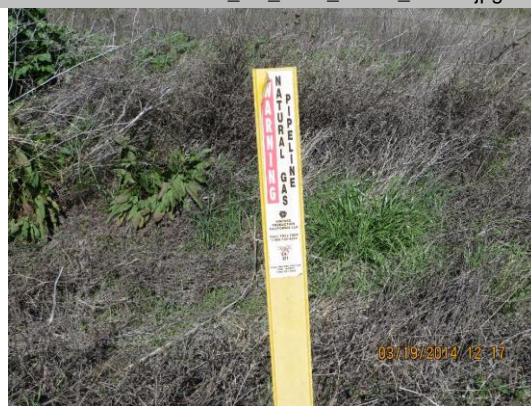
Photo 3 of 3 : UCIP_SP_2017_32566_59108.jpg

LM Start	12.07	Rating **	M	Issue No.	24 (cont)
LM End	12.07	Issue Type +	En	Location *	LS
Category	Supplemental			GPS Latitude/Longitude	
				Start	End
Item	DWR UCIP Field Study			38.358110 °	38.358110 °
				-121.740381 °	-121.740381 °
DWR ID					
Comment Code					
Inspector Comment					
FS_ID:32566					
DS_ID:24845					
EP_NO: N/A					
Repair Type: Non-Urgent					
Crossing Status: Found					
UCIP Comments: Need to verify status with gas company and install signs. No permit identified for crossing, though it may be connected to a permitted line installed in RD 2068 under Permit No. 13490.					
FIELD_STRUCT_DESC: 6-inch steel gasoline through the levee 3-feet below the crown. Signs on East side of levee. Pipe visible on downstream side of roadway bridge.					
FS Date: 3/19/2014

Sign off LS toe on East side of canal.
