**Flood Control Project Maintenance
Levee Inspections**
LMA District Cover Sheet
Spring 2018 Levee Inspection Results

Reclamation District No. 2098 Cache and Haas Slough

Spring 2018 Levee Inspection Results

Waterway			Bank	Unit Miles
Unit No. 01 Yolo Bypass			Right	3.60
	Spring (March - May)	Summer (June - August)	(September - November) Fall	Winter (December - February)
Unit Maintenance Rating (Fall Only)				
Date of Inspection	3/15/2018 - 3/15/2018			
DWR Inspector	Keith Millard			
Accompanied By	Bryan Busch RD 2098

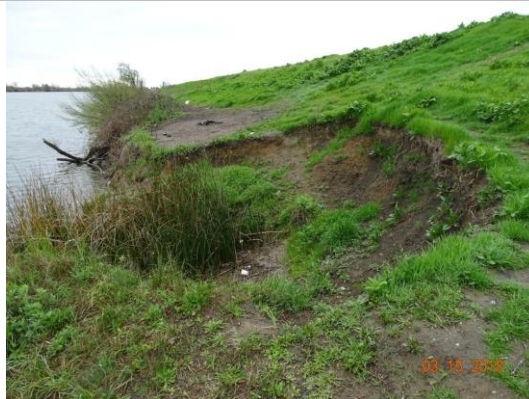
Photo 1 of 1 : SP_2018_RD2098_244_13_20180315_00087.jpg

LM Start	0.57	Rating **	M	Issue No.	13
LM End	1.06	Issue Type +	Ma	Location *	WS
Category	Earthen Levee			GPS Latitude/Longitude	
				Start	End
Item	Erosion / Bank Caving			38.320755 °	38.313700 °
				-121.693982 °	-121.693639 °
DWR ID	DWR_RD2098_01_s_2017_13				
Comment Code					
E2 : Schedule repair of erosion site prior to the next inspection.					
Inspector Comment

Monitor and repair erosion on waterside.

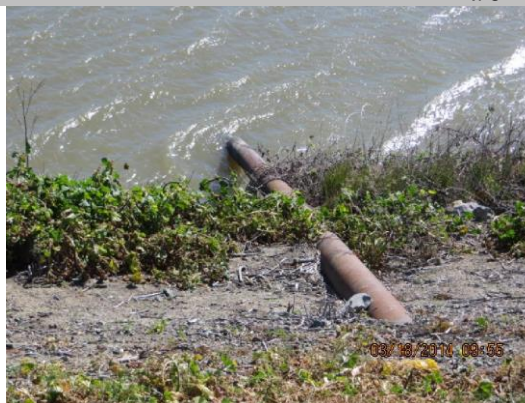
Photo 1 of 3 : UCIP_SP_2018_32197_58662.jpg

LM Start	1.82	Rating **	M	Issue No.	41
LM End	1.82	Issue Type +	En	Location *	
Category	Supplemental			GPS Latitude/Longitude	
				Start	End
Item	DWR UCIP Field Study			38.302770 °	38.302770 °
				-121.693640 °	-121.693640 °
DWR ID					
Comment Code					
Inspector Comment					
FS_ID:32197 DS_ID:20965 EP_NO: 10168 Repair Type: Non-Urgent Crossing Status: Found UCIP Comments: Erosion under pipe at WS toe. FIELD_STRUCT_DESC: 10-inch steel drainage pipe through the levee, 2.8 feet below the crown. Pump in pump house off the landside (LS). (This pipe was retained under Automatic Board Order (ABO) issued as Permit No. 10168, 1974 - Moresco Brothers). [Additional Reference(s): DWR Levee Log, 2003. USACE Sacramento O&M Manual 109, April 1962, (HLM 1.80)]. FS Date: 3/18/2014

Pipe on WS slope.

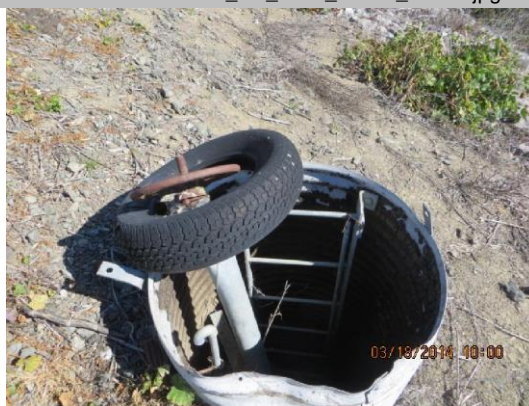
Photo 1 of 3 : UCIP_SP_2018_32207_58665.jpg

Comment Code						
Inspector Comment						
FS_ID:32207 DS_ID:20966 EP_NO: 10168 Repair Type: Non-Urgent Crossing Status: Found UCIP Comments: Slide gate actuator bent but appears to be in closed position. No lid on standpipe. Appears abandoned and if so should be done so properly. FIELD_STRUCT_DESC: 24-inch irrigation pipe of an unknown material through the levee, 24.5 feet below the crown. Two corrugated metal cutoff walls around the pipe at the center of the levee. Slide gate in a 36-inch corrugated metal pipe (CMP) riser on the waterside (WS) slope. Concrete saddle and apron on the WS end. Flap gate and U-shaped headwall on the landside (LS) end. (This pipe was retained under Automatic Board Order (ABO) issued as Permit No. 10168, 1974 - Moresco Brothers). [Additional Reference(s): DWR Levee Log, 2003]. FS Date: 3/18/2014

36-inch CMP riser with bent slide gate actuator on WS slope.

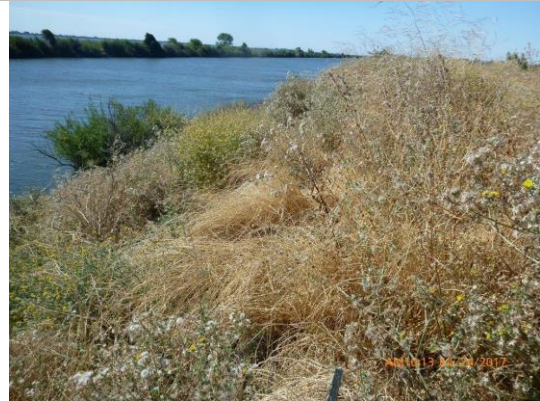
Photo 2 of 3 : LEVAL_SP_2018_416_2727.jpg

Levee Evaluation Comments
Description: The damage consists of erosion, cracking, and sloughing of the waterside levee slope.
Site ID No: 416
Site Designation: LMA-243
Repair Type: Erosion
Rating: Serious
Field Date: 7/24/2017
Notes: Erosion with sloughing. About 2' vertical cut at top of erosion.

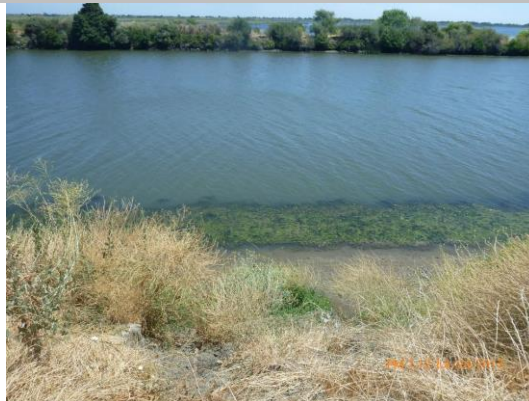
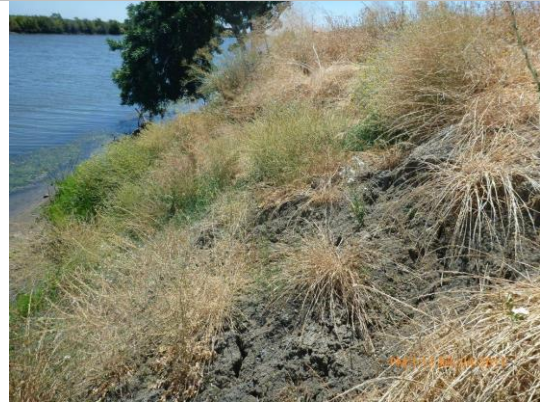
LM Start	2.35	Rating **	M	Issue No.	28
LM End	2.39	Issue Type +	Ma	Location *	
Category	Supplemental			GPS Latitude/Longitude	
				Start	End
Item	2017 Storm Damage			38.295100 °	38.294500 °
				-121.693400 °	-121.693400 °
DWR ID	DWR_RD2098_01_f _ 2017_28				
Comment Code					
Inspector Comment					
Levee Evaluation Comments					
Description:The damage consists of scour, sloughing, and cracking of the lower and mid waterside levee slope.					
Site ID No:423					
Site Designation:LMA-250					
Repair Type: Erosion					
Rating:Area of Concern					
Field Date:7/24/2017					
Notes: 2' of sloughing about half way up the slope.

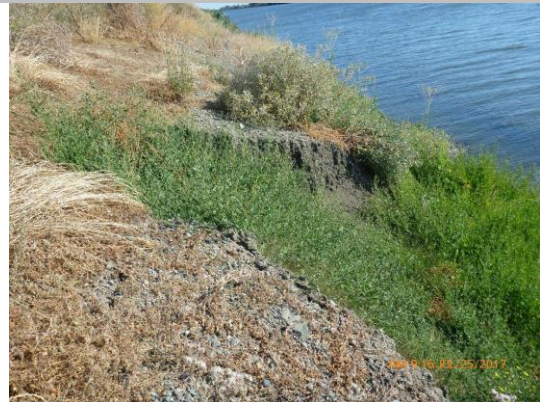
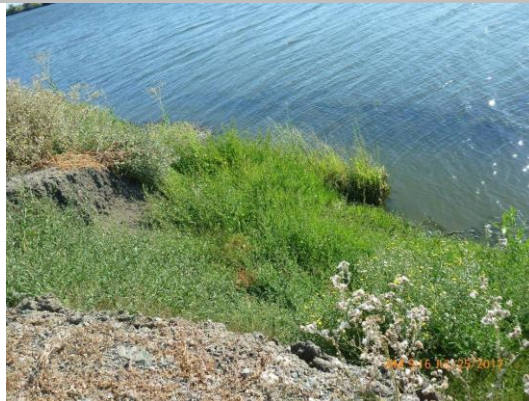
LM Start	2.75	Rating **	A/W	Issue No.	34 (cont)	
LM End	2.78	Issue Type +	Ma	Location *		
Category	Supplemental			GPS Latitude/Longitude		
				Start	End	
Item	2017 Storm Damage			38.289200 °	38.288800 °	
				-121.693500 °	-121.693500 °	
DWR ID	DWR_RD2098_01_f_2017_34					
Comment Code						
Inspector Comment						
Levee Evaluation Comments						
Description:The damage consists of scour and sloughing of the waterside levee slope.						
Site ID No:429						
Site Designation:LMA-256						
Repair Type: Erosion						
Rating:Serious						
Field Date:7/25/2017						
Notes: Erosion at WS toe, causing sloughing half-way down WS slope.						
10/26/17: Dutra repairs in progress.

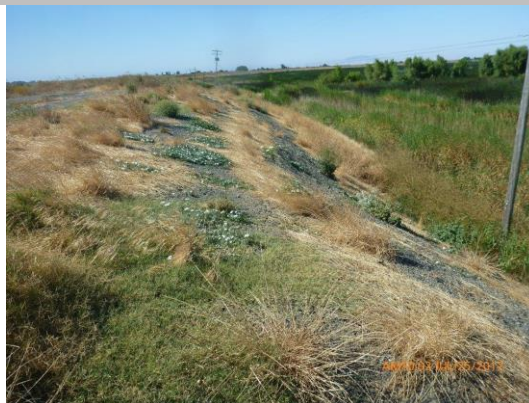
LM Start	2.91	Rating **	A/W	Issue No.	36
LM End	2.93	Issue Type +	Ma	Location *	
Category	Supplemental			GPS Latitude/Longitude	
				Start	End
Item	2017 Storm Damage			38.286900 °	38.286700 °
				-121.693500 °	-121.693500 °
DWR ID	DWR_RD2098_01_f_2017_36				
Comment Code					
Inspector Comment					
Levee Evaluation Comments					
Description:The damage consists of scour and sloughing of the waterside levee slope.					
Site ID No:431					
Site Designation:LMA-258					
Repair Type: Erosion					
Rating:Serious					
Field Date:7/25/2017					
Notes: Erosion of WS toe, resulting in 8' verticle wall. 10/26/17: Dutra repairs in progress.

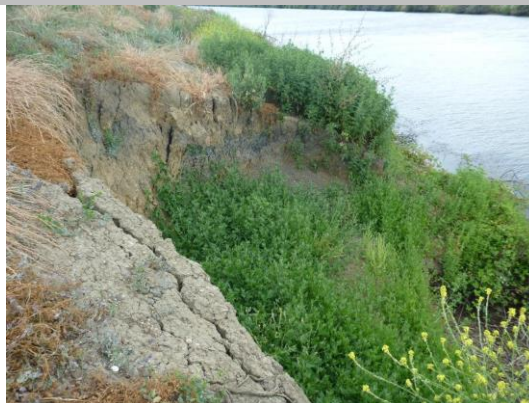
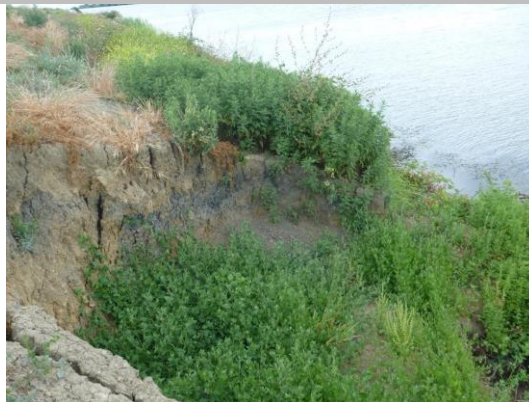
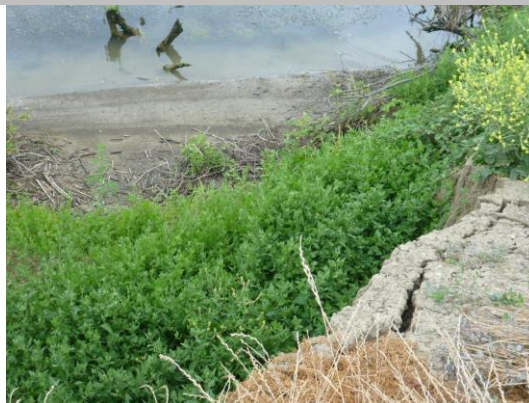
LM Start	3.15	Rating **	M	Issue No.	38
LM End	3.15	Issue Type +	Ma	Location *	
Category	Supplemental			GPS Latitude/Longitude	
				Start	End
Item	2017 Storm Damage			38.283472 °	38.283472 °
				-121.693600 °	-121.693600 °
DWR ID	DWR_RD2098_01_f_2017_38				
Comment Code					
Inspector Comment					
Levee Evaluation Comments					
Description:					
Site ID No:115					
Site Designation:DWR_RD2098_01_s_2012_12					
Repair Type: Erosion					
Rating:Critical					
Field Date:6/9/2017					
Notes: noticable sloughing along Wsslope for entire levee reach					
10/26/17: Dutra has repaired erosion at 3.12-3.14.

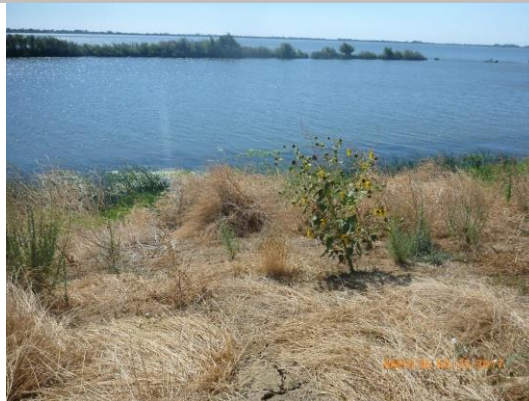
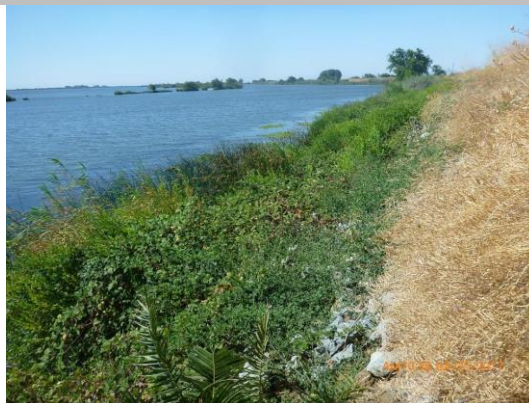
LM Start	3.31	Rating **	A/W	Issue No.	39
LM End	3.32	Issue Type +	Ma	Location *	
Category	Supplemental			GPS Latitude/Longitude	
				Start	End
Item	2017 Storm Damage			38.281200 °	38.281100 °
				-121.694500 °	-121.694600 °
DWR ID	DWR_RD2098_01_f_2017_39				
Comment Code					
Inspector Comment					
Levee Evaluation Comments					
Description:The damage consists of scour and sloughing of the lower waterside levee slope.					
Site ID No:433					
Site Designation:LMA-260					
Repair Type: Erosion					
Rating:Area of Concern					
Field Date:7/25/2017					
Notes: Two combined erosion sites (260 and 261) adjacent to each other at WS toe. Existing rip rap placed at area of concern.

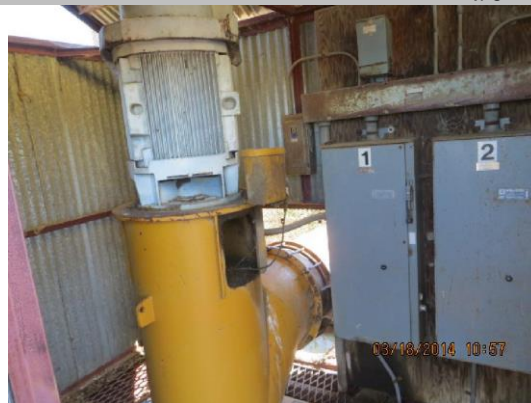
Photo 1 of 3 : UCIP_SP_2018_41717_58704.jpg

Pump in pumphouse on LS toe.

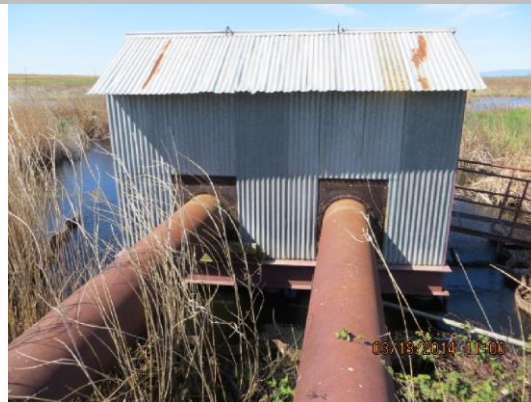
Photo 2 of 3 : UCIP_SP_2018_41717_58703.jpg

Pump in pumphouse on LS toe.

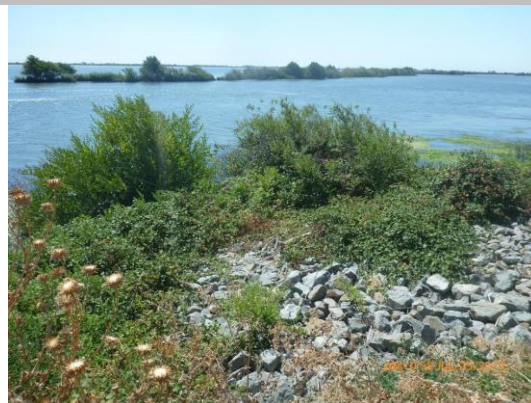
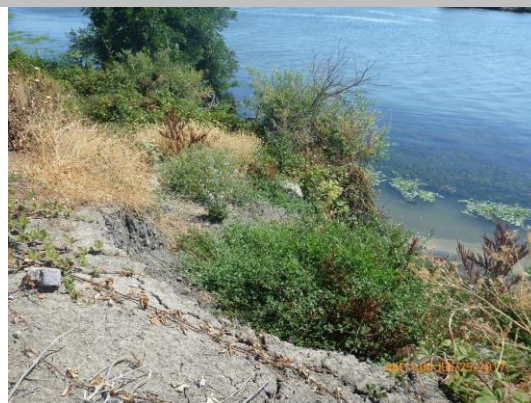
LM Start	3.50	Rating **	M	Issue No.	40 (cont)
LM End	3.56	Issue Type +	Ma	Location *	
Category	Supplemental			GPS Latitude/Longitude	
				Start	End
Item	2017 Storm Damage			38.278700 °	38.278000 °
				-121.695900 °	-121.696100 °
DWR ID	DWR_RD2098_01_f_2017_40				
Comment Code					
Inspector Comment					
Levee Evaluation Comments					
Description:The damage consists of scour and sloughing of the lower and mid waterside levee slope.					
Site ID No:435					
Site Designation:LMA-262					
Repair Type: Erosion					
Rating:Area of Concern					
Field Date:7/25/2017					
Notes: Two combined sloughing sites adjacent to each other on lower waterside slope. Existing rip rap on beginning 100' section of site 262. This site is combined with site 263.

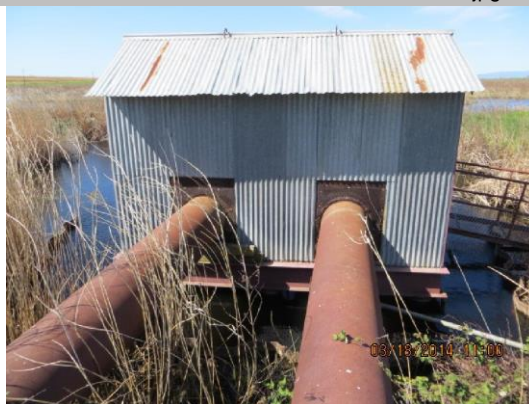
Photo 2 of 3 : UCIP_SP_2018_32245_58709.jpg

Pump in pumphouse on LS toe.

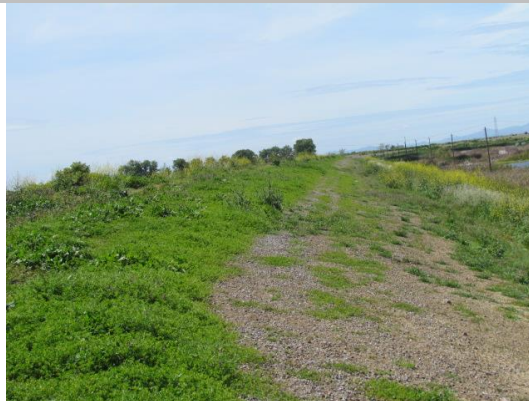
Photo 1 of 1 : SP_2018_RD2098_245_1_20180305_00001.jpg

LM Start	0.00	Rating **	M	Issue No.	1
LM End	0.52	Issue Type +	Ma	Location *	LS
Category	Earthen Levee			GPS Latitude/Longitude	
				Start	End
Item	Vegetation			38.277382 °	38.275722 °
				-121.696270 °	-121.705675 °
DWR ID	DWR_RD2098_01A_s_2017_1				
Comment Code					
V2 : Remove the wild growth other than native grasses from the levee slopes.					
Inspector Comment					
Remove the wild grasses other than native from the levee slope.

RD 2098 1A Looking upstream from levee mile 0.00-0.52 landside slope.

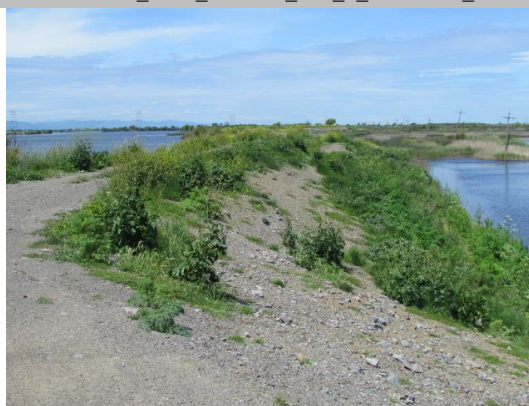
Photo 1 of 1 : SP_2018_RD2098_246_8_20180305_00002.jpg

LM Start	5.30	Rating **	M	Issue No.	8
LM End	6.16	Issue Type +	Ma	Location *	LS
Category	Earthen Levee			GPS Latitude/Longitude	
				Start	End
Item	Vegetation			38.275757 °	38.284800 °
				-121.705818 °	-121.715200 °
DWR ID	DWR_RD2098_02_s_2017_8				
Comment Code					
V2 : Remove the wild growth other than native grasses from the levee slopes.					
Inspector Comment					
Remove the wild weed growth from the landside levee slope and berm.

RD 2098 Unit 2 Levee mile 5.30-7.14 wild growth on the landside slope.

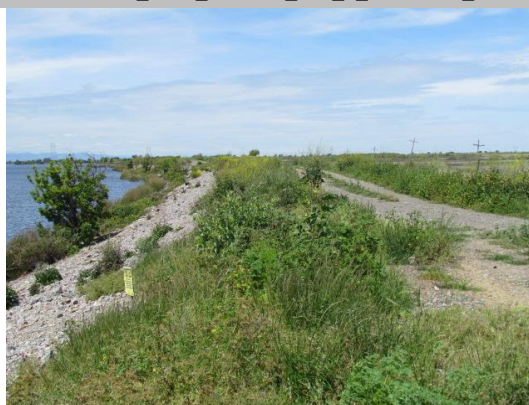
Photo 1 of 1 : SP_2018_RD2098_246_9_20180305_00003.jpg

LM Start	5.30	Rating **	M	Issue No.	9
LM End	6.16	Issue Type +	Ma	Location *	WS
Category	Earthen Levee			GPS Latitude/Longitude	
				Start	End
Item	Vegetation			38.275757 °	38.284800 °
				-121.705818 °	-121.715200 °
DWR ID	DWR_RD2098_02_s_2017_9				
Comment Code					
V2 : Remove the wild growth other than native grasses from the levee slopes.					
Inspector Comment					
Remove the wild weed growth from the waterside levee slope.

RD 2098 Unit 2 levee mile 5.30- 7.14 waterside levee slope and shoulder.

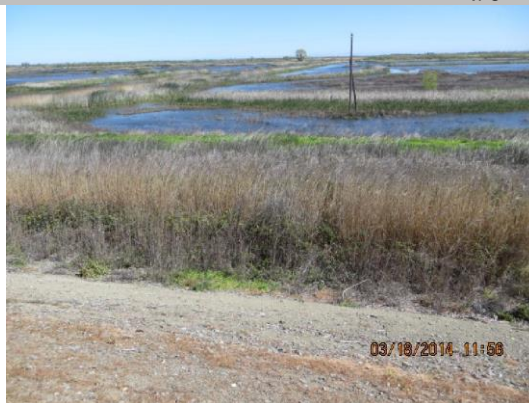
Photo 1 of 3 : UCIP_SP_2018_32287_58755.jpg

Comment Code					
Inspector Comment					
FS_ID:32287 DS_ID:20973 EP_NO: 10172 Repair Type: Non-Urgent Crossing Status: Found UCIP Comments: Pipe appears abandoned and if so should be done so properly. Slide gate appears to be open and should be closed for the season. FIELD_STRUCT_DESC: 24-inch corrugated metal irrigation pipe through the levee, 22.8 feet below the crown. Two cutoff walls around the pipe at the levee shoulders. Slide gate in 36-inch corrugated metal pipe (CMP) riser on the waterside (WS) slope. Flap gate and concrete U-shaped headwall on the landside (LS) end. (This pipe was retained under Automatic Board Order (ABO) issued as Permit No. 10172, 1974 - Moresco Brothers). [Additional Reference(s): DWR Levee Log, 2003]. FS Date: 3/18/2014

LS - no pipe visible.

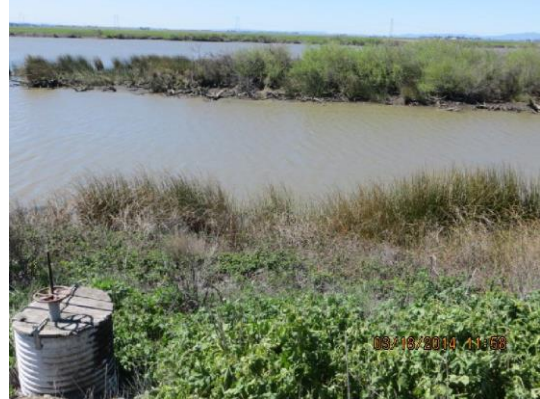
Photo 3 of 3 : UCIP_SP_2018_32287_58753.jpg

Comment Code						
Inspector Comment						
FS_ID:32287 DS_ID:20973 EP_NO: 10172 Repair Type: Non-Urgent Crossing Status: Found UCIP Comments: Pipe appears abandoned and if so should be done so properly. Slide gate appears to be open and should be closed for the season. FIELD_STRUCT_DESC: 24-inch corrugated metal irrigation pipe through the levee, 22.8 feet below the crown. Two cutoff walls around the pipe at the levee shoulders. Slide gate in 36-inch corrugated metal pipe (CMP) riser on the waterside (WS) slope. Flap gate and concrete U-shaped headwall on the landside (LS) end. (This pipe was retained under Automatic Board Order (ABO) issued as Permit No. 10172, 1974 - Moresco Brothers). [Additional Reference(s): DWR Levee Log, 2003]. FS Date: 3/18/2014

Slide gate in 36-inch standpipe on WS slope.

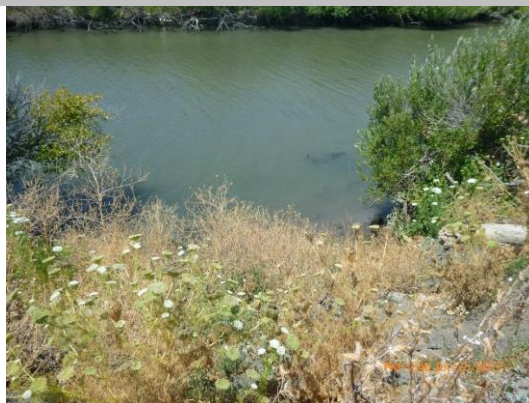
Photo 1 of 3 : SP_2018_RD2098_246_15_20180305_00008.jpg

LM Start	6.46	Rating **	A/W	Issue No.	15
LM End	6.46	Issue Type +	Ma	Location *	
Category	Supplemental		GPS Latitude/Longitude		
			Start	End	
Item	2017 Storm Damage		38.288700 °	38.288800 °	
			-121.717000 °	-121.717000 °	
DWR ID	DWR_RD2098_02_f_2017_15				
Comment Code					
Inspector Comment					
Levee Evaluation Comments Description: The damage consists of scour of the lower and mid waterside levee slope. Site ID No: 440 Site Designation: LMA-267 Repair Type: Erosion Rating: Area of Concern Field Date: 7/25/2017 Notes: Sloughing on waterside slope due to toe erosion.

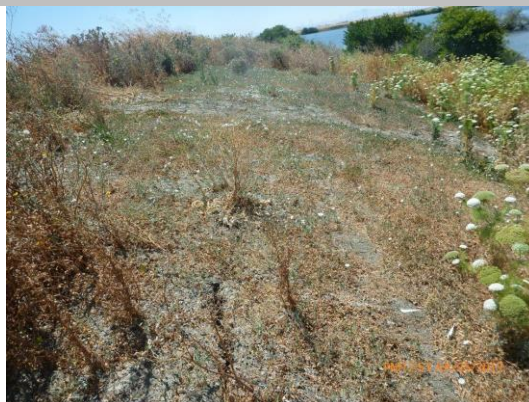
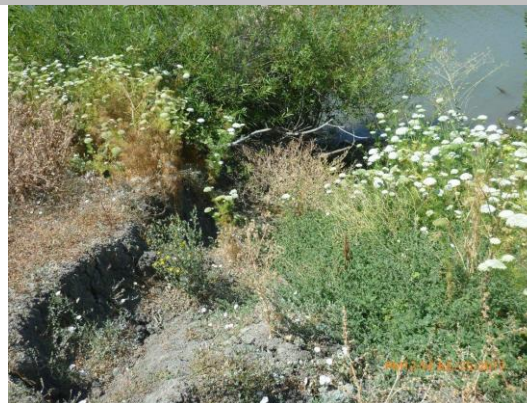
LM Start	6.47	Rating **	A/W	Issue No.	17
LM End	6.48	Issue Type +	Ma	Location *	
Category	Supplemental			GPS Latitude/Longitude	
				Start	End
Item	2017 Storm Damage			38.288900 °	38.289000 °
				-121.717000 °	-121.717000 °
DWR ID	DWR_RD2098_02_f _ 2017_17				
Comment Code					
Inspector Comment					
Levee Evaluation Comments					
Description:The damage consists of scour and sloughing of the lower and mid waterside levee slope.					
Site ID No:441					
Site Designation:LMA-268					
Repair Type: Erosion					
Rating:Area of Concern					
Field Date:7/25/2017					
Notes: Sloughing on waterside slope due to toe erosion.

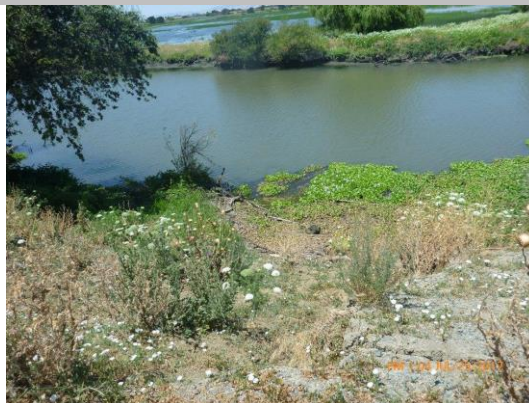
Description: The damage consists of scour, cracking, instability, and sloughing of the waterside levee slope.

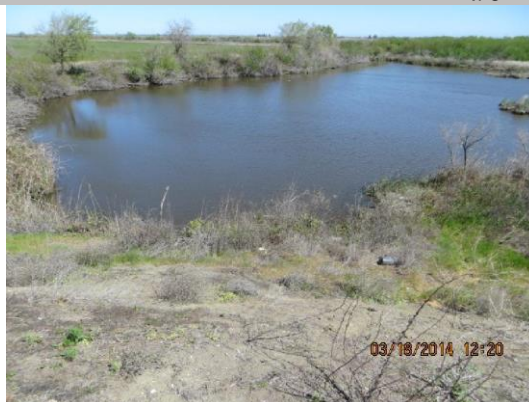
Photo 2 of 3 : UCIP_SP_2018_33784_61161.jpg

Inlet not visible on LS toe.

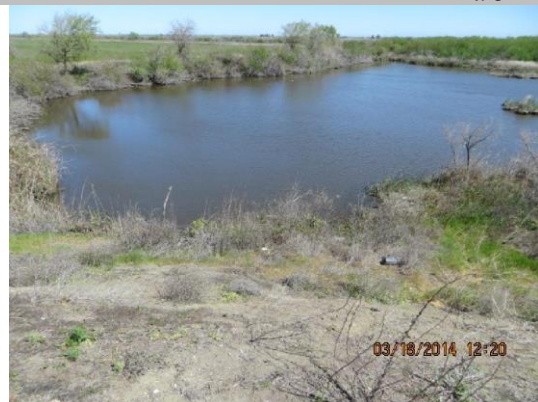
Photo 1 of 3 : UCIP_SP_2018_32285_58749.jpg

Comment Code					
Inspector Comment					
FS_ID:32285 DS_ID:20961 EP_NO: 10172 Repair Type: Non-Urgent Crossing Status: Found UCIP Comments: Headwalls at WS toe failing. It is uncertain if these retaining walls were a permanent fixture or a temporary fix that failed. FIELD_STRUCT_DESC: 2 of 2: 48-inch corrugated metal drainage pipe through the levee, 29 feet below the crown. Two slide gates in a 7-foot-diameter corrugated metal pipe (CMP) riser on the waterside (WS) slope. (two 48-inch pipes [HLM 6.75] authorized under Automatic Board Order (ABO) issued as Permit No. 10172, 1974 - Moresco Brothers). [Additional Reference(s): DWR Levee Log, 2003. USACE Sacramento O&M Manual 109, April 1962, (HLM 6.75)]. FS Date: 3/18/2014

Inlet not visible on LS toe.

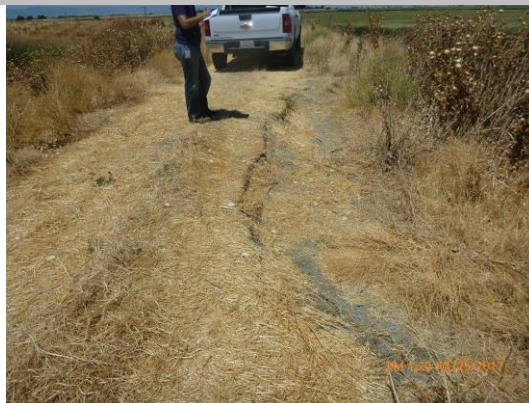
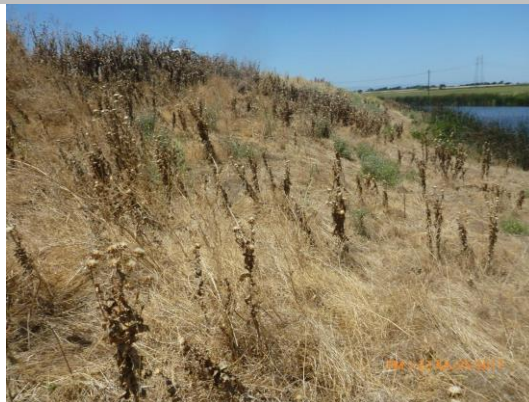
LM Start	6.74	Rating **	A/W	Issue No.	19
LM End	6.75	Issue Type +	Ma	Location *	
Category	Supplemental			GPS Latitude/Longitude	
				Start	End
Item	2017 Storm Damage			38.292500 °	38.292600 °
				-121.716100 °	-121.716200 °
DWR ID	DWR_RD2098_02_f_2017_19				
Comment Code					
Inspector Comment					
Levee Evaluation Comments					
Description:The damage consists of scour and sloughing of the					
landside levee slope.					
Site ID No:443					
Site Designation:LMA-270					
Repair Type: Stability					
Rating:Area of Concern					
Field Date:7/25/2017					
Notes: Sloughing on crown into upper portion of landside levee slope.

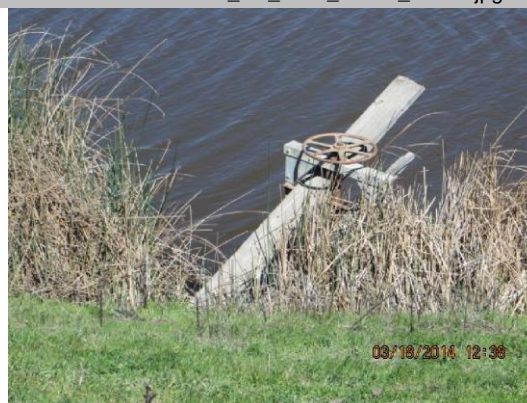
Photo 1 of 3 : UCIP_SP_2018_32290_58764.jpg

Comment Code					
Inspector Comment					
FS_ID:32290 DS_ID:20977 EP_NO: 10171 Repair Type: Non-Urgent Crossing Status: Found UCIP Comments: Pipe appears to be abandoned and if so it should be done so properly. Walkway to gate valve actuator on WS slope is in disrepair and does not appear to be safe for use. FIELD_STRUCT_DESC: 36-inch corrugated metal dual-purpose irrigation and drainage pipe through the levee, 23 feet below the crown. Walkway to slide gate on the waterside (WS) end. Slide gate at the landside (LS) toe. (This pipe was retained under Automatic Board Order (ABO) issued as Permit No. 10171, 1974 - Glenn A. Bowsbey). [Additional Reference(s): DWR Levee Log, 2003. USACE Sacramento O&M Manual 109, April 1962, (HLM 7.23)]. FS Date: 3/18/2014

Slide gate at LS toe.

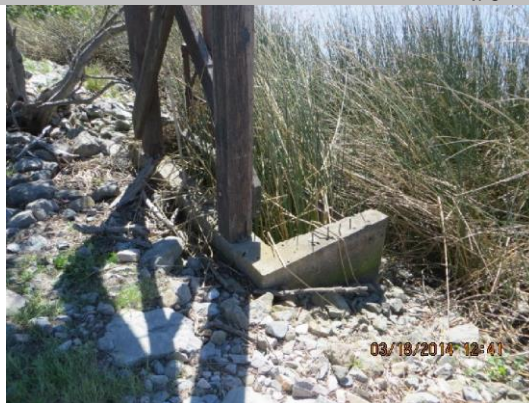
Photo 3 of 3 : UCIP_SP_2018_32290_58762.jpg

Comment Code						
Inspector Comment						
FS_ID:32290						
DS_ID:20977						
EP_NO: 10171						
Repair Type: Non-Urgent						
Crossing Status: Found						
UCIP Comments: Pipe appears to be abandoned and if so it should be done so properly. Walkway to gate valve actuator on WS slope is in disrepair and does not appear to be safe for use.						
FIELD_STRUCT_DESC: 36-inch corrugated metal dual-purpose irrigation and drainage pipe through the levee, 23 feet below the crown. Walkway to slide gate on the waterside (WS) end. Slide gate at the landside (LS) toe. (This pipe was retained under Automatic Board Order (ABO) issued as Permit No. 10171, 1974 - Glenn A. Bowsbey).						
[Additional Reference(s): DWR Levee Log, 2003. USACE Sacramento O&M Manual 109, April 1962, (HLM 7.23)].						
FS Date: 3/18/2014

Concrete U-shaped headwall on WS toe.

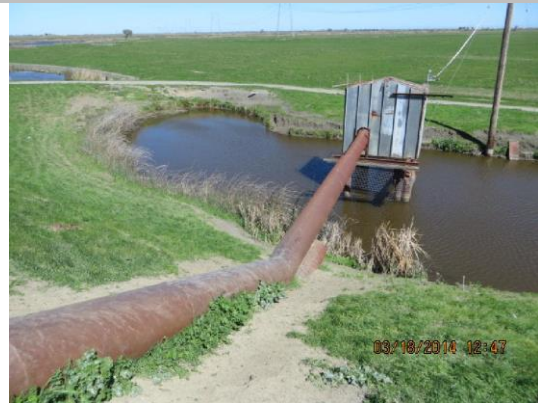
Photo 1 of 3 : UCIP_SP_2018_32303_58782.jpg

FS_ID:32303
DS_ID:20978
EP_NO: 10171
Repair Type: No Action Needed
Crossing Status: Found
UCIP Comments: 09/14/2017 Permit review indicates this 24-inch pipe was authorized as an irrigation and drainage pipe under ABO issued as Permit No. 10171, structure description was updated. Structure type logged as drainage. (DWR UCIP - O. Magana)
FIELD_STRUCT_DESC: *ABANDONED* 24-inch steel dual-purpose irrigation and drainage pipe through the levee, 4.5 feet below the crown. Corrugated metal cutoff wall around the pipe. Pipe has welded steel plate over end on the landside (LS) slope and is not visible on the waterside (WS) slope. (24-inch pipe [HLM 7.23] authorized under Automatic Board Order (ABO) issued as Permit No. 10171, 1974 - Glenn A. Bowsley). [Additional Reference(s): DWR Levee Log, 2003. USACE Sacramento O&M Manual 109, April 1962, (HLM 7.28)].
FS Date: 3/18/2014 7:07:14 AM

Pipe visible under new pipe on LS slope.

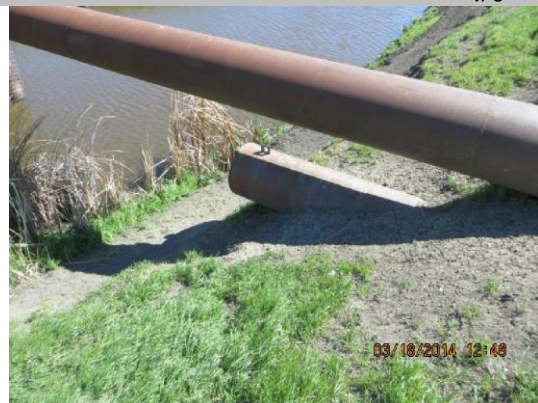
Photo 2 of 3 : UCIP_SP_2018_32303_58781.jpg

Pipe visible under new pipe on LS slope.

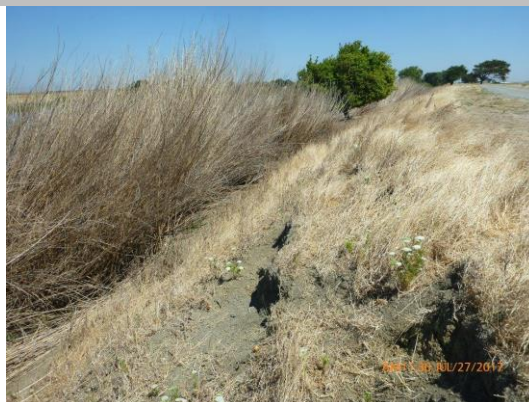
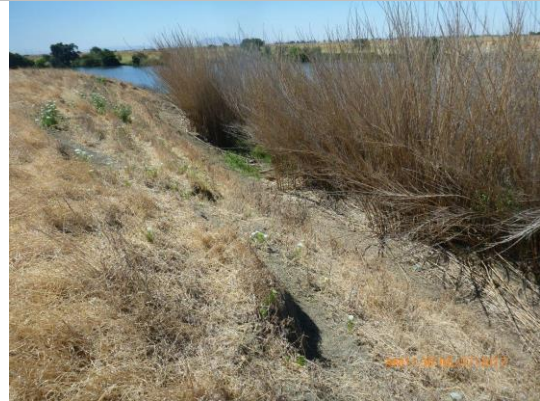
LM Start	7.61	Rating **	M	Issue No.	10
LM End	7.62	Issue Type +	Ma	Location *	
Category	Supplemental			GPS Latitude/Longitude	
				Start	End
Item	2017 Storm Damage			38.297900 °	38.298100 °
				-121.728900 °	-121.728900 °
DWR ID	DWR_RD2098_03_f_2017_10				
Comment Code					
Inspector Comment					
Levee Evaluation Comments					
Description:The damage consists of sloughing of the lower and mid waterside levee slope.					
Site ID No:449					
Site Designation:LMA-276					
Repair Type: Erosion					
Rating:Area of Concern					
Field Date:7/27/2017					
Notes: Sloughing on waterside slope due to erosion at waterside toe.					
LM Start	7.61	Rating **	M	Issue No.	10 (cont)
LM End	7.62	Issue Type +	Ma	Location *

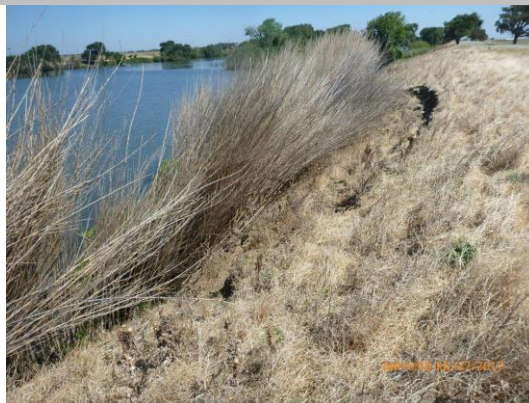
Photo 1 of 3 : SP_2018_RD2098_247_15_20180305_00014.jpg

LM Start	7.66	Rating **	M	Issue No.	15
LM End	7.68	Issue Type +	Ma	Location *	
Category	Supplemental			GPS Latitude/Longitude	
				Start	End
Item	2017 Storm Damage			38.298700 °	38.299000 °
				-121.728700 °	-121.728600 °
DWR ID	DWR_RD2098_03_f _ 2017_15				
Comment Code					
Inspector Comment					
Levee Evaluation Comments					
Description:The damage consists of scour and sloughing of the lower and mid waterside levee slope.					
Site ID No:451					
Site Designation:LMA-278					
Repair Type: Erosion					
Rating:Area of Concern					
Field Date:7/27/2017					
Notes: Sloughing on waterside slope due to watwrside toe erosion.

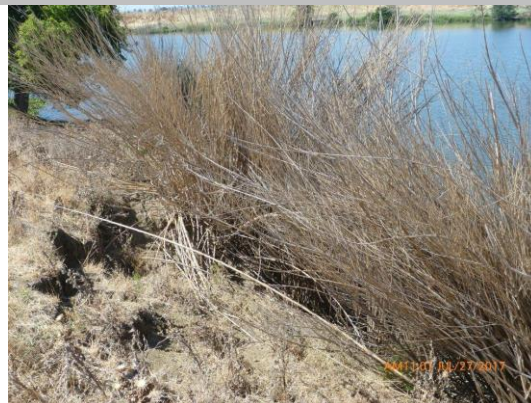
Photo 3 of 3 : SP_2018_RD2098_247_15_20180305_00016.jpg

LM Start	7.66	Rating **	M	Issue No.	15 (cont)
LM End	7.68	Issue Type +	Ma	Location *	
Category	Supplemental			GPS Latitude/Longitude	
				Start	End
Item	2017 Storm Damage			38.298700 °	38.299000 °
				-121.728700 °	-121.728600 °
DWR ID	DWR_RD2098_03_f _ 2017_15				
Comment Code					
Inspector Comment					
Levee Evaluation Comments					
Description:The damage consists of scour and sloughing of the lower and mid waterside levee slope.					
Site ID No:451					
Site Designation:LMA-278					
Repair Type: Erosion					
Rating:Area of Concern					
Field Date:7/27/2017					
Notes: Sloughing on waterside slope due to watwrside toe erosion.

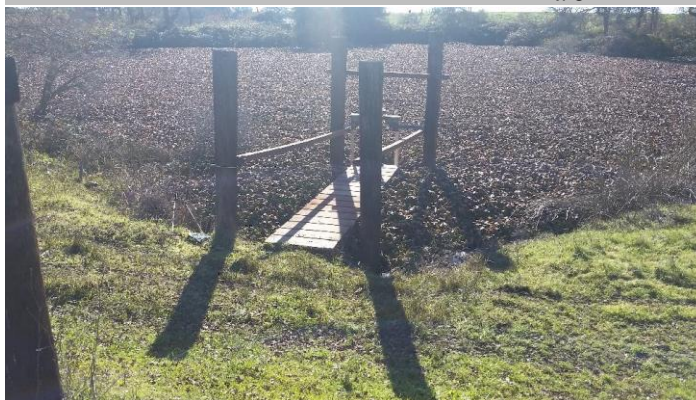
Photo 2 of 3 : UCIP_SP_2018_51453_76861.jpg

FS_ID:51453
DS_ID:20981
EP_NO: 10174
Repair Type: No Action Needed
Crossing Status: Found
UCIP Comments: 12/22/2016 Crossing has been downgraded from Urgent to No Action Needed walkways on both WS and LS have been rebuilt and the WS gate has been upgraded to stainless steel where previous corrodable material was present. (O. Magana - DWR UCIP)03/19/2014 Current walkway to slidegate on WS toe does not provide safe access to operate slidegate. (W. Wylie - DWR UCIP) FIELD_STRUCT_DESC: 36-inch steel dual-purpose irrigation and drainage pipe through the levee, 26 feet below the crown. Two corrugated metal cutoff walls around the pipe. Walkway to the slide gate on the waterside (WS) end. Combination slide and flap gate on the landside (LS) end. 48-inch corrugated metal pipe (CMP) riser and an adjoining pump on a metal pier at the LS toe. (36-inch pipe [HLM 8.20] authorized under Automatic Board Order (ABO) issued as Permit No. 10174, 1974 - Glen A. Bowsbey). [Additional Reference(s): DWR Levee Log, 2003. USACE Sacramento O&M Manual 109, April 1962, (HLM 8.20)].

Walkway has been re-built, photo 2 of 2.

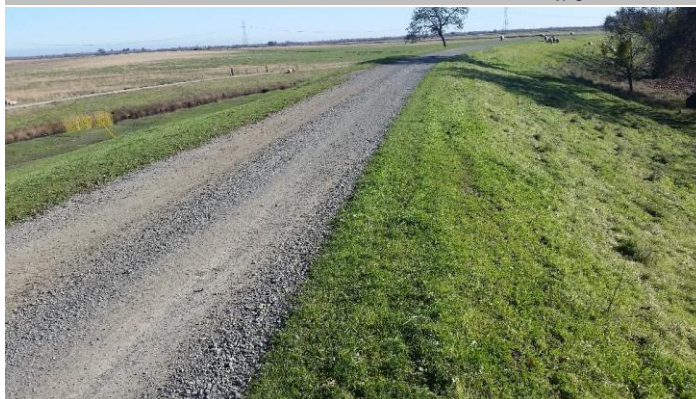
Photo 3 of 3 : UCIP_SP_2018_51453_76859.jpg

View of levee crown at pipe crossing.

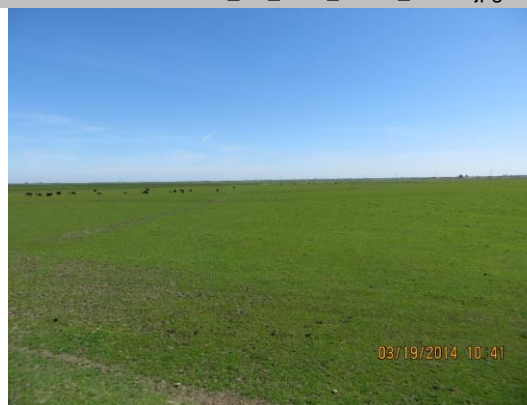
Photo 1 of 2 : UCIP_SP_2018_32383_58881.jpg

LM Start	9.49	Rating **	M	Issue No.	18
LM End	9.49	Issue Type +	En	Location *	
Category	Supplemental			GPS Latitude/Longitude	
				Start	End
Item	DWR UCIP Field Study			38.321032 °	38.321032 °
				-121.740154 °	-121.740154 °
DWR ID					
Comment Code					
Inspector Comment					
FS_ID:32383 DS_ID:20983 EP_NO: N/A Repair Type: Non-Urgent Crossing Status: Indicator Found UCIP Comments: need to verify status of gaslines in region with PG&E (888) 743-7431 Fax: Email: PipelineRequests@pge.com FIELD_STRUCT_DESC: 4-inch gas line of an unknown material through the levee, 2 feet below the crown. Shutoff valve located 370 feet east of the levee crown. [Additional Reference(s): DWR Levee Log, 2003]. FS Date: 3/19/2014

Shutoff valve visible 370-feet off LS toe.

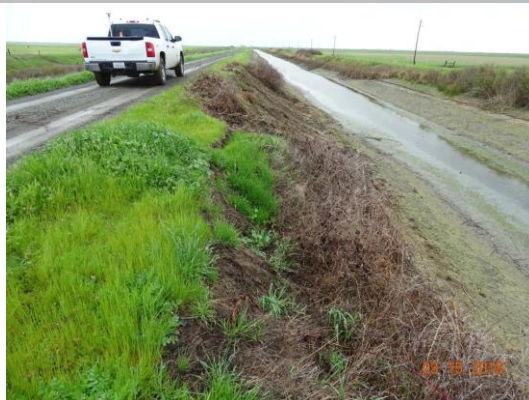
Photo 1 of 1 : SP_2018_RD2098_248_17_20180315_00021.jpg

LM Start	10.02	Rating **	A/W	Issue No.	17
LM End	10.02	Issue Type +	Ma	Location *	LS
Category	Earthen Levee			GPS Latitude/Longitude	
				Start	End
Item	Slope Stability			38.328368 °	38.328438 °
				-121.740617 °	-121.740612 °
DWR ID	DWR_RD2098_04_s_2017_17				
Comment Code					
S2 : Repair the levee slope damaged by foot traffic and prevent access where possible.					
Inspector Comment					
Sloughing landside slope has been temporarily repaired at this specific location, but this area shows cracks along shoulder and should continue to be monitored.

Slumping landside slope should be monitored and repaired as needed.

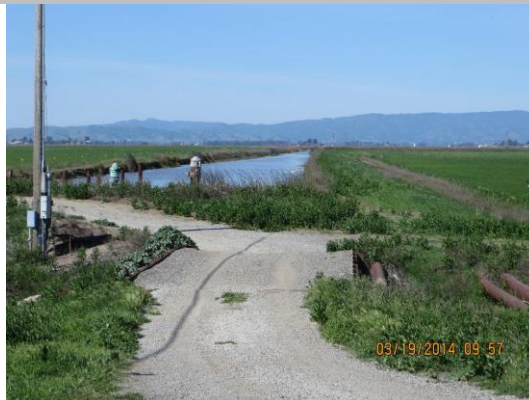
Photo 2 of 3 : UCIP_SP_2018_32403_58904.jpg

Pump on pier in irrigation canal off WS toe.

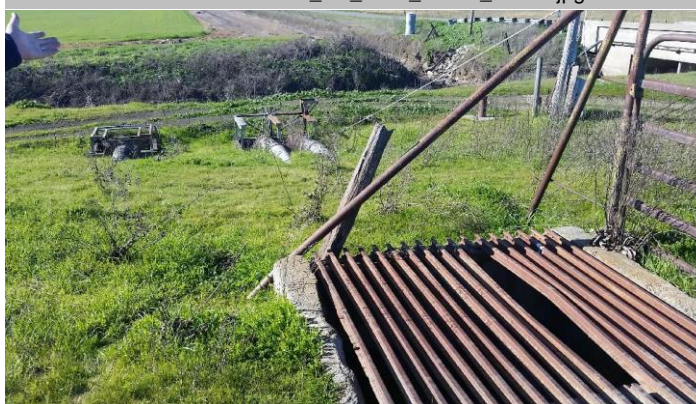
Photo 2 of 3 : UCIP_SP_2018_51454_76872.jpg

View of WS photo taken from levee crown.
