**Flood Control Project Maintenance
Levee Inspections**
LMA District Cover Sheet
Spring 2019 Levee Inspection Results

Reclamation District No. 2098 Cache and Haas Slough

Spring 2019 Levee Inspection Results

Waterway			Bank	Unit Miles
Unit No. 01 Yolo Bypass			Right	3.60
	Spring (March - May)	Summer (June - August)	(September - November) Fall	Winter (December - February)
Unit Maintenance Rating (Fall Only)				
Date of Inspection	3/26/2019 -			
DWR Inspector	David Julian			
Accompanied By	Bryan Busch RD 2098

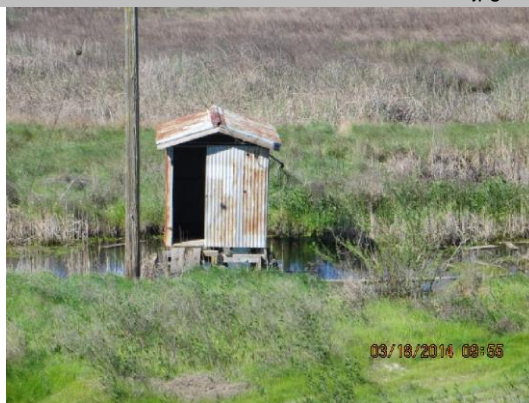
Photo 2 of 3 : UCIP_SP_2019_32197_58661.jpg

Pumphouse at lowpoint off LS toe.

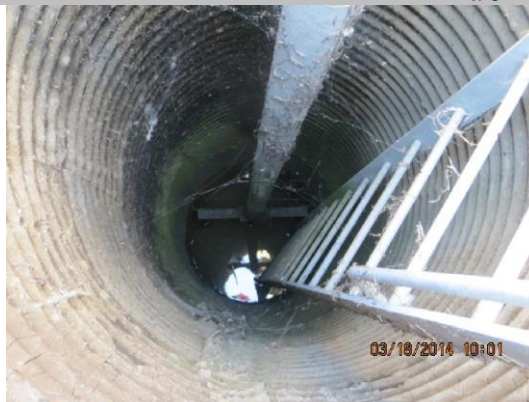
Photo 2 of 3 : UCIP_SP_2019_32207_58664.jpg

No lid on CMP riser that is 24-feet deep.

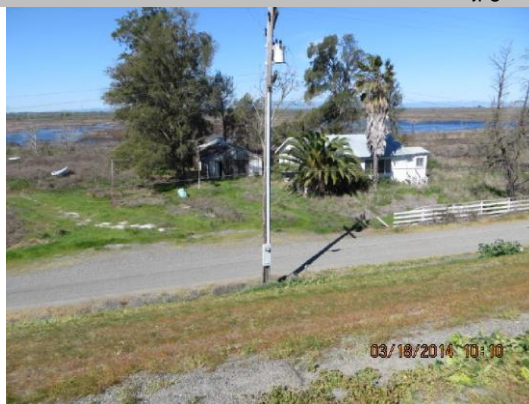
Photo 2 of 3 : UCIP_SP_2019_32225_58686.jpg

Power pole and meter next to spigot on LS toe.

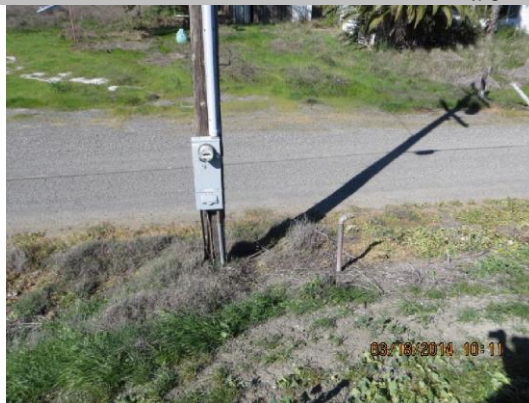
Photo 3 of 3 : UCIP_SP_2019_32225_58685.jpg

Power pole and meter next to spigot on LS toe.

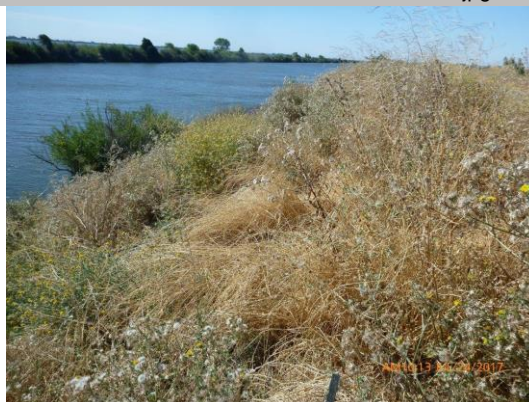
Photo 2 of 3 : LEVAL_SP_2019_416_2727.jpg

LM Start	2.21	Rating **	A/W	Issue No.	21 (cont)	
LM End	2.22	Issue Type +	Ma	Location *		
Category	Supplemental			GPS Latitude/Longitude		
				Start	End	
Item	2017 Storm Damage			38.297100 °	38.297000 °	
				-121.693300 °	-121.693300 °	
DWR ID	DWR_RD2098_01_s _2018_21					
Comment Code						
Inspector Comment						
Levee Evaluation Comments						
Description:The damage consists of erosion, cracking, and sloughing of the waterside levee slope.						
Site ID No:416						
Site Designation:LMA-243						
Repair Type: Erosion						
Rating:Serious						
Field Date:7/24/2017						
Notes: Erosion with sloughing. About 2' vertical cut at top of erosion.

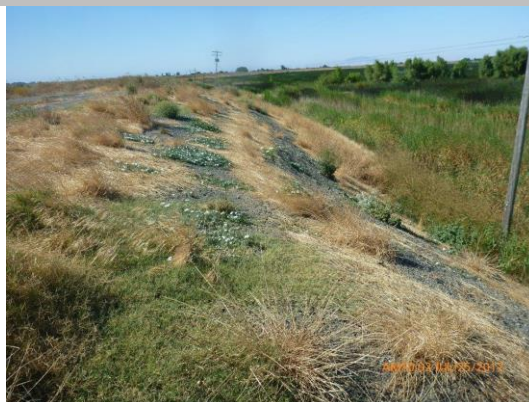
Photo 2 of 3 : SP_2019_RD2098_244_36_20190311_00027.jpg

LM Start	2.91	Rating **	A/W	Issue No.	36 (cont)	
LM End	2.93	Issue Type +	Ma	Location *		
Category	Supplemental			GPS Latitude/Longitude		
				Start	End	
Item	2017 Storm Damage			38.286900 °	38.286700 °	
				-121.693500 °	-121.693500 °	
DWR ID	DWR_RD2098_01_f_2017_36					
Comment Code						
Inspector Comment						
Levee Evaluation Comments						
Description:The damage consists of scour and sloughing of the waterside levee slope.						
Site ID No:431						
Site Designation:LMA-258						
Repair Type: Erosion						
Rating:Serious						
Field Date:7/25/2017						
Notes: Erosion of WS toe, resulting in 8' verticle wall.

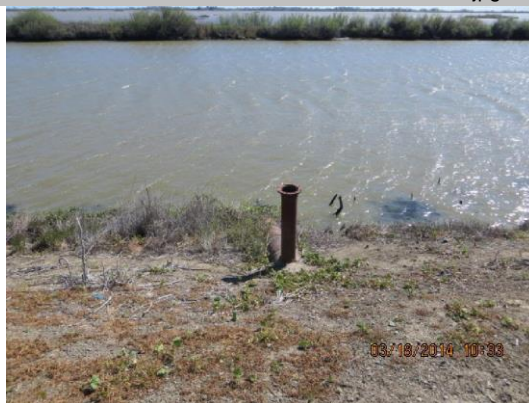
Photo 2 of 3 : UCIP_SP_2019_32227_58691.jpg

Siphon breaker in steel riser on WS slope.

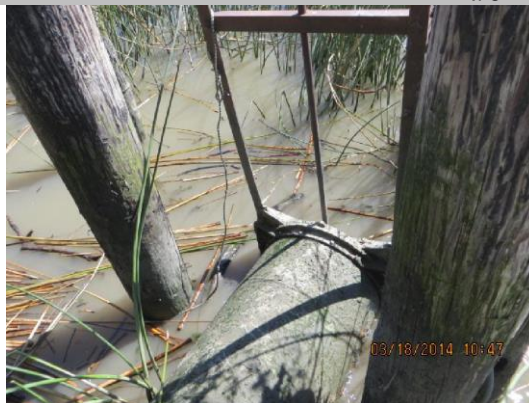
Photo 3 of 3 : UCIP_SP_2019_32243_58700.jpg

Comment Code						
Inspector Comment						
FS_ID:32243 DS_ID:20970 EP_NO: 10168 Repair Type: Non-Urgent Crossing Status: Found UCIP Comments: 03/18/2014 Walkway to slidegate on WS toe is in poor structural condition and may not be safe for accessing the slide gate actuator. Pipe appears abandoned and if so should be done so properly. Outlet on LS toe may be buried. (W. Wylie - DWR UCIP) FIELD_STRUCT_DESC: 24-inch steel irrigation pipe through the levee, 22.3 feet below the crown. Slide gate on the waterside (WS) end. Walkway from the WS shoulder to the slide gate control. Flap gate on the landside (LS) end. (This pipe was retained under Automatic Board Order (ABO) issued as Permit No. 10168, 1974 - Moresco Brothers). [Additional Reference(s): DWR Levee Log, 2003]. FS Date: 3/18/2014

Slidegate on WS toe at pipe.

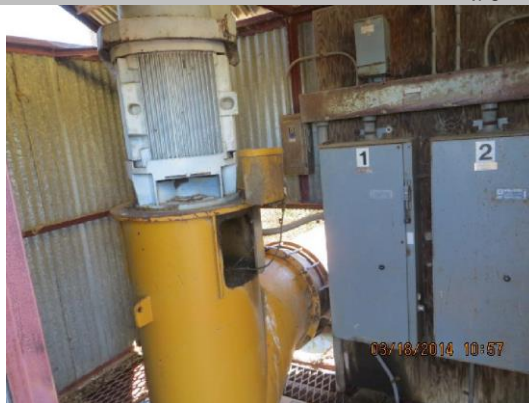
Photo 1 of 3 : UCIP_SP_2019_41717_58704.jpg

Pump in pumphouse on LS toe.

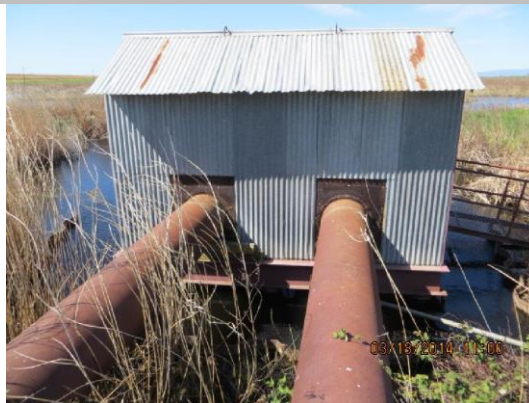
Photo 2 of 3 : UCIP_SP_2019_41717_58703.jpg

Pump in pumphouse on LS toe.

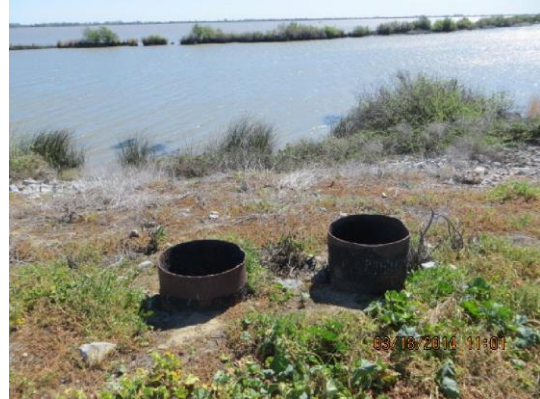
Photo 3 of 3 : UCIP_SP_2019_41717_58707.jpg

Siphon breaker in 24-inch steel riser on WS shoulder.

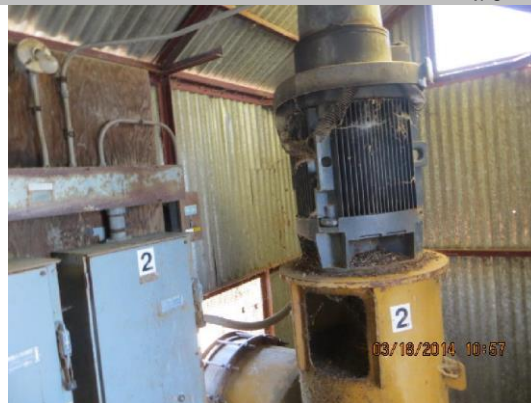
Photo 1 of 3 : UCIP_SP_2019_32245_58710.jpg

Pump in pumphouse on LS toe.

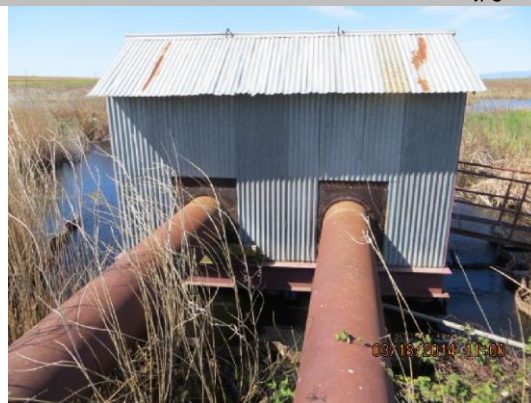
Photo 2 of 3 : UCIP_SP_2019_32245_58709.jpg

Pump in pumphouse on LS toe.

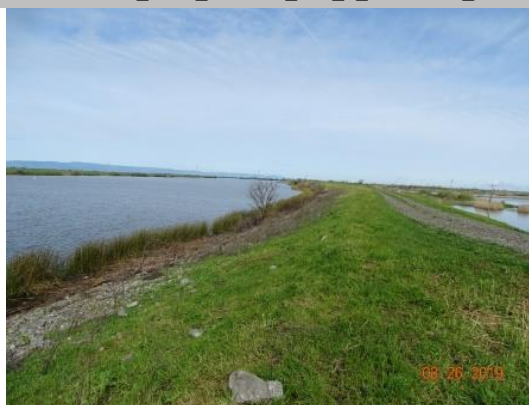
Photo 1 of 1 : SP_2019_RD2098_246_6_20190329_00038.jpg

LM Start	5.30	Rating **	A	Issue No.	6
LM End	7.19	Issue Type +	Ma	Location *	WS
Category	Earthen Levee			GPS Latitude/Longitude	
				Start	End
Item	Vegetation			38.275757 °	38.293139 °
				-121.705818 °	-121.724174 °
DWR ID	DWR_RD2098_02_s_2019_6				
Comment Code					
V1 : Control annual grass and weeds on the levee slopes and easements.					
Inspector Comment					
LMA is doing a good job of maintaining annual vegetation

View looking upstream at annual vegetation on the waterside slope (Spring 2019).

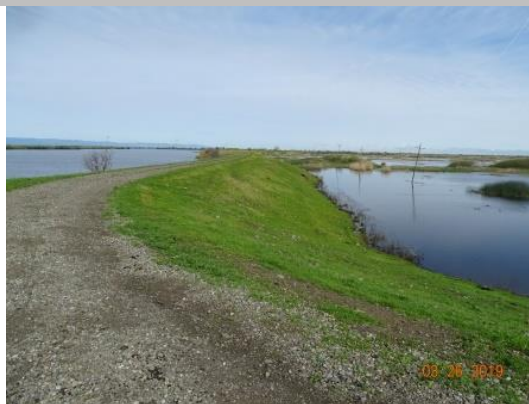
Photo 1 of 1 : SP_2019_RD2098_246_14_20190329_00039.jpg

LM Start	5.30	Rating **	A	Issue No.	14
LM End	7.19	Issue Type +	Ma	Location *	LS
Category	Earthen Levee			GPS Latitude/Longitude	
				Start	End
Item	Vegetation			38.275757 °	38.293139 °
				-121.705818 °	-121.724174 °
DWR ID	DWR_RD2098_02_s_2019_14				
Comment Code					
V1 : Control annual grass and weeds on the levee slopes and easements.					
Inspector Comment					
LMA is doing a good job maintaining annual vegetation

View looking upstream at annual vegetation on the landside slope (Spring 2019).

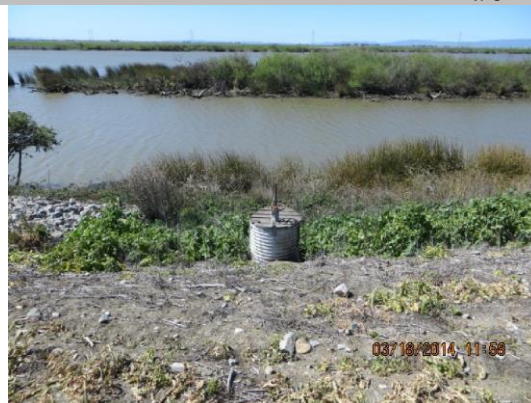
Photo 2 of 3 : UCIP_SP_2019_32287_58754.jpg

Slide gate in 36-inch standpipe on WS slope.

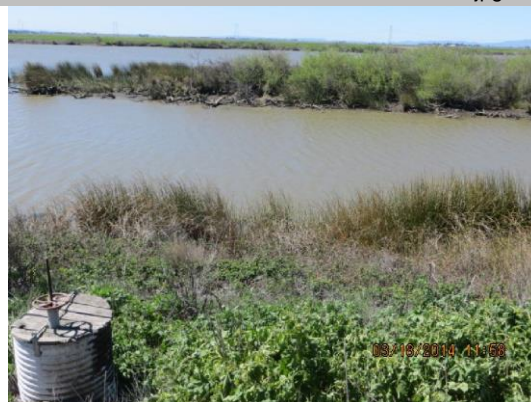
Photo 3 of 3 : UCIP_SP_2019_32287_58753.jpg

Slide gate in 36-inch standpipe on WS slope.

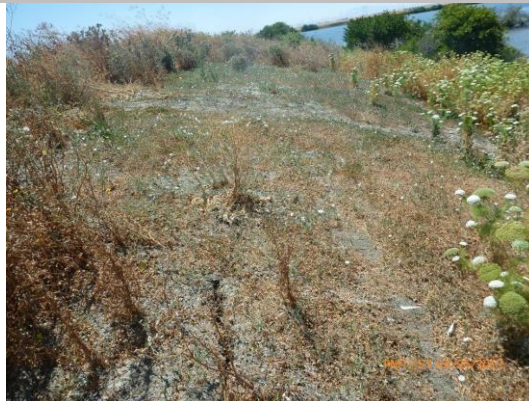
Photo 2 of 3 : SP_2019_RD2098_246_17_20190311_00009.jpg

LM Start	6.47	Rating **	A/W	Issue No.	17 (cont)
LM End	6.48	Issue Type +	Ma	Location *	
Category	Supplemental			GPS Latitude/Longitude	
				Start	End
Item	2017 Storm Damage			38.288900 °	38.289000 °
				-121.717000 °	-121.717000 °
DWR ID	DWR_RD2098_02_f _ 2017_17				
Comment Code					
Inspector Comment					
Levee Evaluation Comments					
Description:The damage consists of scour and sloughing of the lower and mid waterside levee slope.					
Site ID No:441					
Site Designation:LMA-268					
Repair Type: Erosion					
Rating:Area of Concern					
Field Date:7/25/2017					
Notes: Sloughing on waterside slope due to toe erosion.

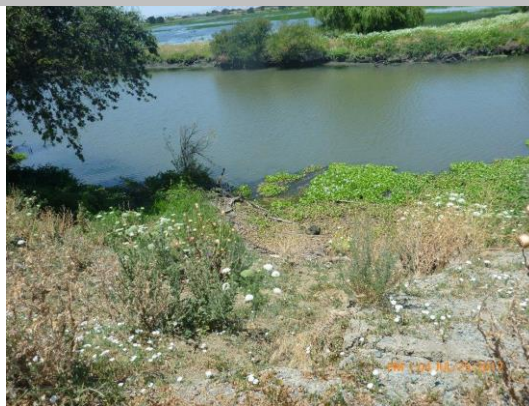
Photo 1 of 3 : SP_2019_RD2098_246_18_20190311_00011.jpg

LM Start	6.64	Rating **	A/W	Issue No.	18
LM End	6.65	Issue Type +	Ma	Location *	
Category	Supplemental			GPS Latitude/Longitude	
				Start	End
Item	2017 Storm Damage			38.291300 °	38.291400 °
				-121.716100 °	-121.716000 °
DWR ID	DWR_RD2098_02_f_2017_18				
Comment Code					
Inspector Comment					
Levee Evaluation Comments					
Description:The damage consists of scour, cracking, instability, and sloughing of the waterside levee slope.					
Site ID No:442					
Site Designation:LMA-269					
Repair Type: Erosion					
Rating:Serious					
Field Date:7/25/2017					
Notes: Two sloughing sections along waterside slope due to toe erosion.

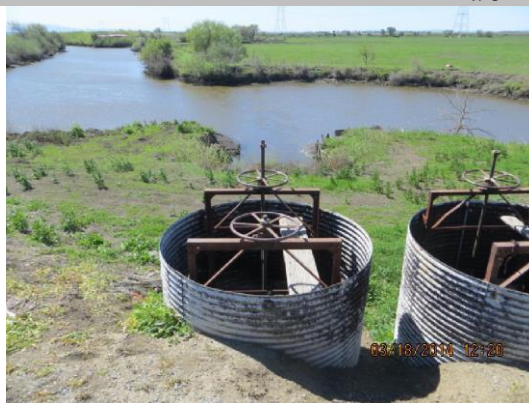
Photo 1 of 3 : UCIP_SP_2019_33784_61162.jpg

Comment Code					
Inspector Comment					
FS_ID:33784 DS_ID:20976 EP_NO: 10172 Repair Type: Non-Urgent Crossing Status: Found UCIP Comments: 03/18/2014 Headwalls on WS toe failing at outlet. It is unclear if these were permanent installations or something that was installed as a temporary fix. (W. Wylie - DWR UCIP) FIELD_STRUCT_DESC: 1 of 2: 48-inch corrugated metal drainage pipe through the levee, 29 feet below the crown. Two slide gates in a 7-foot-diameter corrugated metal pipe (CMP) riser on the waterside (WS) slope. (two 48-inch [HLM 6.75] authorized under Automatic Board Order (ABO) issued as Permit No. 10172, 1974 - Moresco Brothers). [Additional Reference(s): DWR Levee Log, 2003. USACE Sacramento O&M Manual 109, April 1962, (HLM 6.75)]. FS Date: 3/18/2014

Two slide gates in 7-foot diameter CMP riser on waterward slope.

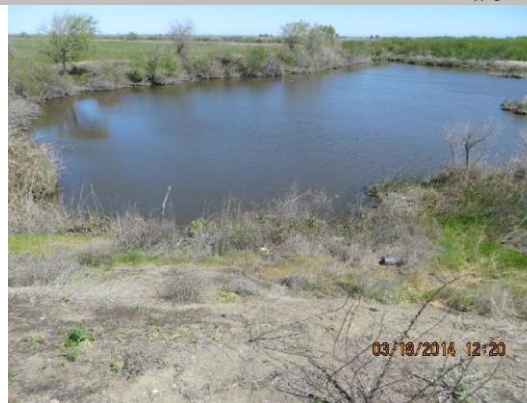
Photo 1 of 3 : UCIP_SP_2019_32285_58749.jpg

Comment Code					
Inspector Comment					
FS_ID:32285 DS_ID:20961 EP_NO: 10172 Repair Type: Non-Urgent Crossing Status: Found UCIP Comments: 03/18/2014 Headwalls at WS toe failing. It is uncertain if these retaining walls were a permanent fixture or a temporary fix that failed. (W. Wylie - DWR UCIP) FIELD_STRUCT_DESC: 2 of 2: 48-inch corrugated metal drainage pipe through the levee, 29 feet below the crown. Two slide gates in a 7-foot-diameter corrugated metal pipe (CMP) riser on the waterside (WS) slope. (two 48-inch pipes [HLM 6.75] authorized under Automatic Board Order (ABO) issued as Permit No. 10172, 1974 - Moresco Brothers). [Additional Reference(s): DWR Levee Log, 2003. USACE Sacramento O&M Manual 109, April 1962, (HLM 6.75)]. FS Date: 3/18/2014

Inlet not visible on LS toe.

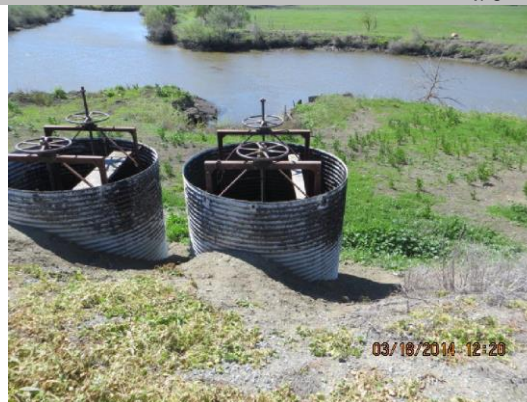
Photo 2 of 3 : UCIP_SP_2019_32285_58748.jpg

7-foot diameter CMP riser with two slide gates inside.

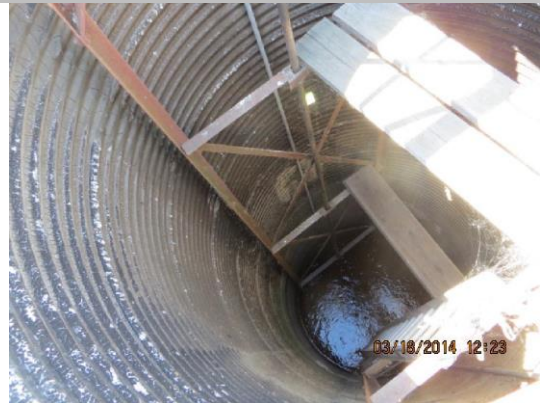
Photo 3 of 3 : UCIP_SP_2019_32285_58747.jpg

Comment Code						
Inspector Comment						
FS_ID:32285						
DS_ID:20961						
EP_NO: 10172						
Repair Type: Non-Urgent						
Crossing Status: Found						
UCIP Comments: 03/18/2014 Headwalls at WS toe failing. It is uncertain if these retaining walls were a permanent fixture or a temporary fix that failed. (W. Wylie - DWR UCIP)						
FIELD_STRUCT_DESC: 2 of 2: 48-inch corrugated metal drainage pipe through the levee, 29 feet below the crown. Two slide gates in a 7-foot-diameter corrugated metal pipe (CMP) riser on the waterside (WS) slope. (two 48-inch pipes [HLM 6.75] authorized under Automatic Board Order (ABO) issued as Permit No. 10172, 1974 - Moresco Brothers).						
[Additional Reference(s): DWR Levee Log, 2003. USACE Sacramento O&M Manual 109, April 1962, (HLM 6.75)].						
FS Date: 3/18/2014

7-foot diameter CMP riser with two slide gates inside.

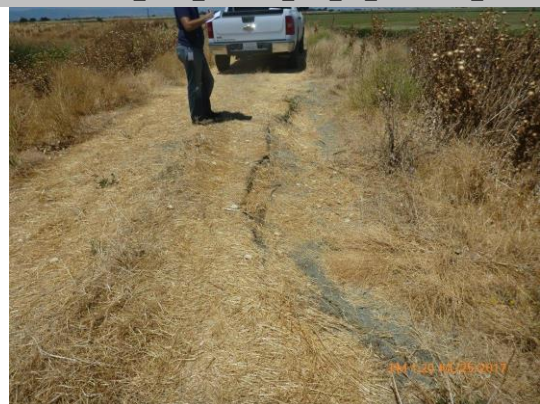
Photo 1 of 3 : SP_2019_RD2098_246_19_20190311_00014.jpg

LM Start	6.74	Rating **	A/W	Issue No.	19
LM End	6.75	Issue Type +	Ma	Location *	LS
Category	Supplemental			GPS Latitude/Longitude	
				Start	End
Item	2017 Storm Damage			38.292500 °	38.292600 °
				-121.716100 °	-121.716200 °
DWR ID	DWR_RD2098_02_f_2017_19				
Comment Code					
Inspector Comment					
Levee Evaluation Comments					
Description:The damage consists of scour and sloughing of the					
landside levee slope.					
Site ID No:443					
Site Designation:LMA-270					
Repair Type: Stability					
Rating:Area of Concern					
Field Date:7/25/2017					
Notes: Sloughing on crown into upper portion of landside levee slope.

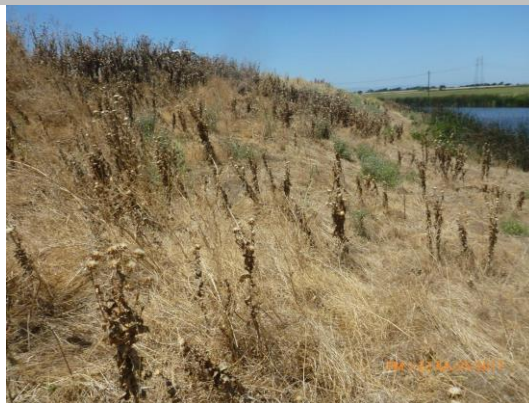
Photo 2 of 3 : SP_2019_RD2098_246_19_20190311_00015.jpg

LM Start	6.74	Rating **	A/W	Issue No.	19 (cont)
LM End	6.75	Issue Type +	Ma	Location *	LS
Category	Supplemental			GPS Latitude/Longitude	
				Start	End
Item	2017 Storm Damage			38.292500 °	38.292600 °
				-121.716100 °	-121.716200 °
DWR ID	DWR_RD2098_02_f_2017_19				
Comment Code					
Inspector Comment					
Levee Evaluation Comments					
Description:The damage consists of scour and sloughing of the					
landside levee slope.					
Site ID No:443					
Site Designation:LMA-270					
Repair Type: Stability					
Rating:Area of Concern					
Field Date:7/25/2017					
Notes: Sloughing on crown into upper portion of landside levee slope.

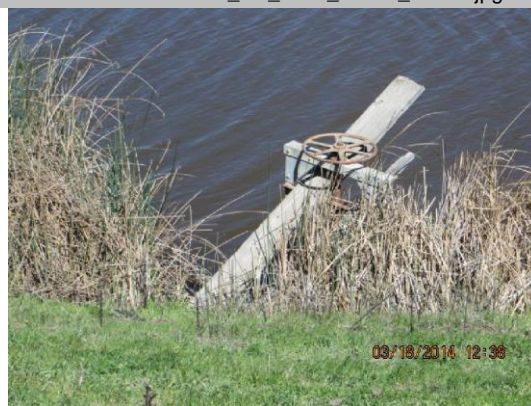
Photo 1 of 3 : UCIP_SP_2019_32290_58764.jpg

Comment Code					
Inspector Comment					
FS_ID:32290 DS_ID:20977 EP_NO: 10171 Repair Type: Non-Urgent Crossing Status: Found UCIP Comments: 12/22/2016 Met with Mike Hadesty, LMA Superintendent, and Brian Bush, LMA General Manager, to go over the list of pipes in RD2098. Per LMA, pipe is a drainage pipe.(O. Magana - DWR UCIP) 03/18/2014 Pipe appears to be abandoned and if so it should be done so properly. Walkway to gate valve actuator on WS slope is in disrepair and does not appear to be safe for use. (W. Wylie - DWR UCIP) FIELD_STRUCT_DESC: 36-inch corrugated metal drainage pipe through the levee, 23 feet below the crown. Walkway to slide gate on the waterside (WS) end. Slide gate at the landside (LS) toe. (This pipe was retained under Automatic Board Order (ABO) issued as Permit No. 10171, 1974 - Glenn A. Bowlsbey). [Additional Reference(s): DWR Levee Log, 2003. USACE Sacramento O&M Manual 109, April 1962, (HLM 7.23)]. FS Date: 3/18/2014

Slide gate at LS toe.

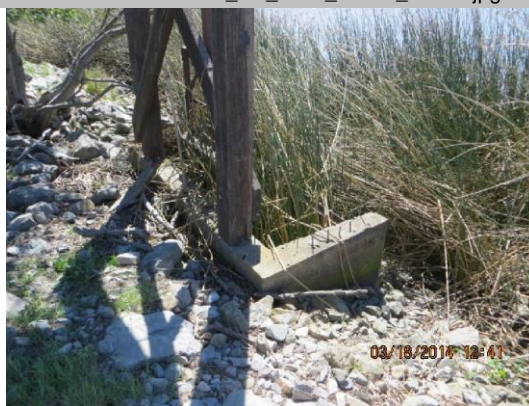
Photo 3 of 3 : UCIP_SP_2019_32290_58762.jpg

Comment Code						
Inspector Comment						
FS_ID:32290 DS_ID:20977 EP_NO: 10171 Repair Type: Non-Urgent Crossing Status: Found UCIP Comments: 12/22/2016 Met with Mike Hadesty, LMA Superintendent, and Brian Bush, LMA General Manager, to go over the list of pipes in RD2098. Per LMA, pipe is a drainage pipe.(O. Magana - DWR UCIP) 03/18/2014 Pipe appears to be abandoned and if so it should be done so properly. Walkway to gate valve actuator on WS slope is in disrepair and does not appear to be safe for use. (W. Wylie - DWR UCIP) FIELD_STRUCT_DESC: 36-inch corrugated metal drainage pipe through the levee, 23 feet below the crown. Walkway to slide gate on the waterside (WS) end. Slide gate at the landside (LS) toe. (This pipe was retained under Automatic Board Order (ABO) issued as Permit No. 10171, 1974 - Glenn A. Bowlsbey). [Additional Reference(s): DWR Levee Log, 2003. USACE Sacramento O&M Manual 109, April 1962, (HLM 7.23)]. FS Date: 3/18/2014

Concrete U-shaped headwall on WS toe.

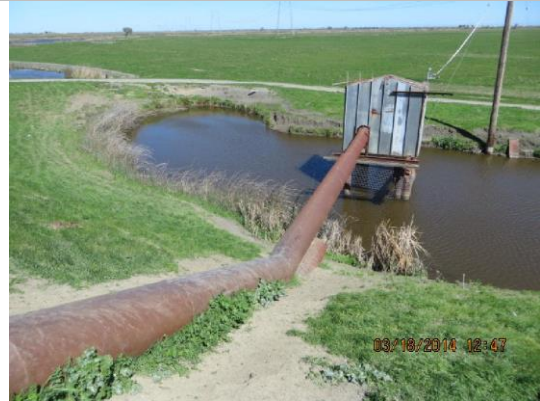
Photo 1 of 3 : UCIP_SP_2019_32303_58782.jpg

FS_ID:32303
DS_ID:20978
EP_NO: 10171
Repair Type: No Action Needed
Crossing Status: Found
UCIP Comments: 09/14/2017 Permit review indicates this 24-inch pipe was authorized as an irrigation and drainage pipe under ABO issued as Permit No. 10171, structure description was updated. Structure type logged as drainage. (DWR UCIP - O. Magana)
FIELD_STRUCT_DESC: *ABANDONED* 24-inch steel dual-purpose irrigation and drainage pipe through the levee, 4.5 feet below the crown. Corrugated metal cutoff wall around the pipe. Pipe has welded steel plate over end on the landside (LS) slope and is not visible on the waterside (WS) slope. (24-inch pipe [HLM 7.23] authorized under Automatic Board Order (ABO) issued as Permit No. 10171, 1974 - Glenn A. Bowlsbey). [Additional Reference(s): DWR Levee Log, 2003. USACE Sacramento O&M Manual 109, April 1962, (HLM 7.28)].
FS Date: 3/18/2014 7:07:14 AM

Pipe visible under new pipe on LS slope.

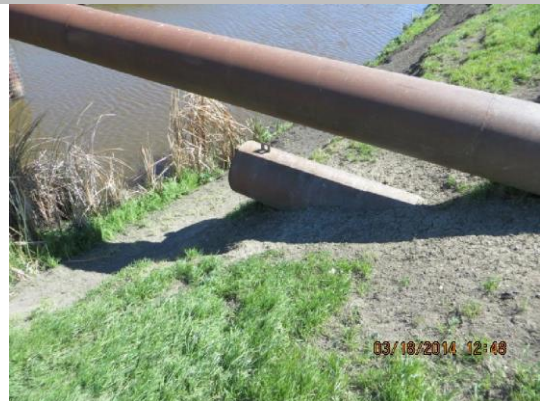
Photo 2 of 3 : UCIP_SP_2019_32303_58781.jpg

Pipe visible under new pipe on LS slope.

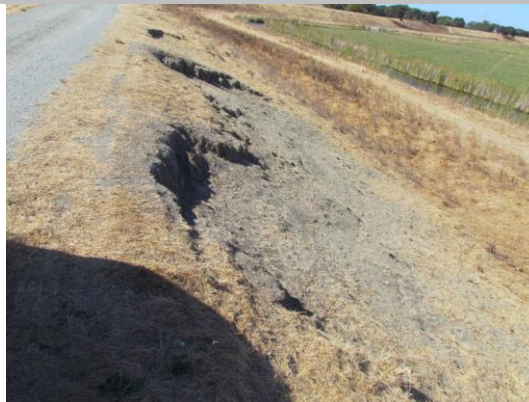
Photo 1 of 3 : SP_2019_RD2098_247_1_20190311_00001.jpg

LM Start	7.51	Rating **	M	Issue No.	1
LM End	7.51	Issue Type +	Ma	Location *	LS
Category	Earthen Levee			GPS Latitude/Longitude	
				Start	End
Item	Slope Stability			38.296846 °	38.296846 °
				-121.727546 °	-121.727546 °
DWR ID	DWR_RD2098_03_f_2016_1				
Comment Code					
S2 : Repair the levee slope damaged by foot traffic and prevent access where possible.					
Inspector Comment					
Livestock activity causing erosion of levee slope.

Close up. Looking upstream.

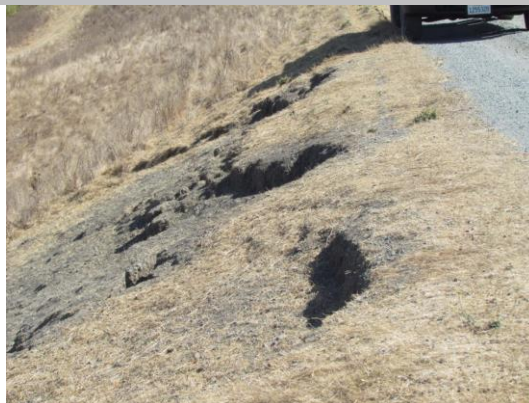
Photo 2 of 3 : SP_2019_RD2098_247_1_20190311_00002.jpg

LM Start	7.51	Rating **	M	Issue No.	1 (cont)	
LM End	7.51	Issue Type +	Ma	Location *	LS	
Category	Earthen Levee			GPS Latitude/Longitude		
				Start		End
Item	Slope Stability			38.296846 °		38.296846 °
				-121.727546 °		-121.727546 °
DWR ID	DWR_RD2098_03_f_2016_1					
Comment Code						
S2 : Repair the levee slope damaged by foot traffic and prevent access where possible.						
Inspector Comment						
Livestock activity causing erosion of levee slope.

Looking downstream.

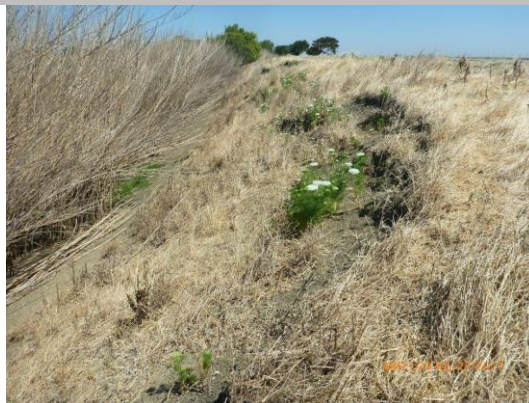
Photo 1 of 3 : SP_2019_RD2098_247_10_20190311_00006.jpg

LM Start	7.61	Rating **	A/W	Issue No.	10
LM End	7.62	Issue Type +	Ma	Location *	
Category	Supplemental			GPS Latitude/Longitude	
				Start	End
Item	2017 Storm Damage			38.297900 °	38.298100 °
				-121.728900 °	-121.728900 °
DWR ID	DWR_RD2098_03_f_2017_10				
Comment Code					
Inspector Comment					
Levee Evaluation Comments					
Description:The damage consists of sloughing of the lower and mid waterside levee slope.					
Site ID No:449					
Site Designation:LMA-276					
Repair Type: Erosion					
Rating:Area of Concern					
Field Date:7/27/2017					
Notes: Sloughing on waterside slope due to erosion at waterside toe.

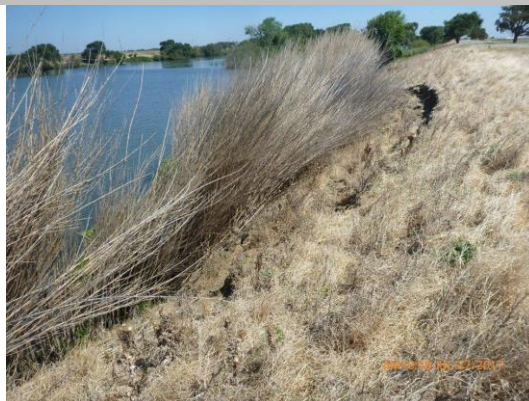
Photo 2 of 4 : SP_2019_RD2098_247_15_20190311_00012.jpg

LM Start	7.66	Rating **	A/W	Issue No.	15
LM End	7.68	Issue Type +	Ma	Location *	
Category	Supplemental			GPS Latitude/Longitude	
				Start	End
Item	2017 Storm Damage			38.298700 °	38.299000 °
				-121.728700 °	-121.728600 °
DWR ID	DWR_RD2098_03_f_2017_15				
Comment Code					
Inspector Comment					
Levee Evaluation Comments					
Description:The damage consists of scour and sloughing of the lower and mid waterside levee slope.					
Site ID No:451					
Site Designation:LMA-278					
Repair Type: Erosion					
Rating:Area of Concern					
Field Date:7/27/2017					
Notes: Sloughing on waterside slope due to waterside toe erosion.					
Additional erosion seen on the spring 2019 inspection. Mitigate erosion then monitor site.

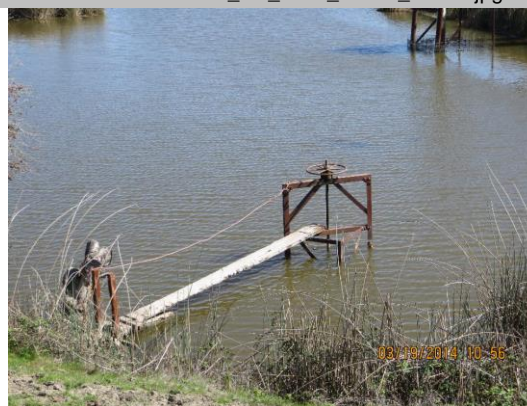
Photo 1 of 2 : UCIP_SP_2019_32384_58883.jpg

LM Start	8.35	Rating **	A/W	Issue No.	18
LM End	8.35	Issue Type +	Ma	Location *	
Category	Supplemental			GPS Latitude/Longitude	
				Start	End
Item	DWR UCIP LMA Responsibility		38.306916 °	38.306916 °	
			-121.731984 °	-121.731984 °	
DWR ID	20962				
Comment Code					
Inspector Comment					
FS_ID:32384 DS_ID:20962 EP_NO: 10174 Repair Type: No Action Needed Crossing Status: Found UCIP Comments: FIELD_STRUCT_DESC: 60-inch corrugated metal drainage pipe through the levee, 25.5 feet below the crown. Walkway to the slide gates at both ends of the pipe. (Permit No. 1607, 1951 - R. F. Moore and Lorraine W. Zanetti. This pipe was retained under Automatic Board Order (ABO) issued as Permit No. 10174, 1974 - Glen A. Bowsbey). [Additional Reference(s): DWR Levee Log, 2003. USACE Sacramento O&M Manual 109, April 1962, (HLM 8.40)]. FS Date: 3/19/2014

Slide gate at LS toe.

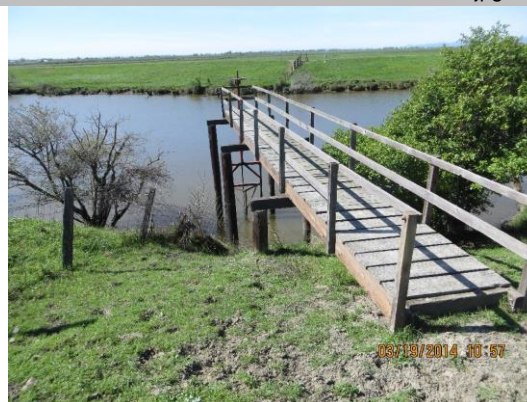
Photo 2 of 2 : UCIP_SP_2019_32384_58882.jpg

Walkway with slide gate on WS toe.

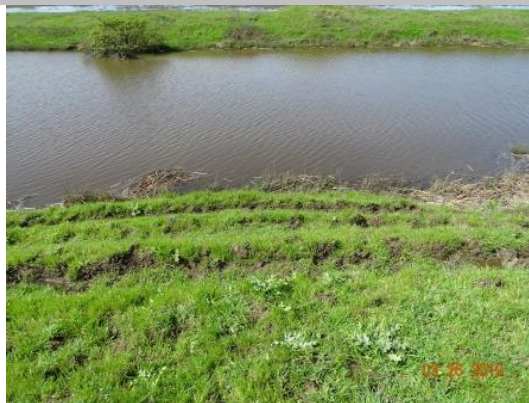
Photo 1 of 3 : SP_2019_RD2098_248_9_20190408_00031.jpg

View looking downslope at deep ruts in the waterside slope made by cows (Spring 2019).

LM Start	9.44	Rating **	M	Issue No.	9 (cont)	
LM End	9.74	Issue Type +	Ma	Location *	WS	
Category	Supplemental			GPS Latitude/Longitude		
				Start	End	
Item	2017 USACE Erosion Survey, DRAFT			38.320240 °	38.324587 °	
				-121.740183 °	-121.740254 °	
DWR ID	DWR_RD2098_04_f_2018_9					
Comment Code						
Inspector Comment						
2017 Site ID: HAS 9.7 L Status: Critical 2018: Some erosion about a third to half way up the slope the whole length. A couple pockets of deeper erosion into the slope. I would mark as unacceptable (Djulian). 2017 Field Notes: Upgraded to CRITICAL. Multiple slump on top of old slumping ; slump is into levee prism. Site History: 2011 - Several scallops of erosion. Erosion primarily due to the weight of cattle on the slope. 2016 - Two new large scallop pockets in the middle of the site.

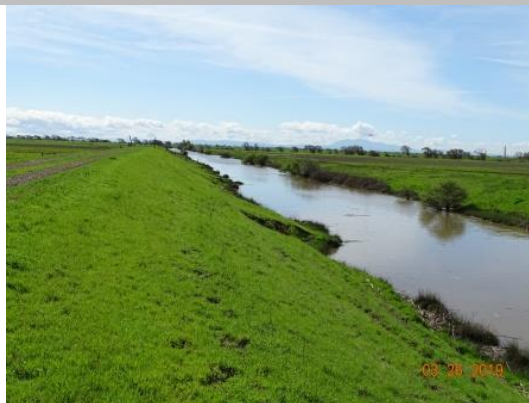
Photo 3 of 3 : SP_2019_RD2098_248_9_20190408_00033.jpg

View looking downstream at worst section of the erosion on the waterside slope (Spring 2019).

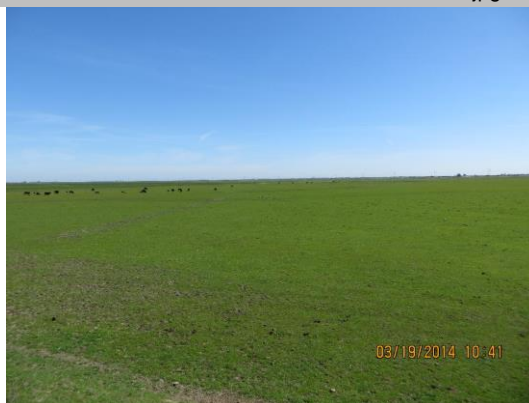
Photo 1 of 2 : UCIP_SP_2019_32383_58881.jpg

LM Start	9.49	Rating **	M	Issue No.	18
LM End	9.49	Issue Type +	En	Location *	
Category	Supplemental			GPS Latitude/Longitude	
				Start	End
Item	DWR UCIP Field Study			38.321032 °	38.321032 °
				-121.740154 °	-121.740154 °
DWR ID	20983				
Comment Code					
Inspector Comment					
FS_ID:32383 DS_ID:20983 EP_NO: N/A Repair Type: Non-Urgent Crossing Status: Indicator Found UCIP Comments: 03/19/2014 need to verify status of gaslines in region with PG&E (888) 743-7431 Email: PipelineRequests@pge.com. (W. Wylie - DWR UCIP) FIELD_STRUCT_DESC: 4-inch gas line of an unknown material through the levee, 2 feet below the crown. Shutoff valve located 370 feet east of the levee crown. [Additional Reference(s): DWR Levee Log, 2003]. FS Date: 3/19/2014

Shutoff valve visible 370-feet off LS toe.

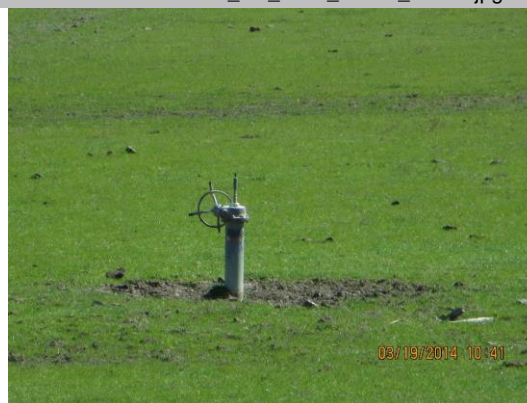
Photo 2 of 2 : UCIP_SP_2019_32383_58880.jpg

LM Start	9.49	Rating **	M	Issue No.	18 (cont)	
LM End	9.49	Issue Type +	En	Location *		
Category	Supplemental			GPS Latitude/Longitude		
				Start	End	
Item	DWR UCIP Field Study			38.321032 °	38.321032 °	
				-121.740154 °	-121.740154 °	
DWR ID	20983					
Comment Code						
Inspector Comment						
FS_ID:32383 DS_ID:20983 EP_NO: N/A Repair Type: Non-Urgent Crossing Status: Indicator Found UCIP Comments: 03/19/2014 need to verify status of gaslines in region with PG&E (888) 743-7431 Email: PipelineRequests@pge.com. (W. Wylie - DWR UCIP) FIELD_STRUCT_DESC: 4-inch gas line of an unknown material through the levee, 2 feet below the crown. Shutoff valve located 370 feet east of the levee crown. [Additional Reference(s): DWR Levee Log, 2003]. FS Date: 3/19/2014

Shutoff valve visible 370-feet off LS toe.

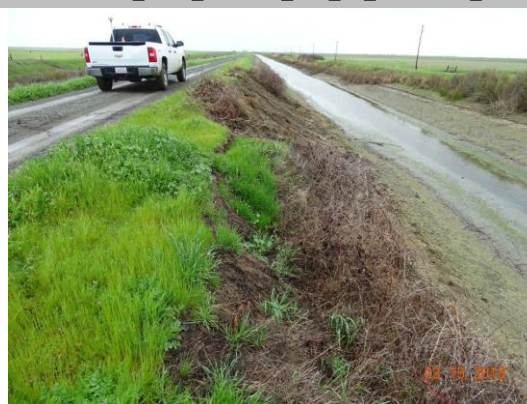
Photo 1 of 1 : SP_2019_RD2098_248_17_20190311_00002.jpg

LM Start	10.02	Rating **	A/W	Issue No.	17
LM End	10.02	Issue Type +	Ma	Location *	LS
Category	Earthen Levee			GPS Latitude/Longitude	
				Start	End
Item	Slope Stability			38.328368 °	38.328438 °
				-121.740617 °	-121.740612 °
DWR ID	DWR_RD2098_04_s_2017_17				
Comment Code					
S2 : Repair the levee slope damaged by foot traffic and prevent access where possible.					
Inspector Comment					
Sloughing landside slope has been temporarily repaired at this specific location, but this area shows cracks along shoulder and should continue to be monitored.

Slumping landside slope should be monitored and repaired as needed.

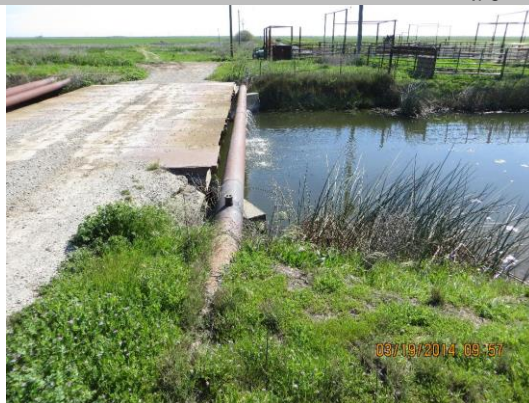
Photo 1 of 3 : UCIP_SP_2019_32403_58905.jpg

Comment Code						
Inspector Comment						
FS_ID:32403 DS_ID:20991 EP_NO: 12851 Repair Type: Non-Urgent Crossing Status: Found UCIP Comments: 12/22/2016 Met with Mike Hadesty, LMA Superintendent, and Brian Bush, LMA General Manager, to go over the list of pipes in RD2098. Per LMA, suspended pipe with leaks was repaired in the summer of 2016. (O. Magana - DWR UCIP) 03/19/2014 Holes in pipe next to rail car bridge may indicate further deterioration of pipe through levee. Good candidate for video inspection. (W. Wylie - DWR UCIP) FIELD_STRUCT_DESC: 12-inch steel irrigation pipe through the levee, 2 feet below the crown. Cutoff wall around the pipe at the center of the levee. Siphon breaker on the landside (LS) toe at the canal. 1-inch polyvinyl chloride (PVC) electrical conduit at the same location (Permit No. 12851, 1980 - Bunker Ranch). [Additional Reference(s): DWR Levee Log, 2003]. FS Date: 3/19/2014

Pipe and siphon breaker visible on LS at canal crossing.

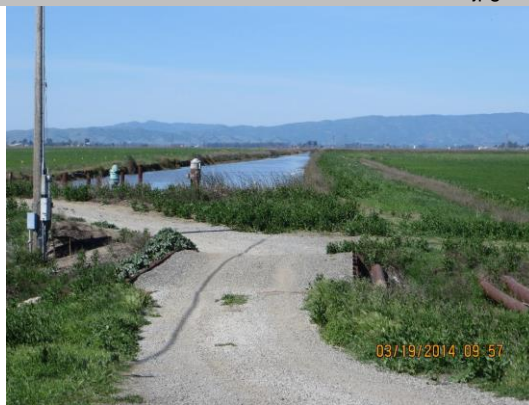
Photo 2 of 3 : UCIP_SP_2019_32403_58904.jpg

Pump on pier in irrigation canal off WS toe.

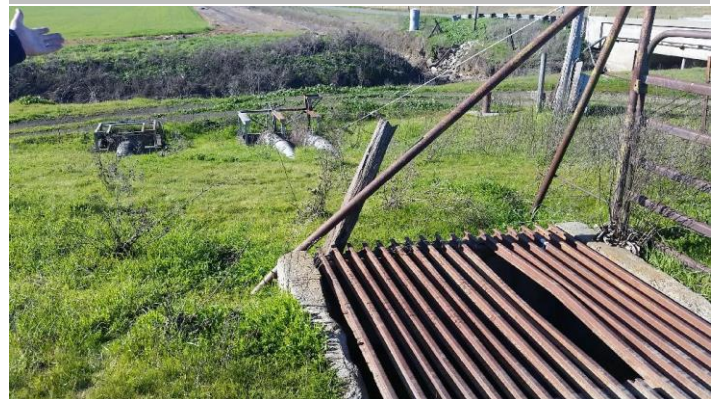
Photo 2 of 3 : UCIP_SP_2019_53381_76872.jpg

View of WS photo taken from levee crown.

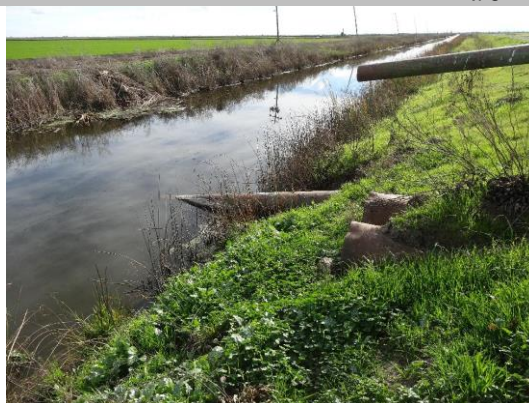
Photo 2 of 3 : UCIP_SP_2019_53382_76876.jpg

View of LS--damaged concrete distribution box has been removed.

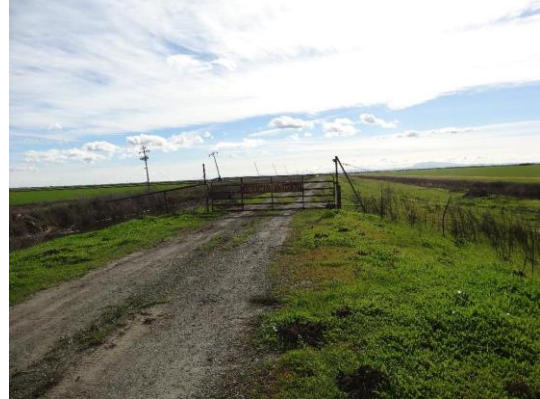
Photo 1 of 3 : UCIP_SP_2019_53383_76883.jpg

FS_ID:53383
DS_ID:21013
EP_NO: 5426-A
Repair Type: Urgent
Crossing Status: Found
UCIP Comments: 10/2/2018 Same as last inspection; remaining as Urgent and recommend internal pipe inspection (D. Sanoski - DWR UCIP). 12/06/2016 Crossing is opened on both WS and LS. Concrete box located on the LS has been removed. According to Mr. Mike Hardesty, this crossing is not abandoned the crossing is out of service for now. Recommend internal integrity inspection and coordinating with CVFPB to comply with Title 23. (O. Magana - DWR UCIP) 03/19/2014 Pipe appears abandoned and if so should be done so properly. Foundation for concrete distribution box on LS toe at canal has failed. Box has fallen into canal and LS slope has erosion at same location. Pipe open on both ends. (W. Wylie - DWR UCIP)
FIELD_STRUCT_DESC: 2 of 2: 18-inch coated steel drainage pipe through the levee, 3 feet below the crown. Vertical pumps missing from steel pad over a 7-foot by 4-foot concrete sump located on the waterside (WS) toe. Concrete cattle guard structure, 7 feet long, 15 feet wide, and 4 feet deep, located on the crown around the pipes. Discharge structure is located on the landside (LS) slope. (Permit No. 5426, 1966, and 5426-A, 1967 - Reclamation District No. 2068. Permit recordation indicates one 14-inch pipe and one 18-inch pipe to be installed). [Additional Reference(s): DWR Levee Log, 2003].

Overview of levee crown at multiple crossings.

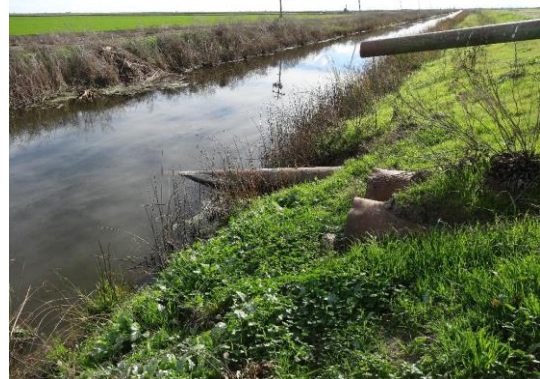
Photo 2 of 3 : UCIP_SP_2019_53383_76884.jpg

View of LS--damage distribution box noted in last inspection has been removed.

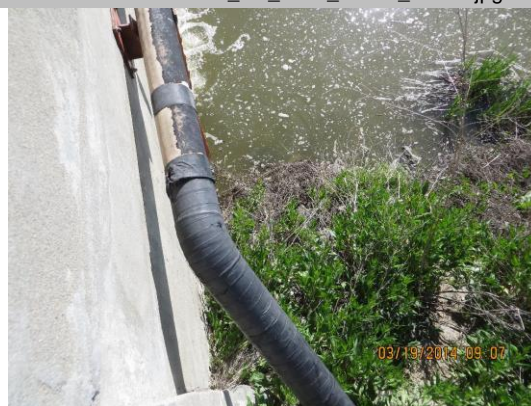
Photo 1 of 3 : UCIP_SP_2019_32566_59110.jpg

LM Start	12.07	Rating **	M	Issue No.	24
LM End	12.07	Issue Type +	En	Location *	
Category	Supplemental			GPS Latitude/Longitude	
				Start	End
Item	DWR UCIP Field Study			38.358110 °	38.358110 °
				-121.740381 °	-121.740381 °
DWR ID	24845				
Comment Code					
Inspector Comment					
FS_ID:32566 DS_ID:24845 EP_NO: N/A Repair Type: Non-Urgent Crossing Status: Found UCIP Comments: 03/19/2014 Need to verify status with gas company and install signs. No permit identified for crossing, though it may be connected to a permitted line installed in RD 2068 under Permit No. 13490. (W. Wylie - DWR UCIP) FIELD_STRUCT_DESC: 6-inch coated steel gas line through the levee, 3 feet below the crown. Signs on the east side of the levee. Pipe visible on the downstream side of the roadway bridge. FS Date: 3/19/2014

Pipe visible on South side of Bridge at Swan Road.

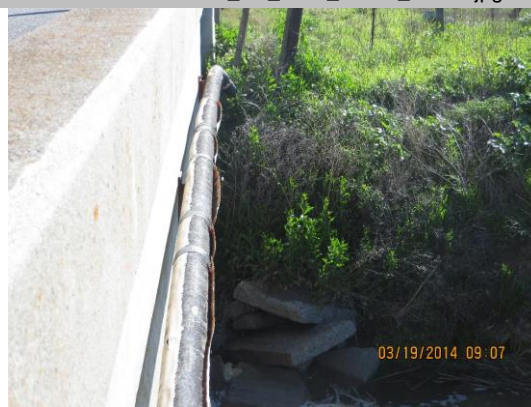
Photo 2 of 3 : UCIP_SP_2019_32566_59109.jpg

Pipe visible on South side of Bridge at Swan Road.
