**Flood Control Project Maintenance
Levee Inspections**
LMA District Cover Sheet
Spring 2020 Levee Inspection Results

Reclamation District No. 2098 Cache and Haas Slough

Spring 2020 Levee Inspection Results

Waterway			Bank	Unit Miles
Unit No. 01 Yolo Bypass			Right	3.60
	Spring (March - May)	Summer (June - August)	(September - November) Fall	Winter (December - February)
Unit Maintenance Rating (Fall Only)				
Date of Inspection	4/24/2020 - 4/24/2020			
DWR Inspector	David Julian			
Accompanied By

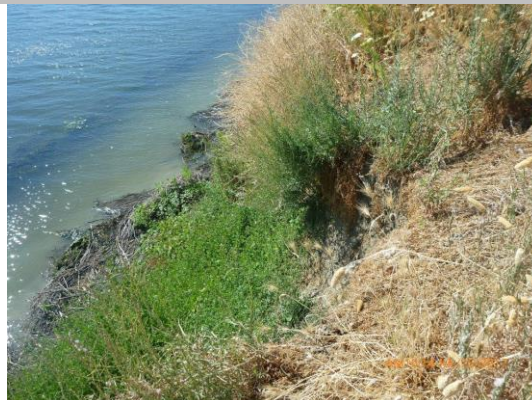
Photo 1 of 2 : SP_2020_RD2098_244_37_20200304_00026.jpg

LM Start	2.99	Rating **	M	Issue No.	37
LM End	3.29	Issue Type +	Ma	Location *	WS
Category	Earthen Levee			GPS Latitude/Longitude	
				Start	End
Item	Erosion / Bank Caving			38.285700 °	38.281500 °
				-121.693500 °	-121.694300 °
DWR ID	LMA-259				
Comment Code					
E2 : Schedule repair of erosion site prior to the next inspection.					
Inspector Comment					
This was a 2017 Storm Damage site. The damage consists of scour and sloughing of the waterside levee slope. Site ID No:432 Site Designation:LMA-259

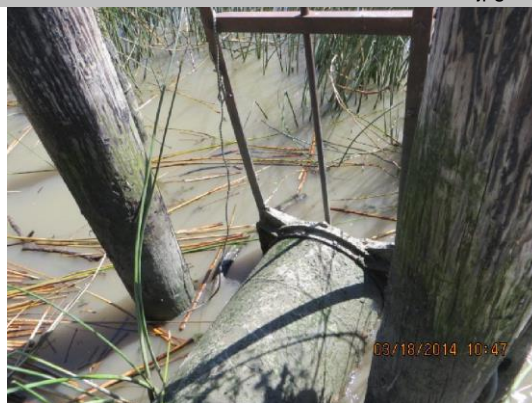
Photo 3 of 3 : UCIP_SP_2020_32243_58700.jpg

Comment Code					
Inspector Comment					
DS_ID:20970 FS_ID:32243 EP_NO: 10168 Repair Type: Non-Urgent Crossing Status: Found UCIP Comments: 03/18/2014 Walkway to slidegate on WS toe is in poor structural condition and may not be safe for accessing the slide gate actuator. Pipe appears abandoned and if so should be done so properly. Outlet on LS toe may be buried. (W. Wylie - DWR UCIP) FIELD_STRUCT_DESC: 24-inch steel irrigation pipe through the levee, 22.3 feet below the crown. Slide gate on the waterside (WS) end. Walkway from the WS shoulder to the slide gate control. Flap gate on the landside (LS) end. (This pipe was retained under Automatic Board Order (ABO) issued as Permit No. 10168, 1974 - Moresco Brothers). [Additional Reference(s): DWR Levee Log, 2003]. FS Date: 3/18/2014

Slidegate on WS toe at pipe.

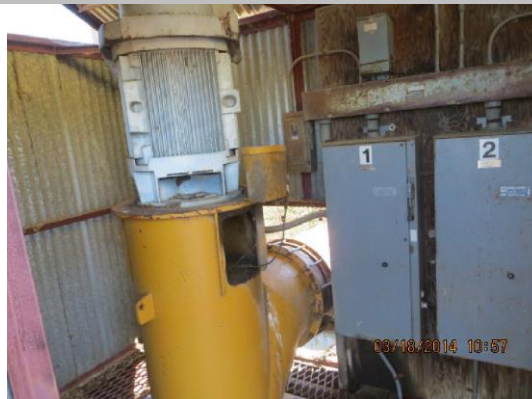
Photo 1 of 3 : UCIP_SP_2020_41717_58704.jpg

DS_ID:20971
FS_ID:41717
EP_NO: 15169
Repair Type: Non-Urgent
Crossing Status: Found
UCIP Comments: 12/22/2016 Met with Mike Hadesty, LMA Superintendent, and Brian Bush, LMA General Manager, to go over the list of pipes in RD2098. Per LMA, pipe is a drainage pipe. New property owner is John Anderson. (O. Magana - DWR UCIP)
03/18/2014 Debris and soil buildup in riser may prevent proper function of siphon breaker. (W. Wylie - DWR UCIP)
FIELD_STRUCT_DESC: 1 of 2: 24-inch coated steel drainage pipe through the levee, 5.6 feet below the crown. Cutoff wall around the pipe at the center of the levee. Siphon breaker at the waterside (WS) shoulder. Flap gate on the WS end. Pump in pump house on piling structure on the landside (LS). (Permit No. 15169, 1989 - Maxim Development). [Additional Reference(s): DWR Levee Log, 2003].
FS Date: 3/18/2014

Pump in pumphouse on LS toe.

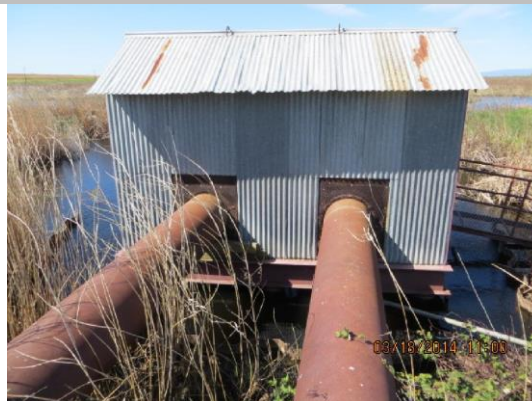
Photo 2 of 3 : UCIP_SP_2020_41717_58703.jpg

Pump in pumphouse on LS toe.

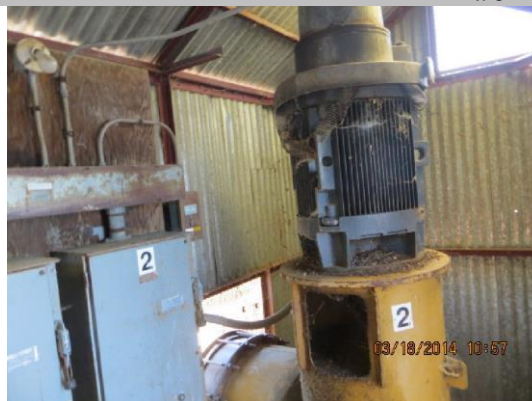
Photo 1 of 3 : UCIP_SP_2020_32245_58710.jpg

DS_ID:20959
FS_ID:32245
EP_NO: 15169
Repair Type: Non-Urgent
Crossing Status: Found
UCIP Comments: 12/22/2016 Met with Mike Hadesty, LMA Superintendent, and Brian Bush, LMA General Manager, to go over the list of pipes in RD2098. Per LMA, pipe is a drainage pipe. New property owner is John Anderson. (O. Magana - DWR UCIP)
03/18/2014 Soil and debris buildup in steel riser on WS shoulder may prevent proper function of siphon breaker. (W. Wylie - DWR UCIP)
FIELD_STRUCT_DESC: 2 of 2: 24-inch coated steel drainage pipe through the levee, 5.6 feet below the crown. Cutoff wall around the pipe at the center of the levee. Siphon breaker on the waterside (WS) shoulder. Flap gate on the WS end. Pump in pump house on piling structure on the landside (LS). (Permit No. 15169, 1989 - Maxim Development). [Additional Reference(s): DWR Levee Log, 2003].
FS Date: 3/18/2014

Pump in pumphouse on LS toe.

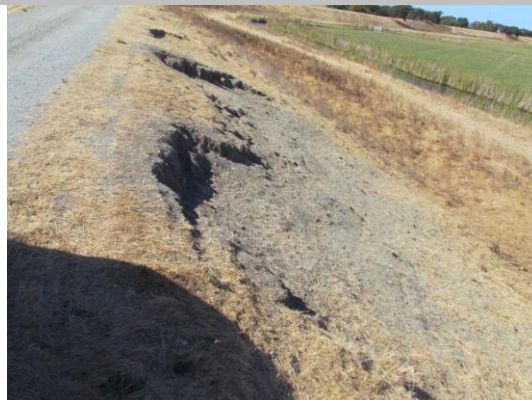
Photo 1 of 1 : SP_2020_RD2098_247_1_20200304_00002.jpg

LM Start	7.51	Rating **	M	Issue No.	1
LM End	7.51	Issue Type +	Ma	Location *	LS
Category	Earthen Levee			GPS Latitude/Longitude	
				Start	End
Item	Erosion / Bank Caving			38.296846 °	38.296846 °
				-121.727546 °	-121.727546 °
DWR ID	DWR_RD2098_03_f_2016_1				
Comment Code					
E2 : Schedule repair of erosion site prior to the next inspection.					
Inspector Comment					
Erosion on landside slope is caused by livestock activity and needs repair.

Close up. Looking upstream.

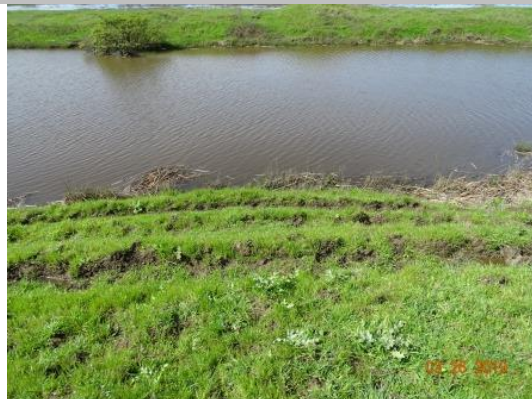
Photo 1 of 3 : SP_2020_RD2098_248_9_20200304_00001.jpg

LM Start	9.44	Rating **	U	Issue No.	9 (cont)
LM End	9.74	Issue Type +	Ma	Location *	WS

View looking downslope at deep ruts in the waterside slope made by cows (Spring 2019).

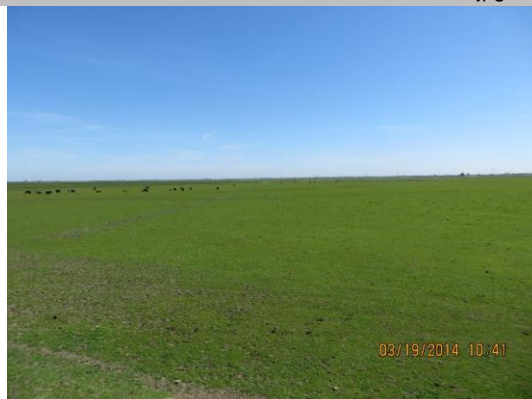
Photo 1 of 2 : UCIP_SP_2020_32383_58881.jpg

DS_ID:20983
 FS_ID:32383
 EP_NO: N/A
 Repair Type: Non-Urgent
 Crossing Status: Indicator Found
 UCIP Comments: 03/19/2014 need to verify status of gaslines in region with PG&E (888) 743-7431 Email: PipelineRequests@pge.com. (W. Wylie - DWR UCIP)
 FIELD_STRUCT_DESC: 4-inch gas line of an unknown material through the levee, 2 feet below the crown. Shutoff valve located 370 feet east of the levee crown. [Additional Reference(s): DWR Levee Log, 2003].
 FS Date: 3/19/2014

Shutoff valve visible 370-feet off LS toe.

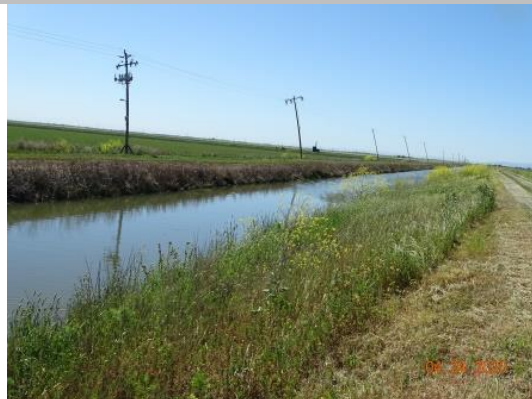
Photo 1 of 1 : SP_2020_RD2098_248_11_20200424_00025.jpg

LM Start	9.83	Rating **	U	Issue No.	11
LM End	12.05	Issue Type +	Ma	Location *	LS
Category	Earthen Levee			GPS Latitude/Longitude	
				Start	End
Item	Vegetation			38.325721 °	38.357780 °
				-121.740509 °	-121.740365 °
DWR ID	DWR_RD2098_04_s_2020_11				
Comment Code					
V1 : Control annual grass and weeds on the levee slopes and easements.					
Inspector Comment

View looking downstream at annual vegetation on the landside slope (Spring 2020).

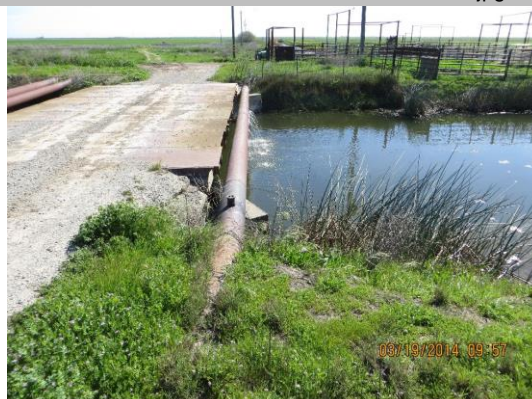
Photo 1 of 3 : UCIP_SP_2020_32403_58905.jpg

Comment Code						
Inspector Comment						
DS_ID:20991 FS_ID:32403 EP_NO: 12851 Repair Type: Non-Urgent Crossing Status: Found UCIP Comments: 12/22/2016 Met with Mike Hadesty, LMA Superintendent, and Brian Bush, LMA General Manager, to go over the list of pipes in RD2098. Per LMA, suspended pipe with leaks was repaired in the summer of 2016. (O. Magana - DWR UCIP) 03/19/2014 Holes in pipe next to rail car bridge may indicate further deterioration of pipe through levee. Good candidate for video inspection. (W. Wylie - DWR UCIP) FIELD_STRUCT_DESC: 12-inch steel irrigation pipe through the levee, 2 feet below the crown. Cutoff wall around the pipe at the center of the levee. Siphon breaker on the landside (LS) toe at the canal. 1-inch polyvinyl chloride (PVC) electrical conduit at the same location (Permit No. 12851, 1980 - Bunker Ranch). [Additional Reference(s): DWR Levee Log, 2003]. FS Date: 3/19/2014

Pipe and siphon breaker visible on LS at canal crossing.

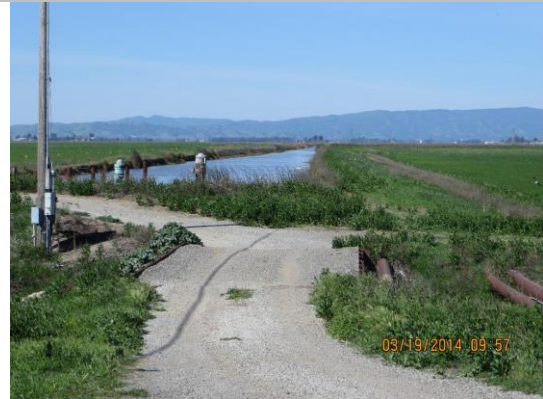
Photo 2 of 3 : UCIP_SP_2020_32403_58904.jpg

Pump on pier in irrigation canal off WS toe.

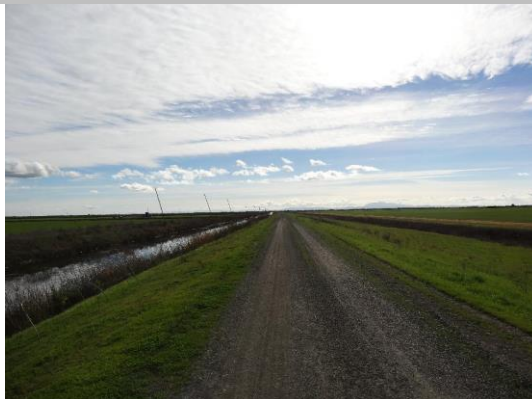
Photo 1 of 1 : UCIP_SP_2020_53380_76889.jpg

Comment Code						
Inspector Comment						
DS_ID:20995 FS_ID:53380 EP_NO: 17842 Repair Type: Non-Urgent Crossing Status: Found UCIP Comments: 10/2/2018 Crossing downgraded to Non-Urgent due to reclassification of gas lines. Need to contact owner to determine current status of crossing (D. Sanoski - DWR UCIP).12/22/2016 same as previous inspection crossing remains Urgent due to unknown status of gas line--no markers present. According to LMA representative, RD 2068 issued a permit for a gas line however, the current status of this line is unknown. Permit issued by RD 2068 is 20040903. Need to contact owner to determine status of crossing. Markers will need to be installed per Title 23. (O. Magana - DWR UCIP)03/19/2014 No markers found. Need to contact owner to determine status and location. (W. Wylie - DWR UCIP) FIELD_STRUCT_DESC: 3-inch gas line of an unknown material bored under the levee and the channel, approximately 37 feet below the crown. (3-inch natural gas line authorized under Permit No. 17842, 2004 - Castle Minerals, Inc.). FS Date: 10/2/2018 4:32:00 PM

View of levee crown and slopes through this section of the levee.

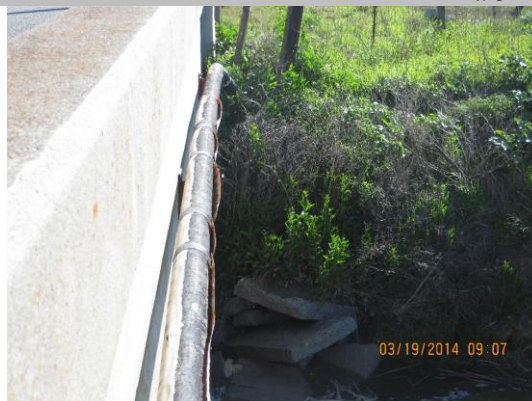
Photo 2 of 3 : UCIP_SP_2020_32566_59109.jpg

Comment Code
<p>DS_ID:24845</p> <p>FS_ID:32566</p> <p>EP_NO: N/A</p> <p>Repair Type: Non-Urgent</p> <p>Crossing Status: Found</p> <p>UCIP Comments: 03/19/2014 Need to verify status with gas company and install signs. No permit identified for crossing, though it may be connected to a permitted line installed in RD 2068 under Permit No. 13490. (W. Wylie - DWR UCIP)</p> <p>FIELD_STRUCT_DESC: 6-inch coated steel gas line through the levee, 3 feet below the crown. Signs on the east side of the levee. Pipe visible on the downstream side of the roadway bridge.</p> <p>FS Date: 3/19/2014</p>

Pipe visible on South side of Bridge at Swan Road.

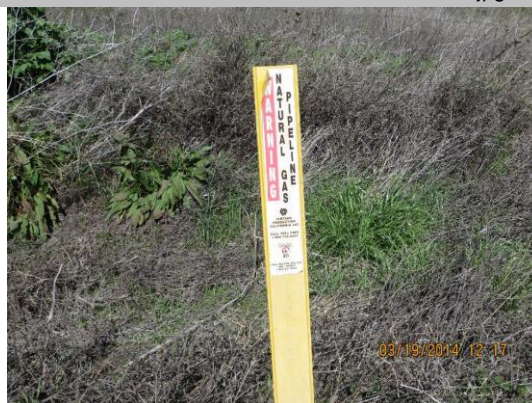
Photo 3 of 3 : UCIP_SP_2020_32566_59108.jpg

Sign off LS toe on East side of canal.
