**Flood Control Project Maintenance
Levee Inspections
LMA District Cover Sheet**

Reclamation District No. 2098 Cache and Haas Slough

**Flood Control Project Maintenance
Levee Inspections
Unit Cover Sheet**

Waterway			Bank	Unit Miles
Unit No. 01 Yolo Bypass			Right	3.60
	Spring (March - May)	Summer (June - August)	(September - November) Fall	Winter (December - February)
Unit Maintenance Rating (Fall Only)				
Date of Inspection	3/18/2022 - 3/18/2022			
DWR Inspector	David Julian			
Accompanied By			Bryan Busch RD 2098

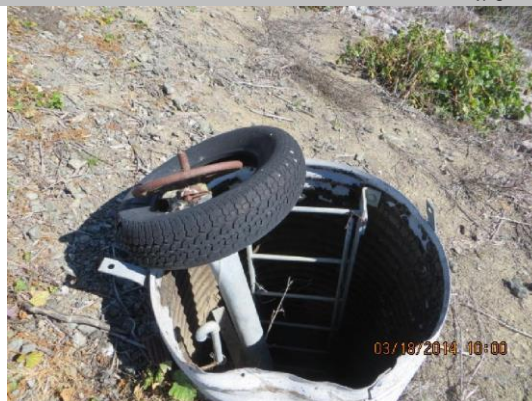
Photo 1 of 3 : UCIP_SP_2022_32207_58665.jpg

LM Start	1.83	Rating **	M	Issue No.	2 (cont)
LM End	1.83	Issue Type +	En	Location *

36-inch CMP riser with bent slide gate actuator on WS slope.

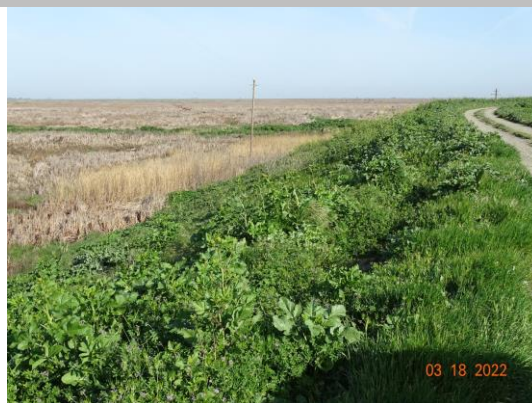
Photo 1 of 1 : SP_2022_RD2098_244_22_20220318_00033.jpg

LM Start	3.23	Rating **	U	Issue No.	22
LM End	3.59	Issue Type +	Ma	Location *	LS
Category	Earthen Levee			GPS Latitude/Longitude	
				Start	End
Item	Vegetation			38.282395 °	38.277577 °
				-121.693982 °	-121.696227 °
DWR ID	DWR_RD2098_01_s_2022_22				
Comment Code					
V1 : Control annual grass and weeds on the levee slopes and easements.					
Inspector Comment

View looking upstream at vegetation on the landside slope (Spring 2022).

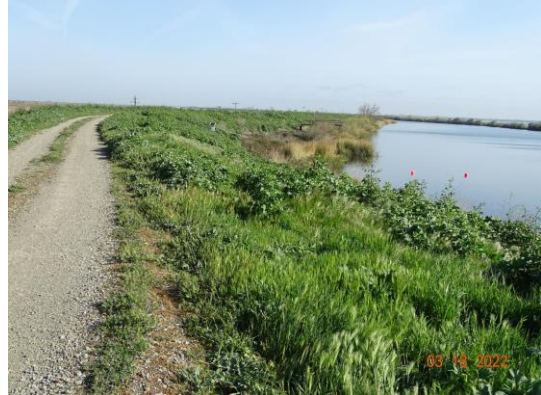
Photo 1 of 1 : SP_2022_RD2098_244_23_20220318_00032.jpg

LM Start	3.23	Rating **	U	Issue No.	23
LM End	3.59	Issue Type +	Ma	Location *	WS
Category	Earthen Levee			GPS Latitude/Longitude	
				Start	End
Item	Vegetation			38.282389 °	38.277577 °
				-121.693987 °	-121.696227 °
DWR ID	DWR_RD2098_01_s _ 2022_23				
Comment Code					
V1 : Control annual grass and weeds on the levee slopes and easements.					
Inspector Comment

View looking upstream at vegetation on the waterside slope (Spring 2022).

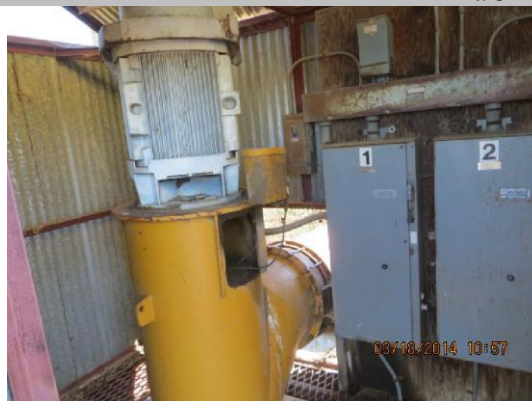
Photo 1 of 3 : UCIP_SP_2022_41717_58704.jpg

FS_ID:41717
DS_ID:20971
EP_NO: 15169
Repair Type: Non-Urgent
Crossing Status: Found
UCIP Comments: 12/22/2016 Met with Mike Hadesty, LMA Superintendent, and Brian Bush, LMA General Manager, to go over the list of pipes in RD2098. Per LMA, pipe is a drainage pipe. New property owner is John Anderson. (O. Magana - DWR UCIP)
03/18/2014 Debris and soil buildup in riser may prevent proper function of siphon breaker. (W. Wylie - DWR UCIP)
FIELD_STRUCT_DESC: 1 of 2: 24-inch coated steel drainage pipe through the levee, 5.6 feet below the crown. Cutoff wall around the pipe at the center of the levee. Siphon breaker at the waterside (WS) shoulder. Flap gate on the WS end. Pump in pump house on piling structure on the landside (LS). (Permit No. 15169, 1989 - Maxim Development). [Additional Reference(s): DWR Levee Log, 2003].
FS Date: 3/18/2014

Pump in pumphouse on LS toe.

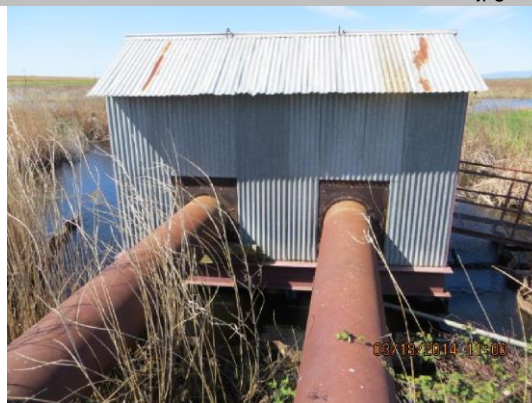
Photo 2 of 3 : UCIP_SP_2022_41717_58703.jpg

Pump in pumphouse on LS toe.

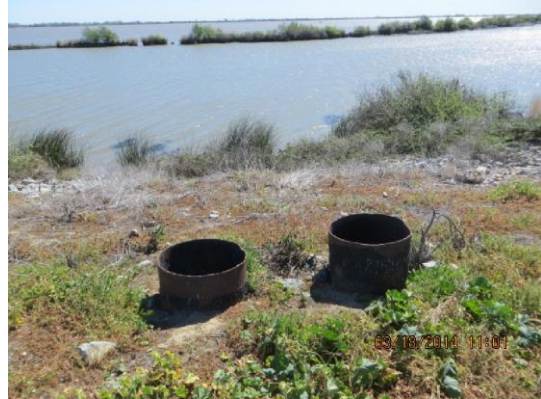
Photo 3 of 3 : UCIP_SP_2022_41717_58707.jpg

LM Start	3.50	Rating **	M	Issue No.	9 (cont)
LM End	3.50	Issue Type +	En	Location *	
Category	Supplemental		GPS Latitude/Longitude		
			Start	End	
Item	DWR UCIP Field Study		38.278770 °	38.278770 °	
			-121.696050 °	-121.696050 °	
DWR ID	20971

Siphon breaker in 24-inch steel riser on WS shoulder.

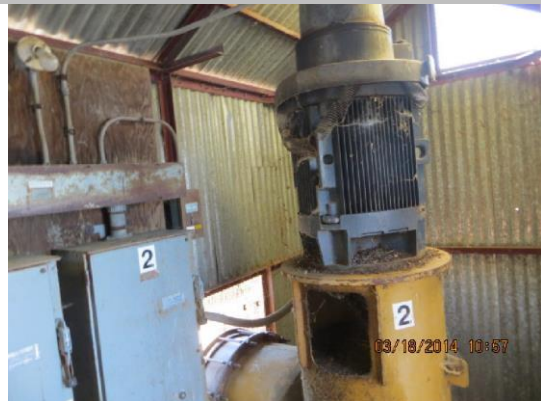
Photo 1 of 3 : UCIP_SP_2022_32245_58710.jpg

FS_ID:32245
DS_ID:20959
EP_NO: 15169
Repair Type: Non-Urgent
Crossing Status: Found
UCIP Comments: 12/22/2016 Met with Mike Hadesty, LMA Superintendent, and Brian Bush, LMA General Manager, to go over the list of pipes in RD2098. Per LMA, pipe is a drainage pipe. New property owner is John Anderson. (O. Magana - DWR UCIP)
03/18/2014 Soil and debris buildup in steel riser on WS shoulder may prevent proper function of siphon breaker. (W. Wylie - DWR UCIP)
FIELD_STRUCT_DESC: 2 of 2: 24-inch coated steel drainage pipe through the levee, 5.6 feet below the crown. Cutoff wall around the pipe at the center of the levee. Siphon breaker on the waterside (WS) shoulder. Flap gate on the WS end. Pump in pump house on piling structure on the landside (LS). (Permit No. 15169, 1989 - Maxim Development). [Additional Reference(s): DWR Levee Log, 2003].
FS Date: 3/18/2014

Pump in pumphouse on LS toe.

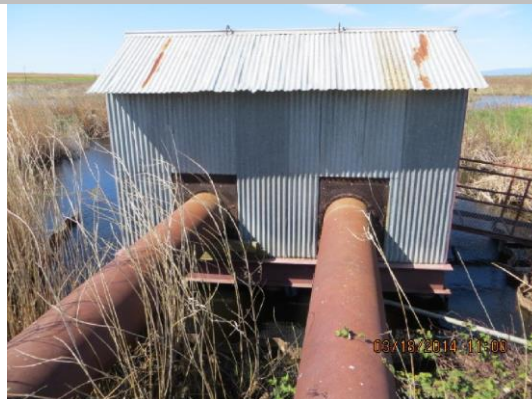
Photo 2 of 3 : UCIP_SP_2022_32245_58709.jpg

Pump in pumphouse on LS toe.

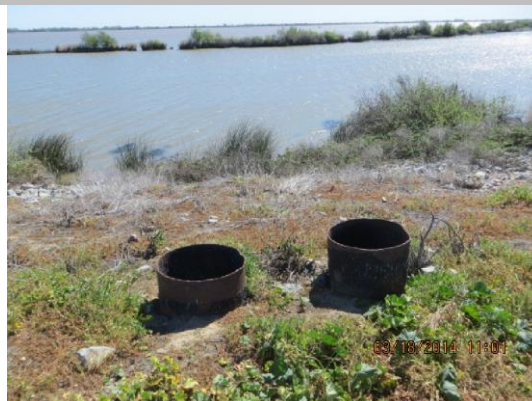
Photo 3 of 3 : UCIP_SP_2022_32245_58708.jpg

Siphon breaker in steel riser on WS shoulder.

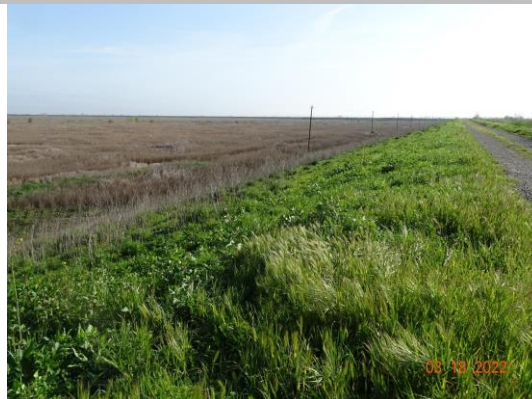
Photo 1 of 1 : SP_2022_RD2098_245_1_20220318_00001.jpg

LM Start	0.01	Rating **	M	Issue No.	1
LM End	0.51	Issue Type +	Ma	Location *	LS
Category	Earthen Levee			GPS Latitude/Longitude	
				Start	End
Item	Vegetation			38.277392 °	38.275739 °
				-121.696396 °	-121.705456 °
DWR ID	DWR_RD2098_01A_f_2021_1				
Comment Code					
V1 : Control annual grass and weeds on the levee slopes and easements.					
Inspector Comment

View looking downstream at vegetation on the landside slope (Spring 2022).

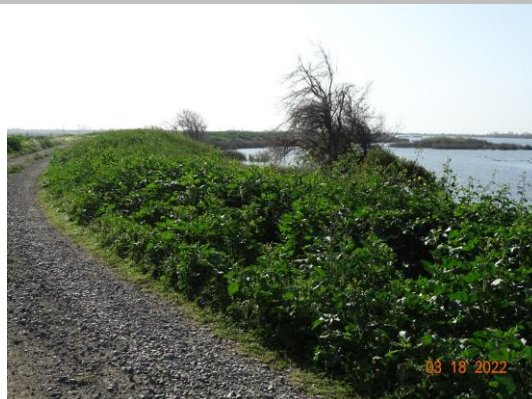
Photo 1 of 1 : SP_2022_RD2098_246_8_20220318_00027.jpg

LM Start	5.31	Rating **	U	Issue No.	8
LM End	7.16	Issue Type +	Ma	Location *	WS
Category	Earthen Levee			GPS Latitude/Longitude	
				Start	End
Item	Vegetation			38.275898 °	38.292985 °
				-121.705914 °	-121.723733 °
DWR ID	DWR_RD2098_02_s_2022_8				
Comment Code					
V1 : Control annual grass and weeds on the levee slopes and easements.					
Inspector Comment

View looking downstream at vegetation on the waterside slope (Spring 2022).

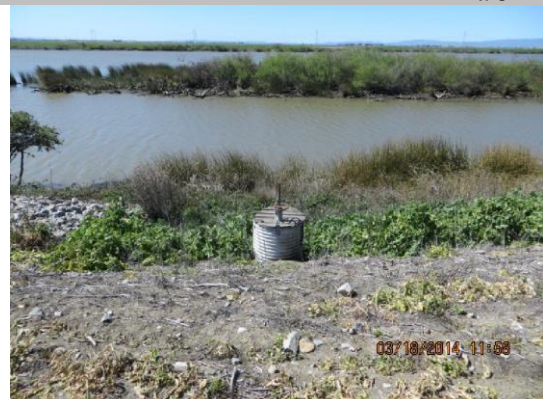
Photo 2 of 3 : UCIP_SP_2022_32287_58754.jpg

Comment Code						
Inspector Comment						
FS_ID:32287 DS_ID:20973 EP_NO: 10172 Repair Type: Non-Urgent Crossing Status: Found UCIP Comments: 12/22/2016 Met with Mike Hadesty, LMA Superintendent, and Brian Bush, LMA General Manager, to go over the list of pipes in RD2098. Per LMA, pipe is a drainage pipe. (O. Magana - DWR UCIP) 03/18/2014 Pipe appears abandoned and if so should be done so properly. Slide gate appears to be open and should be closed for the season. (W. Wylie - DWR UCIP) FIELD_STRUCT_DESC: 24-inch corrugated metal drainage pipe through the levee, 22.8 feet below the crown. Two cutoff walls around the pipe at the levee shoulders. Slide gate in 36-inch corrugated metal pipe (CMP) riser on the waterside (WS) slope. Flap gate and concrete U-shaped headwall on the landside (LS) end. (This pipe was retained under Automatic Board Order (ABO) issued as Permit No. 10172, 1974 - Moresco Brothers). [Additional Reference(s): DWR Levee Log, 2003]. FS Date: 3/18/2014

Slide gate in 36-inch standpipe on WS slope.

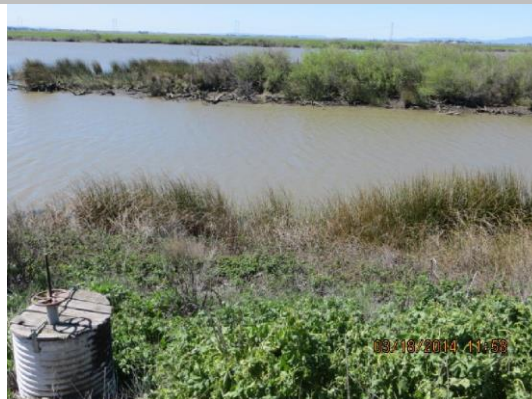
Photo 3 of 3 : UCIP_SP_2022_32287_58753.jpg

LM Start	5.71	Rating **	M	Issue No.	1 (cont)
LM End	5.71	Issue Type +	En	Location *	
Category	Supplemental		GPS Latitude/Longitude		
			Start	End	
Item	DWR UCIP Field Study		38.280788 °	38.280788 °	
			-121.709617 °	-121.709617 °	
DWR ID	20973

Slide gate in 36-inch standpipe on WS slope.

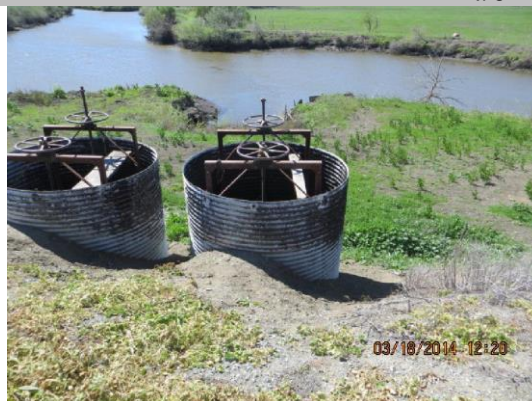
Photo 2 of 3 : UCIP_SP_2022_32285_58748.jpg

LM Start	6.72	Rating **	M	Issue No.	3 (cont)
LM End	6.72	Issue Type +	Ma	Location *	
Category	Supplemental		GPS Latitude/Longitude		
			Start	End	
Item	DWR UCIP LMA Responsibility		38.292234 °	38.292234 °	
			-121.715875 °	-121.715875 °	
DWR ID	20961

7-foot diameter CMP riser with two slide gates inside.

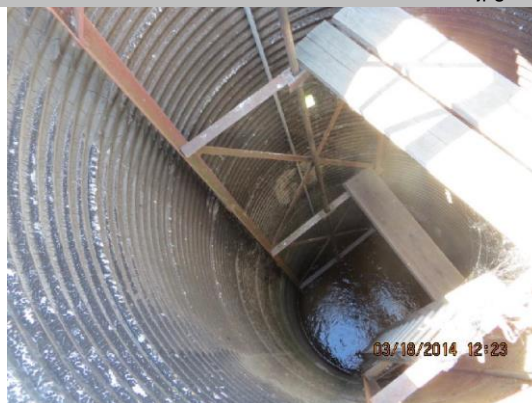
Photo 3 of 3 : UCIP_SP_2022_32285_58747.jpg

7-foot diameter CMP riser with two slide gates inside.

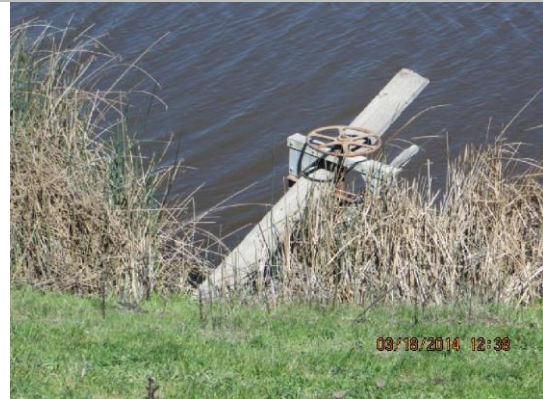
Photo 1 of 3 : UCIP_SP_2022_32290_58764.jpg

LM Start	7.19	Rating **	M	Issue No.	4 (cont)
LM End	7.19	Issue Type +	En	Location *

Slide gate at LS toe.

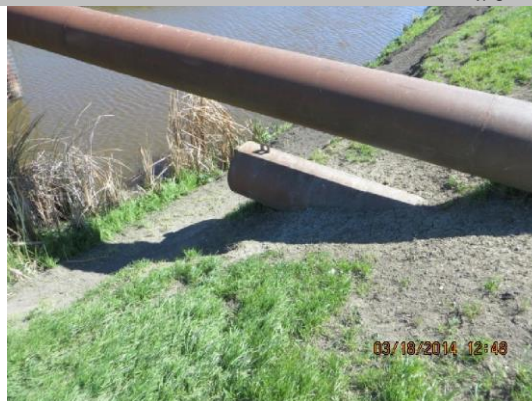
Photo 2 of 3 : UCIP_SP_2022_32303_58781.jpg

LM Start	7.24	Rating **	A/W	Issue No.	5 (cont)
LM End	7.24	Issue Type +	Ma	Location *	
Category	Supplemental			GPS Latitude/Longitude	
				Start	End
Item	DWR UCIP LMA Responsibility			38.293741 °	38.293741 °
				-121.724787 °	-121.724787 °
DWR ID	20978

Pipe visible under new pipe on LS slope.

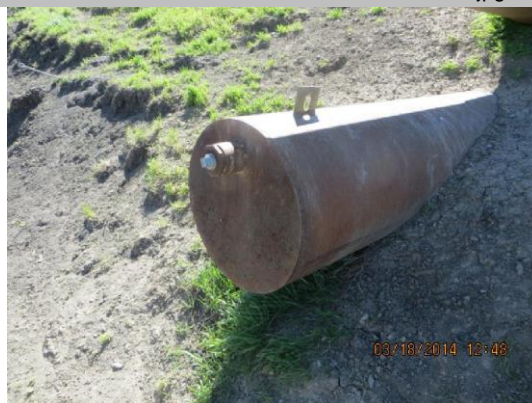
Photo 3 of 3 : UCIP_SP_2022_32303_58780.jpg

Welded steel cap over LS end of pipe.

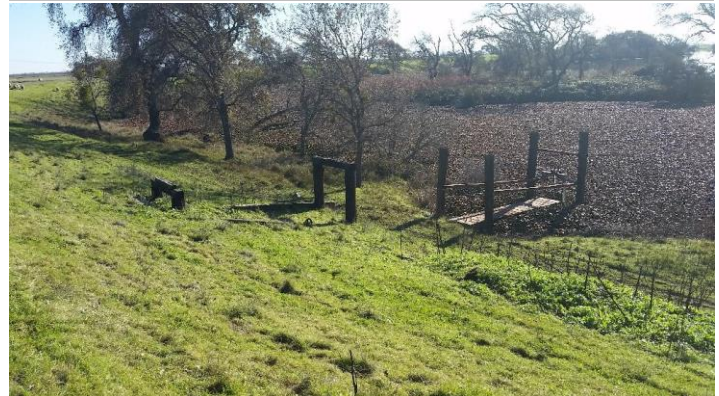
Photo 1 of 3 : UCIP_SP_2022_51453_76858.jpg

Comment Code					
Inspector Comment					
FS_ID:51453 DS_ID:20981 EP_NO: 10174 Repair Type: No Action Needed Crossing Status: Found UCIP Comments: 12/22/2016 Crossing has been downgraded from Urgent to No Action Needed walkways on both WS and LS have been rebuilt and the WS gate has been upgraded to stainless steel where previous corrodable material was present. (O. Magana - DWR UCIP)03/19/2014 Current walkway to slidegate on WS toe does not provide safe access to operate slidegate. (W. Wylie - DWR UCIP) FIELD_STRUCT_DESC: 36-inch steel dual-purpose irrigation and drainage pipe through the levee, 26 feet below the crown. Two corrugated metal cutoff walls around the pipe. Walkway to the slide gate on the waterside (WS) end. Combination slide and flap gate on the landside (LS) end. 48-inch corrugated metal pipe (CMP) riser and an adjoining pump on a metal pier at the LS toe. (36-inch pipe [HLM 8.20] authorized under Automatic Board Order (ABO) issued as Permit No. 10174, 1974 - Glen A. Bowsbey). [Additional Reference(s): DWR Levee Log, 2003. USACE Sacramento O&M Manual 109, April 1962, (HLM 8.20)]. FS Date: 12/22/2016

Walkway has been re-built, photo 1 of 2.

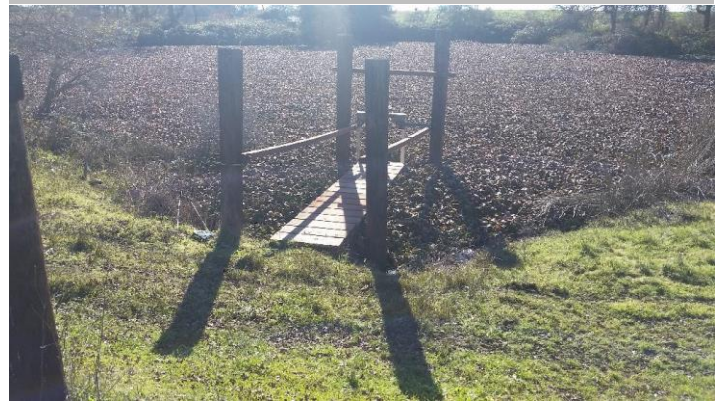
Photo 2 of 3 : UCIP_SP_2022_51453_76861.jpg

LM Start	8.16	Rating **	A/W	Issue No.	2 (cont)
LM End	8.16	Issue Type +	Ma	Location *	
Category	Supplemental		GPS Latitude/Longitude		
			Start	End	
Item	DWR UCIP LMA Responsibility		38.305462 °	38.305462 °	
			-121.728881 °	-121.728881 °	
DWR ID	20981

Walkway has been re-built, photo 2 of 2.

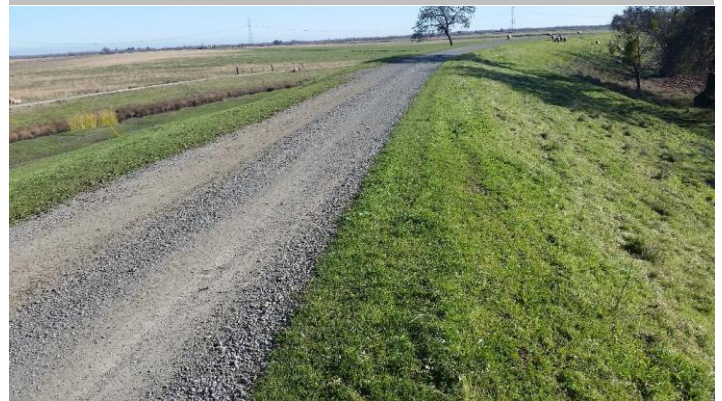
Photo 3 of 3 : UCIP_SP_2022_51453_76859.jpg

View of levee crown at pipe crossing.

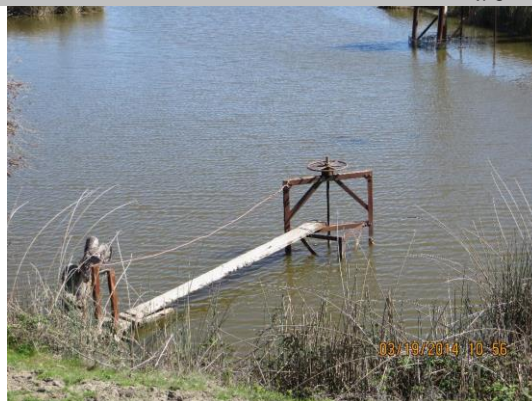
Photo 1 of 2 : UCIP_SP_2022_32384_58883.jpg

LM Start	8.35	Rating **	A/W	Issue No.	3	
LM End	8.35	Issue Type +	Ma	Location *		
Category	Supplemental			GPS Latitude/Longitude		
				Start		End
Item	DWR UCIP LMA Responsibility			38.306916 °	38.306916 °	
				-121.731984 °	-121.731984 °	
DWR ID	20962					
Comment Code						
Inspector Comment						
FS_ID:32384 DS_ID:20962 EP_NO: 10174 Repair Type: No Action Needed Crossing Status: Found UCIP Comments: FIELD_STRUCT_DESC: 60-inch corrugated metal drainage pipe through the levee, 25.5 feet below the crown. Walkway to the slide gates at both ends of the pipe. (Permit No. 1607, 1951 - R. F. Moore and Lorraine W. Zanetti. This pipe was retained under Automatic Board Order (ABO) issued as Permit No. 10174, 1974 - Glen A. Bowlsbey). [Additional Reference(s): DWR Levee Log, 2003. USACE Sacramento O&M Manual 109, April 1962, (HLM 8.40)]. FS Date: 3/19/2014

Slide gate at LS toe.

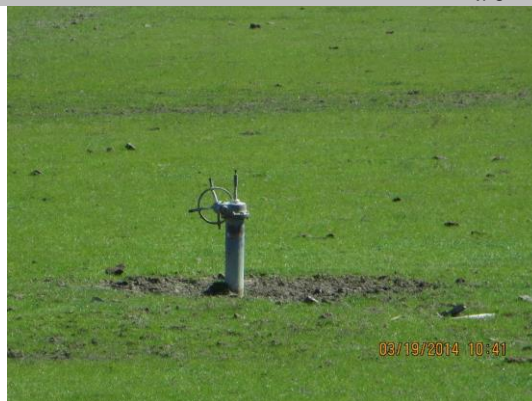
Photo 2 of 2 : UCIP_SP_2022_32383_58880.jpg

LM Start	9.49	Rating **	M	Issue No.	1 (cont)
LM End	9.49	Issue Type +	En	Location *	
Category	Supplemental		GPS Latitude/Longitude		
			Start	End	
Item	DWR UCIP Field Study		38.321032 °	38.321032 °	
			-121.740154 °	-121.740154 °	
DWR ID	20983

Shutoff valve visible 370-feet off LS toe.

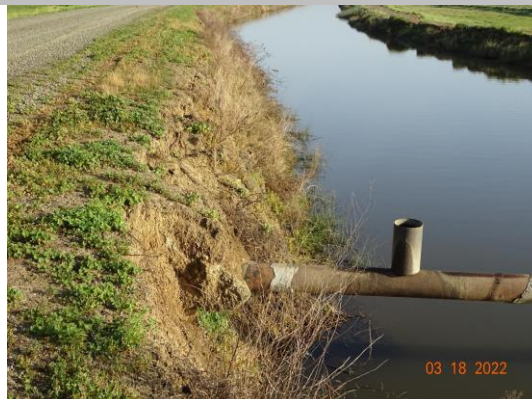
Photo 1 of 1 : SP_2022_RD2098_248_15_20220318_00023.jpg

LM Start	10.55	Rating **	M	Issue No.	15
LM End	10.60	Issue Type +	Ma	Location *	LS
Category	Earthen Levee			GPS Latitude/Longitude	
				Start	End
Item	Erosion / Bank Caving			38.336082 °	38.336754 °
				-121.740663 °	-121.740787 °
DWR ID	DWR_RD2098_04_s_2022_15				
Comment Code					
E1 : Note and monitor erosion site.					
Inspector Comment

View looking upstream at erosion into the landside slope (Spring 2022).

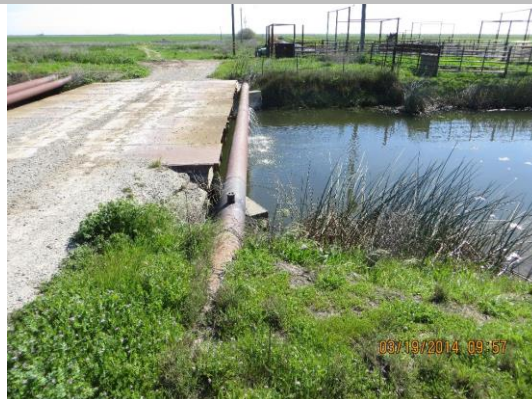
Photo 1 of 3 : UCIP_SP_2022_32403_58905.jpg

Comment Code						
Inspector Comment						
FS_ID:32403 DS_ID:20991 EP_NO: 12851 Repair Type: Non-Urgent Crossing Status: Found UCIP Comments: 12/22/2016 Met with Mike Hadesty, LMA Superintendent, and Brian Bush, LMA General Manager, to go over the list of pipes in RD2098. Per LMA, suspended pipe with leaks was repaired in the summer of 2016. (O. Magana - DWR UCIP) 03/19/2014 Holes in pipe next to rail car bridge may indicate further deterioration of pipe through levee. Good candidate for video inspection. (W. Wylie - DWR UCIP) FIELD_STRUCT_DESC: 12-inch steel irrigation pipe through the levee, 2 feet below the crown. Cutoff wall around the pipe at the center of the levee. Siphon breaker on the landside (LS) toe at the canal. 1-inch polyvinyl chloride (PVC) electrical conduit at the same location (Permit No. 12851, 1980 - Bunker Ranch). [Additional Reference(s): DWR Levee Log, 2003]. FS Date: 3/19/2014

Pipe and siphon breaker visible on LS at canal crossing.

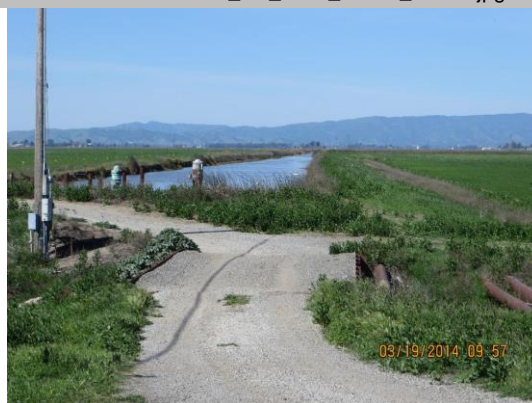
Photo 2 of 3 : UCIP_SP_2022_32403_58904.jpg

Pump on pier in irrigation canal off WS toe.

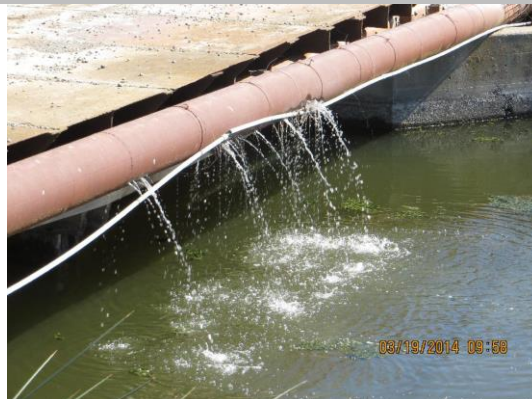
Photo 3 of 3 : UCIP_SP_2022_32403_58903.jpg

Holes in pipe next to bridge. PVC electrical conduit shown.

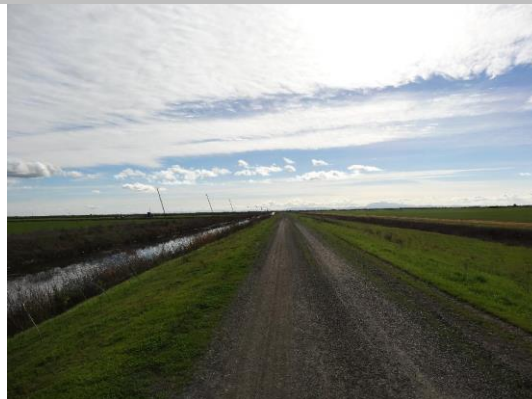
Photo 1 of 1 : UCIP_SP_2022_53380_76889.jpg

Comment Code					
Inspector Comment					
FS_ID:53380 DS_ID:20995 EP_NO: 17842 Repair Type: Non-Urgent Crossing Status: Found UCIP Comments: 10/2/2018 Crossing downgraded to Non-Urgent due to reclassification of gas lines. Need to contact owner to determine current status of crossing (D. Sanoski - DWR UCIP).12/22/2016 same as previous inspection crossing remains Urgent due to unknown status of gas line--no markers present. According to LMA representative, RD 2068 issued a permit for a gas line however, the current status of this line is unknown. Permit issued by RD 2068 is 20040903. Need to contact owner to determine status of crossing. Markers will need to be installed per Title 23. (O. Magana - DWR UCIP)03/19/2014 No markers found. Need to contact owner to determine status and location. (W. Wylie - DWR UCIP) FIELD_STRUCT_DESC: 3-inch gas line of an unknown material bored under the levee and the channel, approximately 37 feet below the crown. (3-inch natural gas line authorized under Permit No. 17842, 2004 - Castle Minerals, Inc.). FS Date: 10/2/2018 4:32:00 PM

View of levee crown and slopes through this section of the levee.

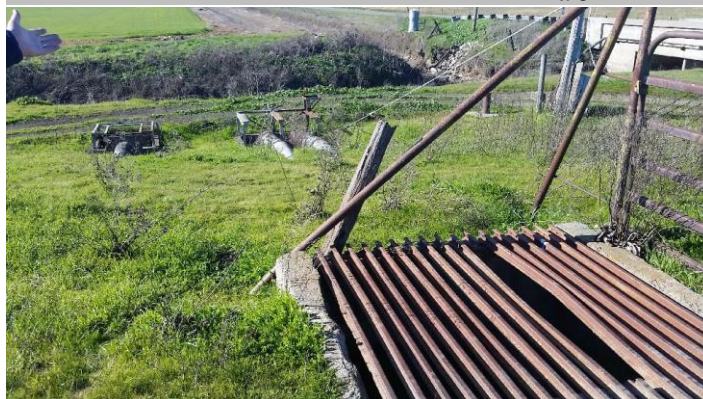
Photo 2 of 3 : UCIP_SP_2022_53381_76872.jpg

View of WS photo taken from levee crown.

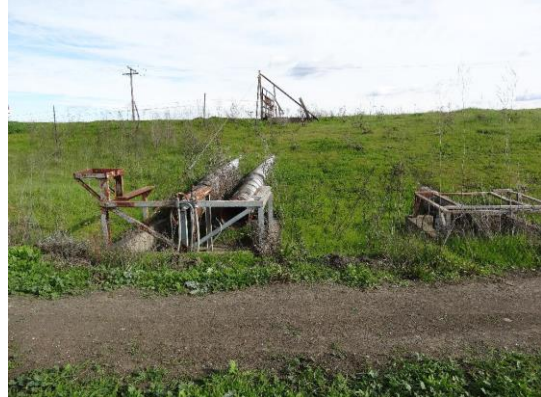
Photo 3 of 3 : UCIP_SP_2022_53381_76868.jpg

View of WS--pipe crossing is located on the right.

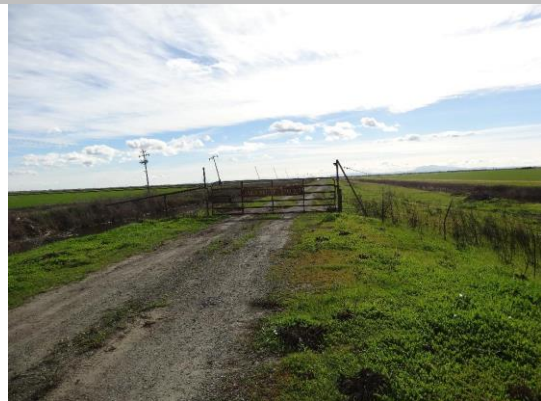
Photo 1 of 3 : UCIP_SP_2022_53382_76875.jpg

FS_ID:53382
DS_ID:20990
EP_NO: 5426-A
Repair Type: Urgent
Crossing Status: Found
UCIP Comments: 10/2/2018 Same as last inspection; remaining as Urgent and recommend internal pipe inspection (D. Sanoski - DWR UCIP).12/06/2016 Crossing is opened on both WS and LS. Concrete box located on the LS has been removed. According to Mr. Mike Hardesty, this crossing is not abandoned the crossing is out of service for now. Recommend internal integrity inspection and coordinating with CVFPB to comply with Title 23. (O. Magana - DWR UCIP)03/19/2014 Pipe appears abandoned and if so should be done so properly. Foundation for concrete distribution box on LS toe at canal has failed. Box has fallen into canal and LS slope has erosion at same location. Pipe open on both ends. (W. Wylie - DWR UCIP)
FIELD_STRUCT_DESC: 1 of 2: 18-inch coated steel drainage pipe through the levee, 3 feet below the crown. Vertical pump missing from steel platform over a 7-foot by 4-foot concrete box located on the waterside (WS) toe. Concrete cattle guard structure, 7 feet long, 15 feet wide, and 4 feet deep, located on the crown around the pipes. Discharge structure is located on the landside (LS) slope. (Permit No. 5426, 1966, and 5426-A, 1967 - Reclamation District No. 2068. Permit recordation indicates one 14-inch pipe and one 18-inch pipe to be installed). [Additional Reference(s): DWR Levee Log, 2003].

Overview of levee crown at multiple pipe crossings.

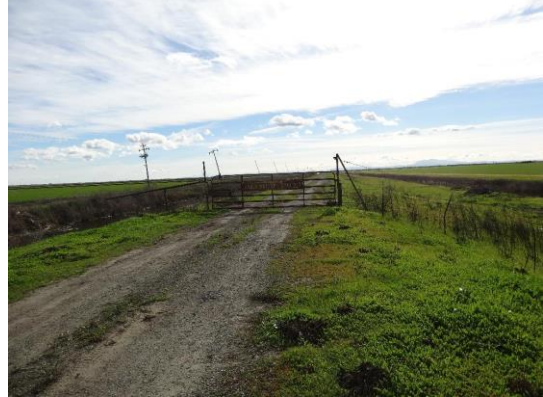
Photo 1 of 3 : UCIP_SP_2022_53383_76883.jpg

FS_ID:53383
DS_ID:21013
EP_NO: 5426-A
Repair Type: Urgent
Crossing Status: Found
UCIP Comments: 10/2/2018 Same as last inspection; remaining as Urgent and recommend internal pipe inspection (D. Sanoski - DWR UCIP).12/06/2016 Crossing is opened on both WS and LS. Concrete box located on the LS has been removed. According to Mr. Mike Hardesty, this crossing is not abandoned the crossing is out of service for now. Recommend internal integrity inspection and coordinating with CVFPB to comply with Title 23. (O. Magana - DWR UCIP)03/19/2014 Pipe appears abandoned and if so should be done so properly. Foundation for concrete distribution box on LS toe at canal has failed. Box has fallen into canal and LS slope has erosion at same location. Pipe open on both ends. (W. Wylie - DWR UCIP)
FIELD_STRUCT_DESC: 2 of 2: 18-inch coated steel drainage pipe through the levee, 3 feet below the crown. Vertical pumps missing from steel pad over a 7-foot by 4-foot concrete sump located on the waterside (WS) toe. Concrete cattle guard structure, 7 feet long, 15 feet wide, and 4 feet deep, located on the crown around the pipes. Discharge structure is located on the landside (LS) slope. (Permit No. 5426, 1966, and 5426-A, 1967 - Reclamation District No. 2068. Permit recordation indicates one 14-inch pipe and one 18-inch pipe to be installed). [Additional Reference(s): DWR Levee Log, 2003].

Overview of levee crown at multiple crossings.

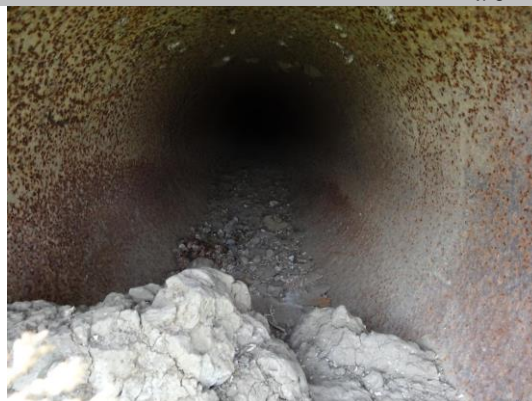
Photo 3 of 3 : UCIP_SP_2022_53383_76885.jpg

Inside view of pipe from LS.

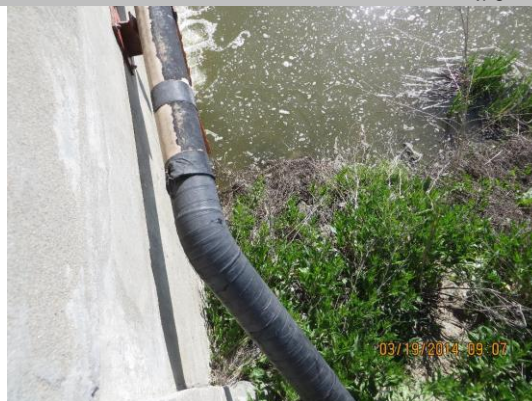
Photo 1 of 3 : UCIP_SP_2022_32566_59110.jpg

LM Start	12.07	Rating **	M	Issue No.	7	
LM End	12.07	Issue Type +	En	Location *		
Category	Supplemental			GPS Latitude/Longitude		
				Start		End
Item	DWR UCIP Field Study			38.358110 °		38.358110 °
				-121.740381 °		-121.740381 °
DWR ID	24845					
Comment Code						
Inspector Comment						
FS_ID:32566 DS_ID:24845 EP_NO: N/A Repair Type: Non-Urgent Crossing Status: Found UCIP Comments: 03/19/2014 Need to verify status with gas company and install signs. No permit identified for crossing, though it may be connected to a permitted line installed in RD 2068 under Permit No. 13490. (W. Wylie - DWR UCIP) FIELD_STRUCT_DESC: 6-inch coated steel gas line through the levee, 3 feet below the crown. Signs on the east side of the levee. Pipe visible on the downstream side of the roadway bridge. FS Date: 3/19/2014

Pipe visible on South side of Bridge at Swan Road.

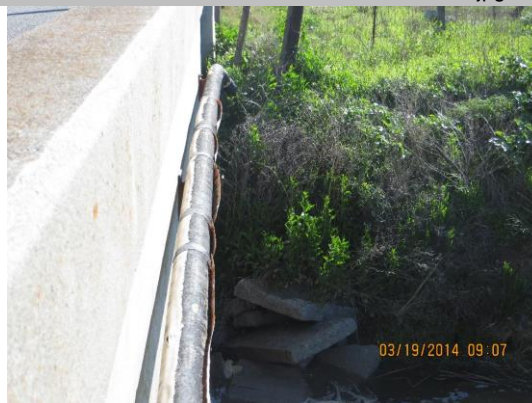
Photo 2 of 3 : UCIP_SP_2022_32566_59109.jpg

Pipe visible on South side of Bridge at Swan Road.

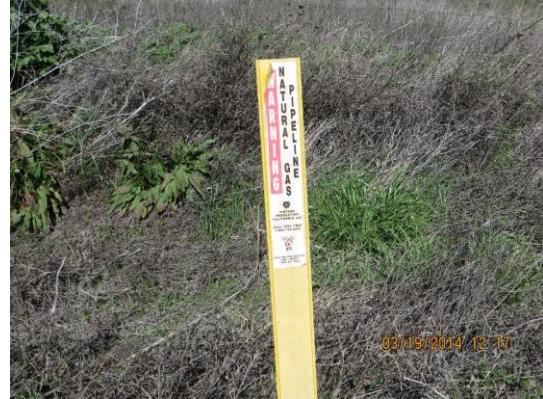
Photo 3 of 3 : UCIP_SP_2022_32566_59108.jpg

Sign off LS toe on East side of canal.
