**Flood Control Project Maintenance  
Levee Inspections**

## Maintenance Issue Types Only, Levee Inspection Report By Mile - Spring 2018

### Reclamation District No. 2098 Cache and Haas Slough

Waterway	Bank	Unit Miles	Inspection Start/End	Inspector
Unit No. 01 Yolo Bypass	Right	3.60	03/15/2018 03/15/2018	Keith Millard

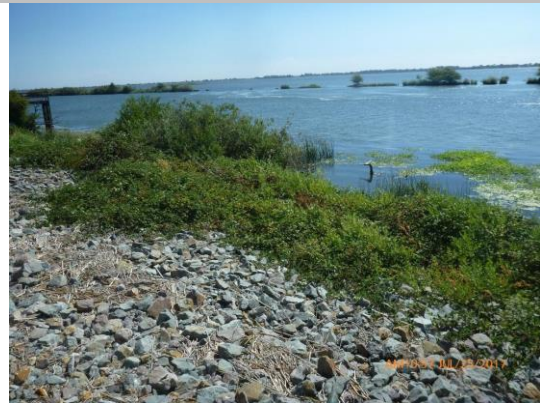
Photo 1 of 3 : SP\_2018\_RD2098\_244\_40\_20180305\_00054.jpg

LM Start	3.50	Rating **	M	Issue No.	40 (cont)	
LM End	3.56	Issue Type +	Ma	Location *		
Category	Supplemental			GPS Latitude/Longitude		
				Start	End	
Item	2017 Storm Damage			38.278700 °	38.278000 °	
				-121.695900 °	-121.696100 °	
DWR ID	DWR_RD2098_01_f_2017_40					
Comment Code						
Inspector Comment						
Levee Evaluation Comments						
Description:The damage consists of scour and sloughing of the lower and mid waterside levee slope.						
Site ID No:435						
Site Designation:LMA-262						
Repair Type: Erosion						
Rating:Area of Concern						
Field Date:7/25/2017						
Notes: Two combined sloughing sites adjacent to each other on lower waterside slope. Existing rip rap on beginning 100' section of site 262.						
This site is combined with site 263.

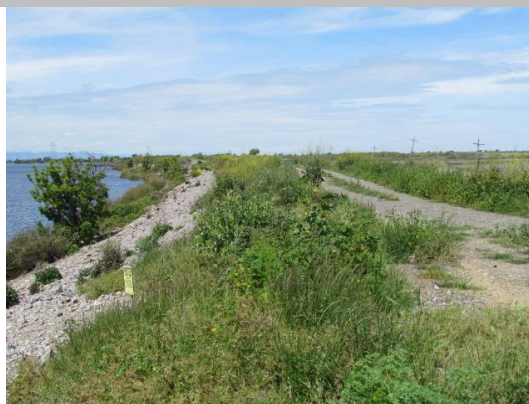
Photo 1 of 1 : SP\_2018\_RD2098\_246\_9\_20180305\_00003.jpg

LM Start	5.30	Rating **	M	Issue No.	9
LM End	6.16	Issue Type +	Ma	Location *	WS
Category	Earthen Levee			GPS Latitude/Longitude	
				Start	End
Item	Vegetation			38.275757 °	38.284800 °
				-121.705818 °	-121.715200 °
DWR ID	DWR_RD2098_02_s_2017_9				
Comment Code					
V2 : Remove the wild growth other than native grasses from the levee slopes.					
Inspector Comment					
Remove the wild weed growth from the waterside levee slope.

RD 2098 Unit 2 levee mile 5.30- 7.14 waterside levee slope and shoulder.

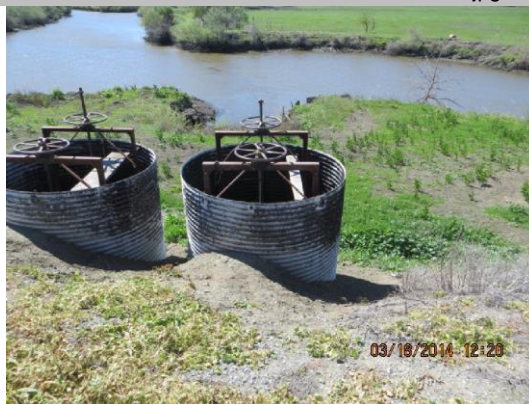
Photo 2 of 3 : UCIP\_SP\_2018\_32285\_58748.jpg

FS\_ID:32285  
DS\_ID:20961  
EP\_NO: 10172  
Repair Type: Non-Urgent  
Crossing Status: Found  
UCIP Comments: Headwalls at WS toe failing. It is uncertain if these retaining walls were a permanent fixture or a temporary fix that failed.  
FIELD\_STRUCT\_DESC: 2 of 2: 48-inch corrugated metal drainage pipe through the levee, 29 feet below the crown. Two slide gates in a 7-foot-diameter corrugated metal pipe (CMP) riser on the waterside (WS) slope. (two 48-inch pipes [HLM 6.75] authorized under Automatic Board Order (ABO) issued as Permit No. 10172, 1974 - Moresco Brothers).  
[Additional Reference(s): DWR Levee Log, 2003. USACE Sacramento O&M Manual 109, April 1962, (HLM 6.75)].  
FS Date: 3/18/2014

7-foot diameter CMP riser with two slide gates inside.

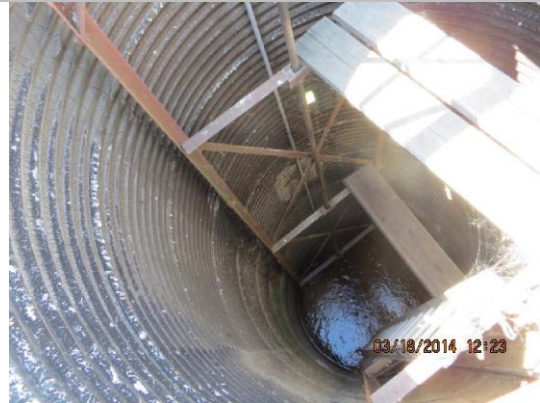
Photo 3 of 3 : UCIP\_SP\_2018\_32285\_58747.jpg

Comment Code						
Inspector Comment						
FS_ID:32285 DS_ID:20961 EP_NO: 10172 Repair Type: Non-Urgent Crossing Status: Found UCIP Comments: Headwalls at WS toe failing. It is uncertain if these retaining walls were a permanent fixture or a temporary fix that failed. FIELD_STRUCT_DESC: 2 of 2: 48-inch corrugated metal drainage pipe through the levee, 29 feet below the crown. Two slide gates in a 7-foot-diameter corrugated metal pipe (CMP) riser on the waterside (WS) slope. (two 48-inch pipes [HLM 6.75] authorized under Automatic Board Order (ABO) issued as Permit No. 10172, 1974 - Moresco Brothers). [Additional Reference(s): DWR Levee Log, 2003. USACE Sacramento O&M Manual 109, April 1962, (HLM 6.75)]. FS Date: 3/18/2014

7-foot diameter CMP riser with two slide gates inside.

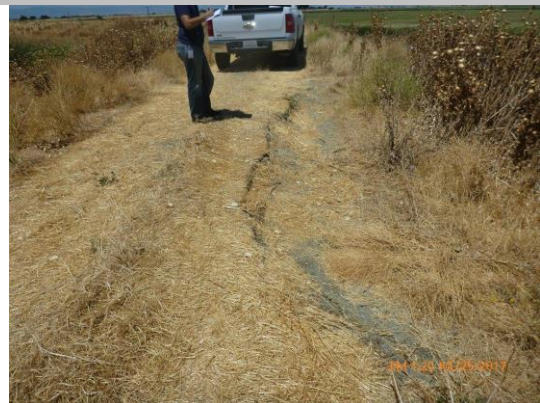
Photo 1 of 3 : SP\_2018\_RD2098\_246\_19\_20180305\_00018.jpg

LM Start	6.74	Rating **	A/W	Issue No.	19
LM End	6.75	Issue Type +	Ma	Location *	
Category	Supplemental			GPS Latitude/Longitude	
				Start	End
Item	2017 Storm Damage			38.292500 °	38.292600 °
				-121.716100 °	-121.716200 °
DWR ID	DWR_RD2098_02_f_2017_19				
Comment Code					
Inspector Comment					
Levee Evaluation Comments					
Description:The damage consists of scour and sloughing of the landside levee slope.					
Site ID No:443					
Site Designation:LMA-270					
Repair Type: Stability					
Rating:Area of Concern					
Field Date:7/25/2017					
Notes: Sloughing on crown into upper portion of landside levee slope.

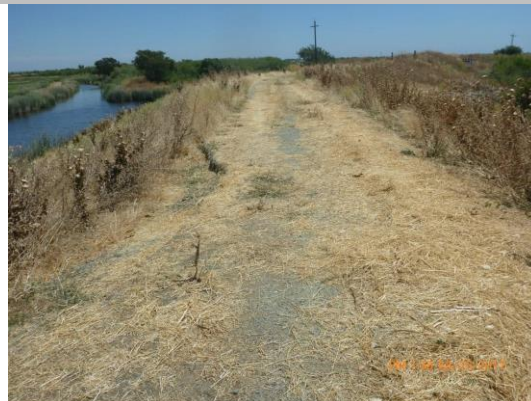
Photo 3 of 4 : SP\_2018\_RD2098\_246\_20\_20180305\_00023.jpg

Description: The damage consists of cracking of the levee crest.

LM Start	<b>6.77</b>	Rating **	A/W	Issue No.	<b>20 (cont)</b>
LM End	<b>6.80</b>	Issue Type +	Ma	Location *

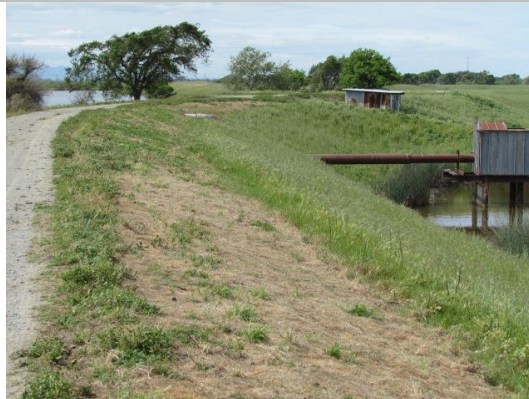
Photo 1 of 2 : SP\_2018\_RD2098\_247\_2\_20180305\_00003.jpg

LM Start	7.19	Rating **	A/W	Issue No.	2
LM End	7.31	Issue Type +	Ma	Location *	LS
Category	Earthen Levee			GPS Latitude/Longitude	
				Start	End
Item	Vegetation			38.293178 °	38.294705 °
				-121.724220 °	-121.725130 °
DWR ID	DWR_RD2098_03_f_2016_2				
Comment Code					
V2 : Remove the wild growth other than native grasses from the levee slopes.					
Inspector Comment					
Landside vegetation is acceptable; continue to maintain.

RD 2098 Looking downstream from levee mile 7.19-7.31

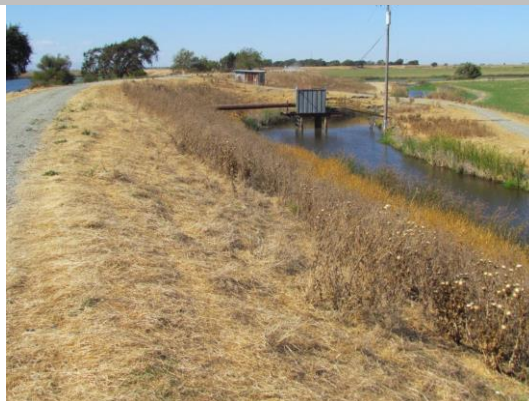
Photo 2 of 2 : SP\_2018\_RD2098\_247\_2\_20180305\_00004.jpg

LM Start	<b>7.19</b>	Rating **	A/W	Issue No.	<b>2 (cont)</b>
LM End	<b>7.31</b>	Issue Type +	Ma	Location *	LS

RD 2098 Looking downstream from levee mile 7.19 landside slope.

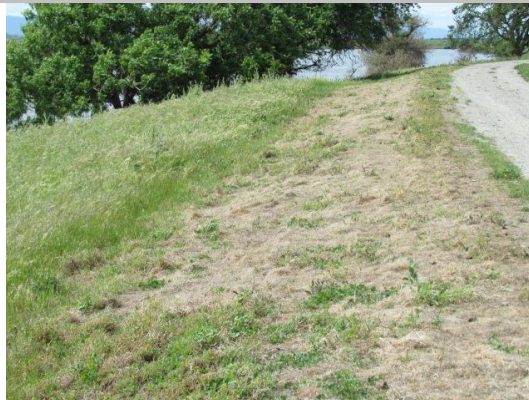
Photo 1 of 1 : SP\_2018\_RD2098\_247\_8\_20180305\_00006.jpg

LM Start	7.19	Rating **	A/W	Issue No.	8
LM End	7.31	Issue Type +	Ma	Location *	WS
Category	Earthen Levee			GPS Latitude/Longitude	
				Start	End
Item	Vegetation			38.293178 °	38.294705 °
				-121.724215 °	-121.725133 °
DWR ID	DWR_RD2098_03_f_2016_8				
Comment Code					
V2 : Remove the wild growth other than native grasses from the levee slopes.					
Inspector Comment					
Waterside vegetation is acceptable; continue to maintain.

RD 2098 Unit 3 levee mile 7.19-7.31 waterside slope.

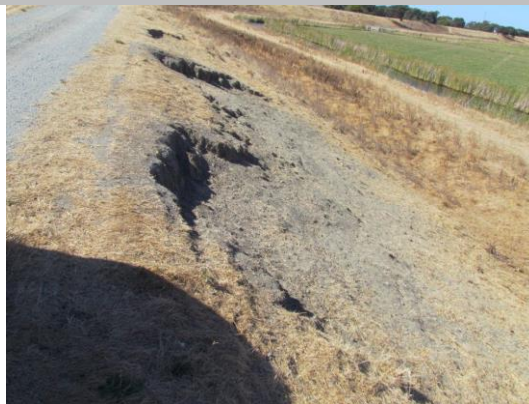
Photo 1 of 3 : SP\_2018\_RD2098\_247\_1\_20180305\_00001.jpg

LM Start	7.51	Rating **	M	Issue No.	1
LM End	7.51	Issue Type +	Ma	Location *	LS
Category	Earthen Levee			GPS Latitude/Longitude	
				Start	End
Item	Slope Stability			38.296846 °	38.296846 °
				-121.727546 °	-121.727546 °
DWR ID	DWR_RD2098_03_f_2016_1				
Comment Code					
S2 : Repair the levee slope damaged by foot traffic and prevent access where possible.					
Inspector Comment					
Make the repairs to the erosion site listed.

Close up. Looking upstream.

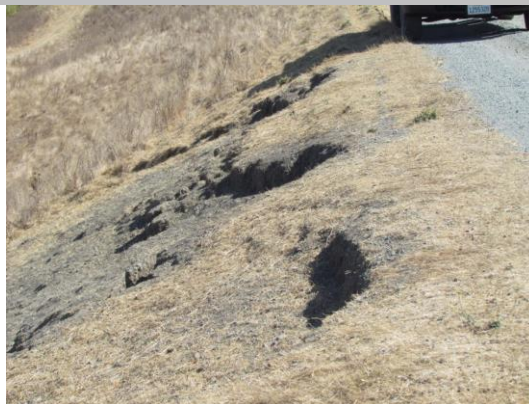
Photo 2 of 3 : SP\_2018\_RD2098\_247\_1\_20180305\_00002.jpg

Looking downstream.

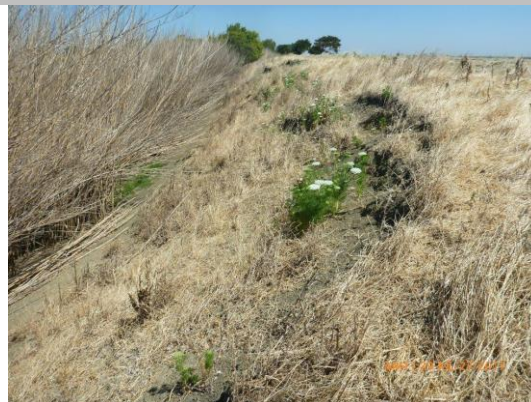
Photo 1 of 3 : SP\_2018\_RD2098\_247\_10\_20180305\_00007.jpg

LM Start	7.61	Rating **	M	Issue No.	10
LM End	7.62	Issue Type +	Ma	Location *	
Category	Supplemental			GPS Latitude/Longitude	
				Start	End
Item	2017 Storm Damage			38.297900 °	38.298100 °
				-121.728900 °	-121.728900 °
DWR ID	DWR_RD2098_03_f_2017_10				
Comment Code					
Inspector Comment					
Levee Evaluation Comments					
Description:The damage consists of sloughing of the lower and mid waterside levee slope.					
Site ID No:449					
Site Designation:LMA-276					
Repair Type: Erosion					
Rating:Area of Concern					
Field Date:7/27/2017					
Notes: Sloughing on waterside slope due to erosion at waterside toe.

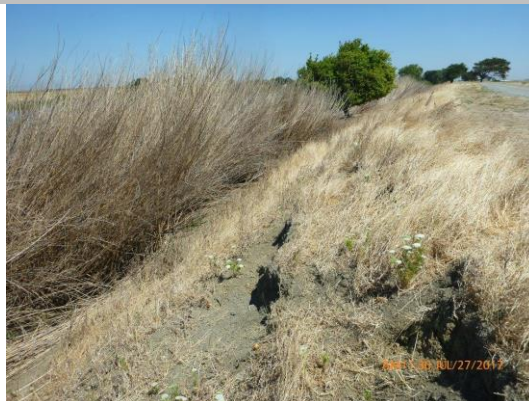
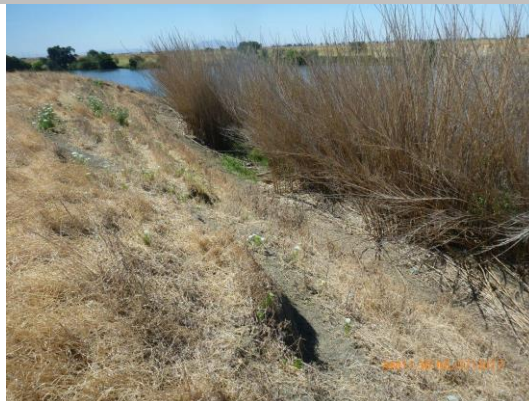
LM Start	7.61	Rating **	M	Issue No.	10 (cont)	
LM End	7.62	Issue Type +	Ma	Location *		
Category	Supplemental			GPS Latitude/Longitude		
				Start		End
Item	2017 Storm Damage			38.297900 °		38.298100 °
				-121.728900 °		-121.728900 °
DWR ID	DWR_RD2098_03_f_2017_10					
Comment Code						
Inspector Comment						
Levee Evaluation Comments						
Description:The damage consists of sloughing of the lower and mid waterside levee slope.						
Site ID No:449						
Site Designation:LMA-276						
Repair Type: Erosion						
Rating:Area of Concern						
Field Date:7/27/2017						
Notes: Sloughing on waterside slope due to erosion at waterside toe.

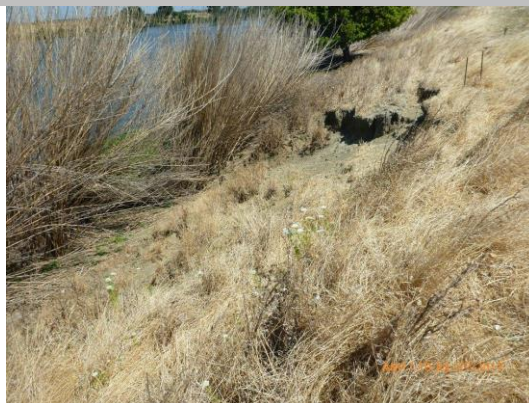
Photo 1 of 3 : SP\_2018\_RD2098\_247\_13\_20180305\_00010.jpg

LM Start	7.63	Rating **	M	Issue No.	13
LM End	7.64	Issue Type +	Ma	Location *	
Category	Supplemental			GPS Latitude/Longitude	
				Start	End
Item	2017 Storm Damage			38.298300 °	38.298400 °
				-121.728800 °	-121.728800 °
DWR ID	DWR_RD2098_03_f_2017_13				
Comment Code					
Inspector Comment					
Levee Evaluation Comments					
Description:The damage consists of scour and sloughing of the waterside levee slope.					
Site ID No:450					
Site Designation:LMA-277					
Repair Type: Erosion					
Rating:Area of Concern					
Field Date:7/27/2017					
Notes: Sloughing on waterside due to waterside toe erosion.

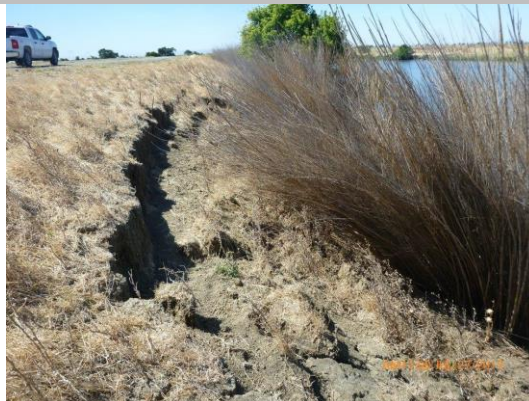
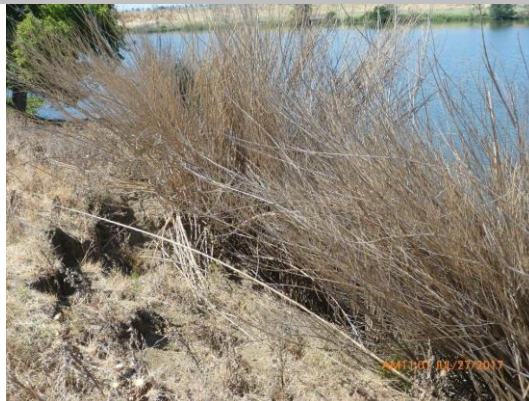
LM Start	7.66	Rating **	M	Issue No.	15 (cont)
LM End	7.68	Issue Type +	Ma	Location *	
Category	Supplemental			GPS Latitude/Longitude	
				Start	End
Item	2017 Storm Damage			38.298700 °	38.299000 °
				-121.728700 °	-121.728600 °
DWR ID	DWR_RD2098_03_f _ 2017_15				
Comment Code					
Inspector Comment					
Levee Evaluation Comments					
Description:The damage consists of scour and sloughing of the lower and mid waterside levee slope.					
Site ID No:451					
Site Designation:LMA-278					
Repair Type: Erosion					
Rating:Area of Concern					
Field Date:7/27/2017					
Notes: Sloughing on waterside slope due to watwrside toe erosion.

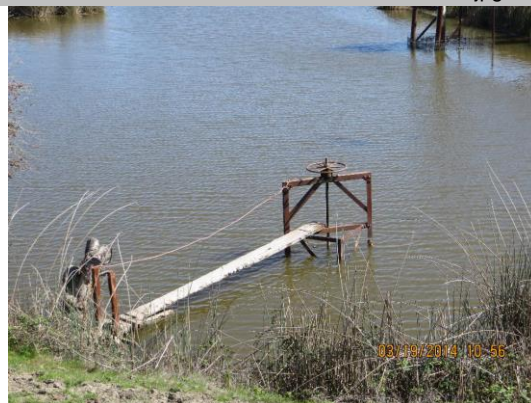
Photo 1 of 2 : UCIP\_SP\_2018\_32384\_58883.jpg

Slide gate at LS toe.

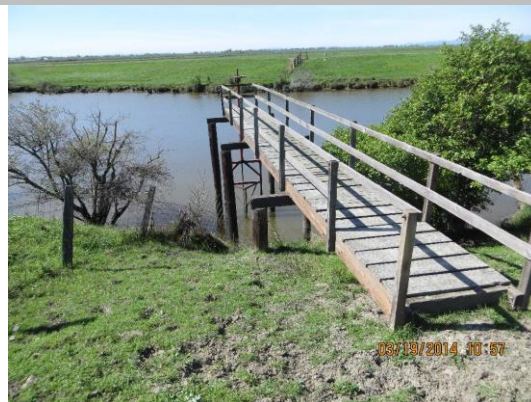
Photo 2 of 2 : UCIP\_SP\_2018\_32384\_58882.jpg

Walkway with slide gate on WS toe.
