**Flood Control Project Maintenance
Levee Inspections**

Maintenance Issue Types Only, Levee Inspection Report By Mile - Spring 2019

Reclamation District No. 2098 Cache and Haas Slough

Waterway	Bank	Unit Miles	Inspection Start/End	Inspector
Unit No. 01 Yolo Bypass	Right	3.60	03/26/2019	David Julian

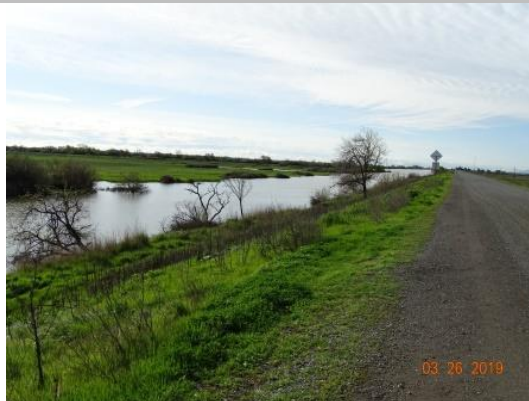
Photo 1 of 2 : SP_2019_RD2098_244_22_20190326_00059.jpg

LM Start	0.07	Rating **	A	Issue No.	22
LM End	0.67	Issue Type +	Ma	Location *	WS
Category	Earthen Levee			GPS Latitude/Longitude	
				Start	End
Item	Vegetation			38.328125 °	38.319367 °
				-121.694047 °	-121.694040 °
DWR ID	DWR_RD2098_01_f_2018_22				
Comment Code					
V1 : Control annual grass and weeds on the levee slopes and easements.					
Inspector Comment					
The LMA is doing a good job of maintaining annual vegetation.

View looking downstream at vegetation on the waterside slope (Spring 2019).

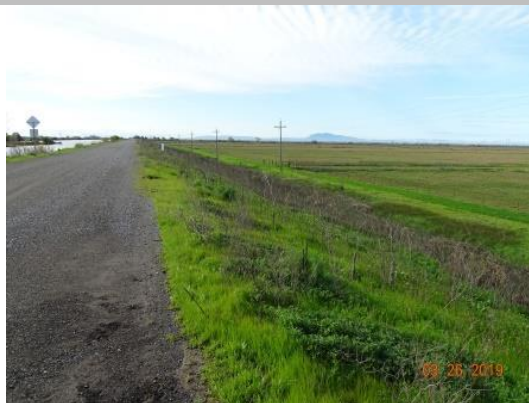
Photo 1 of 2 : SP_2019_RD2098_244_16_20190326_00060.jpg

LM Start	0.07	Rating **	A	Issue No.	16
LM End	1.01	Issue Type +	Ma	Location *	LS
Category	Earthen Levee			GPS Latitude/Longitude	
				Start	End
Item	Vegetation			38.328125 °	38.314483 °
				-121.694047 °	-121.694012 °
DWR ID	DWR_RD2098_01_f_2018_16				
Comment Code					
V1 : Control annual grass and weeds on the levee slopes and easements.					
Inspector Comment					
The LMA is doing a good job of maintaining annual vegetation.

View looking downstream at vegetation on the landside slope (Spring 2019).

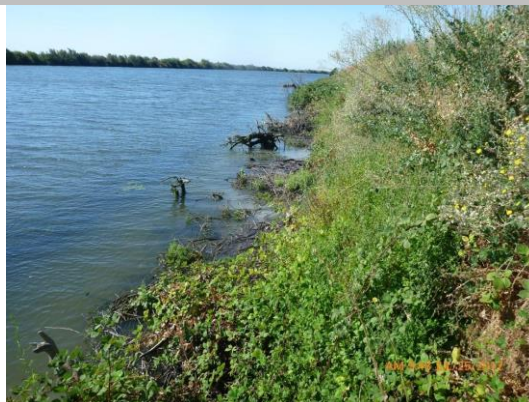
Photo 3 of 3 : SP_2019_RD2098_244_35_20190311_00025.jpg

LM Start	2.78	Rating **	A/W	Issue No.	35 (cont)	
LM End	2.81	Issue Type +	Ma	Location *		
Category	Supplemental			GPS Latitude/Longitude		
				Start		End
Item	2017 Storm Damage			38.288800 °		38.288400 °
				-121.693500 °		-121.693500 °
DWR ID	DWR_RD2098_01_f_2017_35					
Comment Code						
Inspector Comment						
Levee Evaluation Comments						
Description:The damage consists of scour and sloughing of the waterside levee slope.						
Site ID No:430						
Site Designation:LMA-257						
Repair Type: Erosion						
Rating:Serious						
Field Date:7/25/2017						
Notes: Erosion at waterside toe, causing sloughing 2/3 down waterside slope.

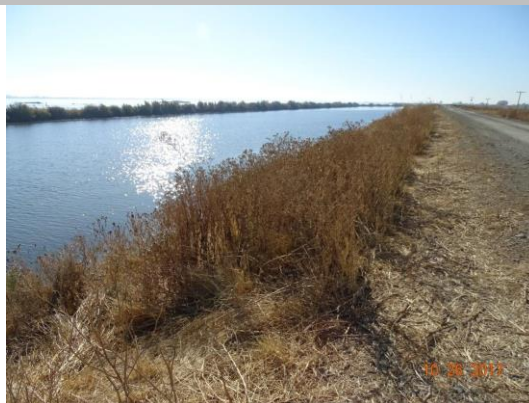
Photo 1 of 1 : SP_2019_RD2098_244_11_20190311_00001.jpg

LM Start	2.80	Rating **	M	Issue No.	11
LM End	2.97	Issue Type +	Ma	Location *	WS
Category	Earthen Levee			GPS Latitude/Longitude	
				Start	End
Item	Vegetation			38.288590 °	38.286013 °
				-121.693645 °	-121.693632 °
DWR ID	DWR_RD2098_01_f_2017_11				
Comment Code					
V2 : Remove the wild growth other than native grasses from the levee slopes.					
Inspector Comment					
Nearby construction operations forced termination of goat grazing. Vegetation should be cleared.

View of vegetation on waterside slope.

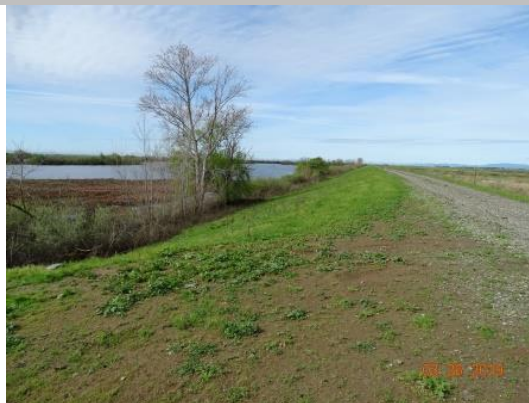
Photo 1 of 1 : SP_2019_RD2098_245_2_20190329_00004.jpg

LM Start	0.00	Rating **	A	Issue No.	2
LM End	0.52	Issue Type +	Ma	Location *	WS
Category	Earthen Levee			GPS Latitude/Longitude	
				Start	End
Item	Vegetation			38.277382 °	38.275722 °
				-121.696270 °	-121.705675 °
DWR ID	DWR_RD2098_01A_s_2019_2				
Comment Code					
V1 : Control annual grass and weeds on the levee slopes and easements.					
Inspector Comment					
Continue to maintain annual vegetation.

View looking upstream at annual vegetation on the waterside slope (Spring 2019).

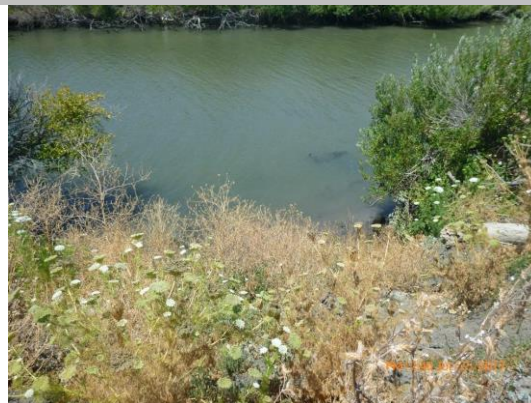
Photo 1 of 3 : SP_2019_RD2098_246_15_20190311_00005.jpg

LM Start	6.46	Rating **	A/W	Issue No.	15
LM End	6.46	Issue Type +	Ma	Location *	
Category	Supplemental			GPS Latitude/Longitude	
				Start	End
Item	2017 Storm Damage			38.288700 °	38.288800 °
				-121.717000 °	-121.717000 °
DWR ID	DWR_RD2098_02_f_2017_15				
Comment Code					
Inspector Comment					
Levee Evaluation Comments					
Description:The damage consists of scour of the lower and mid waterside levee slope.					
Site ID No:440					
Site Designation:LMA-267					
Repair Type: Erosion					
Rating:Area of Concern					
Field Date:7/25/2017					
Notes: Sloughing on waterside slope due to toe erosion.

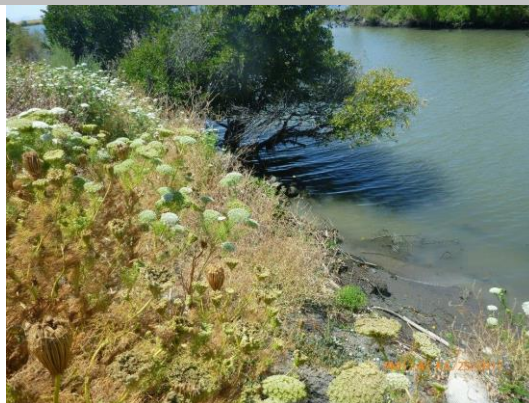
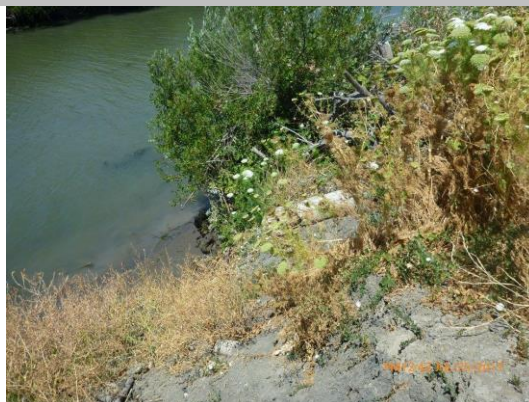
LM Start	6.46	Rating **	A/W	Issue No.	15 (cont)
LM End	6.46	Issue Type +	Ma	Location *	
Category	Supplemental			GPS Latitude/Longitude	
				Start	End
Item	2017 Storm Damage			38.288700 °	38.288800 °
				-121.717000 °	-121.717000 °
DWR ID	DWR_RD2098_02_f _ 2017_15				
Comment Code					
Inspector Comment					
Levee Evaluation Comments					
Description:The damage consists of scour of the lower and mid waterside levee slope.					
Site ID No:440					
Site Designation:LMA-267					
Repair Type: Erosion					
Rating:Area of Concern					
Field Date:7/25/2017					
Notes: Sloughing on waterside slope due to toe erosion.

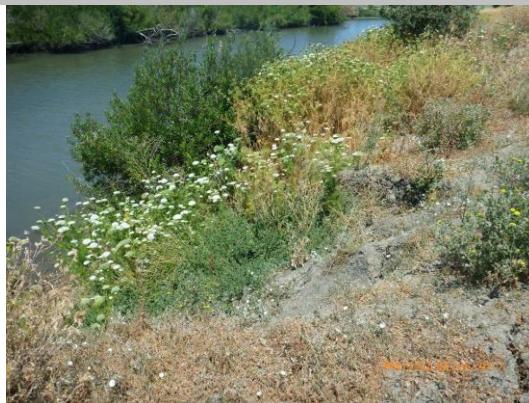
Photo 1 of 3 : SP_2019_RD2098_246_17_20190311_00008.jpg

LM Start	6.47	Rating **	A/W	Issue No.	17
LM End	6.48	Issue Type +	Ma	Location *	
Category	Supplemental			GPS Latitude/Longitude	
				Start	End
Item	2017 Storm Damage			38.288900 °	38.289000 °
				-121.717000 °	-121.717000 °
DWR ID	DWR_RD2098_02_f_2017_17				
Comment Code					
Inspector Comment					
Levee Evaluation Comments					
Description:The damage consists of scour and sloughing of the lower and mid waterside levee slope.					
Site ID No:441					
Site Designation:LMA-268					
Repair Type: Erosion					
Rating:Area of Concern					
Field Date:7/25/2017					
Notes: Sloughing on waterside slope due to toe erosion.

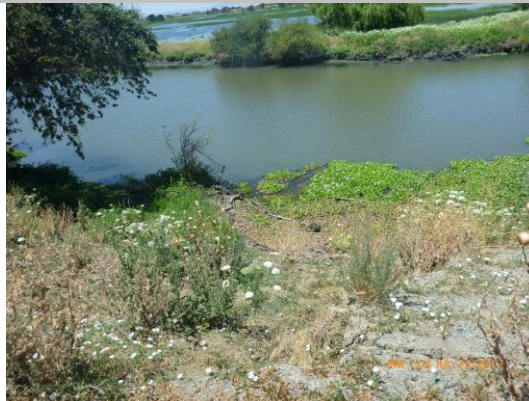
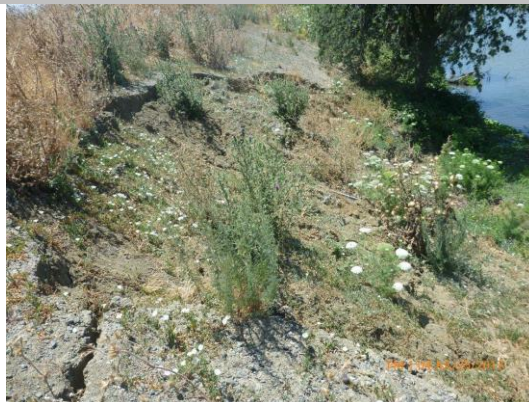
LM Start	6.64	Rating **	A/W	Issue No.	18
LM End	6.65	Issue Type +	Ma	Location *	
Category	Supplemental			GPS Latitude/Longitude	
				Start	End
Item	2017 Storm Damage			38.291300 °	38.291400 °
				-121.716100 °	-121.716000 °
DWR ID	DWR_RD2098_02_f_2017_18				
Comment Code					
Inspector Comment					
Levee Evaluation Comments					
Description:The damage consists of scour, cracking, instability, and sloughing of the waterside levee slope.					
Site ID No:442					
Site Designation:LMA-269					
Repair Type: Erosion					
Rating:Serious					
Field Date:7/25/2017					
Notes: Two sloughing sections along waterside slope due to toe erosion.					
LM Start	6.64	Rating **	A/W	Issue No.	18 (cont)
LM End	6.65	Issue Type +	Ma	Location *

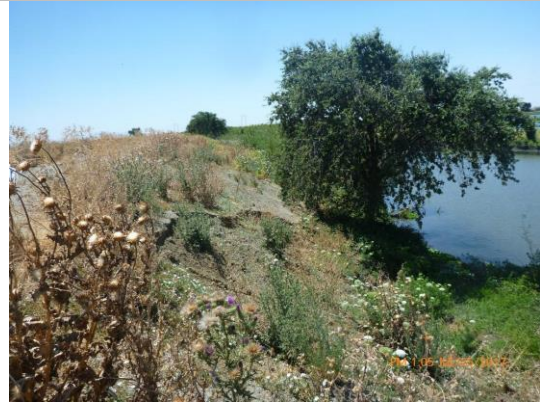
Photo 3 of 3 : SP_2019_RD2098_246_18_20190311_00013.jpg

LM Start	6.64	Rating **	A/W	Issue No.	18 (cont)
LM End	6.65	Issue Type +	Ma	Location *	
Category	Supplemental			GPS Latitude/Longitude	
				Start	End
Item	2017 Storm Damage			38.291300 °	38.291400 °
				-121.716100 °	-121.716000 °
DWR ID	DWR_RD2098_02_f _ 2017_18				
Comment Code					
Inspector Comment					
<p>Levee Evaluation Comments</p> <p>Description: The damage consists of scour, cracking, instability, and sloughing of the waterside levee slope.</p> <p>Site ID No: 442</p> <p>Site Designation: LMA-269</p> <p>Repair Type: Erosion</p> <p>Rating: Serious</p> <p>Field Date: 7/25/2017</p> <p>Notes: Two sloughing sections along waterside slope due to toe erosion.</p>

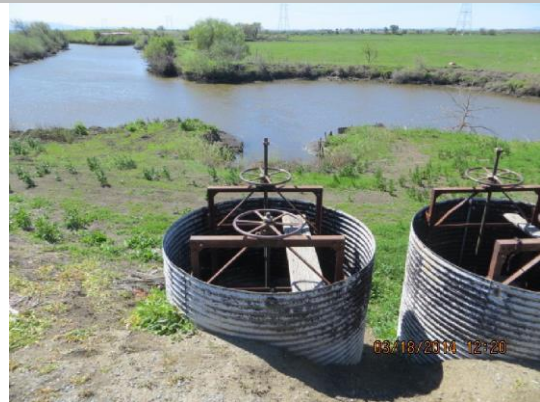
Photo 1 of 3 : UCIP_SP_2019_33784_61162.jpg

Comment Code						
Inspector Comment						
<p>FS_ID:33784</p> <p>DS_ID:20976</p> <p>EP_NO: 10172</p> <p>Repair Type: Non-Urgent</p> <p>Crossing Status: Found</p> <p>UCIP Comments: 03/18/2014 Headwalls on WS toe failing at outlet. It is unclear if these were permanent installations or something that was installed as a temporary fix. (W. Wylie - DWR UCIP)</p> <p>FIELD_STRUCT_DESC: 1 of 2: 48-inch corrugated metal drainage pipe through the levee, 29 feet below the crown. Two slide gates in a 7-foot-diameter corrugated metal pipe (CMP) riser on the waterside (WS) slope. (two 48-inch [HLM 6.75] authorized under Automatic Board Order (ABO) issued as Permit No. 10172, 1974 - Moresco Brothers).</p> <p>[Additional Reference(s): DWR Levee Log, 2003. USACE Sacramento O&M Manual 109, April 1962, (HLM 6.75)].</p> <p>FS Date: 3/18/2014</p>

Two slide gates in 7-foot diameter CMP riser on waterward slope.

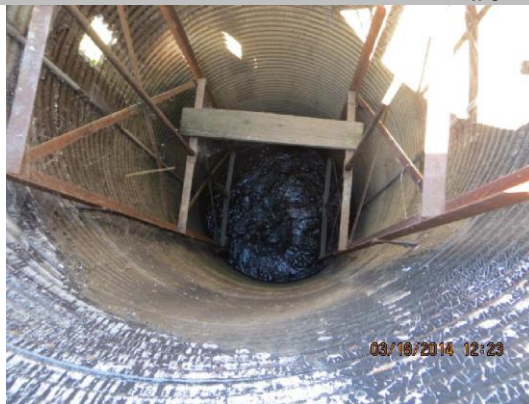
Photo 3 of 3 : UCIP_SP_2019_33784_61160.jpg

View inside CMP riser on WS shoulder.

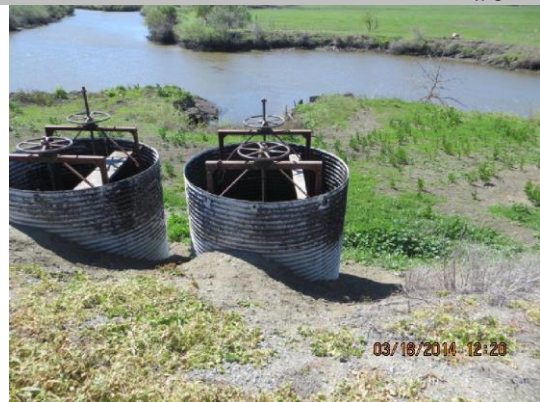
Photo 2 of 3 : UCIP_SP_2019_32285_58748.jpg

7-foot diameter CMP riser with two slide gates inside.

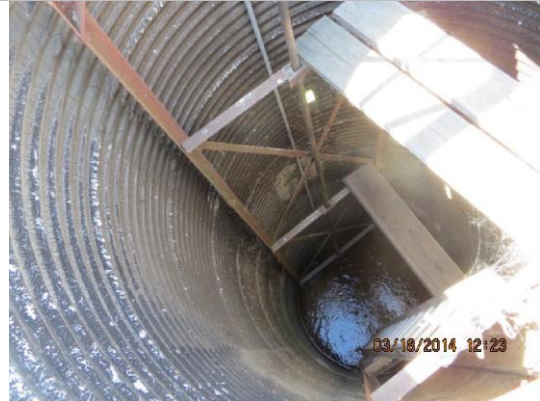
Photo 3 of 3 : UCIP_SP_2019_32285_58747.jpg

Comment Code						
Inspector Comment						
FS_ID:32285						
DS_ID:20961						
EP_NO: 10172						
Repair Type: Non-Urgent						
Crossing Status: Found						
UCIP Comments: 03/18/2014 Headwalls at WS toe failing. It is uncertain if these retaining walls were a permanent fixture or a temporary fix that failed. (W. Wylie - DWR UCIP)						
FIELD_STRUCT_DESC: 2 of 2: 48-inch corrugated metal drainage pipe through the levee, 29 feet below the crown. Two slide gates in a 7-foot-diameter corrugated metal pipe (CMP) riser on the waterside (WS) slope. (two 48-inch pipes [HLM 6.75] authorized under Automatic Board Order (ABO) issued as Permit No. 10172, 1974 - Moresco Brothers).						
[Additional Reference(s): DWR Levee Log, 2003. USACE Sacramento O&M Manual 109, April 1962, (HLM 6.75)].						
FS Date: 3/18/2014

7-foot diameter CMP riser with two slide gates inside.

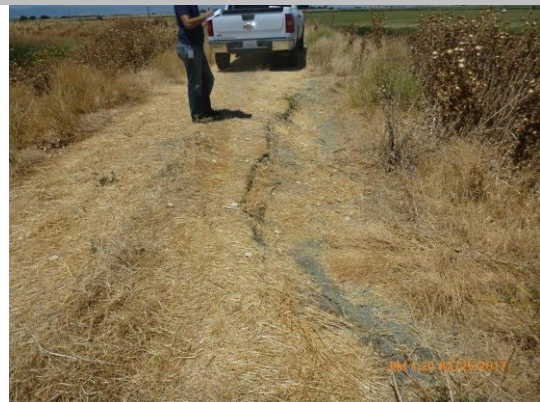
Photo 1 of 3 : SP_2019_RD2098_246_19_20190311_00014.jpg

LM Start	6.74	Rating **	A/W	Issue No.	19
LM End	6.75	Issue Type +	Ma	Location *	LS
Category	Supplemental			GPS Latitude/Longitude	
				Start	End
Item	2017 Storm Damage			38.292500 °	38.292600 °
				-121.716100 °	-121.716200 °
DWR ID	DWR_RD2098_02_f_2017_19				
Comment Code					
Inspector Comment					
Levee Evaluation Comments					
Description:The damage consists of scour and sloughing of the					
landside levee slope.					
Site ID No:443					
Site Designation:LMA-270					
Repair Type: Stability					
Rating:Area of Concern					
Field Date:7/25/2017					
Notes: Sloughing on crown into upper portion of landside levee slope.

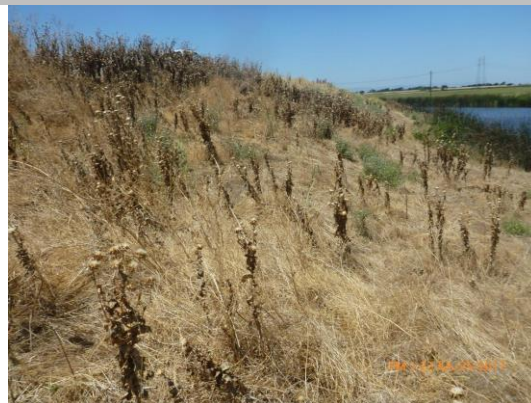
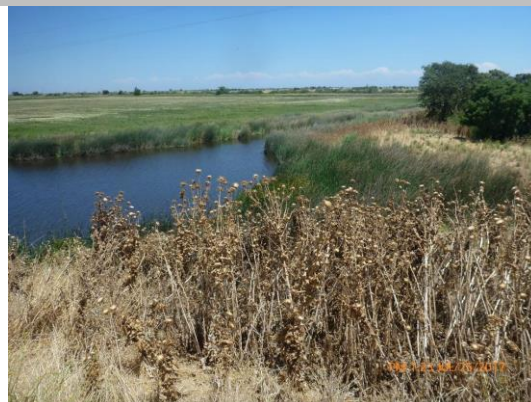
LM Start	6.74	Rating **	A/W	Issue No.	19 (cont)
LM End	6.75	Issue Type +	Ma	Location *	LS
Category	Supplemental			GPS Latitude/Longitude	
				Start	End
Item	2017 Storm Damage			38.292500 °	38.292600 °
				-121.716100 °	-121.716200 °
DWR ID	DWR_RD2098_02_f_2017_19				
Comment Code					
Inspector Comment					
Levee Evaluation Comments					
Description:The damage consists of scour and sloughing of the					
landside levee slope.					
Site ID No:443					
Site Designation:LMA-270					
Repair Type: Stability					
Rating:Area of Concern					
Field Date:7/25/2017					
Notes: Sloughing on crown into upper portion of landside levee slope.

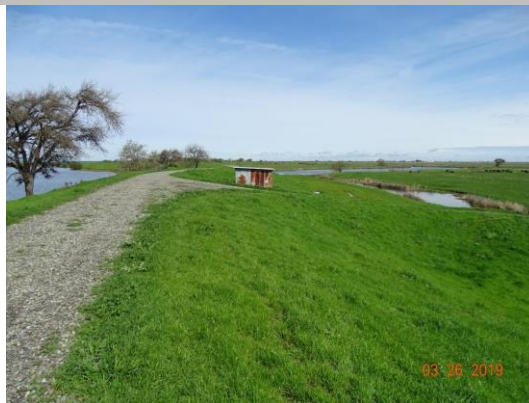
Photo 1 of 1 : SP_2019_RD2098_247_6_20190326_00021.jpg

LM Start	7.29	Rating **	A	Issue No.	6
LM End	8.33	Issue Type +	Ma	Location *	LS
Category	Earthen Levee			GPS Latitude/Longitude	
				Start	End
Item	Vegetation			38.294473 °	38.306635 °
				-121.725092 °	-121.731700 °
DWR ID	DWR_RD2098_03_s_2019_6				
Comment Code					
V1 : Control annual grass and weeds on the levee slopes and easements.					
Inspector Comment					
LMA doing a good job maintaining annual vegetation

View looking upstream at annual vegetation on the landside slope (Spring 2019).

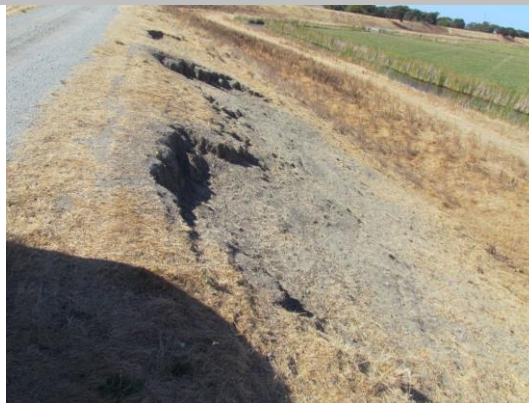
Photo 1 of 3 : SP_2019_RD2098_247_1_20190311_00001.jpg

LM Start	7.51	Rating **	M	Issue No.	1
LM End	7.51	Issue Type +	Ma	Location *	LS
Category	Earthen Levee			GPS Latitude/Longitude	
				Start	End
Item	Slope Stability			38.296846 °	38.296846 °
				-121.727546 °	-121.727546 °
DWR ID	DWR_RD2098_03_f_2016_1				
Comment Code					
S2 : Repair the levee slope damaged by foot traffic and prevent access where possible.					
Inspector Comment					
Livestock activity causing erosion of levee slope.

Close up. Looking upstream.

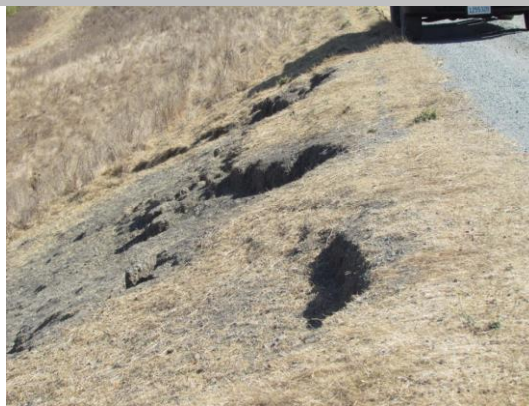
Photo 2 of 3 : SP_2019_RD2098_247_1_20190311_00002.jpg

Looking downstream.

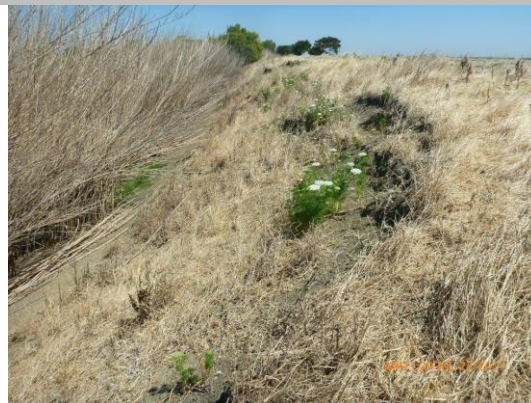
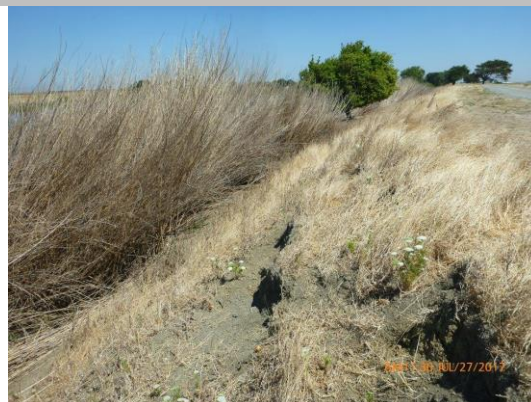
LM Start	7.61	Rating **	A/W	Issue No.	10
LM End	7.62	Issue Type +	Ma	Location *	
Category	Supplemental		GPS Latitude/Longitude		
			Start	End	
Item	2017 Storm Damage		38.297900 °	38.298100 °	
			-121.728900 °	-121.728900 °	
DWR ID	DWR_RD2098_03_f_2017_10

Description: The damage consists of sloughing of the lower and mid waterside levee slope.

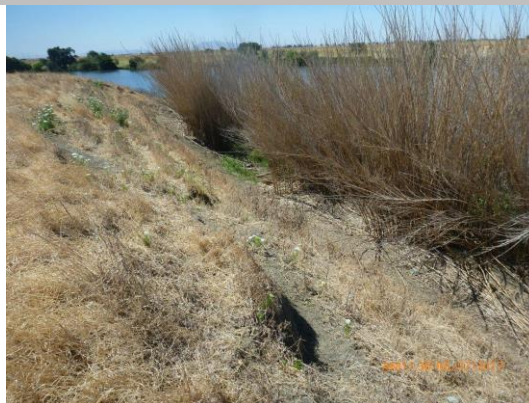
Photo 3 of 3 : SP_2019_RD2098_247_10_20190311_00008.jpg

LM Start	7.61	Rating **	A/W	Issue No.	10 (cont)	
LM End	7.62	Issue Type +	Ma	Location *		
Category	Supplemental			GPS Latitude/Longitude		
				Start		End
Item	2017 Storm Damage			38.297900 °		38.298100 °
				-121.728900 °		-121.728900 °
DWR ID	DWR_RD2098_03_f _ 2017_10					
Comment Code						
Inspector Comment						
Levee Evaluation Comments						
Description:The damage consists of sloughing of the lower and mid waterside levee slope.						
Site ID No:449						
Site Designation:LMA-276						
Repair Type: Erosion						
Rating:Area of Concern						
Field Date:7/27/2017						
Notes: Sloughing on waterside slope due to erosion at waterside toe.

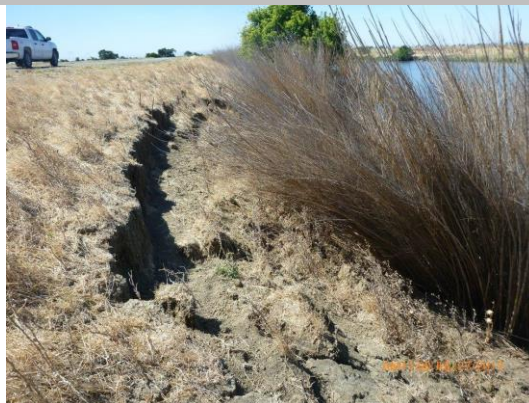
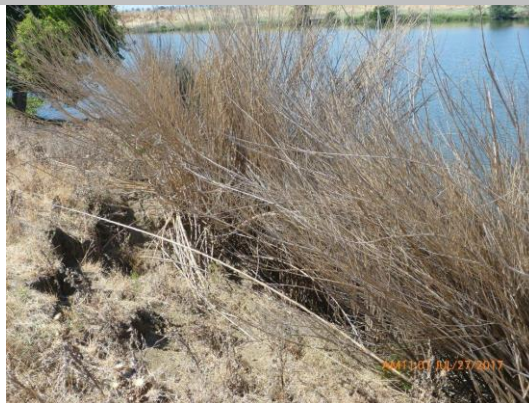
LM Start	7.66	Rating **	A/W	Issue No.	15 (cont)	
LM End	7.68	Issue Type +	Ma	Location *		
Category	Supplemental			GPS Latitude/Longitude		
				Start	End	
Item	2017 Storm Damage			38.298700 °	38.299000 °	
				-121.728700 °	-121.728600 °	
DWR ID	DWR_RD2098_03_f_2017_15					
Comment Code						
Inspector Comment						
Levee Evaluation Comments						
Description:The damage consists of scour and sloughing of the lower and mid waterside levee slope.						
Site ID No:451						
Site Designation:LMA-278						
Repair Type: Erosion						
Rating:Area of Concern						
Field Date:7/27/2017						
Notes: Sloughing on waterside slope due to waterside toe erosion.						
Additional erosion seen on the spring 2019 inspection. Mitigate erosion then monitor site.

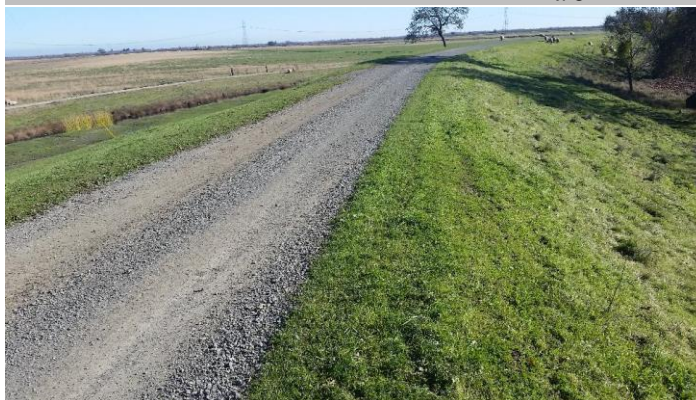
Photo 3 of 3 : UCIP_SP_2019_51453_76859.jpg

Comment Code						
Inspector Comment						
FS_ID:51453 DS_ID:20981 EP_NO: 10174 Repair Type: No Action Needed Crossing Status: Found UCIP Comments: 12/22/2016 Crossing has been downgraded from Urgent to No Action Needed walkways on both WS and LS have been rebuilt and the WS gate has been upgraded to stainless steel where previous corrodable material was present. (O. Magana - DWR UCIP)03/19/2014 Current walkway to slidegate on WS toe does not provide safe access to operate slidegate. (W. Wylie - DWR UCIP) FIELD_STRUCT_DESC: 36-inch steel dual-purpose irrigation and drainage pipe through the levee, 26 feet below the crown. Two corrugated metal cutoff walls around the pipe. Walkway to the slide gate on the waterside (WS) end. Combination slide and flap gate on the landside (LS) end. 48-inch corrugated metal pipe (CMP) riser and an adjoining pump on a metal pier at the LS toe. (36-inch pipe [HLM 8.20] authorized under Automatic Board Order (ABO) issued as Permit No. 10174, 1974 - Glen A. Bowsbey). [Additional Reference(s): DWR Levee Log, 2003. USACE Sacramento O&M Manual 109, April 1962, (HLM 8.20)]. FS Date: 12/22/2016

View of levee crown at pipe crossing.

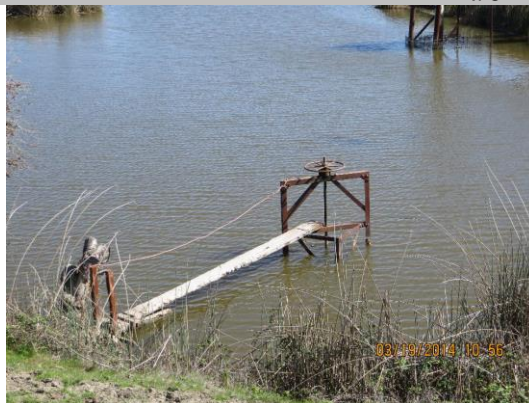
Photo 1 of 2 : UCIP_SP_2019_32384_58883.jpg

LM Start	8.35	Rating **	A/W	Issue No.	18
LM End	8.35	Issue Type +	Ma	Location *	
Category	Supplemental			GPS Latitude/Longitude	
				Start	End
Item	DWR UCIP LMA Responsibility		38.306916 °	38.306916 °	
			-121.731984 °	-121.731984 °	
DWR ID	20962				
Comment Code					
Inspector Comment					
FS_ID:32384 DS_ID:20962 EP_NO: 10174 Repair Type: No Action Needed Crossing Status: Found UCIP Comments: FIELD_STRUCT_DESC: 60-inch corrugated metal drainage pipe through the levee, 25.5 feet below the crown. Walkway to the slide gates at both ends of the pipe. (Permit No. 1607, 1951 - R. F. Moore and Lorraine W. Zanetti. This pipe was retained under Automatic Board Order (ABO) issued as Permit No. 10174, 1974 - Glen A. Bowsbey). [Additional Reference(s): DWR Levee Log, 2003. USACE Sacramento O&M Manual 109, April 1962, (HLM 8.40)]. FS Date: 3/19/2014

Slide gate at LS toe.

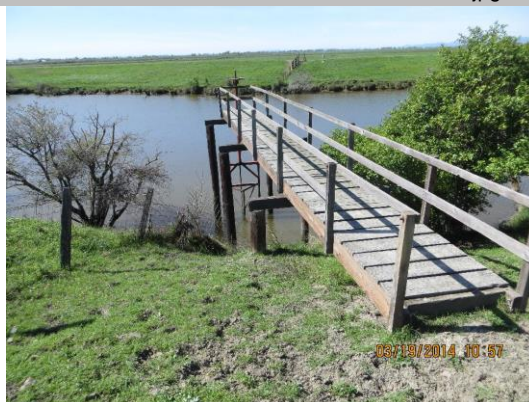
Photo 2 of 2 : UCIP_SP_2019_32384_58882.jpg

Walkway with slide gate on WS toe.

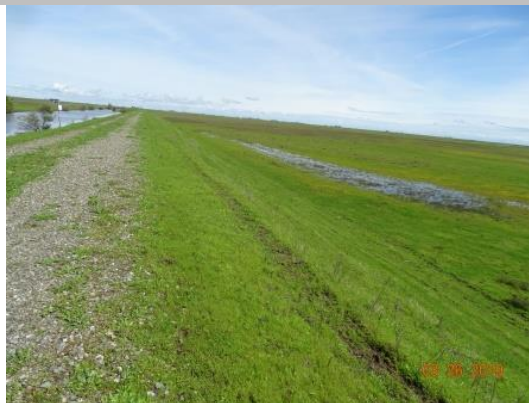
Photo 1 of 1 : SP_2019_RD2098_248_10_20190329_00026.jpg

LM Start	9.18	Rating **	A	Issue No.	10
LM End	9.77	Issue Type +	Ma	Location *	LS
Category	Earthen Levee			GPS Latitude/Longitude	
				Start	End
Item	Vegetation			38.316543 °	38.358110 °
				-121.740085 °	-121.740381 °
DWR ID	DWR_RD2098_04_s_2019_10				
Comment Code					
V1 : Control annual grass and weeds on the levee slopes and easements.					
Inspector Comment					
Vegetation well managed in this area.

View looking upstream at annual vegetation on the landside slope (Spring 2019).

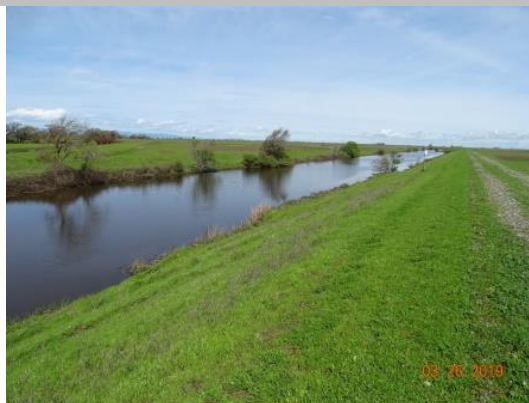
Photo 1 of 1 : SP_2019_RD2098_248_11_20190329_00027.jpg

LM Start	9.18	Rating **	A	Issue No.	11	
LM End	12.07	Issue Type +	Ma	Location *	WS	
Category	Earthen Levee			GPS Latitude/Longitude		
				Start		End
Item	Vegetation			38.316543 °		38.358110 °
				-121.740085 °		-121.740381 °
DWR ID	DWR_RD2098_04_s_2019_11					
Comment Code						
V1 : Control annual grass and weeds on the levee slopes and easements.						
Inspector Comment						
Vegetation well managed in this area.

View looking upstream at vegetation on the waterside slope (Spring 2019).

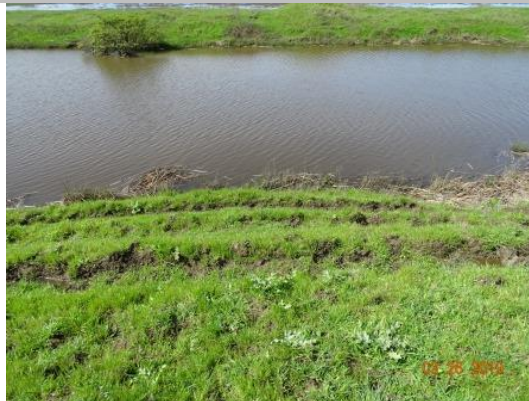
Photo 1 of 3 : SP_2019_RD2098_248_9_20190408_00031.jpg

View looking downslope at deep ruts in the waterside slope made by cows (Spring 2019).
