**Flood Control Project Maintenance
Levee Inspections**

Fall 2015 Levee Maintenance Deficiency Summary Report

Reclamation District No. 2103 Wheatland Vicinity

Waterway		Bank	Unit Miles
Unit No. 01 South Dry Creek		Left	4.64

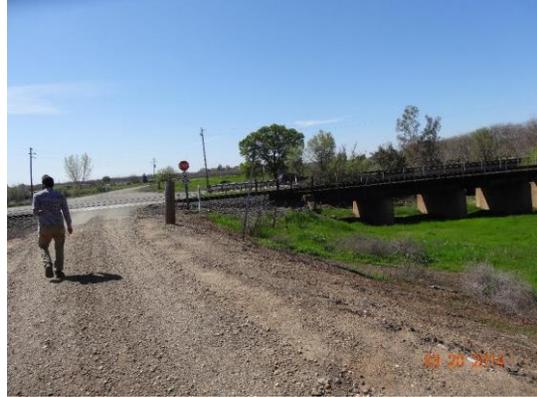
Photo 1 of 3 : UCIP_FA_2015_6312.jpg

LM Start	0.55	Rating **	M	Issue No.	30
LM End	0.55	Issue Type +	En	Location *	LS
Category	Supplemental			GPS Latitude/Longitude	
				Start	End
Item	DWR UCIP Field Study			39.022665 °	39.022665 °
				-121.444688 °	-121.444688 °
DWR ID					
Action/Comments					
Inspector Comments: FS_ID:39987 DS_ID:24879 EP_NO: N/A FS_HLM: 0.574 Repair Type: Non-Urgent Crossing Status: Indicator Found

View of levee crown and waterward side.

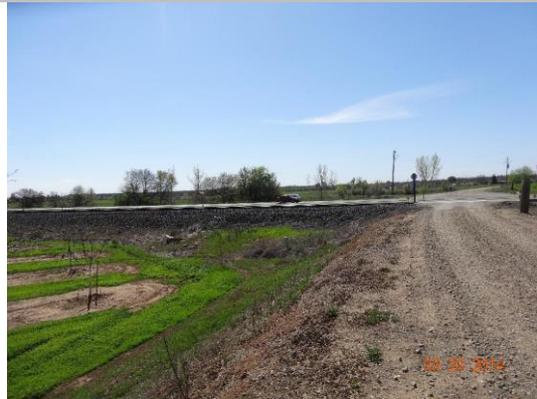
Photo 2 of 3 : UCIP_FA_2015_6313.jpg

View of landward side.

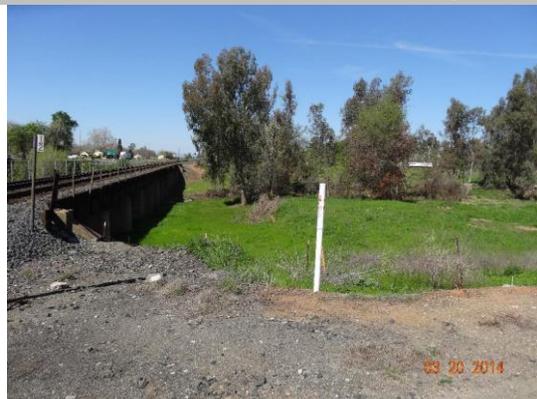
Photo 3 of 3 : UCIP_FA_2015_6314.jpg

View of waterward side.

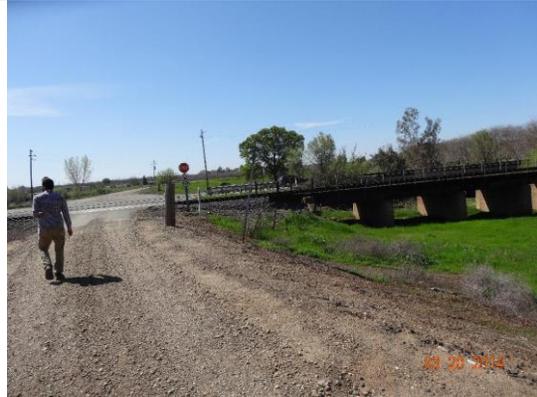
Photo 3 of 3 : UCIP_FA_2015_6626.jpg

LM Start	0.56	Rating **	M	Issue No.	32 (cont)
LM End	0.56	Issue Type +	En	Location *	LS
Category	Supplemental			GPS Latitude/Longitude	
				Start	End
Item	DWR UCIP Field Study			39.022733 °	39.022733 °
				-121.444626 °	-121.444626 °
DWR ID					
Action/Comments					
Inspector Comments: FS_ID:38323 DS_ID:19469 EP_NO: 2098 FS_HLM: 0.58 Repair Type: Non-Urgent Crossing Status: Indicator Found UCIP Comments: Need to contact owner to determine status of crossing. Need date of last inspection and confirmation that crossing is still in operable condition. FIELD_STRUCT_DESC: 16-inch steel gas line through the levee, 3.0 feet below the crown. Marker on waterward slope. (Permit No. 2098-1955). This entry matches the Drainage or Irrigation Structure referenced in O&M manual (HLM 0.56). FS Date: 03/20/2014

View of levee crown at crossing.

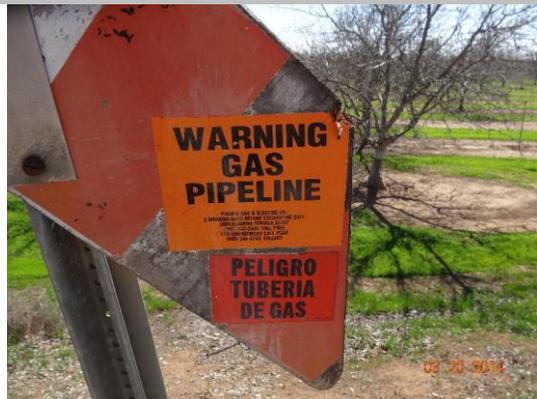
Photo 2 of 3 : UCIP_FA_2015_6628.jpg

LM Start	0.62	Rating **	M	Issue No.	33
LM End	0.62	Issue Type +	En	Location *	LS
Category	Supplemental			GPS Latitude/Longitude	
				Start	End
Item	DWR UCIP Field Study			39.023513 °	39.023513 °
				-121.444168 °	-121.444168 °
DWR ID					
Action/Comments					
Inspector Comments: FS_ID:38324 DS_ID:19470 EP_NO: 789 FS_HLM: 0.64 Repair Type: Non-Urgent Crossing Status: Indicator Found

Contact information for gas pipeline.

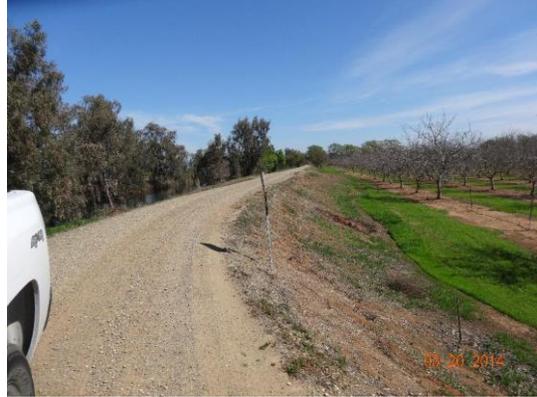
Photo 3 of 3 : UCIP_FA_2015_6629.jpg

LM Start	0.62	Rating **	M	Issue No.	33 (cont)
LM End	0.62	Issue Type +	En	Location *	LS
Category	Supplemental			GPS Latitude/Longitude	
				Start	End
Item	DWR UCIP Field Study			39.023513 °	39.023513 °
				-121.444168 °	-121.444168 °
DWR ID					
Action/Comments					
Inspector Comments: FS_ID:38324 DS_ID:19470 EP_NO: 789 FS_HLM: 0.64 Repair Type: Non-Urgent Crossing Status: Indicator Found

View of levee crown looking upstream.

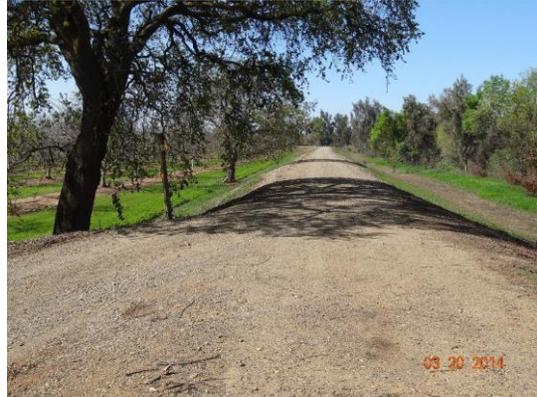
Photo 1 of 3 : UCIP_FA_2015_6315.jpg

LM Start	0.81	Rating **	M	Issue No.	34
LM End	0.81	Issue Type +	En	Location *	CR
Category	Supplemental			GPS Latitude/Longitude	
				Start	End
Item	DWR UCIP Field Study			39.024725 °	39.024725 °
				-121.440978 °	-121.440978 °
DWR ID					
Action/Comments					
Inspector Comments: FS_ID:39988 DS_ID:24880 EP_NO: N/A FS_HLM: 0.81 Repair Type: Non-Urgent Crossing Status: Indicator Found UCIP Comments: No marker found on waterward side--need to confirm with owner if crossing goes through levee. If so, need depth of crossing through levee. Also need to obtain permit number used to authorize crossing. FIELD_STRUCT_DESC: Conduit line through levee. Marker visible on landward side. FS Date: 03/04/2014

View of levee at crossing.

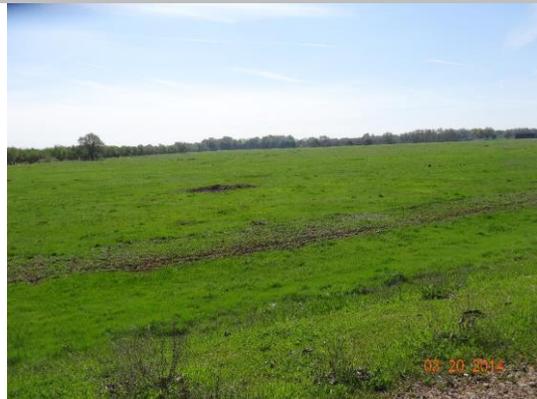
Photo 1 of 3 : UCIP_FA_2015_5242.jpg

LM Start	1.80	Rating **	M	Issue No.	35
LM End	1.80	Issue Type +	En	Location *	CR
Category	Supplemental			GPS Latitude/Longitude	
				Start	End
Item	DWR UCIP Field Study			39.029398 °	39.029398 °
				-121.424906 °	-121.424906 °
DWR ID					
Action/Comments					
Inspector Comments: FS_ID:41183 DS_ID:19473 EP_NO: 1886 FS_HLM: 1.853 Repair Type: Non-Urgent Crossing Status: Indicator Found UCIP Comments: Need to coordinate with owner. Severely corroded section of steel pipe present on waterward side--no other evidence present at this location. Owner will need to coordinate with CVFPB and DWR-Inspector to determine proper action to abandon crossing. FIELD_STRUCT_DESC: Abandoned 12-inch steel irrigation pipe through the levee, 3.1 feet below the crown. Siphon breaker on the waterward slope. Concrete standpipe at the landward toe. Vertical pump on waterward side. Open on waterward end. Permit includes gravel dam through channel of Dry Creek. (Permit No. 1886-1959). This entry matches the Drainage or Irrigation Structure referenced in O&M manual (HLM 1.86). Crossing is angled 45 degrees. FS Date: 03/20/2014

View of landward side.

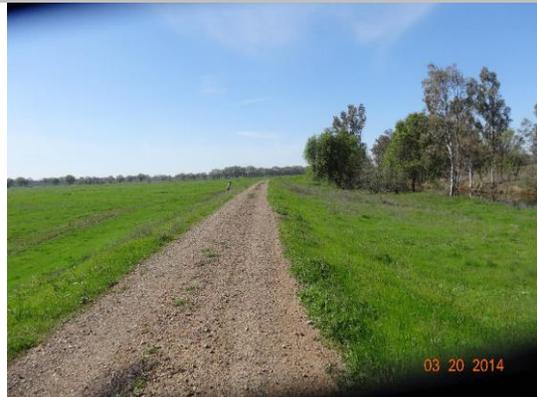
Photo 3 of 3 : UCIP_FA_2015_5244.jpg

Action/Comments
 Inspector Comments: FS_ID:41183
 DS_ID:19473
 EP_NO: 1886
 FS_HLM: 1.853
 Repair Type: Non-Urgent
 Crossing Status: Indicator Found
 UCIP Comments: Need to coordinate with owner. Severely corroded section of steel pipe present on waterward side--no other evidence present at this location. Owner will need to coordinate with CVFPB and DWR-Inspector to determine proper action to abandon crossing.
 FIELD_STRUCT_DESC: Abandoned 12-inch steel irrigation pipe through the levee, 3.1 feet below the crown. Siphon breaker on the waterward slope. Concrete standpipe at the landward toe. Vertical pump on waterward side. Open on waterward end. Permit includes gravel dam through channel of Dry Creek. (Permit No. 1886-1959). This entry matches the Drainage or Irrigation Structure referenced in O&M manual (HLM 1.86). Crossing is angled 45 degrees.
 FS Date: 03/20/2014

Overview of levee crown.

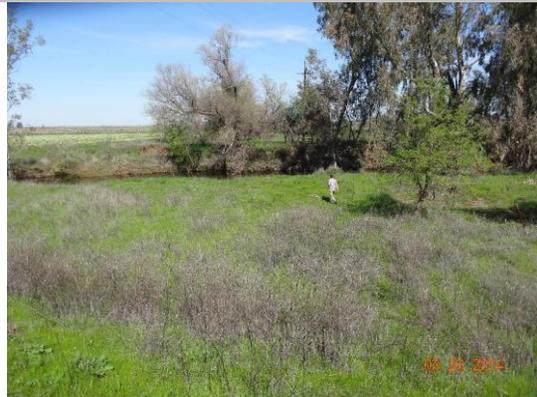
Photo 2 of 3 : UCIP_FA_2015_5190.jpg

LM Start	1.86	Rating **	M	Issue No.	36
LM End	1.86	Issue Type +	En	Location *	CR
Category	Supplemental			GPS Latitude/Longitude	
				Start	End
Item	DWR UCIP Field Study			39.029694 °	39.029694 °
				-121.423946 °	-121.423946 °
DWR ID					
Action/Comments					
Inspector Comments: FS_ID:38327 DS_ID:19512 EP_NO: N/A FS_HLM: 1.913 Repair Type: Non-Urgent Crossing Status: Indicator Found

View of waterward side.

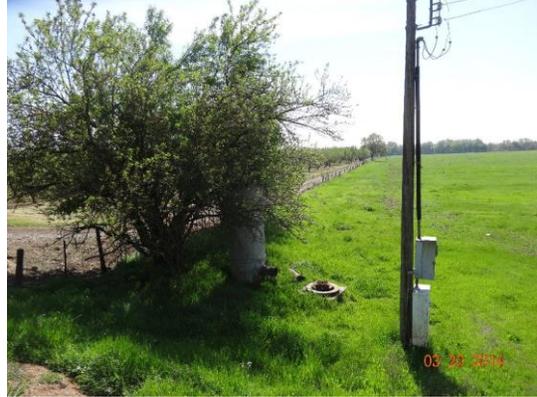
Photo 3 of 3 : UCIP_FA_2015_5191.jpg

LM Start	1.86	Rating **	M	Issue No.	36 (cont)
LM End	1.86	Issue Type +	En	Location *	CR
Category	Supplemental			GPS Latitude/Longitude	
				Start	End
Item	DWR UCIP Field Study			39.029694 °	39.029694 °
				-121.423946 °	-121.423946 °
DWR ID					
Action/Comments					
Inspector Comments: FS_ID:38327 DS_ID:19512 EP_NO: N/A FS_HLM: 1.913 Repair Type: Non-Urgent Crossing Status: Indicator Found

View of landward side.

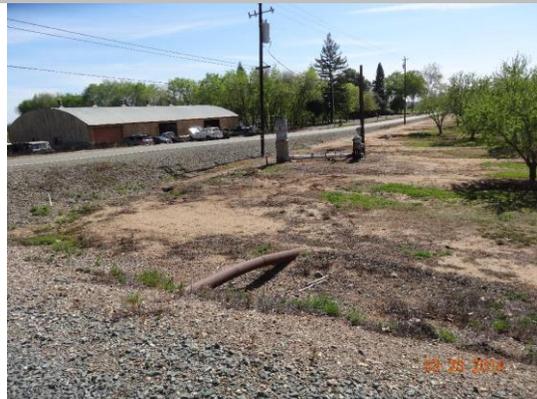
Photo 1 of 3 : UCIP_FA_2015_5192.jpg

LM Start	2.63	Rating **	M	Issue No.	37
LM End	2.63	Issue Type +	En	Location *	CR
Category	Supplemental			GPS Latitude/Longitude	
				Start	End
Item	DWR UCIP Field Study			39.031590 °	39.031590 °
				-121.409870 °	-121.409870 °
DWR ID					
Action/Comments					
Inspector Comments: FS_ID:38331 DS_ID:19477 EP_NO: N/A FS_HLM: 2.715 Repair Type: Non-Urgent Crossing Status: Found UCIP Comments: Need to contact owner to determine status. FIELD_STRUCT_DESC: 8-inch steel irrigation pipe through the levee, 3.1 feet below the crown. Siphon breaker on the waterward slope. Pump on the landward side. Pipe crosses creek to orchard on north side (Permit No. 1887, 1954. (USACE-1962). This entry matches the Drainage or Irrigation Structure referenced in O&M manual (HLM 2.68). FS Date: 03/20/2014

View of landward side.

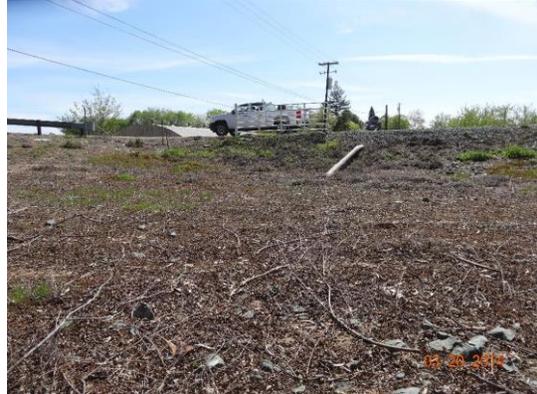
Photo 3 of 3 : UCIP_FA_2015_5194.jpg

LM Start	2.63	Rating **	M	Issue No.	37 (cont)
LM End	2.63	Issue Type +	En	Location *	CR
Category	Supplemental			GPS Latitude/Longitude	
				Start	End
Item	DWR UCIP Field Study			39.031590 °	39.031590 °
				-121.409870 °	-121.409870 °
DWR ID					
Action/Comments					
Inspector Comments: FS_ID:38331 DS_ID:19477 EP_NO: N/A FS_HLM: 2.715 Repair Type: Non-Urgent Crossing Status: Found UCIP Comments: Need to contact owner to determine status. FIELD_STRUCT_DESC: 8-inch steel irrigation pipe through the levee, 3.1 feet below the crown. Siphon breaker on the waterward slope. Pump on the landward side. Pipe crosses creek to orchard on north side (Permit No. 1887, 1954. (USACE-1962). This entry matches the Drainage or Irrigation Structure referenced in O&M manual (HLM 2.68). FS Date: 03/20/2014

Crossing was not visible on waterward side.

View of waterward side.

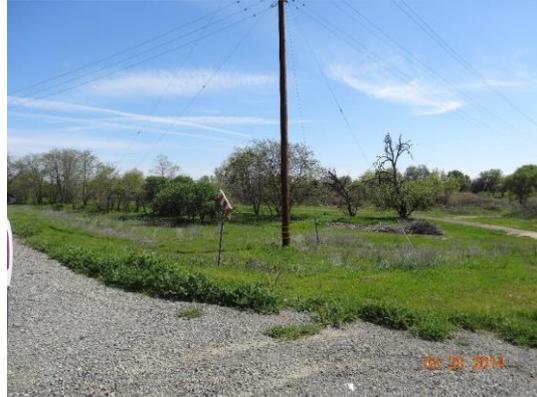
Photo 2 of 2 : UCIP_FA_2015_5239.jpg

LM Start	1.26	Rating **	M	Issue No.	29 (cont)
LM End	1.26	Issue Type +	En	Location *	LS
Category	Supplemental			GPS Latitude/Longitude	
			Start	End	
Item	DWR UCIP Field Study			38.998301 °	38.998301 °
				-121.415182 °	-121.415182 °
DWR ID					
Action/Comments					
Inspector Comments: FS_ID:39993 DS_ID:19486 EP_NO: 5714 FS_HLM: 1.3142 Repair Type: Non-Urgent Crossing Status: Indicator Found UCIP Comments: Need to contact owner to confirm crossing and determine status. FIELD_STRUCT_DESC: 12-inch steel sewer pipes through the levee, 3.1 feet below the crown. Siphon breaker in 24-inch CM pipe riser on the landward shoulder. Standard CM cutoff wall around pipe at centerline of levee. Extends from wastewater treatment plant on landward side to waste water lagoon on waterward side. Permit includes construction of lagoon with surrounding short levee, extending from/to project levee. (Permit No. 5714-1968). FS Date: 03/20/2014

View of waterward side.

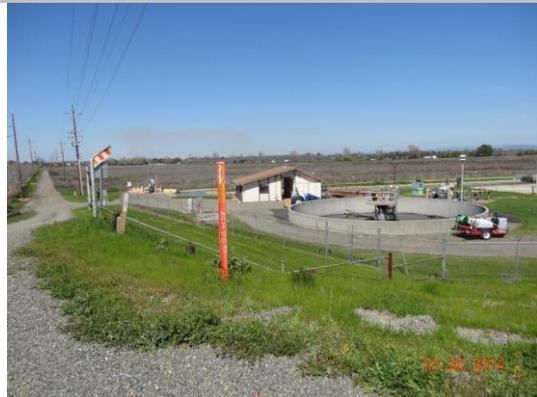
Photo 1 of 3 : UCIP_FA_2015_5195.jpg

LM Start	1.29	Rating **	M	Issue No.	30
LM End	1.29	Issue Type +	En	Location *	LS
Category	Supplemental			GPS Latitude/Longitude	
			Start	End	
Item	DWR UCIP Field Study			38.998322 °	38.998322 °
				-121.414688 °	-121.414688 °
DWR ID					
Action/Comments					
Inspector Comments: FS_ID:39994 DS_ID:19509 EP_NO: N/A FS_HLM: 1.3414 Repair Type: Non-Urgent Crossing Status: Indicator Found UCIP Comments: Need to contact owner to determine details of the crossing through levee. FIELD_STRUCT_DESC: Wheatland Sewage Disposal Plant on waterward side, treatment plant on landward side. Service pole on waterward slope. FS Date: 03/20/2014

View of water treatment located on landward side, photo 2 of 3.

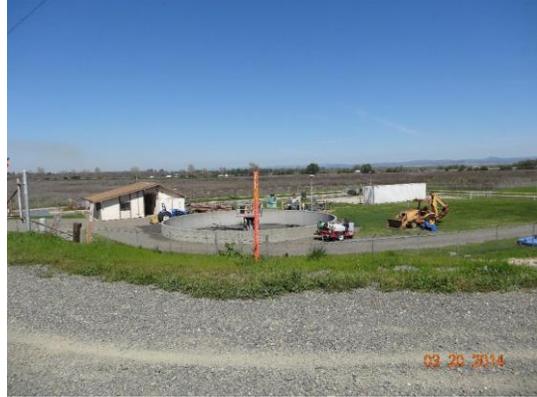
Photo 2 of 3 : UCIP_FA_2015_5196.jpg

LM Start	1.29	Rating **	M	Issue No.	30 (cont)
LM End	1.29	Issue Type +	En	Location *	LS
Category	Supplemental			GPS Latitude/Longitude	
				Start	End
Item	DWR UCIP Field Study			38.998322 °	38.998322 °
				-121.414688 °	-121.414688 °
DWR ID					
Action/Comments					
Inspector Comments: FS_ID:39994 DS_ID:19509 EP_NO: N/A FS_HLM: 1.3414 Repair Type: Non-Urgent Crossing Status: Indicator Found UCIP Comments: Need to contact owner to determine details of the crossing through levee. FIELD_STRUCT_DESC: Wheatland Sewage Disposal Plant on waterward side, treatment plant on landward side. Service pole on waterward slope. FS Date: 03/20/2014

View of water treatment located on landward side, photo 1 of 3.

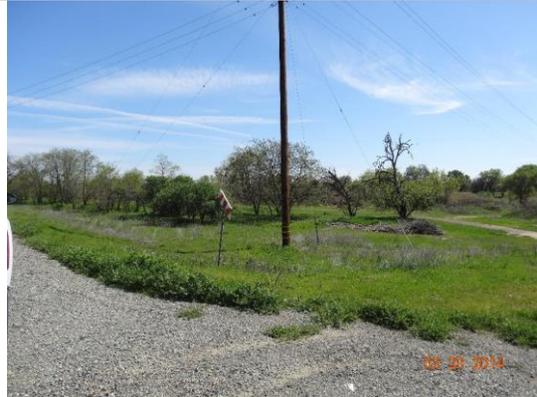
Photo 3 of 3 : UCIP_FA_2015_5237.jpg

View of waterward side.

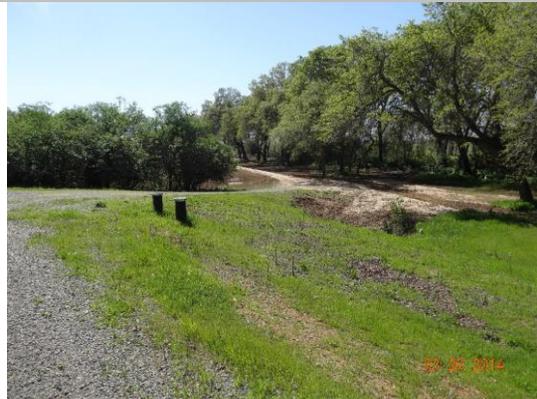
Photo 2 of 3 : UCIP_FA_2015_6387.jpg

Inspector Comments: FS_ID:40045
 DS_ID:19488
 EP_NO: N/A
 FS_HLM: 2.67
 Repair Type: Non-Urgent
 Crossing Status: Found
 UCIP Comments: Pipe has been plugged--visible on landward side. Need to contact owner to obtain additional information about abandoned crossing.
 FIELD_STRUCT_DESC: 1 of 2: 30-inch diameter CM irrigation pipe through levee, 13.8 feet below crown. Slide gates in 42-diameter riser on waterward slope. Concrete "U" headwall at both levee toes. Grouted spillway on landward side. (USACE-1962). This entry matches the Drainage or Irrigation Structure referenced in O&M manual (HLM 2.67).
 FS Date: 03/20/2014

View of waterward shoulder.

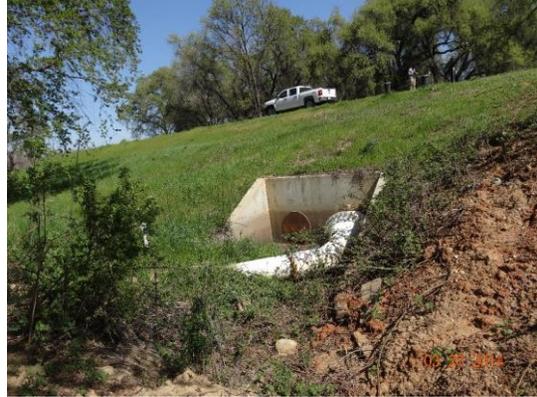
Photo 3 of 3 : UCIP_FA_2015_6388.jpg

LM Start	2.60	Rating **	M	Issue No.	33 (cont)
LM End	2.60	Issue Type +	En	Location *	LS
Category	Supplemental			GPS Latitude/Longitude	
				Start	End
Item	DWR UCIP Field Study			39.009394 °	39.009394 °
				-121.397300 °	-121.397300 °
DWR ID					
Action/Comments					
Inspector Comments: FS_ID:40045 DS_ID:19488 EP_NO: N/A FS_HLM: 2.67 Repair Type: Non-Urgent Crossing Status: Found

View of waterward side.

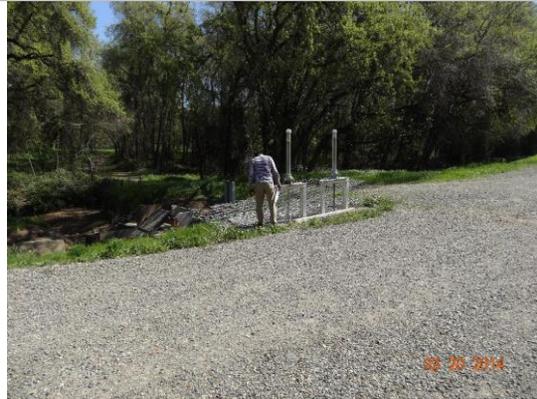
Photo 1 of 3 : UCIP_FA_2015_6389.jpg

LM Start	2.60	Rating **	M	Issue No.	34
LM End	2.60	Issue Type +	En	Location *	LS
Category	Supplemental			GPS Latitude/Longitude	
				Start	End
Item	DWR UCIP Field Study			39.009408 °	39.009408 °
				-121.397296 °	-121.397296 °
DWR ID					
Action/Comments					
Inspector Comments: FS_ID:40046 DS_ID:19504 EP_NO: N/A FS_HLM: 2.671 Repair Type: Non-Urgent Crossing Status: Found UCIP Comments: Need to contact owner to determine status--crossing appears to be modified. Need to contact owner to obtain additional information about modified crossing. FIELD_STRUCT_DESC: 2 of 2: 30-inch diameter CM irrigation pipe through levee, 13.8 feet below crown. Slide gates in 42-diameter riser on waterward slope. Concrete "U" headwall at both levee toes. Grouted spillway on landward side. (USACE-1962). This entry matches the Drainage or Irrigation Structure referenced in O&M manual (HLM 2.67). FS Date: 03/20/2014

View of landward side.

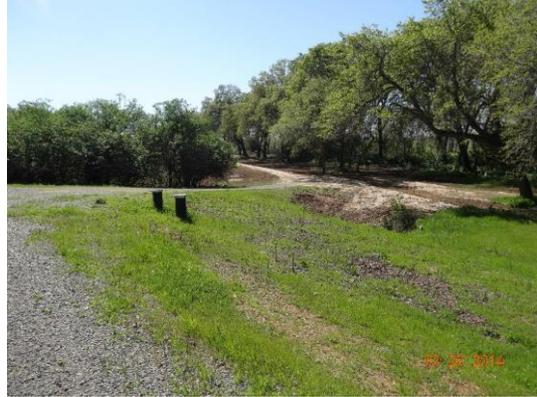
Photo 2 of 3 : UCIP_FA_2015_6390.jpg

View of waterward side.

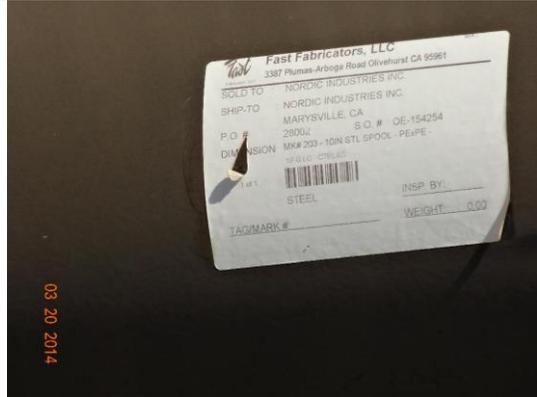
Photo 1 of 3 : UCIP_FA_2015_6412.jpg

LM Start	3.95	Rating **	M	Issue No.	36
LM End	3.95	Issue Type +	En	Location *	LS
Category	Supplemental			GPS Latitude/Longitude	
				Start	End
Item	DWR UCIP Field Study			39.022529 °	39.022529 °
DWR ID				-121.379286 °	-121.379286 °
Action/Comments					
Inspector Comments: FS_ID:40048 DS_ID:19510 EP_NO: N/A FS_HLM: 4.045 Repair Type: Non-Urgent Crossing Status: Found

Label on riser.

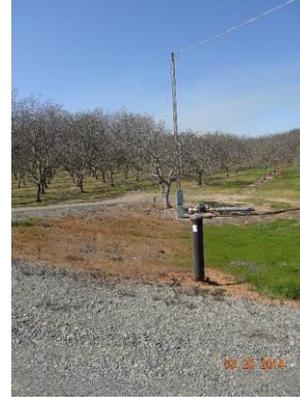
Photo 3 of 3 : UCIP_FA_2015_6414.jpg

LM Start	3.95	Rating **	M	Issue No.	36 (cont)
LM End	3.95	Issue Type +	En	Location *	LS
Category	Supplemental			GPS Latitude/Longitude	
				Start	End
Item	DWR UCIP Field Study			39.022529 °	39.022529 °
				-121.379286 °	-121.379286 °
DWR ID					
Action/Comments					
Inspector Comments: FS_ID:40048 DS_ID:19510 EP_NO: N/A FS_HLM: 4.045 Repair Type: Non-Urgent Crossing Status: Found

View of waterward side.

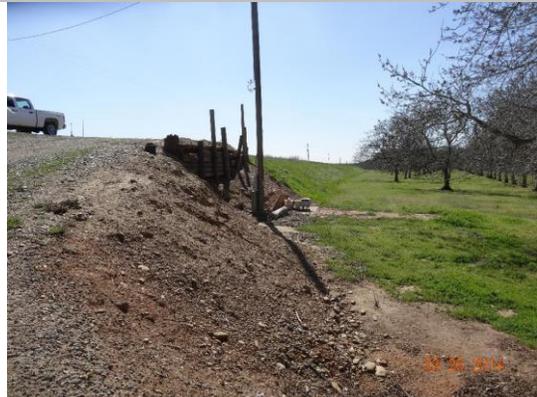
Photo 1 of 3 : UCIP_FA_2015_6415.jpg

LM Start	4.74	Rating **	M	Issue No.	38
LM End	4.74	Issue Type +	En	Location *	LS
Category	Supplemental			GPS Latitude/Longitude	
				Start	End
Item	DWR UCIP Field Study			39.030340 °	39.030340 °
				-121.368535 °	-121.368535 °
DWR ID					
Action/Comments					
Inspector Comments: FS_ID:40049 DS_ID:19493 EP_NO: N/A FS_HLM: 4.857 Repair Type: Non-Urgent Crossing Status: Found UCIP Comments: Crossing has been modified---need to contact owner to obtain permit used for modification. FIELD_STRUCT_DESC: 24-inch corrugated metal irrigation pipe through levee, 10.6 feet below the crown. Slide gate in concrete square riser (not 36-inch CM riser as mentioned in desk study) on the waterward slope. Concrete "U" headwall and trash rack at waterward toe. 5x5-foot concrete distribution box and headwall at landward toe. (USACE-1962). This entry matches the Drainage or Irrigation Structure referenced in O&M manual (HLM 4.87). FS Date: 03/20/2014

Overview of waterward side.
