**Flood Control Project Maintenance  
Levee Inspections**

**Fall 2013 Levee Maintenance Deficiency Summary Report**

**Sacramento Maintenance Yard Cache Creek**

**Levee Inspection Report By Mile - Fall 2013**

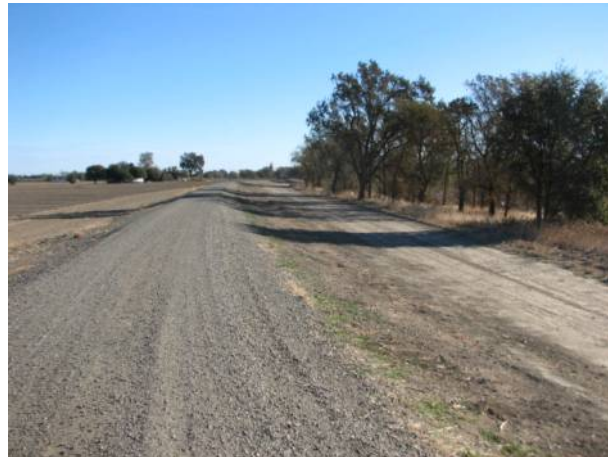
Levee Mile Report Line	5
Start Levee Mile	0.18
End Levee Mile	1.63
Location	Water Side
Category	Earthen Levee
Item	Vegetation

The levee has no unwanted vegetation on it. Fall 2013

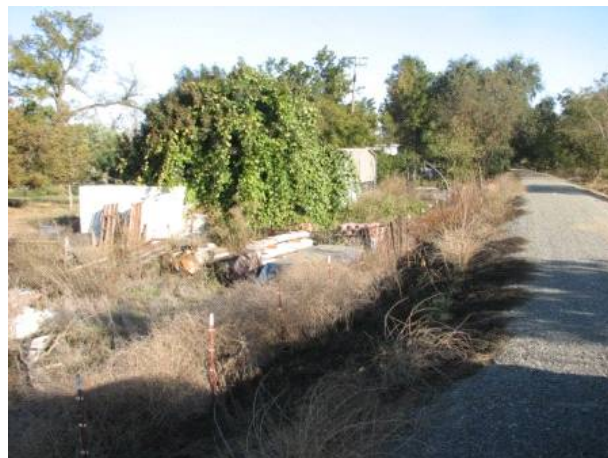
Levee Mile Report Line	6
Start Levee Mile	1.83
End Levee Mile	1.83
Location	Land Side
Category	Earthen Levee
Item	Encroachments

The owner has a lot of building material stored within the easement. Fall 2011

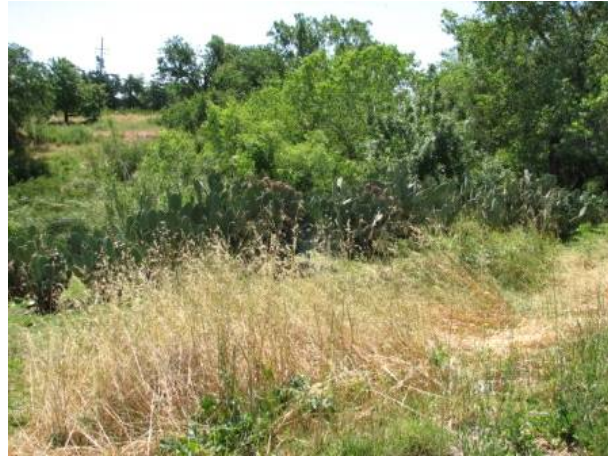
A cactus garden is planted on the waterside of the levee. There is some planted on the landside also.

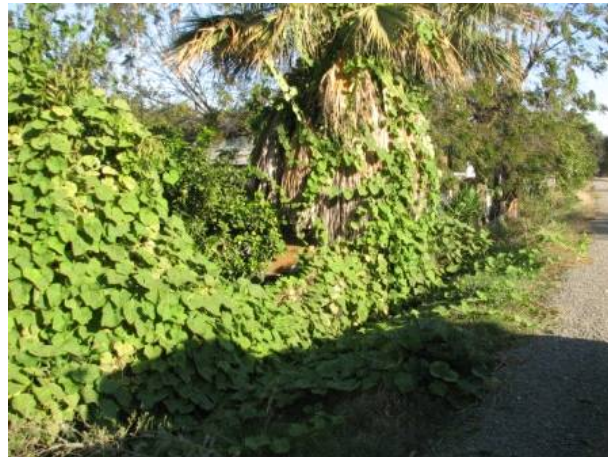
Levee Mile Report Line	10
Start Levee Mile	1.96
End Levee Mile	1.99
Location	Land Side
Category	Earthen Levee
Item	Vegetation

Wild grape and other plants are obstructing the view for inspection. Fall 2011

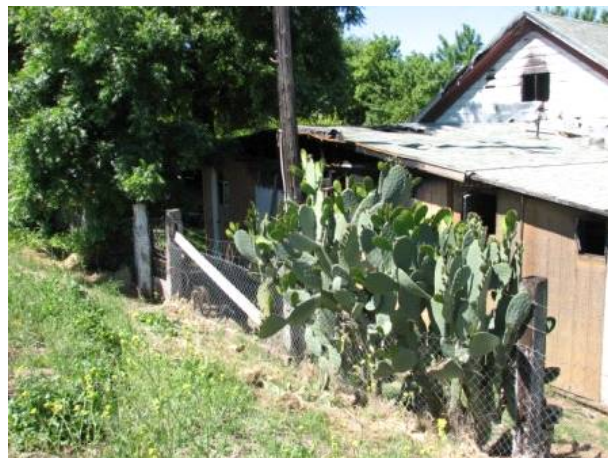
Levee Mile Report Line	11
Start Levee Mile	1.98
End Levee Mile	1.98
Location	Land Side
Category	Earthen Levee
Item	Encroachments

The building is in the easement of the levee. Cactus is planted at the toe obstructs visibility.

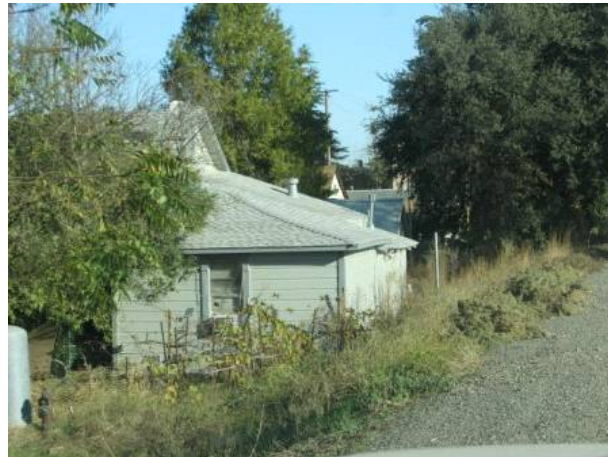
Levee Mile Report Line	13
Start Levee Mile	2.03
End Levee Mile	2.03
Location	Land Side
Category	Earthen Levee
Item	Encroachments

The house is in the easement of the levee toe. Fall 2011

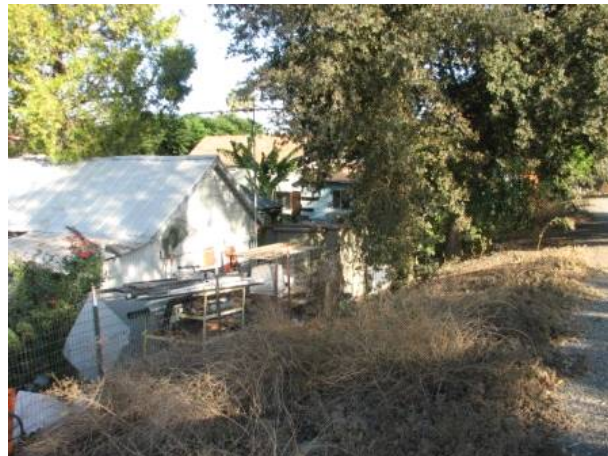
Levee Mile Report Line	14
Start Levee Mile	2.04
End Levee Mile	2.04
Location	Land Side
Category	Earthen Levee
Item	Encroachments

The building is in the easement of the levee. Fall 2011

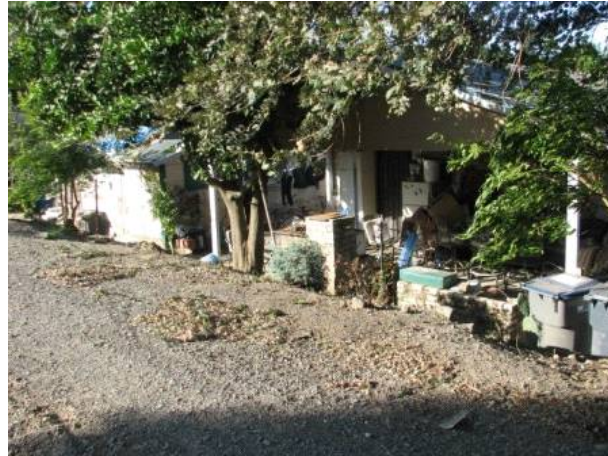
The building is in the easement of the levee. Fall 2011

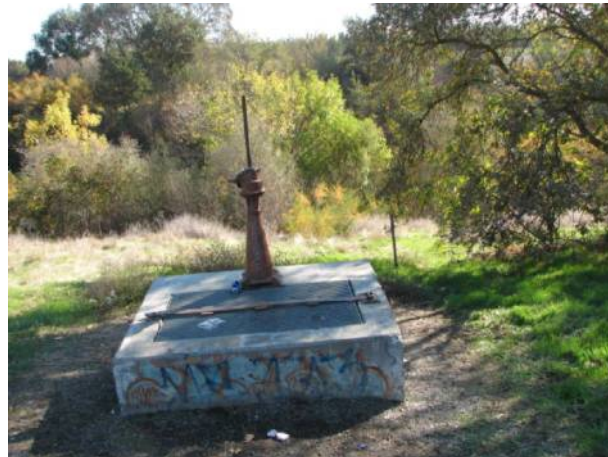
Levee Mile Report Line	17
Start Levee Mile	2.08
End Levee Mile	2.08
Location	Land Side
Category	Supplemental
Item	DWR UCIP Field Study

Waterside view: a concrete control box with slide gate

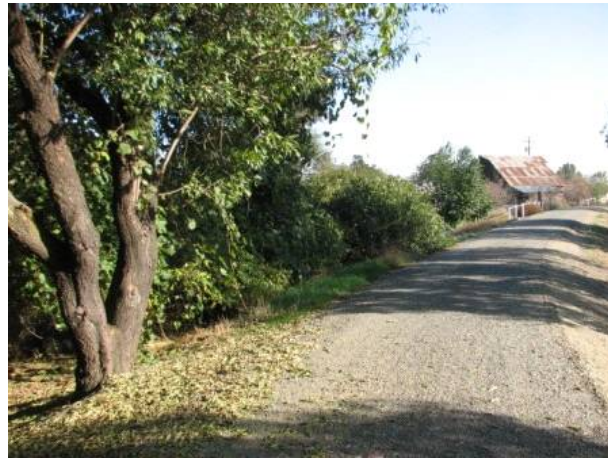
The shrubs block visibility of the levee slope. Fall 2011

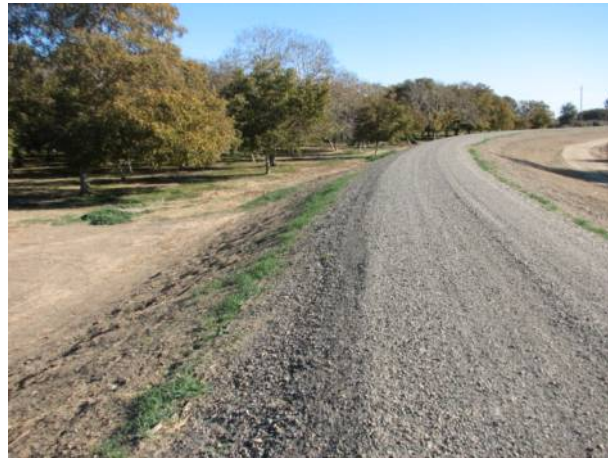
The levee has no unwanted vegetation on the slopes. Fall 2013

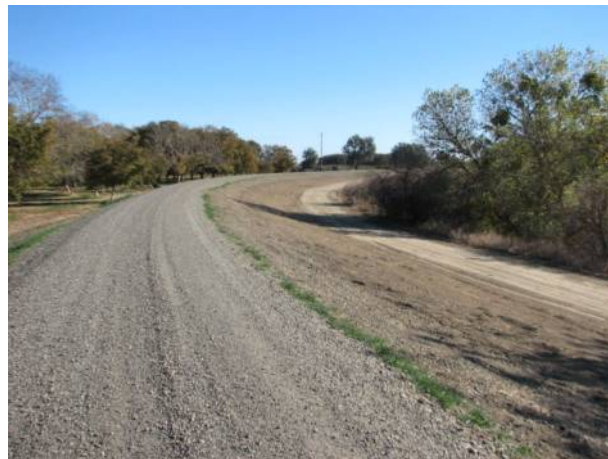
Levee Mile Report Line	24
Start Levee Mile	2.15
End Levee Mile	11.80
Location	Water Side
Category	Earthen Levee
Item	Vegetation

The levee has no unwanted vegetation on the slope. Fall 2013

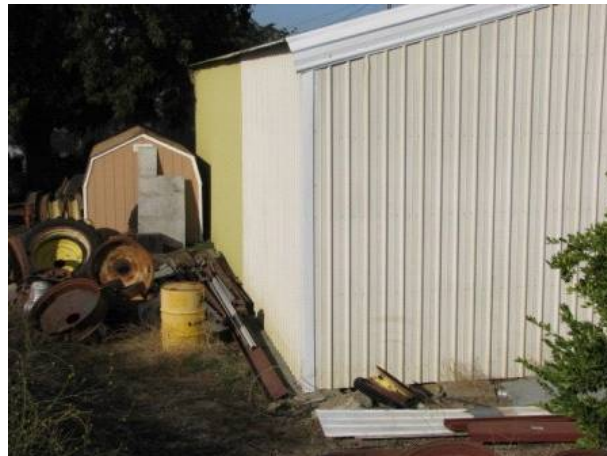
Levee Mile Report Line	27
Start Levee Mile	2.66
End Levee Mile	2.66
Location	Land Side
Category	Earthen Levee
Item	Encroachments

The corner of the shop is within the easement of  
the levee. Fall 2011

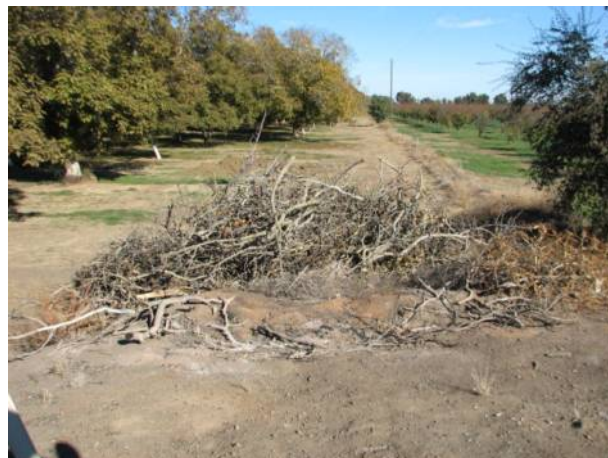
Levee Mile Report Line	29
Start Levee Mile	2.85
End Levee Mile	2.85
Location	Land Side
Category	Earthen Levee
Item	Encroachments

The pruning pile is at the toe of the levee. Fall 2013

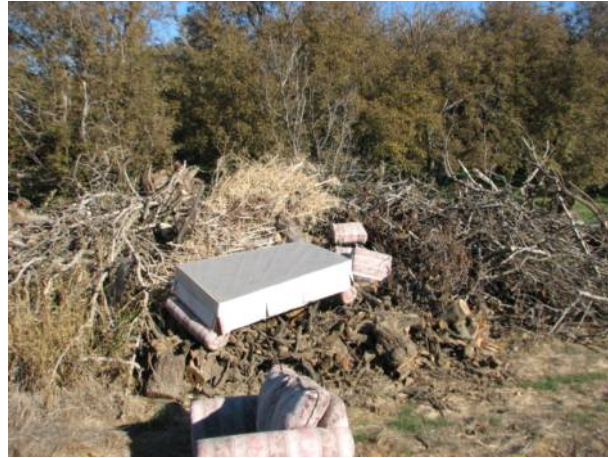
A pruning pile with some furniture is at the toe of the levee. Fall 2013

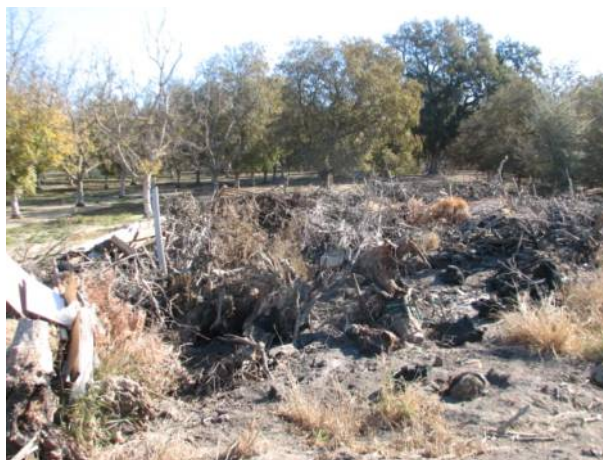
The pruning pile with tree stumps is at the toe of the levee. Fall 2013

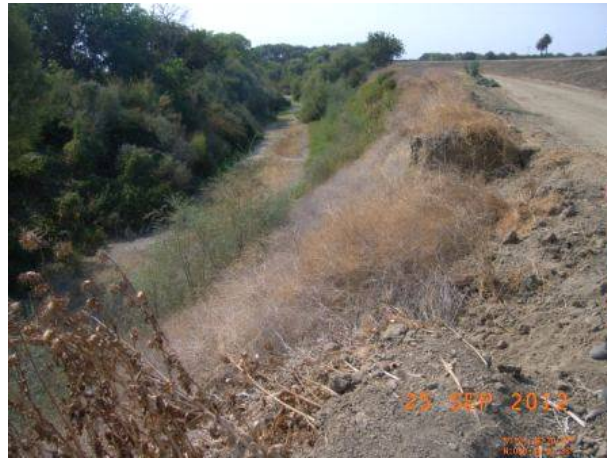
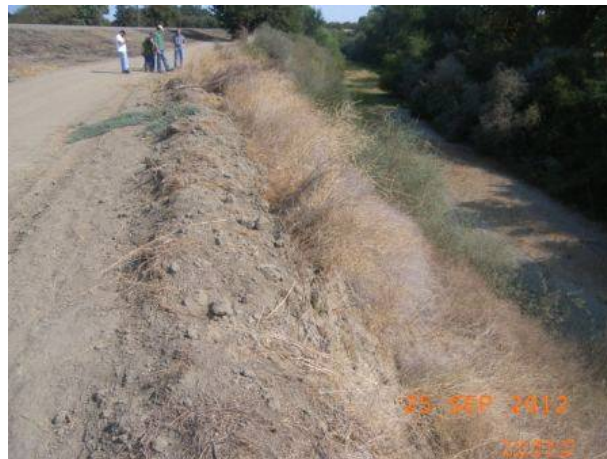
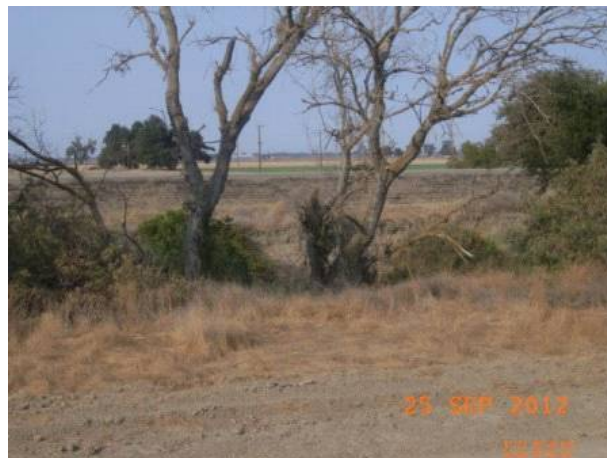
Levee Mile Report Line	36
Start Levee Mile	4.14
End Levee Mile	4.28
Location	Water Side
Category	Supplemental
Item	USACE Erosion Survey

DWR ID:										
36	4.14	4.28	Supplemental	USACE Erosion Survey	WS	U Ma	Inspector Comments: Site identified as CRITICAL in 2006. 2006 - Some significant new erosion, especially fresh upper bank slumping. Also have a small piping failure due to recent overbank flows. 2010 - New erosion, flood fought in early 2010. Planned setback levee by CA DWR, 100% designs complete, construction planned for 2011. 2011 - Large sections of bank have slumped since the previous year. 2012: Significant new erosion along top of bank. Construction planned for 2013 - 2014. [2012 Site ID: CHC_4-2_L]	38.727261 ° -121.776921 °	38.726903 ° -121.774435 °	34 Y
DWR ID:										
37	4.27	4.42	Earthen Levee	Vegetation	LS	M Ma	V6 : Landscaping	38.727047 ° -121.774413 °	38.726113 ° -121.771929 °	27 Y
DWR ID: DWR_ST0001_01_s_2012_27										
38	4.32	4.32	Earthen Levee	Encroachments	LS	M En	PR : Prunings	38.726785 ° -121.773538 °	38.726785 ° -121.773538 °	55 Y

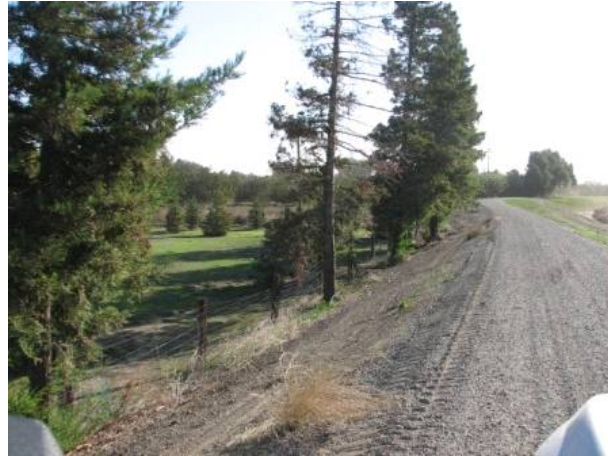
Landscape trees are planted along the levee to and on the slope. Some of the trees are trimmed up for visibility. Fall 2011

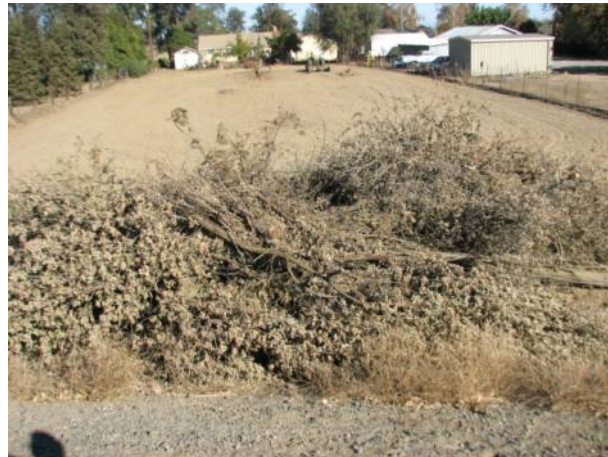
Levee Mile Report Line	38
Start Levee Mile	4.32
End Levee Mile	4.32
Location	Land Side
Category	Earthen Levee
Item	Encroachments

The pruning pile is at the toe of the levee. Fall 2013

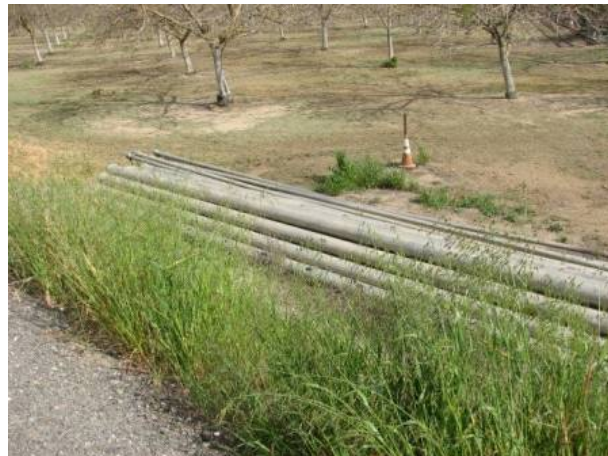
Levee Mile Report Line	39
Start Levee Mile	4.76
End Levee Mile	4.76
Location	Land Side
Category	Earthen Levee
Item	Encroachments

Aluminum irrigation pipe is placed along the landside levee toe.

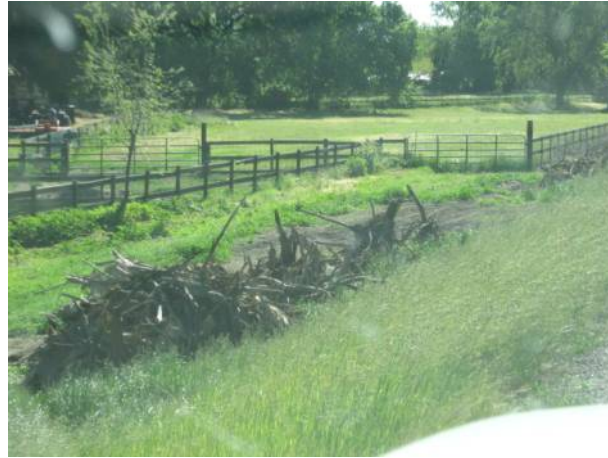
Levee Mile Report Line	40
Start Levee Mile	4.80
End Levee Mile	4.80
Location	Land Side
Category	Earthen Levee
Item	Encroachments
Pruning's and root balls at the toe of the levee. Spring 2013	
johngw_f_20131021_782.JPG

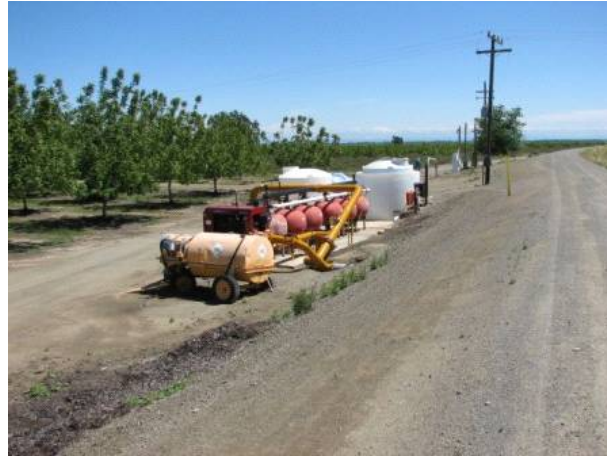
Levee Mile Report Line	45
Start Levee Mile	6.31
End Levee Mile	6.31
Location	Land Side
Category	Earthen Levee
Item	Encroachments
Pipe through levee, filter, and fertilizer tanks are within the easement of the levee.	
johngw_f_20131021_781.jpg

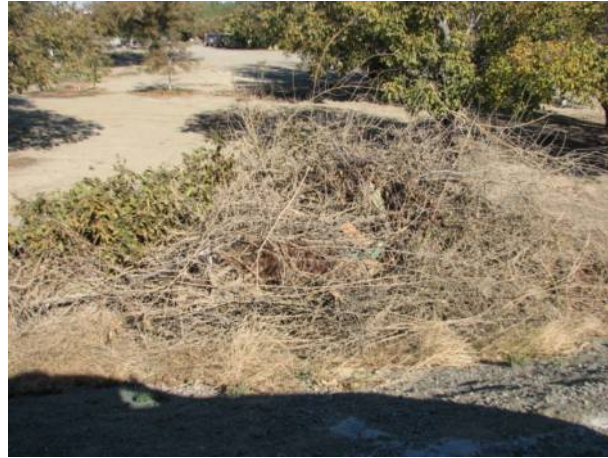
A pruning pile is at the toe of the levee. Fall 2013

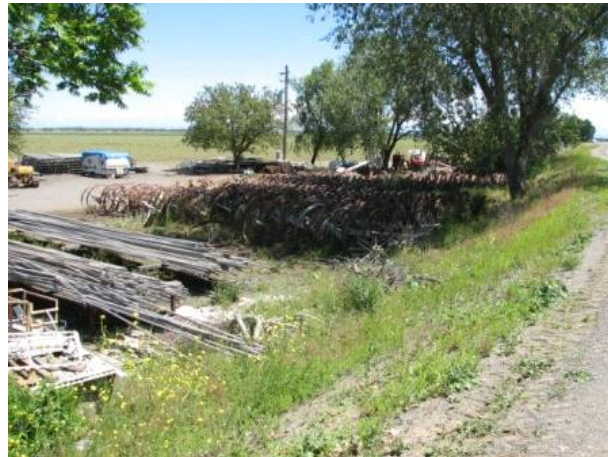
Levee Mile Report Line	48
Start Levee Mile	7.33
End Levee Mile	7.38
Location	Land Side
Category	Earthen Levee
Item	Encroachments

Irrigation pipe and equipment are within the easement of the levee.

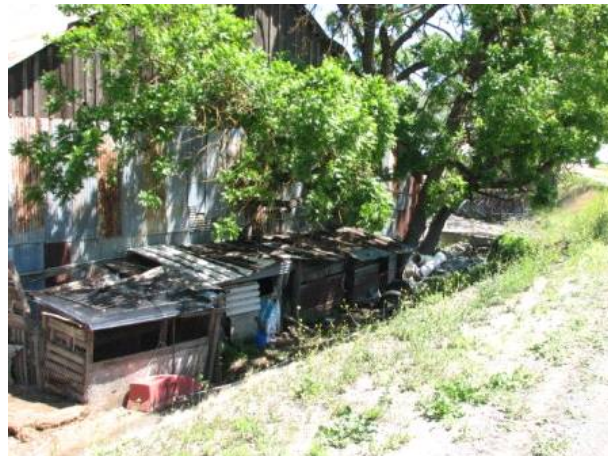
Levee Mile Report Line	49
Start Levee Mile	7.33
End Levee Mile	7.33
Location	Land Side
Category	Earthen Levee
Item	Encroachments

The barn and livestock pens are within the easement of the levee.

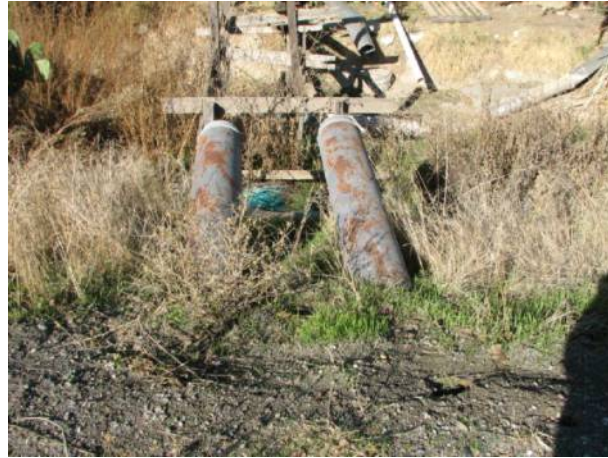
Landside view: overview of the pipes

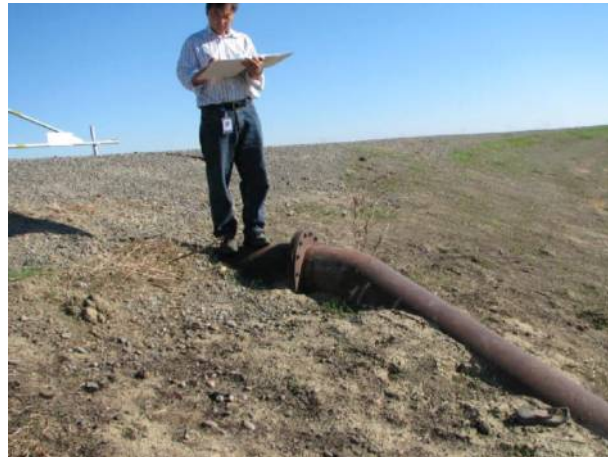
UCIP\_3617.jpg

Waterside view: steel pipe on waterside slope of the levee

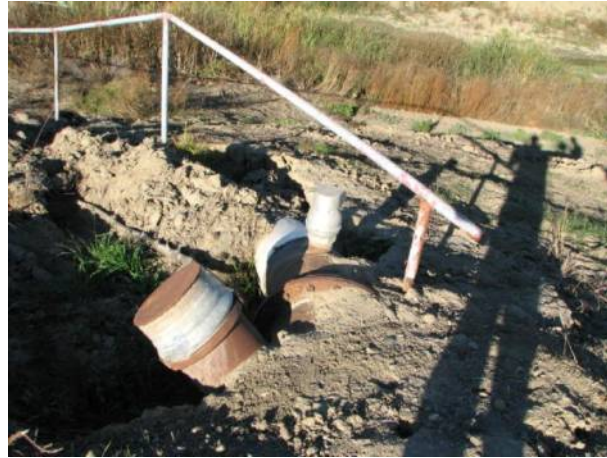
LMR No.	Levee Mile		Category	Item	Location	Rating	Action/Comment	GPS Latitude/Longitude		Issue No. Photo
	Start	End						Start	End	
54	10.85	10.85	Supplemental	DWR UCIP Field Study	LS	M En	Inspector Comments: FS_ID:13984 EP_NO: N/A Repair Type: Non-Urgent Crossing Status: Found UCIP Comments: Pipe leaks, severe erosion from levee shoulder to pipe daylight on landside levee slope. FIELD_STRUCT_DESC: A 18-inch soil proofed Steel Pipe 0.25" thick. FS Date: 5/28/2013 3:22:00 PM	38.701814 ° -121.690832 °	38.701814 ° -121.690832 °	47 Y
DWR ID: DWR_ST0001_01_f_2013_47										
55	10.85	10.85	Supplemental	DWR UCIP Field Study	LS	U En	Inspector Comments: FS_ID:13983 EP_NO: N/A Repair Type: Urgent Crossing Status: Found UCIP Comments: Pipe leaks, severe erosion from levee shoulder to pipe daylight on landside levee slope. FIELD_STRUCT_DESC: A 18-inch soil proofed Steel Pipe 0.25" thick. FS Date: 5/28/2013 3:22:50 PM	38.701814 ° -121.690832 °	38.701814 ° -121.690832 °	48

Levee Mile Report Line	54
Start Levee Mile	10.85
End Levee Mile	10.85
Location	Land Side
Category	Supplemental
Item	DWR UCIP Field Study
Landside view: pipe daylight on LS levee slope	
UCIP_7502.jpg

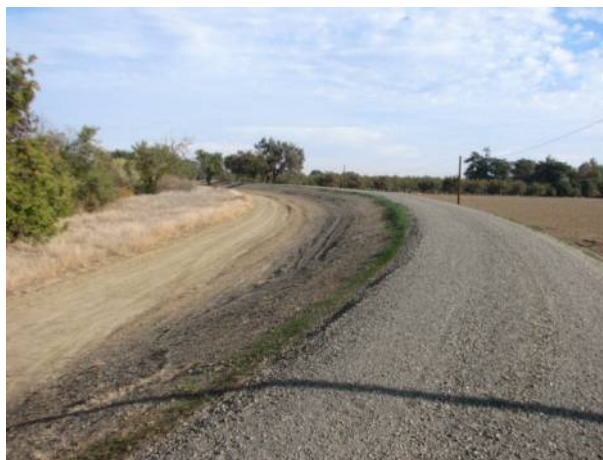
johngw\_f\_20131112\_302.JPG

The levee has no unwanted vegetation on the slope. Fall 2013

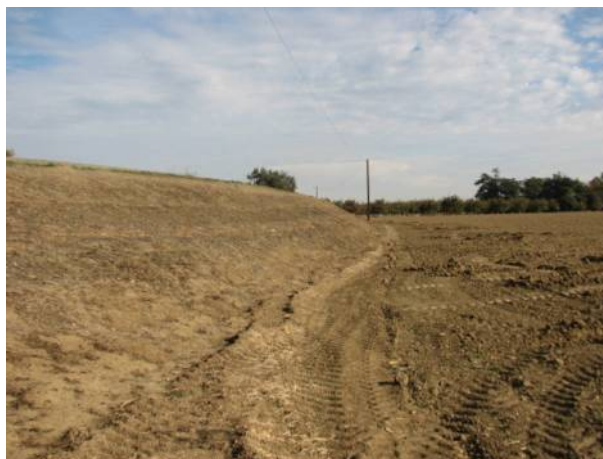
johngw\_f\_20131112\_301.JPG

Levee Mile Report Line	2
Start Levee Mile	0.02
End Levee Mile	11.42
Location	Land Side
Category	Earthen Levee
Item	Vegetation

The levee has no unwanted vegetation on the slope. Fall 2013

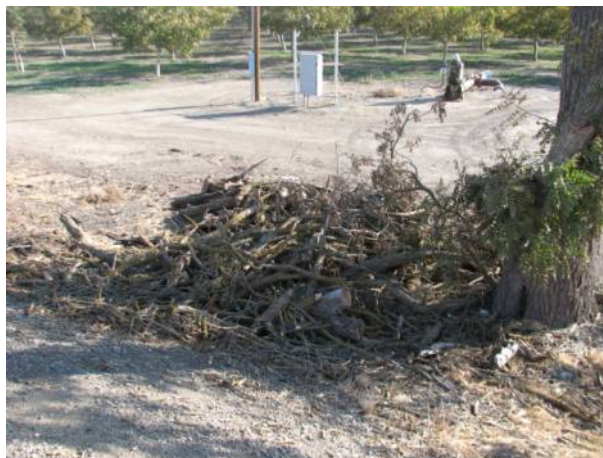
johngw\_f\_20131112\_303.JPG

Levee Mile Report Line	5
Start Levee Mile	0.26
End Levee Mile	0.26
Location	Land Side
Category	Earthen Levee
Item	Encroachments

A pruning pile is within the easement of the levee. Fall 2013

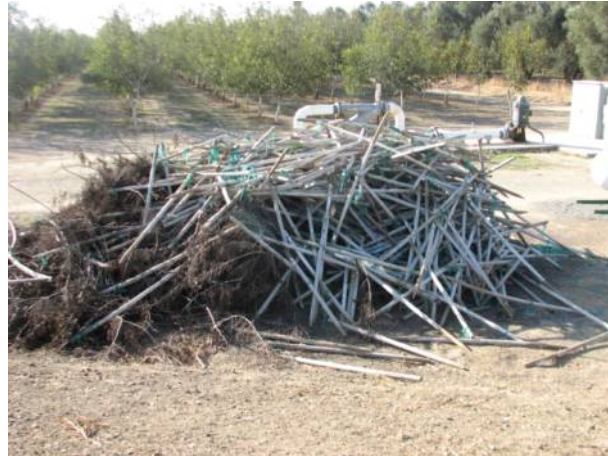
Levee Mile Report Line	8
Start Levee Mile	0.68
End Levee Mile	0.68
Location	Land Side
Category	Earthen Levee
Item	Encroachments
Tree stakes and pruning's are at the toe of the levee. Fall 2013	
johngw_f_20131112_304.JPG

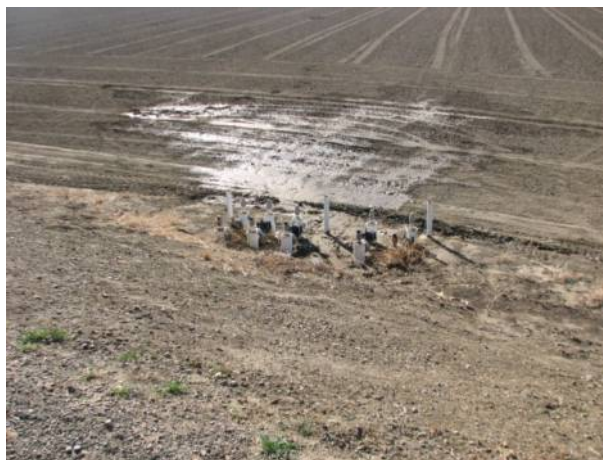
johngw\_f\_20131112\_306.JPG

The irrigation valves are installed at the toe of the levee. Fall 2013

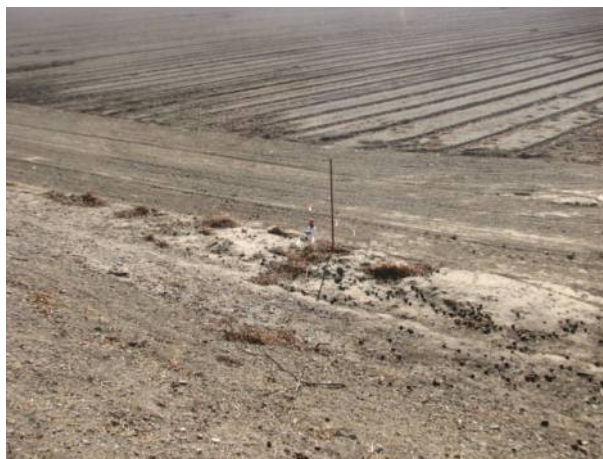
johngw\_f\_20131112\_307.JPG

Levee Mile Report Line	11
Start Levee Mile	2.17
End Levee Mile	2.17
Location	Land Side
Category	Earthen Levee
Item	Encroachments

A relief valve for the drip irrigation system is installed at the toe. Fall 2013

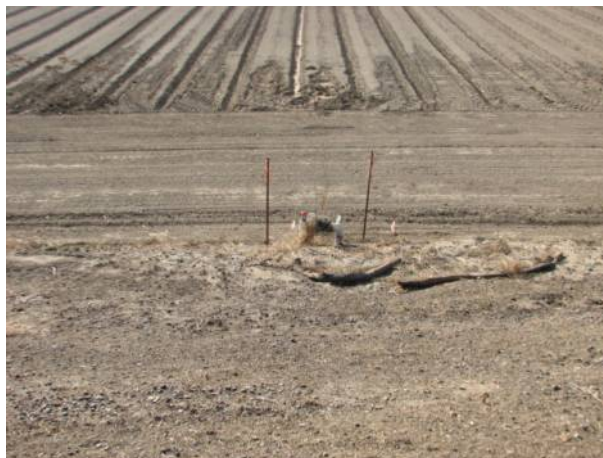
johngw\_f\_20131112\_308.JPG

Levee Mile Report Line	12
Start Levee Mile	2.24
End Levee Mile	2.24
Location	Land Side
Category	Earthen Levee
Item	Encroachments

The irrigation valve and relief valve is installed at the toe. Fall 2013

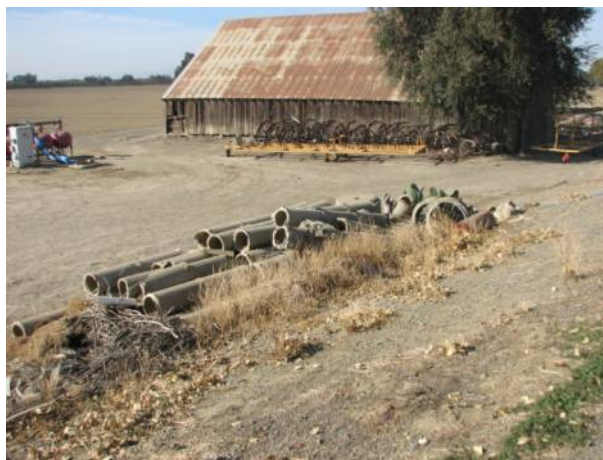
johngw\_f\_20131112\_309.JPG

The concrete pipe is within the easement of the levee. Fall 2013

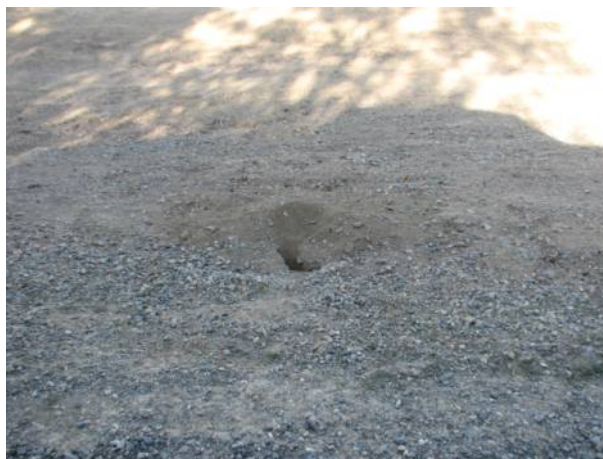
johngw\_f\_20131112\_310.JPG

Levee Mile Report Line	14
Start Levee Mile	3.33
End Levee Mile	3.33
Location	Water Side
Category	Earthen Levee
Item	Animal Control

There was no rodents visible. The LMA has been grouting rodent holes this fall. Fall 2013

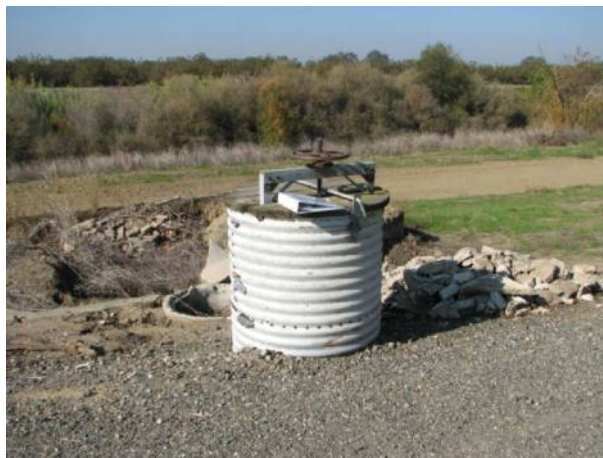
UCIP\_3757.jpg

Levee Mile Report Line	16
Start Levee Mile	3.42
End Levee Mile	3.42
Location	Water Side
Category	Supplemental
Item	DWR UCIP Field Study

Waterside view: 36-inch CMP riser and abandoned pump house

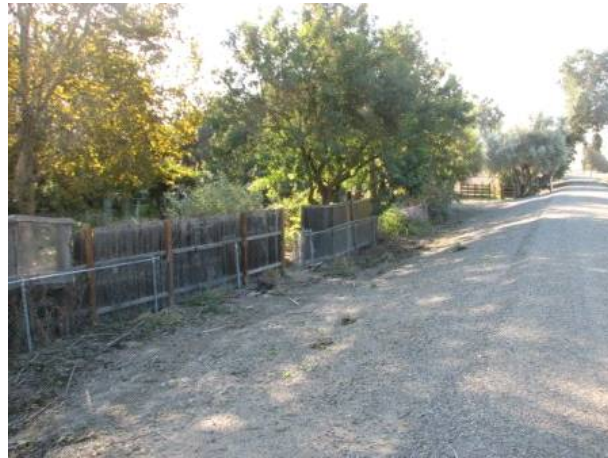
johngw\_f\_20131021\_800.jpg

The landscaping and fence are obstructive to viewing the levee toe. Fall 2011

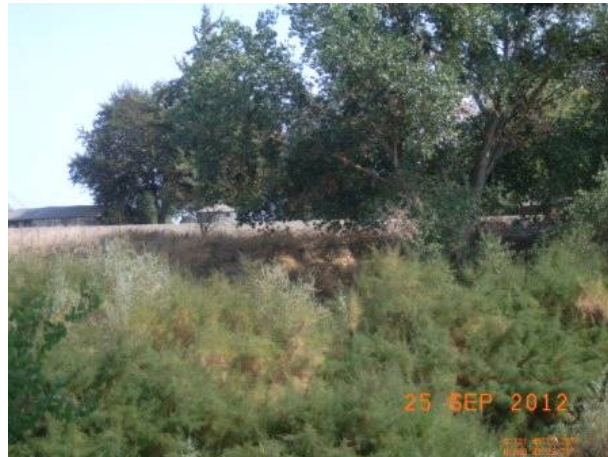
USACE 2012 Photo #1

Levee Mile Report Line	19
Start Levee Mile	3.53
End Levee Mile	3.61
Location	Water Side
Category	Supplemental
Item	USACE Erosion Survey

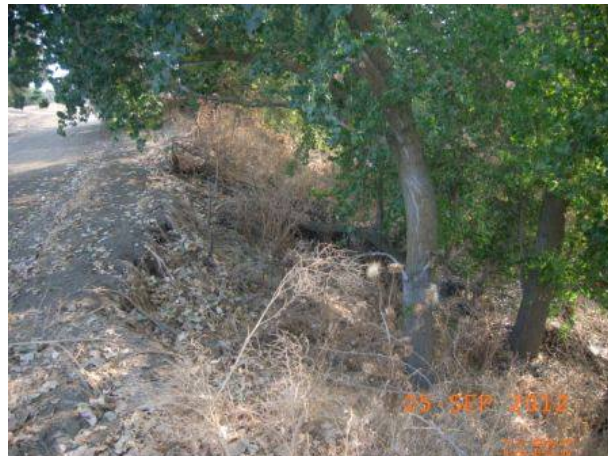
USACE 2012 Photo #2

Levee Mile Report Line	19
Start Levee Mile	3.53
End Levee Mile	3.61
Location	Water Side
Category	Supplemental
Item	USACE Erosion Survey

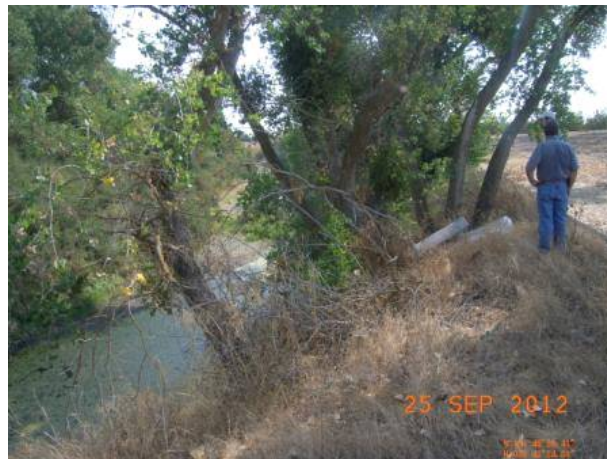
USACE 2012 Photo #1

LMR No.	Levee Mile		Category	Item	Location *	Rating **	Action/Comment	GPS Latitude/Longitude		Issue No. Photo
	Start	End						Start	End	
20	3.58	3.59	Supplemental	USACE Erosion Survey	WS	M Ma	Inspector Comments: 2009 - Erosion into the levee slope. 2010 - Minor new erosion. 2011 - New erosion and a freshly fallen tree. 2012: No observed change. [2012 Site ID: CHC_5-4_L]	38.722933 ° -121.760561 °	38.723467 ° -121.760436 °	20 Y
DWR ID: DWR_ST0001_02_s_2012_8										
21	4.01	4.01	Earthen Levee	Encroachments	LS	M Ma	BU : Building	38.723997 ° -121.752505 °	38.723997 ° -121.752505 °	8 Y
DWR ID: DWR_ST0001_02_s_2012_8										
22	4.03	4.03	Earthen Levee	Encroachments	LS	M En	EQ : Equipment	38.724200 ° -121.752272 °	38.724200 ° -121.752272 °	26 Y
DWR ID: DWR_ST0001_02_f_2013_26										
23	4.04	4.13	Earthen Levee	Vegetation	LS	M En	V6 : Landscaping	38.724317 ° -121.752148 °	38.725242 ° -121.751075 °	9 Y

Levee Mile Report Line	20
Start Levee Mile	3.58
End Levee Mile	3.59
Location	Water Side
Category	Supplemental
Item	USACE Erosion Survey

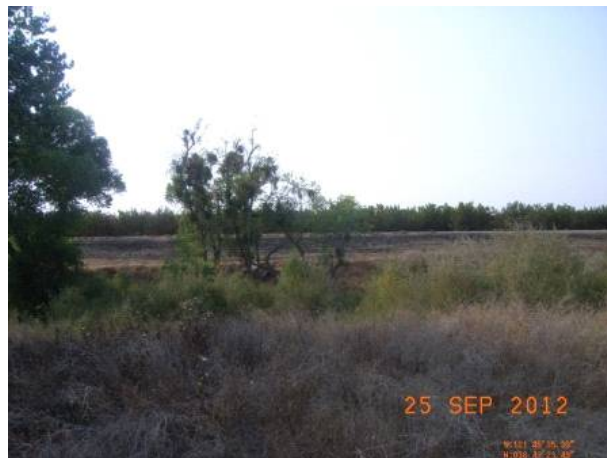
USACE 2012 Photo #2

Levee Mile Report Line	20
Start Levee Mile	3.58
End Levee Mile	3.59
Location	Water Side
Category	Supplemental
Item	USACE Erosion Survey

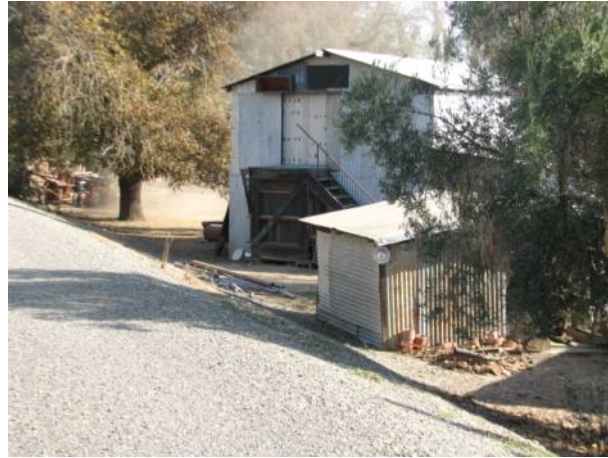
johngw\_f\_20131112\_311.JPG

The out buildings are within the easement of the levee. Fall 2013

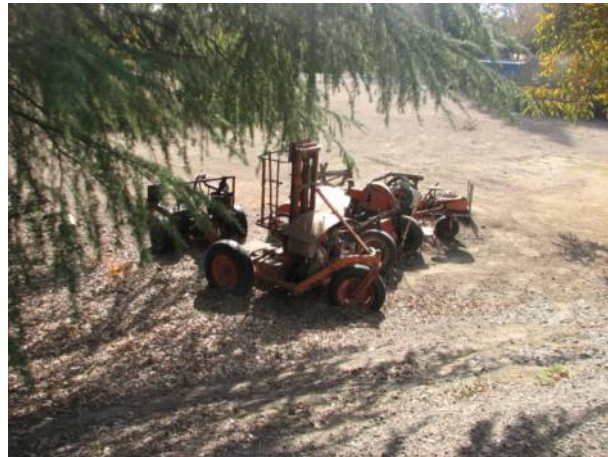
johngw\_f\_20131112\_312.JPG

Levee Mile Report Line	22
Start Levee Mile	4.03
End Levee Mile	4.03
Location	Land Side
Category	Earthen Levee
Item	Encroachments

The are several pieces of equipment near the toe of the levee. Fall 2013

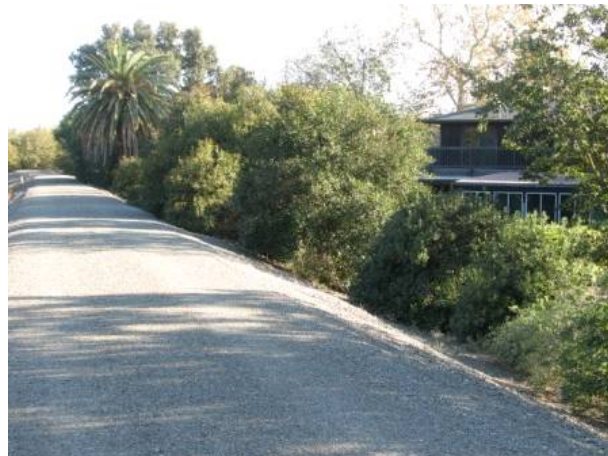
johngw\_f\_20131021\_802.jpg

Levee Mile Report Line	23
Start Levee Mile	4.04
End Levee Mile	4.13
Location	Land Side
Category	Earthen Levee
Item	Vegetation

The landscape shrubs block visibility of the toe. Fall 2011

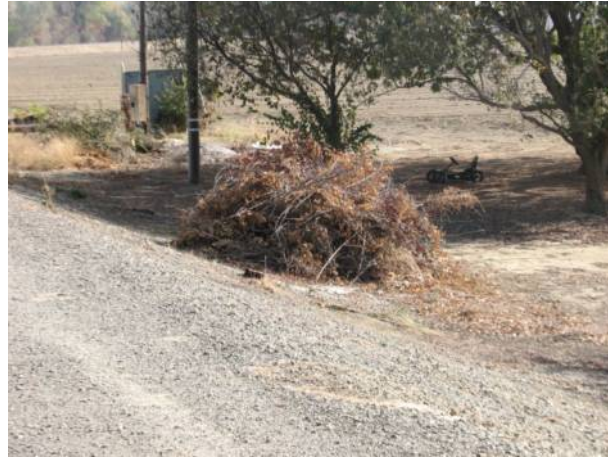
johngw\_f\_20131112\_314.JPG

A pruning pile is at the toe of the levee. Fall 2013

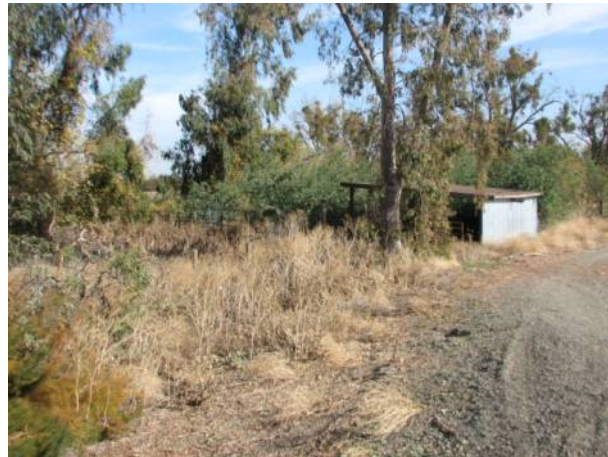
johngw\_f\_20131112\_313.JPG

Levee Mile Report Line	27
Start Levee Mile	4.43
End Levee Mile	4.43
Location	Water Side
Category	Earthen Levee
Item	Encroachments

The horse corral and building are on the waterside berm. Fall 2013

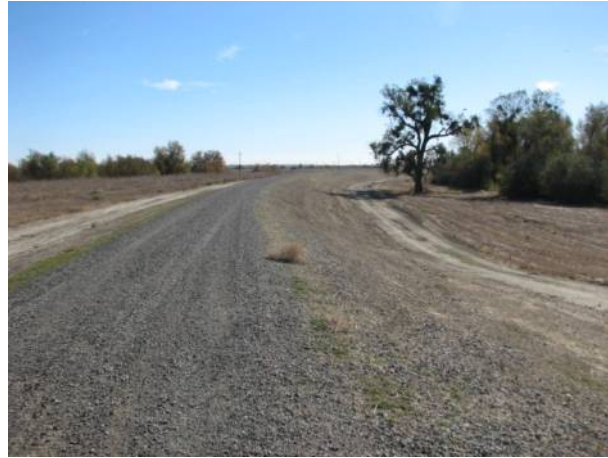
johngw\_f\_20131112\_299.JPG

The levee has no unwanted vegetation on the slope. Fall 2013

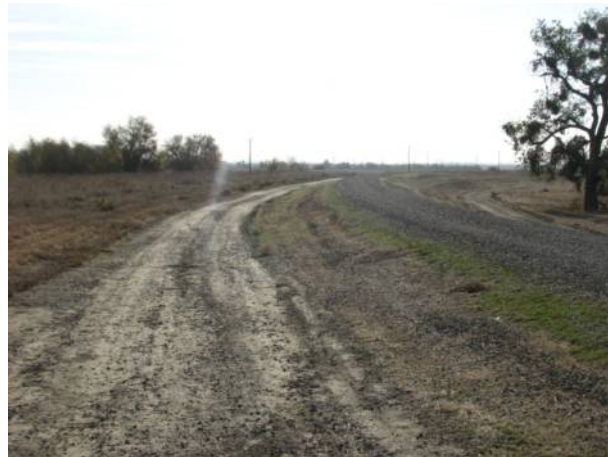
johngw\_f\_20131112\_300.JPG

Levee Mile Report Line	2
Start Levee Mile	2.26
End Levee Mile	2.26
Location	Land Side
Category	Earthen Levee
Item	Vegetation

The levee has no unwanted vegetation on the slope. Fall 2013
