**Flood Control Project Maintenance
Levee Inspections**

Fall 2015 Levee Maintenance Deficiency Summary Report

Sacramento Maintenance Yard Cache Creek

Fall 2015 Levee Inspection Results

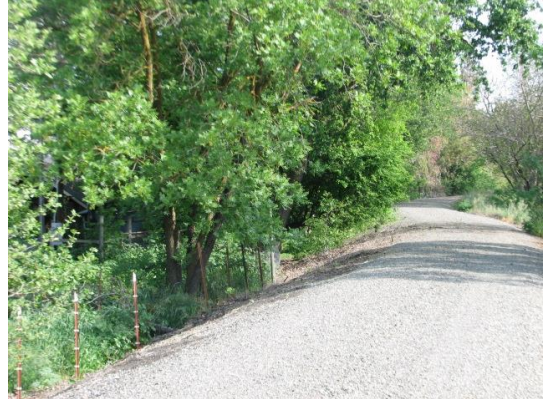
Photo 1 of 2 : FA_2015_ST0001_259_3_20150914_00002.jpg

LM Start	1.89	Rating **	M	Issue No.	3
LM End	1.98	Issue Type +	En	Location *	LS
Category	Earthen Levee			GPS Latitude/Longitude	
				Start	End
Item	Vegetation			38.729828 °	38.731143
				-121.806532 °	-121.806255
DWR ID	DWR_ST0001_01_s _ 2012_3				
Action/Comments					
Landscaping

The landscape needs to be trimmed up. Spring 2014

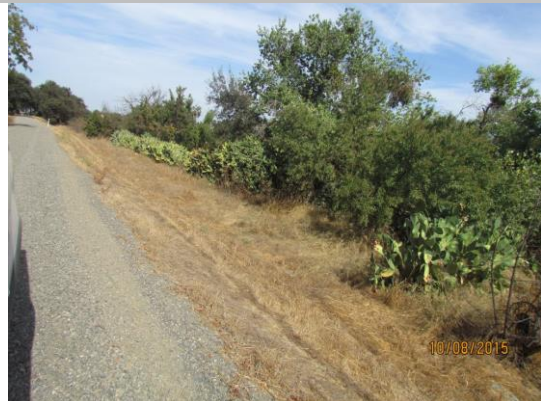
Photo 1 of 1 : FA_2015_ST0001_259_6_20151012_00075.jpg

LM Start	1.98	Rating **	M	Issue No.	6
LM End	2.02	Issue Type +	En	Location *	WS
Category	Earthen Levee			GPS Latitude/Longitude	
				Start	End
Item	Vegetation			38.731197 °	38.731655 °
				-121.806232 °	-121.806068 °
DWR ID	DWR_ST0001_01_s _ 2012_6				
Action/Comments					
Landscaping					
Inspector Comments: Catus on the waterside berm.

View of the cactus landscaping on the waterward side of the levee
looking downstream. Fall 2015.

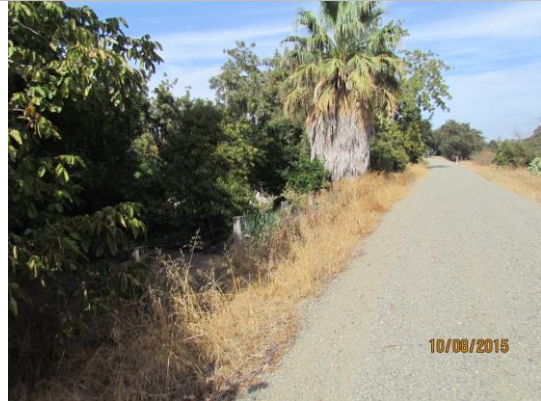
Photo 2 of 2 : FA_2015_ST0001_259_7_20151012_00074.jpg

LM Start	1.98	Rating **	M	Issue No.	7 (cont)
LM End	2.02	Issue Type +	En	Location *	LS
Category	Earthen Levee			GPS Latitude/Longitude	
				Start	End
Item	Vegetation			38.731198 °	38.731650 °
				-121.806230 °	-121.806068 °
DWR ID	DWR_ST0001_01_s_2012_7				
Action/Comments					
Landscaping

View of the landscaping on the landward side of the levee looking downstream. Fall 2015.

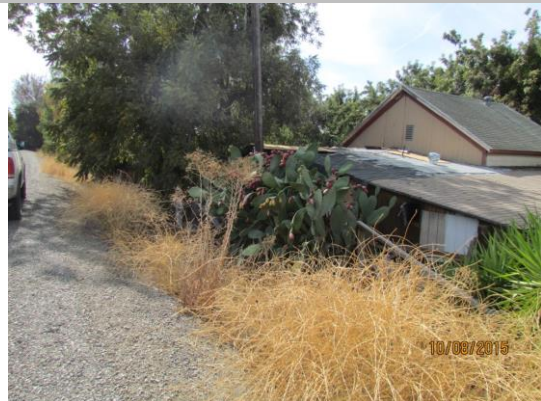
Photo 1 of 1 : FA_2015_ST0001_259_8_20151012_00073.jpg

LM Start	2.01	Rating **	M	Issue No.	8
LM End	2.01	Issue Type +	En	Location *	LS
Category	Earthen Levee			GPS Latitude/Longitude	
				Start	End
Item	Encroachments			38.731507 °	38.731507 °
				-121.806122 °	-121.806122 °
DWR ID	DWR_ST0001_01_s_2012_8				
Action/Comments					
Building

View of the building on the landward side of the levee looking upstream. Cactus planted at the toe obstructs visibility. Fall 2015.

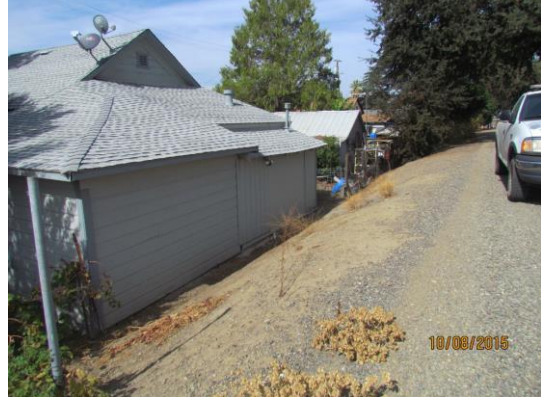
Photo 1 of 1 : FA_2015_ST0001_259_10_20151012_00071.jpg

LM Start	2.05	Rating **	M	Issue No.	10
LM End	2.05	Issue Type +	En	Location *	LS
Category	Earthen Levee			GPS Latitude/Longitude	
				Start	End
Item	Encroachments			38.732162 °	38.732162 °
				-121.805895 °	-121.805895 °
DWR ID	DWR_ST0001_01_s _ 2012_10				
Action/Comments					
Building

View of the house on the landward side of the levee looking downstream. Fall 2015.

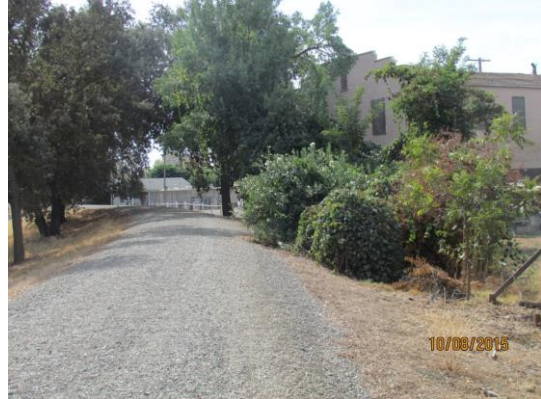
Photo 1 of 1 : FA_2015_ST0001_259_14_20151012_00067.jpg

LM Start	2.12	Rating **	M	Issue No.	14
LM End	2.13	Issue Type +	En	Location *	LS
Category	Earthen Levee			GPS Latitude/Longitude	
				Start	End
Item	Vegetation			38.733117 °	38.733218 °
				-121.805367 °	-121.805263 °
DWR ID	DWR_ST0001_01_s_2012_14				
Action/Comments					
Landscaping

View of the shrubs on the landward side of the levee looking upstream. Fall 2015.

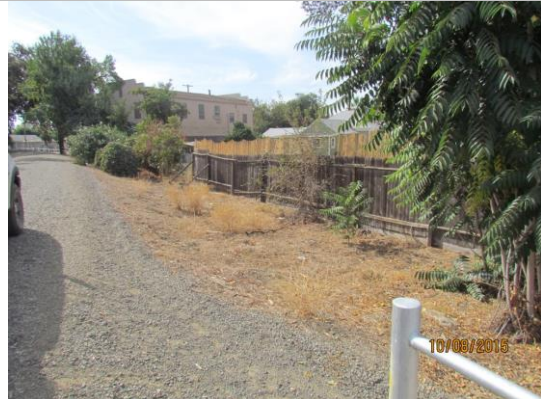
Photo 1 of 1 : FA_2015_ST0001_259_15_20151012_00066.jpg

LM Start	2.13	Rating **	M	Issue No.	15
LM End	2.15	Issue Type +	En	Location *	LS
Category	Earthen Levee			GPS Latitude/Longitude	
				Start	End
Item	Encroachments			38.733215 °	38.733350 °
				-121.805262 °	-121.805082 °
DWR ID	DWR_ST0001_01_s_2012_15				
Action/Comments					
Fence

View of the fence on the landward side of the levee looking upstream. Fall 2015.

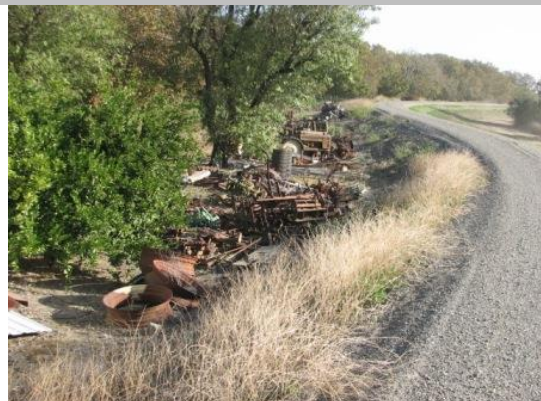
Photo 1 of 2 : FA_2015_ST0001_259_19_20150914_00017.jpg

LM Start	2.68	Rating **	M	Issue No.	19
LM End	2.72	Issue Type +	Ma	Location *	LS
Category	Earthen Levee			GPS Latitude/Longitude	
				Start	End
Item	Encroachments			38.733080 °	38.733492 °
				-121.796013 °	-121.795293 °
DWR ID	DWR_ST0001_01_s_2012_19				
Action/Comments					
Equipment

The equipment is stored at the toe of the levee. Fall 2011

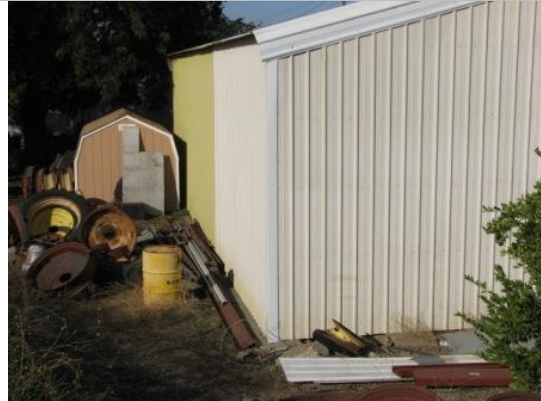
Photo 1 of 2 : FA_2015_ST0001_259_20_20150914_00019.jpg

LM Start	2.68	Rating **	M	Issue No.	20
LM End	2.68	Issue Type +	En	Location *	LS
Category	Earthen Levee			GPS Latitude/Longitude	
				Start	End
Item	Encroachments			38.733132 °	38.733132
				-121.795890 °	-121.795890
DWR ID	DWR_ST0001_01_s_2012_20				
Action/Comments					
Building

The corner of the shop is within the easement of the levee. Fall 2011

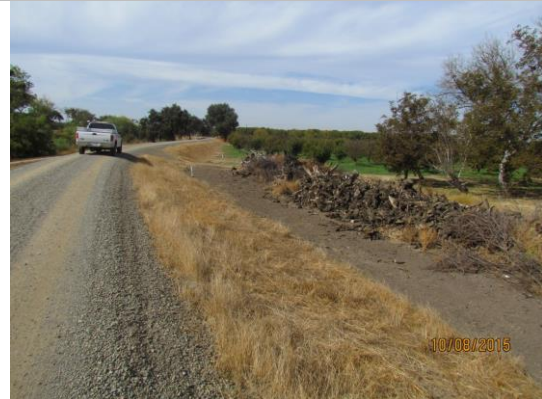
Photo 1 of 1 : FA_2015_ST0001_259_53_20151012_00063.jpg

LM Start	3.10	Rating **	M	Issue No.	53
LM End	3.10	Issue Type +	En	Location *	LS
Category	Earthen Levee			GPS Latitude/Longitude	
				Start	End
Item	Encroachments			38.734363 °	38.734363 °
				-121.788558 °	-121.788558 °
DWR ID	DWR_ST0001_01_f_2013_53				
Action/Comments					
Prunings

View of the pruning pile on the landward side of the levee looking upstream. Fall 2015.

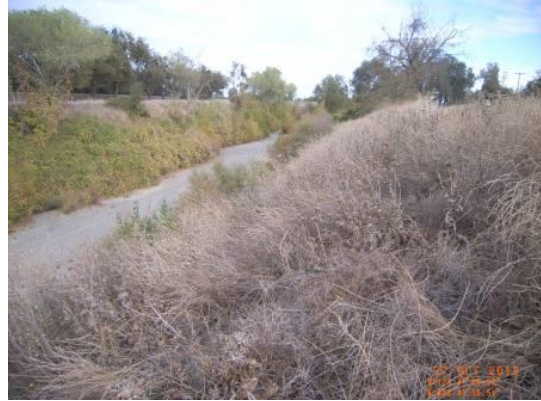
Photo 1 of 1 : USACE2013A_CHC_3-4_L_6.jpg

LM Start	3.48	Rating **	M	Issue No.	1
LM End	3.57	Issue Type +	Ma	Location *	WS
Category	Supplemental			GPS Latitude/Longitude	
				Start	End
Item	2015 USACE Erosion Survey, DRAFT			38.732942 °	38.731626 °
				-121.784965 °	-121.785231 °
DWR ID					
Action/Comments					
Inspector Comments: 2006 - Some significant new erosion, especially fresh upper bank slumping. Still substantial berm. 2010 - Site extended downstream, some new erosion, heavily vegetated and hard to see. Planned setback levee by CA DWR, 60% design complete, construction planned for 2012. 2011 - Construction delayed to 2013 - 2014. 2015: No observed changes. [2015 Site ID: CHC_3-4_L]

USACE 2013 Photo #1

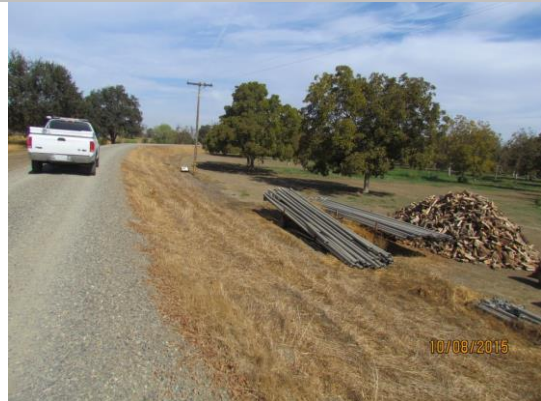
Photo 1 of 1 : FA_2015_ST0001_259_62_20151012_00062.jpg

LM Start	3.60	Rating **	M	Issue No.	62
LM End	3.60	Issue Type +	En	Location *	LS
Category	Earthen Levee			GPS Latitude/Longitude	
				Start	End
Item	Encroachments			38.731134 °	38.731134 °
				-121.785010 °	-121.785010 °
DWR ID	DWR_ST0001_01_f_2015_62				
Action/Comments					
Equipment

View of pipes on the landward side of the levee looking upstream. Fall 2015.

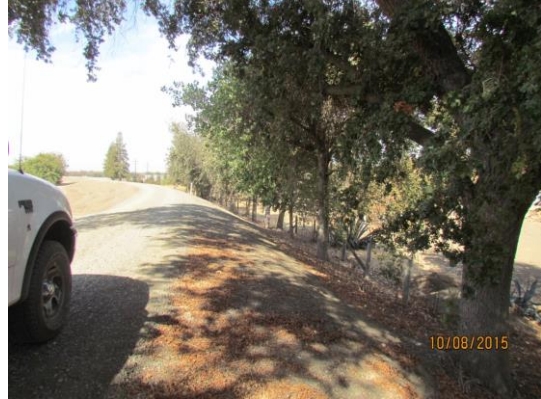
Photo 1 of 1 : FA_2015_ST0001_259_27_20151012_00059.jpg

LM Start	4.28	Rating **	M	Issue No.	27
LM End	4.43	Issue Type +	Ma	Location *	LS
Category	Earthen Levee			GPS Latitude/Longitude	
				Start	End
Item	Vegetation			38.727047 °	38.726113 °
				-121.774413 °	-121.771929 °
DWR ID	DWR_ST0001_01_s _ 2012_27				
Action/Comments					
Landscaping

View of the landscape trees on the landward side of the levee looking upstream. Fall 2015.

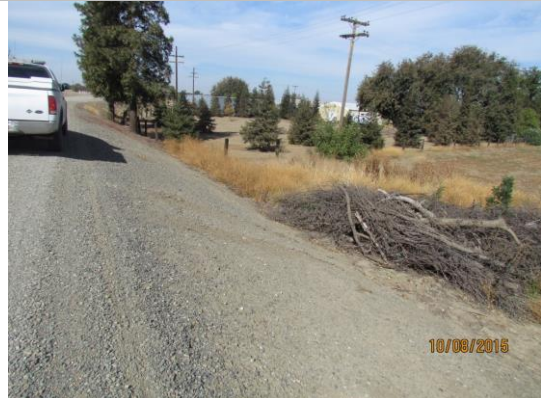
Photo 1 of 1 : FA_2015_ST0001_259_55_20151012_00058.jpg

LM Start	4.33	Rating **	M	Issue No.	55
LM End	4.33	Issue Type +	En	Location *	LS
Category	Earthen Levee			GPS Latitude/Longitude	
				Start	End
Item	Encroachments			38.726785 °	38.726785 °
				-121.773538 °	-121.773538 °
DWR ID	DWR_ST0001_01_f _ 2013_55				
Action/Comments					
Prunings

View of the pruning pile on the landward side of the levee looking upstream. Fall 2015.

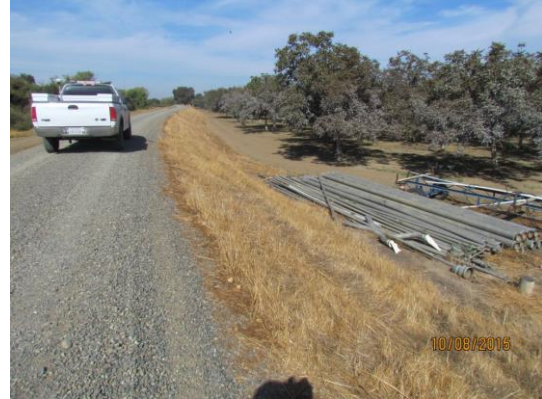
Photo 1 of 1 : FA_2015_ST0001_259_24_20151012_00057.jpg

LM Start	4.78	Rating **	M	Issue No.	24
LM End	4.78	Issue Type +	En	Location *	LS
Category	Earthen Levee			GPS Latitude/Longitude	
				Start	End
Item	Encroachments			38.722590 °	38.722590 °
				-121.767294 °	-121.767294 °
DWR ID	DWR_ST0001_01_s _ 2012_24				
Action/Comments					
Pipe

View of the aluminum irrigation pipe along the levee toe of the landward side looking upstream. Fall 2015.

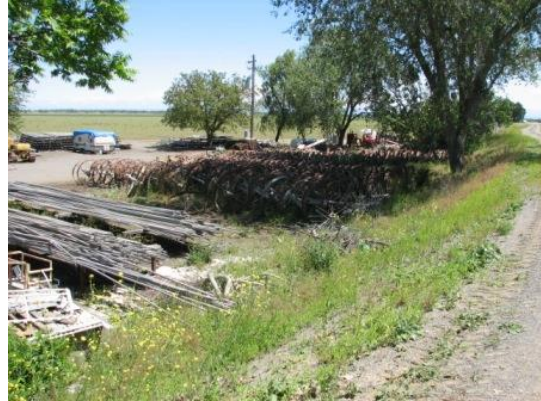
Photo 1 of 2 : FA_2015_ST0001_259_40_20150914_00028.jpg

LM Start	7.30	Rating **	M	Issue No.	40
LM End	7.34	Issue Type +	En	Location *	LS
Category	Earthen Levee			GPS Latitude/Longitude	
				Start	End
Item	Encroachments			38.727878 °	38.728085 °
				-121.728553 °	-121.727740 °
DWR ID	DWR_ST0001_01_s _ 2012_40				
Action/Comments					
Equipment

Irrigation pipe and equipment are within the easement of the levee.

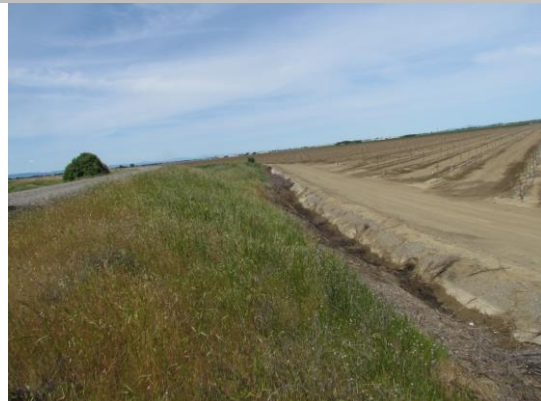
Photo 1 of 2 : FA_2015_ST0001_259_26_20150914_00021.jpg

LM Start	7.36	Rating **	M	Issue No.	26
LM End	7.75	Issue Type +	En	Location *	LS
Category	Earthen Levee			GPS Latitude/Longitude	
				Start	End
Item	Encroachments			38.728188 °	38.728470 °
				-121.727442 °	-121.720812 °
DWR ID	DWR_ST0001_01_s_2015_26				
Action/Comments					
Ditch					
Inspector Comments: Ditch is located at the levee toe.

View of ditch on the landward side of the levee looking upstream. Spring 2015.

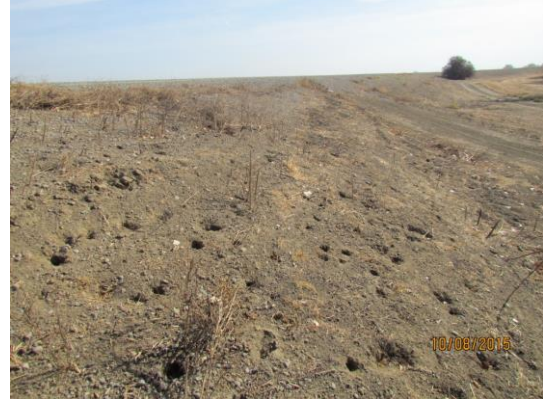
Photo 1 of 1 : FA_2015_ST0001_259_54_20151012_00048.jpg

View of the rodent holes on the waterward side of the levee looking downstream. Fall 2015.

LM Start	7.60	Rating **	M	Issue No.	54
LM End	7.60	Issue Type +	Ma	Location *	WS
Category	Earthen Levee			GPS Latitude/Longitude	
				Start	End
Item	Animal Control			38.729218 °	38.729218 °
				-121.723325 °	-121.723325 °
DWR ID	DWR_ST0001_01_f_2015_54				
Action/Comments					
No rodents visible, but rodent burrows visible; need to backfill and compact or grout burrows.

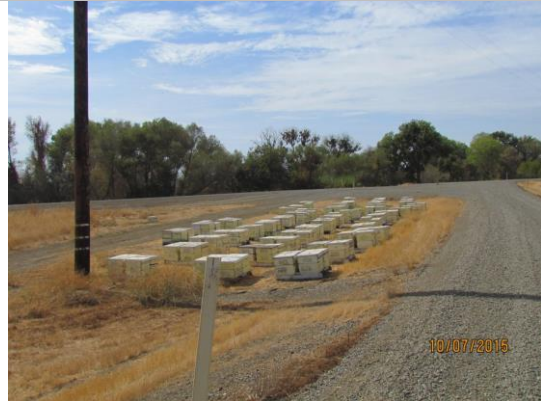
Photo 1 of 1 : FA_2015_ST0001_259_50_20151012_00045.jpg

LM Start	7.95	Rating **	M	Issue No.	50
LM End	7.95	Issue Type +	En	Location *	WS
Category	Earthen Levee			GPS Latitude/Longitude	
				Start	End
Item	Encroachments			38.727271 °	38.727271 °
				-121.717595 °	-121.717595 °
DWR ID	DWR_ST0001_01_f_2015_50				
Action/Comments					
Building

View of the beehives on the waterward side of the levee looking upstream. Fall 2015.

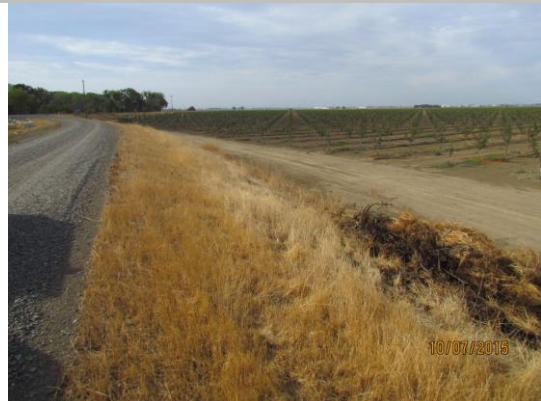
Photo 1 of 1 : FA_2015_ST0001_259_51_20151012_00046.jpg

LM Start	7.99	Rating **	M	Issue No.	51
LM End	7.99	Issue Type +	En	Location *	LS
Category	Earthen Levee			GPS Latitude/Longitude	
				Start	End
Item	Encroachments			38.727167 °	38.727167 °
				-121.716817 °	-121.716817 °
DWR ID	DWR_ST0001_01_f_2015_51				
Action/Comments					
Prunings

View of the prunings at the toe of the levee looking upstream. Fall 2015.

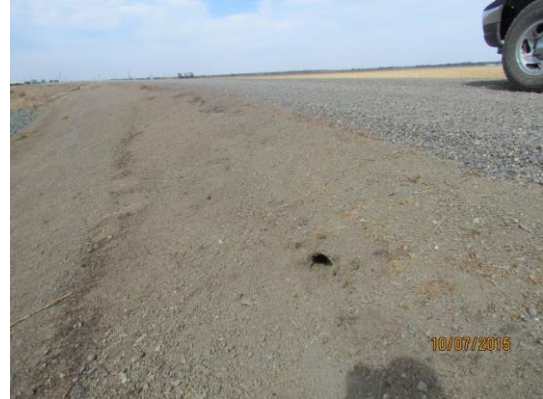
Photo 1 of 2 : FA_2015_ST0001_259_37_20151012_00040.jpg

View of the rodent hole on the waterward side of the levee looking upstream. Fall 2015.

LM Start	9.38	Rating **	M	Issue No.	37
LM End	9.38	Issue Type +	Ma	Location *	WS
Category	Earthen Levee			GPS Latitude/Longitude	
				Start	End
Item	Animal Control			38.719392 °	38.719392 °
				-121.696879 °	-121.696879 °
DWR ID	DWR_ST0001_01_f_2015_37				
Action/Comments					
No rodents visible, but rodent burrows visible; need to backfill and compact or grout burrows.

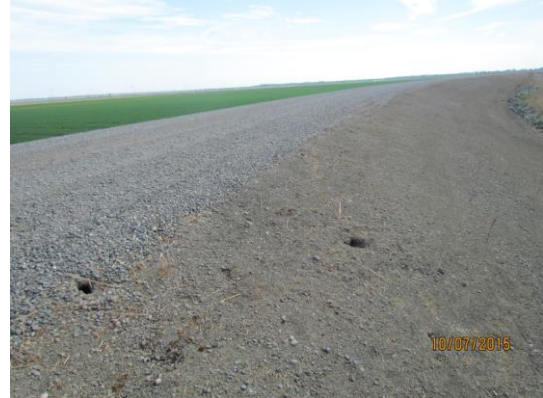
Photo 2 of 2 : FA_2015_ST0001_259_37_20151012_00042.jpg

LM Start	9.38	Rating **	M	Issue No.	37 (cont)
LM End	9.38	Issue Type +	Ma	Location *	WS

View of the rodent hole on the waterward side of the levee looking downstream. Fall 2015.

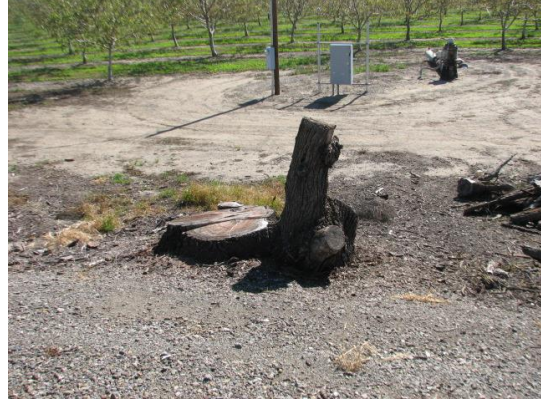
Photo 1 of 1 : FA_2015_ST0001_260_6_20150914_00004.jpg

LM Start	0.27	Rating **	N	Issue No.	6
LM End	0.27	Issue Type +	Ma	Location *	LS
Category	Earthen Levee			GPS Latitude/Longitude	
				Start	End
Item	Trim / Thin Trees			38.730723 °	38.730723 °
				-121.804972 °	-121.804972 °
DWR ID	DWR_ST0001_02_s_2014_6				
Action/Comments					
Tree stumps.

A large black walnut tree stump is at the toe of the levee. Spring 2014

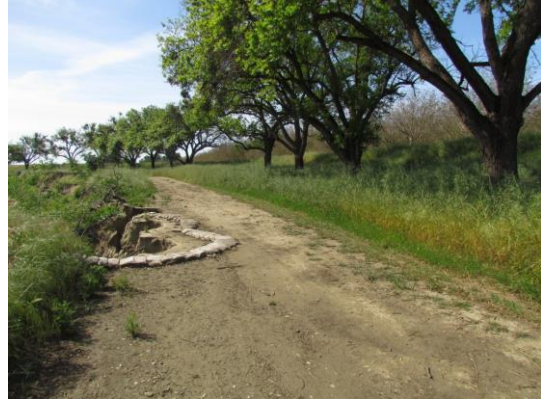
Photo 1 of 2 : FA_2015_ST0001_260_11_20150914_00008.jpg

LM Start	1.60	Rating **	A/W	Issue No.	11
LM End	1.60	Issue Type +	Ma	Location *	WS
Category	Earthen Levee			GPS Latitude/Longitude	
				Start	End
Item	Erosion / Bank Caving			38.731652 °	38.731652 °
				-121.786253 °	-121.786253 °
DWR ID	DWR_ST0001_02_s _ 2015_11				
Action/Comments					
Inspector Comments: The erosion is down by the channel and does not appear to be in the levee prism.

The view of the erosion from a distance. Spring 2015.

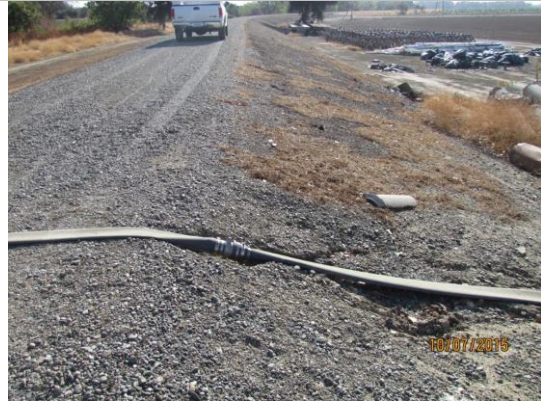
Photo 1 of 2 : FA_2015_ST0001_260_19_20151012_00025.jpg

LM Start	2.40	Rating **	A/W	Issue No.	19
LM End	2.40	Issue Type +	En	Location *	LS
Category	Earthen Levee			GPS Latitude/Longitude	
				Start	End
Item	Encroachments			38.726216 °	38.726216 °
				-121.774927 °	-121.774927 °
DWR ID	DWR_ST0001_02_f_2015_19				
Action/Comments					
Pipe					
Inspector Comments: A hose is on top of the levee and is slowly causing erosion on the landward side of the levee.

View of the hose that goes from the landward side to the waterward side of the levee looking downstream. Fall 2015.

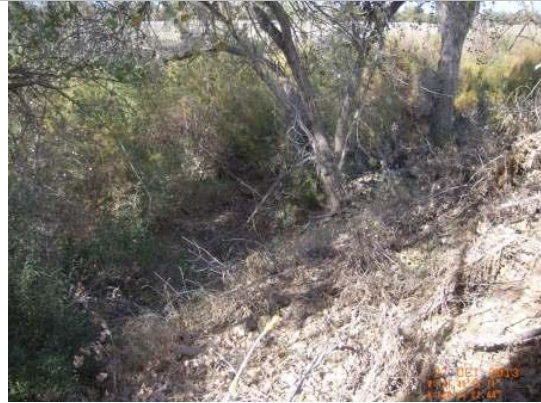
Photo 1 of 1 : USACE2013A_CHC_3-5_R_7.jpg

LM Start	3.53	Rating **	M	Issue No.	2
LM End	3.60	Issue Type +	Ma	Location *	WS
Category	Supplemental			GPS Latitude/Longitude	
				Start	End
Item	2015 USACE Erosion Survey, DRAFT			38.722138 °	38.723294 °
				-121.759736 °	-121.759588 °
DWR ID					
Action/Comments					
Inspector Comments: 2010 - Large slump on the upper berm, a tree has recently slid down the slope. 2011 - Large slump and new erosion. 2012 - Slightly steeper slopes and cracks observed. 2015: No observed changes. [2015 Site ID: CHC_3-5_R]

USACE 2013 Photo #1

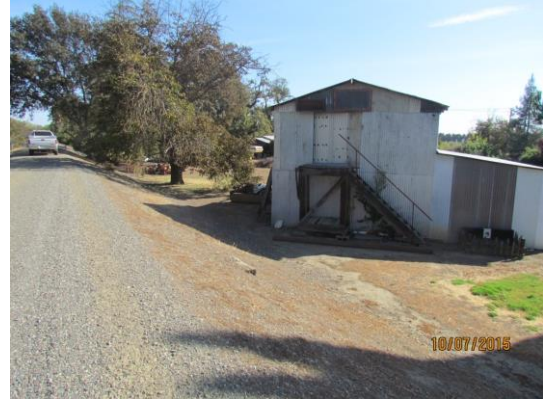
Photo 1 of 1 : FA_2015_ST0001_260_8_20151012_00035.jpg

LM Start	4.06	Rating **	M	Issue No.	8
LM End	4.06	Issue Type +	En	Location *	LS
Category	Earthen Levee			GPS Latitude/Longitude	
				Start	End
Item	Encroachments			38.723997 °	38.723997 °
				-121.752505 °	-121.752505 °
DWR ID	DWR_ST0001_02_s_2012_8				
Action/Comments					
Building					
Inspector Comments: Building is within the easement of the levee.

View of the building on the landward side of the levee looking downstream. Fall 2015.

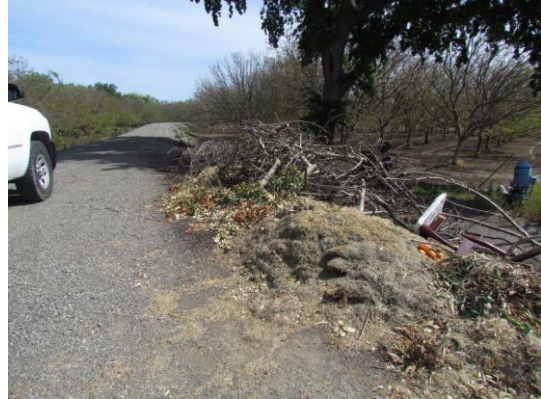
Photo 1 of 1 : FA_2015_ST0001_260_18_20150914_00015.jpg

LM Start	4.18	Rating **	M	Issue No.	18
LM End	4.18	Issue Type +	En	Location *	LS
Category	Earthen Levee			GPS Latitude/Longitude	
				Start	End
Item	Encroachments			38.725320 °	38.725320 °
				-121.751023 °	-121.751023 °
DWR ID	DWR_ST0001_02_s _ 2015_18				
Action/Comments					
Prunings

View of the prunings on the landward side of the levee looking downstream. Spring 2015.

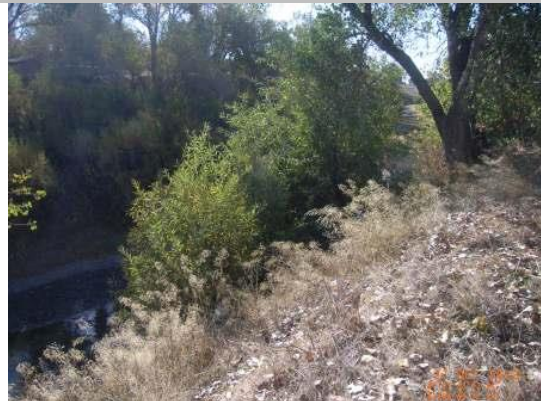
Photo 1 of 1 : USACE2013A_CHC_5-4_L_2.jpg

LM Start	5.33	Rating **	M	Issue No.	13
LM End	5.37	Issue Type +	Ma	Location *	WS
Category	Supplemental			GPS Latitude/Longitude	
				Start	End
Item	2015 USACE Erosion Survey, DRAFT			38.722933 °	38.723467 °
				-121.760561 °	-121.760436 °
DWR ID					
Action/Comments					
Inspector Comments: 2009 - Erosion into the levee slope. 2010 - Minor new erosion. 2011 - New erosion and a freshly fallen tree. 2012 - New animal holes and slightly steeper slopes. 2013 - New tree popout and 2 feet of erosion along the top bank. 2015: No observed changes. [2015 Site ID: CHC_5-4_L]

USACE 2013 Photo #1
