**Flood Control Project Maintenance
Levee Inspections**

Fall 2016 Levee Maintenance Deficiency Summary Report

Sacramento River Basin

Sacramento Maintenance Yard Cache Creek

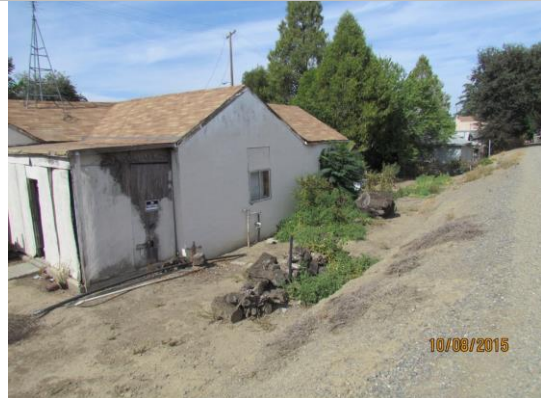
Photo 1 of 1 : FA_2016_ST0001_259_9_20160913_00009.jpg

LM Start	2.04	Rating **	M	Issue No.	9
LM End	2.04	Issue Type +	En	Location *	LS
Category	Earthen Levee			GPS Latitude/Longitude	
				Start	End
Item	Encroachments			38.731927 °	38.731927 °
				-121.805973 °	-121.805973 °
DWR ID	DWR_ST0001_01_s_2012_9				
Comment Code					
BU : Building					
Inspector Comment

View of the house in the town of Yolo on the landward side of the levee looking downstream. Fall 2015.

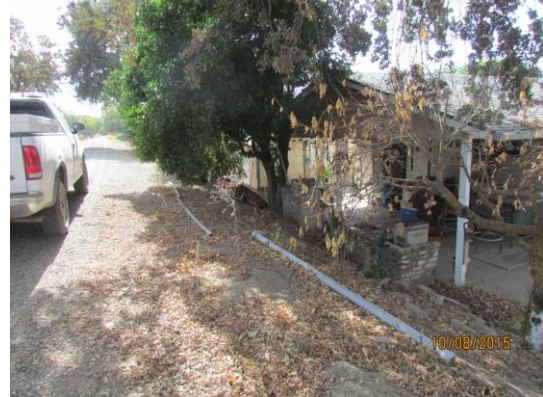
Photo 1 of 1 : FA_2016_ST0001_259_13_20160913_00013.jpg

LM Start	2.08	Rating **	M	Issue No.	13
LM End	2.08	Issue Type +	En	Location *	LS
Category	Earthen Levee			GPS Latitude/Longitude	
				Start	End
Item	Encroachments			38.732537 °	38.732537 °
				-121.805708 °	-121.805708 °
DWR ID	DWR_ST0001_01_s_2012_13				
Comment Code					
BU : Building					
Inspector Comment

View of the building on the landward side of the levee looking upstream.
Fall 2015.

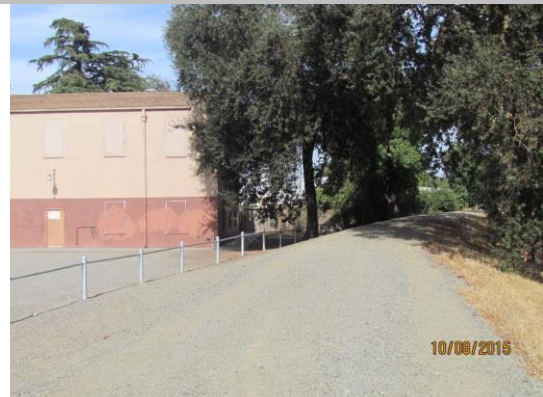
Photo 1 of 1 : FA_2016_ST0001_259_12_20160913_00012.jpg

LM Start	2.12	Rating **	M	Issue No.	12
LM End	2.12	Issue Type +	En	Location *	LS
Category	Earthen Levee			GPS Latitude/Longitude	
				Start	End
Item	Encroachments			38.733000 °	38.733000 °
				-121.805409 °	-121.805409 °
DWR ID	DWR_ST0001_01_s_2012_12				
Comment Code					
BU : Building					
Inspector Comment

View of the building on the landward side of the levee looking downstream. Fall 2015.

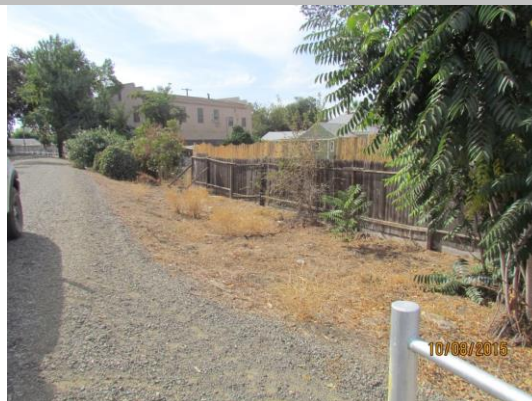
Photo 1 of 1 : FA_2016_ST0001_259_15_20160913_00015.jpg

LM Start	2.13	Rating **	M	Issue No.	15
LM End	2.15	Issue Type +	En	Location *	LS
Category	Earthen Levee			GPS Latitude/Longitude	
				Start	End
Item	Encroachments			38.733215 °	38.733350 °
				-121.805262 °	-121.805082 °
DWR ID	DWR_ST0001_01_s_2012_15				
Comment Code					
FE : Fence					
Inspector Comment

View of the fence on the landward side of the levee looking upstream. Fall 2015.

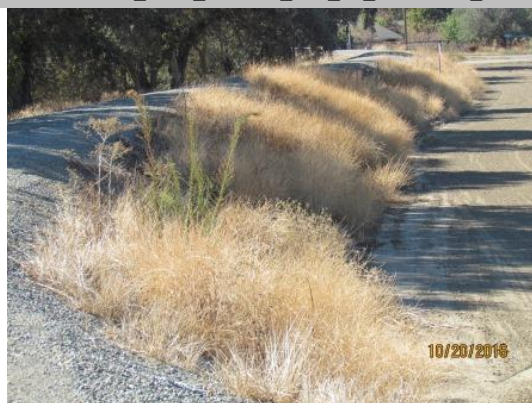
Photo 1 of 1 : FA_2016_ST0001_259_60_20161025_00077.jpg

LM Start	2.26	Rating **	M	Issue No.	60
LM End	2.33	Issue Type +	Ma	Location *	LS
Category	Earthen Levee			GPS Latitude/Longitude	
				Start	End
Item	Vegetation			38.733662 °	38.733555 °
				-121.803069 °	-121.801711 °
DWR ID	DWR_ST0001_01_f_2016_60				
Comment Code					
V2 : Remove the wild growth other than native grasses from the levee slopes.					
Inspector Comment

View of vegetation on LS slope. Fall 2016.

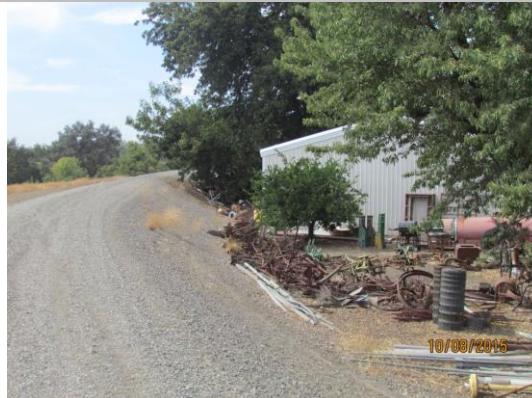
Photo 2 of 2 : FA_2016_ST0001_259_20_20160913_00023.jpg

LM Start	2.69	Rating **	M	Issue No.	20
LM End	2.69	Issue Type +	En	Location *	LS
Category	Earthen Levee			GPS Latitude/Longitude	
				Start	End
Item	Encroachments			38.733145 °	38.733145 °
				-121.795845 °	-121.795845 °
DWR ID	DWR_ST0001_01_s_2012_20				
Comment Code					
BU : Building					
Inspector Comment

View of the building on the landward side of the levee looking upstream. Fall 2015.

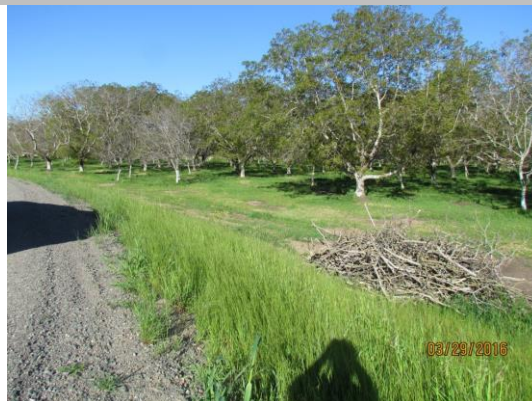
Photo 1 of 1 : FA_2016_ST0001_259_70_20160913_00046.jpg

LM Start	2.82	Rating **	M	Issue No.	70
LM End	2.82	Issue Type +	En	Location *	LS
Category	Earthen Levee			GPS Latitude/Longitude	
				Start	End
Item	Encroachments			38.734450 °	38.734450 °
				-121.793793 °	-121.793793 °
DWR ID	DWR_ST0001_01_s_2016_70				
Comment Code					
PR : Prunings					
Inspector Comment

View of the pruning pile on the landward side of the levee looking upstream. Spring 2016.

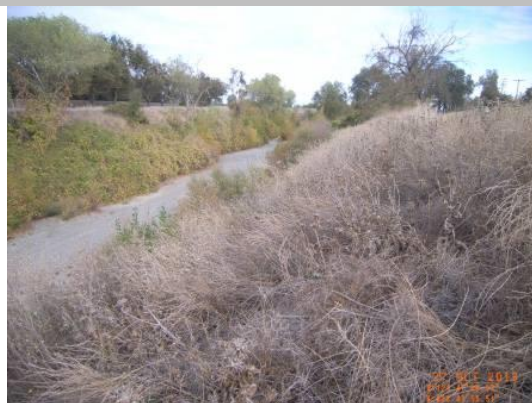
Photo 1 of 1 : FA_2016_ST0001_259_1_20160913_00001.jpg

LM Start	3.48	Rating **	A/W	Issue No.	1
LM End	3.57	Issue Type +	Ma	Location *	WS
Category	Supplemental			GPS Latitude/Longitude	
				Start	End
Item	2015 USACE Erosion Survey, DRAFT			38.732942 °	38.731626 °
				-121.784965 °	-121.785231 °
DWR ID	DWR_ST0001_01_s_2016_1				
Comment Code					
Inspector Comment					
2006 - Some significant new erosion, especially fresh upper bank slumping. Still substantial berm. 2010 - Site extended downstream, some new erosion, heavily vegetated and hard to see. Planned setback levee by CA DWR, 60% design complete, construction planned for 2012. 2011 - Construction delayed to 2013 - 2014. 2015: No observed changes. [2015 Site ID: CHC 3-4 L]

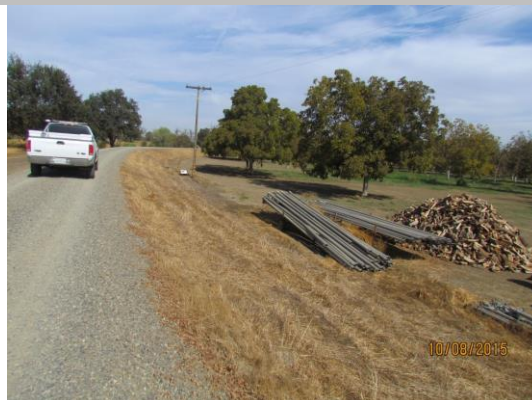
Photo 1 of 1 : FA_2016_ST0001_259_62_20160913_00045.jpg

LM Start	3.60	Rating **	M	Issue No.	62
LM End	3.60	Issue Type +	En	Location *	LS
Category	Earthen Levee			GPS Latitude/Longitude	
				Start	End
Item	Encroachments			38.731134 °	38.731134 °
				-121.785010 °	-121.785010 °
DWR ID	DWR_ST0001_01_f_2015_62				
Comment Code					
EQ : Equipment					
Inspector Comment

View of pipes on the landward side of the levee looking upstream. Fall 2015.

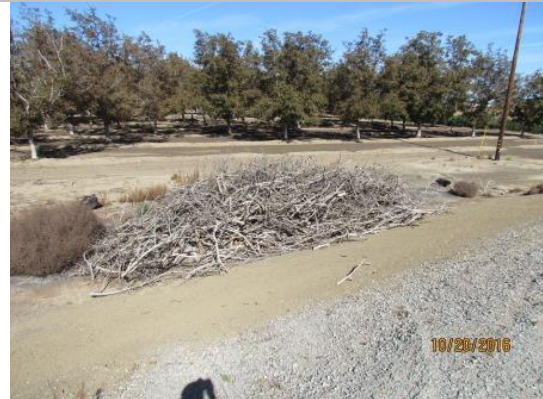
Photo 1 of 1 : FA_2016_ST0001_259_53_20161025_00075.jpg

LM Start	3.85	Rating **	M	Issue No.	53
LM End	3.85	Issue Type +	En	Location *	LS
Category	Earthen Levee			GPS Latitude/Longitude	
				Start	End
Item	Encroachments			38.728712 °	38.728712 °
				-121.782011 °	-121.782011 °
DWR ID	DWR_ST0001_01_f_2016_53				
Comment Code					
PR : Prunings					
Inspector Comment

View of prunings on LS slope. Fall 2016.

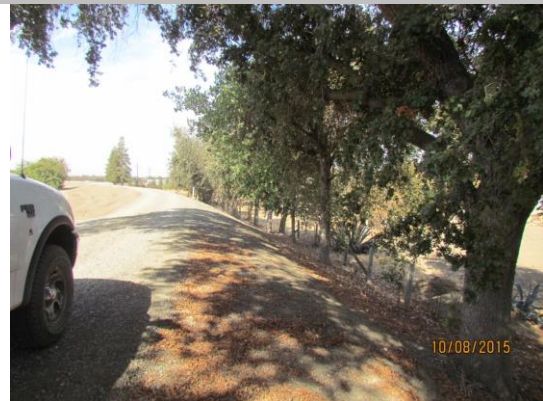
Photo 1 of 1 : FA_2016_ST0001_259_27_20160913_00027.jpg

LM Start	4.28	Rating **	M	Issue No.	27
LM End	4.43	Issue Type +	Ma	Location *	LS
Category	Earthen Levee			GPS Latitude/Longitude	
				Start	End
Item	Vegetation			38.727047 °	38.726113 °
				-121.774413 °	-121.771929 °
DWR ID	DWR_ST0001_01_s_2012_27				
Comment Code					
V6 : Landscaping					
Inspector Comment

View of the landscape trees on the landward side of the levee looking upstream. Fall 2015.

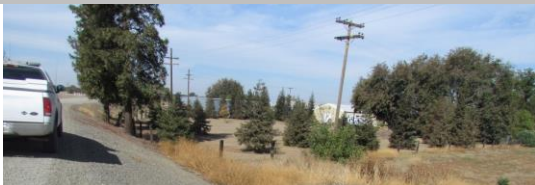
Photo 1 of 1 : FA_2016_ST0001_259_55_20160913_00042.jpg

View of the pruning pile on the landward side of the levee looking upstream. Fall 2015.

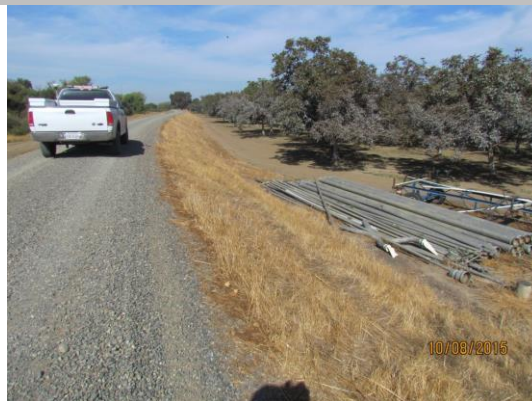
Photo 1 of 1 : FA_2016_ST0001_259_24_20160913_00024.jpg

LM Start	4.78	Rating **	M	Issue No.	24
LM End	4.78	Issue Type +	En	Location *	LS
Category	Earthen Levee			GPS Latitude/Longitude	
				Start	End
Item	Encroachments			38.722590 °	38.722590 °
				-121.767294 °	-121.767294 °
DWR ID	DWR_ST0001_01_s_2012_24				
Comment Code					
PI : Pipe					
Inspector Comment

View of the aluminum irrigation pipe along the levee toe of the landward side looking upstream. Fall 2015.

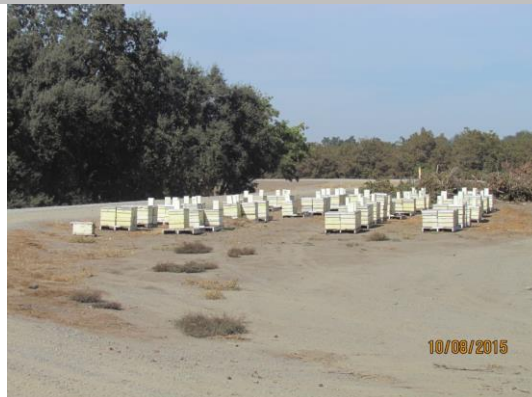
Photo 1 of 1 : FA_2016_ST0001_259_59_20160913_00044.jpg

LM Start	5.67	Rating **	M	Issue No.	59
LM End	5.67	Issue Type +	En	Location *	LS
Category	Earthen Levee			GPS Latitude/Longitude	
				Start	End
Item	Encroachments			38.723839 °	38.723839 °
				-121.755823 °	-121.755823 °
DWR ID	DWR_ST0001_01_f_2015_59				
Comment Code					
BU : Building					
Inspector Comment

View of the beehives on the landward side of the levee looking upstream. Fall 2015.

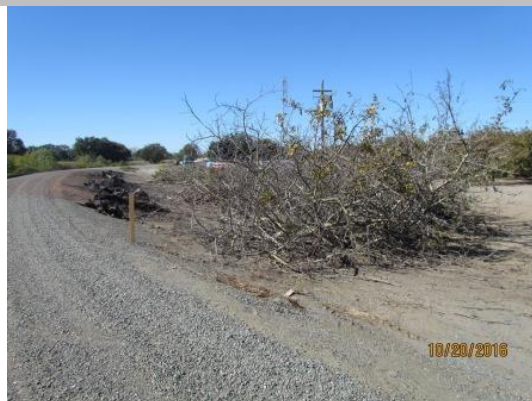
Photo 1 of 1 : FA_2016_ST0001_259_45_20161025_00072.jpg

LM Start	5.74	Rating **	M	Issue No.	45
LM End	5.74	Issue Type +	En	Location *	LS
Category	Earthen Levee			GPS Latitude/Longitude	
				Start	End
Item	Encroachments			38.723735 °	38.723735 °
				-121.754588 °	-121.754588 °
DWR ID	DWR_ST0001_01_s_2016_45				
Comment Code					
PR : Prunings					
Inspector Comment

View of prunings on landside slope. Fall 2016.

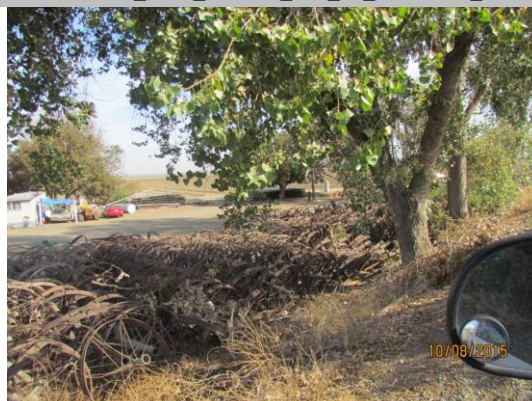
Photo 2 of 2 : FA_2016_ST0001_259_40_20160913_00035.jpg

LM Start	7.30	Rating **	M	Issue No.	40 (cont)
LM End	7.34	Issue Type +	En	Location *	LS

View of the equipment at the levee toe on the landward side looking downstream. Fall 2015.

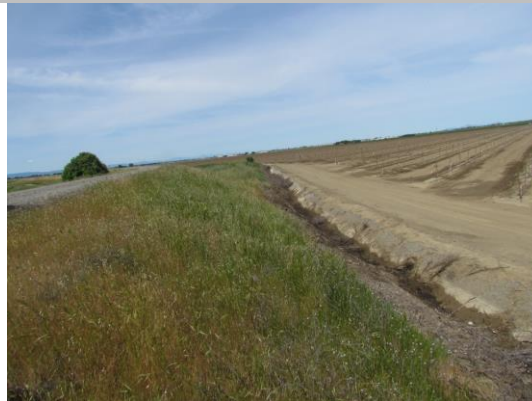
Photo 1 of 2 : FA_2016_ST0001_259_26_20160913_00025.jpg

LM Start	7.36	Rating **	M	Issue No.	26
LM End	7.78	Issue Type +	En	Location *	LS
Category	Earthen Levee			GPS Latitude/Longitude	
				Start	End
Item	Encroachments			38.728188 °	38.728212 °
				-121.727442 °	-121.720304 °
DWR ID	DWR_ST0001_01_s_2015_26				
Comment Code					
DT : Ditch					
Inspector Comment					
Ditch is located at the levee toe.

View of ditch on the landward side of the levee looking upstream. Spring 2015.

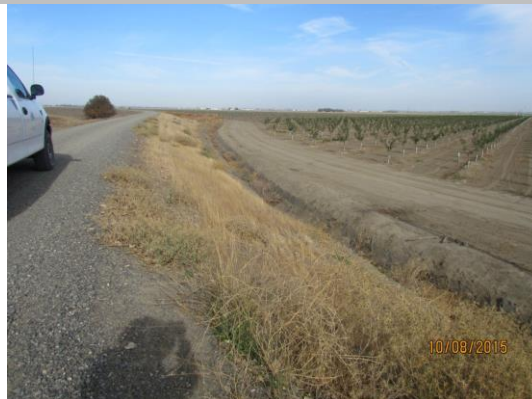
Photo 2 of 2 : FA_2016_ST0001_259_26_20160913_00026.jpg

LM Start	7.36	Rating **	M	Issue No.	26 (cont)
LM End	7.78	Issue Type +	En	Location *	LS

View of the ditch on the landward side of the levee looking upstream. Fall 2015.

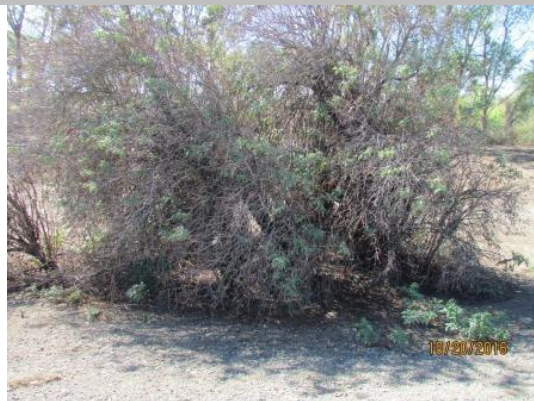
Photo 1 of 1 : FA_2016_ST0001_259_29_20161025_00069.jpg

LM Start	7.69	Rating **	M	Issue No.	29
LM End	7.69	Issue Type +	Ma	Location *	WS
Category	Earthen Levee			GPS Latitude/Longitude	
				Start	End
Item	Vegetation			38.729027 °	38.729027 °
				-121.721683 °	-121.721683 °
DWR ID	DWR_ST0001_01_s_2015_29				
Comment Code					
V4 : Elderberries are blocking visibility and flood fight capability.					
Inspector Comment

View of an elderberry tree on waterward side. Fall 2016.

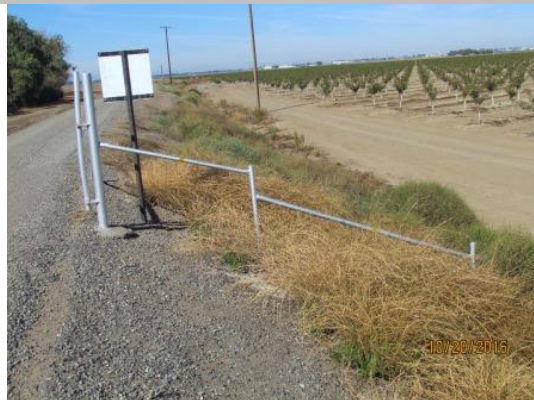
Photo 1 of 1 : FA_2016_ST0001_259_41_20161025_00068.jpg

LM Start	7.86	Rating **	M	Issue No.	41
LM End	7.89	Issue Type +	Ma	Location *	LS
Category	Earthen Levee			GPS Latitude/Longitude	
				Start	End
Item	Vegetation			38.727543 °	38.727341 °
				-121.719083 °	-121.718676 °
DWR ID	DWR_ST0001_01_f_2016_41				
Comment Code					
V2 : Remove the wild growth other than native grasses from the levee slopes.					
Inspector Comment

Vegetation on LS slope. Fall 2016.

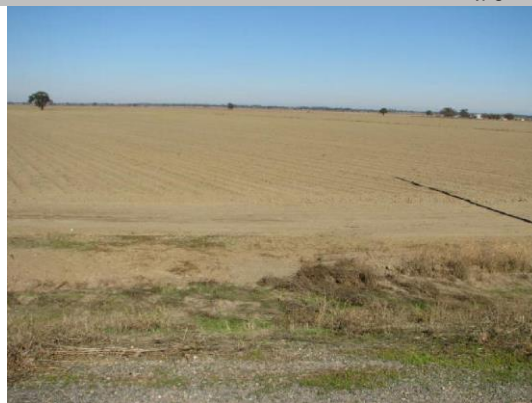
Photo 2 of 2 : UCIP_FA_2016_50811_60196.jpg

LM Start	7.89	Rating **	M	Issue No.	76 (cont)
LM End	7.89	Issue Type +	En	Location *	LS

Landside view: no indicator found.

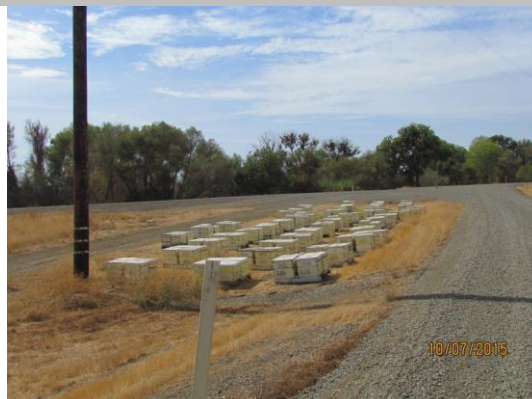
Photo 1 of 1 : FA_2016_ST0001_259_50_20160913_00040.jpg

LM Start	7.95	Rating **	M	Issue No.	50
LM End	7.95	Issue Type +	En	Location *	WS
Category	Earthen Levee			GPS Latitude/Longitude	
				Start	End
Item	Encroachments			38.727271 °	38.727271 °
				-121.717595 °	-121.717595 °
DWR ID	DWR_ST0001_01_f_2015_50				
Comment Code					
BU : Building					
Inspector Comment

View of the beehives on the waterward side of the levee looking upstream. Fall 2015.

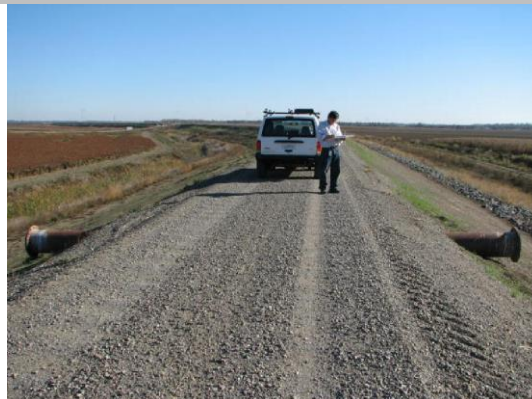
Photo 1 of 2 : UCIP_FA_2016_50812_60219.jpg

LM Start	10.40	Rating **	M	Issue No.	77
LM End	10.40	Issue Type +	En	Location *	WS
Category	Supplemental			GPS Latitude/Longitude	
				Start	End
Item	DWR UCIP Field Study			38.705051 °	38.705051 °
				-121.695577 °	-121.695577 °
DWR ID					
Comment Code					
Inspector Comment					
FS_ID:50812 DS_ID:17115 EP_NO: N/A Repair Type: Non-Urgent Crossing Status: Found UCIP Comments: 10/19/16 w/s capped l/s capped FIELD_STRUCT_DESC: 18-inch soil-proofed 0.25-inch-thick steel irrigation pipe through the levee, 4 feet below the crown. Pipe used for seasonal irrigation. Pipe opening capped on both ends. As-built dwg. North 68+00 FS Date: 11/21/2016 7:56:56 AM

Crown view: overview

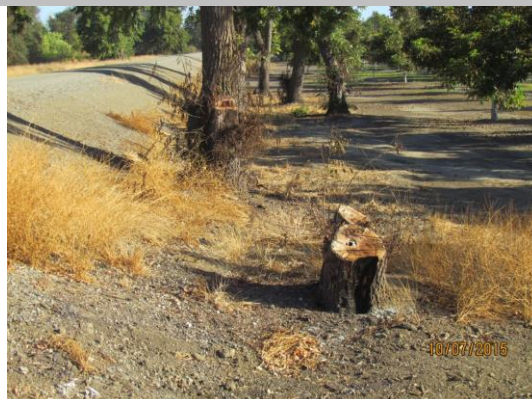
Photo 1 of 1 : FA_2016_ST0001_260_10_20160913_00008.jpg

LM Start	0.18	Rating **	N	Issue No.	10
LM End	0.18	Issue Type +	Ma	Location *	LS
Category	Earthen Levee			GPS Latitude/Longitude	
				Start	End
Item	Trim / Thin Trees			38.729560 °	38.729560 °
				-121.805231 °	-121.805231 °
DWR ID	DWR_ST0001_02_f_2015_10				
Comment Code					
T5 : Tree stumps.					
Inspector Comment					
The stump is located at the levee toe.

View of the tree stump at the landward side of the levee looking downstream. Fall 2015.

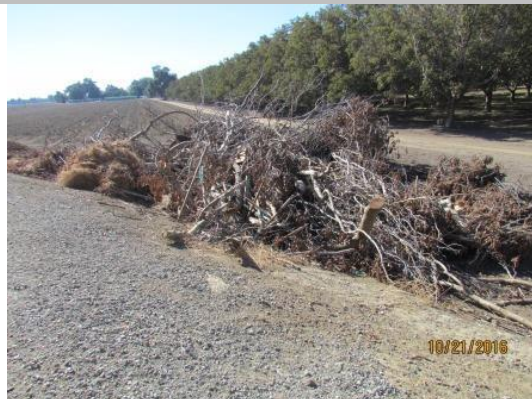
Photo 1 of 1 : FA_2016_ST0001_260_20_20161025_00029.jpg

LM Start	1.68	Rating **	M	Issue No.	20
LM End	1.68	Issue Type +	En	Location *	LS
Category	Earthen Levee			GPS Latitude/Longitude	
				Start	End
Item	Encroachments			38.730567 °	38.730567 °
				-121.786027 °	-121.786027 °
DWR ID	DWR_ST0001_02_f_2016_20				
Comment Code					
PR : Prunings					
Inspector Comment

View of prunings on LS slope of the levee. Fall 2016.

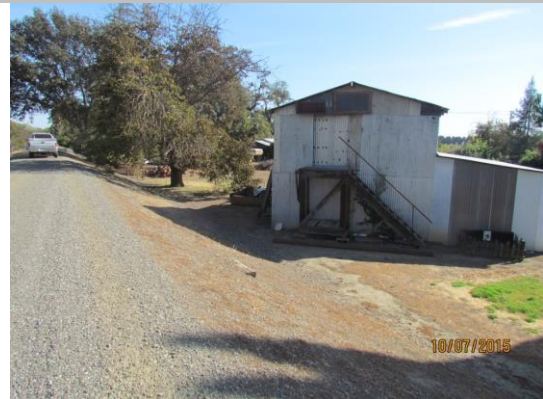
Photo 1 of 1 : FA_2016_ST0001_260_8_20160913_00006.jpg

LM Start	4.06	Rating **	M	Issue No.	8
LM End	4.06	Issue Type +	En	Location *	LS
Category	Earthen Levee			GPS Latitude/Longitude	
				Start	End
Item	Encroachments			38.723997 °	38.723997 °
				-121.752505 °	-121.752505 °
DWR ID	DWR_ST0001_02_s_2012_8				
Comment Code					
BU : Building					
Inspector Comment					
Building is within the easement of the levee.

View of the building on the landward side of the levee looking downstream. Fall 2015.

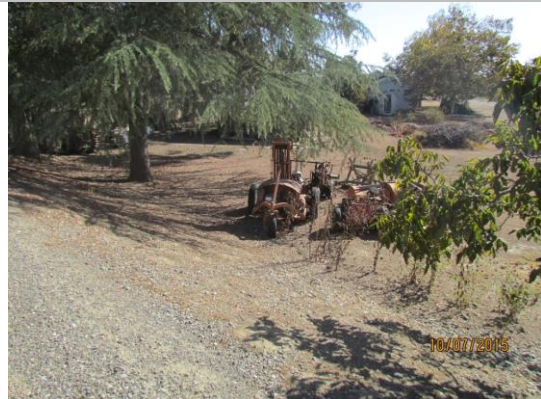
Photo 1 of 1 : FA_2016_ST0001_260_26_20160913_00015.jpg

LM Start	4.08	Rating **	M	Issue No.	26
LM End	4.08	Issue Type +	En	Location *	LS
Category	Earthen Levee			GPS Latitude/Longitude	
				Start	End
Item	Encroachments			38.724200 °	38.724200 °
				-121.752272 °	-121.752272 °
DWR ID	DWR_ST0001_02_f_2013_26				
Comment Code					
EQ : Equipment					
Inspector Comment

View of the equipment at the toe of the landward side of the levee. Fall 2015.

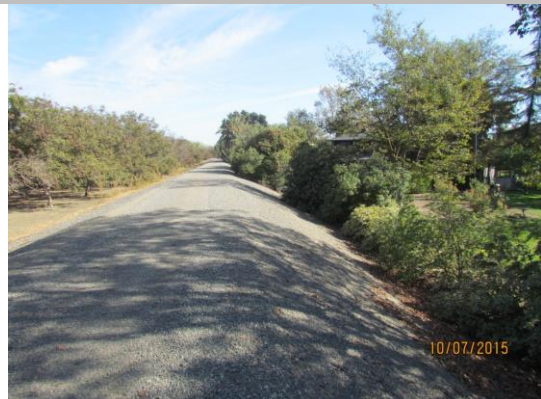
Photo 1 of 1 : FA_2016_ST0001_260_9_20160913_00007.jpg

LM Start	4.09	Rating **	M	Issue No.	9
LM End	4.18	Issue Type +	En	Location *	LS
Category	Earthen Levee			GPS Latitude/Longitude	
				Start	End
Item	Vegetation			38.724317 °	38.725242 °
				-121.752148 °	-121.751075 °
DWR ID	DWR_ST0001_02_s_2012_9				
Comment Code					
V6 : Landscaping					
Inspector Comment

View of the landscaping vegetation on the landward side of the levee looking downstream. Fall 2015.

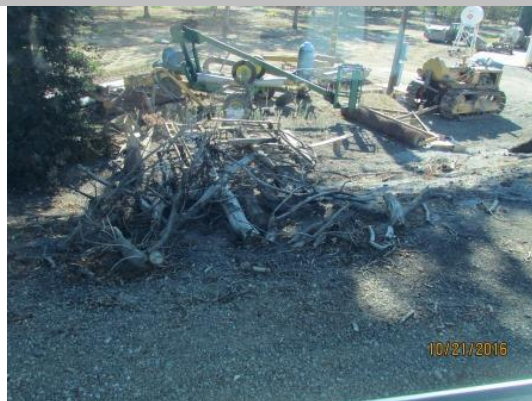
Photo 1 of 1 : FA_2016_ST0001_260_5_20161025_00021.jpg

LM Start	4.19	Rating **	M	Issue No.	5
LM End	4.19	Issue Type +	En	Location *	LS
Category	Earthen Levee			GPS Latitude/Longitude	
				Start	End
Item	Encroachments			38.725409 °	38.725409 °
				-121.750907 °	-121.750907 °
DWR ID	DWR_ST0001_02_f_2016_5				
Comment Code					
PR : Prunings					
Inspector Comment

Prunings on LS levee slope. Fall 2016.

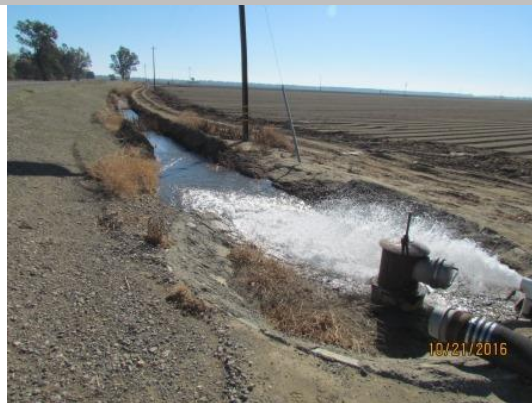
Photo 2 of 2 : FA_2016_ST0001_260_14_20161025_00019.jpg

LM Start	4.69	Rating **	M	Issue No.	14 (cont)
LM End	4.80	Issue Type +	En	Location *	LS

View of ditch on landside near the levee toe looking downstream of Cache Creek. Fall 2016.

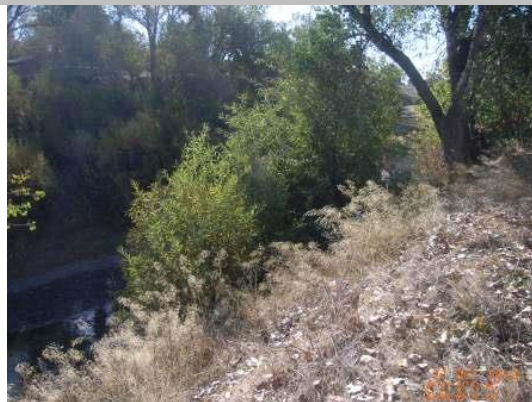
Photo 1 of 1 : FA_2016_ST0001_260_13_20160913_00011.jpg

LM Start	5.33	Rating **	A/W	Issue No.	13
LM End	5.37	Issue Type +	Ma	Location *	WS
Category	Supplemental			GPS Latitude/Longitude	
				Start	End
Item	2015 USACE Erosion Survey, DRAFT			38.722933 °	38.723467 °
				-121.760561 °	-121.760436 °
DWR ID	DWR_ST0001_02_s_2016_13				
Comment Code					
Inspector Comment					
2009 - Erosion into the levee slope. 2010 - Minor new erosion. 2011 - New erosion and a freshly fallen tree. 2012 - New animal holes and slightly steeper slopes. 2013 - New tree popout and 2 feet of erosion along the top bank. 2015: No observed changes. [2015 Site ID: CHC_5-4 L]

USACE 2013 Photo #1

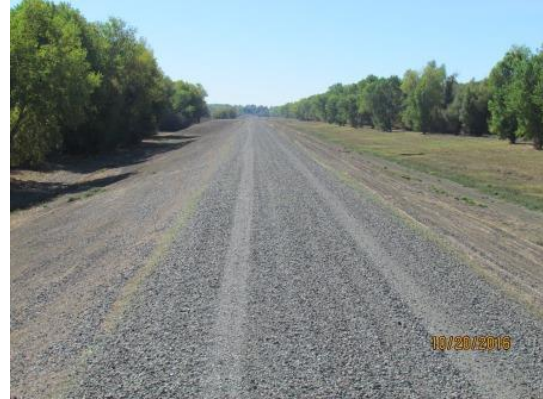
Photo 1 of 1 : FA_2016_ST0001_261_1_20161025_00001.jpg

LM Start	1.15	Rating **	A	Issue No.	1
LM End	1.15	Issue Type +	Ma	Location *	LS
Category	Earthen Levee			GPS Latitude/Longitude	
				Start	End
Item	Vegetation			38.711564 °	38.711564 °
				-121.715113 °	-121.715113 °
DWR ID	DWR_ST0001_04_f _ 2016_1				
Comment Code					
V1 : Control annual grass and weeds on the levee slopes and easements.					
Inspector Comment

Fall 2016.
