**Flood Control Project Maintenance
Levee Inspections**

Fall 2017 Levee Maintenance Deficiency Summary Report

Overall LMA & Unit Ratings, including USACE Erosion Survey

Sacramento River Basin

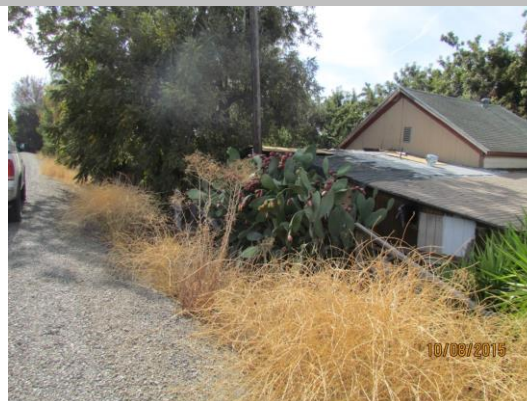
Photo 1 of 1 : FA_2017_ST0001_259_8_20170911_00008.jpg

View of the building on the landward side of the levee looking upstream.
Cactus planted at the toe obstructs visibility. Fall 2015.

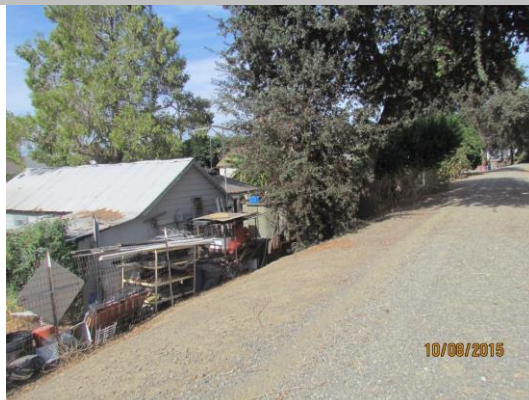
Photo 1 of 1 : FA_2017_ST0001_259_11_20170911_00011.jpg

View of the building on the landward side of the levee looking downstream. Fall 2015.

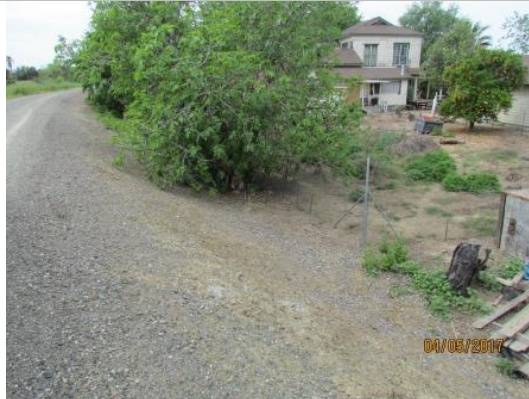
Photo 1 of 1 : FA_2017_ST0001_259_77_20170911_00055.jpg

| Wire fence at landside toe. | | | | | |

Chain fence at landside levee toe. Spring 2017.

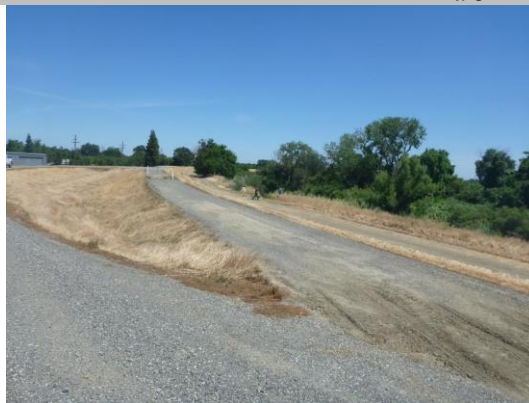
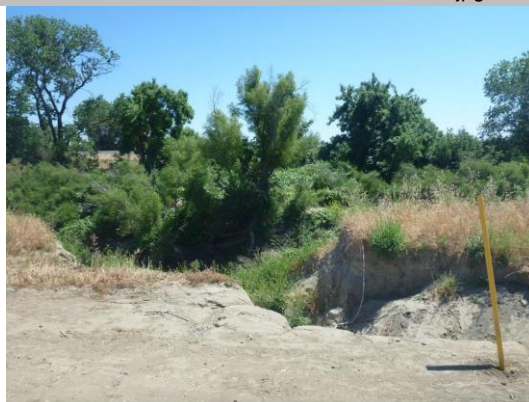
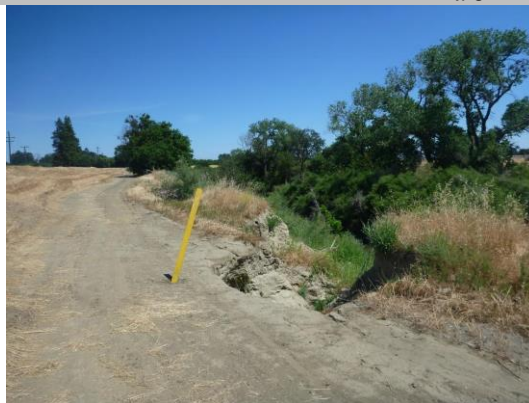
| Repair Type: Erosion | | | | | |

| Notes: setback levee site; remaining berm greater than 86 feet, no section taken, photo only. | | | | | | |

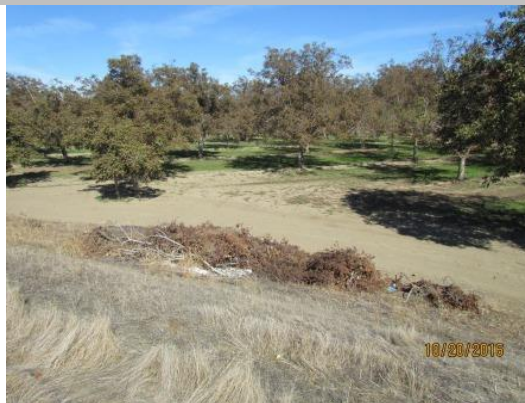
Photo 1 of 1 : FA_2017_ST0001_259_51_20170911_00040.jpg

View of prunings on LS slope. Fall 2016.

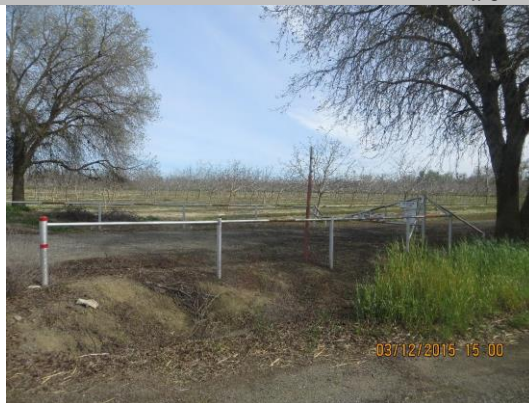
Photo 1 of 2 : UCIP_FA_2017_49112_73504.jpg

Gasline marker next to levee access gate 500-feet north of levee crown.

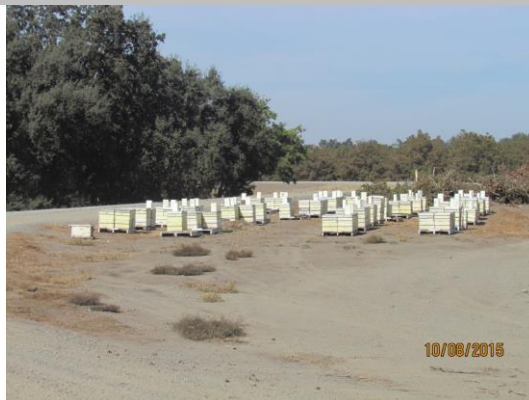
Photo 1 of 1 : FA_2017_ST0001_259_59_20170911_00046.jpg

| Beehives. | | | | | |

View of the beehives on the landward side of the levee looking upstream. Fall 2015.

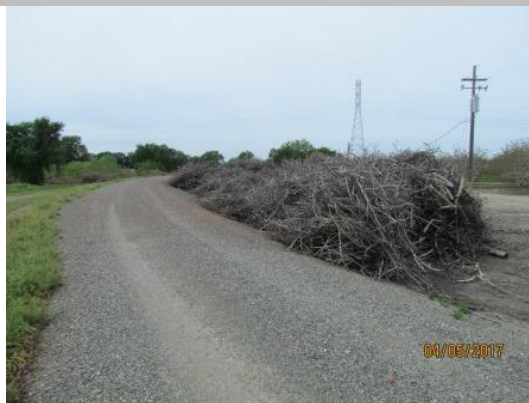
Photo 1 of 2 : FA_2017_ST0001_259_45_20170911_00034.jpg

View of prunings on landside slope. Spring 2017.

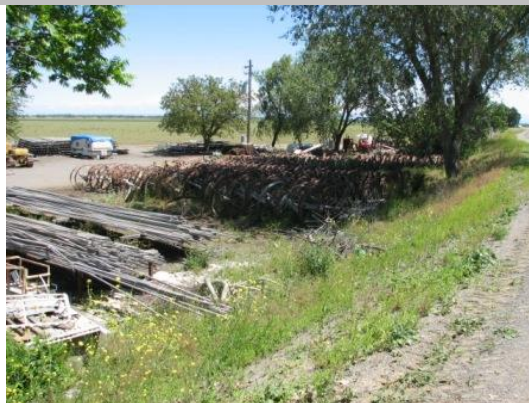
Photo 1 of 2 : FA_2017_ST0001_259_40_20170911_00031.jpg

Irrigation pipe and equipment are within the easement of the levee.

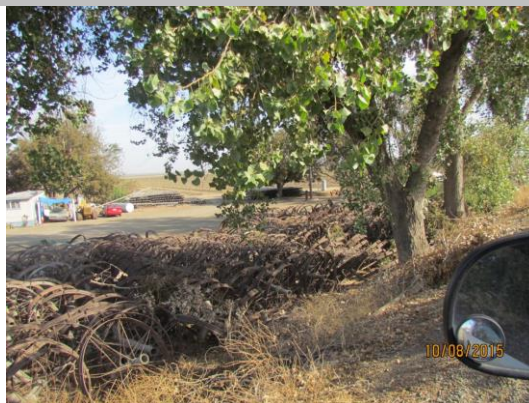
Photo 2 of 2 : FA_2017_ST0001_259_40_20170911_00032.jpg

View of the equipment at the levee toe on the landward side looking downstream. Fall 2015.

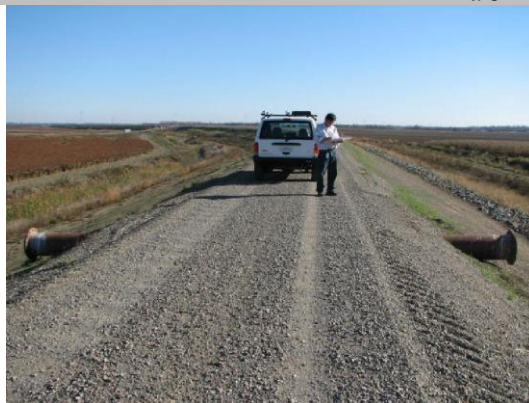
Photo 1 of 3 : UCIP_FA_2017_52531_60219.jpg

Crown view: overview

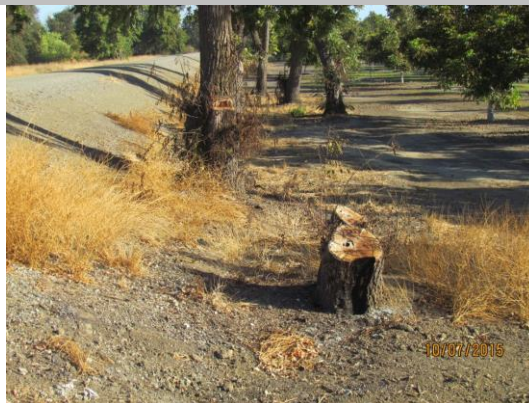
Photo 1 of 1 : FA_2017_ST0001_260_10_20170911_00011.jpg

| The stump is located at the levee toe. | | | | | |

View of the tree stump at the landward side of the levee looking downstream. Fall 2015.

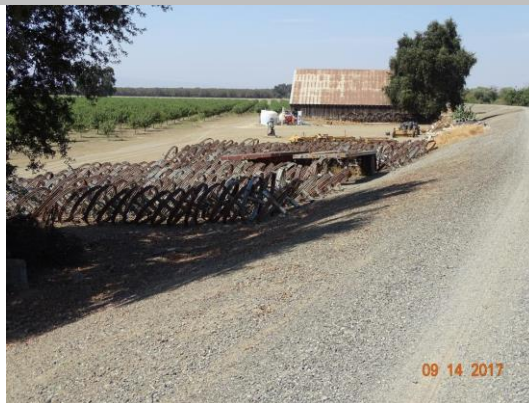
Photo 1 of 1 : FA_2017_ST0001_260_29_20170914_00034.jpg

| Farm equipment at landside toe. | | | | | |

View of farm equipment at landside toe. Fall 2017.

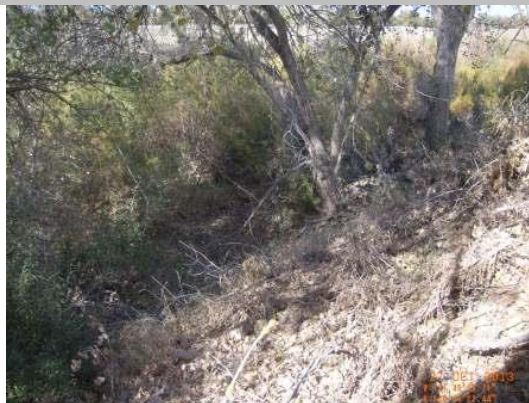
Photo 1 of 1 : FA_2017_ST0001_260_2_20170911_00002.jpg

| 2010 - Large slump on the upper berm, a tree has recently slid down the slope. 2011 - Large slump and new erosion. 2012 - Slightly steeper slopes and cracks observed. 2015: No observed changes. [2015 Site ID: CHC_3-5_R] | | | | | |

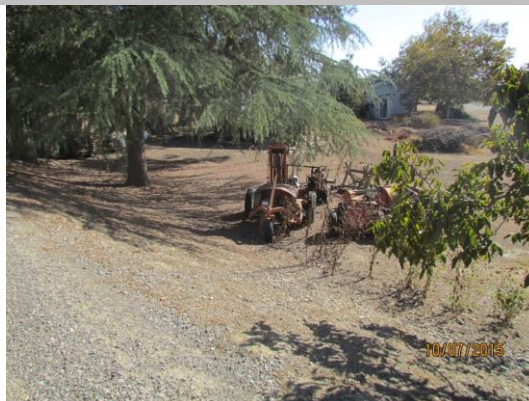
Photo 1 of 1 : FA_2017_ST0001_260_26_20170911_00026.jpg

View of the equipment at the toe of the landward side of the levee. Fall 2015.

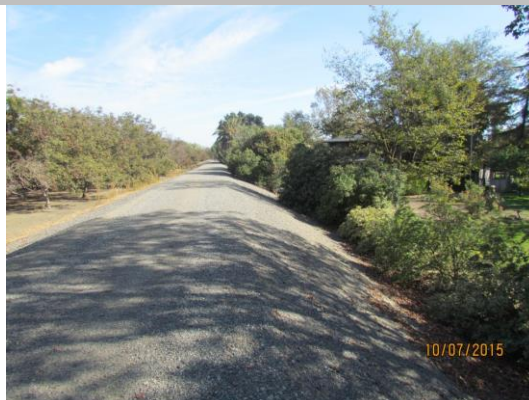
Photo 1 of 1 : FA_2017_ST0001_260_9_20170911_00010.jpg

View of the landscaping vegetation on the landward side of the levee looking downstream. Fall 2015.

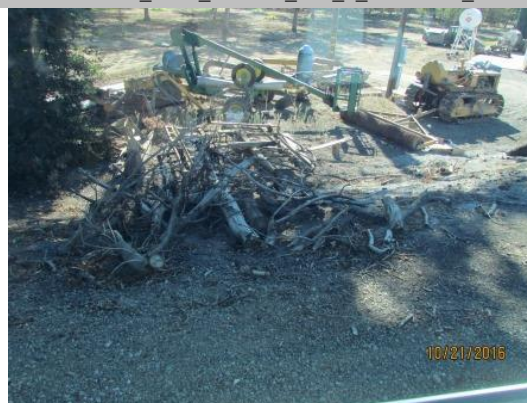
Photo 1 of 1 : FA_2017_ST0001_260_5_20170911_00006.jpg

Prunings on LS levee slope. Fall 2016.

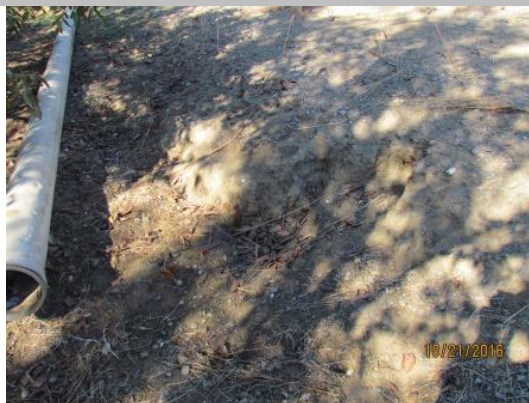
Photo 1 of 1 : FA_2017_ST0001_260_4_20170911_00005.jpg

| Erosion on LS slope near levee toe. | | | | | |

Erosion on LS levee slope toward the toe. Fall 2016.

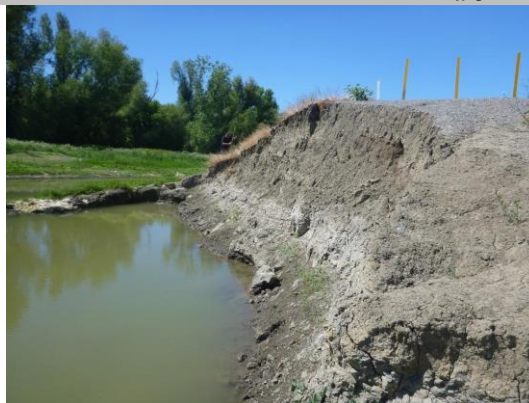
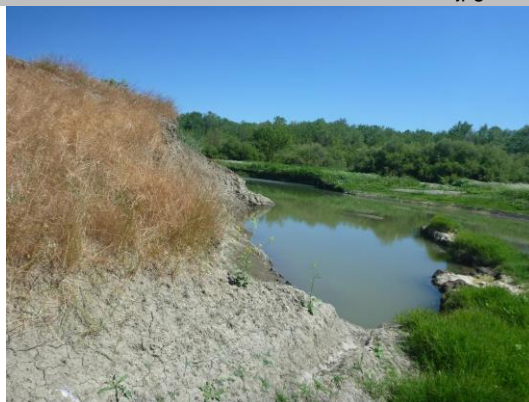
| Notes: training levee end slope where it keys into channel /access ramp erosion | | | | | |
