**Flood Control Project Maintenance
Levee Inspections**

Fall 2018 Levee Maintenance Deficiency Summary Report

Sacramento River Basin

Sacramento Maintenance Yard Cache Creek

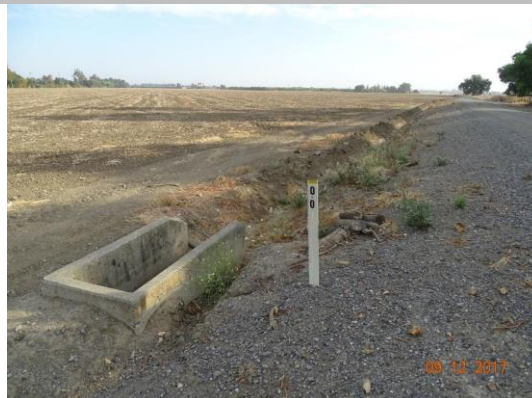
Photo 1 of 2 : FA_2018_ST0001_259_48_20180904_00034.jpg

LM Start	0.03	Rating **	M	Issue No.	48 (cont)
LM End	0.16	Issue Type +	En	Location *	LS

View of the ditch at the landside levee toe. Fall 2017.

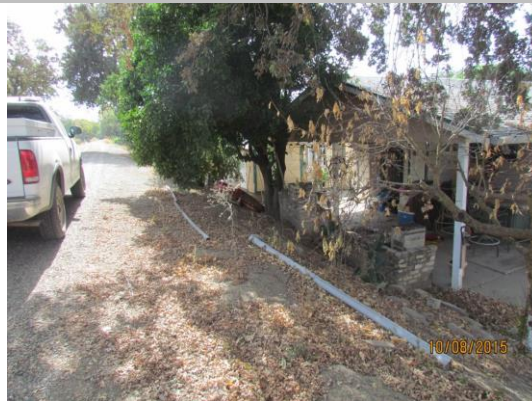
Photo 1 of 1 : FA_2018_ST0001_259_13_20180904_00012.jpg

LM Start	2.08	Rating **	M	Issue No.	13
LM End	2.08	Issue Type +	En	Location *	LS
Category	Earthen Levee			GPS Latitude/Longitude	
				Start	End
Item	Encroachments			38.732523 °	38.732523 °
				-121.805690 °	-121.805690 °
DWR ID	DWR_ST0001_01_s_2012_13				
Comment Code					
BU : Building					
Inspector Comment

View of the building on the landward side of the levee looking upstream.
Fall 2015.

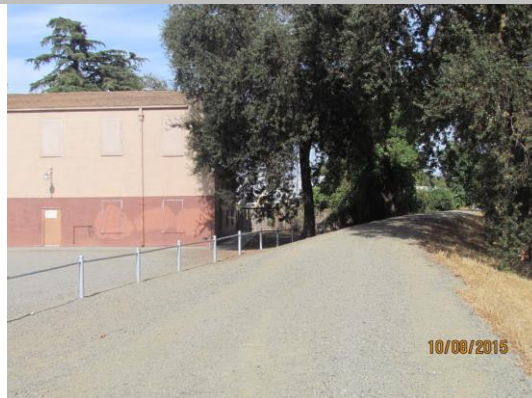
Photo 1 of 1 : FA_2018_ST0001_259_12_20180904_00011.jpg

LM Start	2.12	Rating **	M	Issue No.	12
LM End	2.12	Issue Type +	En	Location *	LS
Category	Earthen Levee			GPS Latitude/Longitude	
				Start	End
Item	Encroachments			38.733000 °	38.733000 °
				-121.805409 °	-121.805409 °
DWR ID	DWR_ST0001_01_s_2012_12				
Comment Code					
BU : Building					
Inspector Comment

View of the building on the landward side of the levee looking downstream. Fall 2015.

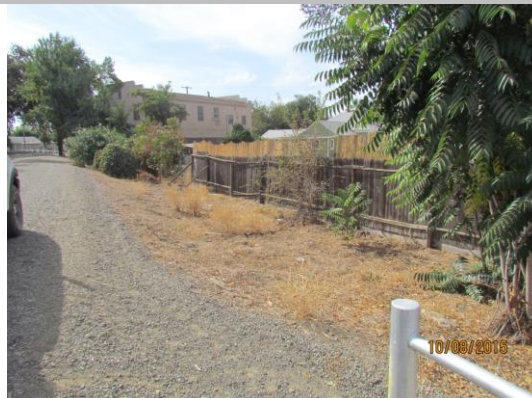
Photo 1 of 1 : FA_2018_ST0001_259_15_20180904_00015.jpg

LM Start	2.13	Rating **	U	Issue No.	15
LM End	2.15	Issue Type +	En	Location *	LS
Category	Earthen Levee			GPS Latitude/Longitude	
				Start	End
Item	Encroachments			38.733215 °	38.733350 °
				-121.805262 °	-121.805082 °
DWR ID	DWR_ST0001_01_s_2012_15				
Comment Code					
FE : Fence					
Inspector Comment

View of the fence on the landward side of the levee looking upstream.
Fall 2015.

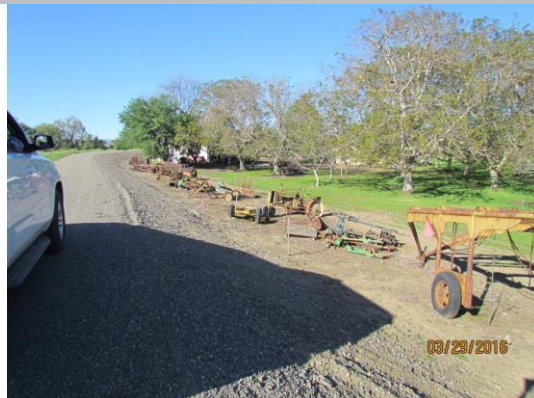
Photo 1 of 1 : FA_2018_ST0001_259_71_20180904_00045.jpg

LM Start	2.67	Rating **	M	Issue No.	71
LM End	2.74	Issue Type +	En	Location *	LS
Category	Earthen Levee			GPS Latitude/Longitude	
				Start	End
Item	Encroachments			38.733075 °	38.733594 °
				-121.796039 °	-121.795131 °
DWR ID	DWR_ST0001_01_s_2016_71				
Comment Code					
EQ : Equipment					
Inspector Comment

View of the equipment on the landward side of the levee looking upstream. Spring 2016.

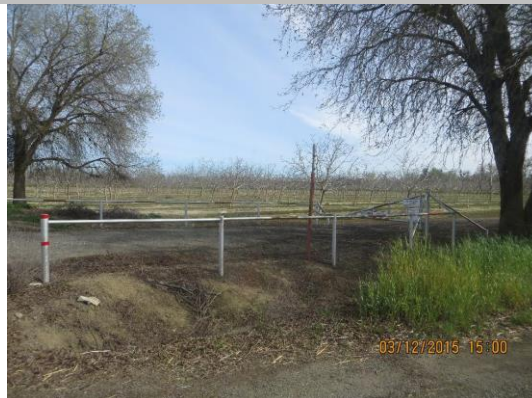
Photo 1 of 2 : UCIP_FA_2018_49112_73504.jpg

LM Start	4.99	Rating **	M	Issue No.	86 (cont)
LM End	4.99	Issue Type +	En	Location *

Gasline marker next to levee access gate 500-feet north of levee crown.

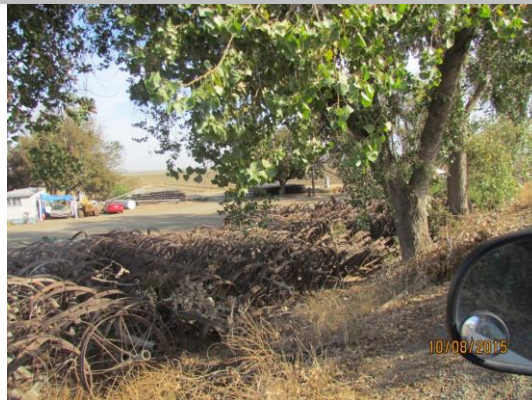
Photo 2 of 2 : FA_2018_ST0001_259_40_20180904_00030.jpg

LM Start	7.30	Rating **	M	Issue No.	40 (cont)	
LM End	7.34	Issue Type +	En	Location *	LS	
Category	Earthen Levee			GPS Latitude/Longitude		
				Start		End
Item	Encroachments			38.727878 °	38.728085 °	
				-121.728553 °	-121.727740 °	
DWR ID	DWR_ST0001_01_s_2012_40					
Comment Code						
EQ : Equipment						
Inspector Comment

View of the equipment at the levee toe on the landward side looking downstream. Fall 2015.

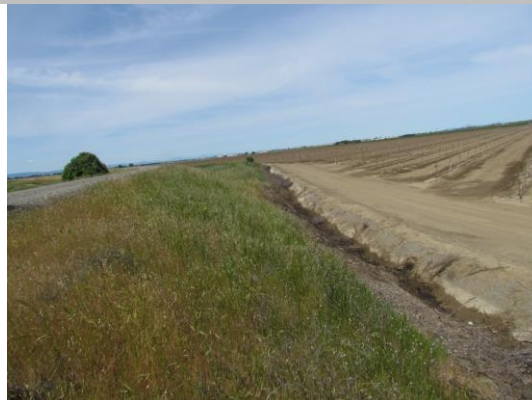
Photo 1 of 2 : FA_2018_ST0001_259_26_20180904_00021.jpg

LM Start	7.36	Rating **	M	Issue No.	26
LM End	7.78	Issue Type +	En	Location *	LS
Category	Earthen Levee			GPS Latitude/Longitude	
				Start	End
Item	Encroachments			38.728188°	38.728194°
				-121.727442°	-121.720255°
DWR ID	DWR_ST0001_01_s_2015_26				
Comment Code					
DT : Ditch					
Inspector Comment					
Ditch is located at the levee toe.

View of ditch on the landward side of the levee looking upstream. Spring 2015.

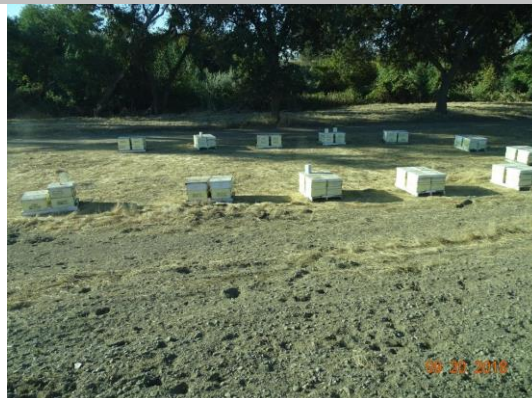
Photo 1 of 1 : FA_2018_ST0001_259_38_20180924_00069.jpg

LM Start	7.94	Rating **	M	Issue No.	38
LM End	7.94	Issue Type +	En	Location *	LS
Category	Earthen Levee			GPS Latitude/Longitude	
				Start	End
Item	Encroachments			38.727277 °	38.727277 °
				-121.717618 °	-121.717618 °
DWR ID	DWR_ST0001_01_f_2018_38				
Comment Code					
EQ : Equipment					
Inspector Comment					
Beehives.

View of beehives at the landside toe. Fall 2018.

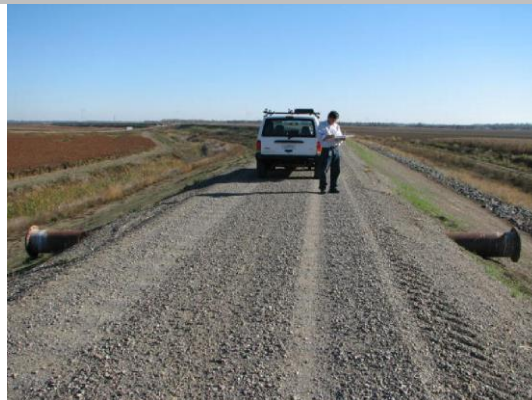
Photo 1 of 3 : UCIP_FA_2018_53214_60219.jpg

LM Start	10.40	Rating **	M	Issue No.	88 (cont)
LM End	10.40	Issue Type +	En	Location *

Crown view: overview

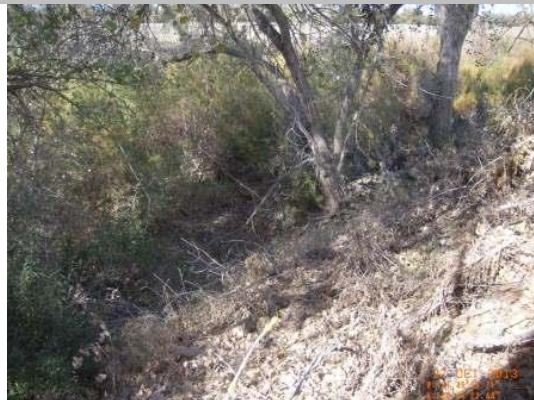
Photo 1 of 1 : FA_2018_ST0001_260_2_20181023_00001.jpg

LM Start	3.53	Rating **	A/W	Issue No.	2
LM End	3.60	Issue Type +	Ma	Location *	WS
Category	Supplemental			GPS Latitude/Longitude	
				Start	End
Item	2017 USACE Erosion Survey, DRAFT			38.722138 °	38.723294 °
				-121.759736 °	-121.759588 °
DWR ID	DWR_ST0001_02_f_2018_2				
Comment Code					
Inspector Comment					
2017 Site ID: CHC 3.5 R					
Status: Eroding					
2017 Field Notes: Significant amount of debris along bank.					
Site History: 2010 - Large slump on the upper berm, a tree has recently slid down the slope. 2011 - Large slump and new erosion. 2012 - Slightly steeper slopes and cracks observed.

USACE 2013 Photo #1

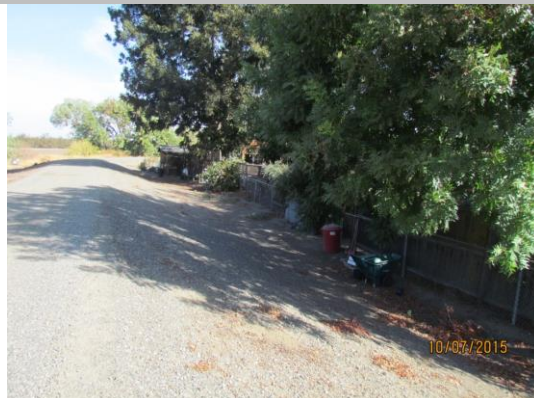
Photo 1 of 1 : FA_2018_ST0001_260_7_20180904_00007.jpg

LM Start	3.53	Rating **	A/W	Issue No.	7
LM End	3.59	Issue Type +	En	Location *	LS
Category	Earthen Levee			GPS Latitude/Longitude	
				Start	End
Item	Vegetation			38.722228 °	38.723109 °
				-121.759663 °	-121.759639 °
DWR ID	DWR_ST0001_02_s_2012_7				
Comment Code					
V6 : Landscaping					
Inspector Comment

View of the landscaping and fence on the landward side of the levee looking downstream. Fall 2015.

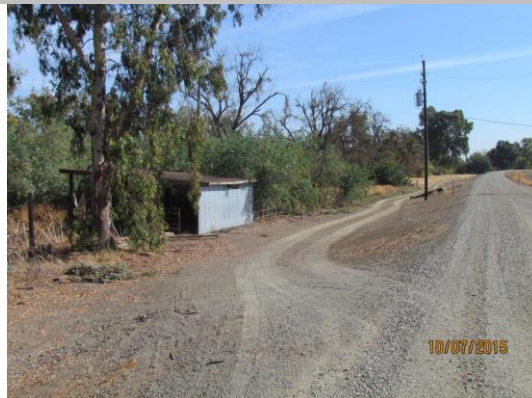
Photo 1 of 1 : FA_2018_ST0001_260_27_20180904_00019.jpg

LM Start	4.49	Rating **	M	Issue No.	27
LM End	4.49	Issue Type +	En	Location *	WS
Category	Earthen Levee			GPS Latitude/Longitude	
				Start	End
Item	Encroachments			38.727065 °	38.727065 °
				-121.746002 °	-121.746002 °
DWR ID	DWR_ST0001_02_f_2013_27				
Comment Code					
BU : Building					
Inspector Comment

View of the horse corral and building on the waterward side of the levee looking downstream. Fall 2015.

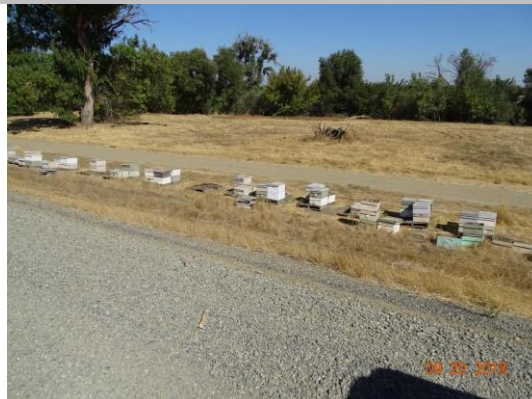
Photo 1 of 1 : FA_2018_ST0001_260_13_20180924_00023.jpg

LM Start	4.73	Rating **	M	Issue No.	13
LM End	4.73	Issue Type +	En	Location *	WS
Category	Earthen Levee			GPS Latitude/Longitude	
				Start	End
Item	Encroachments			38.727431 °	38.727431 °
				-121.741661 °	-121.741661 °
DWR ID	DWR_ST0001_02_f_2018_13				
Comment Code					
EQ : Equipment					
Inspector Comment					
Beehives on waterside toe.

View of beehives on the waterside toe. Fall 2018.

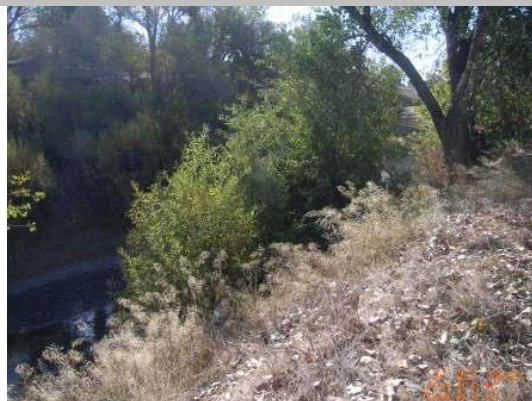
Photo 1 of 1 : FA_2018_ST0001_260_11_20181023_00024.jpg

LM Start	5.33	Rating **	A/W	Issue No.	11
LM End	5.37	Issue Type +	Ma	Location *	WS
Category	Supplemental			GPS Latitude/Longitude	
				Start	End
Item	2017 USACE Erosion Survey, DRAFT			38.722933 °	38.723467 °
				-121.760561 °	-121.760436 °
DWR ID	DWR_ST0001_02_f _ 2018_11				
Comment Code					
Inspector Comment					
2017 Site ID: CHC 5.4 L					
Status: Eroding					
2017 Field Notes: Site continues to erode due to recent high storm events.					
Site History: 2009 - Erosion into the levee slope. 2010 - Minor new erosion. 2011 - New erosion and a freshly fallen tree. 2012 - New animal holes and slightly steeper slopes. 2013 - New tree popout and 2 feet of erosion along the top bank.

USACE 2013 Photo #1
