**Flood Control Project Maintenance
Levee Inspections**

Fall 2019 Levee Maintenance Deficiency Summary Report

Sacramento River Basin

Sacramento Maintenance Yard Cache Creek

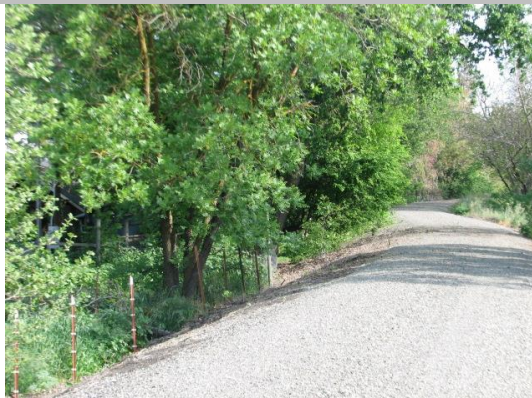
Photo 3 of 3 : FA_2019_ST0001_259_3_20190829_00003.jpg

LM Start	1.90	Rating **	U	Issue No.	3 (cont)	
LM End	1.98	Issue Type +	En	Location *	LS	
Category	Earthen Levee			GPS Latitude/Longitude		
				Start		End
Item	Vegetation			38.730008 °	38.731170 °	
				-121.806497 °	-121.806220 °	
DWR ID	DWR_ST0001_01_s_2012_3					
Comment Code						
V6 : Landscaping						
Inspector Comment

The landscape needs to be trimmed up. Spring 2014

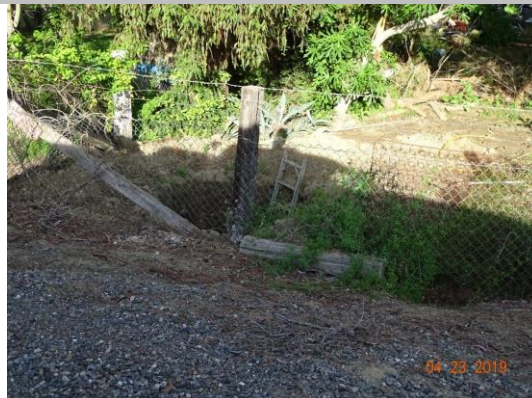
Photo 2 of 2 : FA_2019_ST0001_259_35_20190829_00028.jpg

LM Start	1.98	Rating **	U	Issue No.	35 (cont)	
LM End	1.98	Issue Type +	En	Location *	LS	
Category	Earthen Levee			GPS Latitude/Longitude		
				Start	End	
Item	Encroachments			38.731208 °	38.731208 °	
				-121.806220 °	-121.806220 °	
DWR ID	DWR_ST0001_01_s_2019_35					
Comment Code						
DT : Ditch						
Inspector Comment						
The landowner has dug a 5' diameter hole within 10' of the landside toe and it appears to cut into the levee prism.

View of the hole within the landside easement. Spring 2019.

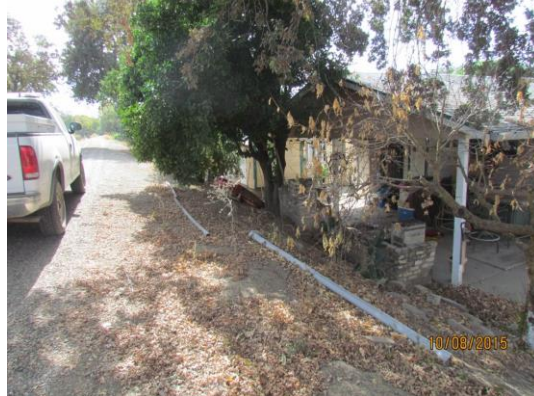
Photo 1 of 1 : FA_2019_ST0001_259_13_20190829_00011.jpg

LM Start	2.08	Rating **	M	Issue No.	13
LM End	2.08	Issue Type +	En	Location *	LS
Category	Earthen Levee			GPS Latitude/Longitude	
				Start	End
Item	Encroachments			38.732523 °	38.732523 °
				-121.805690 °	-121.805690 °
DWR ID	DWR_ST0001_01_s_2012_13				
Comment Code					
BU : Building					
Inspector Comment

View of the building on the landward side of the levee looking upstream.
Fall 2015.

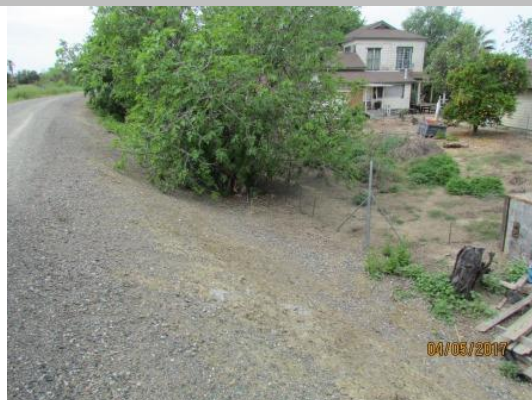
Photo 1 of 1 : FA_2019_ST0001_259_77_20190829_00045.jpg

LM Start	2.62	Rating **	M	Issue No.	77
LM End	2.64	Issue Type +	En	Location *	LS
Category	Earthen Levee			GPS Latitude/Longitude	
				Start	End
Item	Encroachments			38.732795 °	38.732897 °
				-121.797050 °	-121.796547 °
DWR ID	DWR_ST0001_01_s_2017_77				
Comment Code					
FE : Fence					
Inspector Comment					
There is a wire fence at the landside toe.

Chain fence at landside levee toe. Spring 2017.

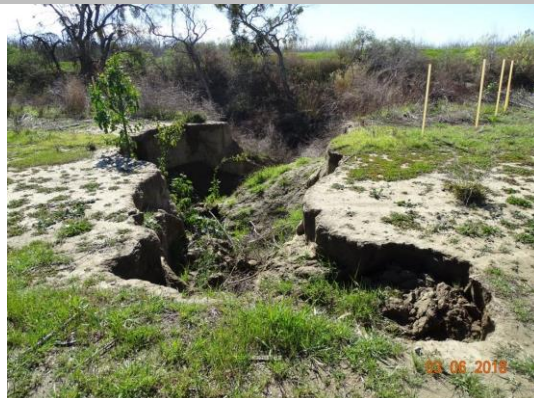
Photo 1 of 5 : FA_2019_ST0001_259_62_20190829_00038.jpg

LM Start	2.84	Rating **	A/W	Issue No.	62 (cont)
LM End	2.84	Issue Type +	Ma	Location *	WS

View of erosion on toe road, looking towards Cache Creek. Spring 2018.

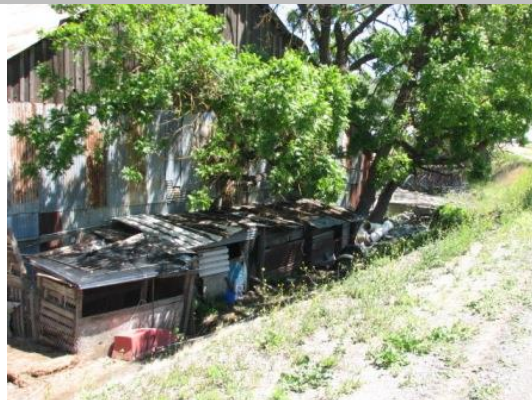
Photo 1 of 1 : FA_2019_ST0001_259_39_20190829_00030.jpg

LM Start	7.30	Rating **	M	Issue No.	39
LM End	7.30	Issue Type +	En	Location *	LS
Category	Earthen Levee			GPS Latitude/Longitude	
				Start	End
Item	Encroachments			38.727870 °	38.727870 °
				-121.728527 °	-121.728527 °
DWR ID	DWR_ST0001_01_s_2012_39				
Comment Code					
BU : Building					
Inspector Comment					
The barn and livestock pens are within the easement of the levee.

View of barn and livestock pens.

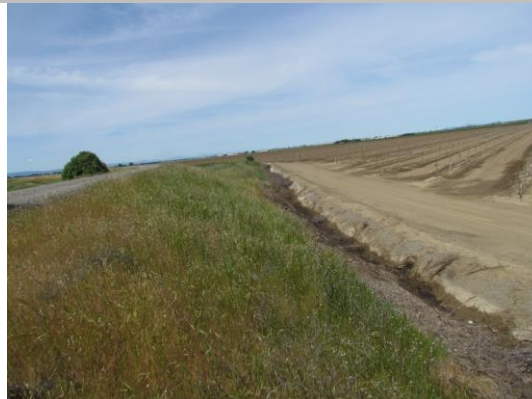
Photo 1 of 2 : FA_2019_ST0001_259_26_20190829_00019.jpg

LM Start	7.36	Rating **	M	Issue No.	26
LM End	7.78	Issue Type +	En	Location *	LS
Category	Earthen Levee			GPS Latitude/Longitude	
				Start	End
Item	Encroachments			38.728188 °	38.728194 °
				-121.727442 °	-121.720255 °
DWR ID	DWR_ST0001_01_s_2015_26				
Comment Code					
DT : Ditch					
Inspector Comment					
A ditch is located at the levee toe.

View of ditch on the landward side of the levee looking upstream. Spring 2015.

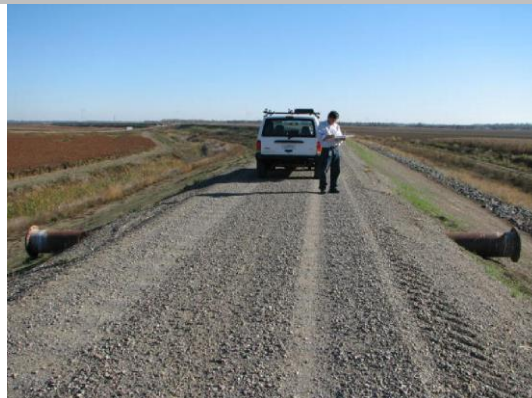
Photo 1 of 3 : UCIP_FA_2019_53214_60219.jpg

LM Start	10.40	Rating **	M	Issue No.	84 (cont)
LM End	10.40	Issue Type +	En	Location *

Crown view: overview

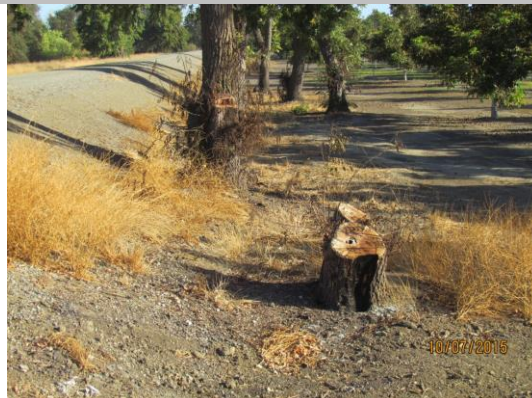
Photo 1 of 1 : FA_2019_ST0001_260_10_20190829_00008.jpg

LM Start	0.18	Rating **	N	Issue No.	10
LM End	0.18	Issue Type +	Ma	Location *	LS
Category	Earthen Levee			GPS Latitude/Longitude	
				Start	End
Item	Trim / Thin Trees			38.729560 °	38.729560 °
				-121.805231 °	-121.805231 °
DWR ID	DWR_ST0001_02_f_2015_10				
Comment Code					
T5 : Tree stumps.					
Inspector Comment					
The stump is located at the levee toe.

View of the tree stump at the landward side of the levee looking downstream. Fall 2015.

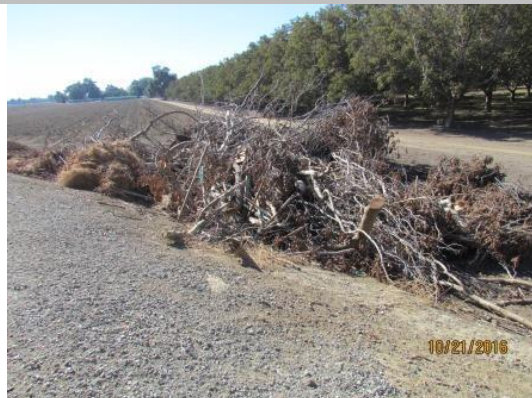
Photo 1 of 1 : FA_2019_ST0001_260_20_20190829_00016.jpg

LM Start	1.68	Rating **	M	Issue No.	20
LM End	1.68	Issue Type +	En	Location *	LS
Category	Earthen Levee			GPS Latitude/Longitude	
				Start	End
Item	Encroachments			38.730567 °	38.730567 °
				-121.786027 °	-121.786027 °
DWR ID	DWR_ST0001_02_f_2016_20				
Comment Code					
PR : Prunings					
Inspector Comment

View of prunings on LS slope of the levee. Fall 2016.

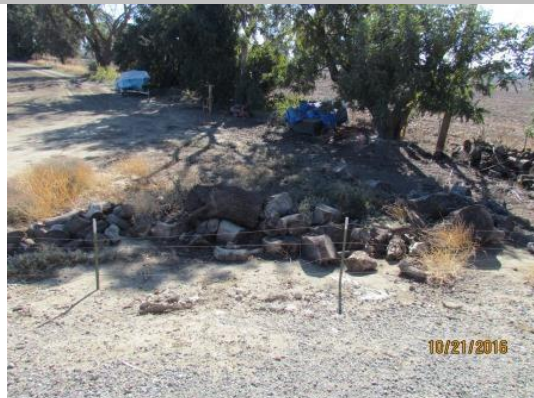
Photo 1 of 1 : FA_2019_ST0001_260_17_20190829_00015.jpg

LM Start	3.39	Rating **	M	Issue No.	17
LM End	3.39	Issue Type +	En	Location *	LS
Category	Earthen Levee			GPS Latitude/Longitude	
				Start	End
Item	Encroachments			38.720204 °	38.720204 °
				-121.759760 °	-121.759760 °
DWR ID	DWR_ST0001_02_f_2016_17				
Comment Code					
FW : Firewood					
Inspector Comment					
There is a firewood pile behind the wire fence.

View of firewood at LS levee toe. Fall 2016.

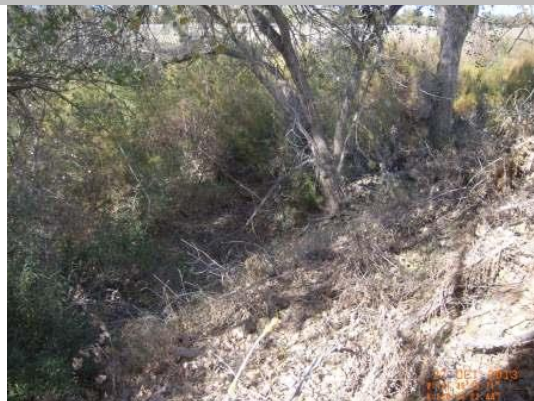
Photo 1 of 1 : FA_2019_ST0001_260_2_20190829_00001.jpg

LM Start	3.53	Rating **	A/W	Issue No.	2
LM End	3.60	Issue Type +	Ma	Location *	WS
Category	Supplemental			GPS Latitude/Longitude	
				Start	End
Item	2017 USACE Erosion Survey			38.722138 °	38.723294 °
				-121.759736 °	-121.759588 °
DWR ID	DWR_ST0001_02_f_2018_2				
Comment Code					
Inspector Comment					
2017 Site ID: CHC 3.5 R					
Status: Eroding					
2017 Field Notes: Significant amount of debris along bank.					
Site History: 2010 - Large slump on the upper berm, a tree has recently slid down the slope. 2011 - Large slump and new erosion. 2012 - Slightly steeper slopes and cracks observed.

USACE 2013 Photo #1

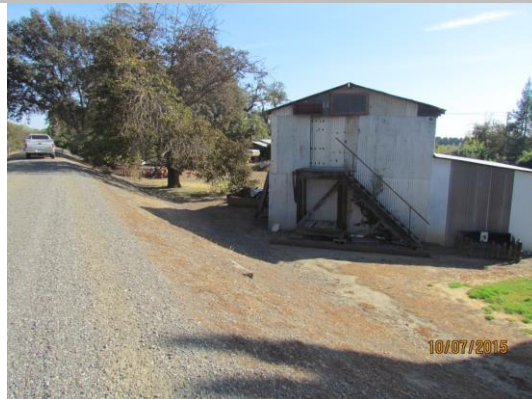
Photo 1 of 1 : FA_2019_ST0001_260_8_20190829_00006.jpg

LM Start	4.06	Rating **	M	Issue No.	8
LM End	4.06	Issue Type +	En	Location *	LS
Category	Earthen Levee			GPS Latitude/Longitude	
				Start	End
Item	Encroachments			38.723992 °	38.723992 °
				-121.752511 °	-121.752511 °
DWR ID	DWR_ST0001_02_s_2012_8				
Comment Code					
BU : Building					
Inspector Comment					
A building is within the easement of the levee.

View of the building on the landward side of the levee looking downstream. Fall 2015.

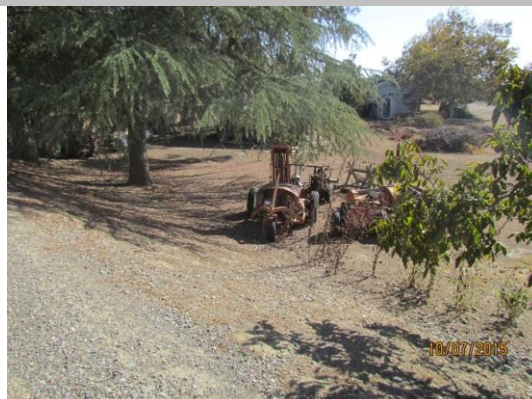
Photo 1 of 1 : FA_2019_ST0001_260_26_20190829_00017.jpg

LM Start	4.08	Rating **	M	Issue No.	26
LM End	4.08	Issue Type +	En	Location *	LS
Category	Earthen Levee			GPS Latitude/Longitude	
				Start	End
Item	Encroachments			38.724219 °	38.724219 °
				-121.752252 °	-121.752252 °
DWR ID	DWR_ST0001_02_f_2013_26				
Comment Code					
EQ : Equipment					
Inspector Comment

View of the equipment at the toe of the landward side of the levee. Fall 2015.

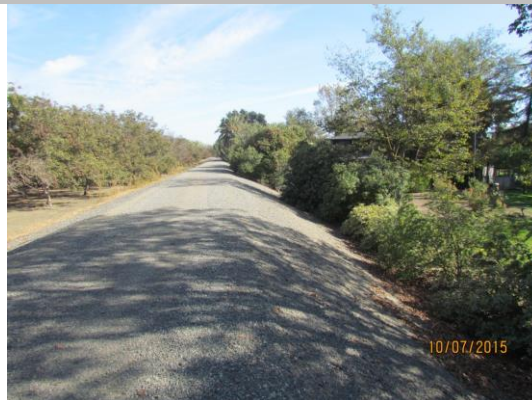
Photo 1 of 1 : FA_2019_ST0001_260_9_20190829_00007.jpg

LM Start	4.09	Rating **	M	Issue No.	9
LM End	4.18	Issue Type +	En	Location *	LS
Category	Earthen Levee			GPS Latitude/Longitude	
				Start	End
Item	Vegetation			38.724317 °	38.725242 °
				-121.752148 °	-121.751075 °
DWR ID	DWR_ST0001_02_s_2012_9				
Comment Code					
V6 : Landscaping					
Inspector Comment

View of the landscaping vegetation on the landward side of the levee looking downstream. Fall 2015.

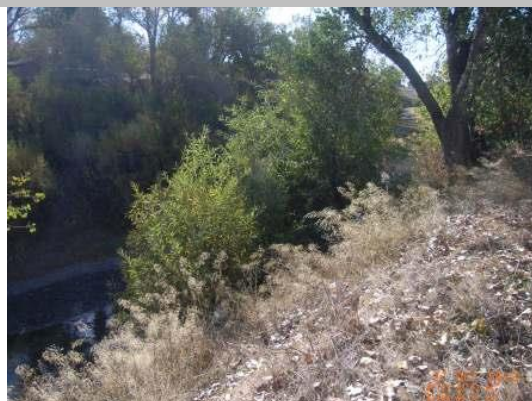
Photo 1 of 1 : FA_2019_ST0001_260_11_20190829_00009.jpg

LM Start	5.33	Rating **	A/W	Issue No.	11
LM End	5.37	Issue Type +	Ma	Location *	WS
Category	Supplemental			GPS Latitude/Longitude	
				Start	End
Item	2017 USACE Erosion Survey			38.722933 °	38.723467 °
				-121.760561 °	-121.760436 °
DWR ID	DWR_ST0001_02_f _ 2018_11				
Comment Code					
Inspector Comment					
2017 Site ID: CHC 5.4 L					
Status: Eroding					
2017 Field Notes: Site continues to erode due to recent high storm events.					
Site History: 2009 - Erosion into the levee slope. 2010 - Minor new erosion. 2011 - New erosion and a freshly fallen tree. 2012 - New animal holes and slightly steeper slopes. 2013 - New tree popout and 2 feet of erosion along the top bank.

USACE 2013 Photo #1

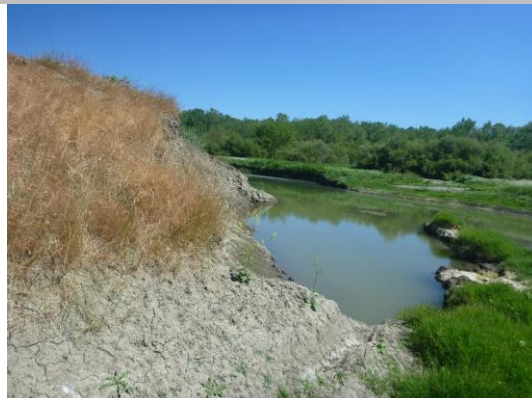
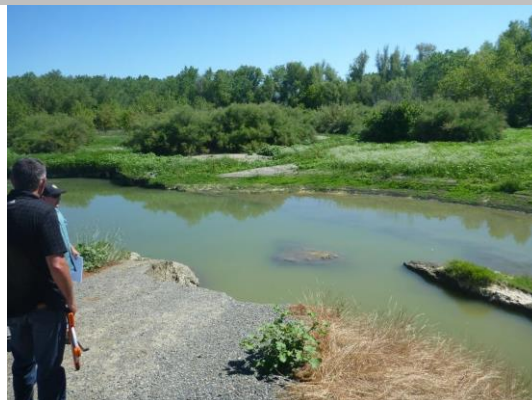
LM Start	2.26	Rating **	M	Issue No.	1 (cont)	
LM End	2.26	Issue Type +	Ma	Location *		
Category	Supplemental			GPS Latitude/Longitude		
				Start		End
Item	2017 Storm Damage			38.695424 °		38.695253 °
				-121.715914 °		-121.715926 °
DWR ID	LMA-58					
Comment Code						
Inspector Comment						
Levee Evaluation Comments						
Description:						
Site ID No:250						
Site Designation:LMA-58						
Repair Type: Erosion						
Rating:Area of Concern						
Field Date:6/2/2017						
Notes: Training levee end slope where it keys into channel/access ramp erosion. No change as of fall 2018 inspection.
