Flood Control Project Maintenance Levee Inspections

Fall 2020 Levee Maintenance Deficiency Summary Report

Sacramento River Basin

Sacramento Maintenance Yard Cache Creek

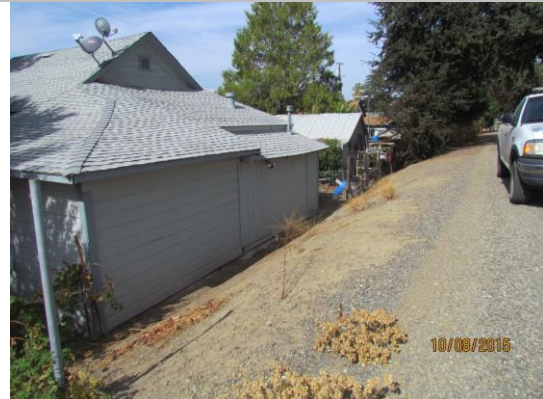
Photo 1 of 1 : FA_2020_ST0001_259_10_20200813_00007.jpg

LM Start	2.05	Rating **	M	Issue No.	10
LM End	2.05	Issue Type +	En	Location *	LS
Category	Earthen Levee			GPS Latitude/Longitude	
				Start	End
Item	Encroachments			38.732162 °	38.732162 °
				-121.805895 °	-121.805895 °
DWR ID	DWR_ST0001_01_s_ 2018_10				
Comment Code					
BU : Building					
Inspector Comment

View of the house on the landward side of the levee looking downstream. Fall 2015.

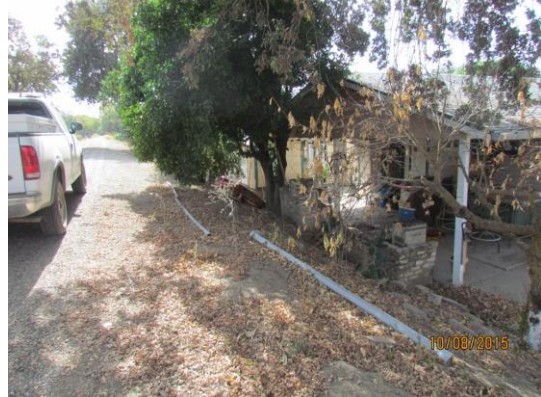
Photo 1 of 1 : FA_2020_ST0001_259_13_20200813_00010.jpg

LM Start	2.08	Rating **	M	Issue No.	13
LM End	2.08	Issue Type +	En	Location *	LS
Category	Earthen Levee			GPS Latitude/Longitude	
				Start	End
Item	Encroachments			38.732523 °	38.732523 °
				-121.805690 °	-121.805690 °
DWR ID	DWR_ST0001_01_f_2020_13				
Comment Code					
BU : Building					
Inspector Comment

View of the building on the landward side of the levee looking upstream.
Fall 2015.

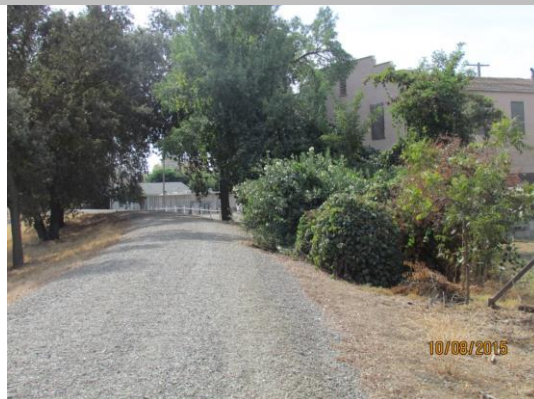
Photo 2 of 2 : FA_2020_ST0001_259_14_20200813_00011.jpg

View of the shrubs on the landward side of the levee looking upstream. Fall 2015.

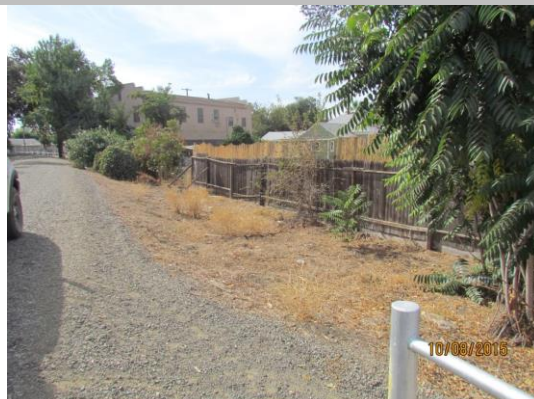
Photo 1 of 1 : FA_2020_ST0001_259_15_20200813_00013.jpg

LM Start	2.13	Rating **	U	Issue No.	15
LM End	2.15	Issue Type +	En	Location *	LS
Category	Earthen Levee			GPS Latitude/Longitude	
				Start	End
Item	Encroachments			38.733215 °	38.733350 °
				-121.805262 °	-121.805082 °
DWR ID	DWR_ST0001_01_s_2012_15				
Comment Code					
FE : Fence					
Inspector Comment

View of the fence on the landward side of the levee looking upstream. Fall 2015.

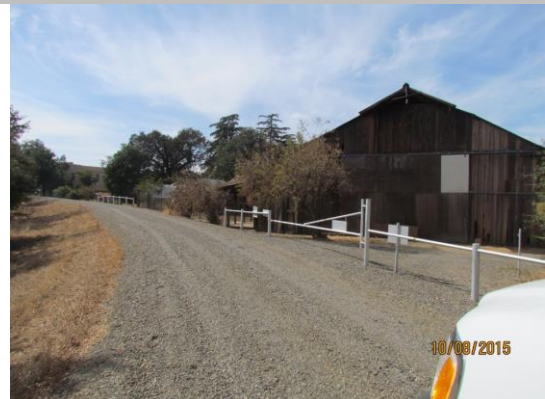
Photo 2 of 2 : FA_2020_ST0001_259_16_20200813_00015.jpg

View of the horse barn on the landward side of the levee looking upstream. Fall 2015.

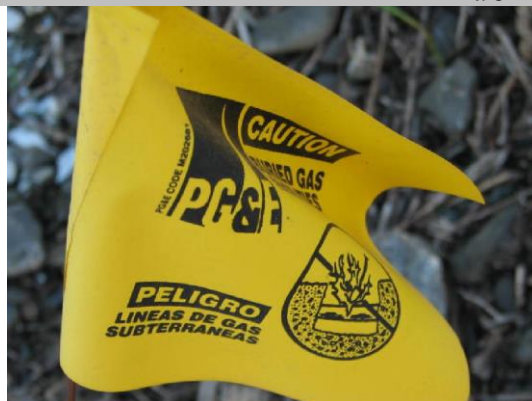
Photo 3 of 3 : UCIP_FA_2020_49099_60165.jpg

Landside view: gasline indicator/flag

Comment Code						
Inspector Comment						
DS_ID:16268 FS_ID:49099 EP_NO: 2415 Repair Type: Non-Urgent EVAL Issue: Crossing Status: Indicator Found UCIP Comments: May need to install gasoline marker on WS slope. FIELD_STRUCT_DESC: 20-inch wrapped steel natural gas pipeline through the levee, 4 feet below the crown. Two cutoff walls. Gas line indicator found on the landside (LS) of the levee. (20-inch wrapped steel natural gas pipeline authorized under Permit No. 2415, 1956 - Pacific Gas and Electric Company [PG&E]). [Additional Reference(s): DWR Levee Log, 1993. USACE Sacramento O&M Manual 126, November 1961, (HLM 2.24)]. FS Date: 6/16/2016 7:00:04 AM

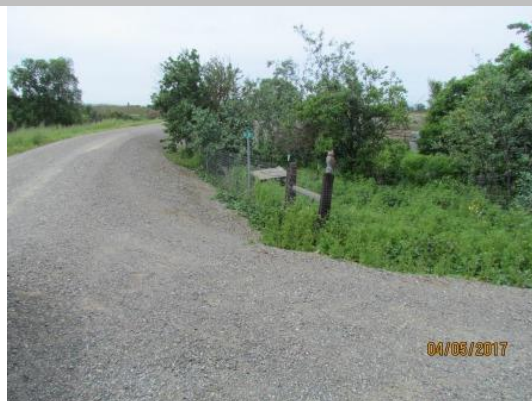
Photo 1 of 1 : FA_2020_ST0001_259_78_20200813_00046.jpg

LM Start	2.54	Rating **	M	Issue No.	78
LM End	2.61	Issue Type +	En	Location *	LS
Category	Earthen Levee			GPS Latitude/Longitude	
				Start	End
Item	Encroachments			38.733285 °	38.732782 °
				-121.798029 °	-121.797167 °
DWR ID	DWR_ST0001_01_s_2017_78				
Comment Code					
FE : Fence					
Inspector Comment					
There is a wire fence at the landside levee toe.

Chain fence at landside levee toe. Spring 2017.

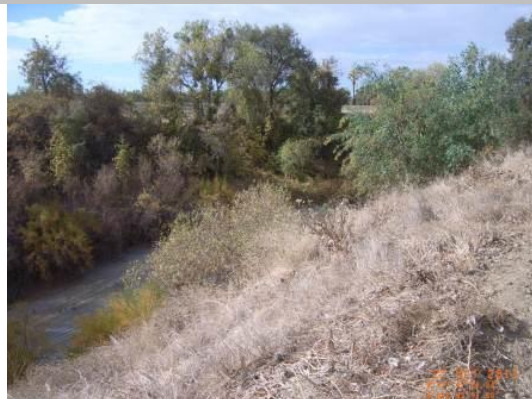
Photo 3 of 3 : FA_2020_ST0001_259_30_20200813_00023.jpg

USACE 2013 Photo #1

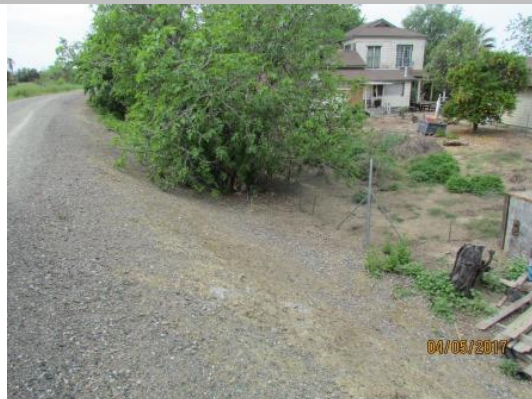
Photo 1 of 1 : FA_2020_ST0001_259_77_20200813_00045.jpg

LM Start	2.62	Rating **	M	Issue No.	77
LM End	2.64	Issue Type +	En	Location *	LS
Category	Earthen Levee			GPS Latitude/Longitude	
				Start	End
Item	Encroachments			38.732795 °	38.732897 °
				-121.797050 °	-121.796547 °
DWR ID	DWR_ST0001_01_s_2017_77				
Comment Code					
FE : Fence					
Inspector Comment					
There is a wire fence at the landside toe.

Chain fence at landside levee toe. Spring 2017.

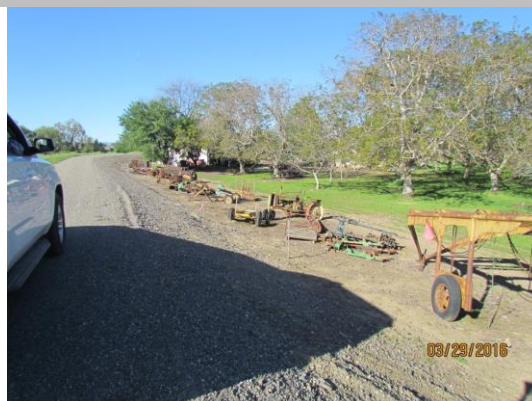
Photo 1 of 1 : FA_2020_ST0001_259_71_20200813_00043.jpg

LM Start	2.67	Rating **	M	Issue No.	71
LM End	2.74	Issue Type +	En	Location *	LS
Category	Earthen Levee			GPS Latitude/Longitude	
				Start	End
Item	Encroachments			38.733075 °	38.733594 °
				-121.796039 °	-121.795131 °
DWR ID	DWR_ST0001_01_s_2016_71				
Comment Code					
EQ : Equipment					
Inspector Comment

View of the equipment on the landward side of the levee looking upstream. Spring 2016.

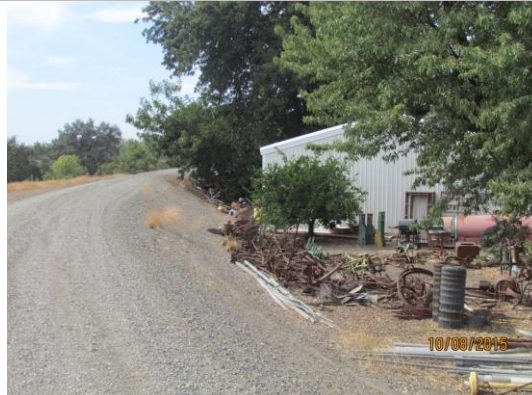
Photo 1 of 2 : FA_2020_ST0001_259_20_20200813_00017.jpg

LM Start	2.69	Rating **	M	Issue No.	20
LM End	2.69	Issue Type +	En	Location *	LS
Category	Earthen Levee			GPS Latitude/Longitude	
				Start	End
Item	Encroachments			38.733145 °	38.733145 °
				-121.795845 °	-121.795845 °
DWR ID	DWR_ST0001_01_s_2012_20				
Comment Code					
BU : Building					
Inspector Comment

View of the building on the landward side of the levee looking upstream. Fall 2015.

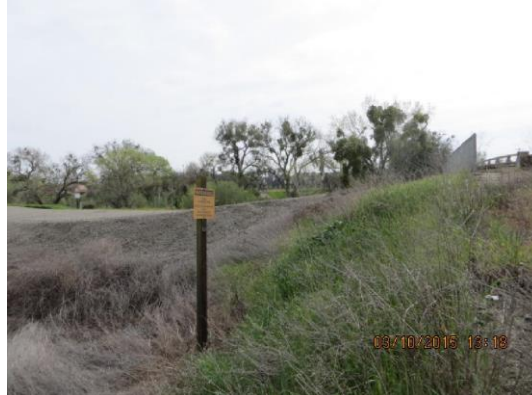
Photo 2 of 2 : UCIP_FA_2020_49111_73500.jpg

Sign on LS toe.

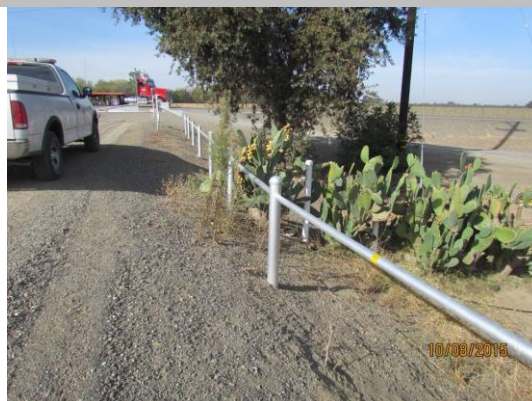
Photo 1 of 1 : FA_2020_ST0001_259_57_20200813_00035.jpg

LM Start	7.25	Rating **	M	Issue No.	57
LM End	7.25	Issue Type +	En	Location *	LS
Category	Earthen Levee			GPS Latitude/Longitude	
				Start	End
Item	Vegetation			38.727705 °	38.727705 °
				-121.729462 °	-121.729462 °
DWR ID	DWR_ST0001_01_f_2015_57				
Comment Code					
V6 : Landscaping					
Inspector Comment					
There is cactus on the landside slope.

View of the cactus on the landward side of the levee looking upstream.
Fall 2015.

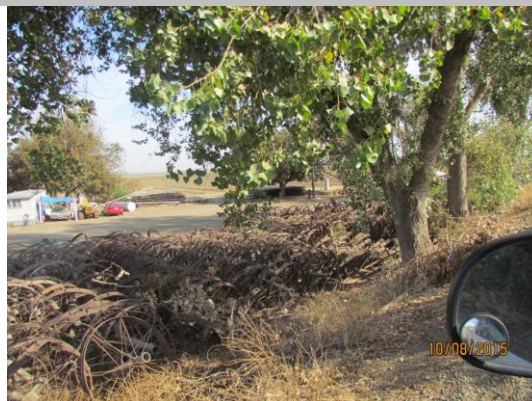
Photo 2 of 2 : FA_2020_ST0001_259_40_20200813_00031.jpg

View of the equipment at the levee toe on the landward side looking downstream. Fall 2015.

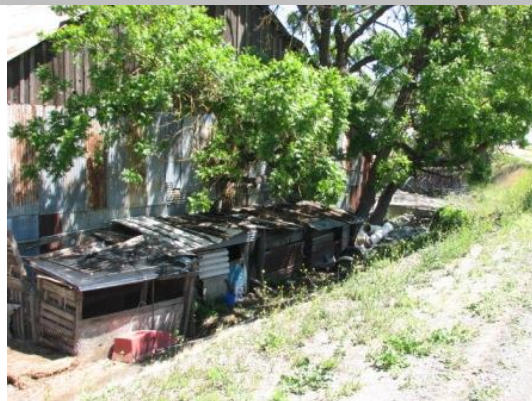
Photo 1 of 1 : FA_2020_ST0001_259_39_20200813_00029.jpg

LM Start	7.30	Rating **	M	Issue No.	39
LM End	7.30	Issue Type +	En	Location *	LS
Category	Earthen Levee			GPS Latitude/Longitude	
				Start	End
Item	Encroachments			38.727870 °	38.727870 °
				-121.728527 °	-121.728527 °
DWR ID	DWR_ST0001_01_s_2012_39				
Comment Code					
BU : Building					
Inspector Comment					
The barn and livestock pens are within the easement of the levee.

View of barn and livestock pens.

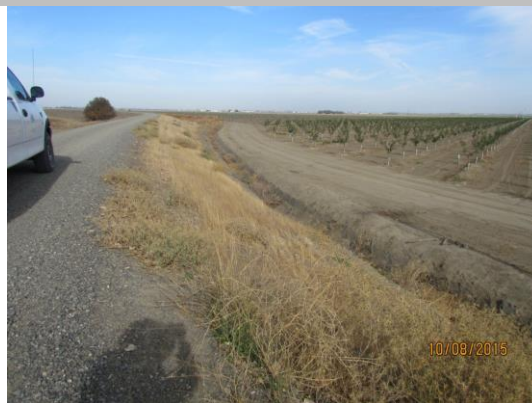
Photo 1 of 1 : FA_2020_ST0001_259_26_20200813_00019.jpg

LM Start	7.36	Rating **	M	Issue No.	26
LM End	7.78	Issue Type +	En	Location *	LS
Category	Earthen Levee			GPS Latitude/Longitude	
				Start	End
Item	Encroachments			38.728188 °	38.728194 °
				-121.727442 °	-121.720255 °
DWR ID	DWR_ST0001_01_s _ 2015_26				
Comment Code					
DT : Ditch					
Inspector Comment					
A ditch is located at the levee toe.

View of the ditch on the landward side of the levee looking upstream.
Fall 2015.

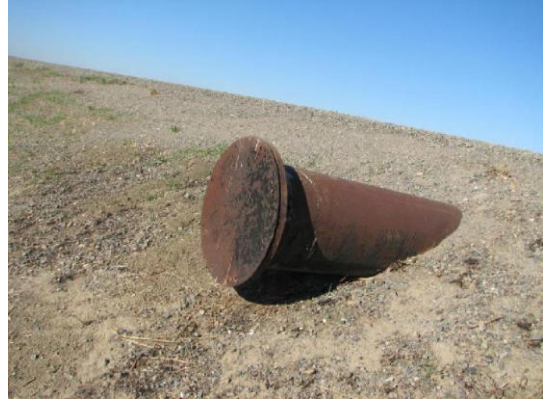
Photo 2 of 3 : UCIP_FA_2020_53214_60223.jpg

Waterside view: closer look at capped pipe.

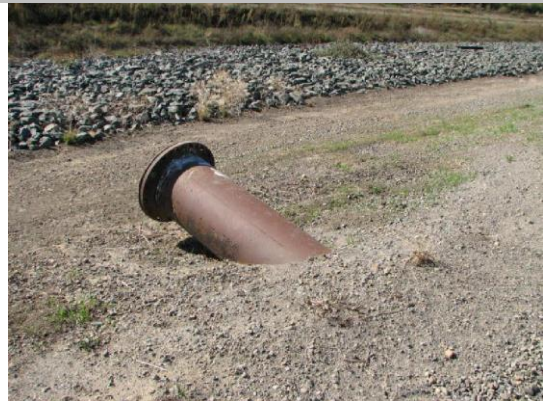
Photo 3 of 3 : UCIP_FA_2020_53214_60222.jpg

Waterside view: steel pipe on the slope of the levee

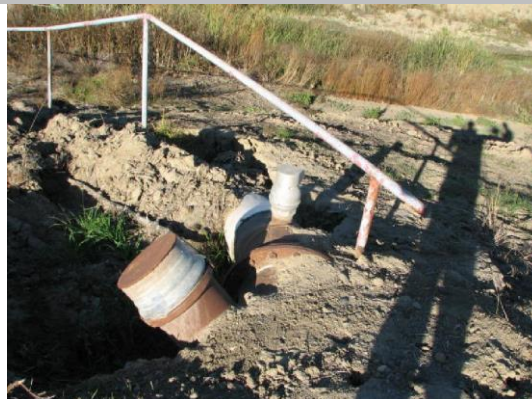
Photo 2 of 3 : UCIP_FA_2020_53215_60147.jpg

Comment Code						
Inspector Comment						
DS_ID:17119 FS_ID:53215 EP_NO: N/A Repair Type: Non-Urgent EVAL Issue: Crossing Status: Found UCIP Comments: 11/3/2016: Per Ted Skidgel, new cap and gasket installed by farmer on LS vent, and siphon breaker/vent installed on WS. No permit was found for this work. Siphon breaker on WS needs cover. Repair Priority changed from No Action Needed to Non-Urgent. (K. Fazel - UCIP)08/16/2016: Repaired erosion L/S 8/16 pipe repaired by farmer prior to erosion. (T. Skidgel - ST0001). (Note: crossing was downgraded from Urgent to No Action Needed)06/28/2016: Erosion still present off LS shoulder, caused by leaking vent. Erosion to be repaired and backfilled this summer by Sac Yard. Pipe leaking at LS toe into ditch (not affecting levee prism) (K. Fazel - UCIP).2013-2016: Pipe leaks, severe erosion from levee shoulder to pipe daylight on landside levee slope, summer of 2013 repaired erosion,pipe needs repaired. (P. Amatya - DWR) FIELD_STRUCT_DESC: 18-inch, 0.25-inch-thick soil-proofed steel irrigation pipe, 2 feet below the crown. Capped vent on the apex of the pipe off the landside (LS) shoulder. Booster pump located off the LS toe at the LS toe ditch. Another groundwater pump is located a further distance off the LS toe. Pumped groundwater is conveyed to the toe ditch and a booster pump pumps water through the levee and into a waterside (WS) ditch in the Cache Creek Settling Basin. Distribution box off the WS toe at the WS toe ditch. Could not locate a positive closure device. [Additional Reference(s): USACE As-Constructed Drawing North Station 49+50]. FS Date: 11/16/2018 8:35:41 AM

Landside view: pipe daylight on LS levee slope

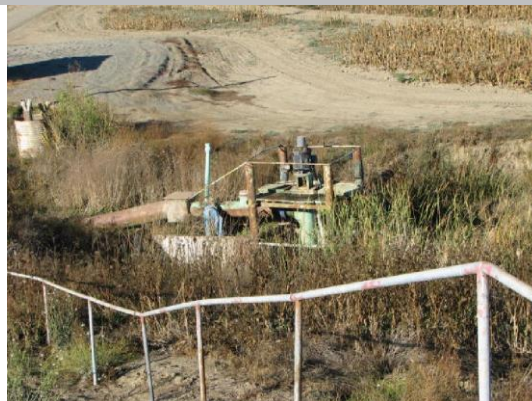
Photo 3 of 3 : UCIP_FA_2020_53215_60149.jpg

Landside view: pumping plant

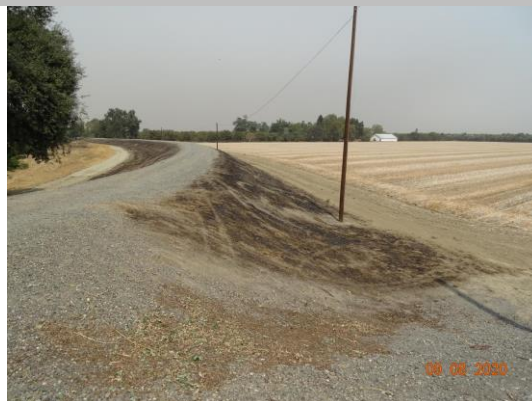
Photo 1 of 1 : FA_2020_ST0001_260_1_20200909_00019.jpg

LM Start	0.00	Rating **	A	Issue No.	1
LM End	0.00	Issue Type +	Ma	Location *	LS
Category	Earthen Levee			GPS Latitude/Longitude	
				Start	End
Item	Vegetation			38.727051 °	38.727051 °
				-121.806299 °	-121.806299 °
DWR ID	DWR_ST0001_02_f_2020_1				
Comment Code					
V1 : Control annual grass and weeds on the levee slopes and easements.					
Inspector Comment					
The LMA maintains the vegetation at a high level.

View of maintained landside slope. Fall 2020.

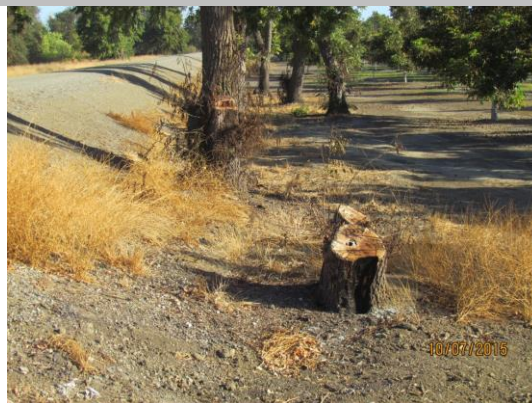
Photo 1 of 1 : FA_2020_ST0001_260_10_20200813_00008.jpg

LM Start	0.18	Rating **	N	Issue No.	10
LM End	0.18	Issue Type +	Ma	Location *	LS
Category	Earthen Levee			GPS Latitude/Longitude	
				Start	End
Item	Trim / Thin Trees			38.729560 °	38.729560 °
				-121.805231 °	-121.805231 °
DWR ID	DWR_ST0001_02_f_2015_10				
Comment Code					
T5 : Tree stumps.					
Inspector Comment					
The stump is located at the levee toe.

View of the tree stump at the landward side of the levee looking downstream. Fall 2015.

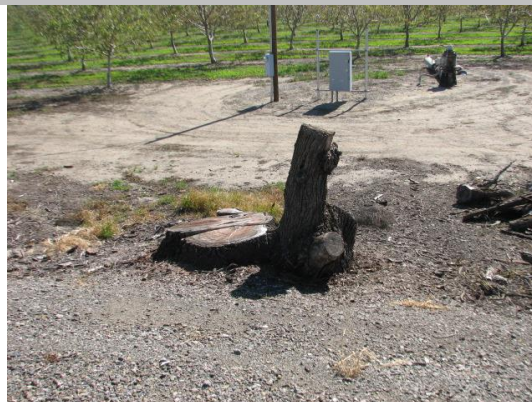
Photo 1 of 1 : FA_2020_ST0001_260_6_20200813_00005.jpg

LM Start	0.27	Rating **	N	Issue No.	6
LM End	0.27	Issue Type +	Ma	Location *	LS
Category	Earthen Levee			GPS Latitude/Longitude	
				Start	End
Item	Trim / Thin Trees			38.730723 °	38.730723 °
				-121.804972 °	-121.804972 °
DWR ID	DWR_ST0001_02_s_2014_6				
Comment Code					
T5 : Tree stumps.					
Inspector Comment					
A large black walnut tree stump is at the toe of the levee.

View of large black walnut tree stump is at the landside toe. Spring 2014

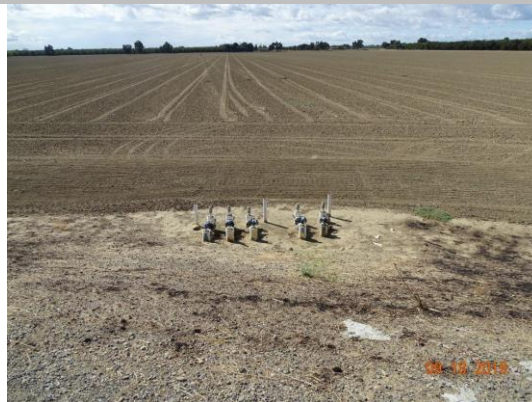
Photo 1 of 1 : FA_2020_ST0001_260_24_20200813_00014.jpg

LM Start	1.97	Rating **	M	Issue No.	24
LM End	1.97	Issue Type +	En	Location *	LS
Category	Earthen Levee			GPS Latitude/Longitude	
				Start	End
Item	Encroachments			38.727653 °	38.727653 °
				-121.782412 °	-121.782412 °
DWR ID	DWR_ST0001_02_f_2019_24				
Comment Code					
EQ : Equipment					
Inspector Comment					
There are small pumps with 10 air valves, and 3 bollards located at the landside toe. The pipes do not appear to cross levee. Need to find permit.

View of the pumps, air valves, and bollards at the landside toe. Fall 2019.

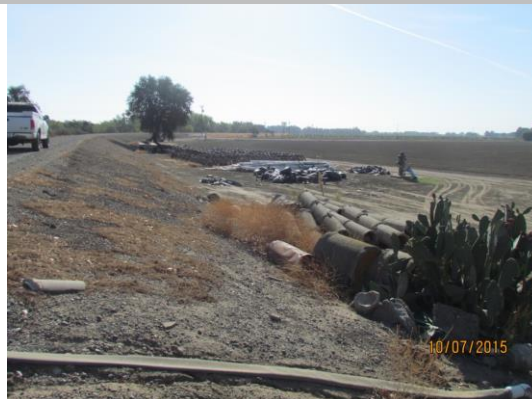
Photo 2 of 2 : FA_2020_ST0001_260_3_20200813_00003.jpg

LM Start	2.41	Rating **	M	Issue No.	3
LM End	2.41	Issue Type +	En	Location *	LS
Category	Earthen Levee			GPS Latitude/Longitude	
				Start	End
Item	Encroachments			38.726141 °	38.726141 °
				-121.774774 °	-121.774774 °
DWR ID	DWR_ST0001_02_s_2018_3				
Comment Code					
DE : Debris					
Inspector Comment					
Irrigation lines and broken concrete pipes are on the landside of the levee.

View of the concrete pile at the toe of the landward side of the levee looking downstream. Fall 2015.

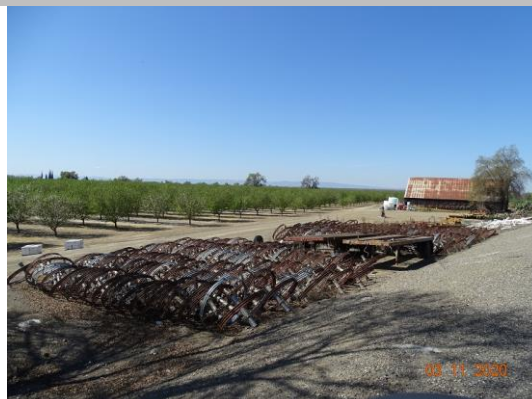
Photo 1 of 1 : FA_2020_ST0001_260_29_20200813_00016.jpg

LM Start	2.43	Rating **	M	Issue No.	29
LM End	2.47	Issue Type +	En	Location *	LS
Category	Earthen Levee			GPS Latitude/Longitude	
				Start	End
Item	Encroachments			38.726036 °	38.725836 °
				-121.774340 °	-121.773688 °
DWR ID	DWR_ST0001_02_f_ 2017_29				
Comment Code					
EQ : Equipment					
Inspector Comment					
There is farm equipment at the landside toe.

View of farm equipment at the landside toe. Spring 2020.

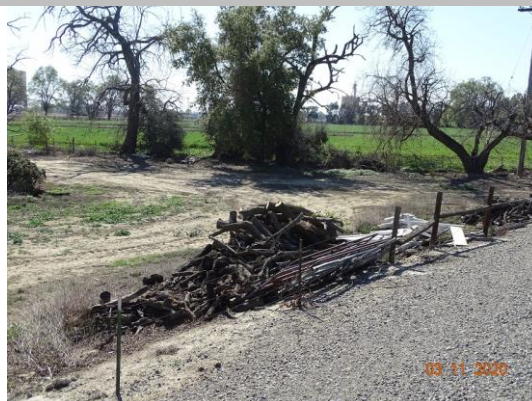
Photo 1 of 1 : FA_2020_ST0001_260_17_20200813_00012.jpg

LM Start	3.39	Rating **	M	Issue No.	17
LM End	3.39	Issue Type +	En	Location *	LS
Category	Earthen Levee			GPS Latitude/Longitude	
				Start	End
Item	Encroachments			38.720204 °	38.720204 °
				-121.759760 °	-121.759760 °
DWR ID	DWR_ST0001_02_f_2016_17				
Comment Code					
FW : Firewood					
Inspector Comment					
There is a firewood pile behind the wire fence.

View of firewood pile. Spring 2020.

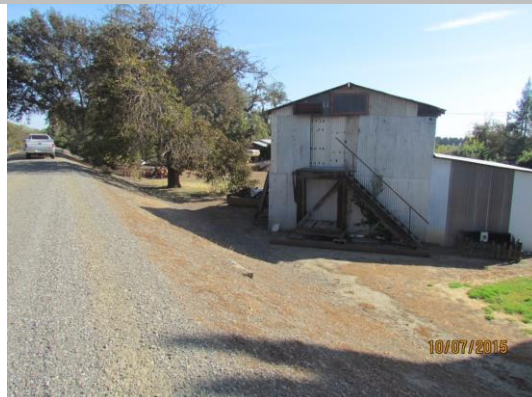
Photo 1 of 1 : FA_2020_ST0001_260_8_20200813_00006.jpg

LM Start	4.06	Rating **	M	Issue No.	8
LM End	4.06	Issue Type +	En	Location *	LS
Category	Earthen Levee			GPS Latitude/Longitude	
				Start	End
Item	Encroachments			38.723992 °	38.723992 °
				-121.752511 °	-121.752511 °
DWR ID	DWR_ST0001_02_s_2012_8				
Comment Code					
BU : Building					
Inspector Comment					
A building is within the easement of the levee.

View of the building on the landward side of the levee looking downstream. Fall 2015.

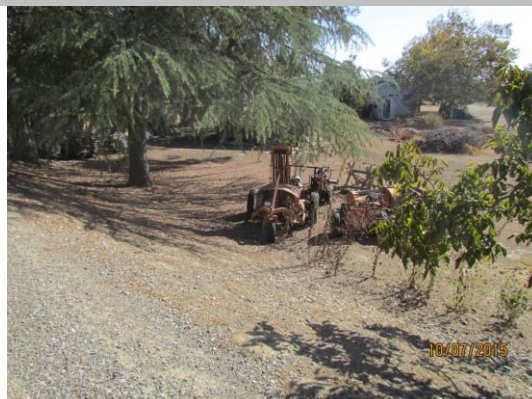
Photo 1 of 1 : FA_2020_ST0001_260_26_20200813_00015.jpg

LM Start	4.08	Rating **	M	Issue No.	26
LM End	4.08	Issue Type +	En	Location *	LS
Category	Earthen Levee			GPS Latitude/Longitude	
				Start	End
Item	Encroachments			38.724219 °	38.724219 °
				-121.752252 °	-121.752252 °
DWR ID	DWR_ST0001_02_f_2013_26				
Comment Code					
EQ : Equipment					
Inspector Comment

View of the equipment at the toe of the landward side of the levee. Fall 2015.

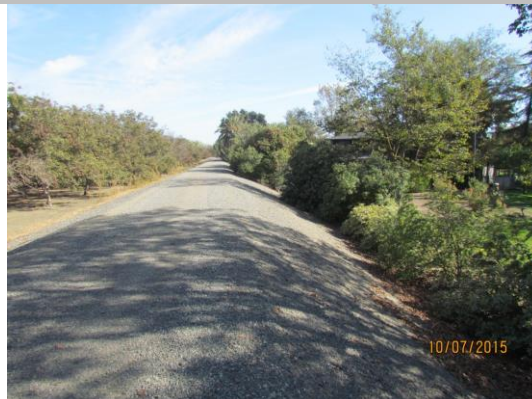
Photo 1 of 1 : FA_2020_ST0001_260_9_20200813_00007.jpg

LM Start	4.09	Rating **	M	Issue No.	9
LM End	4.18	Issue Type +	En	Location *	LS
Category	Earthen Levee			GPS Latitude/Longitude	
				Start	End
Item	Vegetation			38.724317 °	38.725242 °
				-121.752148 °	-121.751075 °
DWR ID	DWR_ST0001_02_s_2012_9				
Comment Code					
V6 : Landscaping					
Inspector Comment

View of the landscaping vegetation on the landward side of the levee looking downstream. Fall 2015.

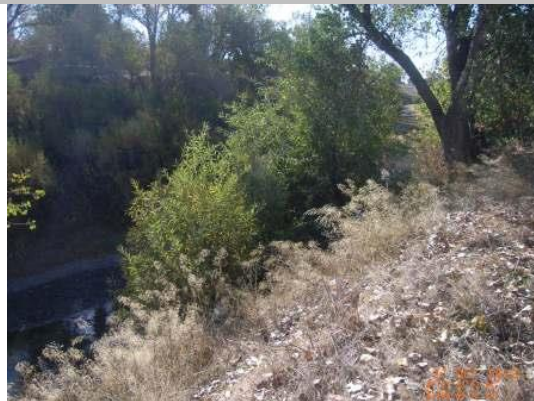
Photo 1 of 1 : FA_2020_ST0001_260_11_20200813_00009.jpg

LM Start	5.33	Rating **	A/W	Issue No.	11
LM End	5.37	Issue Type +	Ma	Location *	WS
Category	Supplemental			GPS Latitude/Longitude	
				Start	End
Item	2017 USACE Erosion Survey			38.722933 °	38.723467 °
				-121.760561 °	-121.760436 °
DWR ID	DWR_ST0001_02_f_2018_11				
Comment Code					
Inspector Comment					
2017 Site ID: CHC 5.4 L					
Status: Eroding					
2017 Field Notes: Site continues to erode due to recent high storm events.					
Site History: 2009 - Erosion into the levee slope. 2010 - Minor new erosion. 2011 - New erosion and a freshly fallen tree. 2012 - New animal holes and slightly steeper slopes. 2013 - New tree popout and 2 feet of erosion along the top bank.

USACE 2013 Photo #1

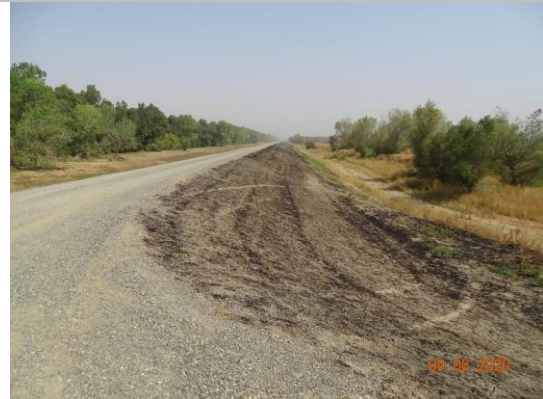
Photo 1 of 1 : FA_2020_ST0001_261_2_20200909_00003.jpg

LM Start	2.25	Rating **	A	Issue No.	2
LM End	2.25	Issue Type +	Ma	Location *	LS
Category	Earthen Levee			GPS Latitude/Longitude	
				Start	End
Item	Vegetation			38.695584 °	38.695584 °
				-121.715874 °	-121.715874 °
DWR ID	DWR_ST0001_04_f_2020_2				
Comment Code					
V1 : Control annual grass and weeds on the levee slopes and easements.					
Inspector Comment					
The LMA maintains the vegetation at a high level.

View of the maintained landside slope. Fall 2020.
