Flood Control Project Maintenance Levee Inspections

Fall 2021 Levee Maintenance Deficiency Summary Report

Sacramento River Basin

Sacramento Maintenance Yard Cache Creek

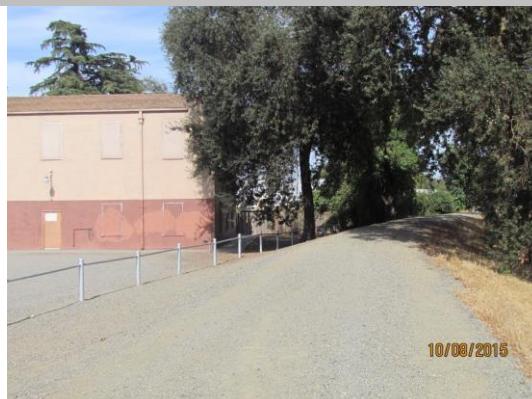
Photo 1 of 1 : FA_2021_ST0001_259_12_20210907_00007.jpg

LM Start	2.12	Rating **	M	Issue No.	12
LM End	2.12	Issue Type +	En	Location *	LS
Category	Earthen Levee			GPS Latitude/Longitude	
				Start	End
Item	Encroachments			38.733000 °	38.733000 °
				-121.805409 °	-121.805409 °
DWR ID	DWR_ST0001_01_f_2019_12				
Comment Code					
BU : Building					
Inspector Comment

View of the building on the landward side of the levee looking downstream. Fall 2015.

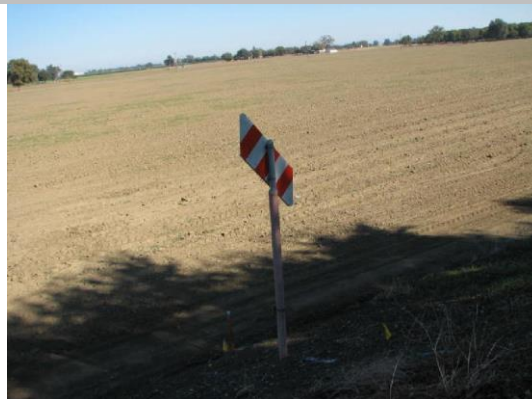
Photo 2 of 3 : UCIP_FA_2021_49099_60163.jpg

Comment Code					
Inspector Comment					
DS_ID:16268					
FS_ID:49099					
EP_NO: 2415					
Repair Type: Non-Urgent					
EVAL Issue:					
Crossing Status: Indicator Found					
UCIP Comments: May need to install gasoline marker on WS slope.					
FIELD_STRUCT_DESC: 20-inch wrapped steel natural gas pipeline through the levee, 4 feet below the crown. Two cutoff walls. Gas line indicator found on the landside (LS) of the levee. (20-inch wrapped steel natural gas pipeline authorized under Permit No. 2415, 1956 - Pacific Gas and Electric Company [PG&E]). [Additional Reference(s): DWR Levee Log, 1993. USACE Sacramento O&M Manual 126, November 1961, (HLM 2.24)].					
FS Date: 6/16/2016 7:00:04 AM

LM Start	2.26	Rating **	M	Issue No.	80 (cont)
LM End	2.26	Issue Type +	En	Location *	
Category	Supplemental		GPS Latitude/Longitude		
			Start	End	
Item	DWR UCIP Field Study		38.733675 °	38.733675 °	
			-121.803009 °	-121.803009 °	
DWR ID	16268

Landside view: gasline indicator

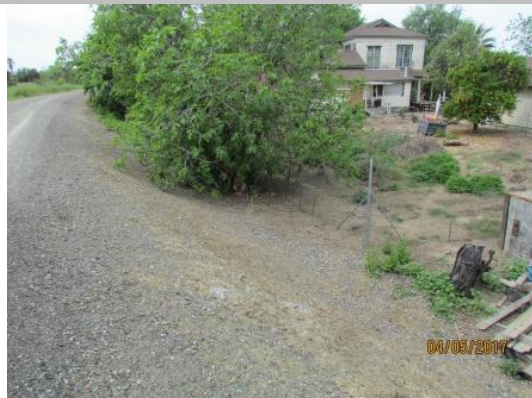
Photo 1 of 1 : FA_2021_ST0001_259_77_20210907_00033.jpg

LM Start	2.62	Rating **	M	Issue No.	77
LM End	2.64	Issue Type +	En	Location *	LS
Category	Earthen Levee			GPS Latitude/Longitude	
				Start	End
Item	Encroachments			38.732795 °	38.732897 °
				-121.797050 °	-121.796547 °
DWR ID	DWR_ST0001_01_s_2017_77				
Comment Code					
FE : Fence					
Inspector Comment					
There is a wire fence at the landside toe.

Chain fence at landside levee toe. Spring 2017.

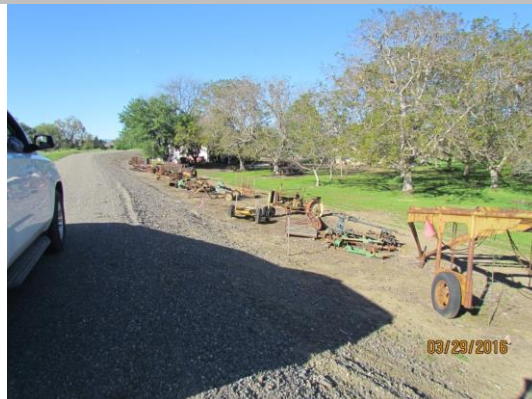
Photo 1 of 1 : FA_2021_ST0001_259_71_20210907_00031.jpg

LM Start	2.67	Rating **	M	Issue No.	71
LM End	2.74	Issue Type +	En	Location *	LS
Category	Earthen Levee			GPS Latitude/Longitude	
				Start	End
Item	Encroachments			38.733075 °	38.733594 °
				-121.796039 °	-121.795131 °
DWR ID	DWR_ST0001_01_s_ 2016_71				
Comment Code					
EQ : Equipment					
Inspector Comment

View of the equipment on the landward side of the levee looking upstream. Spring 2016.

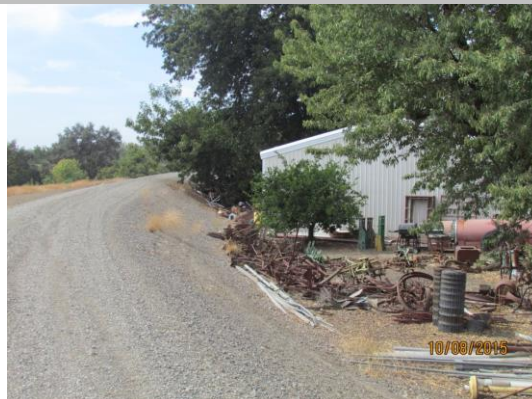
Photo 1 of 1 : FA_2021_ST0001_259_20_20210907_00012.jpg

LM Start	2.69	Rating **	M	Issue No.	20
LM End	2.69	Issue Type +	En	Location *	LS
Category	Earthen Levee			GPS Latitude/Longitude	
				Start	End
Item	Encroachments			38.733145 °	38.733145 °
				-121.795845 °	-121.795845 °
DWR ID	DWR_ST0001_01_s _ 2012_20				
Comment Code					
BU : Building					
Inspector Comment

View of the building on the landward side of the levee looking upstream. Fall 2015.

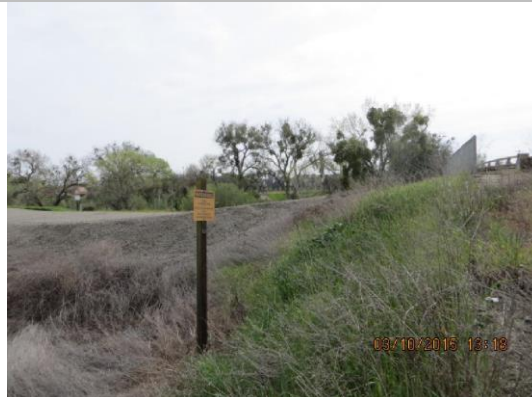
Photo 2 of 2 : UCIP_FA_2021_49111_73500.jpg

LM Start	4.98	Rating **	M	Issue No.	81 (cont)
LM End	4.98	Issue Type +	En	Location *	
Category	Supplemental		GPS Latitude/Longitude		
			Start	End	
Item	DWR UCIP Field Study		38.721038 °	38.721038 °	
			-121.764180 °	-121.764180 °	
DWR ID	16265

Sign on LS toe.

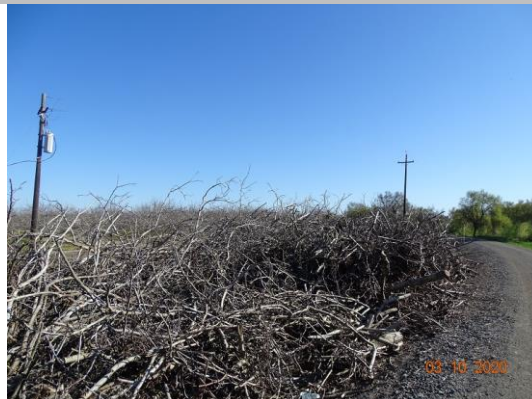
Photo 1 of 1 : FA_2021_ST0001_259_61_20210907_00027.jpg

LM Start	5.72	Rating **	U	Issue No.	61
LM End	5.75	Issue Type +	En	Location *	LS
Category	Earthen Levee			GPS Latitude/Longitude	
				Start	End
Item	Encroachments			38.723678 °	38.723762 °
				-121.755039 °	-121.754542 °
DWR ID	DWR_ST0001_01_s_ 2019_61				
Comment Code					
TR : Tree or limb					
Inspector Comment					
Remove downed trees on the landside slope.

View of downed trees on the landside slope. Spring 2020.

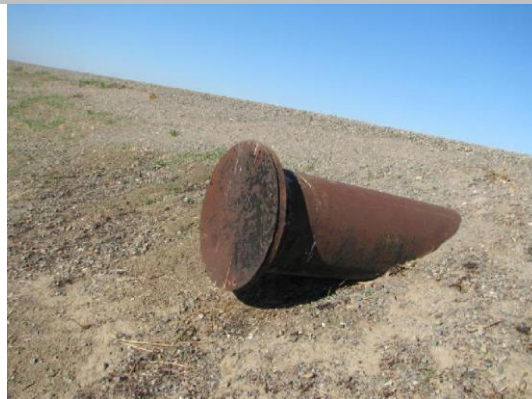
Photo 2 of 3 : UCIP_FA_2021_53214_60223.jpg

LM Start	10.40	Rating **	M	Issue No.	84 (cont)
LM End	10.40	Issue Type +	En	Location *	
Category	Supplemental		GPS Latitude/Longitude		
			Start	End	
Item	DWR UCIP Field Study		38.705051 °	38.705051 °	
			-121.695577 °	-121.695577 °	
DWR ID	17115

Waterside view: closer look at capped pipe.

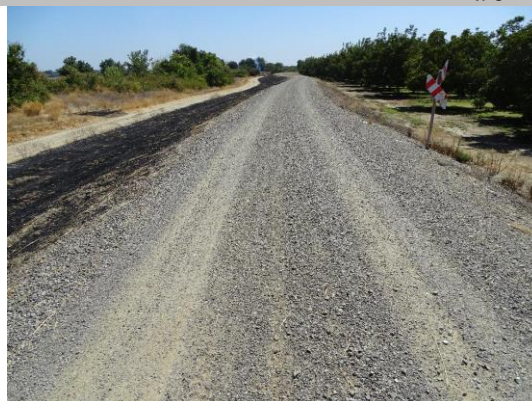
Photo 1 of 3 : UCIP_FA_2021_60013_87297.jpg

LM Start	0.45	Rating **	M	Issue No.	39 (cont)
LM End	0.45	Issue Type +	En	Location *

Overview of Levee Crown looking downstream

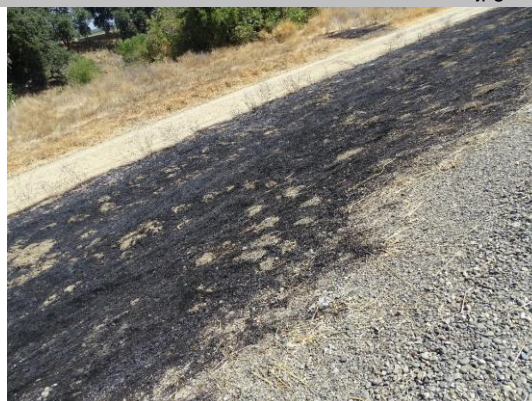
Photo 2 of 3 : UCIP_FA_2021_60013_87298.jpg

Levee Slope - waterside

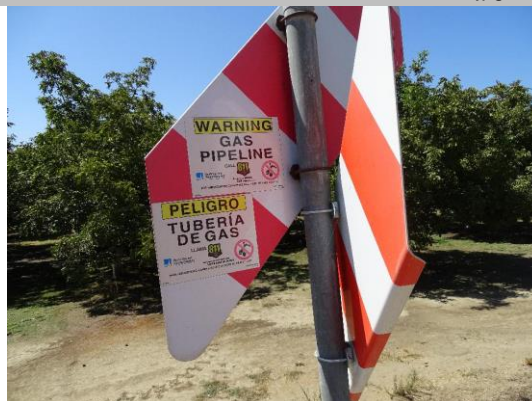
Photo 3 of 3 : UCIP_FA_2021_60013_87299.jpg

LM Start	0.45	Rating **	M	Issue No.	39 (cont)
LM End	0.45	Issue Type +	En	Location *	
Category	Supplemental			GPS Latitude/Longitude	
				Start	End
Item	DWR UCIP Field Study			38.732723 °	38.732723 °
				-121.803134 °	-121.803134 °
DWR ID	16283

Gasline marker at landside slope

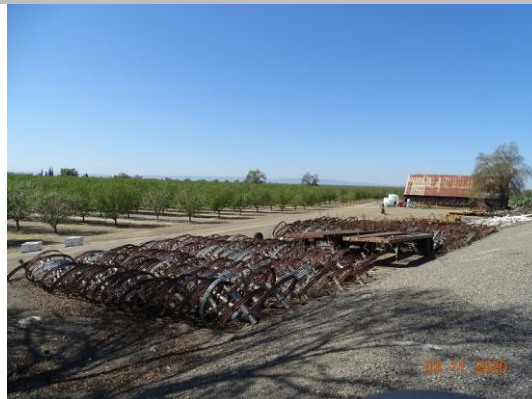
Photo 1 of 1 : FA_2021_ST0001_260_29_20210907_00015.jpg

LM Start	2.43	Rating **	M	Issue No.	29
LM End	2.47	Issue Type +	En	Location *	LS
Category	Earthen Levee			GPS Latitude/Longitude	
				Start	End
Item	Encroachments			38.726036 °	38.725836 °
				-121.774340 °	-121.773688 °
DWR ID	DWR_ST0001_02_f_2017_29				
Comment Code					
EQ : Equipment					
Inspector Comment					
There is farm equipment at the landside toe.

View of farm equipment at the landside toe. Spring 2020.

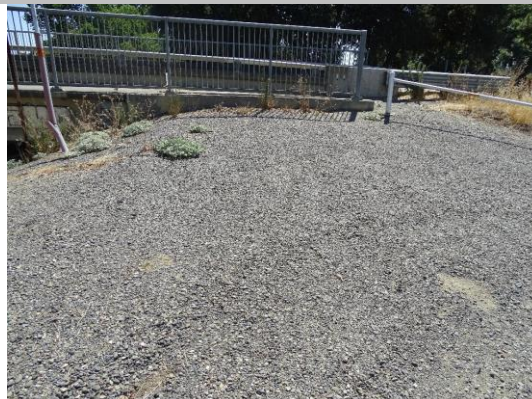
Photo 1 of 3 : UCIP_FA_2021_60019_87302.jpg

LM Start	3.11	Rating **	M	Issue No.	40 (cont)
LM End	3.11	Issue Type +	En	Location *

Overview of Levee Crown looking downstream.

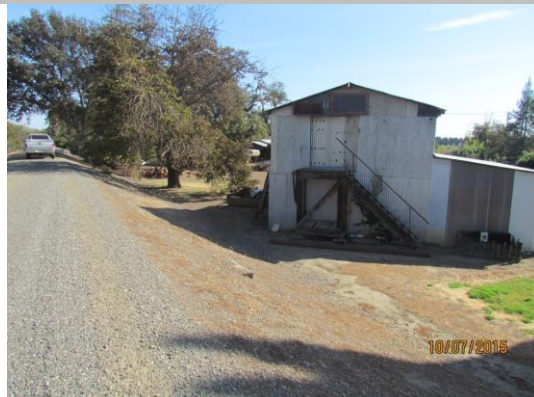
Photo 1 of 1 : FA_2021_ST0001_260_8_20210907_00006.jpg

LM Start	4.06	Rating **	M	Issue No.	8
LM End	4.06	Issue Type +	En	Location *	LS
Category	Earthen Levee			GPS Latitude/Longitude	
				Start	End
Item	Encroachments			38.723992 °	38.723992 °
				-121.752511 °	-121.752511 °
DWR ID	DWR_ST0001_02_s_2012_8				
Comment Code					
BU : Building					
Inspector Comment					
A building is within the easement of the levee.

View of the building on the landward side of the levee looking downstream. Fall 2015.

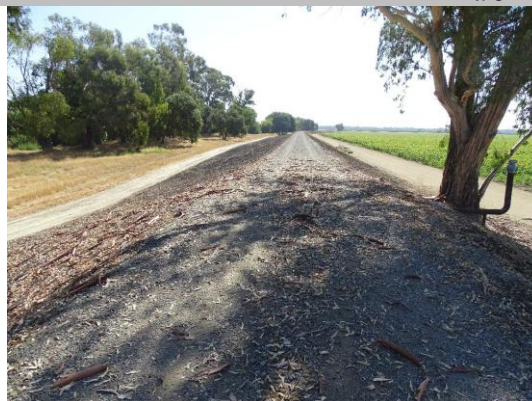
Photo 1 of 3 : UCIP_FA_2021_60096_87380.jpg

LM Start	4.89	Rating **	M	Issue No.	41 (cont)
LM End	4.89	Issue Type +	En	Location *

overview of levee crown looking downstream

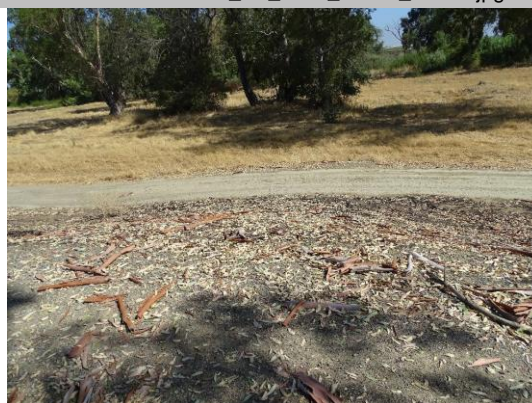
Photo 2 of 3 : UCIP_FA_2021_60096_87381.jpg

levee slope at waterside

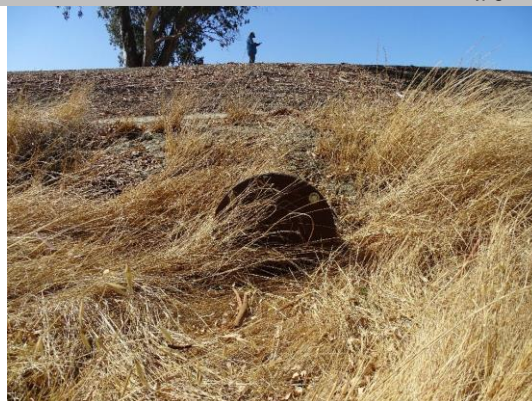
Photo 3 of 3 : UCIP_FA_2021_60096_87382.jpg

LM Start	4.89	Rating **	M	Issue No.	41 (cont)	
LM End	4.89	Issue Type +	En	Location *		
Category	Supplemental			GPS Latitude/Longitude		
				Start		End
Item	DWR UCIP Field Study			38.726833 °	38.726833 °	
				-121.738804 °	-121.738804 °	
DWR ID	16768

levee slope at waterside

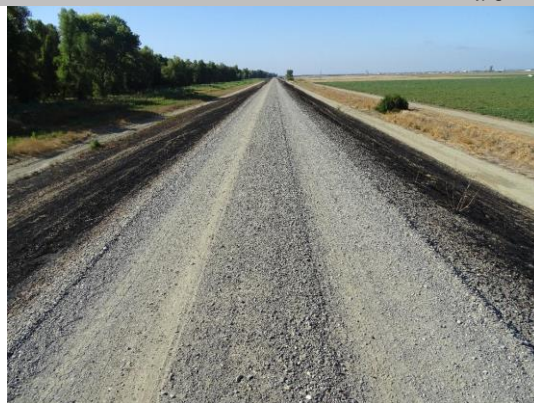
Photo 1 of 3 : UCIP_FA_2021_60171_87463.jpg

overview of levee crown looking downstream

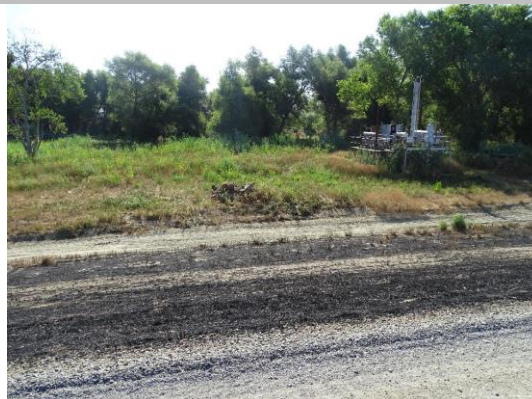
Photo 2 of 3 : UCIP_FA_2021_60171_87464.jpg

LM Start	6.58	Rating **	M	Issue No.	42 (cont)
LM End	6.58	Issue Type +	En	Location *	
Category	Supplemental			GPS Latitude/Longitude	
				Start	End
Item	DWR UCIP Field Study			38.718522 °	38.718522 °
				-121.717335 °	-121.717335 °
DWR ID	25094

waterside view

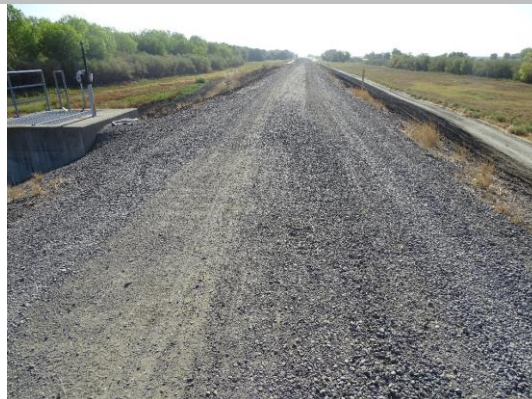
Photo 1 of 3 : UCIP_FA_2021_60172_87468.jpg

LM Start	9.49	Rating **	M	Issue No.	43 (cont)
LM End	9.49	Issue Type +	En	Location *

overview of levee crown looking downstream

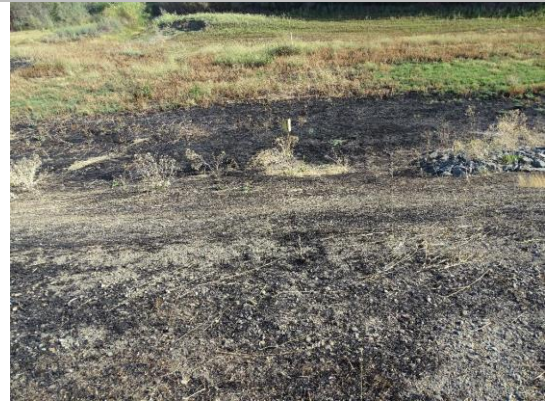
Photo 2 of 3 : UCIP_FA_2021_60175_87481.jpg

LM Start	9.51	Rating **	M	Issue No.	44 (cont)
LM End	9.51	Issue Type +	En	Location *	
Category	Supplemental			GPS Latitude/Longitude	
				Start	End
Item	DWR UCIP Field Study			38.678210 °	38.678210 °
				-121.709318 °	-121.709318 °
DWR ID	17107

waterside slope
