**Flood Control Project Maintenance
Levee Inspections**

Fall 2022 Levee Maintenance Deficiency Summary Report

Sacramento River Basin

Sacramento Maintenance Yard Cache Creek

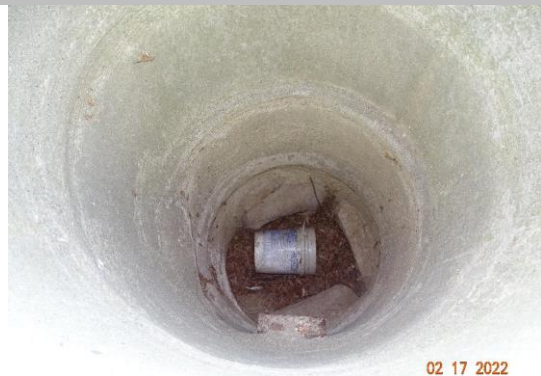
Photo 3 of 3 : UCIP_FA_2022_72495_108480.jpg

Water-Side: Concrete pipes inside concrete standpipe

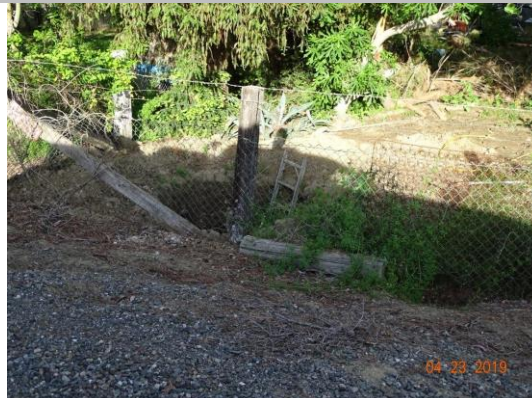
Photo 1 of 1 : FA_2022_ST0001_259_35_20220921_00020.jpg

LM Start	1.98	Rating **	U	Issue No.	35
LM End	1.98	Issue Type +	En	Location *	LS
Category	Earthen Levee			GPS Latitude/Longitude	
				Start	End
Item	Encroachments			38.731208 °	38.731208 °
				-121.806220 °	-121.806220 °
DWR ID	DWR_ST0001_01_s_2020_35				
Comment Code					
DT : Ditch					
Inspector Comment					
The landowner has dug a 5' diameter hole within 10' of the landside toe and it appears to cut into the levee prism.

View of the hole within the landside easement. Spring 2019.

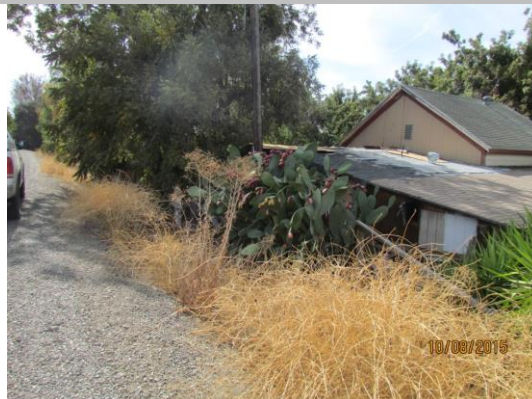
Photo 1 of 1 : FA_2022_ST0001_259_8_20220921_00004.jpg

LM Start	2.01	Rating **	M	Issue No.	8
LM End	2.01	Issue Type +	En	Location *	LS
Category	Earthen Levee			GPS Latitude/Longitude	
				Start	End
Item	Encroachments			38.731507 °	38.731507 °
				-121.806122 °	-121.806122 °
DWR ID	DWR_ST0001_01_s_ 2012_8				
Comment Code					
BU : Building					
Inspector Comment

View of the building on the landward side of the levee looking upstream.
Fall 2015.

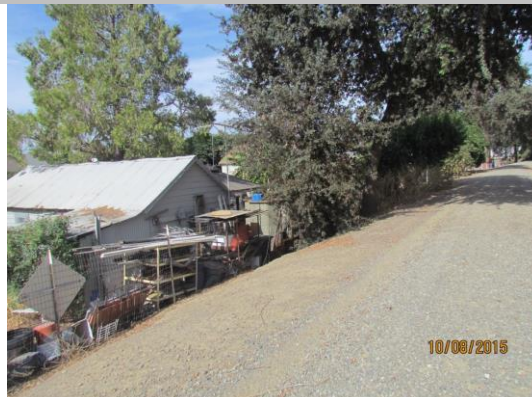
Photo 1 of 1 : FA_2022_ST0001_259_11_20220921_00006.jpg

LM Start	2.06	Rating **	M	Issue No.	11
LM End	2.06	Issue Type +	En	Location *	LS
Category	Earthen Levee			GPS Latitude/Longitude	
				Start	End
Item	Encroachments			38.732268 °	38.732268 °
				-121.805832 °	-121.805832 °
DWR ID	DWR_ST0001_01_s_2012_11				
Comment Code					
BU : Building					
Inspector Comment

View of the building on the landward side of the levee looking downstream. Fall 2015.

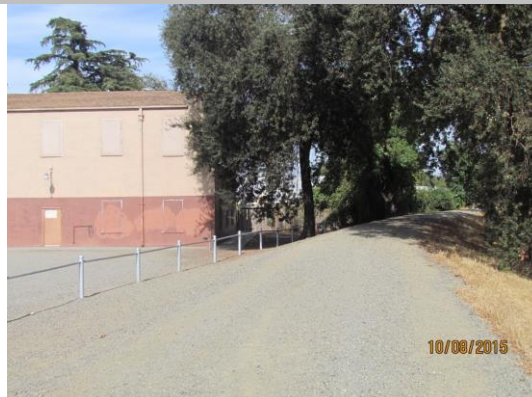
Photo 1 of 1 : FA_2022_ST0001_259_12_20220921_00007.jpg

LM Start	2.12	Rating **	M	Issue No.	12
LM End	2.12	Issue Type +	En	Location *	LS
Category	Earthen Levee			GPS Latitude/Longitude	
				Start	End
Item	Encroachments			38.733000 °	38.733000 °
				-121.805409 °	-121.805409 °
DWR ID	DWR_ST0001_01_f_2019_12				
Comment Code					
BU : Building					
Inspector Comment

View of the building on the landward side of the levee looking downstream. Fall 2015.

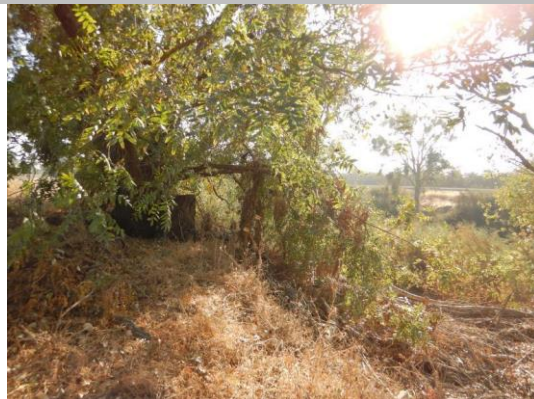
Photo 2 of 2 : FA_2022_ST0001_260_11_20220921_00007.jpg

LM Start	3.53	Rating **	A/W	Issue No.	11 (cont)
LM End	3.60	Issue Type +	Ma	Location *	WS
Category	Supplemental			GPS Latitude/Longitude	
				Start	End
Item	2018 USACE Erosion Survey			38.722138 °	38.723294 °
				-121.759736 °	-121.759588 °
DWR ID	DWR_ST0001_02_s_2022_11

USACE 2018 Erosion Photo #2

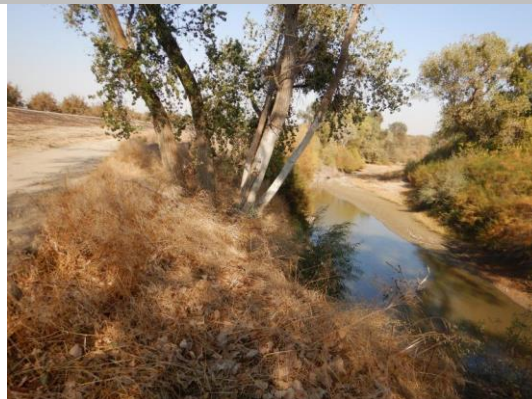
Photo 1 of 2 : FA_2022_ST0001_260_27_20220921_00015.jpg

LM Start	5.33	Rating **	A/W	Issue No.	27 (cont)
LM End	5.37	Issue Type +	Ma	Location *	WS

USACE 2018 Erosion Photo #1
