Flood Control Project Maintenance Levee Inspections

Fall 2023 Levee Maintenance Deficiency Summary Report

Sacramento River Basin

Sacramento Maintenance Yard Cache Creek

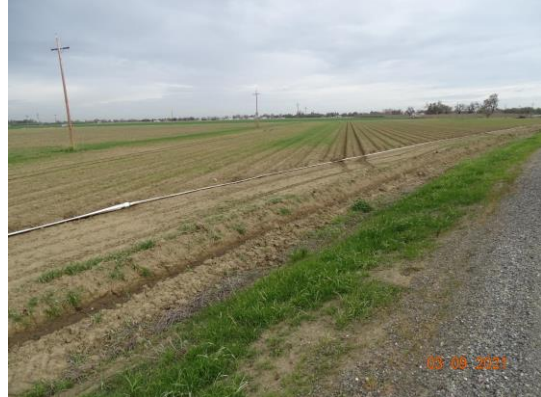
Photo 1 of 1 : FA_2023_ST0001_259_27_20230907_00015.jpg

LM Start	0.92	Rating **	M	Issue No.	27
LM End	1.09	Issue Type +	En	Location *	LS
Category	Earthen Levee			GPS Latitude/Longitude	
				Start	End
Item	Encroachments			38.719051°	38.720864°
				-121.815287°	-121.812980°
DWR ID	DWR_ST0001_01_f_2023_27				
Comment Code					
DT : Ditch					
Inspector Comment					
There is an irrigation ditch at the landside toe.

View of irrigation ditch near the landside toe. Spring 2021.

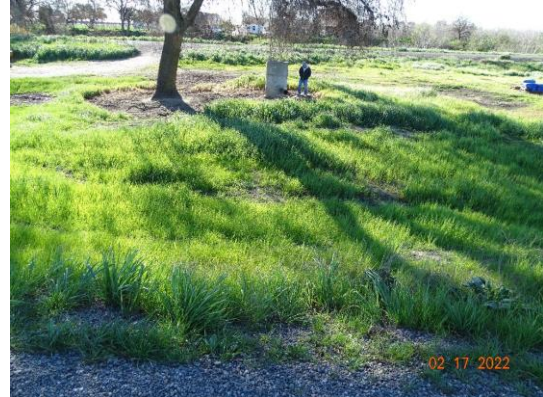
Photo 2 of 3 : UCIP_FA_2023_72495_108479.jpg

Comment Code					
Inspector Comment					
DS_ID:16271 FS_ID:72495 EP_NO: 10192 Repair Type: Non-Urgent EVAL Issue: Crossing Status: Indicator Found UCIP Comments: 02/17/2022 Record updated from No Action Needed to Non-Urgent. Concrete pipes are visible inside concrete riser on waterside. Unable to confirm that pipe is crossing new levee setback. Geophysical results did not confirm presence of pipe through levee. Record will remain in UCIP's inspection records until future Levee Improvement Project can confirm no crossing was found through the levee. No permit has been identified authorizing pipe. Crossing appears abandoned. Concrete debris, abandoned CMP riser at riverbank. Pipe was crossing old levee at angle. (O.Yakimov - DWR UCIP) 11/16/2018 There is a concrete standpipe and no other pipes connected to this standpipe. The standpipe is located between setback levee and the old levee. No other structure or pipe found. (Ted Skidgel - Sac Yard) FIELD_STRUCT_DESC: 24-inch corrugated metal drainage pipe through the levee, 6 feet below the crown. Slide gate in a concrete riser on the waterside (WS) shoulder. Plate welded on the waterside end. Well, pump, and discharge box on the landside (LS). (24-inch steel pipe [HLM 1.17] authorized under Automatic Board Order (ABO) issued as Permit No. 10192, 1974 - Harry H. and Jane Dewey). [Additional Reference(s): DWR Levee Log, 1993 (HLM 1.17), listed as abandoned 24-inch pipe. USACE Sacramento O&M Manual 126, November 1961, (HLM 1.17)]. USACE As-Built Drawing No. 50-04-3227, January 1960, Sheet 3, STA 215+50]. FS Date: 2/17/2022 9:28:04 AM

Water-Side: View of levee slope looking from crown

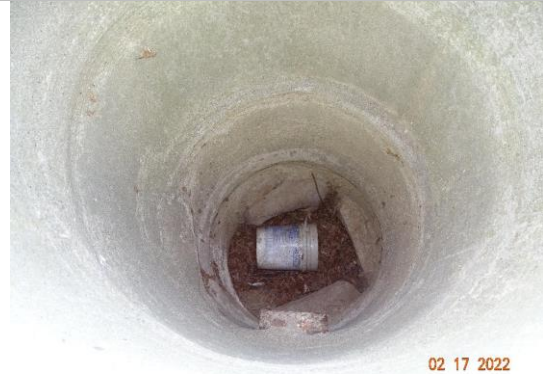
Photo 3 of 3 : UCIP_FA_2023_72495_108480.jpg

Water-Side: Concrete pipes inside concrete standpipe

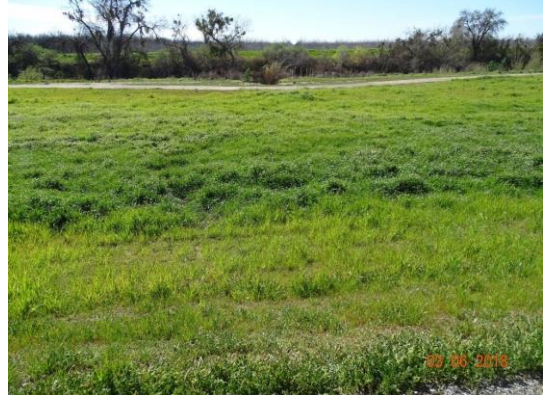
Photo 2 of 2 : FA_2023_ST0001_259_62_20230907_00028.jpg

LM Start	2.84	Rating **	A/W	Issue No.	62 (cont)
LM End	2.84	Issue Type +	Ma	Location *	WS
Category	Earthen Levee			GPS Latitude/Longitude	
				Start	End
Item	Erosion / Bank Caving			38.734514°	38.734514°
				-121.793418°	-121.793418°
DWR ID	DWR_ST0001_01_s _ 2022_62

View of erosion from levee crown, facing Cache Creek. Fall 2018.

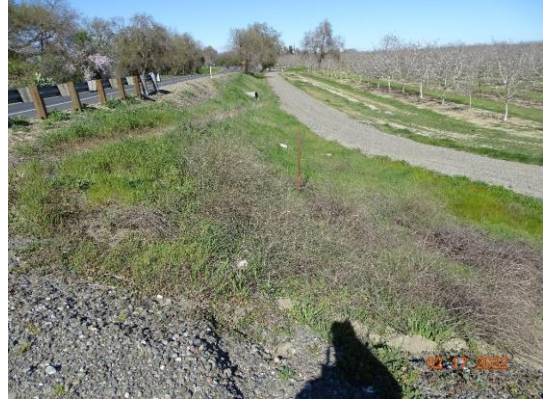
Photo 3 of 3 : UCIP_FA_2023_72612_108756.jpg

Comment Code					
Inspector Comment					
DS_ID:16265 FS_ID:72612 EP_NO: 7232 Repair Type: Non-Urgent EVAL Issue: 11, Maintenance Compliance Issue Crossing Status: Indicator Found UCIP Comments: 02/17/2022 Record remains Non-Urgent. Broken communication line sign found at landside toe needs repair. (O.Yakimov - DWR UCIP) 06/16/2016 May need marker on WS (Ted Skidgel - Sac Yard) FIELD_STRUCT_DESC: Telephone conduit of an unknown size or material through the levee, 2.5 feet below the crown. Communications marker located on the east side of Highway 113 on the landside (LS) toe. (Telephone conduit authorized under Permits No. 7232, 7232-A, issued in 1970 and 1971 correspondingly - Pacific Telephone and Telegraph Company [PT&T]). [Additional Reference(s): DWR Levee Log, 1993 (HLM 4.97)]. FS Date: 2/17/2022 9:12:09 AM

Land-Side: View of levee slope looking from crown

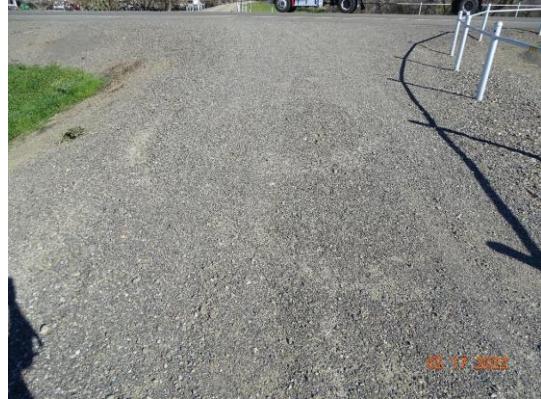
Photo 1 of 3 : UCIP_FA_2023_72622_108798.jpg

Top of Levee: View of levee crown looking downstream

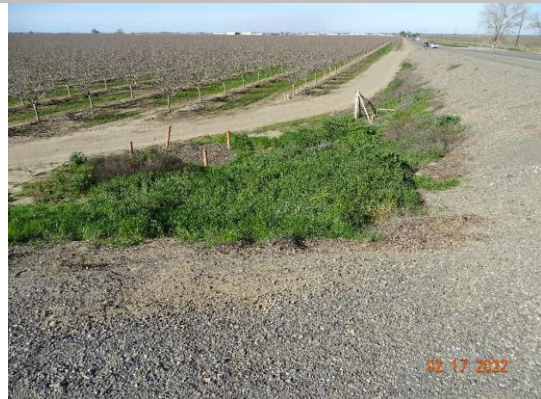
Photo 2 of 3 : UCIP_FA_2023_72622_108795.jpg

Land-Side: View of levee slope looking from crown

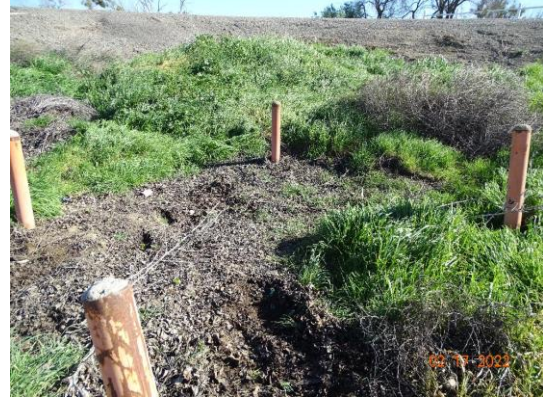
Photo 3 of 3 : UCIP_FA_2023_72622_108797.jpg

Comment Code						
Inspector Comment						
DS_ID:25072 FS_ID:72622 EP_NO: 7668 Repair Type: Non-Urgent EVAL Issue: 11, Maintenance Compliance Issue Crossing Status: Indicator Found UCIP Comments: 02/17/2022 Record is Non-Urgent. Manholes covered with debris. Markers are not installed on any side of levee. (O.Yakimov - DWR UCIP) FIELD_STRUCT_DESC: 4-inch telephone conduit of an unknown material through both levees and under Cache Creek, 6 feet below the crown. Conduit runs 10 feet west along County Road 102. Manhole just off the landside toe next to CO RD 102. (Telephone conduit authorized under Permit No. 7668, 1971 - Pacific Telephone and Telegraph Company [PT&T]). [Additional Reference(s): DWR Levee Log, 1993 (HLM 7.21)]. FS Date: 2/17/2022 11:22:31 AM

Land-Side: Manholes covered with vegetation and debris

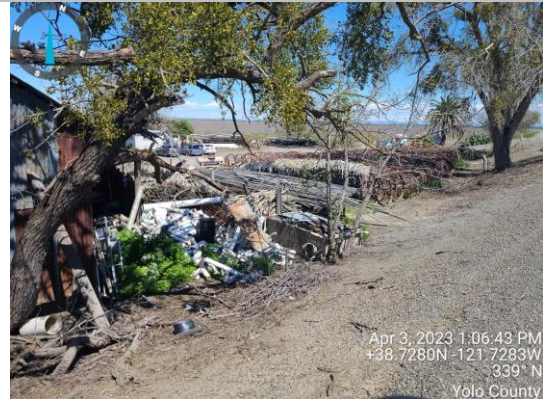
Photo 1 of 1 : FA_2023_ST0001_259_40_20230907_00022.jpg

LM Start	7.30	Rating **	M	Issue No.	40
LM End	7.34	Issue Type +	En	Location *	LS
Category	Earthen Levee			GPS Latitude/Longitude	
				Start	End
Item	Encroachments			38.727878°	38.728085°
				-121.728553°	-121.727740°
DWR ID	DWR_ST0001_01_s_2023_40				
Comment Code					
EQ : Equipment					
Inspector Comment

View of equipment on landside toe. Spring 2023.

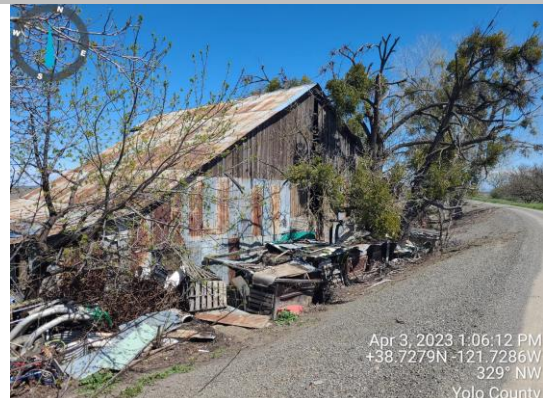
Photo 1 of 1 : FA_2023_ST0001_259_39_20230907_00021.jpg

LM Start	7.30	Rating **	M	Issue No.	39
LM End	7.30	Issue Type +	En	Location *	LS
Category	Earthen Levee			GPS Latitude/Longitude	
				Start	End
Item	Encroachments			38.727870°	38.727870°
				-121.728527°	-121.728527°
DWR ID	DWR_ST0001_01_s _ 2012_39				
Comment Code					
BU : Building					
Inspector Comment					
The barn and livestock pens are within the easement of the levee.

View of building within landside easement. Spring 2023.

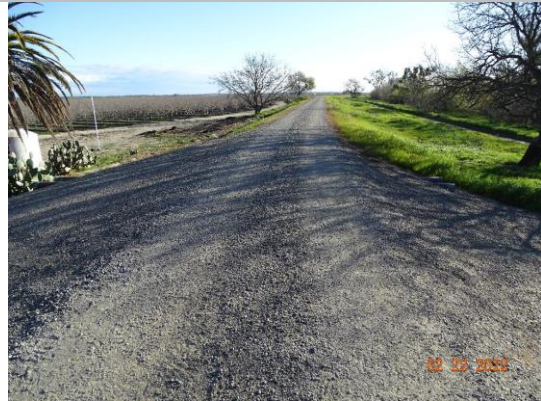
Photo 1 of 3 : UCIP_FA_2023_72738_109096.jpg

Top of Levee: View of levee crown looking downstream

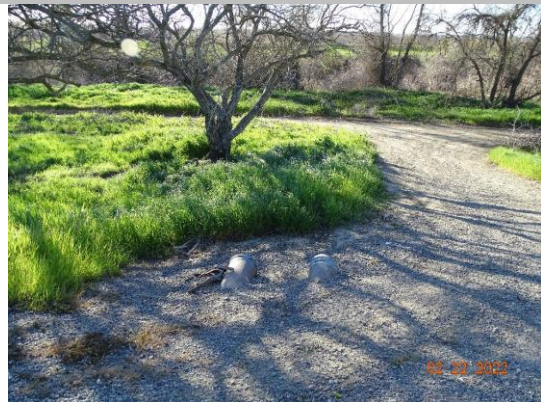
Photo 2 of 3 : UCIP_FA_2023_72738_109097.jpg

Water-Side: View of levee slope looking from crown

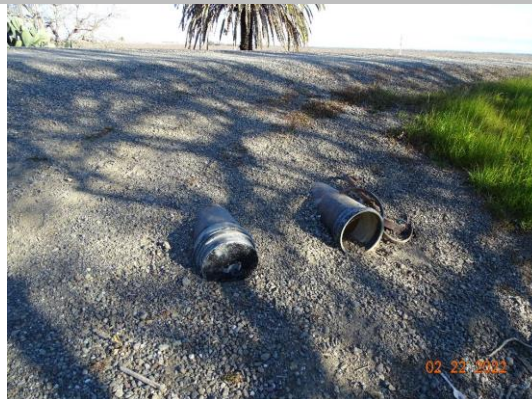
Photo 3 of 3 : UCIP_FA_2023_72738_109094.jpg

Comment Code					
Inspector Comment					
DS_ID:16765 FS_ID:72738 EP_NO: 16810 Repair Type: Non-Urgent EVAL Issue: 11, Maintenance Compliance Issue Crossing Status: Found UCIP Comments: 02/22/2022 Record updated from No Action Needed to Non-Urgent. Pipe is open on landside. Recommend owner to install a cap on landside pipe end. (O.Yakimov - DWR UCIP) 11/16/18 Two pipes W/S 1 capped, L/S both open. (Ted Skidgel - Sac Yard) FIELD_STRUCT_DESC: 1 of 2: 14-inch coated steel irrigation pipe through the levee approximately 2-3 feet below the crown. Pipe connects to a seasonal 14-inch polyvinyl chloride (PVC) pipe and a 100-horsepower mobile pumping plant on the waterside slope. (One 14-inch steel pipe authorized under Permit No. 16810, 1998 - W. Ashley Payne, permit inspection notes indicate that two 14-inch pipes were installed). (Retention of two 14-inch pipes authorized under Permit No. 16810-R, 2002 - Ashley Payne). FS Date: 2/22/2022 3:41:16 PM

Water-Side: pipes on levee slope. Cap is installed on pipe end

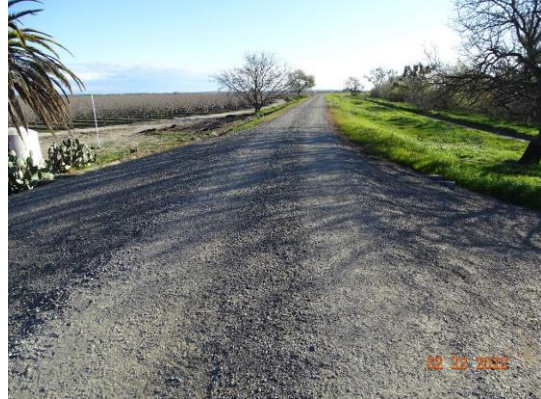
Photo 1 of 3 : UCIP_FA_2023_72745_109120.jpg

Comment Code					
Inspector Comment					
DS_ID:17032 FS_ID:72745 EP_NO: 16810 Repair Type: Urgent EVAL Issue: 3a, Flood Risk Crossing Status: Found UCIP Comments: 02/22/2022 Record updated from No Action Needed to Urgent. Straight through pipe open on both ends provides flood threat to the landside during high water events. (O.Yakimov - DWR UCIP) 11/16/18 Waterside: 1 open 1 closed, landside: both open. (Ted Skidgel - Sac Yard) FIELD_STRUCT_DESC: 2 of 2: 14-inch coated steel irrigation pipe through the levee approximately 2-3 feet below the crown. Pipe connects to a seasonal 14-inch polyvinyl chloride (PVC) pipe and a 100-horsepower mobile pumping plant on the waterside slope. (One 14-inch steel pipe authorized under Permit No. 16810, 1998 - W. Ashley Payne, permit inspection notes indicate that two 14-inch pipes were installed). (Retention of two 14-inch pipes authorized under Permit No. 16810-R, 2002 - Ashley Payne). FS Date: 2/22/2022 4:16:46 PM

Top of Levee: View of levee crown looking downstream

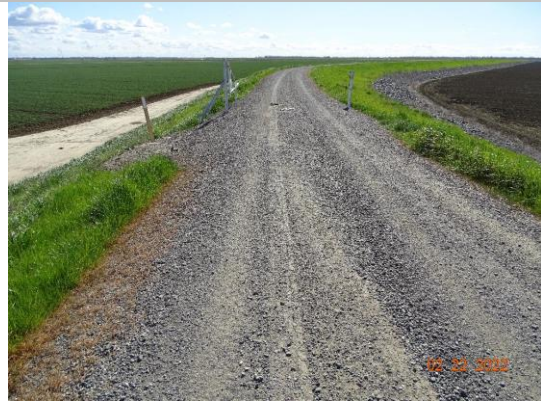
Photo 1 of 3 : UCIP_FA_2023_72789_109241.jpg

Comment Code					
Inspector Comment					
DS_ID:17113 FS_ID:72789 EP_NO: N/A Repair Type: Non-Urgent EVAL Issue: 11, Maintenance Compliance Issue Crossing Status: Found UCIP Comments: 02/22/2022 Record updated from No Action Needed to Non-Urgent. No permit has been found authorizing this pipe through the levee. Damaged siphon breaker on landside shoulder needs maintenance. (O.Yakimov - DWR UCIP) 11/16/2018 Waterside buried landside closed. (Ted Skidgel - Sac Yard) FIELD_STRUCT_DESC: 18-inch, 0.25-inch-thick soil-proofed steel irrigation pipe, 3 feet below the crown. Installed during Cache Creek Settling Basin enlargement in 1991. (24-inch steel irrigation pipes at 5 locations authorized under Permit No. 12705, 1979 - Layton Knaggs. Permit was administratively closed). [Additional Reference(s): DWR Levee Log, 1993 (HLM 9.37), listed as 24-inch pipe0. USACE As-Built Drawing No. CC5-04-0070, 6 May 1991, Sheet 15, STA UNK]. FS Date: 2/22/2022 10:59:45 AM

Top of Levee: View of levee crown looking downstream

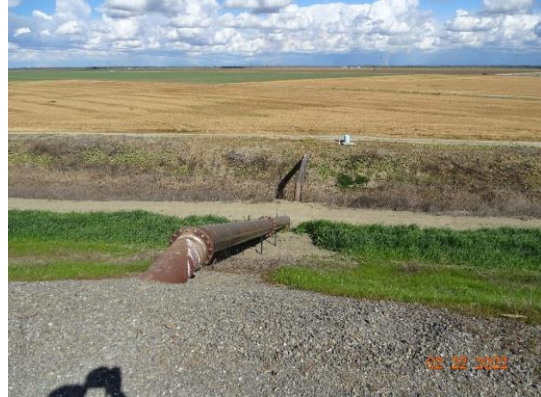
Photo 1 of 3 : UCIP_FA_2023_72795_109251.jpg

Land-Side: View of levee slope looking from crown. Pipe on the slope and over irrigation ditch

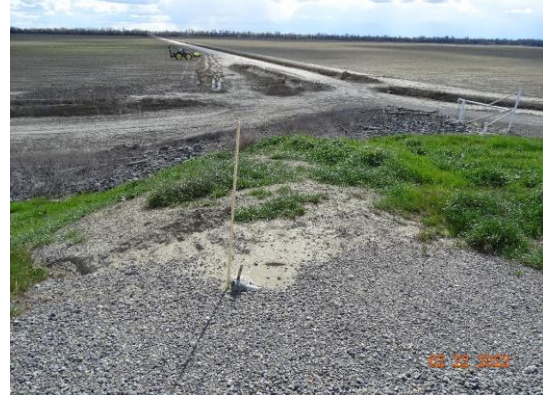
Photo 1 of 3 : UCIP_FA_2023_72797_109260.jpg

FIELD_STRUCT_DESC: 18-inch soil-proofed steel irrigation pipe, 2.2 feet below the crown. Capped vent on the apex of the pipe off the landside (LS) shoulder. Booster pump located off the LS toe at the LS toe ditch. Another groundwater pump is located a further distance off the LS toe. Pumped groundwater is conveyed to the toe ditch and a booster pump pumps water through the levee and into a waterside (WS) ditch in the Cache Creek Settling Basin. Distribution box off the WS toe at the WS toe ditch. Could not locate a positive closure device. (24-inch steel irrigation pipes at 5 locations authorized under Permit No. 12705, 1979 - Layton Knaggs. Permit was administratively closed). [Additional Reference(s): DWR Levee Log, 1993 (HLM 10.83), listed as 24-inch pipe. USACE As-Built Drawing No. CC5-04-0070, 6 May 1991, Sheet 22, STA 49+50].						
FS Date: 2/22/2022 1:20:49 PM

Water-Side: View of levee slope looking from crown

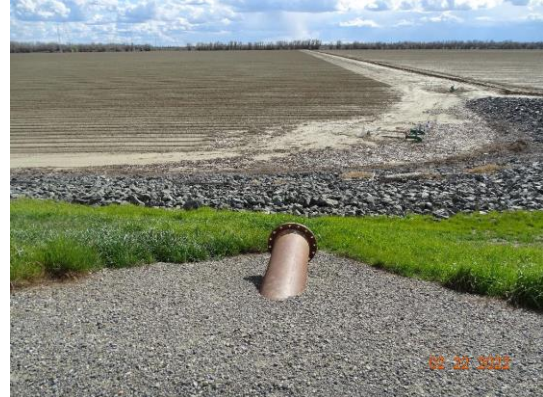
Photo 1 of 3 : UCIP_FA_2023_72802_109280.jpg

Water-Side: View of levee slope looking from crown. Pipe end is open

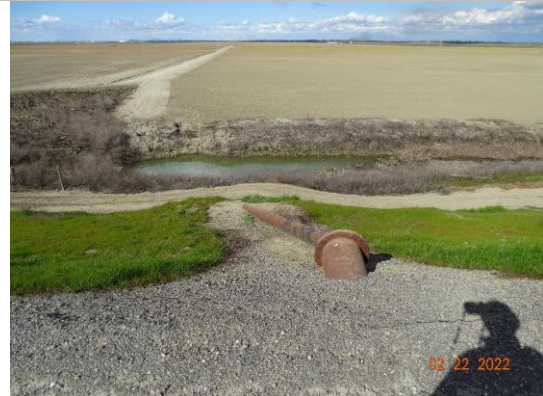
Photo 2 of 3 : UCIP_FA_2023_72802_109281.jpg

Land-Side: View of levee slope looking from crown

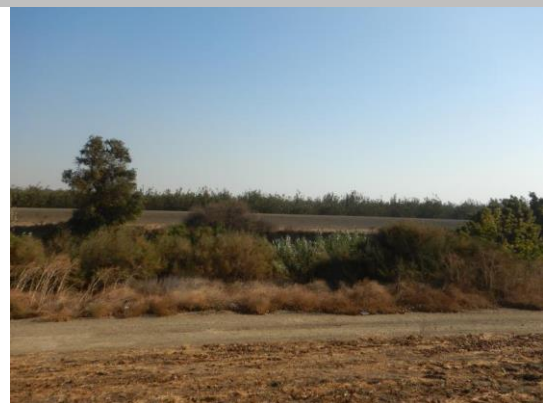
Photo 1 of 2 : FA_2023_ST0001_260_2_20230907_00002.jpg

LM Start	0.90	Rating **	A/W	Issue No.	2
LM End	0.92	Issue Type +	Ma	Location *	WS
Category	Supplemental			GPS Latitude/Longitude	
				Start	End
Item	2018 USACE Erosion Survey			38.732678°	38.732903°
				-121.795347°	-121.795017°
DWR ID	DWR_ST0001_02_f_2022_2				
Comment Code					
Inspector Comment					
2018 Site ID: CHC 0.9 R					
Status: Eroding New					
2018 Field Notes: Vertical eroding bank slope.					
Site History:

USACE 2018 Erosion Photo #1

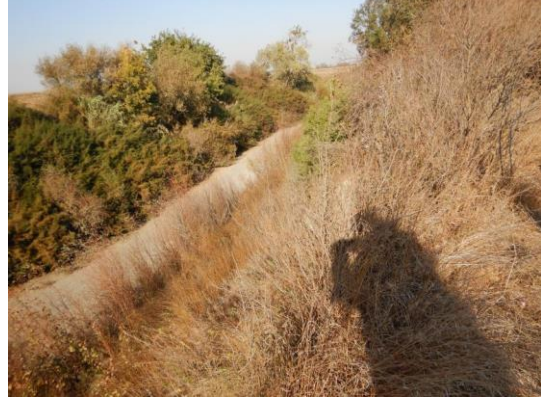
Photo 2 of 2 : FA_2023_ST0001_260_2_20230907_00003.jpg

USACE 2018 Erosion Photo #2

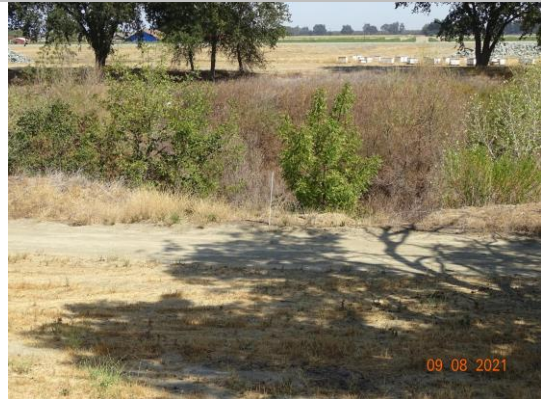
Photo 1 of 1 : FA_2023_ST0001_260_16_20230907_00010.jpg

LM Start	1.60	Rating **	A/W	Issue No.	16
LM End	1.60	Issue Type +	Ma	Location *	WS
Category	Earthen Levee			GPS Latitude/Longitude	
				Start	End
Item	Erosion / Bank Caving			38.731659°	38.731577°
				-121.785931°	-121.785936°
DWR ID	ST1-01				
Comment Code					
E1 : Note and monitor erosion site.					
Inspector Comment					
Erosion is on the bank and is starting to cut into the WS toe road.					
Site ID No:181					
Site Designation:ST1-01

View of erosion on waterside toe road. Fall 2021.

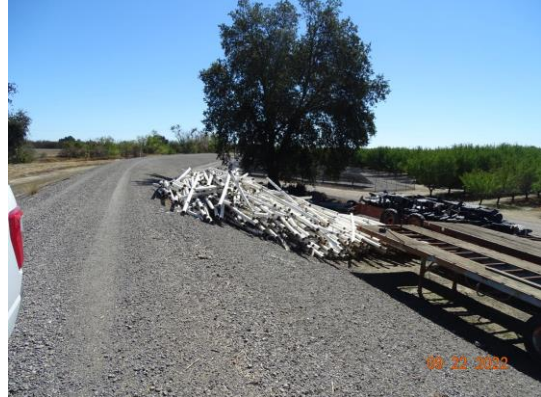
Photo 1 of 1 : FA_2023_ST0001_260_29_20230907_00016.jpg

LM Start	2.43	Rating **	M	Issue No.	29
LM End	2.47	Issue Type +	En	Location *	LS
Category	Earthen Levee			GPS Latitude/Longitude	
				Start	End
Item	Encroachments			38.726036°	38.725836°
				-121.774340°	-121.773688°
DWR ID	DWR_ST0001_02_f_2017_29				
Comment Code					
EQ : Equipment					
Inspector Comment					
There is farm equipment at the landside toe.

View of equipment on the landside shoulder. Fall 2022.

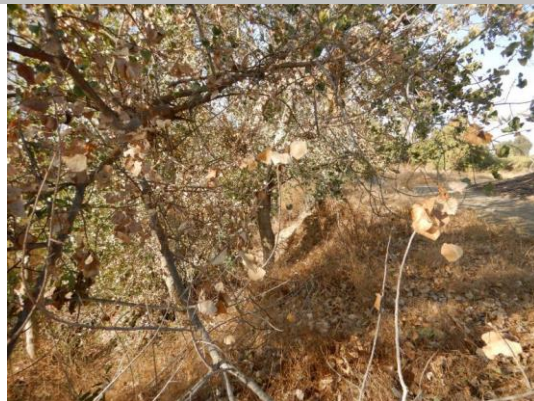
Photo 1 of 2 : FA_2023_ST0001_260_11_20230907_00007.jpg

USACE 2018 Erosion Photo #1

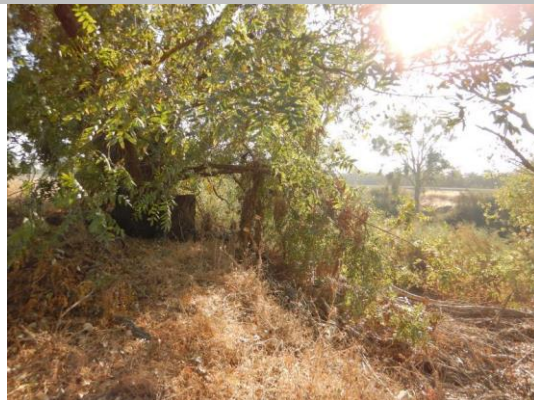
Photo 2 of 2 : FA_2023_ST0001_260_11_20230907_00008.jpg

USACE 2018 Erosion Photo #2

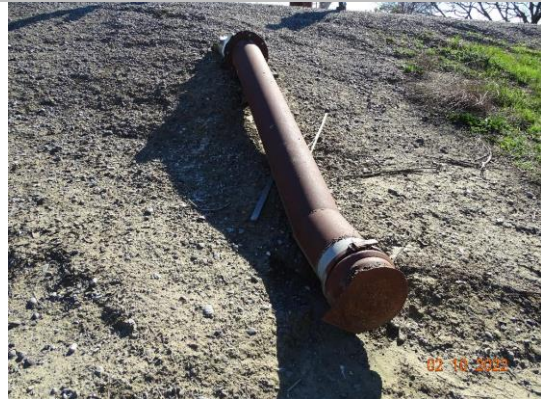
Photo 1 of 3 : UCIP_FA_2023_72295_107644.jpg

Comment Code						
Inspector Comment						
DS_ID:16767 FS_ID:72295 EP_NO: 17174 Repair Type: Non-Urgent EVAL Issue: 11, Maintenance Compliance Issue Crossing Status: Found UCIP Comments: 02/10/2022 Record updated from No Action Needed to Non-Urgent. Crossing appears abandoned. Waterside pipe end is capped, landside end is open. Recommend closing landside end. (O.Yakimov - DWR UCIP) 08/05/2020: same observation as previous inspection.11/17/2017: water side closed, landside open FIELD_STRUCT_DESC: 14-inch coated steel irrigation pipe through the levee, 2 feet below the crown. Seasonal removable pipe and pump facility on the waterside (WS) slope. (14-inch irrigation pipe, removable pipe, and pump facility authorized under Permit No. 17174, 2000 - Howald Farms). FS Date: 2/10/2022 11:40:24 AM

LM Start	4.51	Rating **	M	Issue No.	39 (cont)
LM End	4.51	Issue Type +	En	Location *

Water-Side: View of levee slope looking from toe. Capped pipe on the slope

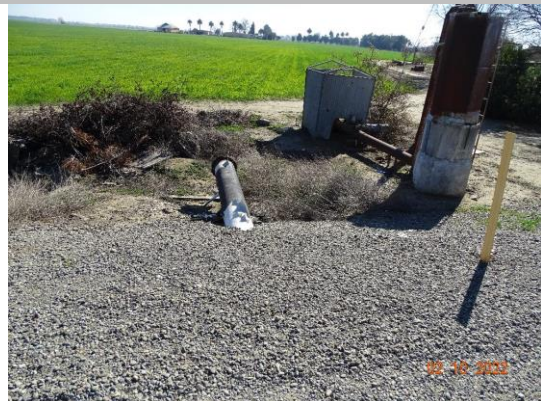
Photo 2 of 3 : UCIP_FA_2023_72295_107647.jpg

Land-Side: View of levee slope looking from crown

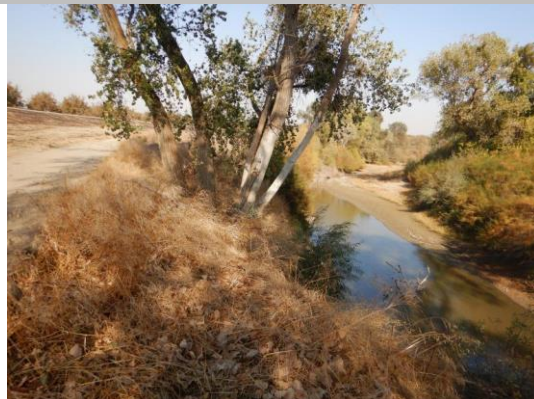
Photo 1 of 2 : FA_2023_ST0001_260_27_20230907_00013.jpg

LM Start	5.33	Rating **	A/W	Issue No.	27 (cont)
LM End	5.37	Issue Type +	Ma	Location *	WS

USACE 2018 Erosion Photo #1

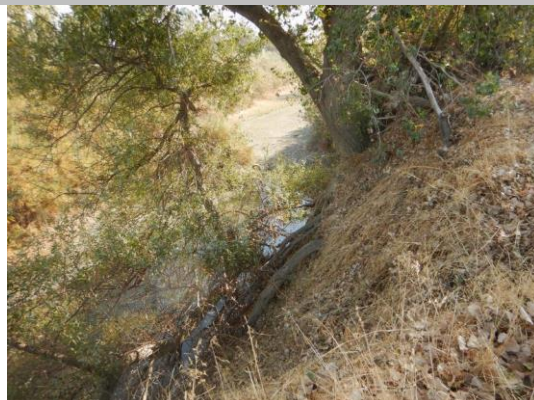
Photo 2 of 2 : FA_2023_ST0001_260_27_20230907_00014.jpg

USACE 2018 Erosion Photo #2
