**Flood Control Project Maintenance  
Levee Inspections**  
**LMA District Cover Sheet**  
**Spring 2014 Levee Inspection Results**

**Sacramento Maintenance Yard Cache Creek**

**Spring 2014 Levee Inspection Results**

Waterway	Bank	Unit Miles
Unit No. 01 North Levee	Left	11.81

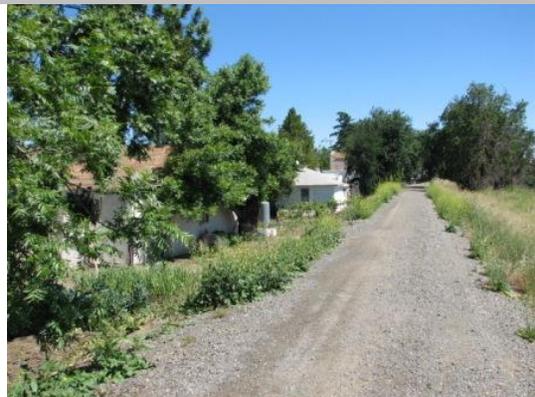
Photo 1 of 1 : johngw\_s\_20140306\_530.jpg

LM Start	<b>2.01</b>	Rating **	M	Issue No.	<b>9</b>
LM End	<b>2.01</b>	Issue Type +	En	Location *	LS
Category	Earthen Levee		GPS Latitude/Longitude		
			Start	End	
Item	Encroachments		38.731927 °	38.731927 °	
			-121.805973 °	-121.805973 °	
DWR ID	DWR_ST0001_01_s_2012_9				
Action/Comments					
Building

A photo looking downstream of homes in the town of Yolo.

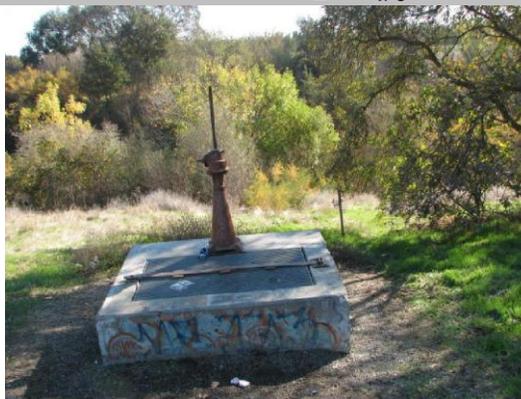
Photo 1 of 1 : UCIP\_5424.jpg

LM Start	<b>2.08</b>	Rating **	M	Issue No.	<b>17</b>
LM End	<b>2.08</b>	Issue Type +	En	Location *	LS
Category	Supplemental			GPS Latitude/Longitude	
				Start	End
Item	DWR UCIP Field Study			38.732665 °	38.732665 °
				-121.805604 °	-121.805604 °
DWR ID	DWR_ST0001_01_s_2014_17				
Action/Comments					
Inspector Comments: FS_ID:27503 EP_NO: N/A Repair Type: Crossing Status: UCIP Comments: A pump house located LS across the road. A debris is blocking the outlet channel of the pipe. It needs to be removed (an abandoned sofa). FIELD_STRUCT_DESC: Pipe through the levee, screw gate on waterward slope. One of two pipes (30" diameter and 10" diameter) of a storm drainage system. A gate riser structure approximately 4 ft waterward of the waterside levee shoulder. A flap gate on the pipeline at the discharge structure. FS Date: 1/21/2014 2:55:22 PM

Waterside view: a concrete control box with slide gate

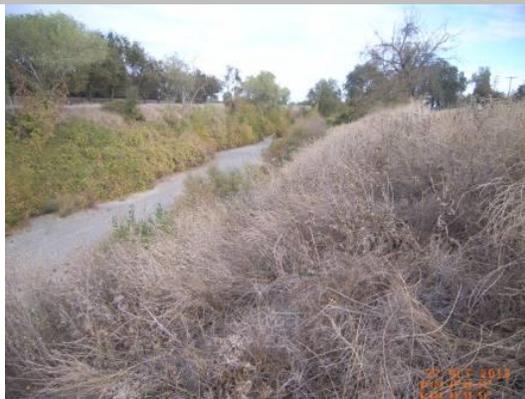
Photo 1 of 1 : USACE2013A\_CHC\_3-4\_L\_6.jpg

LM Start	<b>3.48</b>	Rating **	M	Issue No.	<b>18</b>
LM End	<b>3.56</b>	Issue Type +	Ma	Location *	WS
Category	Supplemental		GPS Latitude/Longitude		
			Start	End	
Item	USACE Erosion Survey		38.732942 °	38.731626 °	
			-121.784965 °	-121.785231 °	
DWR ID					
Action/Comments					
Inspector Comments: 2006 - Some significant new erosion, especially fresh upper bank slumping. Still substantial berm. 2010 - Site extended downstream, some new erosion, heavily vegetated and hard to see. Planned setback levee by CA DWR, 60% design complete, construction planned for 2012. 2011 - Construction delayed to 2013 - 2014. 2013: No observed changes. [2013 Site ID: CHC_3-4_L]

USACE 2013 Photo #1

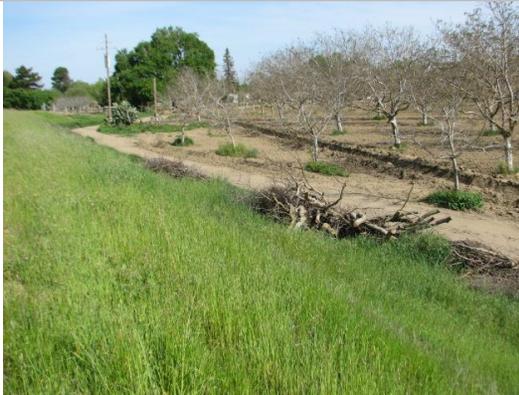
Photo 1 of 1 : johngw\_s\_20140502\_99014.jpg

LM Start	<b>4.48</b>	Rating **	M	Issue No.	<b>42</b>
LM End	<b>4.48</b>	Issue Type +	En	Location *	LS
Category	Earthen Levee		GPS Latitude/Longitude		
			Start	End	
Item	Encroachments		38.725552 °	38.725552 °	
			-121.771159 °	-121.771159 °	
DWR ID	DWR_ST0001_01_s_2014_42				
Action/Comments					
Prunings

A pruning pile at the toe of the levee. Spring 1014

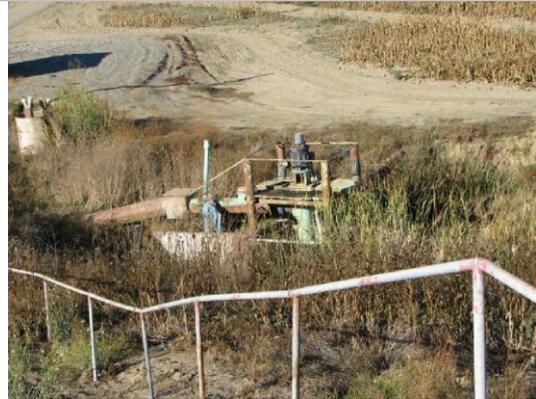
Photo 1 of 1 : UCIP\_938.jpg

LM Start	<b>10.85</b>	Rating **	M	Issue No.	<b>22</b>
LM End	<b>10.85</b>	Issue Type +	En	Location *	LS
Category	Supplemental			GPS Latitude/Longitude	
				Start	End
Item	DWR UCIP Field Study			38.701814 °	38.701814 °
				-121.690832 °	-121.690832 °
DWR ID	DWR_ST0001_01_s_2014_22				
Action/Comments					
Inspector Comments: FS_ID:13984 EP_NO: N/A Repair Type: Crossing Status: UCIP Comments: Pipe leaks, severe erosion from levee shoulder to pipe daylight on landside levee slope. FIELD_STRUCT_DESC: A 18-inch soil proofed Steel Pipe 0.25" thick. FS Date: 5/28/2013 3:22:00 PM

Landside view: pumping plant

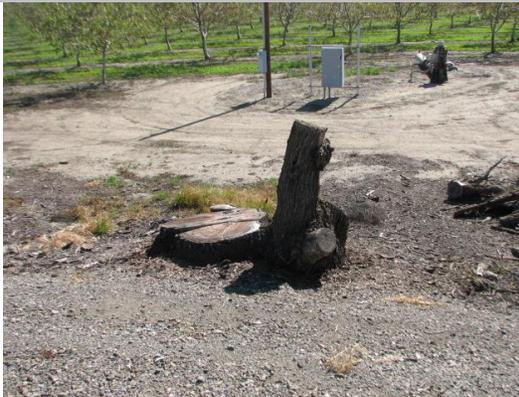
Photo 1 of 1 : johngw\_s\_20140502\_99019.jpg

LM Start	<b>0.26</b>	Rating **	N	Issue No.	<b>6</b>
LM End	<b>0.26</b>	Issue Type +	Ma	Location *	LS
Category	Earthen Levee			GPS Latitude/Longitude	
				Start	End
Item	Trim / Thin Trees			38.730723 °	38.730723 °
				-121.804972 °	-121.804972 °
DWR ID	DWR_ST0001_02_s_2014_6				
Action/Comments					
Tree stumps.

A large black walnut tree stump is at the toe of the levee. Spring 2014

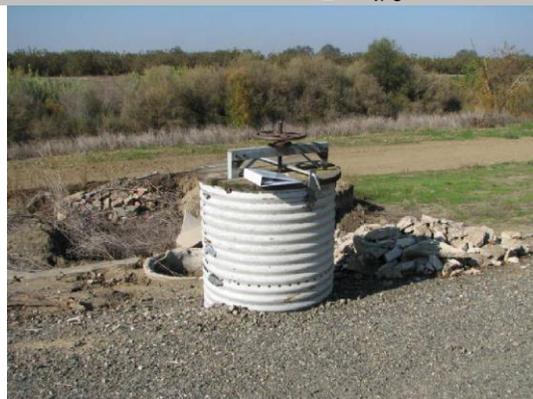
Photo 1 of 1 : UCIP\_943.jpg

LM Start	<b>3.42</b>	Rating **	M	Issue No.	<b>2</b>
LM End	<b>3.42</b>	Issue Type +	En	Location *	LS
Category	Supplemental		GPS Latitude/Longitude		
			Start	End	
Item	DWR UCIP Field Study		38.721348 °	38.721348 °	
			-121.759503 °	-121.759503 °	
DWR ID	DWR_ST0001_02_s_2014_2				
Action/Comments					
Inspector Comments: FS_ID:13985

Waterside view: 36-inch CMP riser and abandoned pump house

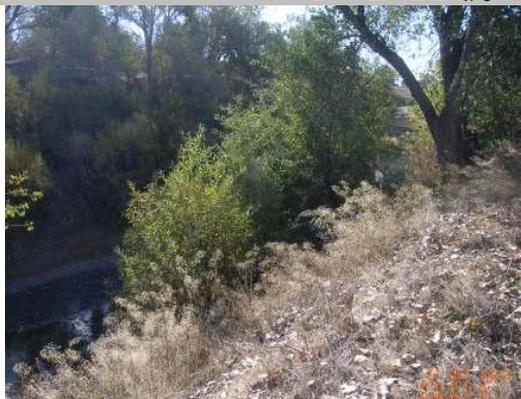
Photo 1 of 1 : USACE2013A\_CHC\_5-4\_L\_2.jpg

LM Start	<b>3.58</b>	Rating **	M	Issue No.	<b>14</b>
LM End	<b>3.59</b>	Issue Type +	Ma	Location *	WS
Category	Supplemental			GPS Latitude/Longitude	
				Start	End
Item	USACE Erosion Survey			38.722933 °	38.723467 °
				-121.760561 °	-121.760436 °
DWR ID					
Action/Comments					
Inspector Comments: 2009 - Erosion into the levee slope. 2010 - Minor new erosion. 2011 - New erosion and a freshly fallen tree. 2012 - New animal holes and slightly steeper slopes. 2013: New tree popout and 2 feet of erosion along the top bank. [2013 Site ID: CHC_5-4_L]

USACE 2013 Photo #1

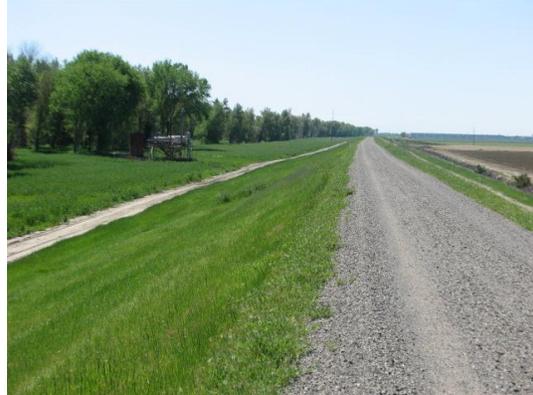
Photo 1 of 1 : johngw\_s\_20140502\_99023.jpg

LM Start	<b>6.41</b>	Rating **	A	Issue No.	<b>11</b>
LM End	<b>11.42</b>	Issue Type +	Ma	Location *	WS
Category	Earthen Levee		GPS Latitude/Longitude		
			Start	End	
Item	Vegetation		38.720124 °	38.678026 °	
			-121.717334 °	-121.673131 °	
DWR ID	DWR_ST0001_02_s_2014_11				
Action/Comments					
Control annual grass and weeds on the levee slopes and easements.

The grasses complies with the standards. Spring 2014

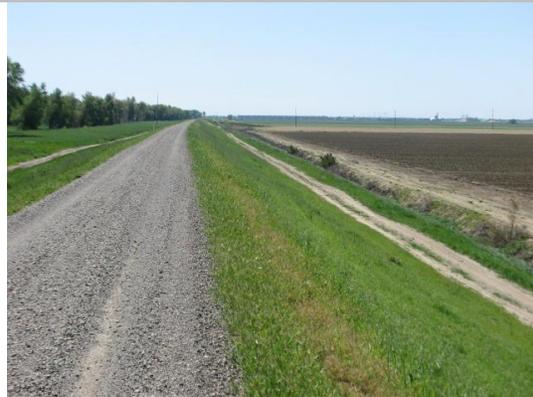
Photo 1 of 1 : johngw\_s\_20140502\_99024.jpg

LM Start	<b>6.41</b>	Rating **	A	Issue No.	<b>10</b>
LM End	<b>11.42</b>	Issue Type +	Ma	Location *	LS
Category	Earthen Levee		GPS Latitude/Longitude		
			Start	End	
Item	Vegetation		38.720086 °	38.678025 °	
			-121.717337 °	-121.673130 °	
DWR ID	DWR_ST0001_02_s_2014_10				
Action/Comments					
Control annual grass and weeds on the levee slopes and easements.

The grasses are between 2-4 inches in height. Spring 2014

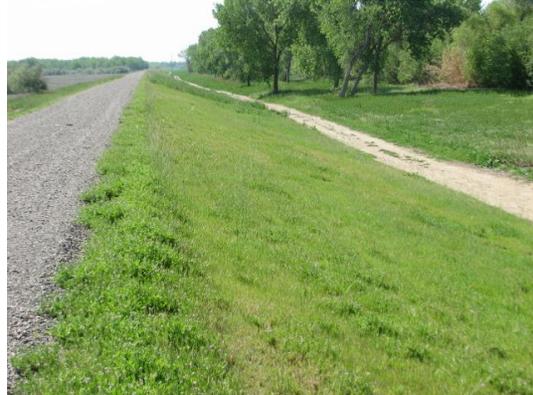
Photo 1 of 1 : johngw\_s\_20140502\_99025.jpg

LM Start	<b>0.04</b>	Rating **	A	Issue No.	<b>2</b>
LM End	<b>2.27</b>	Issue Type +	Ma	Location *	WS
Category	Earthen Levee		GPS Latitude/Longitude		
			Start	End	
Item	Vegetation		38.727029 °	38.695496 °	
			-121.717904 °	-121.715923 °	
DWR ID	DWR_ST0001_04_s_2014_2				
Action/Comments					
Control annual grass and weeds on the levee slopes and easements.

The vegetation complies with the standards. Spring 2014

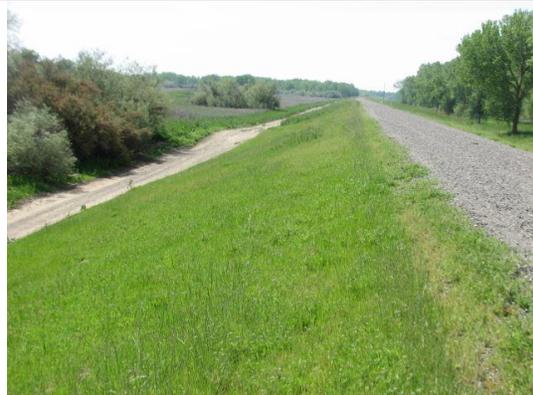
Photo 1 of 1 : johngw\_s\_20140502\_99026.jpg

LM Start	<b>0.04</b>	Rating **	A	Issue No.	<b>1</b>
LM End	<b>2.27</b>	Issue Type +	Ma	Location *	LS
Category	Earthen Levee		GPS Latitude/Longitude		
			Start	End	
Item	Vegetation		38.727029 °	38.695495 °	
			-121.717904 °	-121.715920 °	
DWR ID	DWR_ST0001_04_s_2014_1				
Action/Comments					
Control annual grass and weeds on the levee slopes and easements.

The vegetation complies with the standards. Spring 2014
