**Flood Control Project Maintenance
Levee Inspections**
LMA District Cover Sheet
Spring 2015 Levee Inspection Results

Sacramento Maintenance Yard Cache Creek

Spring 2015 Levee Inspection Results

Waterway	Bank	Unit Miles
Unit No. 01 North Levee	Left	11.69

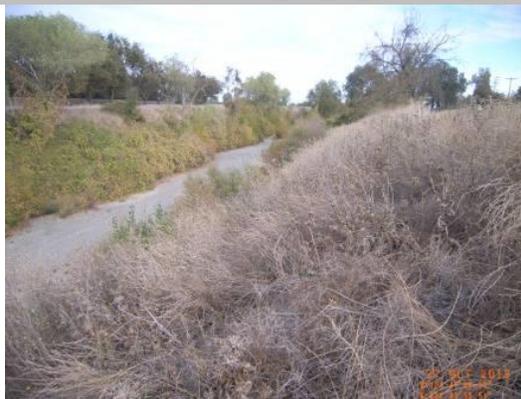
Photo 1 of 1 : SP_2015_ST0001_259_18_20150316_00019.jpg

LM Start	3.48	Rating **	M	Issue No.	18
LM End	3.57	Issue Type +	Ma	Location *	WS
Category	Supplemental		GPS Latitude/Longitude		
			Start	End	
Item	USACE Erosion Survey		38.732942 °	38.731626 °	
			-121.784965 °	-121.785231 °	
DWR ID	DWR_ST0001_01_f_2014_18				
Action/Comments					
Inspector Comments: 2006 - Some significant new erosion, especially fresh upper bank slumping. Still substantial berm. 2010 - Site extended downstream, some new erosion, heavily vegetated and hard to see. Planned setback levee by CA DWR, 60% design complete, construction planned for 2012. 2011 - Construction delayed to 2013 - 2014. 2013: No observed changes. [2013 Site ID: CHC_3-4_L]

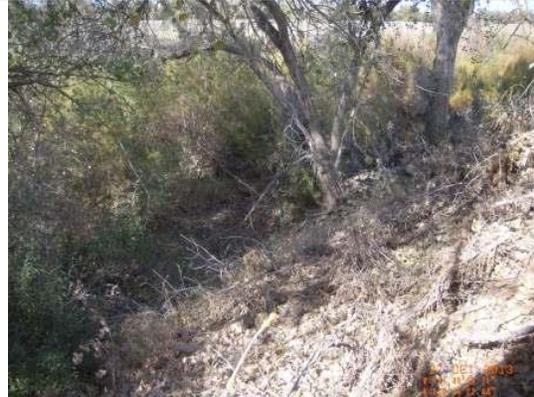
Photo 1 of 1 : SP_2015_ST0001_260_13_20150316_00011.jpg

LM Start	3.53	Rating **	M	Issue No.	13
LM End	3.60	Issue Type +	Ma	Location *	WS
Category	Supplemental			GPS Latitude/Longitude	
				Start	End
Item	USACE Erosion Survey			38.722138 °	38.723294 °
				-121.759736 °	-121.759588 °
DWR ID	DWR_ST0001_02_f_2014_13				
Action/Comments					
Inspector Comments: 2010 - Large slump on the upper berm, a tree has recently slid down the slope. 2011 - Large slump and new erosion. 2012 - Slightly steeper slopes and cracks observed. 2013: No observed changes. [2013 Site ID: CHC_3-5_R]

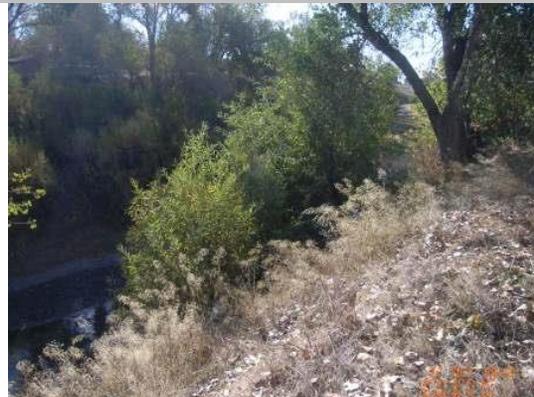
Photo 1 of 1 : SP_2015_ST0001_260_14_20150316_00012.jpg

LM Start	3.58	Rating **	M	Issue No.	14
LM End	3.59	Issue Type +	Ma	Location *	WS
Category	Supplemental			GPS Latitude/Longitude	
				Start	End
Item	USACE Erosion Survey			38.722933 °	38.723467 °
				-121.760561 °	-121.760436 °
DWR ID	DWR_ST0001_02_f_2014_14				
Action/Comments					
Inspector Comments: 2009 - Erosion into the levee slope. 2010 - Minor new erosion. 2011 - New erosion and a freshly fallen tree. 2012 - New animal holes and slightly steeper slopes. 2013: New tree popout and 2 feet of erosion along the top bank. [2013 Site ID: CHC_5-4_L]
