**Flood Control Project Maintenance
Levee Inspections**
LMA District Cover Sheet
Spring 2016 Levee Inspection Results

Sacramento Maintenance Yard Cache Creek

Spring 2016 Levee Inspection Results

Waterway	Bank	Unit Miles
Unit No. 01 North Levee	Left	11.69

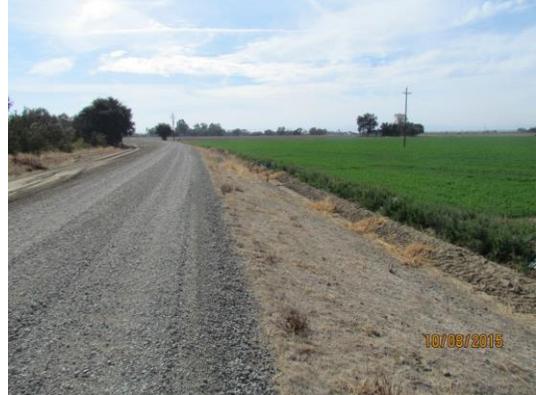
Photo 1 of 1 : SP_2016_ST0001_259_47_20160304_00040.jpg

LM Start	0.93	Rating **	M	Issue No.	47
LM End	1.02	Issue Type +	En	Location *	WS
Category	Earthen Levee		GPS Latitude/Longitude		
			Start	End	
Item	Encroachments		38.719222 °	38.720183 °	
			-121.815130 °	-121.813995 °	
DWR ID	DWR_ST0001_01_s_2015_47				
Comment Code					
DT : Ditch					
Inspector Comment					
Ditch is located at the toe levee.

View of the ditch on the landward side of the levee looking upstream. Fall 2015.

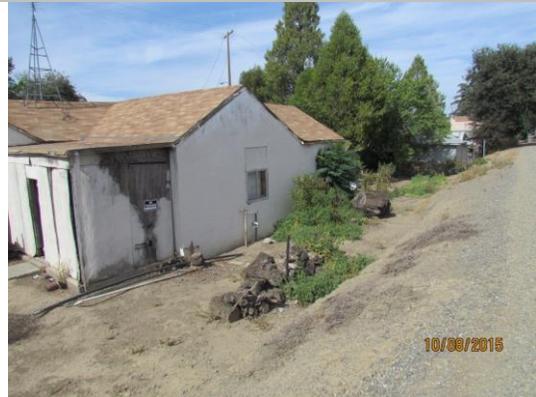
Photo 1 of 1 : SP_2016_ST0001_259_9_20160304_00009.jpg

LM Start	2.04	Rating **	M	Issue No.	9
LM End	2.04	Issue Type +	En	Location *	LS
Category	Earthen Levee		GPS Latitude/Longitude		
			Start	End	
Item	Encroachments		38.731927 °	38.731927 °	
			-121.805973 °	-121.805973 °	
DWR ID	DWR_ST0001_01_s_2012_9				
Comment Code					
BU : Building					
Inspector Comment

View of the house in the town of Yolo on the landward side of the levee looking downstream. Fall 2015.

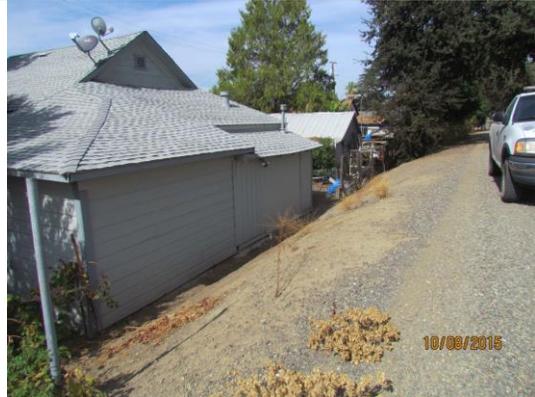
Photo 1 of 1 : SP_2016_ST0001_259_10_20160304_00010.jpg

LM Start	2.05	Rating **	M	Issue No.	10
LM End	2.05	Issue Type +	En	Location *	LS
Category	Earthen Levee		GPS Latitude/Longitude		
			Start	End	
Item	Encroachments		38.732162 °	38.732162 °	
			-121.805895 °	-121.805895 °	
DWR ID	DWR_ST0001_01_s_2012_10				
Comment Code					
BU : Building					
Inspector Comment

View of the house on the landward side of the levee looking downstream. Fall 2015.

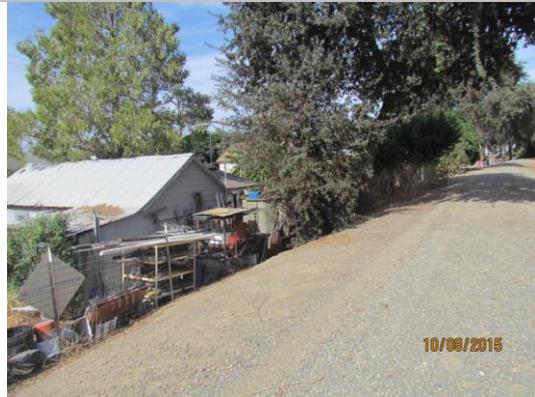
Photo 1 of 1 : SP_2016_ST0001_259_11_20160304_00011.jpg

LM Start	2.06	Rating **	M	Issue No.	11
LM End	2.06	Issue Type +	En	Location *	LS
Category	Earthen Levee		GPS Latitude/Longitude		
			Start	End	
Item	Encroachments		38.732268 °	38.732268 °	
			-121.805832 °	-121.805832 °	
DWR ID	DWR_ST0001_01_s_2012_11				
Comment Code					
BU : Building					
Inspector Comment

View of the building on the landward side of the levee looking downstream. Fall 2015.

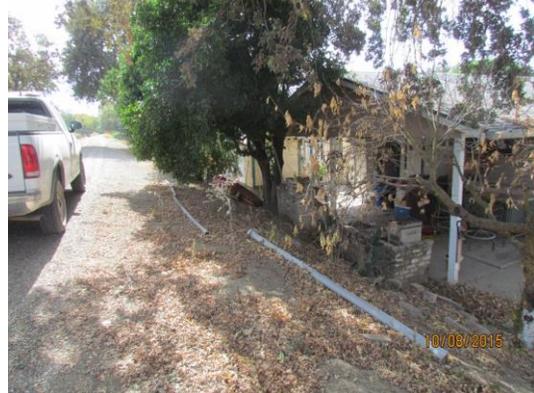
Photo 1 of 1 : SP_2016_ST0001_259_13_20160304_00013.jpg

LM Start	2.08	Rating **	M	Issue No.	13
LM End	2.08	Issue Type +	En	Location *	LS
Category	Earthen Levee		GPS Latitude/Longitude		
			Start	End	
Item	Encroachments		38.732537 °	38.732537 °	
			-121.805708 °	-121.805708 °	
DWR ID	DWR_ST0001_01_s_2012_13				
Comment Code					
BU : Building					
Inspector Comment

View of the building on the landward side of the levee looking upstream. Fall 2015.

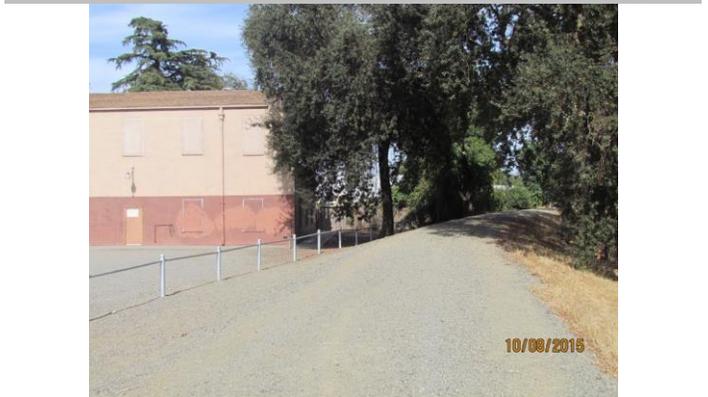
Photo 1 of 1 : SP_2016_ST0001_259_12_20160304_00012.jpg

LM Start	2.12	Rating **	M	Issue No.	12
LM End	2.12	Issue Type +	En	Location *	LS
Category	Earthen Levee			GPS Latitude/Longitude	
				Start	End
Item	Encroachments			38.733000 °	38.733000 °
				-121.805409 °	-121.805409 °
DWR ID	DWR_ST0001_01_s_2012_12				
Comment Code					
BU : Building					
Inspector Comment

View of the building on the landward side of the levee looking downstream. Fall 2015.

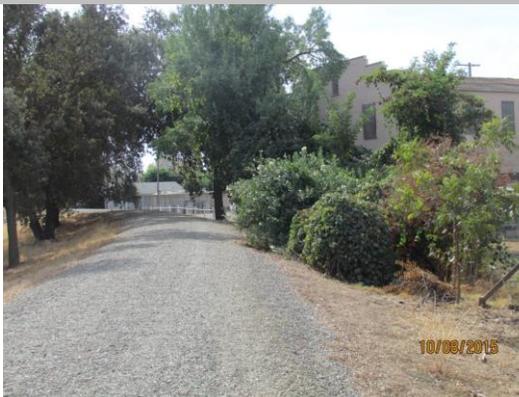
Photo 1 of 1 : SP_2016_ST0001_259_14_20160304_00014.jpg

LM Start	2.12	Rating **	M	Issue No.	14
LM End	2.13	Issue Type +	En	Location *	LS
Category	Earthen Levee		GPS Latitude/Longitude		
			Start	End	
Item	Vegetation		38.733117 °	38.733218 °	
			-121.805367 °	-121.805263 °	
DWR ID	DWR_ST0001_01_s_2012_14				
Comment Code					
V6 : Landscaping					
Inspector Comment

View of the shrubs on the landward side of the levee looking upstream. Fall 2015.

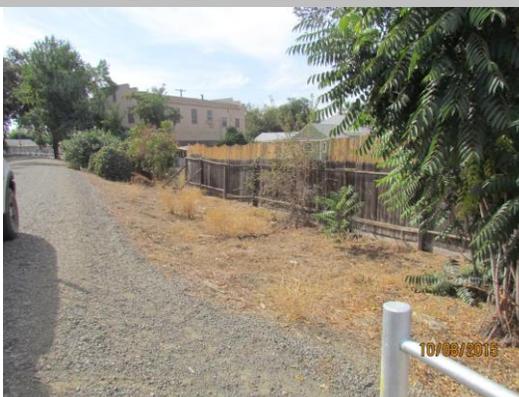
Photo 1 of 1 : SP_2016_ST0001_259_15_20160304_00015.jpg

LM Start	2.13	Rating **	M	Issue No.	15
LM End	2.15	Issue Type +	En	Location *	LS
Category	Earthen Levee		GPS Latitude/Longitude		
			Start	End	
Item	Encroachments		38.733215 °	38.733350 °	
			-121.805262 °	-121.805082 °	
DWR ID	DWR_ST0001_01_s_2012_15				
Comment Code					
FE : Fence					
Inspector Comment

View of the fence on the landward side of the levee looking upstream. Fall 2015.

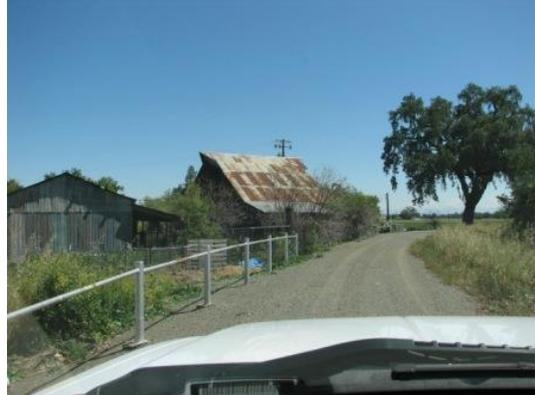
Photo 1 of 2 : SP_2016_ST0001_259_16_20160304_00016.jpg

LM Start	2.17	Rating **	M	Issue No.	16 (cont)
LM End	2.17	Issue Type +	En	Location *	LS

Horse barn and corral are within the easement of the levee.

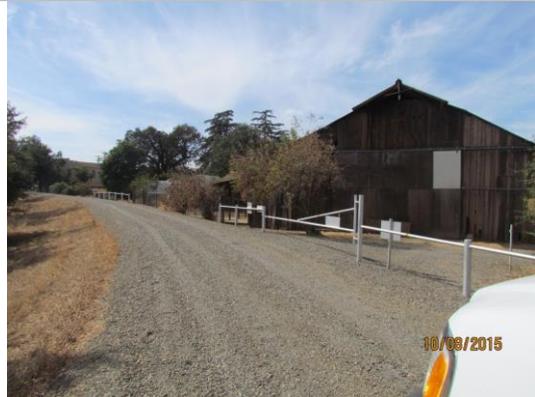
Photo 2 of 2 : SP_2016_ST0001_259_16_20160304_00017.jpg

View of the horse barn on the landward side of the levee looking upstream. Fall 2015.

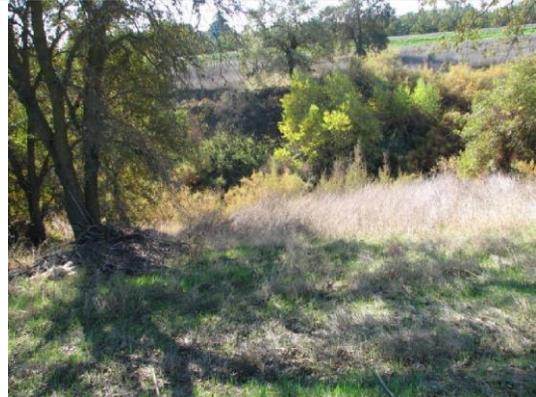
Photo 1 of 2 : UCIP_SP_2016_46681_60164.jpg

LM Start	2.26	Rating **	M	Issue No.	75
LM End	2.26	Issue Type +	En	Location *	LS
Category	Supplemental			GPS Latitude/Longitude	
				Start	End
Item	DWR UCIP Field Study			38.733675 °	38.733675 °
				-121.803009 °	-121.803009 °
DWR ID					
Comment Code					
Inspector Comment					
FS_ID:46681 DS_ID:16268 EP_NO: 2415 Repair Type: Non-Urgent Crossing Status: Indicator Found UCIP Comments: May need to install gasoline marker on WS slope. FIELD_STRUCT_DESC: 20-inch gas line through the levee 4.0 feet below the crown. Two cutoff walls. Gasline indicator found on landside of the levee (Permit No. 2415 - PG&E) FS Date: 10/5/2015 2:23:47 PM

Waterside view: no indicators found

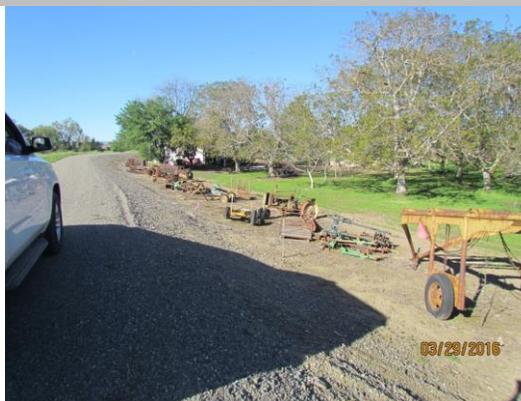
Photo 1 of 1 : SP_2016_ST0001_259_71_20160407_00075.jpg

LM Start	2.67	Rating **	M	Issue No.	71
LM End	2.74	Issue Type +	En	Location *	LS
Category	Earthen Levee		GPS Latitude/Longitude		
			Start	End	
Item	Encroachments		38.733075 °	38.733594 °	
			-121.796039 °	-121.795131 °	
DWR ID	DWR_ST0001_01_s_2016_71				
Comment Code					
EQ : Equipment					
Inspector Comment

View of the equipment on the landward side of the levee looking upstream. Spring 2016.

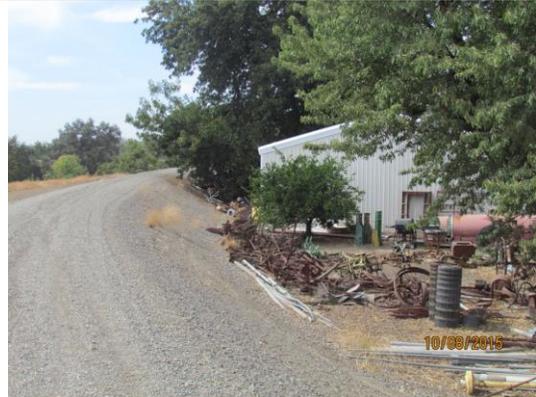
Photo 2 of 2 : SP_2016_ST0001_259_20_20160304_00022.jpg

LM Start	2.69	Rating **	M	Issue No.	20 (cont)
LM End	2.69	Issue Type +	En	Location *	LS
Category	Earthen Levee			GPS Latitude/Longitude	
				Start	End
Item	Encroachments			38.733145 °	38.733145 °
				-121.795845 °	-121.795845 °
DWR ID	DWR_ST0001_01_s_2012_20				
Comment Code					
BU : Building					
Inspector Comment

View of the building on the landward side of the levee looking upstream. Fall 2015.

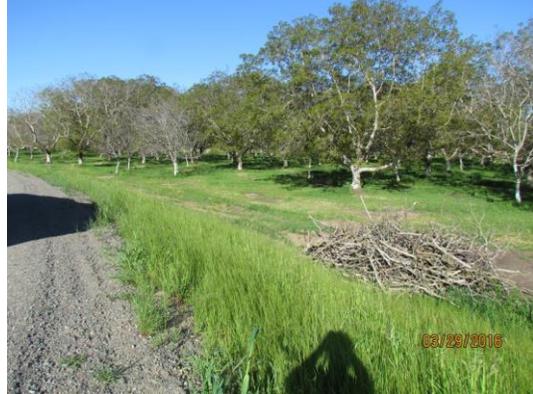
Photo 1 of 1 : SP_2016_ST0001_259_70_20160407_00074.jpg

LM Start	2.82	Rating **	M	Issue No.	70
LM End	2.82	Issue Type +	En	Location *	LS
Category	Earthen Levee		GPS Latitude/Longitude		
			Start	End	
Item	Encroachments		38.734450 °	38.734450 °	
			-121.793793 °	-121.793793 °	
DWR ID	DWR_ST0001_01_s_2016_70				
Comment Code					
PR : Prunings					
Inspector Comment

View of the pruning pile on the landward side of the levee looking upstream. Spring 2016.

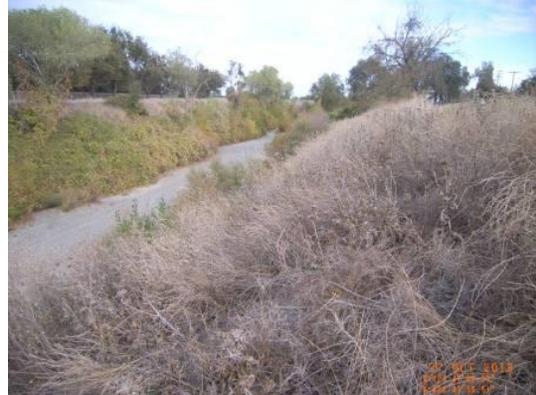
Photo 1 of 1 : SP_2016_ST0001_259_1_20160304_00001.jpg

LM Start	3.48	Rating **	A/W	Issue No.	1
LM End	3.57	Issue Type +	Ma	Location *	WS
Category	Supplemental			GPS Latitude/Longitude	
				Start	End
Item	2015 USACE Erosion Survey, DRAFT			38.732942 °	38.731626 °
				-121.784965 °	-121.785231 °
DWR ID	DWR_ST0001_01_s_2016_1				
Comment Code					
Inspector Comment					
2006 - Some significant new erosion, especially fresh upper bank slumping. Still substantial berm. 2010 - Site extended downstream, some new erosion, heavily vegetated and hard to see. Planned setback levee by CA DWR, 60% design complete, construction planned for 2012. 2011 - Construction delayed to 2013 - 2014. 2015: No observed changes. [2015 Site ID: CHC_3-4_L]

USACE 2013 Photo #1

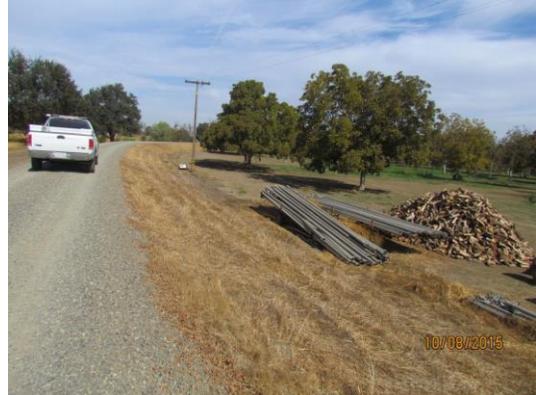
Photo 1 of 1 : SP_2016_ST0001_259_62_20160304_00053.jpg

LM Start	3.60	Rating **	M	Issue No.	62
LM End	3.60	Issue Type +	En	Location *	LS
Category	Earthen Levee			GPS Latitude/Longitude	
				Start	End
Item	Encroachments			38.731134 °	38.731134 °
				-121.785010 °	-121.785010 °
DWR ID	DWR_ST0001_01_f_2015_62				
Comment Code					
EQ : Equipment					
Inspector Comment

View of pipes on the landward side of the levee looking upstream. Fall 2015.

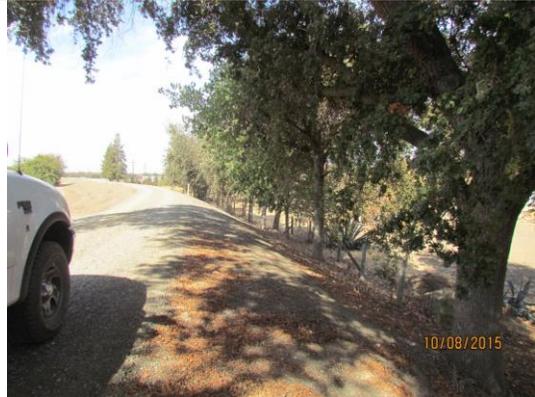
Photo 1 of 1 : SP_2016_ST0001_259_27_20160304_00026.jpg

LM Start	4.28	Rating **	M	Issue No.	27
LM End	4.43	Issue Type +	Ma	Location *	LS
Category	Earthen Levee		GPS Latitude/Longitude		
			Start	End	
Item	Vegetation		38.727047 °	38.726113 °	
			-121.774413 °	-121.771929 °	
DWR ID	DWR_ST0001_01_s_2012_27				
Comment Code					
V6 : Landscaping					
Inspector Comment

View of the landscape trees on the landward side of the levee looking upstream. Fall 2015.

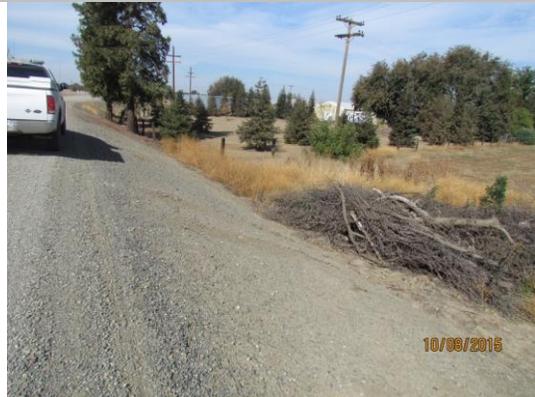
Photo 1 of 1 : SP_2016_ST0001_259_55_20160304_00048.jpg

LM Start	4.33	Rating **	M	Issue No.	55
LM End	4.33	Issue Type +	En	Location *	LS
Category	Earthen Levee		GPS Latitude/Longitude		
			Start	End	
Item	Encroachments		38.726785 °	38.726785 °	
			-121.773538 °	-121.773538 °	
DWR ID	DWR_ST0001_01_f_2013_55				
Comment Code					
PR : Prunings					
Inspector Comment

View of the pruning pile on the landward side of the levee looking upstream. Fall 2015.

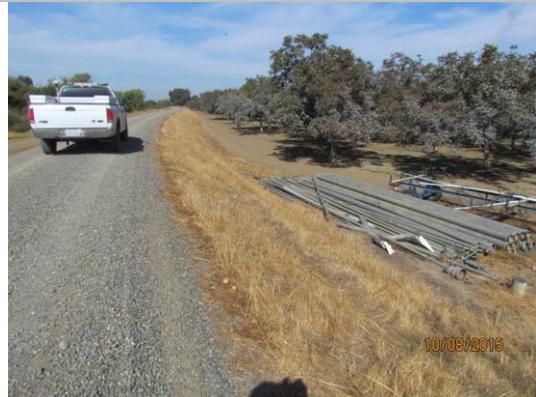
Photo 1 of 1 : SP_2016_ST0001_259_24_20160304_00023.jpg

LM Start	4.78	Rating **	M	Issue No.	24
LM End	4.78	Issue Type +	En	Location *	LS
Category	Earthen Levee		GPS Latitude/Longitude		
			Start	End	
Item	Encroachments		38.722590 °	38.722590 °	
			-121.767294 °	-121.767294 °	
DWR ID	DWR_ST0001_01_s_2012_24				
Comment Code					
PI : Pipe					
Inspector Comment

View of the aluminum irrigation pipe along the levee toe of the landward side looking upstream. Fall 2015.

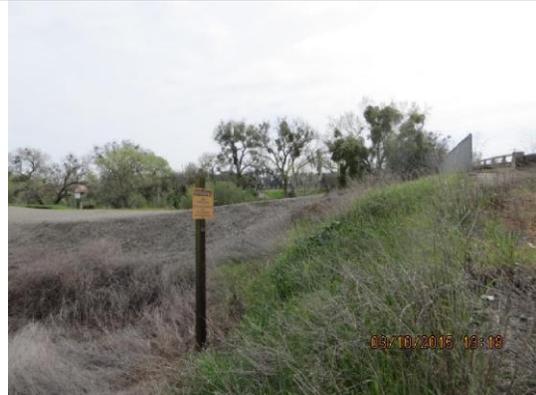
Photo 2 of 2 : UCIP_SP_2016_46685_73500.jpg

LM Start	4.98	Rating **	M	Issue No.	76
LM End	4.98	Issue Type +	En	Location *	LS
Category	Supplemental			GPS Latitude/Longitude	
				Start	End
Item	DWR UCIP Field Study			38.721038 °	38.721038 °
				-121.764180 °	-121.764180 °
DWR ID					
Comment Code					
Inspector Comment					
FS_ID:46685 DS_ID:16265 EP_NO: 7232 Repair Type: Non-Urgent Crossing Status: Indicator Found UCIP Comments: May need marker on WS. FIELD_STRUCT_DESC: Submarine Communication cable through the levee 2.5-feet below the crown. Communication marker located on eastside of highway 113 on LS toe. (Permit No. 7232 - PT&T). FS Date: 10/5/2015 2:26:16 PM

Sign on LS toe.

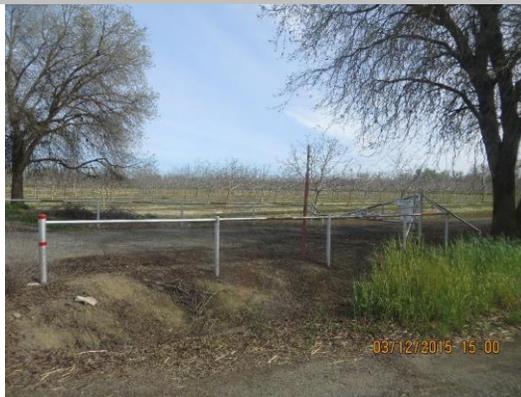
Photo 1 of 2 : UCIP_SP_2016_46686_73504.jpg

LM Start	4.99	Rating **	M	Issue No.	77
LM End	4.99	Issue Type +	En	Location *	LS
Category	Supplemental			GPS Latitude/Longitude	
				Start	End
Item	DWR UCIP Field Study			38.721025 °	38.721025 °
				-121.764147 °	-121.764147 °
DWR ID					
Comment Code					
Inspector Comment					
FS_ID:46686 DS_ID:16756 EP_NO: 3089 Repair Type: Non-Urgent Crossing Status: Indicator Found UCIP Comments: Signage in disrepair and need signs at Levee. Need to contact owner to determine status of crossing and install new signs if appropriate to do so. FIELD_STRUCT_DESC: 4-inch steel gas line through the levee 4-feet below the crown. Gasline marker located 500-feet north of levee crossing at levee access road/gate. Pipe alignment to east of bridge (Permit No. 3089, 1959). FS Date: 10/5/2015 2:26:42 PM

Gasline marker next to levee access gate 500-feet north of levee crown.

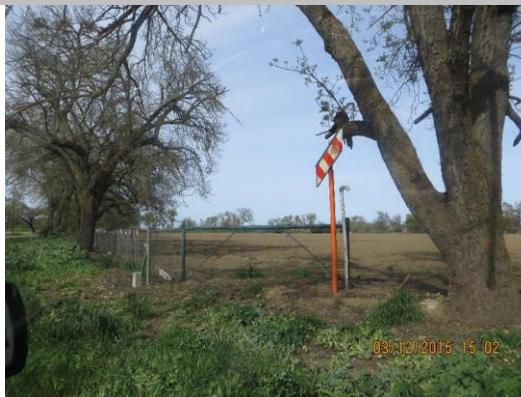
Photo 2 of 2 : UCIP_SP_2016_46686_73503.jpg

Gasline marker at Best Ranch Road, 1500-feet south of levee crossing.

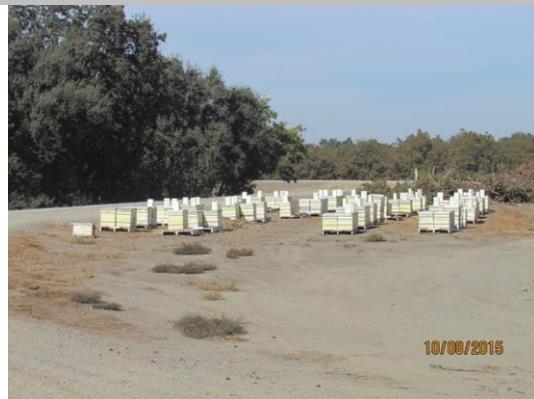
Photo 1 of 1 : SP_2016_ST0001_259_59_20160304_00051.jpg

LM Start	5.67	Rating **	M	Issue No.	59
LM End	5.67	Issue Type +	En	Location *	LS
Category	Earthen Levee			GPS Latitude/Longitude	
				Start	End
Item	Encroachments			38.723839 °	38.723839 °
				-121.755823 °	-121.755823 °
DWR ID	DWR_ST0001_01_f_2015_59				
Comment Code					
BU : Building					
Inspector Comment

View of the beehives on the landward side of the levee looking upstream. Fall 2015.

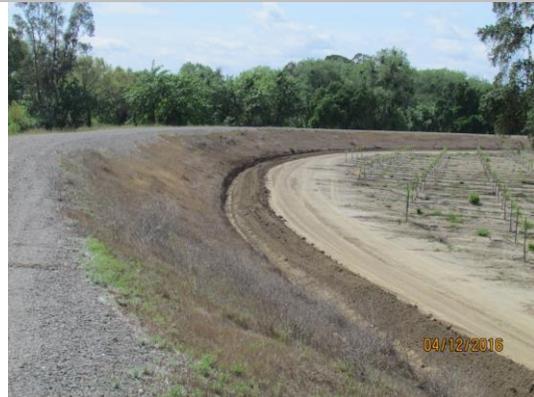
Photo 2 of 3 : SP_2016_ST0001_259_19_20160413_00076.jpg

Perspective view of the ditch along the levee toe on the landward side looking upstream. Spring 2016.

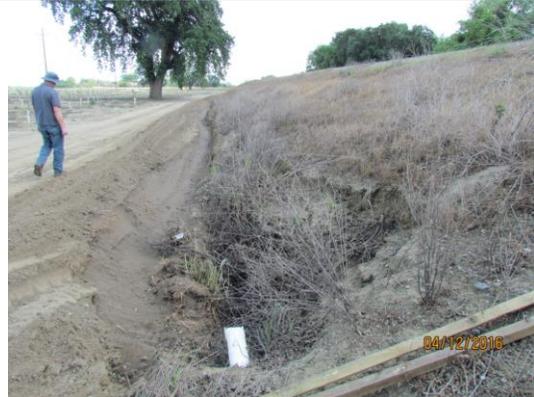
Photo 3 of 3 : SP_2016_ST0001_259_19_20160413_00079.jpg

LM Start	6.91	Rating **	M	Issue No.	19 (cont)
LM End	7.20	Issue Type +	En	Location *	LS
Category	Earthen Levee		GPS Latitude/Longitude		
			Start	End	
Item	Encroachments		38.728051 °	38.727472 °	
			-121.735366 °	-121.730309 °	
DWR ID	DWR_ST0001_01_s_2016_19				
Comment Code					
DT : Ditch					
Inspector Comment					
Ditch is freshly dug at the toe of the levee. About 3 feet wide and 1.5 ft deep. V-ditch.

View of the ditch and pvc pipe looking upstream. Spring 2016.

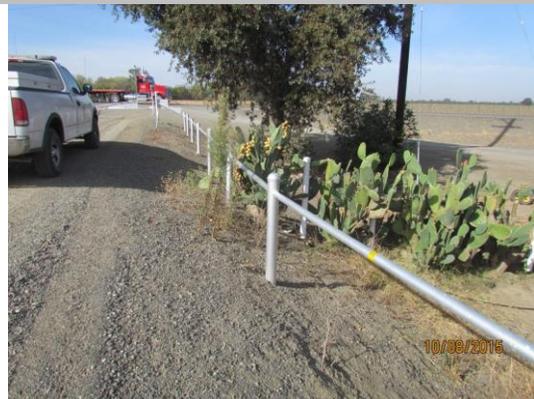
Photo 1 of 1 : SP_2016_ST0001_259_57_20160304_00050.jpg

LM Start	7.25	Rating **	M	Issue No.	57
LM End	7.25	Issue Type +	En	Location *	LS
Category	Earthen Levee		GPS Latitude/Longitude		
			Start	End	
Item	Vegetation		38.727705 °	38.727705 °	
			-121.729462 °	-121.729462 °	
DWR ID	DWR_ST0001_01_f_2015_57				
Comment Code					
V6 : Landscaping					
Inspector Comment

View of the cactus on the landward side of the levee looking upstream. Fall 2015.

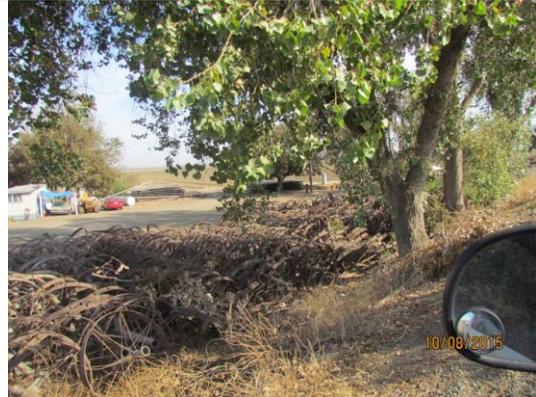
Photo 2 of 2 : SP_2016_ST0001_259_40_20160304_00036.jpg

LM Start	7.30	Rating **	M	Issue No.	40 (cont)
LM End	7.34	Issue Type +	En	Location *	LS
Category	Earthen Levee			GPS Latitude/Longitude	
				Start	End
Item	Encroachments			38.727878 °	38.728085 °
				-121.728553 °	-121.727740 °
DWR ID	DWR_ST0001_01_s_2012_40				
Comment Code					
EQ : Equipment					
Inspector Comment

View of the equipment at the levee toe on the landward side looking downstream. Fall 2015.

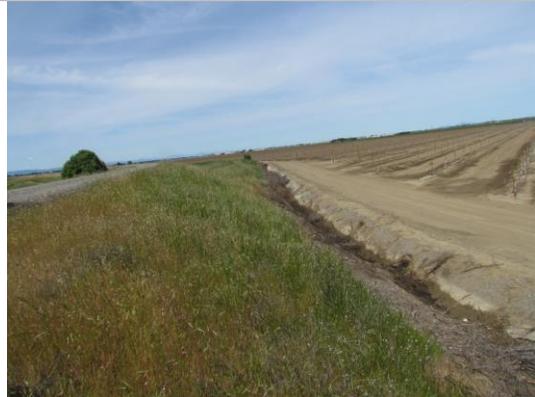
Photo 1 of 2 : SP_2016_ST0001_259_26_20160304_00024.jpg

View of ditch on the landward side of the levee looking upstream. Spring 2015.

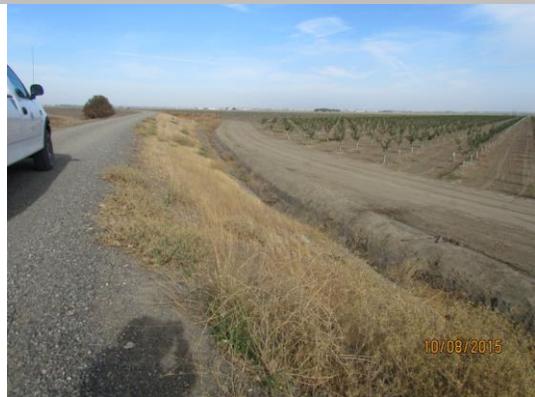
Photo 2 of 2 : SP_2016_ST0001_259_26_20160304_00025.jpg

View of the ditch on the landward side of the levee looking upstream. Fall 2015.

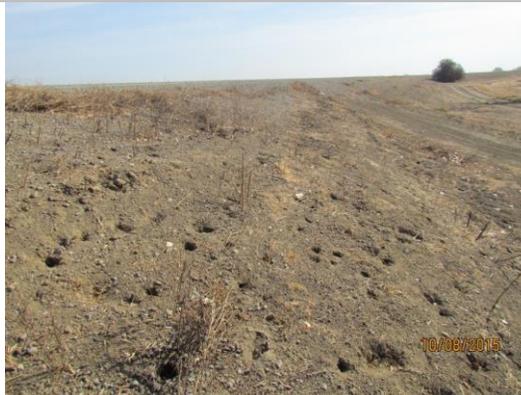
Photo 1 of 1 : SP_2016_ST0001_259_54_20160304_00047.jpg

LM Start	7.60	Rating **	M	Issue No.	54
LM End	7.60	Issue Type +	Ma	Location *	WS
Category	Earthen Levee		GPS Latitude/Longitude		
			Start	End	
Item	Animal Control		38.729218 °	38.729218 °	
			-121.723325 °	-121.723325 °	
DWR ID	DWR_ST0001_01_f_2015_54				
Comment Code					
A3 : No rodents visible, but rodent burrows visible; need to backfill and compact or grout burrows.					
Inspector Comment

View of the rodent holes on the waterward side of the levee looking downstream. Fall 2015.

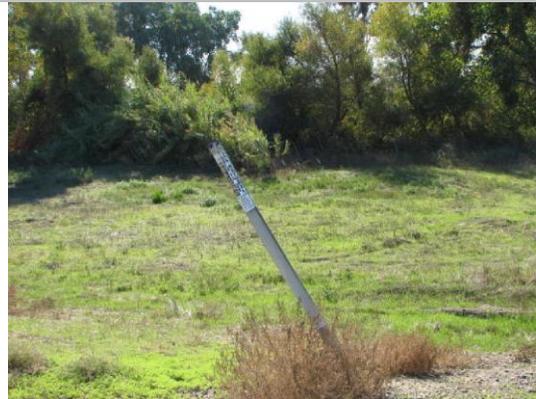
Photo 1 of 2 : UCIP_SP_2016_46696_60197.jpg

LM Start	7.89	Rating **	M	Issue No.	78
LM End	7.89	Issue Type +	En	Location *	WS
Category	Supplemental			GPS Latitude/Longitude	
				Start	End
Item	DWR UCIP Field Study			38.727333 °	38.727333 °
				-121.718558 °	-121.718558 °
DWR ID					
Comment Code					
Inspector Comment					
FS_ID:46696 DS_ID:16264 EP_NO: 12983 Repair Type: Non-Urgent Crossing Status: Indicator Found UCIP Comments: Gasline markers in disrepair and should be replaced. Gasline indicator found on waterside of the levee. FIELD_STRUCT_DESC: 6-inch diameter gas pipeline through the levee (App. No. 12983 - Shell Oil Co.). To install a 4-inch and 6-inch gas pipeline crossing Cache Creek, Cache Creek levees, and the Cache Creek Settling Basin. FS Date: 10/5/2015 2:37:25 PM

Waterside view: gasline indicator

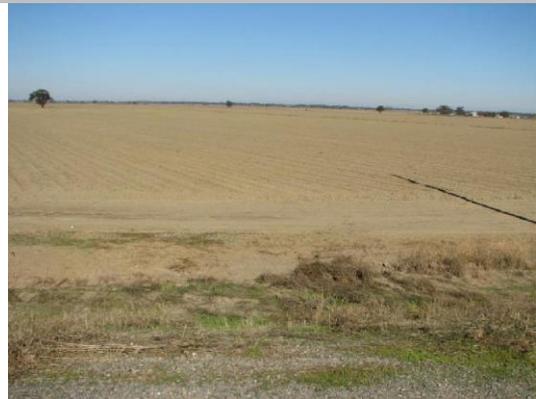
Photo 2 of 2 : UCIP_SP_2016_46696_60196.jpg

Landside view: no indicator found.

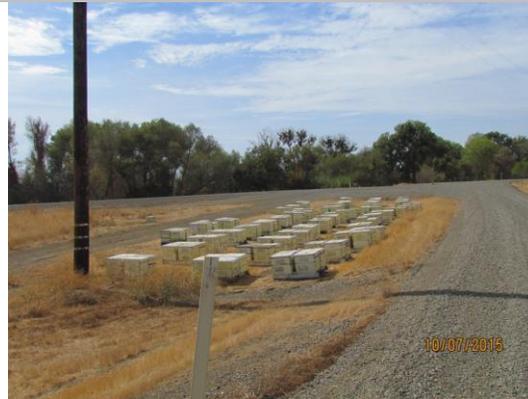
Photo 1 of 1 : SP_2016_ST0001_259_50_20160304_00043.jpg

LM Start	7.95	Rating **	M	Issue No.	50
LM End	7.95	Issue Type +	En	Location *	WS
Category	Earthen Levee		GPS Latitude/Longitude		
			Start	End	
Item	Encroachments		38.727271 °	38.727271 °	
			-121.717595 °	-121.717595 °	
DWR ID	DWR_ST0001_01_f_2015_50				
Comment Code					
BU : Building					
Inspector Comment

View of the beehives on the waterward side of the levee looking upstream. Fall 2015.

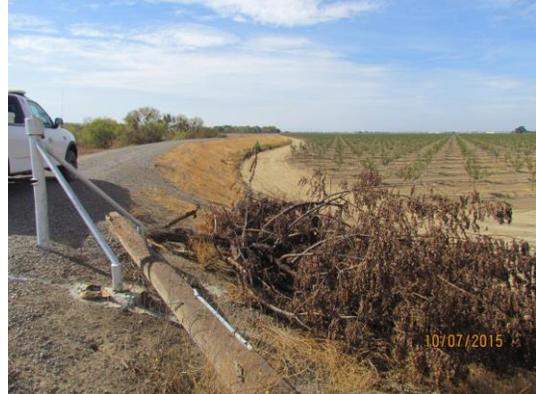
Photo 1 of 1 : SP_2016_ST0001_259_46_20160304_00039.jpg

LM Start	8.38	Rating **	M	Issue No.	46
LM End	8.38	Issue Type +	En	Location *	LS
Category	Earthen Levee		GPS Latitude/Longitude		
			Start	End	
Item	Encroachments		38.726502 °	38.726502 °	
			-121.709818 °	-121.709818 °	
DWR ID	DWR_ST0001_01_f_2015_46				
Comment Code					
PR : Prunings					
Inspector Comment

View of the pile of prunings on the landward side of the levee looking upstream. Fall 2015.

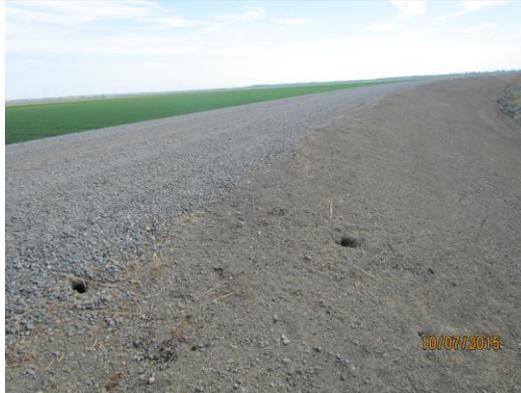
Photo 2 of 2 : SP_2016_ST0001_259_37_20160304_00032.jpg

LM Start	9.38	Rating **	M	Issue No.	37 (cont)
LM End	9.38	Issue Type +	Ma	Location *	WS
Category	Earthen Levee			GPS Latitude/Longitude	
				Start	End
Item	Animal Control			38.719392 °	38.719392 °
				-121.696879 °	-121.696879 °
DWR ID	DWR_ST0001_01_f_2015_37				
Comment Code					
A3 : No rodents visible, but rodent burrows visible; need to backfill and compact or grout burrows.					
Inspector Comment

View of the rodent hole on the waterward side of the levee looking downstream. Fall 2015.

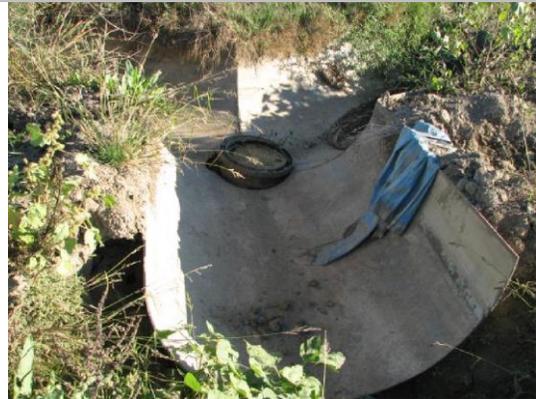
Photo 1 of 2 : UCIP_SP_2016_46707_60148.jpg

LM Start	10.75	Rating **	U	Issue No.	72
LM End	10.75	Issue Type +	En	Location *	WS
Category	Supplemental		GPS Latitude/Longitude		
			Start	End	
Item	DWR UCIP Field Study		38.701814 °	38.701814 °	
			-121.690832 °	-121.690832 °	
DWR ID					
Comment Code					
Inspector Comment					
FS_ID:46707 DS_ID:17119 EP_NO: N/A Repair Type: Urgent Crossing Status: Found UCIP Comments: Pipe leaks, severe erosion from levee shoulder to pipe daylight on landside levee slope, summer of 2013 repaired erosion, pipe needs repaired. FIELD_STRUCT_DESC: A 18-inch soil proofed Steel Pipe 0.25" thick. FS Date: 10/5/2015 2:47:13 PM

Waterside view: pipe in the ditch

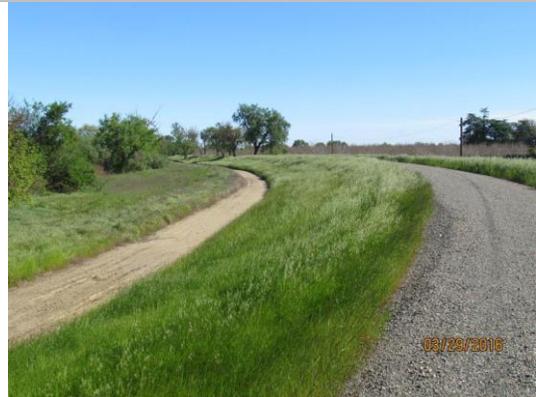
Photo 1 of 1 : SP_2016_ST0001_260_4_20160407_00024.jpg

LM Start	0.03	Rating **	M	Issue No.	4
LM End	4.11	Issue Type +	Ma	Location *	WS
Category	Earthen Levee		GPS Latitude/Longitude		
			Start	End	
Item	Vegetation		38.727475 °	38.724525 °	
			-121.806003 °	-121.751916 °	
DWR ID	DWR_ST0001_02_s_2016_4				
Comment Code					
V1 : Control annual grass and weeds on the levee slopes and easements.					
Inspector Comment

View of the vegetation on the waterward side of the levee looking downstream. Spring 2016.

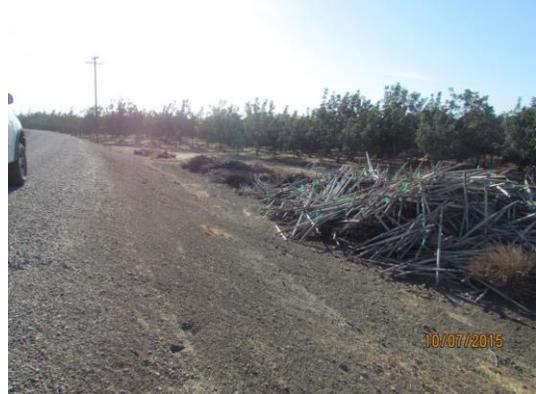
Photo 1 of 1 : SP_2016_ST0001_260_1_20160304_00001.jpg

LM Start	0.68	Rating **	M	Issue No.	1
LM End	0.68	Issue Type +	En	Location *	LS
Category	Earthen Levee			GPS Latitude/Longitude	
				Start	End
Item	Encroachments			38.732293 °	38.732293 °
				-121.799071 °	-121.799071 °
DWR ID	DWR_ST0001_02_s_2012_1				
Comment Code					
DE : Debris					
Inspector Comment

View of the prunings and stakes at the toe of the landward side of the levee looking downstream. Fall 2015.

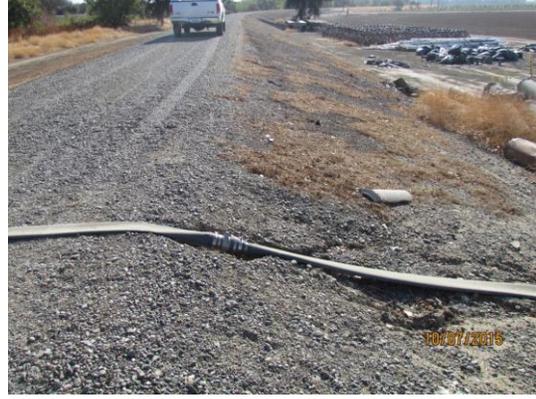
Photo 2 of 2 : SP_2016_ST0001_260_19_20160304_00015.jpg

View of the hose that goes from the landward side to the waterward side of the levee looking downstream. Fall 2015.

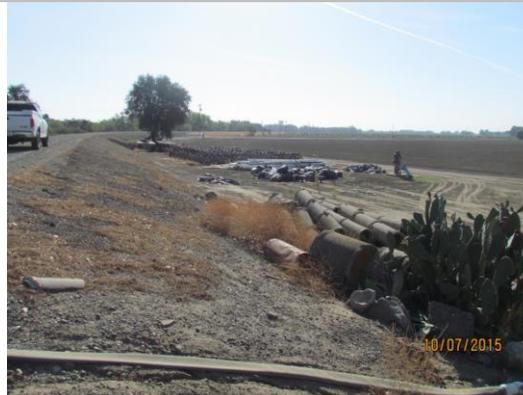
Photo 1 of 1 : SP_2016_ST0001_260_3_20160304_00003.jpg

LM Start	2.40	Rating **	M	Issue No.	3
LM End	2.40	Issue Type +	Ma	Location *	LS
Category	Earthen Levee		GPS Latitude/Longitude		
			Start	End	
Item	Encroachments		38.726182 °	38.726182 °	
			-121.774835 °	-121.774835 °	
DWR ID	DWR_ST0001_02_s_2012_3				
Comment Code					
DE : Debris					
Inspector Comment

View of the concrete pile at the toe of the landward side of the levee looking downstream. Fall 2015.

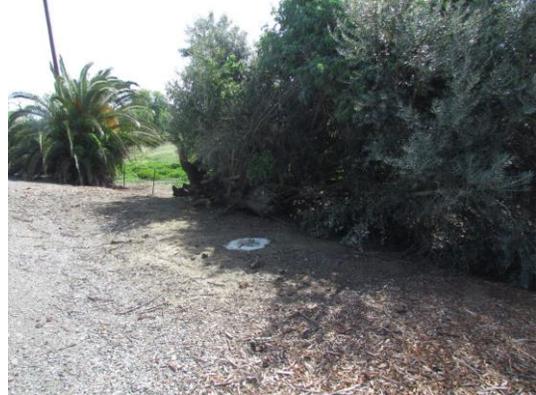
Photo 1 of 1 : SP_2016_ST0001_260_435_20160304_00023.jpg

LM Start	3.32	Rating **	M	Issue No.	435
LM End	3.32	Issue Type +	En	Location *	LS
Category	Earthen Levee			GPS Latitude/Longitude	
				Start	End
Item	Vegetation			38.719648 °	38.719648 °
				-121.760691 °	-121.760691 °
DWR ID	DWR_ST0001_02_f_2014_435				
Comment Code					
V6 : Landscaping					
Inspector Comment

View of the landscaping vegetation on the landward side of the levee looking downstream. The pile of pruning has been removed. Spring 2015.

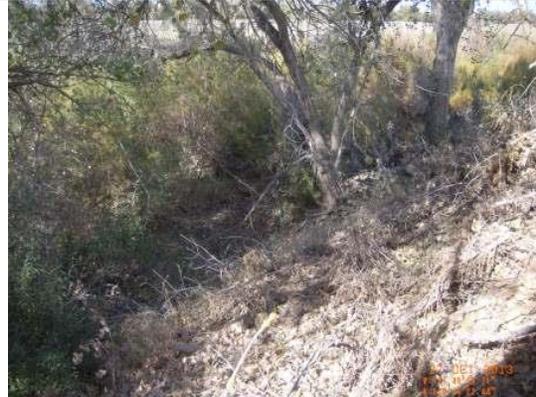
Photo 1 of 1 : SP_2016_ST0001_260_2_20160304_00002.jpg

LM Start	3.53	Rating **	M	Issue No.	2
LM End	3.60	Issue Type +	Ma	Location *	WS
Category	Supplemental			GPS Latitude/Longitude	
				Start	End
Item	2015 USACE Erosion Survey, DRAFT			38.722138 °	38.723294 °
				-121.759736 °	-121.759588 °
DWR ID	DWR_ST0001_02_s_2016_2				
Comment Code					
Inspector Comment					
2010 - Large slump on the upper berm, a tree has recently slid down the slope. 2011 - Large slump and new erosion. 2012 - Slightly steeper slopes and cracks observed. 2015: No observed changes. [2015 Site ID: CHC_3-5_R]

USACE 2013 Photo #1

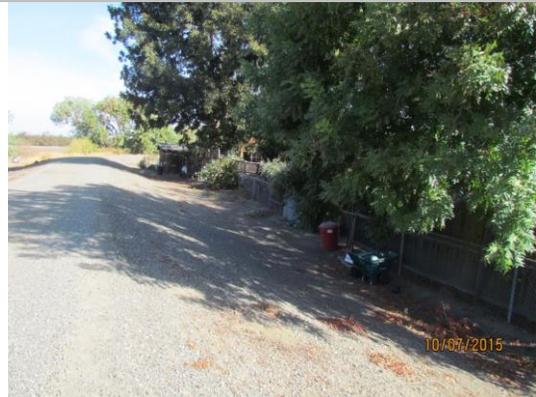
Photo 1 of 1 : SP_2016_ST0001_260_7_20160304_00005.jpg

LM Start	3.53	Rating **	A/W	Issue No.	7
LM End	3.62	Issue Type +	Ma	Location *	LS
Category	Earthen Levee			GPS Latitude/Longitude	
				Start	End
Item	Vegetation			38.722228 °	38.723322 °
				-121.759663 °	-121.759317 °
DWR ID	DWR_ST0001_02_s_2012_7				
Comment Code					
V6 : Landscaping					
Inspector Comment

View of the landscaping and fence on the landward side of the levee looking downstream. Fall 2015.

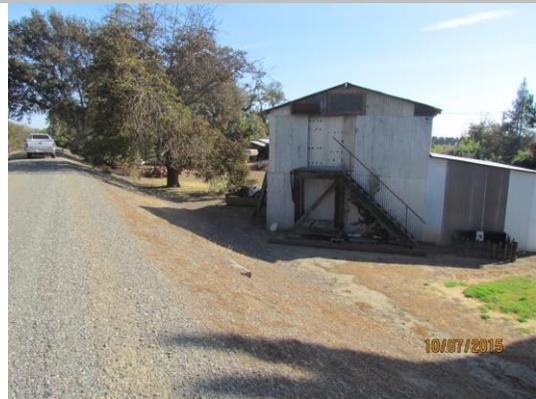
Photo 1 of 1 : SP_2016_ST0001_260_8_20160304_00006.jpg

LM Start	4.06	Rating **	M	Issue No.	8
LM End	4.06	Issue Type +	En	Location *	LS
Category	Earthen Levee		GPS Latitude/Longitude		
			Start	End	
Item	Encroachments		38.723997°	38.723997°	
			-121.752505°	-121.752505°	
DWR ID	DWR_ST0001_02_s_2012_8				
Comment Code					
BU : Building					
Inspector Comment					
Building is within the easement of the levee.

View of the building on the landward side of the levee looking downstream. Fall 2015.

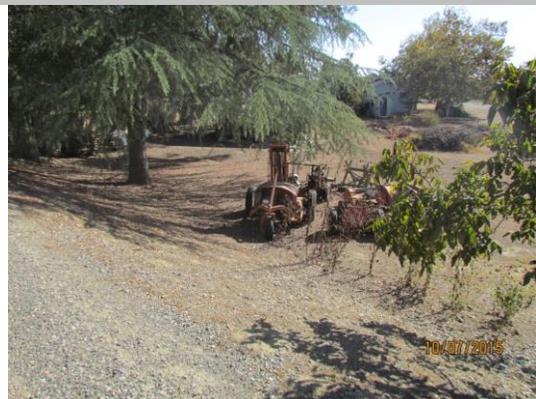
Photo 1 of 1 : SP_2016_ST0001_260_26_20160304_00021.jpg

LM Start	4.08	Rating **	M	Issue No.	26
LM End	4.08	Issue Type +	En	Location *	LS
Category	Earthen Levee		GPS Latitude/Longitude		
			Start	End	
Item	Encroachments		38.724200°	38.724200°	
			-121.752272°	-121.752272°	
DWR ID	DWR_ST0001_02_f_2013_26				
Comment Code					
EQ : Equipment					
Inspector Comment

View of the equipment at the toe of the landward side of the levee. Fall 2015.

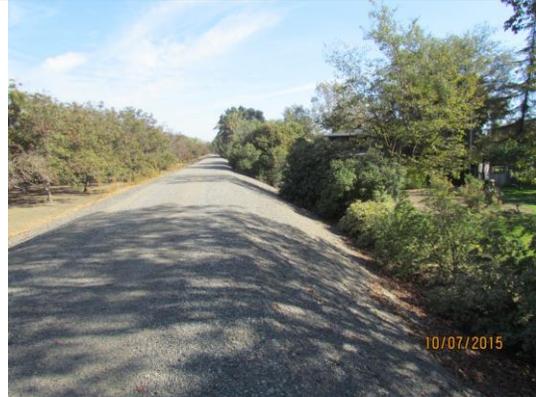
Photo 1 of 1 : SP_2016_ST0001_260_9_20160304_00007.jpg

LM Start	4.09	Rating **	M	Issue No.	9
LM End	4.18	Issue Type +	En	Location *	LS
Category	Earthen Levee		GPS Latitude/Longitude		
			Start	End	
Item	Vegetation		38.724317 °	38.725242 °	
			-121.752148 °	-121.751075 °	
DWR ID	DWR_ST0001_02_s_2012_9				
Comment Code					
V6 : Landscaping					
Inspector Comment

View of the landscaping vegetation on the landward side of the levee looking downstream. Fall 2015.

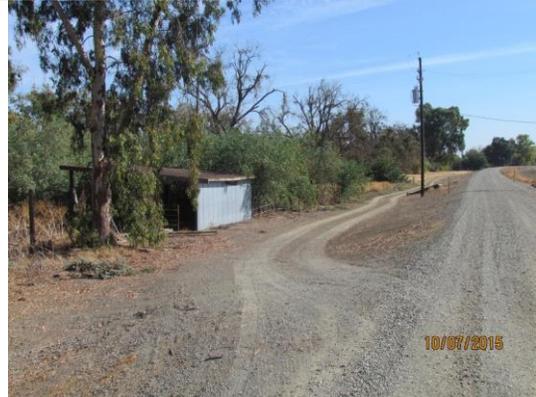
Photo 1 of 1 : SP_2016_ST0001_260_27_20160304_00022.jpg

LM Start	4.49	Rating **	M	Issue No.	27
LM End	4.49	Issue Type +	En	Location *	WS
Category	Earthen Levee		GPS Latitude/Longitude		
			Start	End	
Item	Encroachments		38.727065 °	38.727065 °	
			-121.746002 °	-121.746002 °	
DWR ID	DWR_ST0001_02_f_2013_27				
Comment Code					
BU : Building					
Inspector Comment

View of the horse corral and building on the waterward side of the levee looking downstream. Fall 2015.

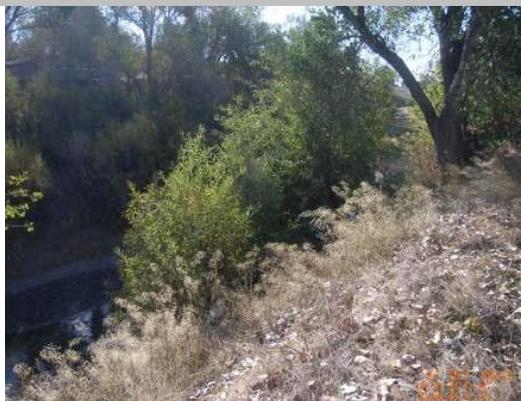
Photo 1 of 1 : SP_2016_ST0001_260_13_20160304_00012.jpg

LM Start	5.33	Rating **	A/W	Issue No.	13
LM End	5.37	Issue Type +	Ma	Location *	WS
Category	Supplemental		GPS Latitude/Longitude		
			Start	End	
Item	2015 USACE Erosion Survey, DRAFT		38.722933 °	38.723467 °	
			-121.760561 °	-121.760436 °	
DWR ID	DWR_ST0001_02_s_2016_13				
Comment Code					
Inspector Comment					
2009 - Erosion into the levee slope. 2010 - Minor new erosion. 2011 - New erosion and a freshly fallen tree. 2012 - New animal holes and slightly steeper slopes. 2013 - New tree popout and 2 feet of erosion along the top bank. 2015: No observed changes. [2015 Site ID: CHC_5-4_L]

USACE 2013 Photo #1

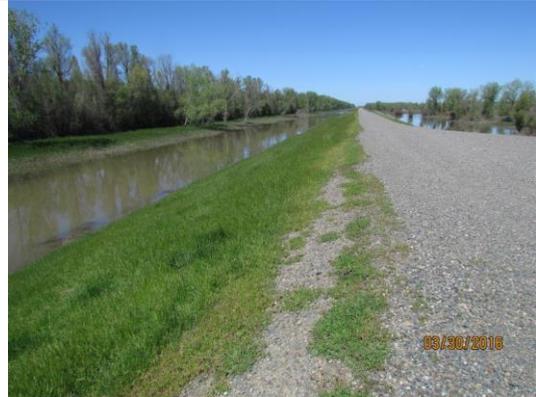
Photo 1 of 1 : SP_2016_ST0001_261_1_20160411_00001.jpg

LM Start	0.00	Rating **	M	Issue No.	1
LM End	2.25	Issue Type +	Ma	Location *	LS
Category	Earthen Levee		GPS Latitude/Longitude		
			Start	End	
Item	Vegetation		38.727196°	38.695490°	
			-121.718264°	-121.715930°	
DWR ID	DWR_ST0001_04_s_2016_1				
Comment Code					
V1 : Control annual grass and weeds on the levee slopes and easements.					
Inspector Comment					
Both sides of the levee are waterward side. This side is on the Cache Creek side.

View of the vegetation on the slope of the levee looking upstream. Spring 2016.

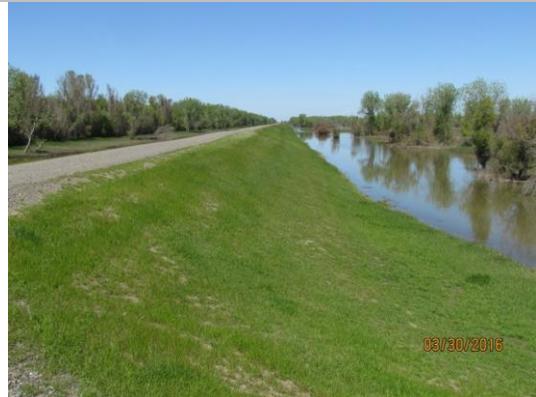
Photo 1 of 1 : SP_2016_ST0001_261_2_20160411_00002.jpg

LM Start	0.02	Rating **	M	Issue No.	2
LM End	2.25	Issue Type +	Ma	Location *	WS
Category	Earthen Levee		GPS Latitude/Longitude		
			Start	End	
Item	Vegetation		38.727022°	38.695490°	
			-121.717916°	-121.715930°	
DWR ID	DWR_ST0001_04_s_2016_2				
Comment Code					
V1 : Control annual grass and weeds on the levee slopes and easements.					
Inspector Comment					
This side is on the Cache Creek Settling Basin.

View of the vegetation on the slope of the levee looking upstream. Spring 2016.
