**Flood Control Project Maintenance  
Levee Inspections**

## Maintenance Issue Types Only, Levee Inspection Report By Mile - Spring 2018

### Sacramento Maintenance Yard Putah Creek

Waterway	Bank	Unit Miles	Inspection Start/End	Inspector
Unit No. 01 Putah Creek or North Levee	Left	8.79	03/08/2018 03/08/2018	Keith Millard

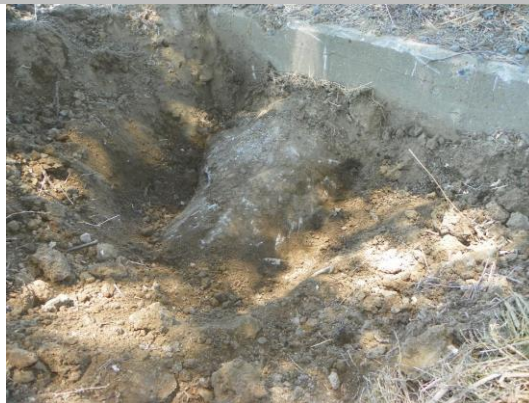
Photo 1 of 3 : UCIP\_SP\_2018\_33374\_60426.jpg

FS\_ID:33374  
DS\_ID:499  
EP\_NO: 10256  
Repair Type: No Action Needed  
Crossing Status: Found  
UCIP Comments: 09/14/2017 Permit review authorized this crossing as an irrigation pipe with pump located on WS. Structure type was changed from drainage to irrigation. Also need an additional photo to show that both WS and LS were capped with concrete, there is only one photo showing concrete used to plug the inlet or outlet. (DWR UCIP - O. Magana)  
05/06/2013 inlet and outlet are capped with concrete. See pictures (DWR Sacramento Yard - unknown)  
04/04/2012 unable to determine if end of pipe is CAP with concrete. Dirt needs to be removed from both ends to verify proper abandonment. (DWR UCIP - W. Wylie)  
FIELD\_STRUCT\_DESC: \*ABANDONED\* 24-inch corrugated metal irrigation pipe through the levee, 9.5 feet below the crown. Headwalls on both the waterside (WS) and landside (LS). Pump is located on the WS, not found 2012. (24-inch pipe [HLM 4.90] authorized under Automatic Board Order (ABO) issued as Permit No. 10256, 1974 - Albert H. Lederer). [Additional Reference(s): DWR Levee Log, 2005. USACE Sacramento O&M Manual 119, December 1952, (Station 56+25 PCT)].

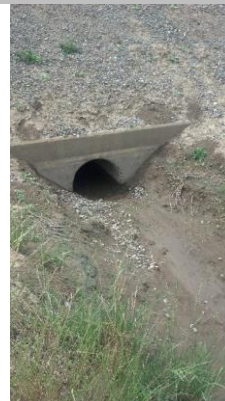
Photo 1 of 3 : UCIP\_SP\_2018\_33371\_60418.jpg

FS\_ID:33371  
DS\_ID:500  
EP\_NO: 10256  
Repair Type: No Action Needed  
Crossing Status: Found  
UCIP Comments: Debris removed. See picture  
FIELD\_STRUCT\_DESC: 24-inch corrugated metal drainage pipe through the levee, 15 feet below the crown. Slide gate on the waterside (WS) end. Concrete headwall on the landside (LS) end. (24-inch pipe [HLM 5.39] authorized under Automatic Board Order (ABO) issued as Permit No. 10256, 1974 - Albert H. Lederer). [Additional Reference(s): DWR Levee Log, 2005. USACE Sacramento O&M Manual 119, December 1952, (Station 83+70 PCT)].  
FS Date: 4/10/2014 2:37:39 PM
