**Flood Control Project Maintenance  
Levee Inspections**

## Maintenance Issue Types Only, Levee Inspection Report By Mile - Spring 2019

### Sacramento Maintenance Yard Putah Creek

Waterway	Bank	Unit Miles	Inspection Start/End	Inspector
Unit No. 01 Putah Creek or North Levee	Left	8.79	04/18/2019 04/18/2019	David Julian

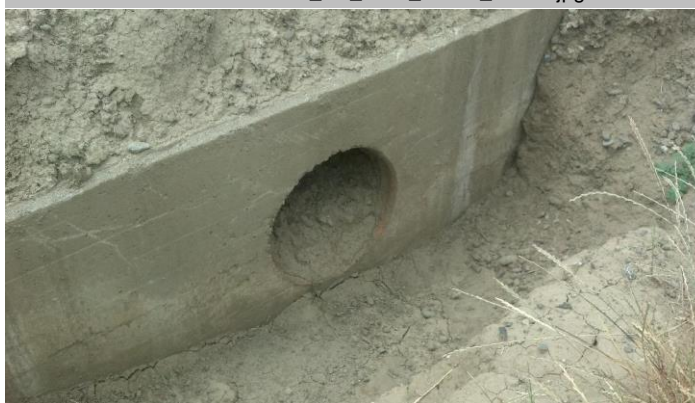
Photo 1 of 3 : UCIP\_SP\_2019\_33328\_60329.jpg

Comment Code					
Inspector Comment					
FS_ID:33328					
DS_ID:520					
EP_NO: 10247					
Repair Type: No Action Needed					
Crossing Status: Found					
UCIP Comments: Cleaned inlet and outlets. Owner of pipe may need to clean pipe					
FIELD_STRUCT_DESC: 24-inch corrugated metal drainage pipe through the levee, 8 feet below the crown. Slide gate on the waterside (WS) end. (24-inch pipe [HLM 8.45] authorized under Automatic Board Order (ABO) issued as Permit No. 10247, 1974 - University of California, Office of the Regents). [Additional Reference(s): DWR Levee Log, 2005. USACE Sacramento O&M Manual 119, December 1952, (Station 241+50 PCT)].					
FS Date: 4/10/2014 2:23:46 PM

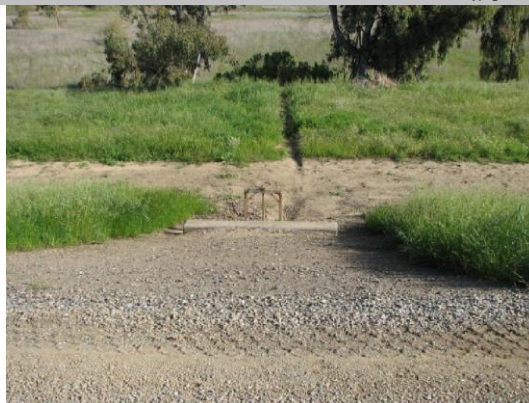
Photo 1 of 3 : UCIP\_SP\_2019\_33369\_60411.jpg

Comment Code						
Inspector Comment						
FS_ID:33369 DS_ID:16620 EP_NO: 10267 Repair Type: No Action Needed Crossing Status: Found UCIP Comments: Gate has been oiled and debris removed from outlet on land side FIELD_STRUCT_DESC: 24-inch corrugated metal drainage pipe through the levee, 13 feet below the crown. Slide gate on the waterside (WS) slope. Concrete headwalls on both ends. (24-inch pipe [HLM 5.56] authorized under Automatic Board Order (ABO) issued as Permit No. 10267, 1974 - Davis Laboratories, Inc.). [Additional Reference(s): DWR Levee Log, 2005. USACE Sacramento O&M Manual 119, December 1952, (Station 177+80 PCT)]. FS Date: 4/10/2014 2:35:57 PM
