**Flood Control Project Maintenance  
Levee Inspections**  
**LMA District Cover Sheet**  
**Spring 2017 Levee Inspection Results**

**Sutter Maintenance Yard Wadsworth Canal**

**Levee Inspection Report By Mile - Spring 2017**

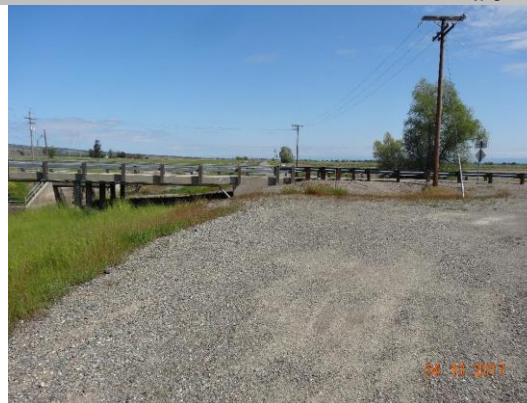
Photo 1 of 3 : UCIP\_SP\_2017\_51501\_76953.jpg

LM Start	<b>3.30</b>	Rating **	M	Issue No.	<b>112 (cont)</b>
LM End	<b>3.30</b>	Issue Type +	En	Location *	WS

Levee overview looking upstream.

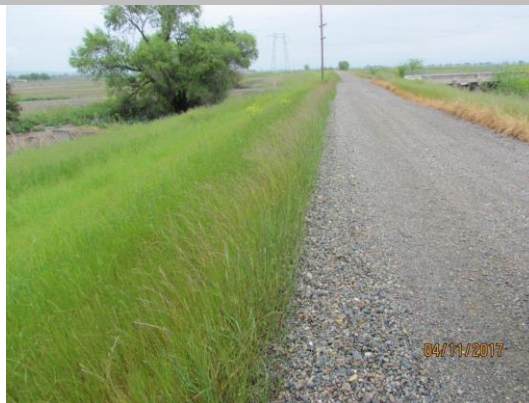
Photo 2 of 2 : SP\_2017\_ST0010\_43\_22\_20170413\_00039.jpg

LM Start	2.95	Rating **	M	Issue No.	22 (cont)	
LM End	2.95	Issue Type +	Ob	Location *	LS	
Category	Earthen Levee			GPS Latitude/Longitude		
				Start		End
Item	Cracking			39.148938 °		39.148938 °
				-121.737620 °		-121.737620 °
DWR ID	DWR_ST0010_02_f_2016_22					
Comment Code						
CR1 : Monitor and have inspected by geotechnical engineer.						
Inspector Comment						
Longitudinal cracks caused by fat clay.

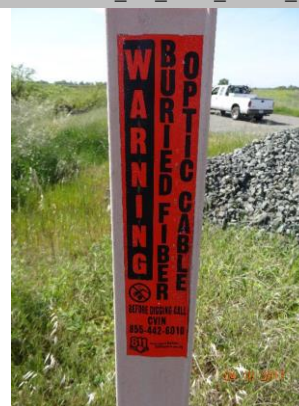
Photo 1 of 3 : UCIP\_SP\_2017\_51516\_76965.jpg

LM Start	<b>3.28</b>	Rating **	M	Issue No.	<b>29 (cont)</b>
LM End	<b>3.28</b>	Issue Type +	En	Location *	LS

Close up of marker.

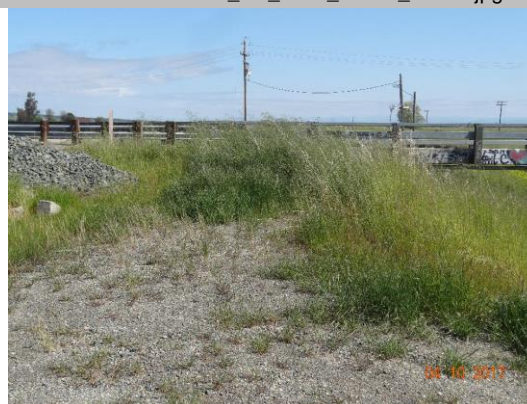
Photo 2 of 3 : UCIP\_SP\_2017\_51516\_76966.jpg

Levee crown overview looking upstream
