**Flood Control Project Maintenance
Levee Inspections**
LMA District Cover Sheet
Spring 2018 Levee Inspection Results

Spring 2018 Levee Inspection Results

Sutter Maintenance Yard Wadsworth Canal

Waterway			Bank	Unit Miles
Unit No. 01 Wadsworth Canal			Left	4.63
	Spring (March - May)	Summer (June - August)	(September - November) Fall	Winter (December - February)
Unit Maintenance Rating (Fall Only)				
Date of Inspection	3/29/2018 - 3/29/2018			
DWR Inspector	Bob Duffey			
Accompanied By	Steve Beckley Sutter Maintenance Yard

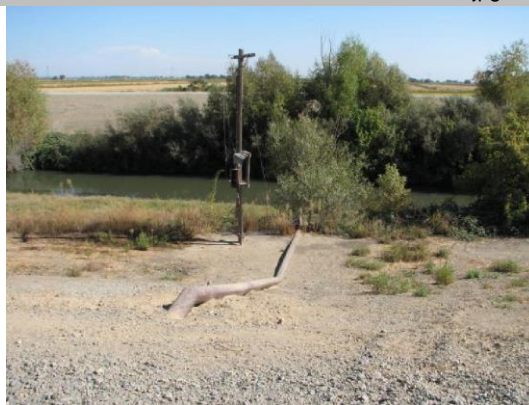
Photo 2 of 3 : UCIP_SP_2018_51506_64727.jpg

FS_ID:51506
DS_ID:17069
EP_NO: N/A
Repair Type: Non-Urgent
Crossing Status: Found
UCIP Comments: 4/10/2017 Abandoned crossing with heavy rodent activity around it. Needs to be removed. (DWR Sutter Yard-AFreitag)10/12/2016 Abandoned crossing.(DWR Sutter Yard -afreitag)4/19/2016 Abandoned crossing. Rodent activity still present on WS slope.5/12/2015 Abandoned crossing. Signs of rodent activity on both sides of levee.11/18/2014 Same as last inspection.5/13/2014 Same as last inspection.10/29/2013 Same as last inspection.5/16/2013 Same as last inspection.10/9/2012 Pipe appears improperly abandoned. No motor present, electrical equipment is stripped. Heavy rodent activity along pipe WS and LS. Pipe needs to be removed or properly abandoned.
FIELD_STRUCT_DESC: *ABANDONED* 10-inch steel irrigation pipe through the levee, 4.8 feet below the crown. Pump mounted on concrete pad near canal bank located on the waterside (WS). Service pole located on the berm. 36-inch concrete standpipe located on the landside (LS) toe. (Permit No. 945, 1944 - Becker). [Additional Reference(s): DWR Levee Log, 2005. USACE Sacramento O&M Manual 135, May 1953, (Station 61+10)].

Pipe and pump facilities on WS slope.

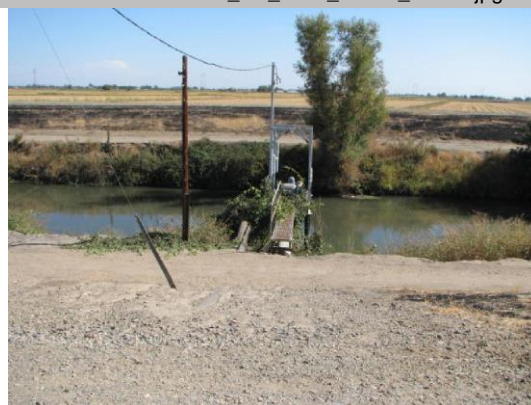
Photo 3 of 3 : UCIP_SP_2018_51512_64734.jpg

Pipe on left without pump.

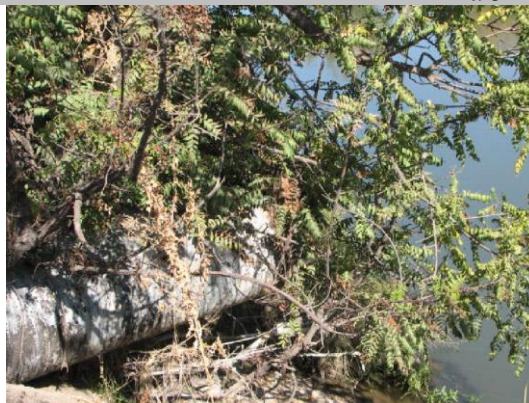
Photo 3 of 3 : UCIP_SP_2018_51515_64742.jpg

Comment Code						
Inspector Comment						
FS_ID:51515 DS_ID:17077 EP_NO: 7209 Repair Type: Non-Urgent Crossing Status: Found UCIP Comments: 4/10/2017 Tree still present and a problem at the WS pipe outlet. LS inlet is still vegetated. (DWR Sutter Yard-AFreitag)10/12/2016 Tree at the WS pipe end is still an issue and needs to be cut away. LS inlet is also being overgrown with vegetation.(DWR Sutter Yard - afreitag)4/19/2016 Tree at WS pipe end needs to be trimmed back and/or removed. 5/12/2015 Tree growing near WS pipe end is getting too big and will affect the crossing. It needs to be cut back or removed.11/18/2014 Same as last inspection.5/13/2014 Same as last inspection.10/29/2013 Same as last inspection.5/16/2013 Same as last inspection. FIELD_STRUCT_DESC: 36-inch corrugated metal drainage pipe (permit records indicate 30-inch pipe, O&M pipe replaced with new 30-inch pipe) through the levee, 14 feet below the crown. Flap gate located on the waterside (WS) end. (Original O&M manual crossing was replaced under Permit No. 7209, 1970 - Department of Water Resources [DWR]). [Additional Reference(s): DWR Levee Log, 2005. USACE Sacramento O&M Manual 135, May 1953, (Station 158+35)]. FS Date: 4/12/2017 10:16:27 AM

Pipe and flap gate at WS outlet.

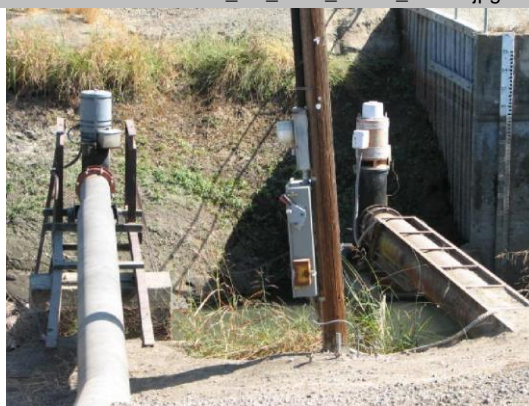
Photo 1 of 2 : UCIP_SP_2018_51517_64761.jpg

Pump on steel pier at WS toe.

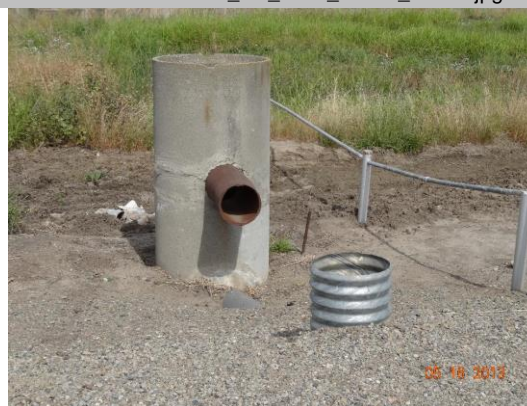
Photo 2 of 3 : UCIP_SP_2018_51518_64763.jpg

Comment Code						
Inspector Comment						
FS_ID:51518 DS_ID:17081 EP_NO: 5622 Repair Type: Urgent Crossing Status: Found UCIP Comments: 4/10/2017 WS appears to be in good condition. No repairs appear to have been made yet to the LS. Pipe measures to be 15" (DWR Sutter Yard- AFreitag)10/12/2016 WS seems to be in good conditon. No repairs have been made yet where the pipe appears to be leaking under the LS toe road.(DWR Sutter Yard - aFreitag)4/19/2016 No repairs seem to have been made yet. Pipe still appears to be leaking under the LS toe road. (DWR Sutter Yard - aFreitag)5/12/2015 Pipe appears to have not yet been repaired. Still looks to be leaking under the LS toe road. (DWR Sutter Yard - aFreitag)11/18/2014 Same as last inspection. (DWR Sutter Yard - aFreitag)5/13/2014 Same as last inspection. (DWR Sutter Yard - aFreitag)10/29/2013 Same as last inspection. (DWR Sutter Yard - aFreitag)5/16/2013 Signs of leaks near concrete stand pipe on LS toe-road. Area about 20ft. long is muddy and there has not been any rain for a few weeks. (DWR Sutter Yard - aFreitag) FIELD_STRUCT_DESC: 15-inch steel irrigation pipe through the levee, 2.7 feet below the crown. Vertical pumps located in the channel. Power pole on the waterside (WS) slope. Pipe discharges into 36-inch concrete standpipe located on the landside (LS) toe. 16-inch corrugated metal pipe (CMP) riser located on the LS shoulder. [Additional Reference(s): DWR Levee Log, 2005. USACE Sacramento O&M Manual 135, May 1953, (Station 174+60)]. FS Date: 4/12/2017 10:22:36 AM

36in. concrete standpipe and 12in. cm riser on LS.

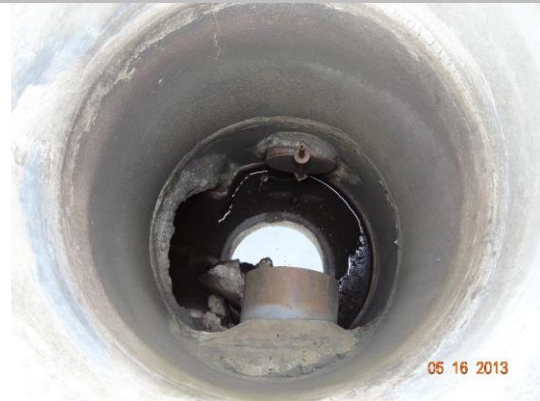
Photo 3 of 3 : UCIP_SP_2018_51518_64762.jpg

Comment Code						
Inspector Comment						
FS_ID:51518 DS_ID:17081 EP_NO: 5622 Repair Type: Urgent Crossing Status: Found UCIP Comments: 4/10/2017 WS appears to be in good condition. No repairs appear to have been made yet to the LS. Pipe measures to be 15" (DWR Sutter Yard- afreitag)10/12/2016 WS seems to be in good condition. No repairs have been made yet where the pipe appears to be leaking under the LS toe road.(DWR Sutter Yard - afreitag)4/19/2016 No repairs seem to have been made yet. Pipe still appears to be leaking under the LS toe road. (DWR Sutter Yard - afreitag)5/12/2015 Pipe appears to have not yet been repaired. Still looks to be leaking under the LS toe road. (DWR Sutter Yard - afreitag)11/18/2014 Same as last inspection. (DWR Sutter Yard - afreitag)5/13/2014 Same as last inspection. (DWR Sutter Yard - afreitag)10/29/2013 Same as last inspection. (DWR Sutter Yard - afreitag)5/16/2013 Signs of leaks near concrete stand pipe on LS toe-road. Area about 20ft. long is muddy and there has not been any rain for a few weeks. (DWR Sutter Yard - afreitag) FIELD_STRUCT_DESC: 15-inch steel irrigation pipe through the levee, 2.7 feet below the crown. Vertical pumps located in the channel. Power pole on the waterside (WS) slope. Pipe discharges into 36-inch concrete standpipe located on the landside (LS) toe. 16-inch corrugated metal pipe (CMP) riser located on the LS shoulder. [Additional Reference(s): DWR Levee Log, 2005. USACE Sacramento O&M Manual 135, May 1953, (Station 174+60)]. FS Date: 4/12/2017 10:22:36 AM

Inside of 36in. concrete riser
