**Flood Control Project Maintenance  
Levee Inspections**  
**LMA District Cover Sheet**  
**Spring 2019 Levee Inspection Results**

**Sutter Maintenance Yard Wadsworth Canal**

**Spring 2019 Levee Inspection Results**

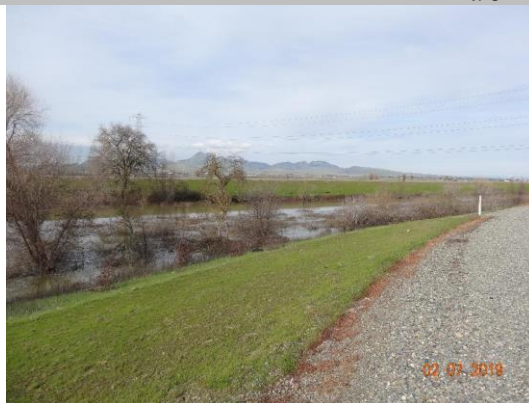
Photo 1 of 3 : UCIP\_SP\_2019\_53741\_78653.jpg

WS view: Clean slope with no evidence of line present.

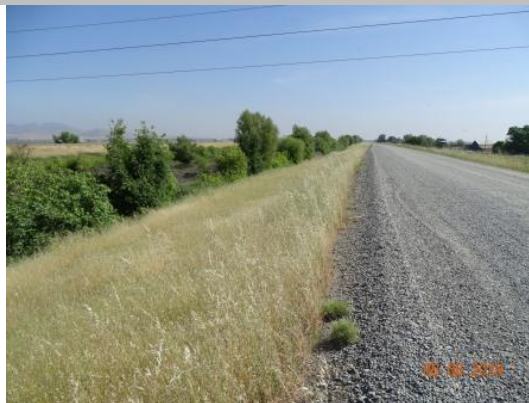
Photo 1 of 1 : SP\_2019\_ST0010\_42\_9\_20190510\_00053.jpg

LM Start	0.03	Rating **	U	Issue No.	9
LM End	4.61	Issue Type +	Ma	Location *	WS
Category	Earthen Levee			GPS Latitude/Longitude	
				Start	End
Item	Vegetation			39.113805 °	39.170986 °
				-121.768283 °	-121.726687 °
DWR ID	DWR_ST0010_01_s_2012_9				
Comment Code					
V1 : Control annual grass and weeds on the levee slopes and easements.					
Inspector Comment

View of the vegetation on the waterside slope. Spring 2019.

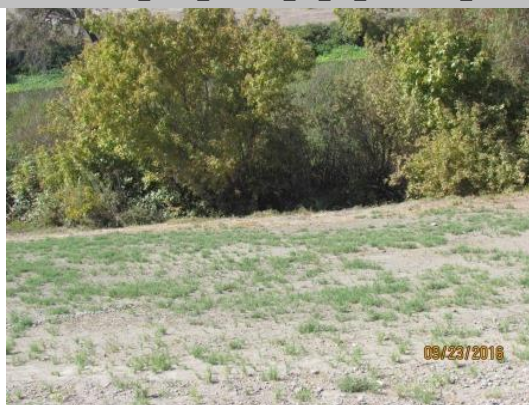
Photo 1 of 1 : SP\_2019\_ST0010\_42\_20\_20190327\_00013.jpg

LM Start	0.06	Rating **	A/W	Issue No.	20
LM End	0.12	Issue Type +	Ma	Location *	WS
Category	Earthen Levee			GPS Latitude/Longitude	
				Start	End
Item	Erosion / Bank Caving			39.114203 °	39.114842 °
				-121.768015 °	-121.767382 °
DWR ID	DWR_ST0010_01_f_2016_20				
Comment Code					
E1 : Note and monitor erosion site.					
Inspector Comment

View of the erosion along the waterside toe.

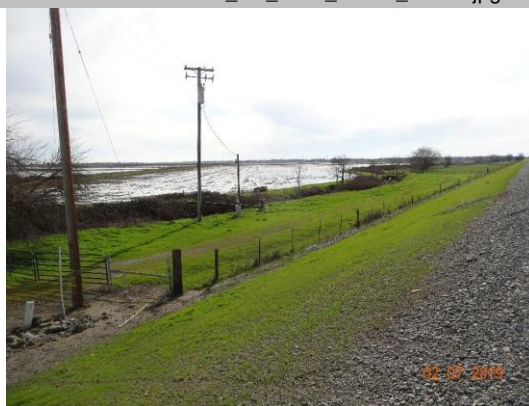
Photo 1 of 3 : UCIP\_SP\_2019\_53591\_78658.jpg

LS view: overview of LS looking downstream.

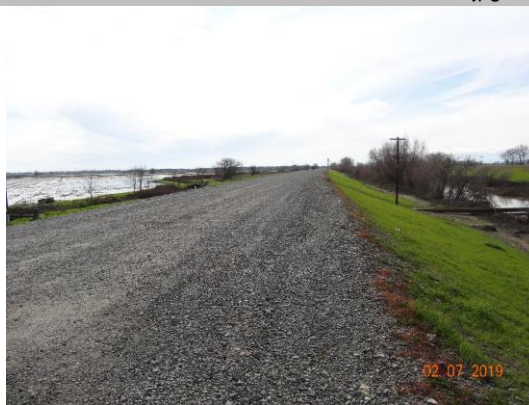
Photo 2 of 3 : UCIP\_SP\_2019\_53591\_78656.jpg

Overview of levee crown at pipe crossing.

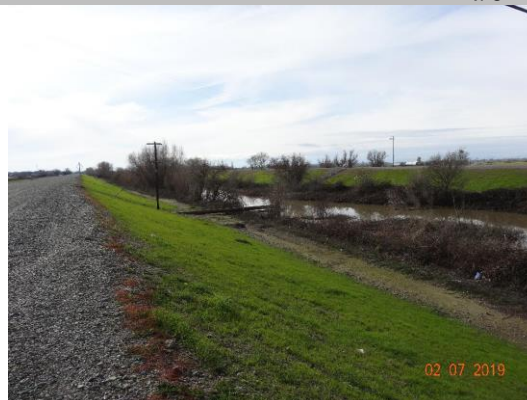
Photo 3 of 3 : UCIP\_SP\_2019\_53591\_78657.jpg

WS view: overview of WS looking downstream.

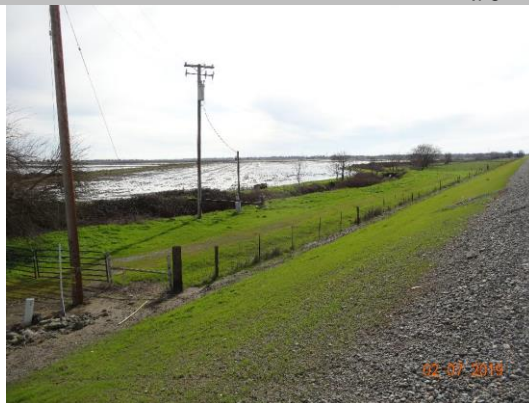
Photo 1 of 3 : UCIP\_SP\_2019\_53595\_78664.jpg

LS view: gas marker visible by gate located on LS toe near first power pole.

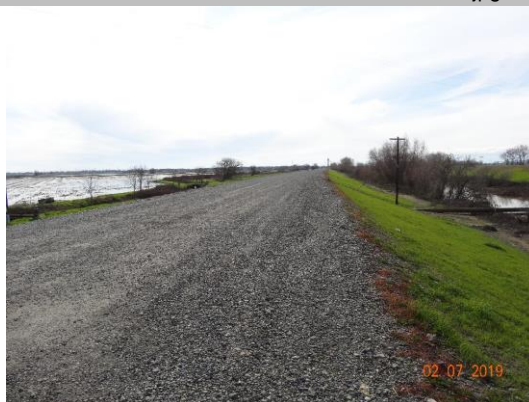
Photo 2 of 3 : UCIP\_SP\_2019\_53595\_78662.jpg

Overview of levee crown at pipe crossing.

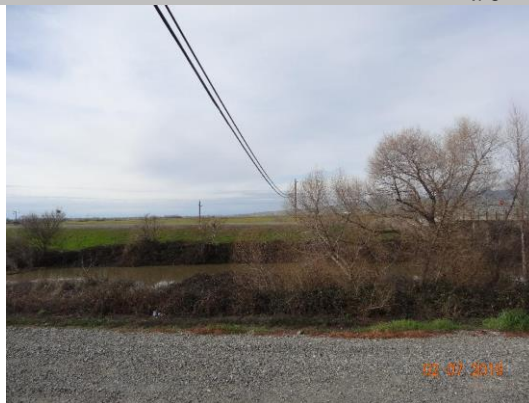
Photo 1 of 3 : UCIP\_SP\_2019\_53593\_78669.jpg

WS view: only overhead power lines visible at this location.

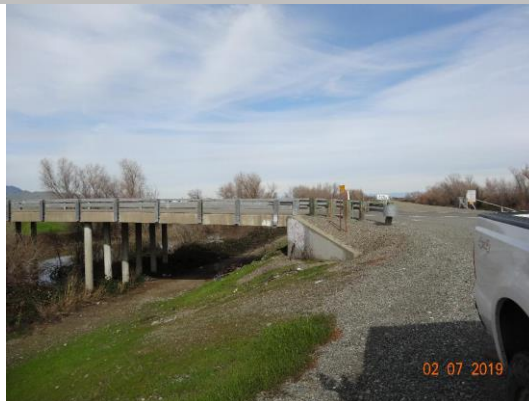
Photo 2 of 3 : UCIP\_SP\_2019\_53593\_78667.jpg

Overview of levee crown and WS.

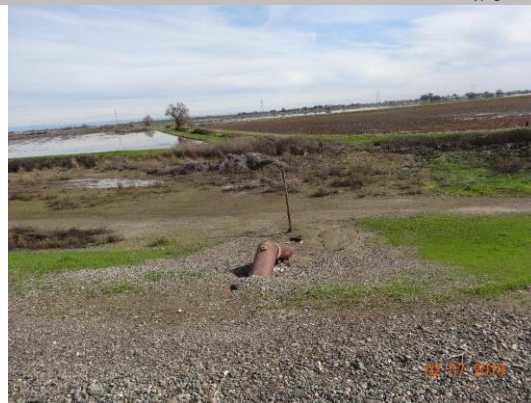
Photo 1 of 3 : UCIP\_SP\_2019\_53594\_78675.jpg

LS view: overview of LS.

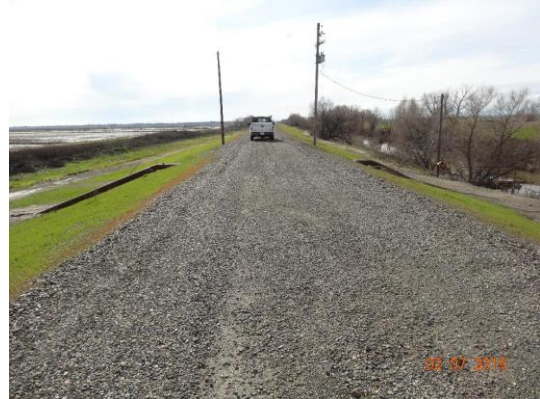
Photo 2 of 3 : UCIP\_SP\_2019\_53594\_78676.jpg

Overview of crossing looking downstream towards crossing.

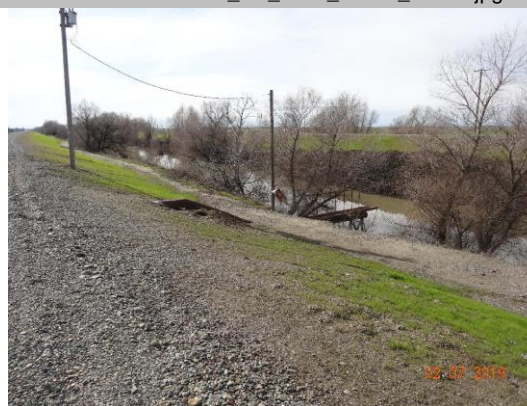
Photo 3 of 3 : UCIP\_SP\_2019\_53594\_78677.jpg

WS view: overview of WS.

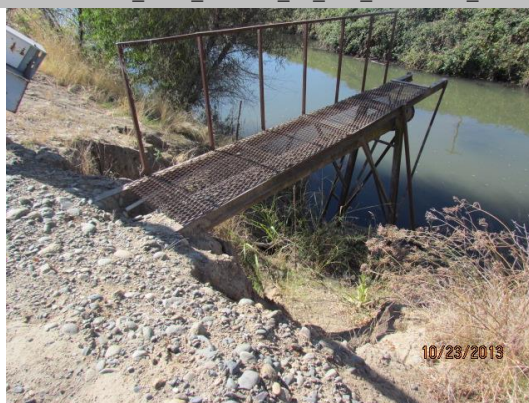
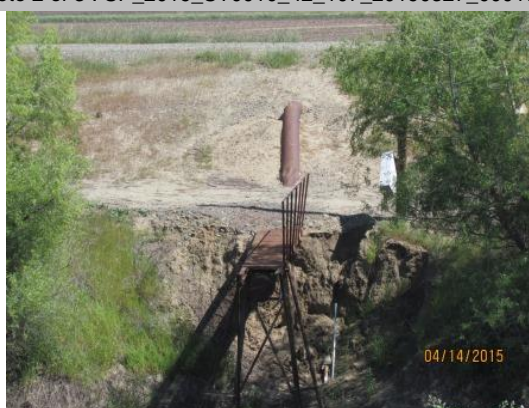
LM Start	1.85	Rating **	U	Issue No.	107
LM End	1.85	Issue Type +	Ma	Location *	WS
Category	Earthen Levee			GPS Latitude/Longitude	
				Start	End
Item	Erosion / Bank Caving			39.135110 °	39.135110 °
				-121.748230 °	-121.748230 °
DWR ID	DWR_ST0010_01_f_2013_107				
Comment Code					
E2 : Schedule repair of erosion site prior to the next inspection.					
Inspector Comment

View of the erosion along both sides of the abandoned pump.

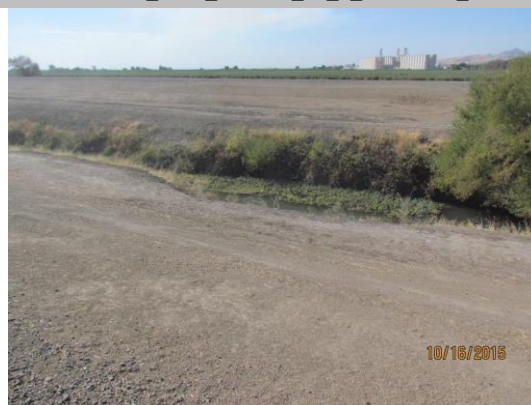
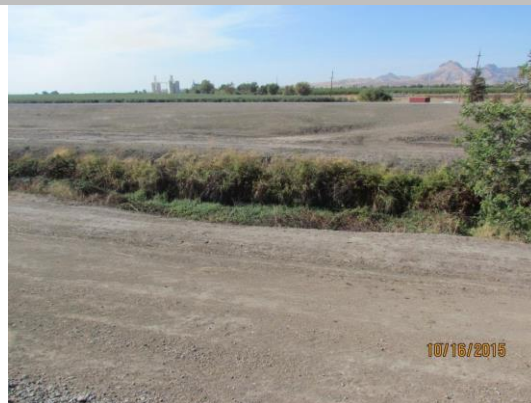
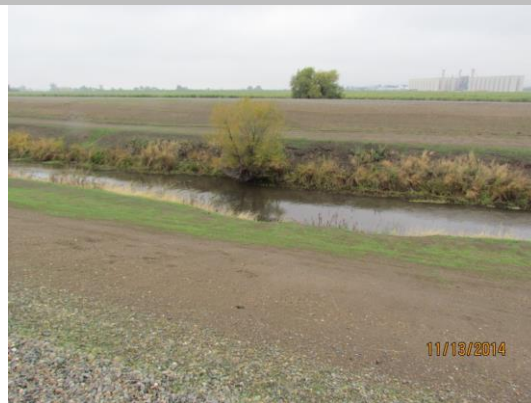
LM Start	2.43	Rating **	M	Issue No.	6
LM End	3.30	Issue Type +	Ma	Location *	WS
Category	Supplemental			GPS Latitude/Longitude	
				Start	End
Item	2017 USACE Erosion Survey, DRAFT			39.142235 °	39.153095 °
				-121.742609 °	-121.734390 °
DWR ID	DWR_ST0010_01_f_2018_6				
Comment Code					
Inspector Comment					
2017 Site ID: WAC 2.4 L					
Status: Eroding					
2017 Field Notes: Significant new erosion along lower bank.					
Site History: 2010 - Over steepened levees, some slumping, reach-wide problem. 2011 - Still a reach-wide problem.

View of the erosion along the waterside toe.

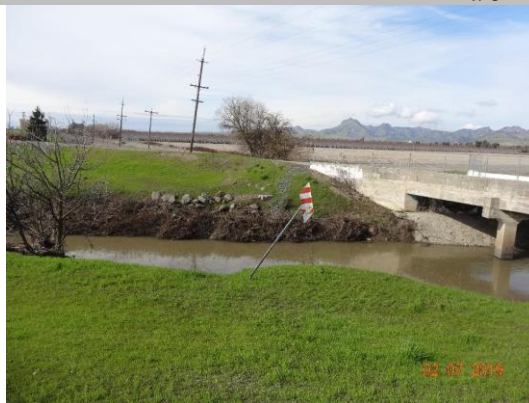
Photo 1 of 3 : UCIP\_SP\_2019\_53596\_78683.jpg

WS view: line crosses both left and right bank, markers visible on opposite levee.

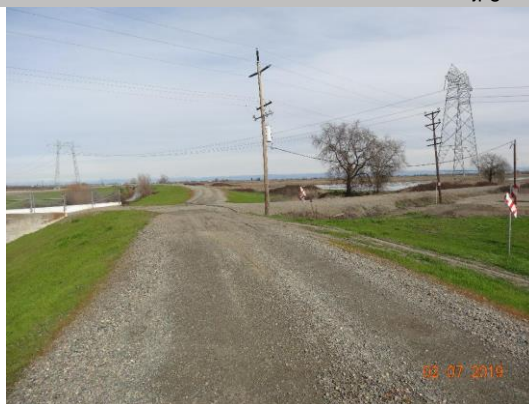
Photo 2 of 3 : UCIP\_SP\_2019\_53596\_78681.jpg

Overview of levee crown at pipe crossing.

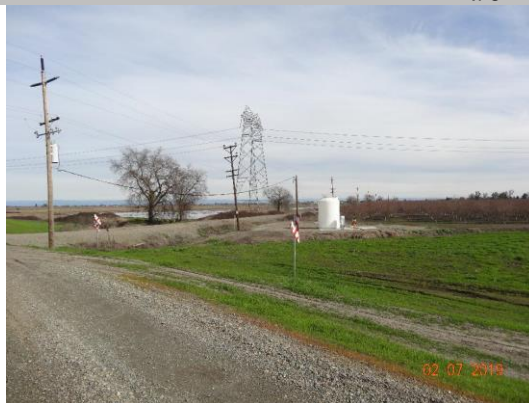
Photo 3 of 3 : UCIP\_SP\_2019\_53596\_78682.jpg

LS view: overview of LS looking upstream towards crossing.

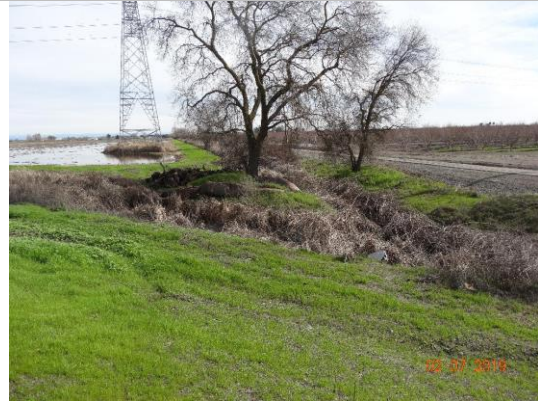
Photo 1 of 3 : UCIP\_SP\_2019\_53597\_78688.jpg

FS\_ID:53597  
 DS\_ID:17065  
 EP\_NO: 7209  
 Repair Type: Non-Urgent  
 Crossing Status: Found  
 UCIP Comments: 02/07/2019 (O. Magana - DWR UCIP)4/10/2017  
 Ws pipe end is in good condition. LS pipe end is still deformed and  
 vegetated. (DWR Sutter Yard- A Freitag)10/12/2016 LS inlet is still  
 deformed and being overgrown by vegetation.(DWR Sutter Yard -  
 a Freitag)4/19/2016 Crossing appears to be in good  
 condition.5/12/2015 LS inlet still deformed a little but does not affect  
 the crossing function.11/18/2014 Same as last  
 inspection.5/13/2014 Same as last inspection.10/29/2013 Same as  
 last inspection.5/16/2013 Pipe intake on LS appears to be bent and  
 damaged but that does not appear to be affecting water flow or channel  
 bank.  
 FIELD\_STRUCT\_DESC: 36-inch corrugated metal drainage pipe  
 (permit records indicate 30-inch, USACE O&M pipe replaced with new  
 30-inch pipe) through the levee, 9 feet below the crown. Flap gate

LS view: overview of LS.

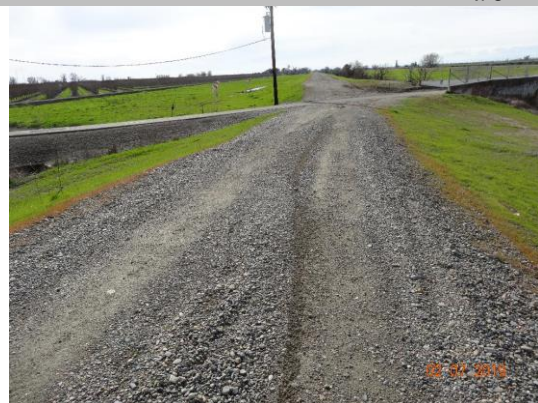
Photo 2 of 3 : UCIP\_SP\_2019\_53597\_78687.jpg

Overview of levee crown looking downstream at crossing.

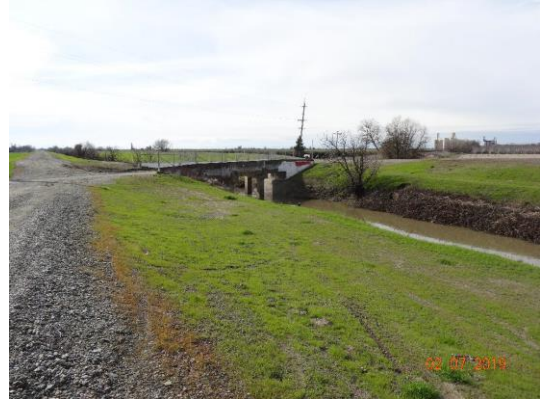
Photo 3 of 3 : UCIP\_SP\_2019\_53597\_78686.jpg

WS view: overview of WS.

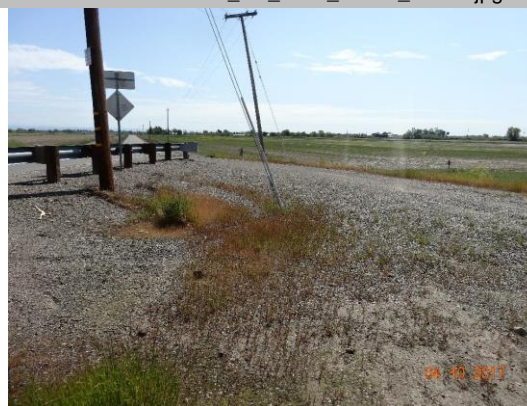
Photo 1 of 3 : UCIP\_SP\_2019\_53598\_76957.jpg

LS overview

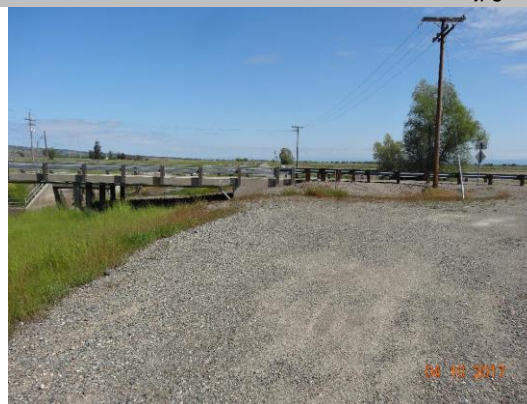
Photo 2 of 3 : UCIP\_SP\_2019\_53598\_76953.jpg

Levee overview looking upstream.

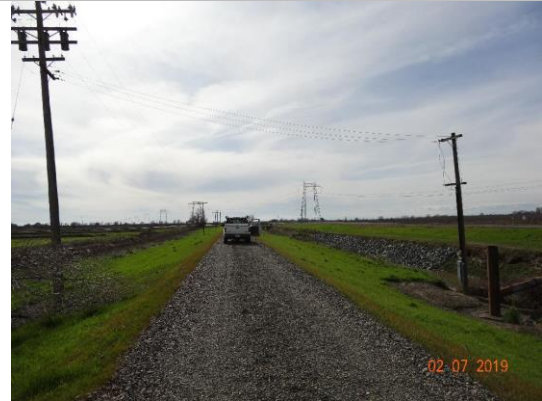
Photo 1 of 3 : UCIP\_SP\_2019\_53599\_78704.jpg

Overview of levee crown lookin downstream towards crossing.

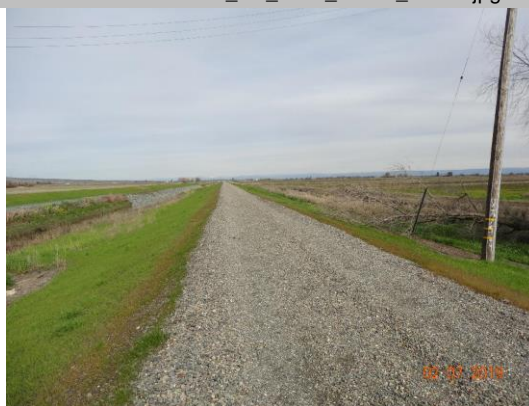
Photo 2 of 3 : UCIP\_SP\_2019\_53599\_78701.jpg

Overview of levee crown looking upstream towards crossing.

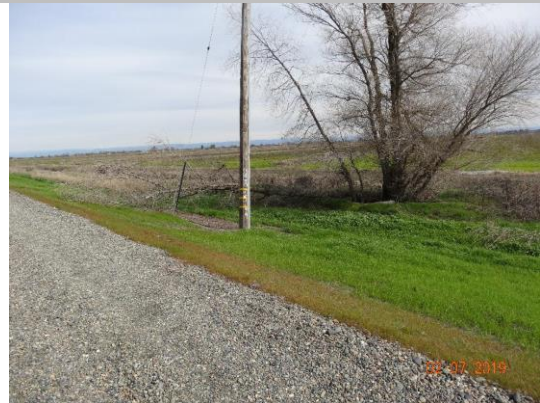
Photo 3 of 3 : UCIP\_SP\_2019\_53599\_78702.jpg

Comment Code						
Inspector Comment						
FS_ID:53599 DS_ID:17066 EP_NO: N/A Repair Type: Non-Urgent Crossing Status: Found UCIP Comments: 02/07/2019 (O. Magana - DWR UCIP)01/28/2019 USACE O&M dwg shows 12-inch and 24-inch on LS. (O. Magana - DWR UCIP) 4/10/2017 LS heavily vegetated but nothing appears to have changed with the crossing. LS headwall still silted in and pipe discharges directly into the rice field. (DWR Sutter Yard- A Freitag)10/12/2016 Crossing appears to be in good condition.4/19/2016 Crossing has not changed since the last inspection. LS headwall is silted in and not being used. LS pipe end discharges into the rice field.5/12/2015 Concrete headwall on LS is completely silted in. LS pipe end is located near the edge of rice field. No issues seen on WS.11/18/2014 Same as last inspection.5/13/2014 Same as last inspection.10/29/2013 Concrete headwall is silted in and appears to be abandoned. Discharge end of pipe is approx. 100ft. from LS toe on the edge of the rice field.5/16/2013 Same as last inspection. FIELD_STRUCT_DESC: 24-inch steel irrigation pipe (USACE O&M refers to 24-inch corrugated metal pipe, 14-inch pipe [measured] connected to pump) through the levee, 11 feet below the crown. Slide gate in 4-foot by 6-foot concrete distribution box located at the waterside (WS) toe. (not found in 2012) Vertical pump mounted on a steel structure in channel. Service pole on the berm with 16-inch (measured) standpipe located on the WS toe. Concrete "U" shaped headwall located on the landside (LS) toe. [Additional Reference(s): DWR Levee Log, 2005. USACE Sacramento O&M Manual 135, May 1953, (Station 184+87), Dwg. No. 50-04-1949, page 2 of 3]. FS Date: 2/7/2019 2:54:00 PM

LS view: power pole located on LS.

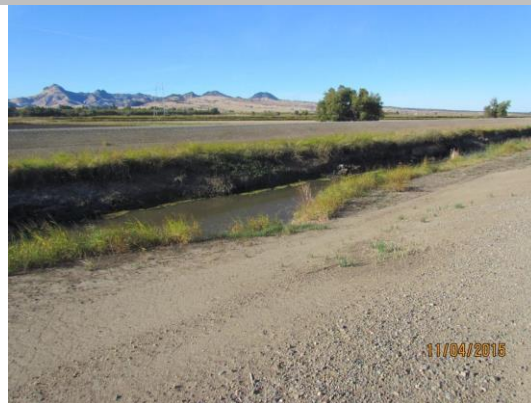
Photo 1 of 1 : SP\_2019\_ST0010\_42\_17\_20190327\_00010.jpg

LM Start	3.84	Rating **	A/W	Issue No.	17
LM End	3.96	Issue Type +	Ma	Location *	WS
Category	Earthen Levee			GPS Latitude/Longitude	
				Start	End
Item	Erosion / Bank Caving			39.160442 °	39.162235 °
				-121.731067 °	-121.730912 °
DWR ID	DWR_ST0010_01_f_2014_17				
Comment Code					
E1 : Note and monitor erosion site.					
Inspector Comment

View of the erosion along the waterside toe.

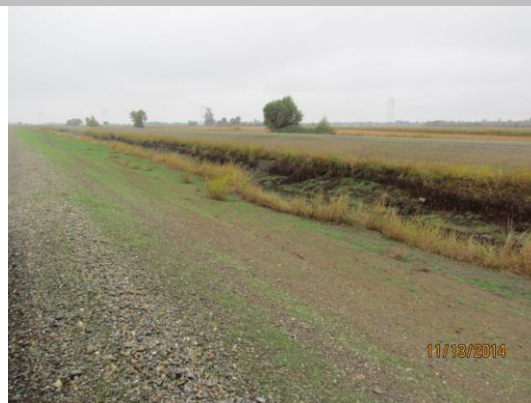
Photo 1 of 2 : SP\_2019\_ST0010\_42\_5\_20190327\_00004.jpg

LM Start	4.23	Rating **	A/W	Issue No.	5
LM End	4.23	Issue Type +	Ma	Location *	WS
Category	Earthen Levee			GPS Latitude/Longitude	
				Start	End
Item	Erosion / Bank Caving			39.165845 °	39.165845 °
				-121.728877 °	-121.728877 °
DWR ID	DWR_ST0010_01_s_2012_5				
Comment Code					
E1 : Note and monitor erosion site.					
Inspector Comment

View of the erosion along the waterside toe.

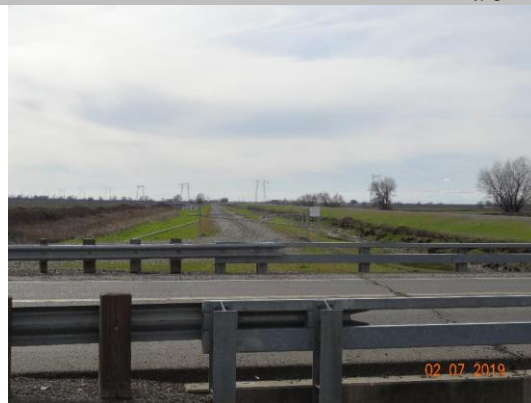
Photo 1 of 3 : UCIP\_SP\_2019\_53600\_78705.jpg

Comment Code						
Inspector Comment						
FS_ID:53600 DS_ID:17067 EP_NO: 4680 Repair Type: Non-Urgent Crossing Status: Indicator Found UCIP Comments: 02/07/2019 (O. Magana - DWR UCIP)4/10/2017 Aerial lines. (DWR Sutter Yard- AFreitag)10/12/2016 Crossing appears to be in good condition.(DWR Sutter Yard - afreitag)4/19/2016 Crossing appears to be in good condition.5/12/2015 Crossing appears in good condition. No noticeable issues to report.11/18/2014 Same as last inspection.5/13/2014 Same as last inspection.10/29/2013 Same as last inspection.5/16/2013 Same as last inspection.10/9/2012 Communication line on Pole 400-feet west of canal. Likely now an aerial on North side of roadway. (W. Wylie - DWR UCIP) FIELD_STRUCT_DESC: 4-inch steel communication conduit (telephone cable inside) through the levee, 2.3 feet below the crown. Conduit line goes through Wadsworth Canal and its levees. Annular space between pipe and conduit grouted. Line is attached to south side of the Butte House Road bridge (no longer attached in 2012). (4-inch conduit authorized under Permit No. 4680, 1964 - Pacific Telephone and Telegraph Company [PT&T]). [Additional Reference(s): DWR Levee Log, 2005]. FS Date: 2/7/2019 2:54:00 PM

LM Start	<b>4.31</b>	Rating **	M	Issue No.	<b>117 (cont)</b>
LM End	<b>4.31</b>	Issue Type +	En	Location *

No markers visible on levee crown for conduit, photo 1 of 2.

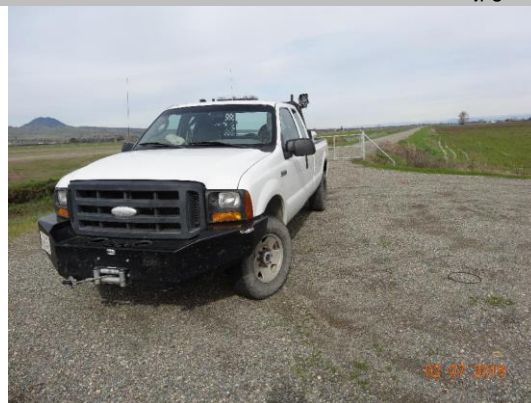
Photo 2 of 3 : UCIP\_SP\_2019\_53601\_78708.jpg

Comment Code						
Inspector Comment						
FS_ID:53601 DS_ID:17058 EP_NO: N/A Repair Type: Non-Urgent Crossing Status: Not Found UCIP Comments: 02/07/2019 (O. Magana - DWR UCIP)4/10/2017 Unable to locate. (DWR Sutter Yard- AFreitag)10/12/2016 Unable to locate.4/19/2016 Unable to locate.5/12/2015 Unable to locate.11/18/2014 Unable to locate.5/13/2014 Same as last inspection.10/29/2013 Same as last inspection.5/16/2013 Same as last inspection.10/9/2012 unable to locate FIELD_STRUCT_DESC: 12-inch corrugated metal drainage pipe through the levee, 8.7 feet below the crown. Pipe is open at both the waterside (WS) and landside (LS) ends. [Additional Reference(s): DWR Levee Log, 2005. USACE Sacramento O&M Manual 135, May 1953, (Station 228+00), Dwg No. 50-04-1949, page 2 of 3, 12-inch CMP referenced at 228+25]. FS Date: 2/7/2019 12:13:00 PM

LM Start	<b>4.32</b>	Rating **	M	Issue No.	<b>118 (cont)</b>
LM End	<b>4.32</b>	Issue Type +	En	Location *

Overview of levee crown where crossing should be.

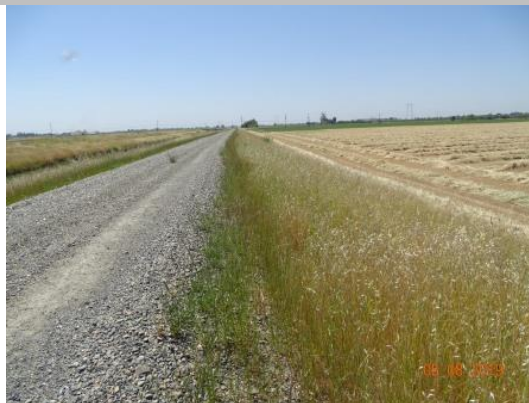
Photo 1 of 1 : SP\_2019\_ST0010\_43\_1\_20190510\_00054.jpg

LM Start	0.02	Rating **	U	Issue No.	1
LM End	4.57	Issue Type +	Ma	Location *	LS
Category	Earthen Levee			GPS Latitude/Longitude	
				Start	End
Item	Vegetation			39.114417 °	39.170959 °
				-121.769270 °	-121.727250 °
DWR ID	DWR_ST0010_02_f_2012_1				
Comment Code					
V1 : Control annual grass and weeds on the levee slopes and easements.					
Inspector Comment

View of the vegetation on the landside slope. Spring 2019.

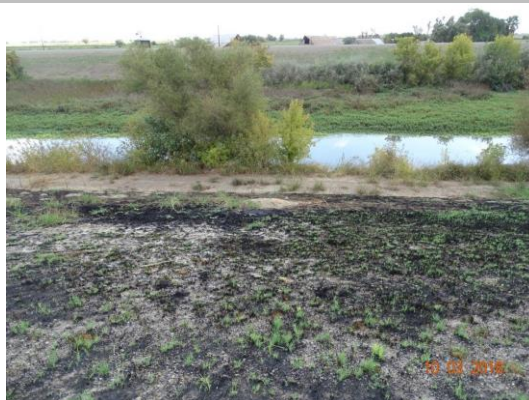
Photo 1 of 1 : SP\_2019\_ST0010\_43\_17\_20190327\_00007.jpg

LM Start	0.24	Rating **	M	Issue No.	17
LM End	0.24	Issue Type +	Ma	Location *	WS
Category	Earthen Levee			GPS Latitude/Longitude	
				Start	End
Item	Animal Control			39.116913 °	39.116913 °
				-121.766768 °	-121.766768 °
DWR ID	DWR_ST0010_02_f_2018_17				
Comment Code					
A3 : No rodents visible, but rodent burrows visible; need to backfill and compact or grout burrows.					
Inspector Comment

View of the rodent hole along the waterside slope.

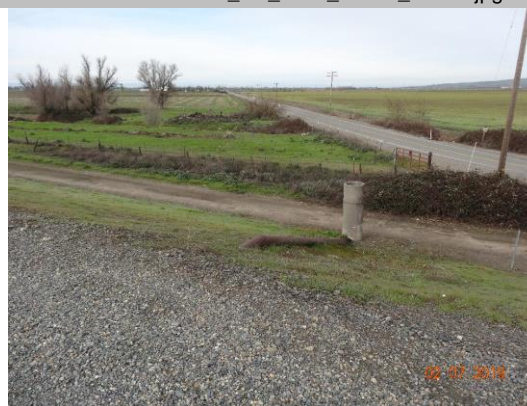
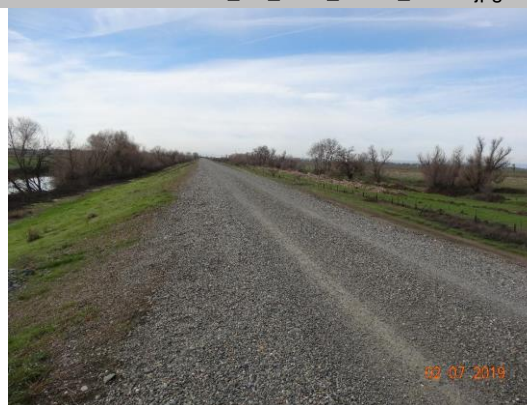
FS\_ID:53604  
DS\_ID:17069  
EP\_NO: N/A  
Repair Type: Non-Urgent  
Crossing Status: Found  
UCIP Comments: 02/07/2019 (O. Magana - DWR UCIP)4/10/2017 Abandoned crossing with heavy rodent activity around it. Needs to be removed. (DWR Sutter Yard- A Freitag)10/12/2016 Abandoned crossing.(DWR Sutter Yard - a Freitag)4/19/2016 Abandoned crossing. Rodent activity still present on WS slope.5/12/2015 Abandoned crossing. Signs of rodent activity on both sides of levee.11/18/2014 Same as last inspection.5/13/2014 Same as last inspection.10/29/2013 Same as last inspection.5/16/2013 Same as last inspection.10/9/2012 Pipe appears improperly abandoned. No motor present, electrical equipment is stripped. Heavy rodent activity along pipe WS and LS. Pipe needs to be removed or properly abandoned. (W. Wylie - DWR UCIP)  
FIELD\_STRUCT\_DESC: \*ABANDONED\* 10-inch steel irrigation pipe through the levee, 4.8 feet below the crown. Pump mounted on concrete pad near canal bank located on the waterside (WS). Service pole located on the berm. 36-inch concrete standpipe located on the landside (LS) toe. (10-inch pipe authorized under Permit No. 945, 1944 - Becker). [Additional Reference(s): DWR Levee Log, 2005. USACE Sacramento O&M Manual 135, May 1953, (Station 61+10), Dwg. No. 50-04-1949, page 1 of 3].

LM Start	<b>1.16</b>	Rating **	M	Issue No.	<b>25 (cont)</b>
LM End	<b>1.16</b>	Issue Type +	En	Location *

LS view: overview of LS.

Overview of levee crown at pipe crossing.

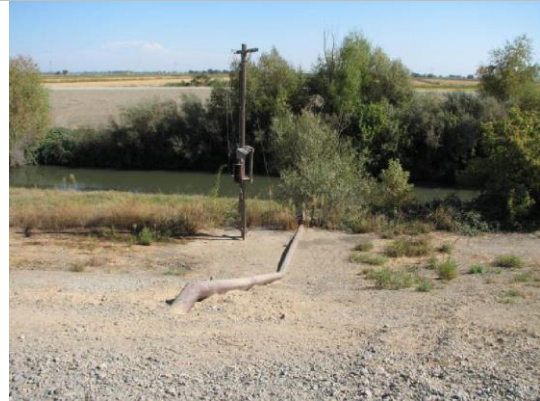
Photo 3 of 3 : UCIP\_SP\_2019\_53604\_64727.jpg

Comment Code						
Inspector Comment						
FS_ID:53604 DS_ID:17069 EP_NO: N/A Repair Type: Non-Urgent Crossing Status: Found UCIP Comments: 02/07/2019 (O. Magana - DWR UCIP)4/10/2017 Abanoned crossing with heavy rodent activity around it. Needs to be removed. (DWR Sutter Yard- A Freitag)10/12/2016 Abandoned crossing.(DWR Sutter Yard - a Freitag)4/19/2016 Abandoned crossing. Rodent activity still present on WS slope.5/12/2015 Abandoned crossing. Signs of rodent activity on both sides of levee.11/18/2014 Same as last inspection.5/13/2014 Same as last inspection.10/29/2013 Same as last inspection.5/16/2013 Same as last inspection.10/9/2012 Pipe appears improperly abandoned. No motor present, electrical equipment is stripped. Heavy rodent activity along pipe WS and LS. Pipe needs to be removed or properly abandoned. (W. Wylie - DWR UCIP) FIELD_STRUCT_DESC: *ABANDONED* 10-inch steel irrigation pipe through the levee, 4.8 feet below the crown. Pump mounted on concrete pad near canal bank located on the waterside (WS). Service pole located on the berm. 36-inch concrete standpipe located on the landside (LS) toe. (10-inch pipe authorized under Permit No. 945, 1944 - Becker). [Additional Reference(s): DWR Levee Log, 2005. USACE Sacramento O&M Manual 135, May 1953, (Station 61+10), Dwg. No. 50-04-1949, page 1 of 3]. FS Date: 2/7/2019 11:11:00 AM

Pipe and pump facilities on WS slope.

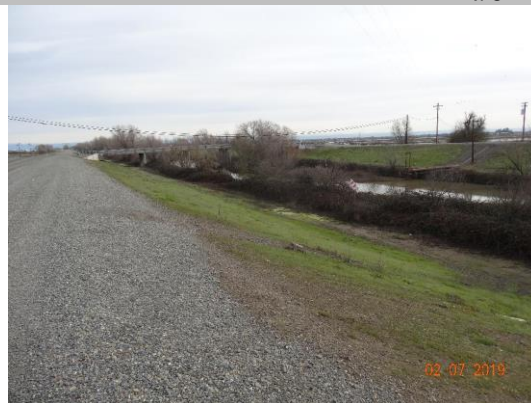
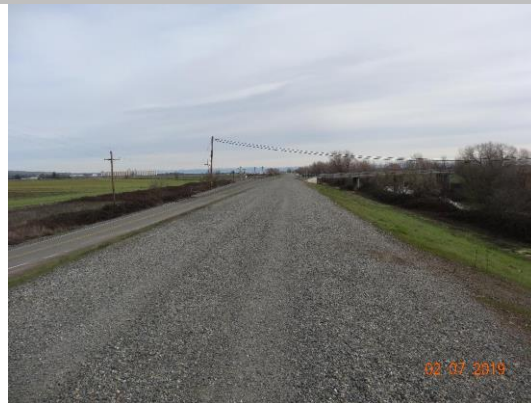
FS\_ID:53605  
DS\_ID:17084  
EP\_NO: 17478  
Repair Type: Non-Urgent  
Crossing Status: Indicator Found  
UCIP Comments: 02/07/2019 (O. Magana - DWR UCIP)4/10/2017 Crossing appears to be in good condition. New markers are present on the LS shoulder and WS toe. (DWR Sutter Yard- A Freitag)10/12/2016 Crossing appears to be in good condition.(DWR Sutter Yard - a Freitag)4/19/2016 Crossing appears to be in good condition.5/12/2015 Crossing appears in good condition. No noticeable issues to report.11/18/2014 Same as last inspection.5/13/2014 Same as last inspection.10/29/2013 Same as last inspection.5/16/2013 Same as last inspection.  
FIELD\_STRUCT\_DESC: 8-inch steel gas line bored across and under Wadsworth Canal and its levees, approximately 30 and 60 feet below channel and levees. Line was reinstalled because the County replaced the bridge over Wadsworth Canal. Gas line markers present on Franklin Roadside. No pipe attached to the upstream side of Franklin Road bridge as shown in the permit records. (8-inch gas line authorized and existing 12-inch line removed under Permit No. 17478 and 17478-R, 2002 - Pacific Gas & Electric Company [PG&E]). [Additional Reference(s): DWR Levee Log, 2005].

LM Start	1.17	Rating **	M	Issue No.	26 (cont)
LM End	1.17	Issue Type +	En	Location *

WS view: overview of WS.

Overview of levee crown where line crosses.

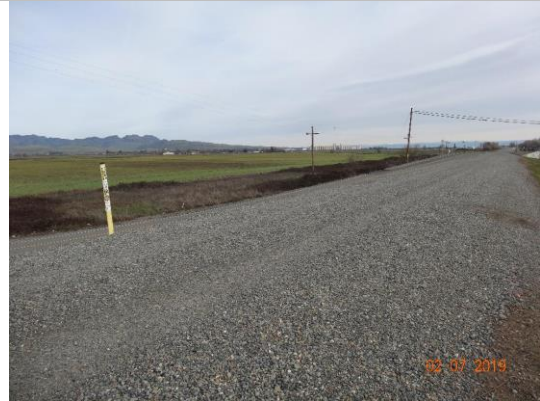
Photo 3 of 3 : UCIP\_SP\_2019\_53605\_78724.jpg

Comment Code						
Inspector Comment						
FS_ID:53605 DS_ID:17084 EP_NO: 17478 Repair Type: Non-Urgent Crossing Status: Indicator Found UCIP Comments: 02/07/2019 (O. Magana - DWR UCIP)4/10/2017 Crossing appears to be in good condition. New markers are present on the LS shoulder and WS toe. (DWR Sutter Yard-AFreitag)10/12/2016 Crossing appears to be in good condition.(DWR Sutter Yard - afreitag)4/19/2016 Crossing appears to be in good condition.5/12/2015 Crossing appears in good condition. No noticeable issues to report.11/18/2014 Same as last inspection.5/13/2014 Same as last inspection.10/29/2013 Same as last inspection.5/16/2013 Same as last inspection. FIELD_STRUCT_DESC: 8-inch steel gas line bored across and under Wadsworth Canal and its levees, approximately 30 and 60 feet below channel and levees. Line was reinstalled because the County replaced the bridge over Wadsworth Canal. Gas line markers present on Franklin Roadside. No pipe attached to the upstream side of Franklin Road bridge as shown in the permit records. (8-inch gas line authorized and existing 12-inch line removed under Permit No. 17478 and 17478-R, 2002 - Pacific Gas & Electric Company [PG&E]). [Additional Reference(s): DWR Levee Log, 2005]. FS Date: 2/7/2019 11:12:00 AM

LS view: paddle marker visible on LS shoulder.

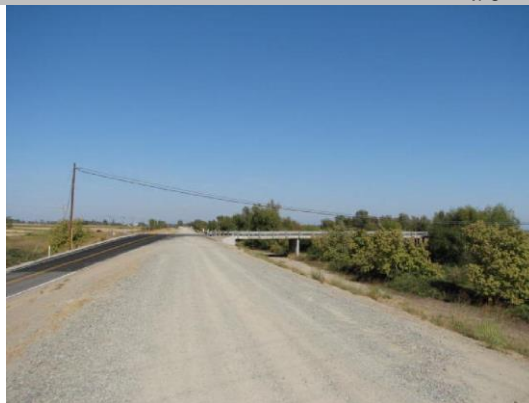
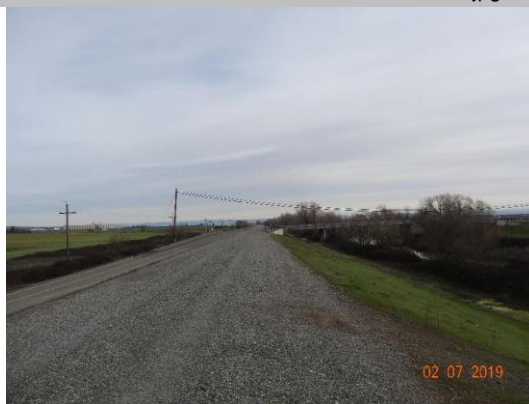
FS\_ID:53606  
DS\_ID:17071  
EP\_NO: 13362  
Repair Type: Non-Urgent  
Crossing Status: Indicator Found  
UCIP Comments: 02/07/2019 (O. Magana - DWR UCIP)4/10/2017 Aerial lines. (DWR Sutter Yard- AFreitag)10/12/2016 Crossing appears to be in good condition.(DWR Sutter Yard - afreitag)4/19/2016 Crossing appears to be in good condition.5/12/2015 Crossing now appears to be the aerial line. No noticeable issues to report.11/18/2014 Same as last inspection.5/13/2014 Same as last inspection.10/29/2013 Same as last inspection.5/16/2013 Same as last inspection.  
FIELD\_STRUCT\_DESC: 4-inch steel communication conduit with multiple telephone cables inside through the levee, 2.6 feet below the crown. Telephone cables installed inside existing 4-inch conduit. The conduit is no longer attached to the downstream side of the bridge. It is likely that this communication line is now an aerial. (Original 4-inch conduit was installed under Permit No. 6906, 1970 - Pacific Telephone and Telegraph Company [PT&T]. Telephone cables through existing conduit were authorized under Permit No. 13362, 1982 - PT&T).

LM Start	1.24	Rating **	M	Issue No.	27 (cont)
LM End	1.24	Issue Type +	En	Location *

Aerial communication line over levee where underground communication line once was.

Overview of levee crown looking towards where crossing should be.

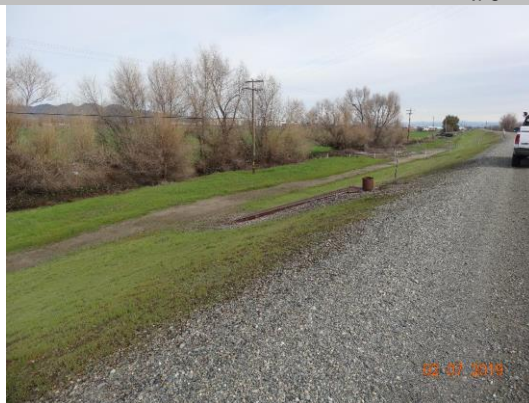
Photo 1 of 3 : UCIP\_SP\_2019\_53608\_78743.jpg

FS\_ID:53608  
DS\_ID:17074  
EP\_NO: 1096  
Repair Type: Non-Urgent  
Crossing Status: Found  
UCIP Comments: 02/07/2019 (O. Magana - DWR UCIP)4/10/2017 Crossing appears to be in good condition. It measure to be 16" on LS and 20" on WS where visible near pump. (DWR Sutter Yard-AFreitag)10/12/2016 Crossing appears to be in good condition. Minor rodent activity nearby.(DWR Sutter Yard - afreitag)4/19/2016 No signs of pipe leaks. Still some minor rodent activity under the pipe on LS slope.5/12/2015 Rodent activity near pipe on LS.11/18/2014 Levee inspection is aware of problem and repairs seem to have been made. Slope has also been rocked to prevent erosion.5/13/2014 Air vent on LS shoulder leaks and is causing minor erosion to the LS slope.10/29/2013 Same as last inspection.5/16/2013 Same as last inspection.10/9/2012 Heavy rodent activity on LS slope along pipe alignment. (W. Wylie - DWR UCIP)

FIELD\_STRUCT\_DESC: 16-inch steel irrigation pipe (USACE O&M refers to 15-inch pipe) through the levee, 4.4 feet below the crown. Pump mounted on a steel structure located on the waterside (WS) bank. Siphon breaker located on the WS slope. 48-inch concrete standpipe located on the landside (LS) berm (not found in 2012). (16-inch pipe authorized under Permit No. 1096, 1946 - Fritz Ziegenmeyer. Owner name change for structure authorized under Permit No. 1479, 1950 - H.D and H. T. Brown). [Additional Reference(s): DWR Levee Log, 2005. USACE Sacramento O&M Manual 135, May 1953, (Station 93+55), Dwg. No. 50-04-1949, page 1 of 3].  
FS Date: 2/7/2019 11:16:00 AM

LS view: overview of LS looking upstream towards pipe.

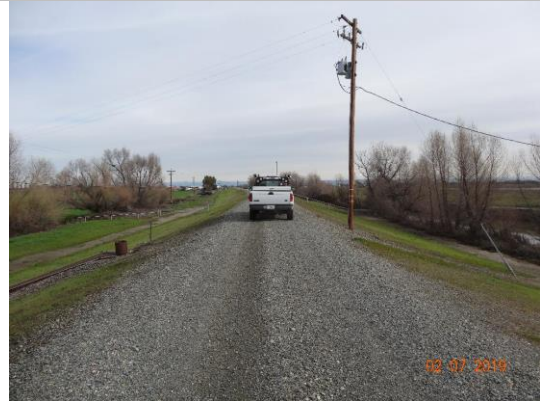
Photo 2 of 3 : UCIP\_SP\_2019\_53608\_78742.jpg

FS\_ID:53608  
DS\_ID:17074  
EP\_NO: 1096  
Repair Type: Non-Urgent  
Crossing Status: Found  
UCIP Comments: 02/07/2019 (O. Magana - DWR UCIP)4/10/2017 Crossing appears to be in good condition. It measure to be 16" on LS and 20" on WS where visible near pump. (DWR Sutter Yard-AFreitag)10/12/2016 Crossing appears to be in good condition. Minor rodent activity nearby.(DWR Sutter Yard - afreitag)4/19/2016 No signs of pipe leaks. Still some minor rodent activity under the pipe on LS slope.5/12/2015 Rodent activity near pipe on LS.11/18/2014 Levee inspection is aware of problem and repairs seem to have been made. Slope has also been rocked to prevent erosion.5/13/2014 Air vent on LS shoulder leaks and is causing minor erosion to the LS slope.10/29/2013 Same as last inspection.5/16/2013 Same as last inspection.10/9/2012 Heavy rodent activity on LS slope along pipe alignment. (W. Wylie - DWR UCIP)

Overview of levee crown at pipe crossing.

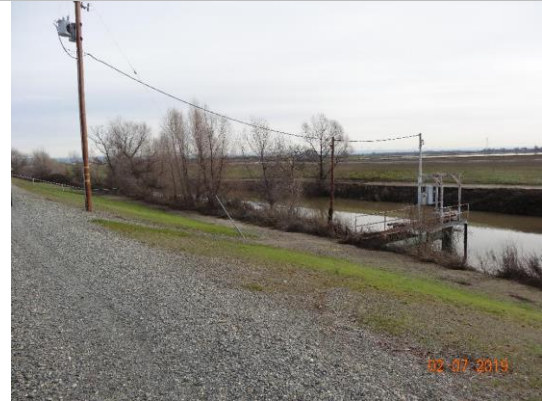
Photo 3 of 3 : UCIP\_SP\_2019\_53608\_78744.jpg

FIELD\_STRUCT\_DESC: 16-inch steel irrigation pipe (USACE O&M refers to 15-inch pipe) through the levee, 4.4 feet below the crown. Pump mounted on a steel structure located on the waterside (WS) bank. Siphon breaker located on the WS slope. 48-inch concrete standpipe located on the landside (LS) berm (not found in 2012). (16-inch pipe authorized under Permit No. 1096, 1946 - Fritz Ziegenmeyer. Owner name change for structure authorized under Permit No. 1479, 1950 - H.D and H. T. Brown). [Additional Reference(s): DWR Levee Log, 2005. USACE Sacramento O&M Manual 135, May 1953, (Station 93+55), Dwg. No. 50-04-1949, page 1 of 3].  
FS Date: 2/7/2019 11:16:00 AM

WS view: overview of WS looking upstream towards pipe.

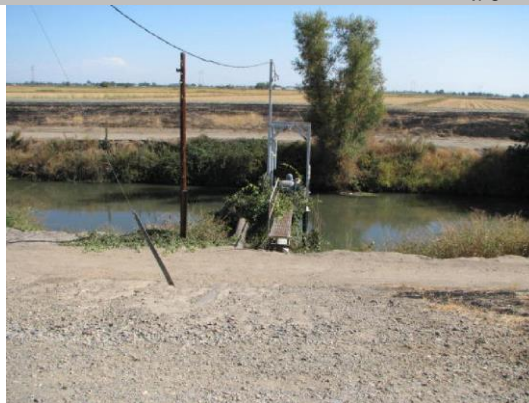
Photo 3 of 3 : UCIP\_SP\_2019\_53609\_64734.jpg

Comment Code						
Inspector Comment						
FS_ID:53609 DS_ID:17082 EP_NO: N/A Repair Type: Non-Urgent Crossing Status: Found UCIP Comments: 02/07/2019 (O. Magana - DWR UCIP)4/10/2017 Abandoned crossing. Pipe measures to be 16" on both sides of levee. (DWR Sutter Yard- AFreitag)10/12/2016 Abandoned crossing. Minor rodent activity near by.(DWR Sutter Yard - afreitag)4/19/2016 Crossing appears abandoned. Minor rodent activity under pipe on LS slope.5/12/2015 Abandoned crossing that needs to be properly abandoned. Rodent activity near LS pipe.11/18/2014 Same as last inspection.5/13/2014 Same as last inspection.10/29/2013 Same as last inspection.5/16/2013 Same as last inspection.10/9/2012 Heavy rodent activity along LS alignment of pipe. No pump on structure and it appears to be abandoned. Should be abandoned properly. (W. Wylie - DWR UCIP) FIELD_STRUCT_DESC: *ABANDONED* 16-inch steel irrigation pipe through the levee, 4.4 feet below the crown. Pump mounted on a timber structure located on the waterside (WS). Siphon breaker located on the landside (LS) slope. 48-inch concrete standpipe located on the LS berm (not found in 2012). (16-inch pipe authorized under Permit No. 1104, 1946 - A. H. Muns). [Additional Reference(s): DWR Levee Log, 2005. USACE Sacramento O&M Manual 135, May 1953, (Station 93+50), listed as a 12-inch pipe, Dwg. No. 50-04-1949, page 1 of 3]. FS Date: 2/7/2019 11:16:00 AM

Pipe on left without pump.

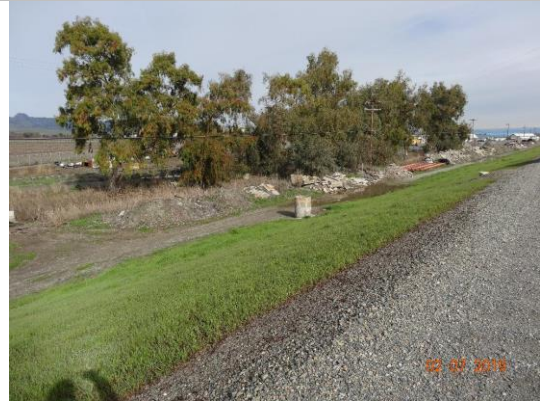
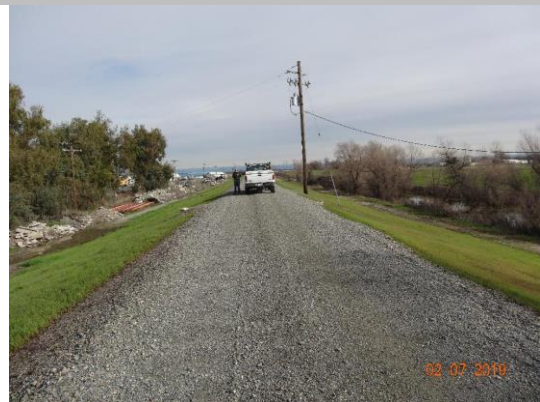
LM Start	<b>2.09</b>	Rating **	M	Issue No.	<b>30 (cont)</b>
LM End	<b>2.09</b>	Issue Type +	En	Location *

LS view: overview of LS.

Overview of levee crown.

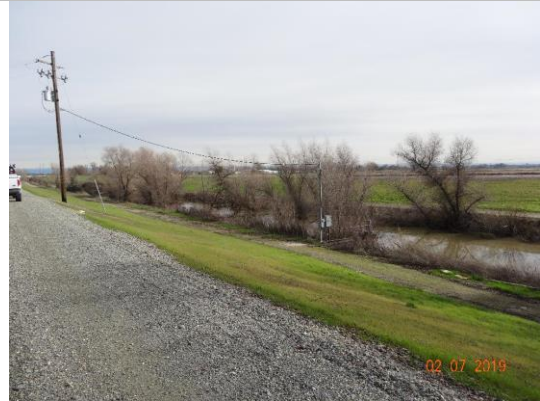
Photo 3 of 3 : UCIP\_SP\_2019\_53610\_78758.jpg

Comment Code						
Inspector Comment						
FS_ID:53610 DS_ID:17075 EP_NO: 1859 Repair Type: Non-Urgent Crossing Status: Found UCIP Comments: 02/07/2019 (O. Magana - DWR UCIP)4/10/2017 Crossing appears to be in good condition. (DWR Sutter Yard-AFreitag)10/12/2016 Crossing appears to be in good condition.(DWR Sutter Yard - afreitag)4/19/2016 Crossing appears to be in good condition.5/12/2015 Crossing appears in good condition. No noticeable issues to report.11/18/2014 Same as last inspection.5/13/2014 Same as last inspection.10/29/2013 Same as last inspection.5/16/2013 Same as last inspection. FIELD_STRUCT_DESC: 14-inch steel irrigation pipe through the levee, 3.8 feet below the crown. Pump on platform located on the waterside (WS). Pipe discharges into a 36-inch concrete standpipe at the landside (LS) toe. Siphon breakers in 14-inch risers located on the LS and butterfly shutoff valve located on the WS shoulders. Service pole located on the berm. (14-inch pipe authorized under Permit No. 1859, 1959 - Thomason. Permit renewal due to pipe leak repair authorized under Permit No. 1859-A, 1965 - Thomasen). [Additional Reference(s): DWR Levee Log, 2005]. FS Date: 2/7/2019 11:17:00 AM

WS view: overview of WS.

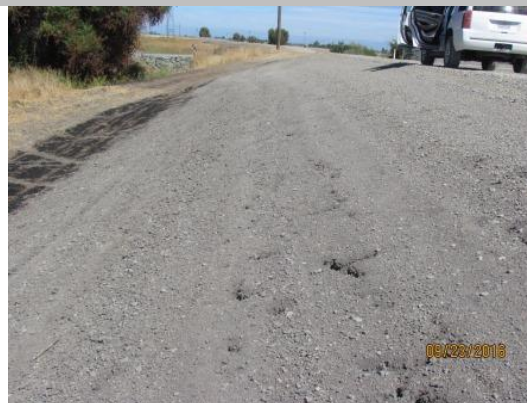
Photo 1 of 2 : SP\_2019\_ST0010\_43\_22\_20190327\_00011.jpg

LM Start	2.95	Rating **	M	Issue No.	22
LM End	2.95	Issue Type +	Ob	Location *	LS
Category	Earthen Levee			GPS Latitude/Longitude	
				Start	End
Item	Cracking			39.148938 °	39.148938 °
				-121.737620 °	-121.737620 °
DWR ID	DWR_ST0010_02_f_2016_22				
Comment Code					
CR1 : Monitor and have inspected by geotechnical engineer.					
Inspector Comment					
Longitudinal cracks caused by fat clay.

View of the longitudinal cracks along the landside slope.

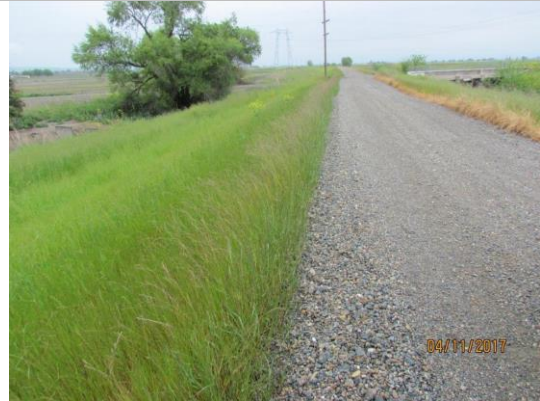
Photo 2 of 2 : SP\_2019\_ST0010\_43\_22\_20190327\_00012.jpg

LM Start	2.95	Rating **	M	Issue No.	22 (cont)	
LM End	2.95	Issue Type +	Ob	Location *	LS	
Category	Earthen Levee			GPS Latitude/Longitude		
				Start	End	
Item	Cracking			39.148938 °	39.148938 °	
				-121.737620 °	-121.737620 °	
DWR ID	DWR_ST0010_02_f_2016_22					
Comment Code						
CR1 : Monitor and have inspected by geotechnical engineer.						
Inspector Comment						
Longitudinal cracks caused by fat clay.

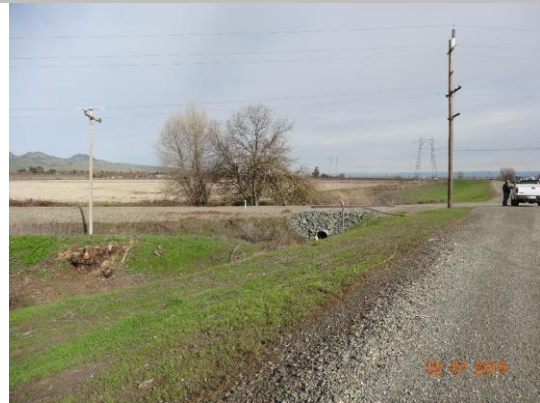
Photo 1 of 3 : UCIP\_SP\_2019\_53611\_78767.jpg

Comment Code					
Inspector Comment					
FS_ID:53611 DS_ID:17076 EP_NO: 9191 Repair Type: Non-Urgent Crossing Status: Indicator Found UCIP Comments: 02/07/2019 (O. Magana - DWR UCIP)4/10/2017 Crossing appears to be in good condition. (DWR Sutter Yard-AFreitag)10/12/2016 Crossing appears to be in good condition.(DWR Sutter Yard - afreitag)4/19/2016 Crossing appears to be in good condition.5/12/2015 Crossing appears in good condition. No noticeable issues to report.11/18/2014 Same as last inspection.5/13/2014 Same as last inspection.10/29/2013 Same as last inspection.5/16/2013 Same as last inspection. FIELD_STRUCT_DESC: 6-inch (not 7-inch as mentioned in the levee log) asphalt coated steel gas line through the levee, 1.1 feet below the crown. Gas line crosses Wadsworth Canal and its levees. Gas line markers located on the landside (LS) toe and across channel. (6-inch gas line authorized under Permit No. 764, 1939 - Pacific Gas and Electric Company [PG&E]. 6-inch Pipe reconstructed under Permit No. 9191, 1974 - PG&E). [Additional Reference(s): DWR Levee Log, 2005. USACE Sacramento O&M Manual 135, May 1953, (Station 157+35), Dwg. No. 50-04-1949, page 2 of 3]. FS Date: 2/7/2019 11:17:00 AM

LS view: overview of LS.

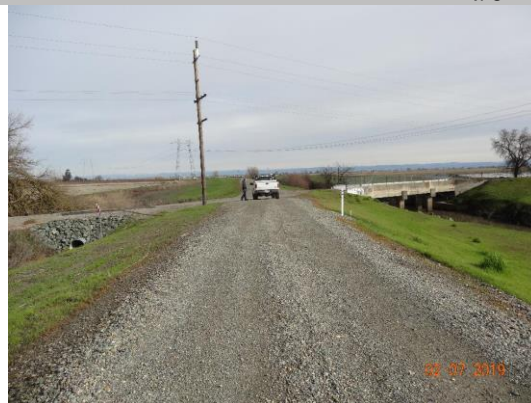
Photo 2 of 3 : UCIP\_SP\_2019\_53611\_78765.jpg

Comment Code						
Inspector Comment						
FS_ID:53611 DS_ID:17076 EP_NO: 9191 Repair Type: Non-Urgent Crossing Status: Indicator Found UCIP Comments: 02/07/2019 (O. Magana - DWR UCIP)4/10/2017 Crossing appears to be in good condition. (DWR Sutter Yard-AFreitag)10/12/2016 Crossing appears to be in good condition.(DWR Sutter Yard - afreitag)4/19/2016 Crossing appears to be in good condition.5/12/2015 Crossing appears in good condition. No noticeable issues to report.11/18/2014 Same as last inspection.5/13/2014 Same as last inspection.10/29/2013 Same as last inspection.5/16/2013 Same as last inspection. FIELD_STRUCT_DESC: 6-inch (not 7-inch as mentioned in the levee log) asphalt coated steel gas line through the levee, 1.1 feet below the crown. Gas line crosses Wadsworth Canal and its levees. Gas line markers located on the landside (LS) toe and across channel. (6-inch gas line authorized under Permit No. 764, 1939 - Pacific Gas and Electric Company [PG&E]. 6-inch Pipe reconstructed under Permit No. 9191, 1974 - PG&E). [Additional Reference(s): DWR Levee Log, 2005. USACE Sacramento O&M Manual 135, May 1953, (Station 157+35), Dwg. No. 50-04-1949, page 2 of 3]. FS Date: 2/7/2019 11:17:00 AM

Overview of levee crown looking upstream towards crossing.

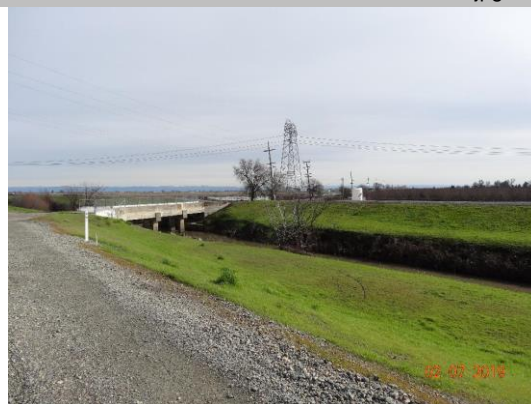
Photo 3 of 3 : UCIP\_SP\_2019\_53611\_78766.jpg

WS view: overview of WS.

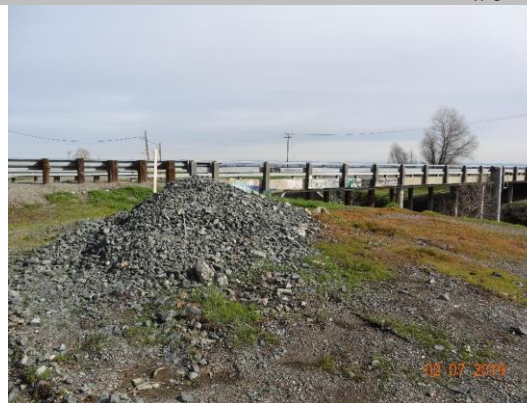
Photo 1 of 3 : UCIP\_SP\_2019\_53614\_78779.jpg

Comment Code					
Inspector Comment					
FS_ID:53614 DS_ID:23098 EP_NO: N/A Repair Type: Non-Urgent Crossing Status: Found UCIP Comments: 02/07/2019 (O. Magana - DWR UCIP)4/10/2017 Crossing appears to be in good condition. (DWR Sutter Yard-AFreitag)10/12/2016 Crossing appears to be in good condition.(DWR Sutter Yard - afreitag)5/27/2016 Need photos of markers and levee overview. (O. Magana)4/19/2016 Crossing appears to be in good condition. No permit on file.5/12/2015 Crossing is in good condition but does not have a permit on file for it.11/18/2014 Same as last inspection.5/13/2014 Same as last inspection.10/29/2013 Same as last inspection.5/16/2013 No known permit for work. FIELD_STRUCT_DESC: 4-inch steel communication conduit through the levee, 2 feet below the crown. Fiber optics line attached to bottom of downstream side of South Butte Road bridge. Position marked with orange markers on both the waterside (WS) and landside (LS). No permit has been identified since crossing was field discovered in 2012. FS Date: 2/7/2019 11:19:00 AM

WS view: overview of WS.

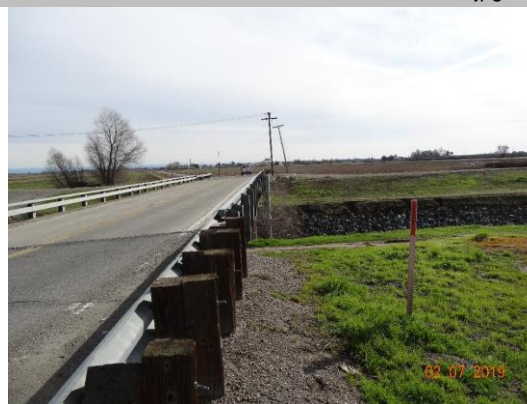
Photo 2 of 3 : UCIP\_SP\_2019\_53614\_78783.jpg

WS view: overview of bridge.

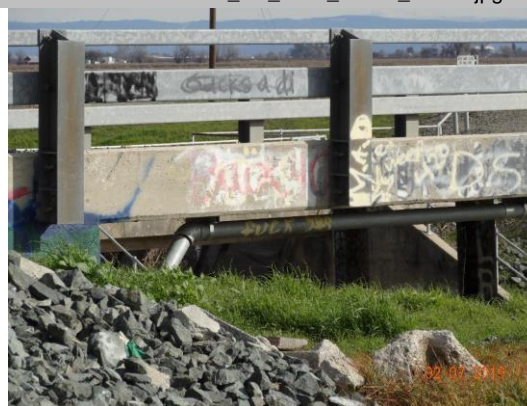
Photo 3 of 3 : UCIP\_SP\_2019\_53614\_78780.jpg

Comment Code						
Inspector Comment						
FS_ID:53614 DS_ID:23098 EP_NO: N/A Repair Type: Non-Urgent Crossing Status: Found UCIP Comments: 02/07/2019 (O. Magana - DWR UCIP)4/10/2017 Crossing appears to be in good condition. (DWR Sutter Yard-AFreitag)10/12/2016 Crossing appears to be in good condition.(DWR Sutter Yard - afreitag)5/27/2016 Need photos of markers and levee overview. (O. Magana)4/19/2016 Crossing appears to be in good condition. No permit on file.5/12/2015 Crossing is in good condition but does not have a permit on file for it.11/18/2014 Same as last inspection.5/13/2014 Same as last inspection.10/29/2013 Same as last inspection.5/16/2013 No known permit for work. FIELD_STRUCT_DESC: 4-inch steel communication conduit through the levee, 2 feet below the crown. Fiber optics line attached to bottom of downstream side of South Butte Road bridge. Position marked with orange markers on both the waterside (WS) and landside (LS). No permit has been identified since crossing was field discovered in 2012. FS Date: 2/7/2019 11:19:00 AM

WS view: conduit attached to bridge.

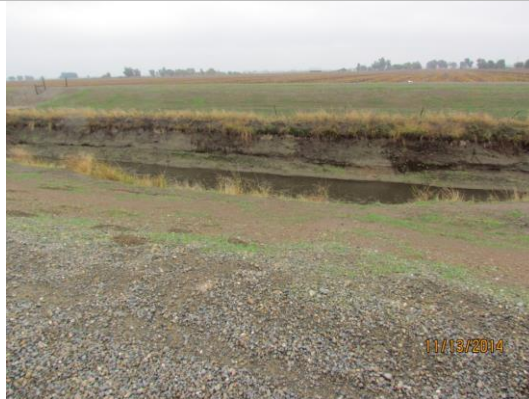
Photo 2 of 2 : SP\_2019\_ST0010\_43\_9\_20190327\_00004.jpg

LM Start	3.30	Rating **	A/W	Issue No.	9 (cont)	
LM End	4.58	Issue Type +	Ma	Location *	WS	
Category	Supplemental			GPS Latitude/Longitude		
				Start		End
Item	2017 USACE Erosion Survey, DRAFT			39.153320 °		39.171031 °
				-121.734573 °		-121.727040 °
DWR ID	DWR_ST0010_02_f_2018_9					
Comment Code						
Inspector Comment						
2017 Site ID: WAC 4.3 R						
Status: Eroding						
2017 Field Notes: Site extended downstream. Significant lower bank erosion.						
Site History: 2011 - Small erosion pocket.

View of the erosion along the waterside toe.
