**Flood Control Project Maintenance  
Levee Inspections**  
**LMA District Cover Sheet**  
**Spring 2019 Levee Inspection Results**

**Sutter Maintenance Yard Wadsworth Canal**

**Spring 2019 Levee Inspection Results**

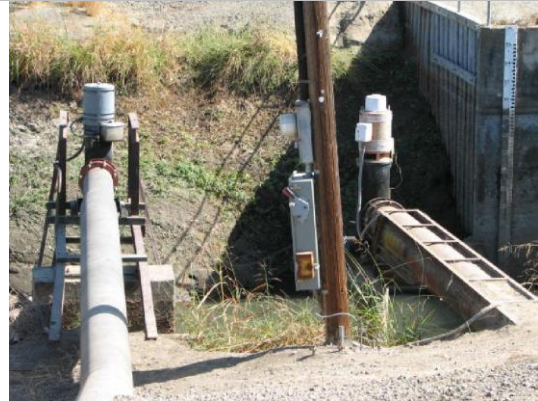
Photo 1 of 3 : UCIP\_SP\_2019\_53615\_64761.jpg

FS\_ID:53615  
DS\_ID:17078  
EP\_NO: 10473  
Repair Type: Urgent  
Crossing Status: Found  
UCIP Comments: 02/07/2019 (O. Magana - DWR UCIP)10/04/2018 Two sink holes visible on the LS slope. Crossing has been upgraded from Non-Urgent to Urgent because there are signs that the pipe has failed through the LS slope. Recommend video inspection to confirm pipe failure through the levee. Need to coordinate with CVFPB to have them contact the owner of the crossing. Unable to determine the extent of damage (size of sink holes) due to dense vegetation. Notified J. Peterson with CVFPB - Enforcement Section about the updated inspection for this pipe (sink holes now present). The CVFPB - Enforcement Section is pursuing corrective actions for this pipe under CVFPB Enforcement Id (Enf ID) 14602. (O. Magana - DWR UCIP)4/10/2017 WS appears to be in good condition. No repairs appear to have been made to the LS yet. Pipe measures to be 16". (DWR Sutter Yard- AFreitag)10/12/2016 WS appears to be in good condition. LS is still very rusted where it extends over the LS ditch.(DWR Sutter Yard - afreitag)4/19/2016 No changes have been made to this crossing. LS pipe outlet is still very rusted. 5/12/2015 Pipe is very rusty at Outlet in LS channel. No noticeable issues with WS.11/18/2014 Same as last inspection.5/13/2014 Same as last inspection.10/29/2013 Same as last inspection.5/16/2013 Same as last inspection.10/9/2012 Pipe shows signs of heavy rust at outlet in channel. Good candidate for video inspection. (W. Wylie - DWR UCIP) FIELD\_STRUCT\_DESC: 16-inch asphalt coated steel irrigation pipe through the levee, 2.7 feet below the crown. 16-inch pipe was measured during the UCIP field inspection. Record sources at this location reference the following pipe diameter size: USACE O&M manual references a 24-inch pipe, levee log references a 22-inch pipe, and permit records reference a 22-inch pipe. Unable to determine if original 22-inch pipe is still present through the levee. Vertical pump in the channel with a service pole on the waterside (WS) berm. Pipe discharges into a 36-inch concrete standpipe located on the landside (LS) toe of the levee. (Retain existing 22-inch pipe through levee and remove existing 12-inch pipe and replaced with 12-inch pipe under Permit No. 5622, 1967 - Webb. Remove 12-inch pipe and replace with 12-inch pipe under Permit No. 10473, 1976 - Brown. Install 16-inch pipe from canal to levee slope and modify existing 22-inch pipe under Permit No. 10473-A, 1976 - Brown). [Additional Reference(s): DWR Levee Log, 2005. USACE Sacramento O&M Manual 135, May 1953, (Station 174+63), Dwg. No. 50-04-1949, page 2 of 3, 24-inch pipe listed]. FS Date: 2/7/2019 12:10:00 PM

Pump on steel pier at WS toe.

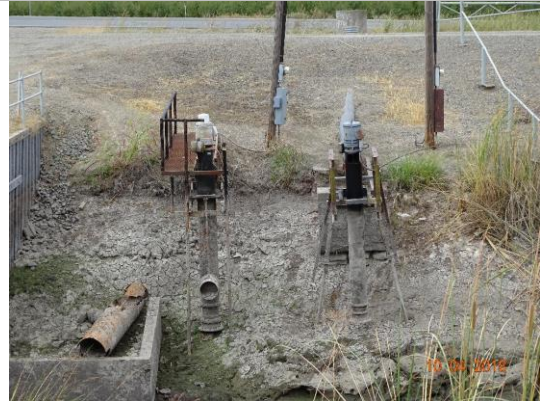
Photo 3 of 3 : UCIP\_SP\_2019\_53615\_78288.jpg

FS\_ID:53615  
DS\_ID:17078  
EP\_NO: 10473  
Repair Type: Urgent  
Crossing Status: Found  
UCIP Comments: 02/07/2019 (O. Magana - DWR UCIP)10/04/2018 Two sink holes visible on the LS slope. Crossing has been upgraded from Non-Urgent to Urgent because there are signs that the pipe has failed through the LS slope. Recommend video inspection to confirm pipe failure through the levee. Need to coordinate with CVFPB to have them contact the owner of the crossing. Unable to determine the extent of damage (size of sink holes) due to dense vegetation. Notified J. Peterson with CVFPB - Enforcement Section about the updated inspection for this pipe (sink holes now present). The CVFPB - Enforcement Section is pursuing corrective actions for this pipe under CVFPB Enforcement Id (Enf ID) 14602. (O. Magana - DWR UCIP)4/10/2017 WS appears to be in good condition. No repairs appear to have been made to the LS yet. Pipe measures to be 16". (DWR Sutter Yard- AFreitag)10/12/2016 WS appears to be in good condition. LS is still very rusted where it extends over the LS ditch.(DWR Sutter Yard - afreitag)4/19/2016 No changes have been made to this crossing. LS pipe outlet is still very rusted. 5/12/2015 Pipe is very rusty at Outlet in LS channel. No noticeable issues with WS.11/18/2014 Same as last inspection.5/13/2014 Same as last inspection.10/29/2013 Same as last inspection.5/16/2013 Same as last inspection.10/9/2012 Pipe shows signs of heavy rust at outlet in channel. Good candidate for video inspection. (W. Wylie - DWR UCIP) FIELD\_STRUCT\_DESC: 16-inch asphalt coated steel irrigation pipe through the levee, 2.7 feet below the crown. 16-inch pipe was measured during the UCIP field inspection. Record sources at this location reference the following pipe diameter size: USACE O&M manual references a 24-inch pipe, levee log references a 22-inch pipe, and permit records reference a 22-inch pipe. Unable to determine if original 22-inch pipe is still present through the levee. Vertical pump in the channel with a service pole on the waterside (WS) berm. Pipe discharges into a 36-inch concrete standpipe located on the landside (LS) toe of the levee. (Retain existing 22-inch pipe through levee and remove existing 12-inch pipe and replaced with 12-inch pipe under Permit No. 5622, 1967 - Webb. Remove 12-inch pipe and replace with 12-inch pipe under Permit No. 10473, 1976 - Brown. Install 16-inch pipe from canal to levee slope and modify existing 22-inch pipe under Permit No. 10473-A, 1976 - Brown). [Additional Reference(s): DWR Levee Log, 2005. USACE Sacramento O&M Manual 135, May 1953, (Station 174+63), Dwg. No. 50-04-1949, page 2 of 3, 24-inch pipe listed].

Overview photo of crossings from opposite bank. Pipe to left is associated with dsid 17078 and pipe to right is dsid 17081.

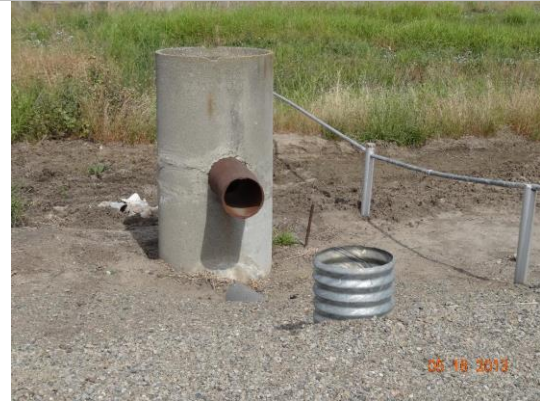
Photo 2 of 3 : UCIP\_SP\_2019\_53616\_64763.jpg

FS\_ID:53616  
DS\_ID:17081  
EP\_NO: 5622  
Repair Type: Urgent  
Crossing Status: Found  
UCIP Comments: 02/07/2019 (O. Magana - DWR UCIP)10/04/2018  
Pipe measured in the field: Pipe size is 14 inches instead of 15 inches, as previously referenced. Unable to locate the hole rusted through the 12-inch pipe previously referenced in 2013 due to dense vegetation. Crossing remains Urgent due to the unknown conditions through the levee and from the standpipe to LS exposed pipe section. Recommend video inspection through the crossing to determine pipe integrity. Notified J. Peterson with CVFPB - Enforcement Section about the updated inspection for this pipe. The CVFPB - Enforcement Section is pursuing corrective actions for this pipe under CVFPB Enforcement Id (Enf ID) 14602. (O. Magana - DWR UCIP)4/10/2017 WS appears to be in good condition. No repairs appear to have been made yet to the LS. Pipe measures to be 15" (DWR Sutter Yard-AFreitag)10/12/2016 WS seems to be in good condition. No repairs have been made yet where the pipe appears to be leaking under the LS toe road.(DWR Sutter Yard - afreitag)4/19/2016 No repairs seem to have been made yet. Pipe still appears to be leaking under the LS toe road. (DWR Sutter Yard - afreitag)5/12/2015 Pipe appears to have not yet been repaired. Still looks to be leaking under the LS toe road. (DWR Sutter Yard - afreitag)11/18/2014 Same as last inspection. (DWR Sutter Yard - afreitag)5/13/2014 Same as last inspection. (DWR Sutter Yard - afreitag)10/29/2013 Same as last inspection. (DWR Sutter Yard - afreitag)5/16/2013 Signs of leaks near concrete stand pipe on LS toe-road. Area about 20ft. long is muddy and there has not been any rain for a few weeks. (DWR Sutter Yard - afreitag) FIELD\_STRUCT\_DESC: 14-inch steel irrigation pipe through the levee, 2.7 feet below the crown. Vertical pumps located in the channel. Power pole on the waterside (WS) slope. Pipe discharges into 36-inch concrete standpipe located on the landside (LS) toe. 16-inch corrugated metal pipe (CMP) riser located on the LS shoulder. [Additional Reference(s): DWR Levee Log, 2005. USACE Sacramento O&M Manual 135, May 1953, (Station 174+60), Dwg. No. 50-04-1949, page 2 of 3, 15-inch steel pipe listed].

36in. concrete standpipe and 12in. cm riser on LS.

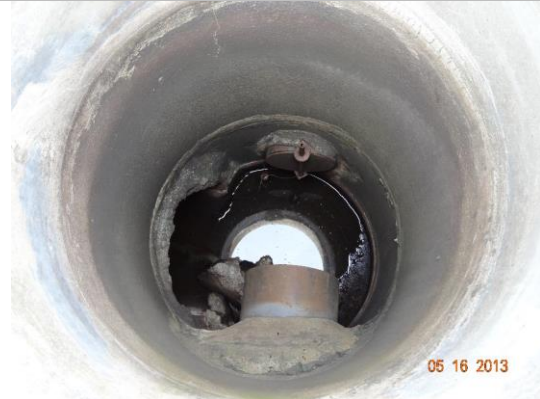
Photo 3 of 3 : UCIP\_SP\_2019\_53616\_64762.jpg

FS\_ID:53616  
DS\_ID:17081  
EP\_NO: 5622  
Repair Type: Urgent  
Crossing Status: Found  
UCIP Comments: 02/07/2019 (O. Magana - DWR UCIP)10/04/2018  
Pipe measured in the field: Pipe size is 14 inches instead of 15 inches, as previously referenced. Unable to locate the hole rusted through the 12-inch pipe previously referenced in 2013 due to dense vegetation. Crossing remains Urgent due to the unknown conditions through the levee and from the standpipe to LS exposed pipe section. Recommend video inspection through the crossing to determine pipe integrity. Notified J. Peterson with CVFPB - Enforcement Section about the updated inspection for this pipe. The CVFPB - Enforcement Section is pursuing corrective actions for this pipe under CVFPB Enforcement Id (Enf ID) 14602. (O. Magana - DWR UCIP)4/10/2017 WS appears to be in good condition. No repairs appear to have been made yet to the LS. Pipe measures to be 15" (DWR Sutter Yard - AFreitag)10/12/2016 WS seems to be in good condition. No repairs have been made yet where the pipe appears to be leaking under the LS toe road. (DWR Sutter Yard - afreitag)4/19/2016 No repairs seem to have been made yet. Pipe still appears to be leaking under the LS toe road. (DWR Sutter Yard - afreitag)5/12/2015 Pipe appears to have not yet been repaired. Still looks to be leaking under the LS toe road. (DWR Sutter Yard - afreitag)11/18/2014 Same as last inspection. (DWR Sutter Yard - afreitag)5/13/2014 Same as last inspection. (DWR Sutter Yard - afreitag)10/29/2013 Same as last inspection. (DWR Sutter Yard - afreitag)5/16/2013 Signs of leaks near concrete stand pipe on LS toe-road. Area about 20ft. long is muddy and there has not been any rain for a few weeks. (DWR Sutter Yard - afreitag) FIELD\_STRUCT\_DESC: 14-inch steel irrigation pipe through the levee, 2.7 feet below the crown. Vertical pumps located in the channel. Power pole on the waterside (WS) slope. Pipe discharges into 36-inch concrete standpipe located on the landside (LS) toe. 16-inch corrugated metal pipe (CMP) riser located on the LS shoulder. [Additional Reference(s): DWR Levee Log, 2005. USACE Sacramento O&M Manual 135, May 1953, (Station 174+60), Dwg. No. 50-04-1949, page 2 of 3, 15-inch steel pipe listed].

Inside of 36in. concrete riser

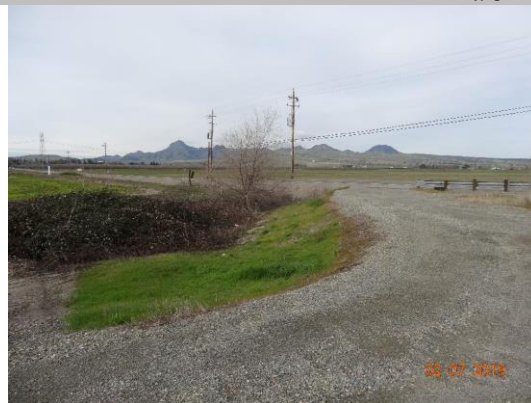
Photo 1 of 3 : UCIP\_SP\_2019\_53834\_78795.jpg

Comment Code						
Inspector Comment						
FS_ID:53834 DS_ID:17079 EP_NO: N/A Repair Type: Non-Urgent Crossing Status: Found UCIP Comments: 02/07/2019 (O. Magana - DWR UCIP)4/10/2017 Crossing appears to be in good condition. Pipe measures to be 14". (DWR Sutter Yard- AFreitag)10/12/2016 Crossing appears to be in good condition.(DWR Sutter Yard - afreitag)4/19/2016 Crossing appears to be in good condition.5/12/2015 Crossing appears in good condition. No noticeable issues to report.11/18/2014 Same as last inspection.5/13/2014 Same as last inspection.10/29/2013 Same as last inspection.5/16/2013 Same as last inspection. FIELD_STRUCT_DESC: 14-inch steel irrigation pipe (USACE O&M refers to 15-inch pipe) through the levee, 2.2 feet below the crown. Pump in corrugated metal (CM) pump house located on the waterside (WS). Pipe discharges into a 36-inch concrete standpipe located on the landside (LS) toe. Service pole located on the WS shoulder. (Pipe of unknown size authorized under Permit No. 1095, 1946 - Williamson). [Additional Reference(s): DWR Levee Log, 2005. USACE Sacramento O&M Manual 135, May 1953, (Station 226+00), Dwg. No. 50-04-1949, page 2 or 3]. FS Date: 2/7/2019 12:12:00 PM

LS view: overview of LS.

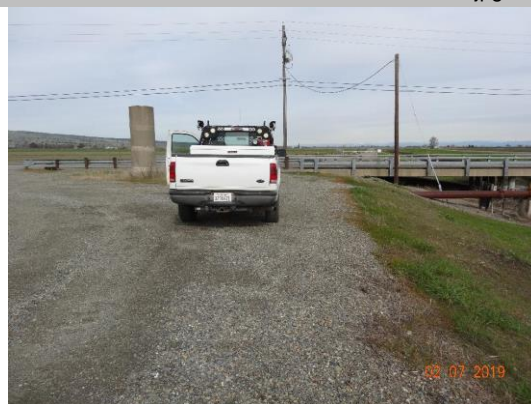
Photo 2 of 3 : UCIP\_SP\_2019\_53834\_78794.jpg

Overview of levee crown looking towards crossing.

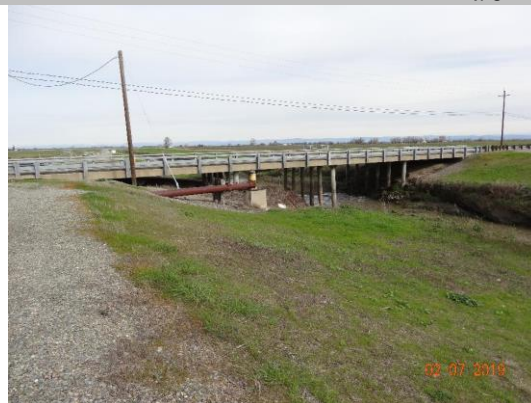
Photo 3 of 3 : UCIP\_SP\_2019\_53834\_78796.jpg

Comment Code						
Inspector Comment						
FS_ID:53834 DS_ID:17079 EP_NO: N/A Repair Type: Non-Urgent Crossing Status: Found UCIP Comments: 02/07/2019 (O. Magana - DWR UCIP)4/10/2017 Crossing appears to be in good condition. Pipe measures to be 14". (DWR Sutter Yard- A Freitag)10/12/2016 Crossing appears to be in good condition.(DWR Sutter Yard - a Freitag)4/19/2016 Crossing appears to be in good condition.5/12/2015 Crossing appears in good condition. No noticeable issues to report.11/18/2014 Same as last inspection.5/13/2014 Same as last inspection.10/29/2013 Same as last inspection.5/16/2013 Same as last inspection. FIELD_STRUCT_DESC: 14-inch steel irrigation pipe (USACE O&M refers to 15-inch pipe) through the levee, 2.2 feet below the crown. Pump in corrugated metal (CM) pump house located on the waterside (WS). Pipe discharges into a 36-inch concrete standpipe located on the landside (LS) toe. Service pole located on the WS shoulder. (Pipe of unknown size authorized under Permit No. 1095, 1946 - Williamson). [Additional Reference(s): DWR Levee Log, 2005. USACE Sacramento O&M Manual 135, May 1953, (Station 226+00), Dwg. No. 50-04-1949, page 2 or 3]. FS Date: 2/7/2019 12:12:00 PM

WS view: overview of WS.

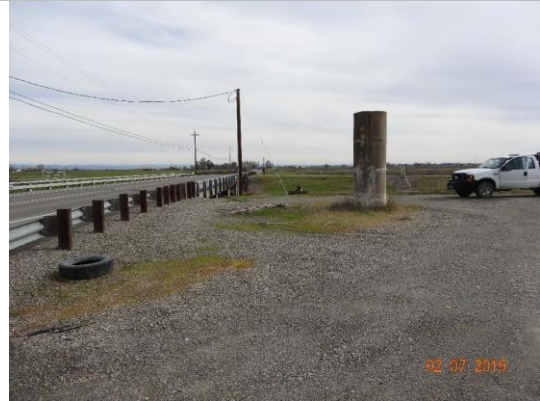
Photo 1 of 3 : UCIP\_SP\_2019\_53618\_78803.jpg

FS\_ID:53618  
DS\_ID:17070  
EP\_NO: 4680  
Repair Type: Non-Urgent  
Crossing Status: Indicator Found  
UCIP Comments: 02/07/2019 (O. Magana - DWR UCIP)4/10/2017 Aerial lines. (DWR Sutter Yard- AFreitag)10/12/2016 Crossing appears to be in good condition.(DWR Sutter Yard - afreitag)4/19/2016 Crossing appears to be in good condition.5/12/2015 Crossing now appears to be an aerial line. No issues to report.11/18/2014 Same as last inspection.5/13/2014 Same as last inspection.10/29/2013 Same as last inspection.5/16/2013 Same as last inspection.10/9/2012 Appears lines no longer cross levee at downstream side of bridge as there is no conduit. (W. Wylie - DWR UCIP)  
FIELD\_STRUCT\_DESC: 4-inch steel communication conduit (telephone cable inside) through the levee, 2.3 feet below the crown. Conduit line goes through Wadsworth Canal and its levees. Annular space between pipe and conduit grouted. Line is attached to the south side of the Butte House Road bridge (no longer attached in 2012). (4-inch conduit authorized under Permit No. 4680, 1964-Pacific Telephone and Telegraph Company [PT&T]). [Additional Reference(s): DWR Levee Log, 2005].

Overview of levee crown where crossing goes through levee.
