**Flood Control Project Maintenance  
Levee Inspections  
LMA District Cover Sheet**

**Sutter Maintenance Yard Wadsworth Canal**

**Flood Control Project Maintenance  
Levee Inspections**

**Levee Inspection Report By Mile - Spring 2023**

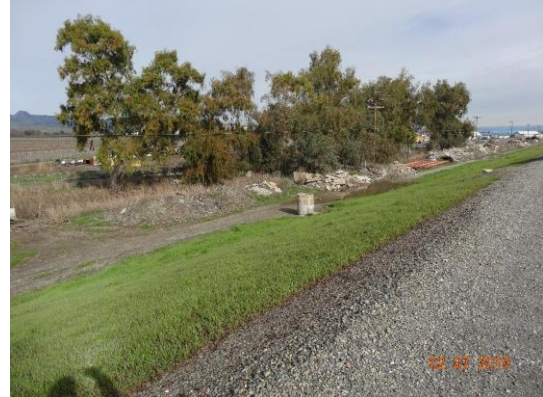
Photo 1 of 3 : UCIP\_SP\_2023\_60126\_78759.jpg

FIELD\_STRUCT\_DESC: 14-inch steel irrigation pipe through the levee, 3.8 feet below the crown. Pump on platform located on the waterside (WS). Pipe discharges into a 36-inch concrete standpipe at the landside (LS) toe. Siphon breakers in 14-inch risers located on the LS and butterfly shutoff valve located on the WS shoulders. Service pole located on the berm. (14-inch pipe authorized under Permit No. 1859, 1959 - Thomason. Permit renewal due to pipe leak repair authorized under Permit No. 1859-A, 1965 - Thomasen). [Additional Reference(s): DWR Levee Log, 2005 (HLM 2.11)].  
FS Date: 2/7/2019 11:17:00 AM

LS view: overview of LS.

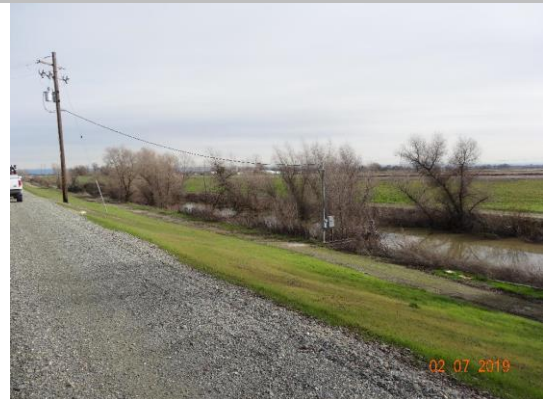
Photo 3 of 3 : UCIP\_SP\_2023\_60126\_78758.jpg

WS view: overview of WS.

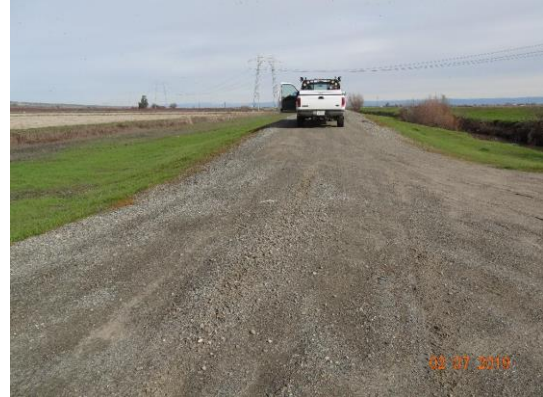
Photo 2 of 3 : UCIP\_SP\_2023\_60129\_78777.jpg

DS\_ID:17077  
 FS\_ID:60129  
 EP\_NO: 7209  
 Repair Type: Urgent  
 EVAL Issue: 1, Pipe Integrity  
 Crossing Status: Found  
 UCIP Comments: 01/06/2022 Record updated from Non-Urgent to Urgent. DMP internal video inspection has found pipe integrity issues. LoF of crossing is 5.1 due to holes less than 10 feet from pipe end and deformation less or equal 10%. Crossing will be monitored until funding becomes available to address the issues. (O.Yakimov - DWR UCIP) 02/07/2019 Record remains Non-Urgent due to the tree obstructing access to the WS pipe outlet. Maintenance will need to be performed to clear some of the vegetation preventing access to the flap gate. This pipe qualifies as an LMA responsible crossing as it was originally listed in the USACE O&M manual as a drainage pipe. The CVFPB issued a permit in 1970 for the replacement of the original USACE drainage pipe. (O. Magana - DWR UCIP)04/10/2017 Tree still present and a problem at the WS pipe outlet. LS inlet is still vegetated. (A. Freitag - DWR Sutter Yard)10/12/2016 Tree at the WS pipe end is still an issue and needs to be cut away. LS inlet is also being overgrown with vegetation. (A. Freitag - DWR Sutter Yard)04/19/2016 Tree at WS pipe end needs to be trimmed back and/or removed. (A. Freitag - DWR Sutter Yard) 05/12/2015 Tree growing near WS pipe end is getting too big and will affect the crossing. It needs to be cut back or removed. (A. Freitag - DWR Sutter Yard)11/18/2014 Same as last inspection. (A. Freitag - DWR Sutter Yard)05/13/2014 Same as last inspection. (A. Freitag - DWR Sutter Yard)10/29/2013 Same as last inspection. (A. Freitag - DWR Sutter Yard)05/16/2013 Same as last inspection. (A. Freitag - DWR Sutter Yard)

LM Start	3.00	Rating **	U	Issue No.	5 (cont)	
LM End	3.00	Issue Type +	En	Location *		
Category	Supplemental			GPS Latitude/Longitude		
				Start	End	
Item	DWR UCIP Field Study			39.149561°	39.149561°	
				-121.737080°	-121.737080°	
DWR ID	17077

Overview of levee crown.

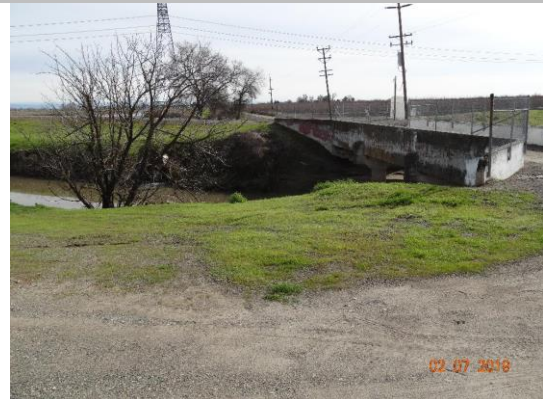
Photo 3 of 3 : UCIP\_SP\_2023\_60129\_78771.jpg

WS view: overview of WS.

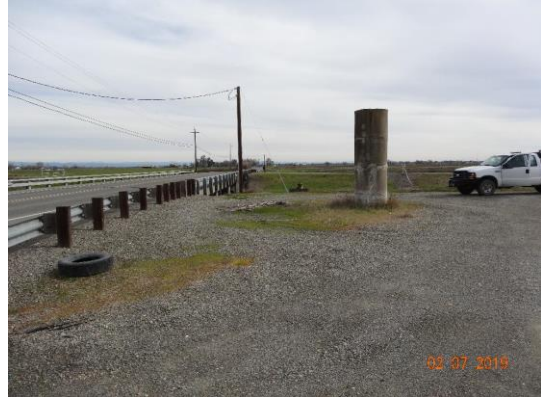
Photo 1 of 3 : UCIP\_SP\_2023\_60136\_78803.jpg

Comment Code					
Inspector Comment					
DS_ID:17070 FS_ID:60136 EP_NO: 4680 Repair Type: Non-Urgent EVAL Issue: 10, Unauthorized Modification or Non-Compliant Permit Crossing Status: Indicator Found UCIP Comments: 02/07/2019 Record has been updated from No Action Needed to Non-Urgent due to modifications made to authorized encroachment. Unable to determine the status of the buried conduit and the permit authorizing the aerial lines at this location. (O. Magana - DWR UCIP)04/10/2017 Aerial lines. (A. Freitag - DWR Sutter Yard)10/12/2016 Crossing appears to be in good condition. (A. Freitag - DWR Sutter Yard)04/19/2016 Crossing appears to be in good condition. (A. Freitag - DWR Sutter Yard)05/12/2015 Crossing now appears to be an aerial line. No issues to report. (A. Freitag - DWR Sutter Yard)11/18/2014 Same as last inspection. (A. Freitag - DWR Sutter Yard)05/13/2014 Same as last inspection. (A. Freitag - DWR Sutter Yard)10/29/2013 Same as last inspection. (A. Freitag - DWR Sutter Yard)05/16/2013 Same as last inspection. (A. Freitag - DWR Sutter Yard)10/09/2012 Appears lines no longer cross levee at downstream side of bridge as there is no conduit. (W. Wylie - DWR UCIP) FIELD_STRUCT_DESC: 4-inch steel communication conduit (telephone cable inside) through the levee, 2.3 feet below the crown. Conduit line goes through Wadsworth Canal and its levees. Annular space between pipe and conduit grouted. Line is attached to the south side of the Butte House Road bridge (no longer attached in 2012). (4-inch conduit authorized under Permit No. 4680, 1964-Pacific Telephone and Telegraph Company [PT&T]). [Additional Reference(s): DWR Levee Log, 2005 (HLM 4.34)]. FS Date: 2/7/2019 12:12:00 PM

Overview of levee crown where crossing goes through levee.
