Flood Control Project Maintenance
Levee Inspections
LMA District Cover Sheet

Sutter Maintenance Yard Wadsworth Canal

Levee Inspection Report By Mile - Spring 2024

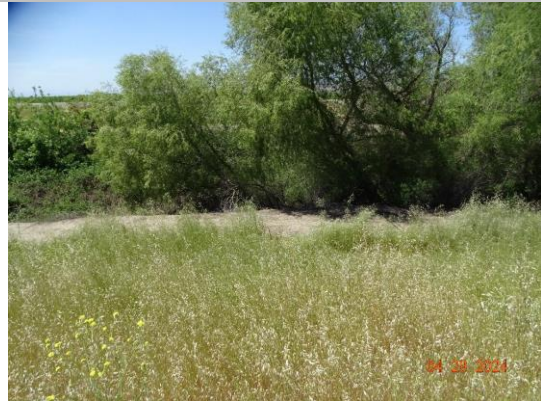
Photo 3 of 3 : UCIP_SP_2024_83609_122536.jpg

LM Start	1.25	Rating **	M	Issue No.	25 (cont)
LM End	1.25	Issue Type +	En	Location *

WS view: General overview looking from crown.

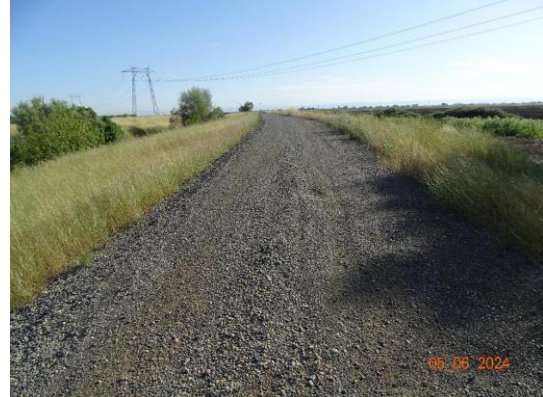
Photo 1 of 3 : UCIP_SP_2024_83620_122556.jpg

DS_ID:17065
FS_ID:83620
EP_NO: 7209
Repair Type: No Action Needed
EVAL Issue:
Crossing Status: Found
UCIP Comments: 05/06/2024 Record remains No Action Needed. Pipe was CIPP lined. DMP internal video inspection has found none or minor pipe defects. No issues observed during inspection. (M. Thao - DWR UCIP)
09/25/2023 DMP internal video inspection has found none or minor pipe defects. Recommend next video inspection in 5 years. (J. Taylor - DWR UCIP)01/06/2022 LoF of crossing is 5.2 due to pin size holes less than 10 feet from pipe end. Crossing remains Non-Urgent because pipe damage located outside of levee prism and does not pose a threat to levee. (O. Yakimov - DWR UCIP) 02/07/2019 Record remains Non-Urgent due to of few maintenance issues observed during inspection. Pipe is being used as a shooting target. Multiple holes are visible on the exposed WS section of the pipe. The inlet pipe section located on the LS has been damaged (pipe wall section pulled). This pipe qualifies as an LMA responsible crossing as it was originally listed in the USACE O&M manual as a drainage pipe. The CVFPB issued a permit in 1970 for the replacement of the original USACE drainage pipe. (O. Magana - DWR UCIP)04/10/2017 WS pipe end is in good condition. LS pipe end is still deformed and vegetated. (A. Freitag - DWR Sutter Yard)10/12/2016 LS inlet is still deformed and being overgrown by vegetation. (A. Freitag - DWR Sutter Yard)04/19/2016 Crossing appears to be in good condition. (A. Freitag - DWR Sutter Yard)05/12/2015 LS inlet still deformed a little but does not affect the crossing function. (A. Freitag - DWR Sutter Yard)11/18/2014 Same as last inspection. (A. Freitag - DWR Sutter Yard)05/13/2014 Same as last inspection. (A. Freitag - DWR Sutter Yard)10/29/2013 Same as last inspection. (A. Freitag - DWR Sutter Yard)05/16/2013 Pipe intake on LS appears to be bent and damaged but that does not appear to be affecting water flow or channel bank. (A. Freitag - DWR Sutter Yard)

FIELD_STRUCT_DESC: 36-inch CIPP-lined corrugated metal drainage pipe (permit records indicate 30-inch, USACE O&M pipe replaced with new 30-inch pipe) through the levee, 9 feet below the crown. Flap gate located on the waterside (WS) end. This crossing replaces 36-inch pipe (see DSID 25618). (36-inch pipe removed and replaced under Permit No. 7209, 1970 - Department of Water Resources [DWR], replacement pipe size not referenced drawing shows pipe is 9-feet 2-inches below the levee crown) [Additional Reference(s): DWR Levee Log, 2005 (HLM 3.06, listed as 36-inch CMP 14-feet below the crown). USACE Sacramento O&M Manual, Unit 135, May 1953, (Station 160+25), listed as 36-inch CMP w/ steel flap valve, USACE As-built Drawing No. 50-04-1949, Drawing No. 2, Sheet 3, March 1952, sheet 2 of 3].

Levee crown looking upstream.

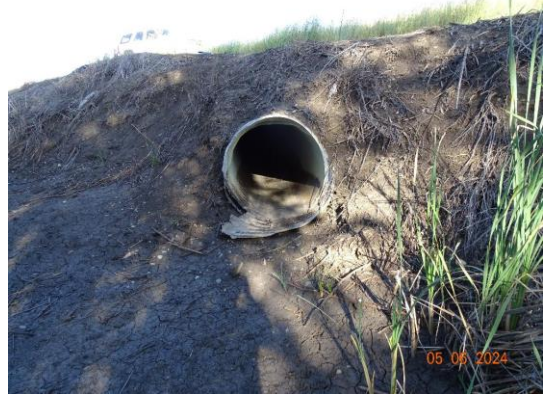
Photo 2 of 3 : UCIP_SP_2024_83620_122557.jpg

LM Start	3.04	Rating **	A	Issue No.	26 (cont)
LM End	3.04	Issue Type +	Ma	Location *

LS view: Pipe inlet located at the toe; looking toward levee.

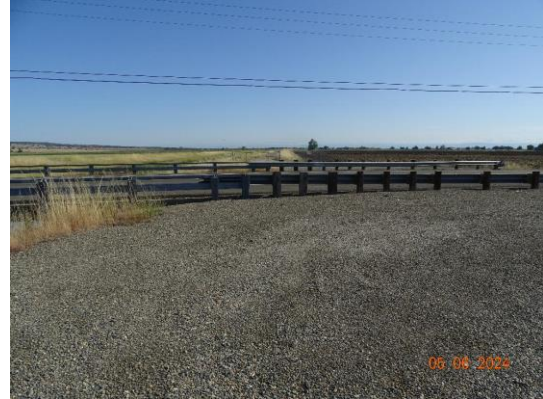
Photo 1 of 3 : UCIP_SP_2024_83668_122718.jpg

Comment Code						
Inspector Comment						
DS_ID:17067 FS_ID:83668 EP_NO: 4680 Repair Type: Non-Urgent EVAL Issue: 10, Unauthorized Modification or Non-Compliant Permit Crossing Status: Indicator Found UCIP Comments: 05/06/2024 Record remains Non-Urgent. No indication of buried conduit crossing levee; however, utility pole with electric box located approximately 225 feet from levee centerline. Buried line may have been modified to an aerial crossing located on the north side of Butte House Road. (M. Thao - DWR UCIP) 02/07/2019 Record has been updated from No Action Needed to Non-Urgent, buried line appears to have been changed to an aerial line. No signs were present of the buried conduit instead there appears to be an aerial line at this location now. Need to coordinate with owner to determine if 4-inch conduit was properly abandoned or removed per Title 23. If modifications were not approved by the CVFPB, owner will need to coordinate with the CVFPB to comply with Title 23 requirements. (O. Magana - DWR UCIP)04/10/2017 Aerial lines. (A. Freitag - DWR Sutter Yard)10/12/2016 Crossing appears to be in good condition. (A. Freitag - DWR Sutter Yard)04/19/2016 Crossing appears to be in good condition. (A. Freitag - DWR Sutter Yard)05/12/2015 Crossing appears in good condition. No noticeable issues to report. (A. Freitag - DWR Sutter Yard)11/18/2014 Same as last inspection. (A. Freitag - DWR Sutter Yard)05/13/2014 Same as last inspection. (A. Freitag - DWR Sutter Yard)10/29/2013 Same as last inspection. (A. Freitag - DWR Sutter Yard)05/16/2013 Same as last inspection. (A. Freitag - DWR Sutter Yard)10/09/2012 Communication line on Pole 400-feet west of canal. Likely now an aerial on North side of roadway. (W. Wylie - DWR UCIP) FIELD_STRUCT_DESC: 4-inch steel communication conduit (telephone cable inside) through the levee, 2.3 feet below the crown. Conduit line goes through Wadsworth Canal and its levees. Annular space between pipe and conduit grouted. Line is attached to south side of the Butte House Road bridge (no longer attached in 2012). (4-inch conduit authorized under Permit No. 4680, 1964 - Pacific Telephone and Telegraph Company [PT&T]). [Additional Reference(s): DWR Levee Log, 2005 (HLM 4.37, listed as 4-inch steel conduit)]. FS Date: 5/6/2024 2:15:06 PM

Levee crown looking upstream.

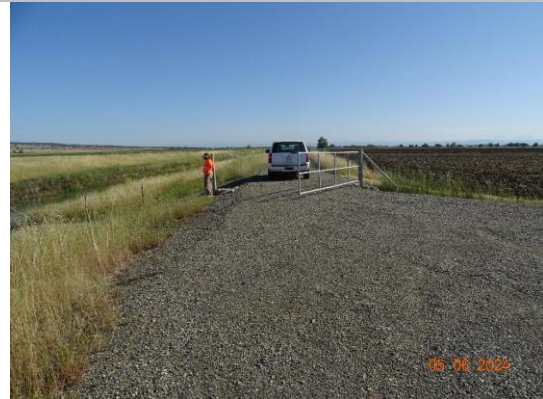
Photo 1 of 3 : UCIP_SP_2024_83673_122741.jpg

Comment Code						
Inspector Comment						
DS_ID:17058 FS_ID:83673 EP_NO: N/A Repair Type: Non-Urgent EVAL Issue: Crossing Status: Not Found UCIP Comments: 05/06/2024 Record remains Non-Urgent. Crossing not found. Geophysical results did not confirm presence of pipe through levee. Record will remain in UCIP's inspection records until future Levee Improvement Project can confirm no crossing was found through the levee. (M. Thao - DWR UCIP) 02/07/2019 Record has been updated from No Action Needed to Non-Urgent, unable to confirm status of pipe through the levee. Unable to locate pipe or appurtenances through this section of the levee. The DWR DMP geophysical investigation report indicates no signal received of suggestive target. Record will remain in UCIP's inspection records until future Levee Improvement Project can confirm no crossing was found through the levee. Also there is no permit identified for the authorization of this pipe. (O. Magana - DWR UCIP)04/10/2017 Unable to locate. (A. Freitag - DWR Sutter Yard)10/12/2016 Unable to locate. (A. Freitag - DWR Sutter Yard)04/19/2016 Unable to locate. (A. Freitag - DWR Sutter Yard)05/12/2015 Unable to locate. (A. Freitag - DWR Sutter Yard)11/18/2014 Unable to locate. (A. Freitag - DWR Sutter Yard)05/13/2014 Same as last inspection. (A. Freitag - DWR Sutter Yard)10/29/2013 Same as last inspection. (A. Freitag - DWR Sutter Yard)05/16/2013 Same as last inspection. (A. Freitag - DWR Sutter Yard)10/09/2012 Unable to locate. (W. Wylie - DWR UCIP) FIELD_STRUCT_DESC: 12-inch corrugated metal drainage pipe through the levee, 8.7 feet below the crown. Pipe is open at both the waterside (WS) and landside (LS) ends. [Additional Reference(s): DWR Levee Log, 2005 (HLM 4.38, listed as 12-inch CMP). USACE Sacramento O&M Manual, Unit 135, May 1953, (Station 228+00), listed as 12-inch CMP, USACE Drawing No. 50-04-1949, Drawing No. 2, Sheet 3, March 1952, page 2 of 3, 12-inch CMP referenced at 228+25]. FS Date: 5/6/2024 2:26:47 PM

Levee crown looking upstream.

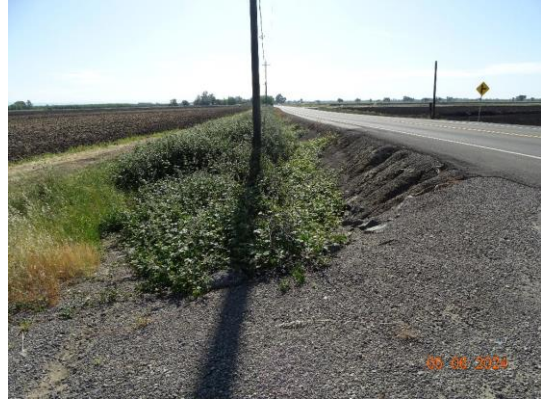
Photo 2 of 3 : UCIP_SP_2024_83673_122740.jpg

LM Start	4.32	Rating **	M	Issue No.	29 (cont)	
LM End	4.32	Issue Type +	Ma	Location *		
Category	Supplemental			GPS Latitude/Longitude		
				Start		End
Item	DWR UCIP LMA Responsibility			39.167098°	39.167098°	
				-121.728341°	-121.728341°	
DWR ID	17058

LS view: General overview looking from crown.

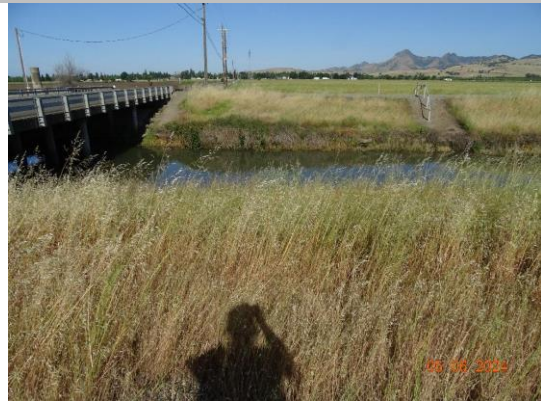
Photo 3 of 3 : UCIP_SP_2024_83673_122742.jpg

LM Start	4.32	Rating **	M	Issue No.	29 (cont)
LM End	4.32	Issue Type +	Ma	Location *

WS view: General overview looking from crown.

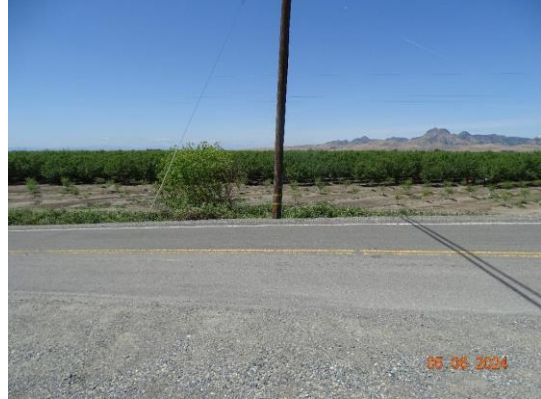
Photo 2 of 3 : UCIP_SP_2024_83686_122774.jpg

LM Start	1.24	Rating **	M	Issue No.	30 (cont)
LM End	1.24	Issue Type +	En	Location *	
Category	Supplemental		GPS Latitude/Longitude		
			Start	End	
Item	DWR UCIP Field Study		39.128414°	39.128414°	
			-121.755585°	-121.755585°	
DWR ID	17071

LS view: General overview looking from crown; wooden utility pole near toe.

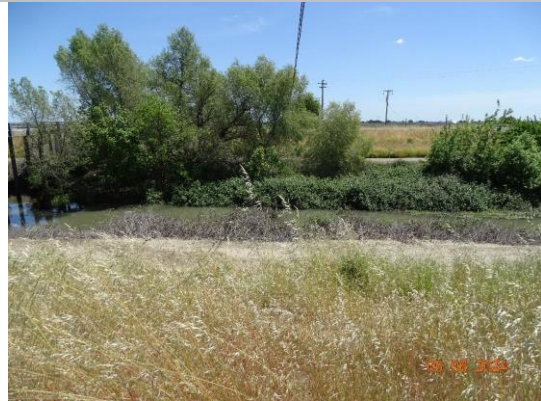
Photo 3 of 3 : UCIP_SP_2024_83686_122776.jpg

LM Start	1.24	Rating **	M	Issue No.	30 (cont)
LM End	1.24	Issue Type +	En	Location *

WS view: General overview looking from crown; aerial lines crossing over levees and canal.

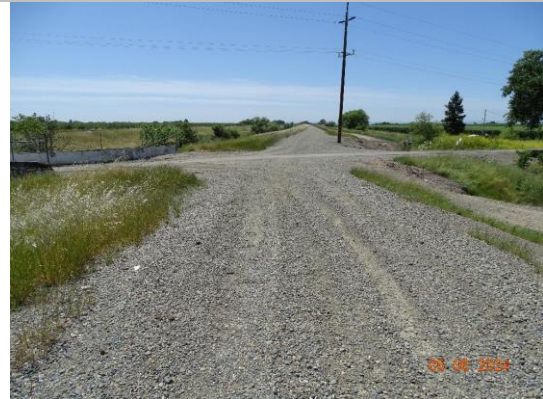
Photo 1 of 3 : UCIP_SP_2024_83700_122809.jpg

FIELD_STRUCT_DESC: 36-inch CIPP-lined corrugated metal drainage pipe (permit records indicate 30-inch pipe, O&M pipe replaced with new 30-inch pipe) through the levee, 14 feet below the crown. Flap gate located on the waterside (WS) end. (36-inch pipe was removed and replaced under Permit No. 7209, 1970 - Department of Water Resources [DWR], replacement pipe size not referenced). [Additional Reference(s): DWR Levee Log, 2005 (HLM 3.04). USACE Sacramento O&M Manual, Unit 135, May 1953, (Station 158+35), listed as 36-inch CMP with steel flap valve, USACE As-built Drawing No. 50-04-1949, Drawing No. 2, Sheet 3, March 1952, page 2 of 3].
FS Date: 5/6/2024 12:52:17 PM

Levee crown looking downstream.

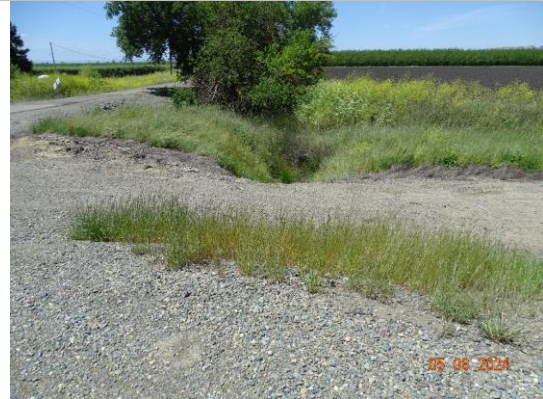
Photo 2 of 3 : UCIP_SP_2024_83700_122811.jpg

LM Start	3.00	Rating **	A	Issue No.	33 (cont)
LM End	3.00	Issue Type +	Ma	Location *

LS view: General overview looking from crown.
