**Flood Control Project Maintenance  
Levee Inspections**

**Fall 2017 Levee Maintenance Deficiency Summary Report**

## Sacramento Maintenance Yard West Levee Yolo Bypass

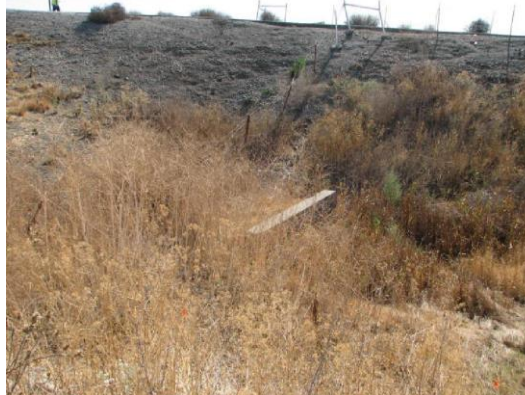
Photo 3 of 3 : UCIP\_FA\_2017\_44826\_60520.jpg

LM Start	0.60	Rating **	A/W	Issue No.	33 (cont)	
LM End	0.60	Issue Type +	Ma	Location *		
Category	Supplemental			GPS Latitude/Longitude		
				Start		End
Item	DWR UCIP LMA Responsibility			38.565704 °	38.565704 °	
				-121.638650 °	-121.638650 °	
DWR ID						
Comment Code						
Inspector Comment						
FS_ID:44826 DS_ID:528 EP_NO: 10304 Repair Type: No Action Needed Crossing Status: Found UCIP Comments: FIELD_STRUCT_DESC: 30-inch corrugated metal gravity drainage pipe through the levee, 22 feet below the crown. Flap gate on the waterside (WS) end. (30-inch pipe [HLM 0.59] authorized under Automatic Board Order (ABO) issued as Permit No. 10304, 1974 - Southern Pacific Transportation Company). [Additional Reference(s): DWR Levee Log, 2004. USACE Sacramento O&M Manual 120, June 1952, (Station 446+08)]. FS Date: 4/28/2015 2:58:55 PM

Landside view: overview

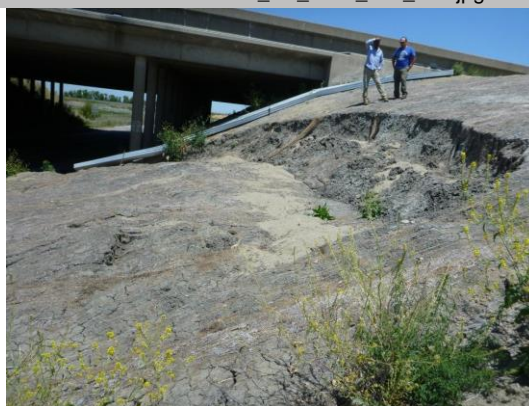
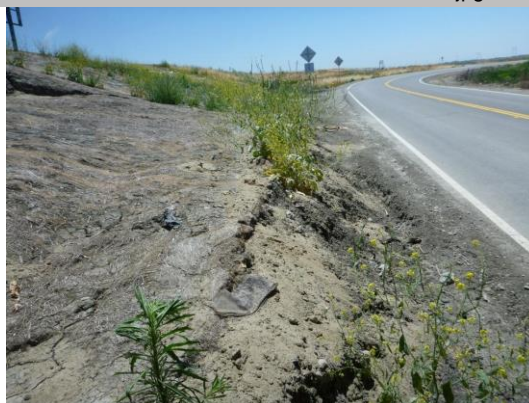
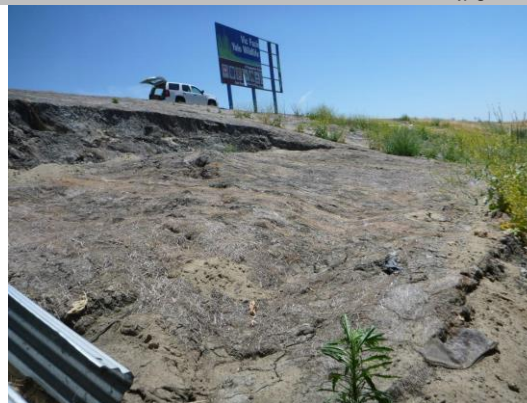
LM Start	0.77	Rating **	A/W	Issue No.	15
LM End	0.78	Issue Type +	Ma	Location *	
Category	Supplemental			GPS Latitude/Longitude	
				Start	End
Item	2017 Storm Damage			38.563289 °	38.563157 °
				-121.638367 °	-121.638344 °
DWR ID	DWR_ST0011_04_f_2017_15				
Comment Code					
Inspector Comment					
Levee Evaluation Comments					
Description:					
Site ID No:205					
Site Designation:ST11-U4-02					
Repair Type: Erosion					
Rating:Serious					
Field Date:6/5/2017					
Notes: LS levee slope failure -starts at mid slope, about 5.6' vertical drop, and mass extends 9' beyond levee toe, 26' wide asphalt road at toe, damaged erosion control fabrics noted. Site repaired as of the date of this inspection.

LM Start	0.77	Rating **	A/W	Issue No.	15 (cont)	
LM End	0.78	Issue Type +	Ma	Location *		
Category	Supplemental			GPS Latitude/Longitude		
				Start	End	
Item	2017 Storm Damage			38.563289 °	38.563157 °	
				-121.638367 °	-121.638344 °	
DWR ID	DWR_ST0011_04_f_2017_15					
Comment Code						
Inspector Comment						
Levee Evaluation Comments						
Description:						
Site ID No:205						
Site Designation:ST11-U4-02						
Repair Type: Erosion						
Rating:Serious						
Field Date:6/5/2017						
Notes: LS levee slope failure -starts at mid slope, about 5.6' vertical drop, and mass extends 9' beyond levee toe, 26' wide asphalt road at toe, damaged erosion control fabrics noted. Site repaired as of the date of this inspection.

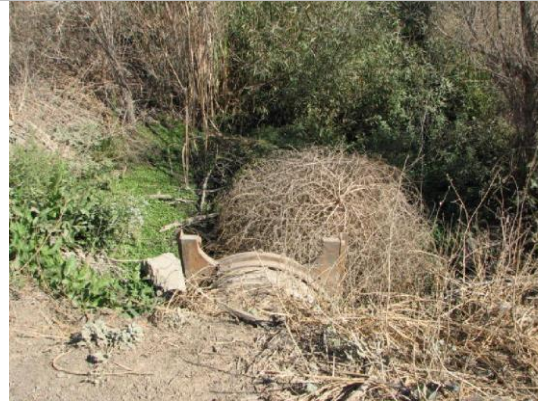
Photo 1 of 3 : UCIP\_FA\_2017\_52492\_60527.jpg

FS\_ID:52492  
DS\_ID:529  
EP\_NO: 2849  
Repair Type: Urgent  
Crossing Status: Found  
UCIP Comments: 09/19/2017 DWR Levee Inspector, Zachary Jojola, visited the site and it appears that Caltrans has completed some maintenance to clear out vegetation adjacent to the pipe (see updated photos). Work at this site, by Caltrans, is still in progress. (DWR UCIP - O. Magana) 07/17/2017 Received notification from the DWR Levee Inspection Section that the CVFPB sent out an Enforcement Letter dated July 14, 2017 for noncompliant 36-inch pipe authorized under Permit No. 2849 and referenced as Enforcement Case: 2016-514. The CVFPB is requesting Caltrans (pipe owner) to include in the 36-inch CMP drain Repair Plan the following items: provide adequate drainage capacity through the levee for current freeway conditions, prevent the flooding of County Road 32A and East Chiles Road underneath I-80, and prevent highway drainage from falling on top of the West Levee of the Yolo Bypass. Owner has until August 14, 2017 to respond to CVFPB's letter. (DWR UCIP - O. Magana) 04/20/2017 As per Spring 2015 inspection photos, Zach Jojola, DWR Inspector, informed me of flap gate not closing completely. Need to remove any obstructions so that gate can function properly. Crossing has been upgraded from No Action to Urgent. (K. Fazel - DWR)

FIELD\_STRUCT\_DESC: 36-inch corrugated metal gravity drainage pipe through the levee, 25 feet below the crown. Slide gate in a 36-inch corrugated metal pipe (CMP) riser on the waterside (WS) slope. Flap gate on the WS end. (36-inch pipe authorized under Permit No. 2849, 1958 - California Department of Transportation [Caltrans], District 3). [Additional Reference(s): DWR Levee Log, 2004].  
FS Date: 9/19/2017

Waterside view: overview

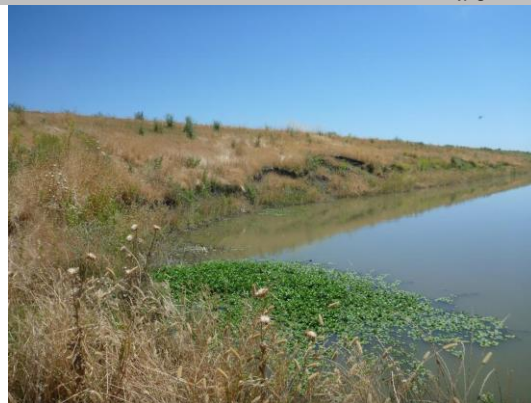
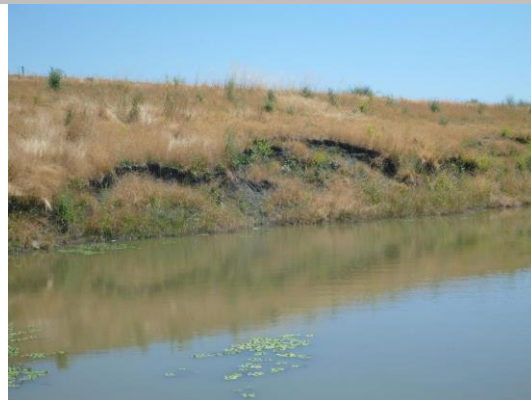
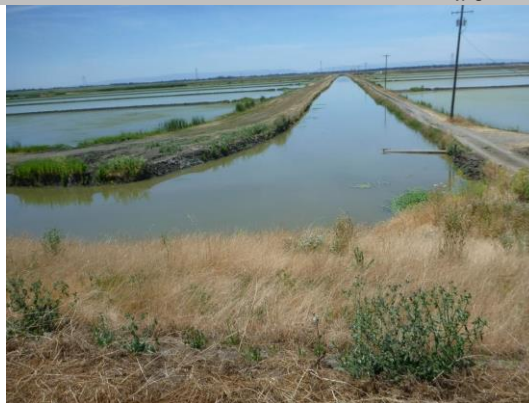
LM Start	2.76	Rating **	A/W	Issue No.	18 (cont)	
LM End	2.83	Issue Type +	Ma	Location *		
Category	Supplemental			GPS Latitude/Longitude		
				Start	End	
Item	2017 Storm Damage			38.535980 °	38.535037 °	
				-121.631430 °	-121.631416 °	
DWR ID	DWR_ST0011_04_f_2017_18					
Comment Code						
Inspector Comment						
Levee Evaluation Comments						
Description:						
Site ID No:204						
Site Designation:ST11-U4-01						
Repair Type: Erosion						
Rating:Critical						
Field Date:6/5/2017						
Notes: riparian scrub
