**Flood Control Project Maintenance
Levee Inspections**

Fall 2019 Levee Maintenance Deficiency Summary Report

**Flood Control Project Maintenance
Levee Inspections****LMA District Cover Sheet****Fall 2019 Levee Inspection Results****Sacramento Maintenance Yard West Levee Yolo Bypass**

Sacramento Maintenance Yard West Levee Yolo Bypass

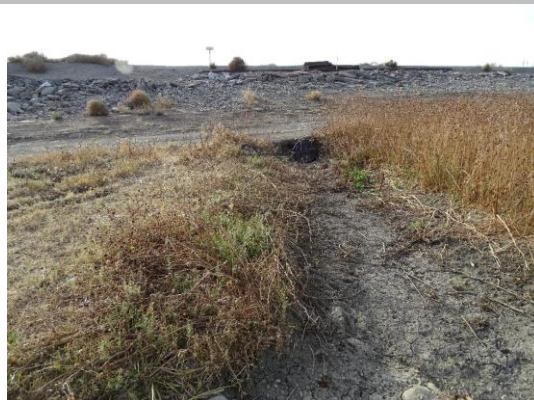
Photo 1 of 3 : UCIP_FA_2019_55949_83298.jpg

LM Start	0.60	Rating **	M	Issue No.	24 (cont)
LM End	0.60	Issue Type +	Ma	Location *

View of WS slope looking towards levee

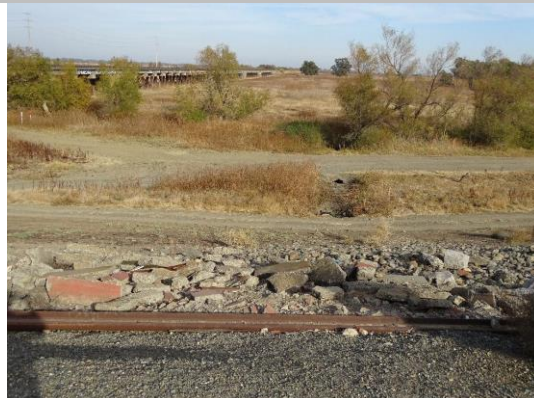
Photo 2 of 3 : UCIP_FA_2019_55949_83300.jpg

View of WS looking from levee crown

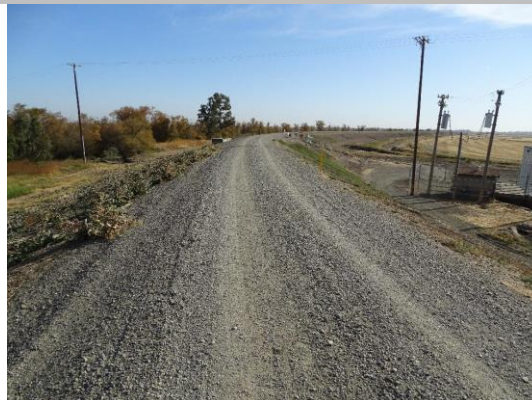
Photo 1 of 3 : UCIP_FA_2019_55957_83314.jpg

Comment Code					
Inspector Comment					
DS_ID:583 FS_ID:55957 EP_NO: 16846 Repair Type: Non-Urgent Crossing Status: Not Found UCIP Comments: 11/07/2019 Current status of permit 16846 doesn't show that construction has been completed. Unable to confirm installation of gas line through the levee. (O.Yakimov - DWR UCIP) FIELD_STRUCT_DESC: *NOT INSTALLED* To directionally bore a 2-inch coated steel natural gas pipeline under the right bank (west) levee of the Yolo Bypass, at an unknown depth. Also, to drill two natural gas wells. (two 3-inch gas lines under the right bank (west) levee and the bypass were authorized under Permit No. 16846, 1998 - Slawson Exploration/Irani Engineering; permit recordation, Permit Inspection Sheet, indicate no work done as of April 18, 2001). FS Date: 11/7/2019 10:39:52 AM

View of levee crown at potential crossing

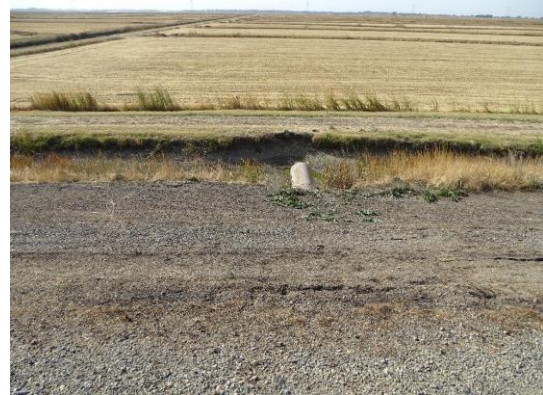
Photo 1 of 3 : UCIP_FA_2019_56030_83249.jpg

Comment Code						
Inspector Comment						
DS_ID:17736 FS_ID:56030 EP_NO: 10306 Repair Type: Non-Urgent Crossing Status: Found UCIP Comments: 11/07/2019 Permit authorizing crossing modification is not available. (O.Yakimov - DWR UCIP)04/28/2015 Farmer cleans this screw gate every year FIELD_STRUCT_DESC: 48-inch corrugated metal gravity drainage pipe through the levee, 21.5 feet below the crown. 42-inch steel pipe inside the 48-inch pipe. Slide gate on the waterside (WS) with two cutoff walls, one headwall, and one saddle and apron. (48-inch pipe [HLM 2.12] authorized under Automatic Board Order (ABO) issued as Permit No. 10306, 1974 - Wells Fargo Bank, Trustees for Cowell Foundation). [Additional Reference(s): USACE Sacramento O&M Manual 119, December 1952, (Station 80+00), dwg no. 50-04-2280, page 1 of 2]. FS Date: 11/7/2019

View of LS looking from levee crown

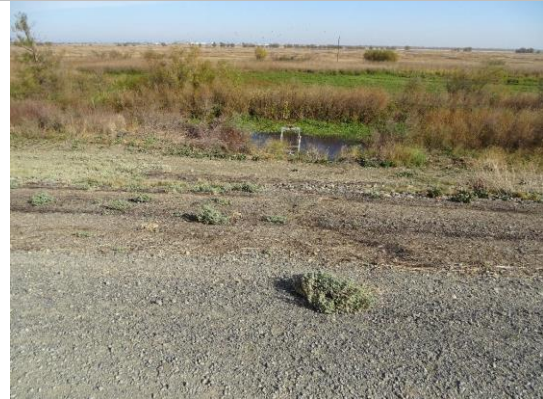
Photo 2 of 3 : UCIP_FA_2019_56030_83250.jpg

View of WS looking from levee crown

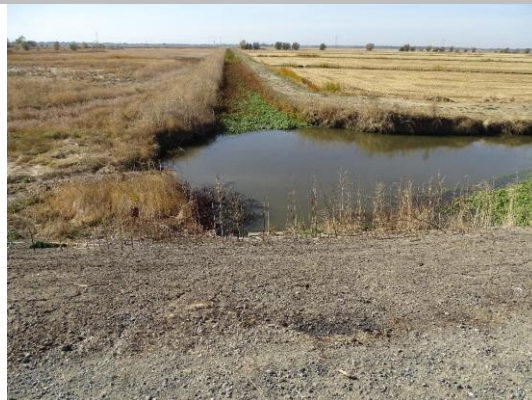
Photo 1 of 3 : UCIP_FA_2019_55963_83334.jpg

LM Start	3.61	Rating **	M	Issue No.	34 (cont)
LM End	3.61	Issue Type +	En	Location *

View of LS looking from levee crown

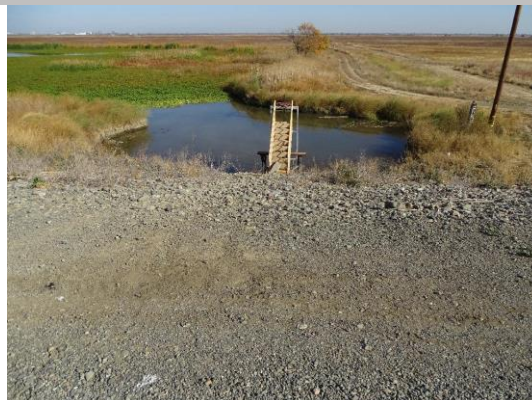
Photo 2 of 3 : UCIP_FA_2019_55963_83335.jpg

View of WS looking from levee crown
