Flood Control Project Maintenance Levee Inspections

Fall 2020 Levee Maintenance Deficiency Summary Report

Sacramento River Basin

Sacramento Maintenance Yard West Levee Yolo Bypass

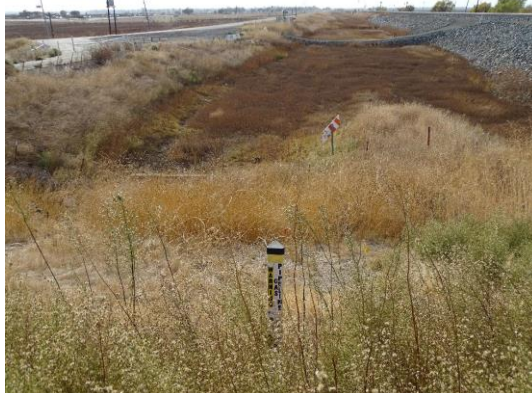
Photo 2 of 3 : UCIP_FA_2020_60259_83296.jpg

LM Start	0.59	Rating **	M	Issue No.	36 (cont)
LM End	0.59	Issue Type +	En	Location *	
Category	Supplemental		GPS Latitude/Longitude		
			Start	End	
Item	DWR UCIP Field Study		38.565784 °	38.565784 °	
			-121.638683 °	-121.638683 °	
DWR ID	572

Landside view: gasline markers

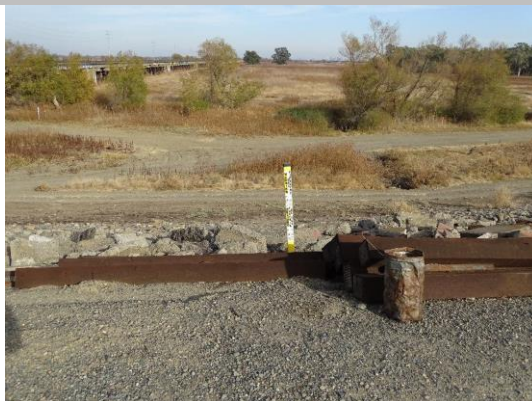
Photo 3 of 3 : UCIP_FA_2020_60259_83297.jpg

Waterside view: gasline marker

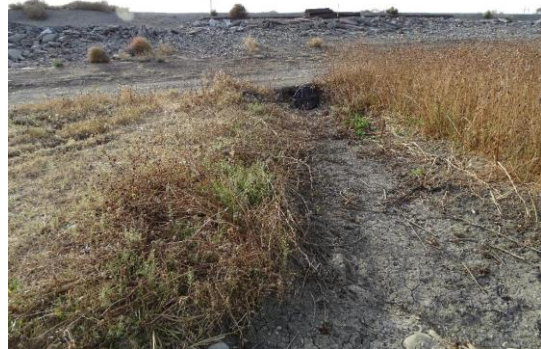
Photo 1 of 3 : UCIP_FA_2020_60660_83298.jpg

Comment Code						
Inspector Comment						
DS_ID:528 FS_ID:60660 EP_NO: 10304 Repair Type: Non-Urgent EVAL Issue: Unauthorized Encroachment, installed decades prior Crossing Status: Found UCIP Comments: 11/07/2019 Record updated from No Action Needed to Non-Urgent. Need to have CVFPB review ABO and determine current owner. (O.Yakimov - DWR UCIP) FIELD_STRUCT_DESC: 30-inch CIPP-lined corrugated metal gravity drainage pipe through the levee, 22 feet below the crown. Flap gate on the waterside (WS) end. (30-inch pipe [HLM 0.59] authorized under Automatic Board Order (ABO) issued as Permit No. 10304, 1974 - Southern Pacific Transportation Company). [Additional Reference(s): DWR Levee Log, 2004, (HLM 0.63, listed as a 30-inch pipe). USACE Sacramento O&M Manual, Unit 120, June 1952, Revised 29 December 2016, (Station 446+08), listed as 30-inch CMP. USACE As-Built Drawing No. 50-04-2281, Sheet 5, page 5 of 5 pdf file, January 1947]. FS Date: 11/7/2019 8:24:00 AM

View of WS slope looking towards levee

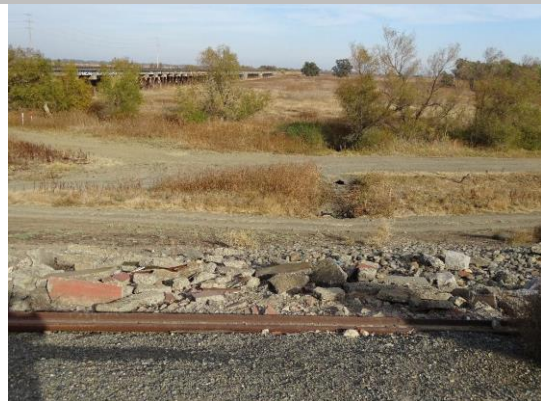
Photo 2 of 3 : UCIP_FA_2020_60660_83300.jpg

View of WS looking from levee crown

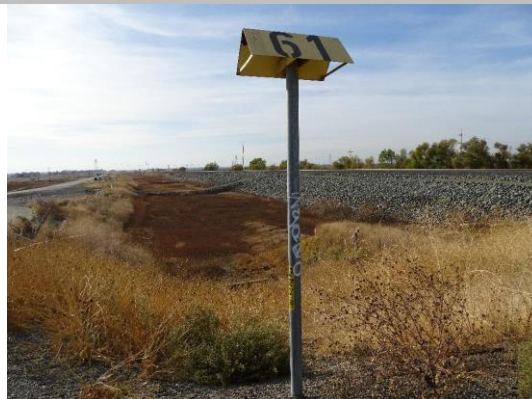
Photo 2 of 3 : UCIP_FA_2020_60263_83305.jpg

LM Start	0.60	Rating **	M	Issue No.	40 (cont)
LM End	0.60	Issue Type +	En	Location *	
Category	Supplemental		GPS Latitude/Longitude		
			Start	End	
Item	DWR UCIP Field Study		38.565667 °	38.565667 °	
			-121.638637 °	-121.638637 °	
DWR ID	577

View of LS looking from levee crown

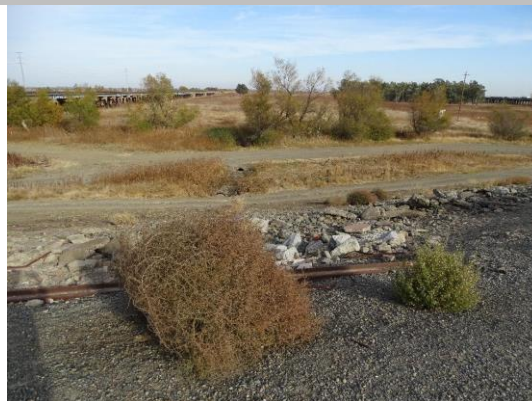
Photo 3 of 3 : UCIP_FA_2020_60263_83306.jpg

View of WS looking from levee crown

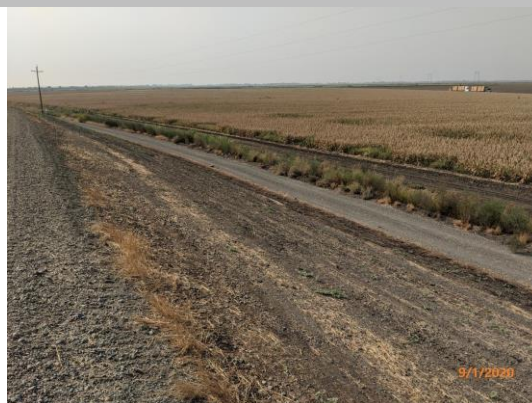
Photo 1 of 1 : FA_2020_ST0011_294_27_20200902_00039.jpg

LM Start	1.03	Rating **	A	Issue No.	27
LM End	1.03	Issue Type +	Ma	Location *	LS
Category	Earthen Levee			GPS Latitude/Longitude	
				Start	End
Item	Vegetation			38.559531 °	38.559531 °
				-121.637787 °	-121.637787 °
DWR ID	DWR_ST0011_04_f_2020_27				
Comment Code					
V1 : Control annual grass and weeds on the levee slopes and easements.					
Inspector Comment					
The LMA maintains the vegetation at a high level.

View of the landside slope. Fall 2020.
