**Flood Control Project Maintenance
Levee Inspections**

Fall 2022 Levee Maintenance Deficiency Summary Report

Sacramento River Basin

Sacramento Maintenance Yard West Levee Yolo Bypass

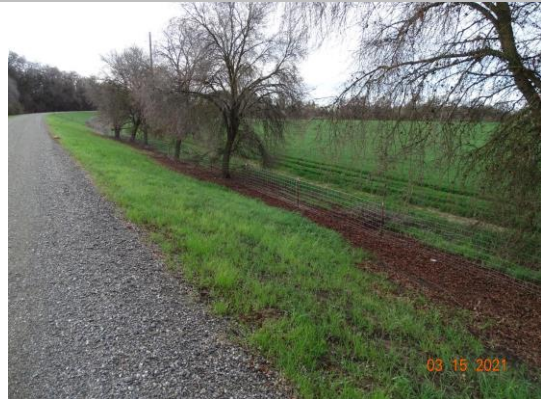
Photo 1 of 1 : FA_2022_ST0011_291_10_20220921_00005.jpg

LM Start	0.12	Rating **	M	Issue No.	10
LM End	1.55	Issue Type +	En	Location *	LS
Category	Earthen Levee			GPS Latitude/Longitude	
				Start	End
Item	Encroachments			38.758827 °	38.738955 °
				-121.665492 °	-121.660280 °
DWR ID	DWR_ST0011_01_s_ 2022_10				
Comment Code					
FE : Fence					
Inspector Comment

View of fence at landside toe. Spring 2021.

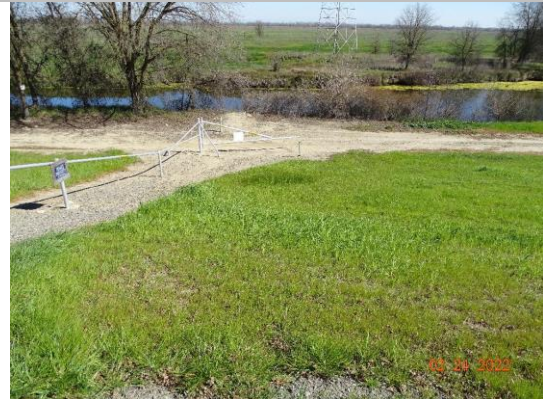
Photo 1 of 3 : UCIP_FA_2022_72806_109294.jpg

Comment Code					
Inspector Comment					
DS_ID:17745 FS_ID:72806 EP_NO: 10284 Repair Type: Non-Urgent EVAL Issue: Crossing Status: Found UCIP Comments: 02/24/2022 Record is Non-Urgent. Steel plate welded landside pipe end found in drainage ditch. Grout filler tube on the top of pipe, crossing appears abandoned by grouting. Unable to find a permit authorizing abandonment. Another pipe end is visible at riverbank. Geophysical results did not confirm presence of pipe through levee. Record will remain in UCIP's inspection records until future Levee Improvement Project can confirm no crossing was found through the levee. (O.Yakimov - DWR UCIP) FIELD_STRUCT_DESC: 24-inch corrugated metal gravity drainage pipe through the levee, 18 feet below the crown. Slide gate on the waterside (WS) slope. (24-inch pipe [HLM 0.94] authorized under Automatic Board Order (ABO) issued as Permit No. 10284, 1974 - La Borde and Hoover). [Additional Reference(s): DWR Levee Log, 2004 (HLM 0.94, listed as 24-inch pipe). USACE Sacramento O&M Manual, Unit 127, June 1953, Revised 16 November 2018, (Station 43+95), listed as 24-inch CMP]. FS Date: 2/24/2022 10:15:34 AM

Water-Side: View of levee slope looking from crown

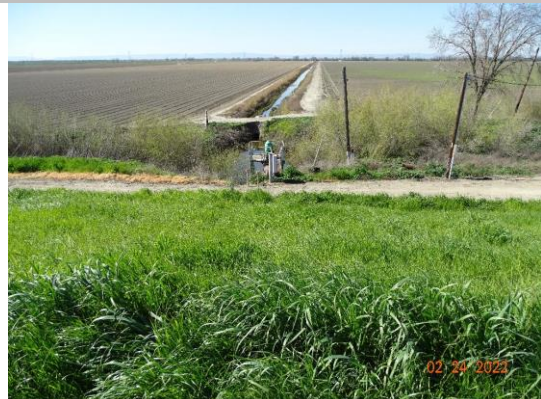
Photo 2 of 3 : UCIP_FA_2022_72852_109329.jpg

Land-Side: View of levee slope looking from crown. Drainage ditch off levee toe

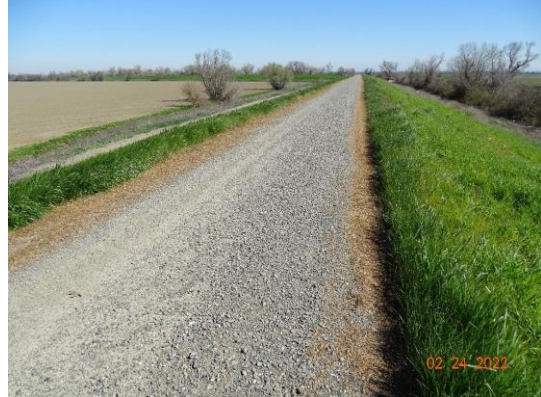
Photo 1 of 3 : UCIP_FA_2022_72854_109335.jpg

Comment Code						
Inspector Comment						
DS_ID:17742 FS_ID:72854 EP_NO: 10284 Repair Type: Non-Urgent EVAL Issue: Crossing Status: Found UCIP Comments: 02/24/2022 Record updated from No Action Needed to Non-Urgent. Crossing appears grouted. Grout filler tube on the top of pipe at concrete distribution box on landside. Marks of concrete around pipe. Unable to find a permit and confirm that pipe was properly abandoned. No signs of pipe on waterside. (O.Yakimov - DWR UCIP) 11/16/2018 Pipe is Grouted. (T. Skidgel - DWR Sacramento Yard)04/10/2014 Screw gates where removed and pipe was abanded by farmer, How pipe was abanded is unknown. (T. Skidgel - DWR Sacramento Yard)10/17/2012 Slide gate not found. (P. Amatya - DWR UCIP) FIELD_STRUCT_DESC: 1 of 2: 42-inch corrugated metal gravity drainage pipe through the levee, 23.6 feet below the crown. Slide gate on the waterside (WS) slope. Concrete distribution box at the landside (LS) toe. (42-inch pipe [HLM 2.63] authorized under Automatic Board Order (ABO) issued as Permit No. 10284, 1974 - La Borde and Hoover). [Additional Reference(s): DWR Levee Log, 2004 (HLM 2.63, listed as two 42-inch pipes). USACE Sacramento O&M Manual, Unit 127, June 1953, Revised 16 November 2018, (Station 133+82), listed as two 42-inch CMP]. FS Date: 2/24/2022 3:30:41 PM

Top of Levee: View of levee crown looking upstream

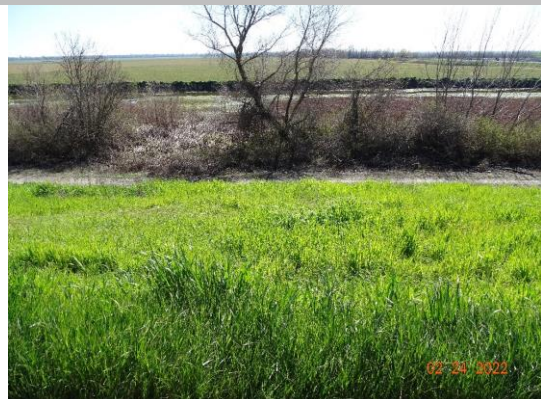
Photo 2 of 3 : UCIP_FA_2022_72854_109332.jpg

Water-Side: View of levee slope looking from crown. Pipe not found on waterside

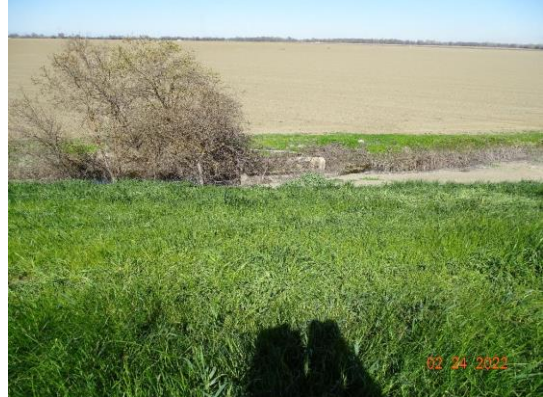
Photo 3 of 3 : UCIP_FA_2022_72854_109331.jpg

Land-Side: View of levee slope looking from crown, concrete distribution box at levee toe

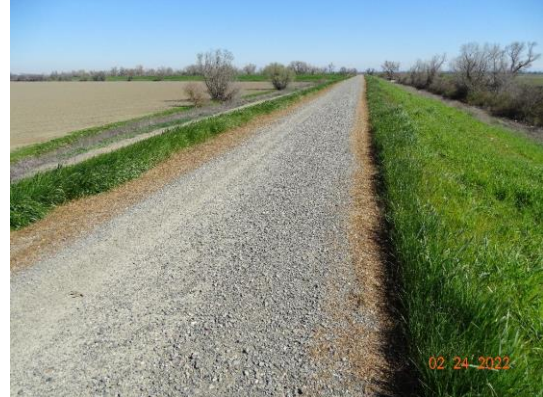
Photo 1 of 3 : UCIP_FA_2022_72858_109337.jpg

Comment Code						
Inspector Comment						
DS_ID:17747 FS_ID:72858 EP_NO: 10284 Repair Type: Non-Urgent EVAL Issue: Crossing Status: Found UCIP Comments: 02/24/2022 Record updated from No Action Needed to Non-Urgent. Crossing appears grouted. Grout filler tube on the top of pipe at concrete distribution box on landside. Marks of concrete around pipe. Unable to find a permit and confirm that pipe was properly abandoned. No signs of pipe on waterside. Geophysical results did not confirm presence of pipe through levee. Record will remain in UCIP's inspection records until future Levee Improvement Project can confirm no crossing was found through the levee. (O.Yakimov - DWR UCIP) 10/14/2014 Screw gate removed and pipe abandon by farmer, How pipe was abandoned is unknown. (T. Skidgel - DWR Sacramento Yard)10/17/2012 No slide gate found. (P. Amatya - DWR UCIP) FIELD_STRUCT_DESC: 2 of 2: 42-inch corrugated metal gravity drainage pipe through the levee, 23.6 feet below the crown. Slide gate on the waterside (WS) slope. Concrete distribution box at the landside (LS) toe. (42-inch pipe [HLM 2.63] authorized under Automatic Board Order (ABO) issued as Permit No. 10284, 1974 - La Borda and Hoover). [Additional Reference(s): DWR Levee Log, 2004 (HLM 2.63, listed as two 42-inch pipes). USACE Sacramento O&M Manual, Unit 127, June 1953, Revised 16 November 2018, (Station 133+82), listed as two 42-inch CMPs]. FS Date: 2/24/2022 3:41:05 PM

Top of Levee: View of levee crown looking upstream

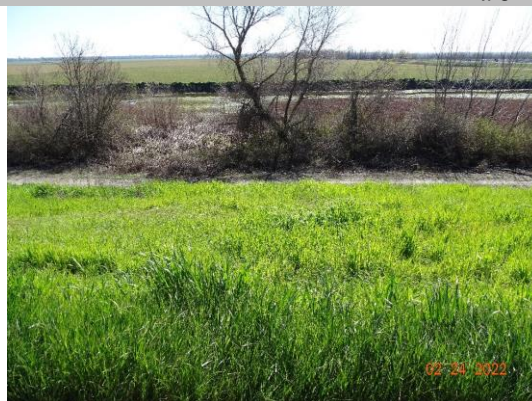
Photo 2 of 3 : UCIP_FA_2022_72858_109339.jpg

Water-Side: View of levee slope looking from crown. Pipe not found on waterside

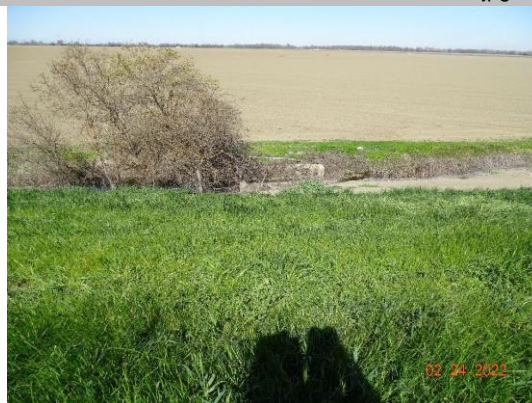
Photo 3 of 3 : UCIP_FA_2022_72858_109338.jpg

Land-Side: View of levee slope looking from crown, concrete distribution box at levee toe

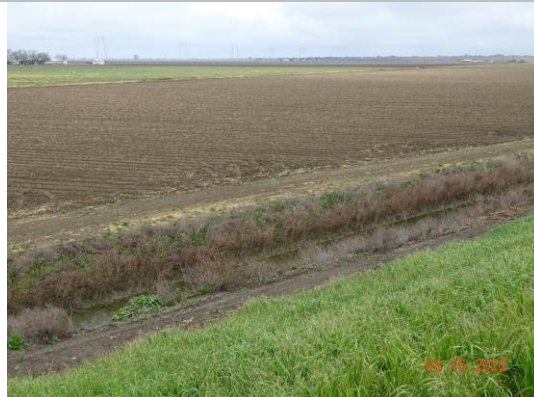
Photo 1 of 1 : FA_2022_ST0011_292_3_20220921_00001.jpg

LM Start	0.47	Rating **	M	Issue No.	3
LM End	0.97	Issue Type +	En	Location *	LS
Category	Earthen Levee			GPS Latitude/Longitude	
				Start	End
Item	Encroachments			38.712813 °	38.706018 °
				-121.667349 °	-121.670831 °
DWR ID	DWR_ST0011_02_s_2012_3				
Comment Code					
DT : Ditch					
Inspector Comment					
The ditch is approximately 10 ft deep.

View of ditch at the landside toe. Spring 2022.

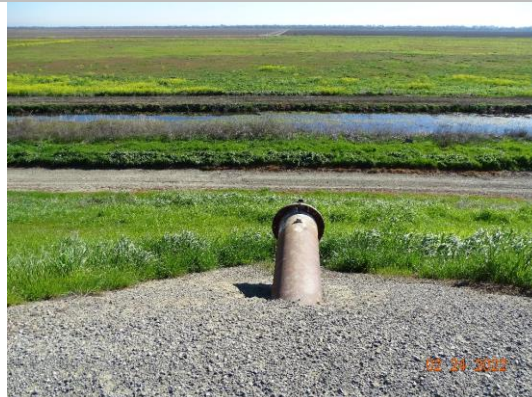
Photo 3 of 3 : UCIP_FA_2022_73243_109709.jpg

Land-Side: View of levee slope looking from crown

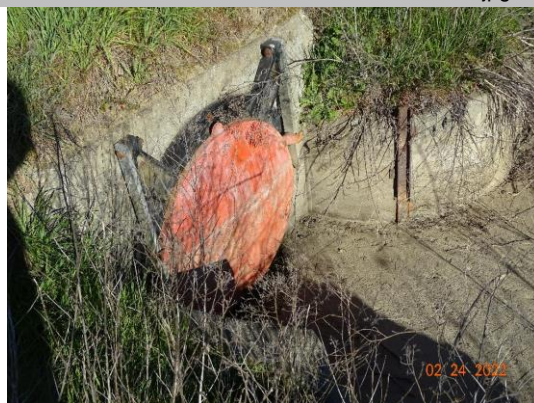
Photo 3 of 3 : UCIP_FA_2022_73263_109749.jpg

Water-Side: Headwall and flap gate

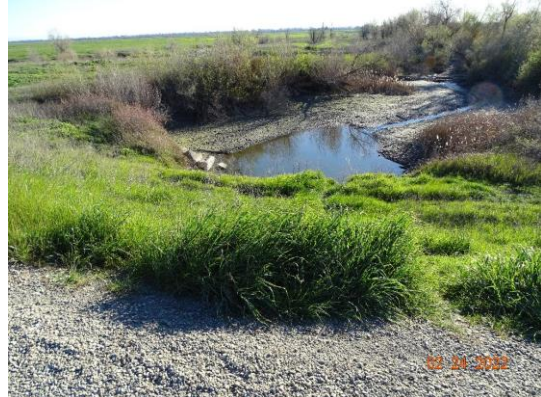
Photo 1 of 3 : UCIP_FA_2022_73265_109755.jpg

Comment Code					
Inspector Comment					
DS_ID:17753 FS_ID:73265 EP_NO: 10296 Repair Type: Urgent EVAL Issue: 3a, Flood Risk Crossing Status: Found UCIP Comments: 02/24/2022 Record updated from No Action Needed to Urgent. Flap gate cannot be properly closed due to debris accumulation. Unauthorized encroachment recorded in Levee Log. Need to have CVFPB review ABO and determine current owner. (O.Yakimov - DWR UCIP) 08/20/2020 Need to obtain a copy of USACE Drawing As-Built listed under additional references. Drawing information was listed by previous inspector. (O. Magana - DWR UCIP) 04/10/2014 summer of 2013 removed debris and mud. (T. Skidgel - DWR Sacramento Yard)10/17/2012 Flap gate was partially opened during field survey period. Intake pipe on LS was buried with floated debris/logs. Debris removal or trash rack/screen is required. Two pipes are 5 ft apart from each other. Slide gate on landward end not found. (P. Amatya - DWR UCIP) FIELD_STRUCT_DESC: 1 of 2: 36-inch corrugated metal gravity drainage pipe through the levee, 20 feet below the crown. Slide gate on the landside (LS) end. (36-inch pipe authorized under Automatic Board Order (ABO) issued as Permit No. 10296, 1974 - Woodland Farms, Ltd.). (Intention to remove and replace pipe is pending authorization under Permit No. 19624, permit not yet issued). [Additional Reference(s): DWR Levee Log, 2004 (HLM 1.48, listed as two 36-inch pipes). USACE Drawing referenced as E-2 at Station 1+75, As-Built Drawing: USACE, Sacramento Districts. Levee Repair- Cache Creek Settling Basin, Wahler Associates, May 1991] FS Date: 2/24/2022 4:37:29 PM

Water-Side: View of levee slope looking from crown

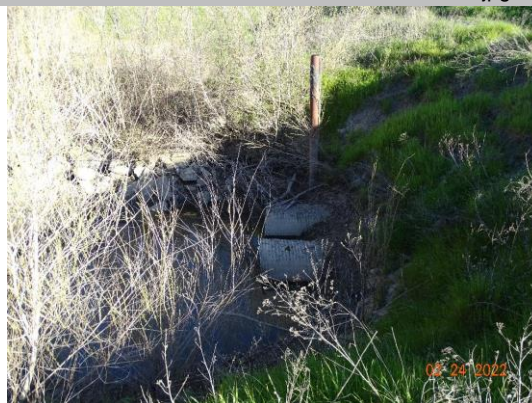
Photo 3 of 3 : UCIP_FA_2022_73266_109757.jpg

Land-Side: Pipe End visible in drainage ditch

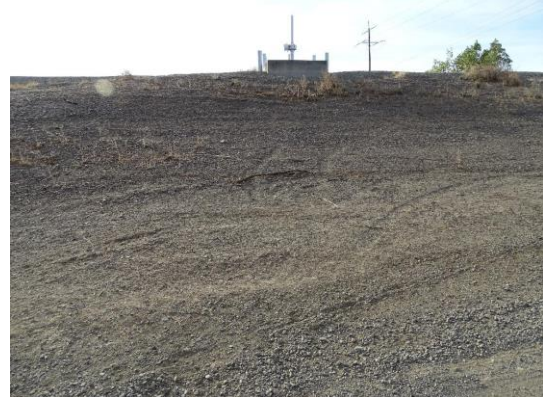
Photo 1 of 3 : UCIP_FA_2022_60250_83281.jpg

Comment Code						
Inspector Comment						
DS_ID:569 FS_ID:60250 EP_NO: 16096 Repair Type: Urgent EVAL Issue: 3a, Flood Risk Crossing Status: Found UCIP Comments: 11/07/2019 Flap gate at WS headwall not closing completely. A wooden stick on the top prevents flap gate closing leaving space for backflow. Provide maintenance on flap gate. About 20-foot long surface cracking observed on levee crown closer to LS shoulder. Not sure if cracking is related to this crossing (potential levee damage concern). (O.Yakimov - DWR UCIP)10/18/2012 The culvert was constructed in 1993. (P. Amatya - DWR UCIP) FIELD_STRUCT_DESC: 60-inch by 60-inch reinforced concrete box gravity drainage culvert through the right bank (west) levee of the Yolo Bypass, 20 feet below the crown. 60-inch by 60-inch culvert replaced an existing 30-inch gravity drain pipeline. (60-inch by 60-inch culvert authorized under Permit No. 16096, 1993 - Yolo County Flood Control and Water Conservation District, square culvert installed about 28 feet south of existing 30-inch pipe). FS Date: 11/7/2019 3:23:00 PM

View of WS slope looking towards levee

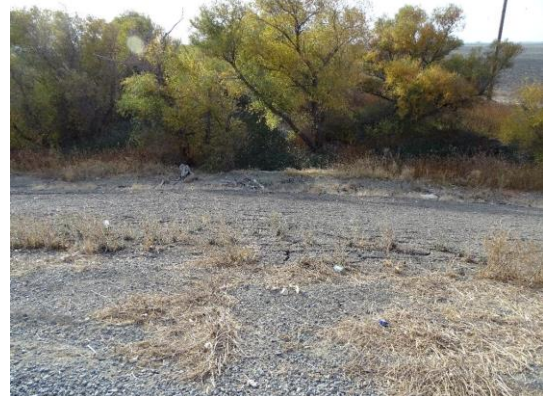
Photo 2 of 3 : UCIP_FA_2022_60250_83282.jpg

View of LS looking from levee crown

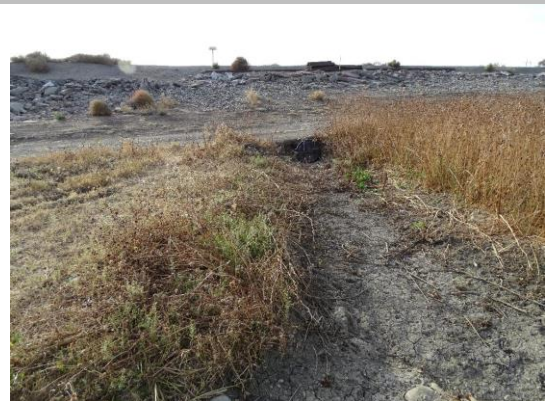
Photo 1 of 3 : UCIP_FA_2022_60660_83298.jpg

DS_ID:528
 FS_ID:60660
 EP_NO: 10304
 Repair Type: Non-Urgent
 EVAL Issue:
 Crossing Status: Found
 UCIP Comments: 11/07/2019 Record updated from No Action Needed to Non-Urgent. Need to have CVFPB review ABO and determine current owner. (O.Yakimov - DWR UCIP)
 FIELD_STRUCT_DESC: 30-inch CIPP-lined corrugated metal gravity drainage pipe through the levee, 22 feet below the crown. Flap gate on the waterside (WS) end. (30-inch pipe [HLM 0.59] authorized under Automatic Board Order (ABO) issued as Permit No. 10304, 1974 - Southern Pacific Transportation Company). [Additional Reference(s): DWR Levee Log, 2004, (HLM 0.63, listed as a 30-inch pipe). USACE Sacramento O&M Manual, Unit 120, June 1952, Revised 29 December 2016, (Station 446+08), listed as 30-inch CMP. USACE As-Built Drawing No. 50-04-2281, Sheet 5, page 5 of 5 pdf file, January 1947].
 FS Date: 11/7/2019 8:24:00 AM

View of WS slope looking towards levee

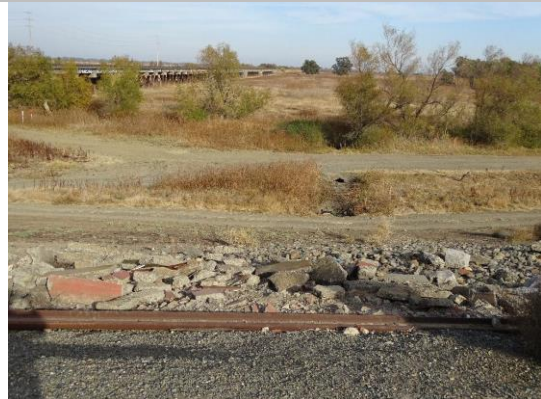
Photo 2 of 3 : UCIP_FA_2022_60660_83300.jpg

LM Start	0.60	Rating **	M	Issue No.	29 (cont)
LM End	0.60	Issue Type +	Ma	Location *	
Category	Supplemental		GPS Latitude/Longitude		
			Start	End	
Item	DWR UCIP LMA Responsibility		38.565704 °	38.565704 °	
			-121.638650 °	-121.638650 °	
DWR ID	528

View of WS looking from levee crown

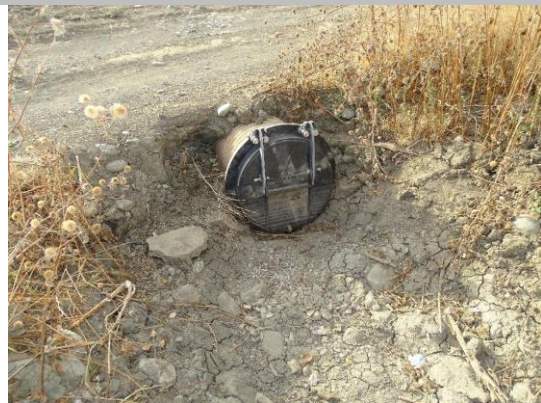
Photo 3 of 3 : UCIP_FA_2022_60660_83299.jpg

Pipe and flap gate at WS levee toe

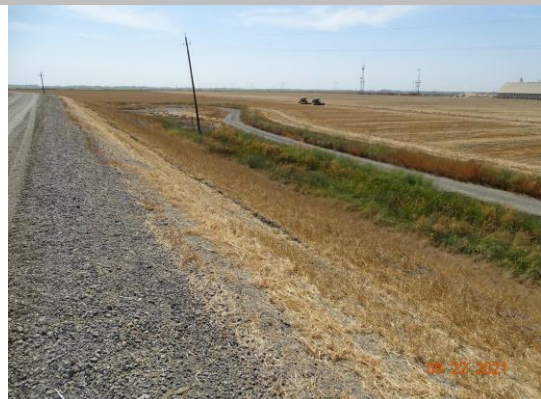
Photo 1 of 1 : FA_2022_ST0011_294_6_20220921_00003.jpg

LM Start	0.91	Rating **	M	Issue No.	6
LM End	1.03	Issue Type +	En	Location *	LS
Category	Earthen Levee			GPS Latitude/Longitude	
				Start	End
Item	Encroachments			38.561233 °	38.559502 °
				-121.638182 °	-121.637810 °
DWR ID	DWR_ST0011_04_s_2015_6				
Comment Code					
DT : Ditch					
Inspector Comment					
The ditch is at the toe of the levee on the landward side.

View of ditch at landside toe. Fall 2021.

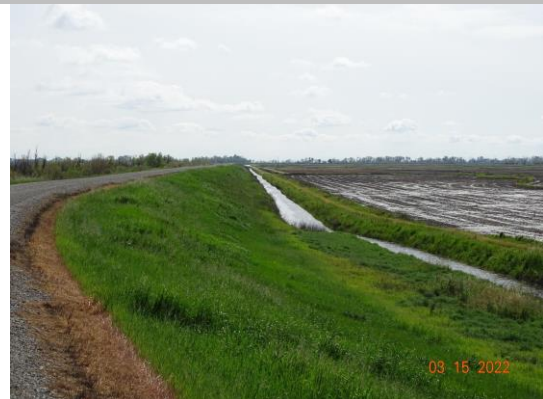
Photo 1 of 1 : FA_2022_ST0011_294_3_20220921_00001.jpg

LM Start	1.77	Rating **	M	Issue No.	3
LM End	2.69	Issue Type +	En	Location *	LS
Category	Earthen Levee			GPS Latitude/Longitude	
				Start	End
Item	Encroachments			38.550387 °	38.536958 °
				-121.631257 °	-121.631450 °
DWR ID	DWR_ST0011_04_s_2012_3				
Comment Code					
DT : Ditch					
Inspector Comment					
The ditch is at the toe of the levee on the landward side.

View of the irrigation ditch at the landside toe. Spring 2022.

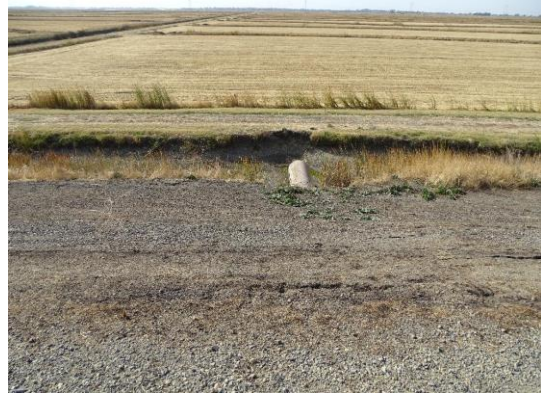
Photo 1 of 3 : UCIP_FA_2022_60661_83249.jpg

Comment Code					
Inspector Comment					
DS_ID:17736 FS_ID:60661 EP_NO: 10306 Repair Type: Urgent EVAL Issue: 1, Pipe Integrity Crossing Status: Found UCIP Comments: 11/07/2019 Record updated from No Action Needed to Non-Urgent. Need to have CVFPB review ABO and determine current owner. Permit authorizing crossing modification is not available. (O.Yakimov - DWR UCIP)06/20/2013 Farmer cleans this screw gate everyyear. (C. Lund - DWR Sacramento Yard)10/18/2012 Outlet pipe blocked half way by mud and debris on WS of the levee. (P. Amatya - DWR UCIP) FIELD_STRUCT_DESC: 48-inch corrugated metal gravity drainage pipe through the levee, 21.5 feet below the crown. 42-inch steel pipe inside the 48-inch pipe. Slide gate on the waterside (WS) with two cutoff walls, one headwall, and one saddle and apron. (48-inch pipe [HLM 2.12] authorized under Automatic Board Order (ABO) issued as Permit No. 10306, 1974 - Wells Fargo Bank, Trustees for Cowell Foundation). [Additional Reference(s): USACE Sacramento O&M Manual, Unit 119, December 1952, Revised 29 December 2016, (Station 80+00), listed as 48-inch CMP. USACE As-Built Drawing No. 50-04-2280, Sheet 1, page 1 of 2 pdf file, May 1946]. FS Date: 11/7/2019

View of LS looking from levee crown

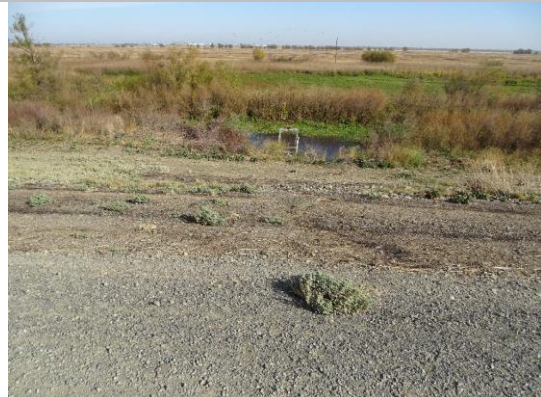
Photo 2 of 3 : UCIP_FA_2022_60661_83250.jpg

View of WS looking from levee crown

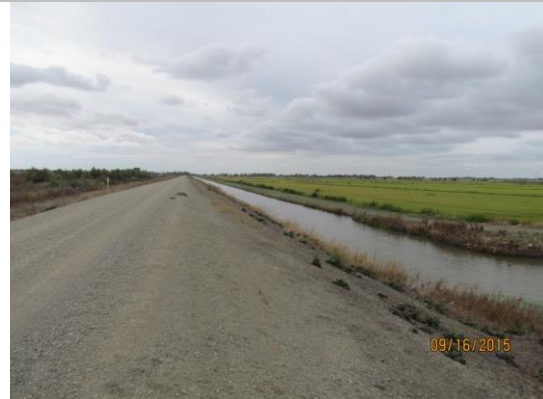
Photo 1 of 1 : FA_2022_ST0011_294_4_20220921_00002.jpg

LM Start	2.75	Rating **	M	Issue No.	4
LM End	3.60	Issue Type +	En	Location *	LS
Category	Earthen Levee			GPS Latitude/Longitude	
				Start	End
Item	Encroachments			38.536100 °	38.523807 °
				-121.631425 °	-121.631535 °
DWR ID	DWR_ST0011_04_f _ 2018_4				
Comment Code					
DT : Ditch					
Inspector Comment					
The ditch is at the levee toe on the landward side of the levee.

The ditch is at the levee toe on the landward side of the levee looking downstream. Fall 2015.
