Flood Control Project Maintenance Levee Inspections

Fall 2023 Levee Maintenance Deficiency Summary Report

Sacramento River Basin

Sacramento Maintenance Yard West Levee Yolo Bypass

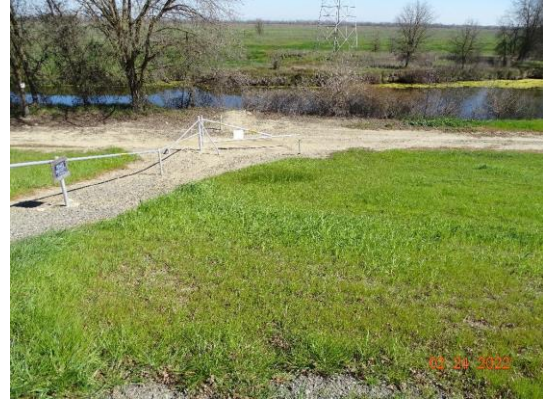
Photo 1 of 3 : UCIP_FA_2023_72806_109294.jpg

Water-Side: View of levee slope looking from crown

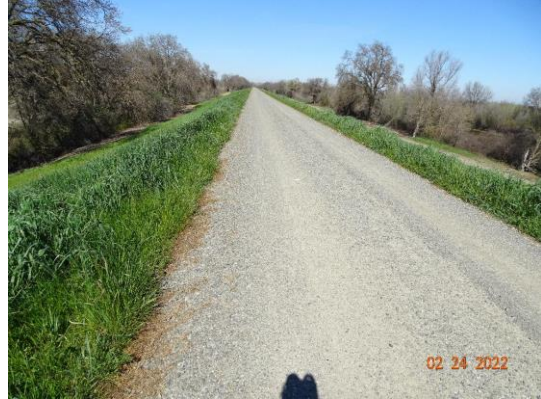
Photo 1 of 3 : UCIP_FA_2023_72846_109326.jpg

Comment Code					
Inspector Comment					
DS_ID:17744					
FS_ID:72846					
EP_NO: 10284					
Repair Type: Non-Urgent					
EVAL Issue:					
Crossing Status: Indicator Found					
UCIP Comments: 02/24/2022 Record updated from No Action Needed to Non-Urgent. Crossing not found. CMP and steel pipe debris at landside toe. Geophysical results did not confirm presence of pipe through levee. Record will remain in UCIP's inspection records until future Levee Improvement Project can confirm no crossing was found through the levee. Previous inspection comment indicate that pipe was abandoned. No permit has been identified authorizing pipe. Need to have CVFPB review ABO and determine current owner. (O.Yakimov - DWR UCIP)					
04/10/2014 This was abandoned by farmer, how Unknown. need to have verified if removed or concreted. (T. Skidgel - DWR Sacramento Yard) 10/17/2012 Found abandoned 42-inch CM pipe on LS berm of the levee. (P. Amatya - DWR UCIP)

FIELD_STRUCT_DESC: 42-inch corrugated metal gravity drainage pipe through the levee, 25 feet below the crown. Slide gate on the waterside (WS) end. (42-inch pipe [HLM 1.85] authorized under Automatic Board Order (ABO) issued as Permit No. 10284, 1974 - La Borda and Hoover). [Additional Reference(s): DWR Levee Log, 2004 (HLM 1.85). USACE Sacramento O&M Manual, Unit 127, June 1953, Revised 23 November 2021, (STA 92+35), listed as 42-inch CMP. USACE As-Built Drawing No. 50-04-1548, July 1936, Sheet 1, STA number is unclear].					
FS Date: 2/24/2022

Top of Levee: View of levee crown looking upstream

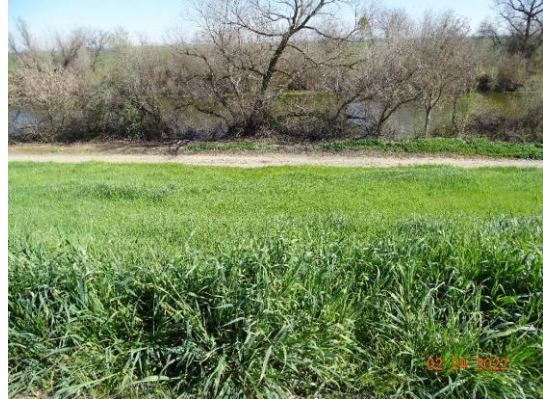
Photo 3 of 3 : UCIP_FA_2023_72846_109324.jpg

Water-Side: View of levee crown looking from crown. No evidence of pipe

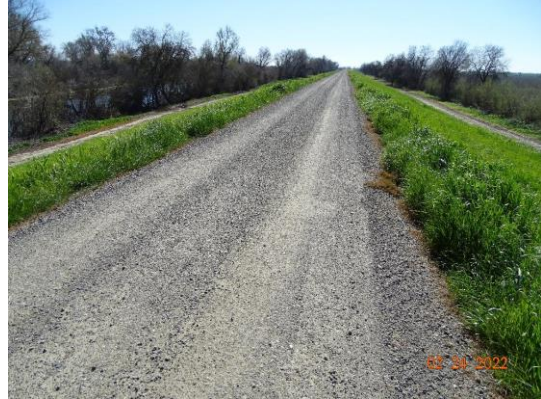
Photo 1 of 3 : UCIP_FA_2023_72852_109328.jpg

Comment Code						
Inspector Comment						
DS_ID:17743 FS_ID:72852 EP_NO: 6306 Repair Type: Non-Urgent EVAL Issue: 4b, Safety Issue Crossing Status: Found UCIP Comments: 02/24/2022 Record updated from No Action Needed to Non-Urgent. Siphon breaker riser needs to have top cover restored. (O.Yakimov - DWR UCIP) 10/17/2012 Walkway on LS to pump is in poor structural condition. Seems pump has been used for dual purpose. There is another pipe (approx. 12-inch) found near the pump crossing the ditch. (T. Skidgel - DWR UCIP)10/17/2012 The pipe is about 18-ft below the crown. Seems pump has been used for dual purpose. There is another pipe (approx. 12-inch) found near the pump crossing the ditch. Two closing valves also found in pumping station. (P. Amatya - DWR UCIP) FIELD_STRUCT_DESC: 20-inch coated steel drainage pipe through the levee, 5.8 feet below the crown. Pump and switch panel at the landside (LS) toe. Siphon breaker on the LS slope. Butterfly valves at pump on the LS toe. This crossing replaces 20-inch pipe (see DSID 25371). (20-inch pipe replacement authorized under Permit No. 6306, 1968 - William P. Wilson). [Additional Reference(s): DWR Levee Log, 2004 (HLM 1.85). USACE Sacramento O&M Manual, Unit 127, June 1953, Revised 23 November 2021, (STA 92+31.5), listed as 20-inch steel pipe]. FS Date: 2/24/2022 3:22:03 PM

Top of Levee: View of levee crown looking downstream

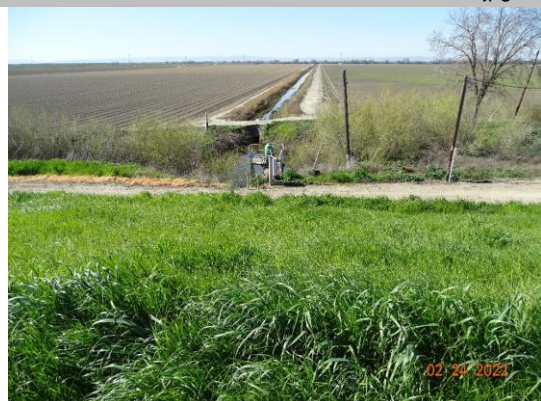
Photo 2 of 3 : UCIP_FA_2023_72852_109329.jpg

Land-Side: View of levee slope looking from crown crown. Drainage ditch off levee toe

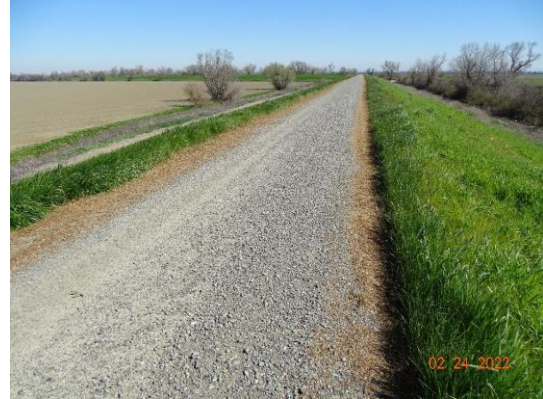
Photo 1 of 3 : UCIP_FA_2023_72854_109335.jpg

Comment Code						
Inspector Comment						
DS_ID:17742 FS_ID:72854 EP_NO: 10284 Repair Type: Non-Urgent EVAL Issue: Crossing Status: Found UCIP Comments: 02/24/2022 Record updated from No Action Needed to Non-Urgent. Crossing appears grouted. Grout filler tube on the top of pipe at concrete distribution box on landside. Marks of concrete around pipe. Unable to find a permit and confirm that pipe was properly abandoned. No signs of pipe on waterside. (O.Yakimov - DWR UCIP) 11/16/2018 Pipe is Grouted. (T. Skidgel - DWR Sacramento Yard)04/10/2014 Screw gates where removed and pipe was abanded by farmer, How pipe was abanded is unknown. (T. Skidgel - DWR Sacramento Yard)10/17/2012 Slide gate not found. (P. Amatya - DWR UCIP) FIELD_STRUCT_DESC: 1 of 2: 42-inch corrugated metal gravity drainage pipe through the levee, 23.6 feet below the crown. Slide gate on the waterside (WS) slope. Concrete distribution box at the landside (LS) toe. (42-inch pipe [HLM 2.63] authorized under Automatic Board Order (ABO) issued as Permit No. 10284, 1974 - La Borde and Hoover). [Additional Reference(s): DWR Levee Log, 2004 (HLM 2.63). USACE Sacramento O&M Manual, Unit 127, June 1953, Revised 23 November 2021, (STA 133+82), listed as two 42-inch CMP. USACE As-Built Drawing No. 50-04-1548, July 1936, Sheet 1, STA 18+90, listed as two 42-inch pipes]. FS Date: 2/24/2022 3:30:41 PM

Top of Levee: View of levee crown looking upstream

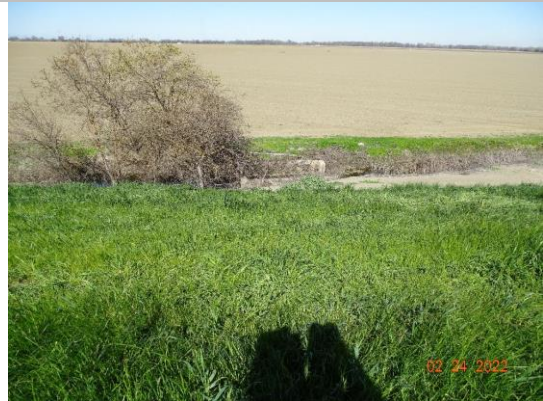
Photo 3 of 3 : UCIP_FA_2023_72854_109331.jpg

Land-Side: View of levee slope looking from crown, concrete distribution box at levee toe

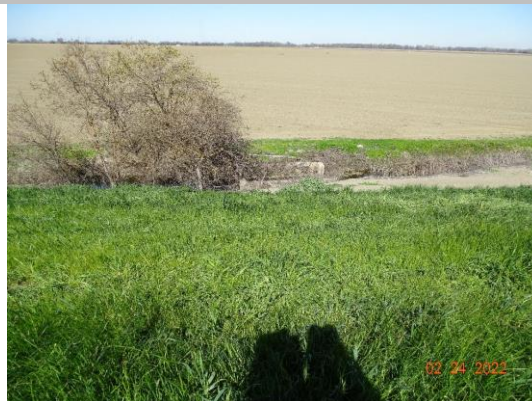
Photo 3 of 3 : UCIP_FA_2023_72858_109338.jpg

Comment Code					
Inspector Comment					
DS_ID:17747 FS_ID:72858 EP_NO: 10284 Repair Type: Non-Urgent EVAL Issue: Crossing Status: Found UCIP Comments: 02/24/2022 Record updated from No Action Needed to Non-Urgent. Crossing appears grouted. Grout filler tube on the top of pipe at concrete distribution box on landside. Marks of concrete around pipe. Unable to find a permit and confirm that pipe was properly abandoned. No signs of pipe on waterside. Geophysical results did not confirm presence of pipe through levee. Record will remain in UCIP's inspection records until future Levee Improvement Project can confirm no crossing was found through the levee. (O.Yakimov - DWR UCIP) 10/14/2014 Screw gate removed and pipe abandon by farmer, How pipe was abandoned is unknown. (T. Skidgel - DWR Sacramento Yard)10/17/2012 No slide gate found. (P. Amatya - DWR UCIP) FIELD_STRUCT_DESC: 2 of 2: 42-inch corrugated metal gravity drainage pipe through the levee, 23.6 feet below the crown. Slide gate on the waterside (WS) slope. Concrete distribution box at the landside (LS) toe. (42-inch pipe [HLM 2.63] authorized under Automatic Board Order (ABO) issued as Permit No. 10284, 1974 - La Borde and Hoover). [Additional Reference(s): DWR Levee Log, 2004 (HLM 2.63). USACE Sacramento O&M Manual, Unit 127, June 1953, Revised 23 November 2021, (STA 133+82), listed as two 42-inch CMP. USACE As-Built Drawing No. 50-04-1548, July 1936, Sheet 1, STA 18+90, listed as two 42-inch pipes]. FS Date: 2/24/2022 3:41:05 PM

Land-Side: View of levee slope looking from crown, concrete distribution box at levee toe

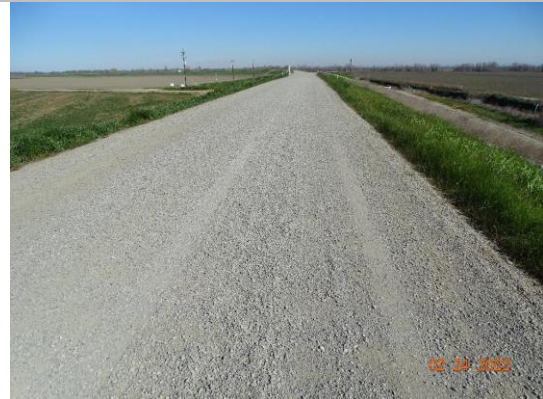
Photo 1 of 3 : UCIP_FA_2023_72994_109365.jpg

Comment Code						
Inspector Comment						
DS_ID:17750 FS_ID:72994 EP_NO: 10288 Repair Type: Non-Urgent EVAL Issue: Crossing Status: Indicator Found UCIP Comments: 02/24/2022 Record is Non-Urgent. Crossing appears abandoned. Previous inspection comment indicates that pipe was filled with grout. Unable to confirm proper abandonment. Crossing not found in the field. Geophysical study indicates possible presence of pipe through levee. Owner needs to coordinate with the CVFPB to remove or abandon crossing according to Title 23 requirements. (O.Yakimov - DWR UCIP) 05/29/2013 This pipe has been abandoned and filled with grout. (T. Skidgel - DWR Sacramento Yard) FIELD_STRUCT_DESC: 24-inch corrugated metal pipe drainage pipe through the levee, 23 feet below the crown. Flap gate on the waterside (WS) end. (24-inch pipe [HLM 0.33] authorized under Automatic Board Order (ABO) issued as Permit No. 10288, 1974 - Cache Creek Ranch Company). [Additional Reference(s): DWR Levee Log, 2004 (HLM 0.33), listed as abandoned 24-inch pipe). USACE As-Built Drawing No. 50-04-1548, July 1936, Sheet 1, approximate STA 60+30. USACE As-Built Drawing No. 50-04-2185, October 1943, Sheet 1, approximate STA 201+00, listed as 24-inch CMP]. FS Date: 2/24/2022 9:04:33 AM

Top of Levee: View of levee crown looking upstream

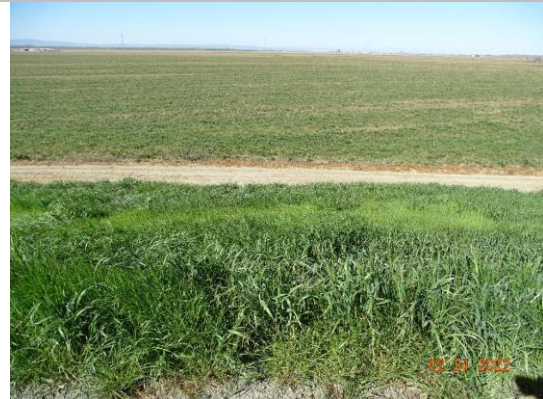
Photo 2 of 3 : UCIP_FA_2023_72994_109364.jpg

Land-Side: View of levee slope looking from crown

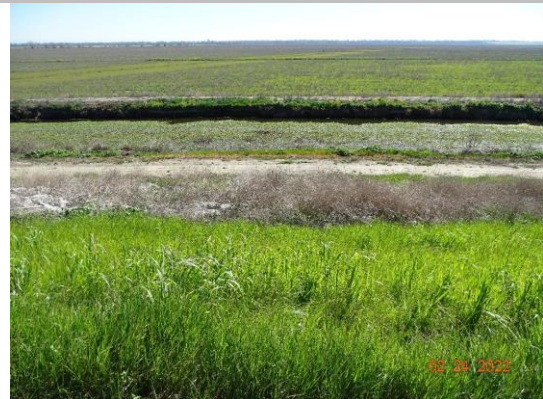
Photo 3 of 3 : UCIP_FA_2023_72994_109366.jpg

Water-Side: View of levee slope looking from crown

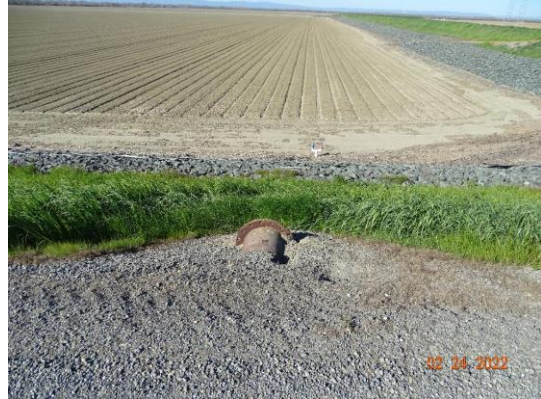
Photo 1 of 3 : UCIP_FA_2023_73243_109714.jpg

Comment Code					
Inspector Comment					
DS_ID:17756 FS_ID:73243 EP_NO: N/A Repair Type: Non-Urgent EVAL Issue: 11, Maintenance Compliance Issue Crossing Status: Found UCIP Comments: 02/24/2022 Record remains Non-Urgent. Pipe is open on waterside. Recommend capping the pipe. Sediment buildup inside the pipe. Permit associated with this pipe was administratively closed, no other permits authorizing pipe installation were identified. (O.Yakimov - DWR UCIP) 08/20/2020 Need to obtain a copy of USACE Drawing As-Built listed under additional references. Drawing information was listed by previous inspector. (O. Magana - DWR UCIP) 10/17/2012 Pipe not properly abandoned. (P. Amatya - DWR UCIP) FIELD_STRUCT_DESC: 18-inch steel irrigation or drainage pipe through the levee, 1.5 feet below the crown. (24-inch steel irrigation pipes at 5 locations authorized under Permit No. 12705, 1979 - Layton Knaggs. Permit was administratively closed). [Additional Reference(s): USACE As-Built Drawing No. CC5-04-0070, Revised 27 January 1994, Sheet 15, STA 74+00]. FS Date: 2/24/2022 10:58:56 AM

Water-Side: View of levee slope looking from crown

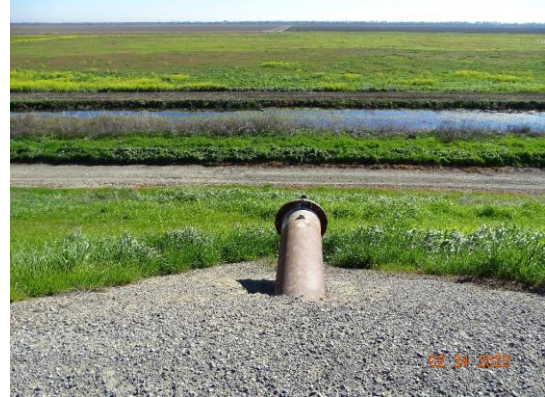
Photo 3 of 3 : UCIP_FA_2023_73243_109709.jpg

Land-Side: View of levee slope looking from crown

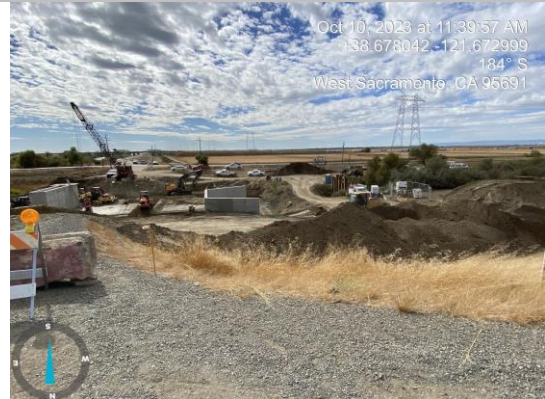
Photo 1 of 1 : FA_2023_ST0011_293_6_20231010_00013.jpg

LM Start	1.42	Rating **	A/W	Issue No.	6
LM End	1.48	Issue Type +	En	Location *	WS
Category	Earthen Levee			GPS Latitude/Longitude	
				Start	End
Item	Encroachments			38.678089°	38.677197°
				-121.673010°	-121.672772°
DWR ID	DWR_ST0011_03_f_2023_6				
Comment Code					
LC : Authorized Levee Construction					
Inspector Comment					
Permitted levee construction.

View of permitted construction (Fall 2023).

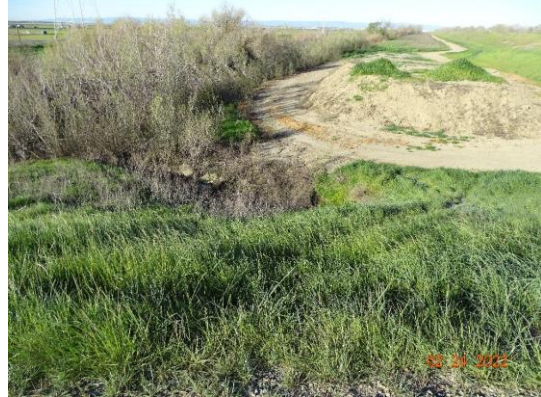
Photo 1 of 3 : UCIP_FA_2023_73263_109748.jpg

Comment Code					
Inspector Comment					
DS_ID:17754 FS_ID:73263 EP_NO: 10295 Repair Type: Urgent EVAL Issue: 1, Pipe Integrity Crossing Status: Found UCIP Comments: 02/24/2022 Record remains Urgent. DMP internal video inspection has found pipe integrity issues. LOF of crossing is between 5 and 6. Crossing will be monitored until funding becomes available to address the issues. Pipe inlet on landside is out of round shape. Sinkhole on landside slope is still present. Pipe is approaching levee at an angle on landside. No permit other then ABO has been identified authorizing pipe. (O.Yakimov - DWR UCIP) 08/20/2020 Need to obtain a copy of USACE Drawing As-Built listed under additional references. Drawing information was listed by previous inspector. (O. Magana - DWR UCIP) 04/09/2019 Internal inspection was completed and the inspection shows separation of pipe at 22 degree turn. Sink hole visible on LS slope. Coordinating with DMP - Vince Rodriguez. Recommend repair or replace. (T. Skidgel - DWR Sacramento Yard)10/17/2012 Found 48-inch CMP (not concrete culvert) and slide gate not found on LS end. (P. Amatya - DWR UCIP) FIELD_STRUCT_DESC: 48-inch corrugated metal pipe culvert through the levee, 18 feet below the crown. Slide gate on the landside (LS) end. (48-inch concrete culvert [HLM 1.45] authorized under Automatic Board Order (ABO) issued as Permit No. 10295, 1974 - City of Woodland). (Intention to abandon pipe in place by grouting is pending authorization under Permit No. 19624, City of Woodland, permit not yet issued). [Additional Reference(s): DWR Levee Log, 2004 (HLM 1.45, listed as 48-inch concrete culvert). USACE As-Built Drawing No. 50-04-3227, Sheet 14, just south of STA 882+00, March 11, 1960, listed as 48-inch CMP]. FS Date: 2/24/2022 4:12:46 PM

Land-Side: View of levee slope looking from crown

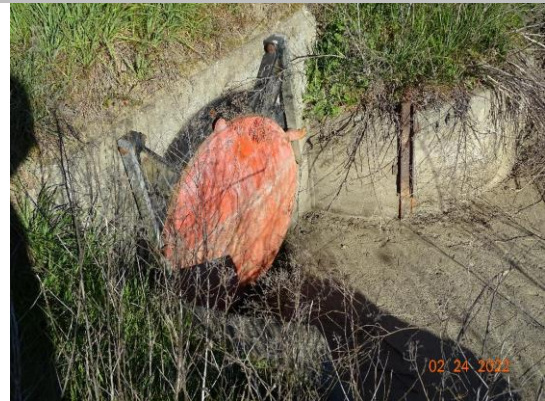
Photo 3 of 3 : UCIP_FA_2023_73263_109749.jpg

Water-Side: Headwall and flap gate

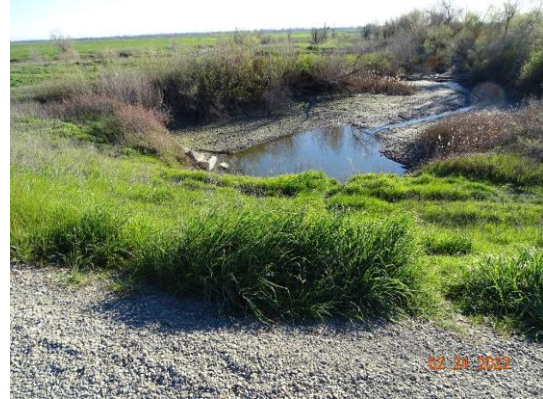
Photo 1 of 3 : UCIP_FA_2023_73265_109755.jpg

Comment Code					
Inspector Comment					
DS_ID:17753 FS_ID:73265 EP_NO: 10296 Repair Type: Urgent EVAL Issue: 3a, Flood Risk Crossing Status: Found UCIP Comments: 02/24/2022 Record updated from No Action Needed to Urgent. Flap gate cannot be properly closed due to debris accumulation. Unauthorized encroachment recorded in Levee Log. Need to have CVFPB review ABO and determine current owner. (O.Yakimov - DWR UCIP) 08/20/2020 Need to obtain a copy of USACE Drawing As-Built listed under additional references. Drawing information was listed by previous inspector. (O. Magana - DWR UCIP) 04/10/2014 summer of 2013 removed debris and mud. (T. Skidgel - DWR Sacramento Yard)10/17/2012 Flap gate was partially opened during field survey period. Intake pipe on LS was buried with floated debris/logs. Debris removal or trash rack/screen is required. Two pipes are 5 ft apart from each other. Slide gate on landward end not found. (P. Amatya - DWR UCIP) FIELD_STRUCT_DESC: 1 of 2: 36-inch corrugated metal gravity drainage pipe through the levee, 20 feet below the crown. Slide gate on the landside (LS) end. (Two 36-inch pipes [HLM 1.48] authorized under Automatic Board Order (ABO) issued as Permit No. 10296, 1974 - Woodland Farms, Ltd.). (Intention to remove and replace pipe is pending authorization under Permit No. 19624, permit not yet issued). [Additional Reference(s): DWR Levee Log, 2004 (HLM 1.48). USACE Drawing referenced as E-2 at Station 1+75, As-Built Drawing: USACE, Sacramento Districts. Levee Repair- Cache Creek Settling Basin, Wahler Associates, May 1991] FS Date: 2/24/2022 4:37:29 PM

Water-Side: View of levee slope looking from crown

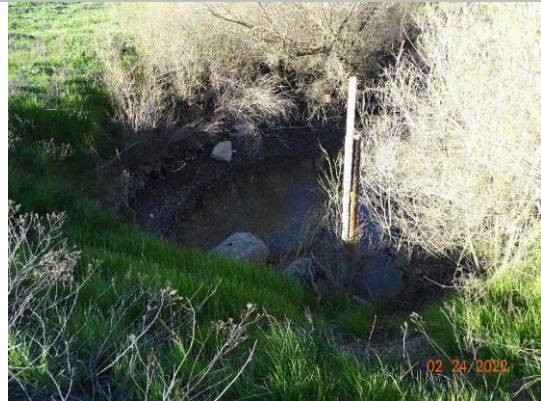
Photo 3 of 3 : UCIP_FA_2023_73265_109753.jpg

Land-Side: Pipe visible in drainage ditch

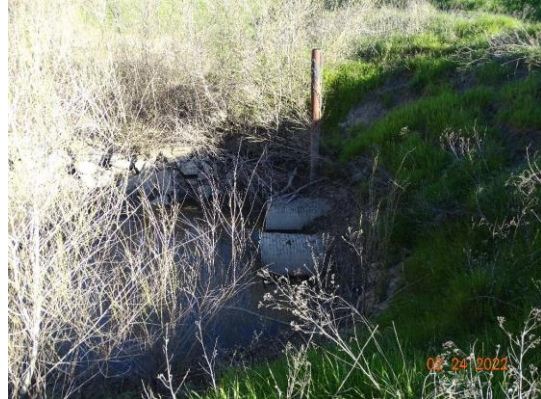
Photo 3 of 3 : UCIP_FA_2023_73266_109757.jpg

Comment Code					
Inspector Comment					
DS_ID:17761 FS_ID:73266 EP_NO: 10296 Repair Type: Urgent EVAL Issue: 3a, Flood Risk Crossing Status: Found UCIP Comments: 02/24/2022 Record updated from No Action Needed to Urgent. Flap gate cannot be properly closed due to debris accumulation. Unauthorized encroachment recorded in Levee Log. Need to have CVFPB review ABO and determine current owner. (O.Yakimov - DWR UCIP) 08/20/2020 Need to obtain a copy of USACE Drawing As-Built listed under additional references. Drawing information was listed by previous inspector. (O. Magana - DWR UCIP) 04/10/2014 summer of 2013 removed debris. (T. Skidgel - DWR Sacramento Yard)10/17/2012 Flap gate was partially open. Intake pipes in LS burried with floating debris/wooden logs. Debris removal or trash rack/screen is required. Two pipes are 5 ft apart from each other. (P. Amatya - DWR UCIP) FIELD_STRUCT_DESC: 2 of 2: 36-inch corrugated metal gravity drainage pipe through the levee, 20 feet below the crown. Slide gate on the landside (LS) end. (Two 36-inch pipes [HLM 1.48] authorized under Automatic Board Order (ABO) issued as Permit No. 10296, 1974 - Woodland Farms, Ltd.). (Intention to remove and replace pipe is pending authorization under Permit No. 19624, permit not yet issued). [Additional Reference(s): DWR Levee Log, 2004 (HLM 1.48). USACE Drawing referenced as E-2 at Station 1+75, As-Built Drawing: USACE, Sacramento Districts. Levee Repair- Cache Creek Settling Basin, Wahler Associates, May 1991] FS Date: 2/24/2022 4:41:41 PM

Land-Side: Pipe End visible in drainage ditch

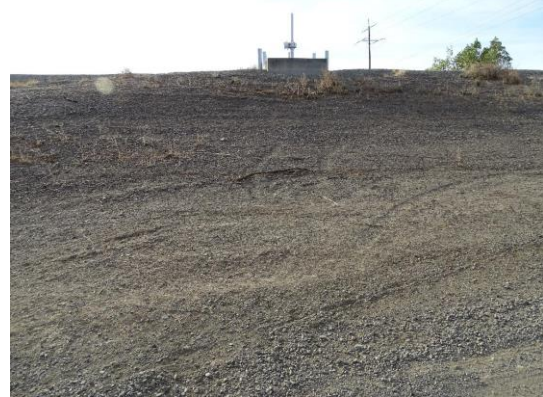
Photo 1 of 3 : UCIP_FA_2023_60250_83281.jpg

Comment Code					
Inspector Comment					
DS_ID:569 FS_ID:60250 EP_NO: 16096 Repair Type: Urgent EVAL Issue: 3a, Flood Risk Crossing Status: Found UCIP Comments: 11/07/2019 Flap gate at WS headwall not closing completely. A wooden stick on the top prevents flap gate closing leaving space for backflow. Provide maintenance on flap gate. About 20-foot long surface cracking observed on levee crown closer to LS shoulder. Not sure if cracking is related to this crossing (potential levee damage concern). (O.Yakimov - DWR UCIP)10/18/2012 The culvert was constructed in 1993. (P. Amatya - DWR UCIP) FIELD_STRUCT_DESC: 60-inch by 60-inch reinforced concrete box gravity drainage culvert through the right bank (west) levee of the Yolo Bypass, 20 feet below the crown. 60-inch by 60-inch culvert replaced an existing 30-inch gravity drain pipeline. (60-inch by 60-inch culvert authorized under Permit No. 16096, 1993 - Yolo County Flood Control and Water Conservation District, square culvert installed about 28 feet south of existing 30-inch pipe). FS Date: 11/7/2019 3:23:00 PM

View of WS slope looking towards levee

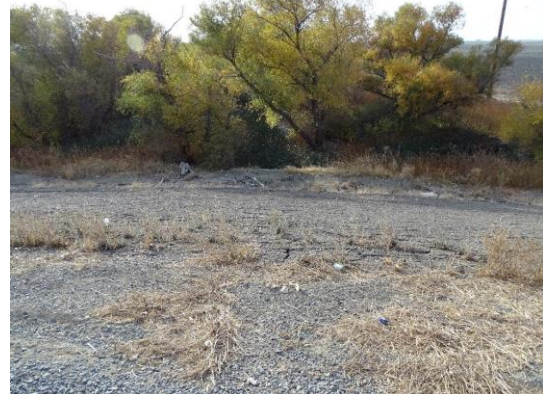
Photo 2 of 3 : UCIP_FA_2023_60250_83282.jpg

View of LS looking from levee crown

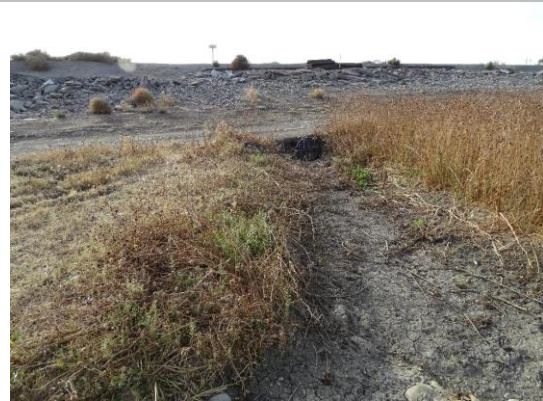
Photo 1 of 3 : UCIP_FA_2023_81057_83298.jpg

DS_ID:528
FS_ID:81057
EP_NO: 10304
Repair Type: No Action Needed
EVAL Issue:
Crossing Status: Found
UCIP Comments: 09/20/2023 DMP internal video inspection has found none or minor pipe defects. Recommend next video inspection in 5 years. (J. Taylor - DWR UCIP)11/07/2019 Record updated from No Action Needed to Non-Urgent. Need to have CVFPB review ABO and determine current owner. (O.Yakimov - DWR UCIP)
FIELD_STRUCT_DESC: 30-inch CIPP-lined corrugated metal gravity drainage pipe through the levee, 22 feet below the crown. Flap gate on the waterside (WS) end. (30-inch pipe [HLM 0.59] authorized under Automatic Board Order (ABO) issued as Permit No. 10304, 1974 - Southern Pacific Transportation Company). [Additional Reference(s): DWR Levee Log, 2004, (HLM 0.63, listed as a 30-inch pipe). USACE Sacramento O&M Manual, Unit 120, June 1952, Revised 29 December 2016, (Station 446+08), listed as 30-inch CMP. USACE As-Built Drawing No. 50-04-2281, Sheet 5, page 5 of 5 pdf file, January 1947].

View of WS slope looking towards levee

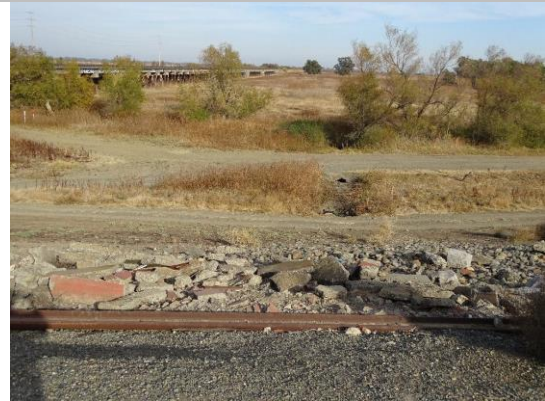
Photo 2 of 3 : UCIP_FA_2023_81057_83300.jpg

View of WS looking from levee crown

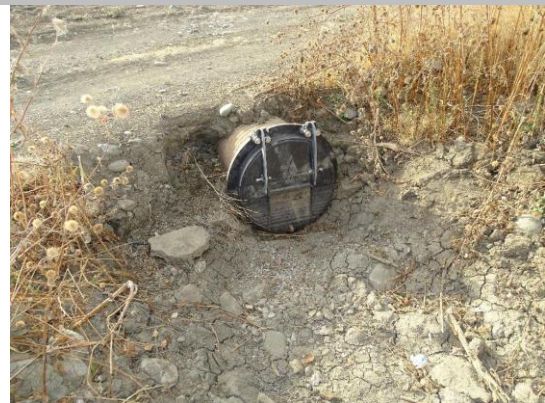
Photo 3 of 3 : UCIP_FA_2023_81057_83299.jpg

Pipe and flap gate at WS levee toe

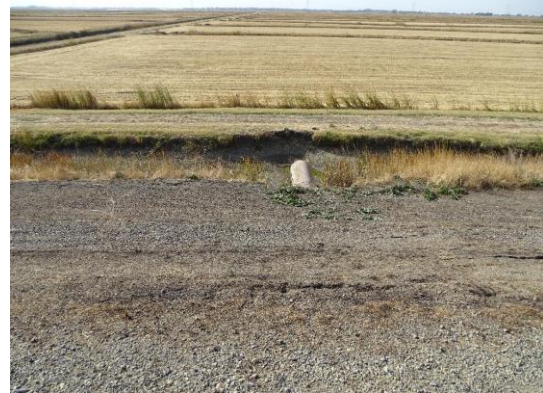
Photo 1 of 3 : UCIP_FA_2023_60661_83249.jpg

View of LS looking from levee crown

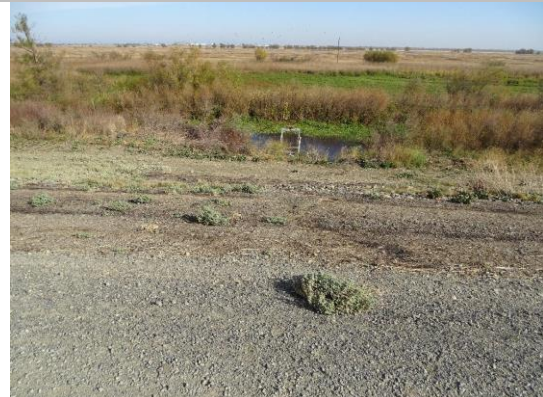
Photo 2 of 3 : UCIP_FA_2023_60661_83250.jpg

View of WS looking from levee crown

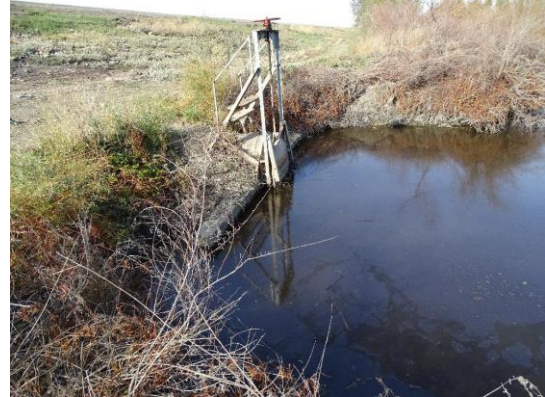
Photo 3 of 3 : UCIP_FA_2023_60661_83251.jpg

Slide gate and pipe outlet on waterside
