## Flood Control Project Maintenance Levee Inspections

### Fall 2024 Levee Maintenance Deficiency Summary Report

#### Sacramento River Basin

**Sacramento Maintenance Yard West Levee Yolo Bypass**

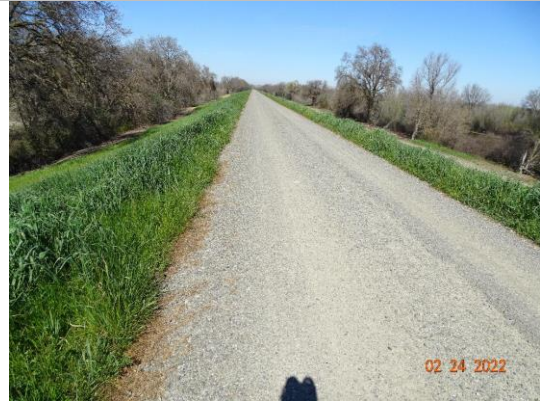
Photo 1 of 3 : UCIP\_FA\_2024\_72846\_109326.jpg

Comment Code						
Inspector Comment						
DS_ID:17744 FS_ID:72846 EP_NO: 10284 Repair Type: Non-Urgent EVAL Issue: Crossing Status: Indicator Found UCIP Comments: 02/24/2022 Record updated from No Action Needed to Non-Urgent. Crossing not found. CMP and steel pipe debris at landside toe. Geophysical results did not confirm presence of pipe through levee. Record will remain in UCIP's inspection records until future Levee Improvement Project can confirm no crossing was found through the levee. Previous inspection comment indicate that pipe was abandoned. No permit has been identified authorizing pipe. Need to have CVFPB review ABO and determine current owner. (O.Yakimov - DWR UCIP) 04/10/2014 This was abandoned by farmer, how Unknown. need to have verified if removed or concreted. (T. Skidgel - DWR Sacramento Yard) 10/17/2012 Found abandoned 42-inch CM pipe on LS berm of the levee. (P. Amatya - DWR UCIP) FIELD_STRUCT_DESC: 42-inch corrugated metal gravity drainage pipe through the levee, 25 feet below the crown. Slide gate on the waterside (WS) end. (42-inch pipe [HLM 1.85] authorized under Automatic Board Order (ABO) issued as Permit No. 10284, 1974 - La Borde and Hoover). [Additional Reference(s): DWR Levee Log, 2004 (HLM 1.85). USACE Sacramento O&M Manual, Unit 127, June 1953, Revised 23 November 2021, (STA 92+35), listed as 42-inch CMP. USACE As-Built Drawing No. 50-04-1548, July 1936, Sheet 1, STA number is unclear]. FS Date: 2/24/2022

Top of Levee: View of levee crown looking upstream

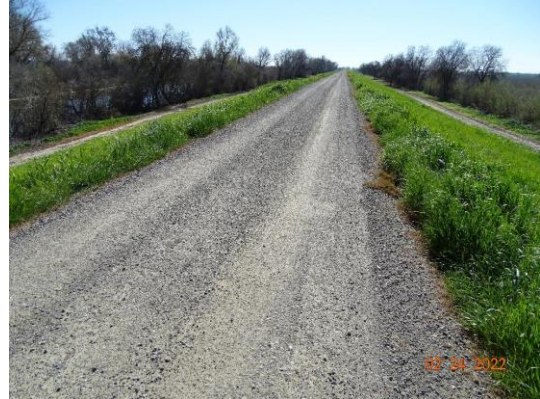
Photo 1 of 3 : UCIP\_FA\_2024\_72852\_109328.jpg

Comment Code						
Inspector Comment						
DS_ID:17743 FS_ID:72852 EP_NO: 6306 Repair Type: Non-Urgent EVAL Issue: 4b, Safety Issue Crossing Status: Found UCIP Comments: 02/24/2022 Record updated from No Action Needed to Non-Urgent. Siphon breaker riser needs to have top cover restored. (O.Yakimov - DWR UCIP) 10/17/2012 Walkway on LS to pump is in poor structural condition. Seems pump has been used for dual purpose. There is another pipe (approx. 12-inch) found near the pump crossing the ditch. (T. Skidgel - DWR UCIP)10/17/2012 The pipe is about 18-ft below the crown. Seems pump has been used for dual purpose. There is another pipe (approx. 12-inch) found near the pump crossing the ditch. Two closing valves also found in pumping station. (P. Amatya - DWR UCIP) FIELD_STRUCT_DESC: 20-inch coated steel drainage pipe through the levee, 5.8 feet below the crown. Pump and switch panel at the landside (LS) toe. Siphon breaker on the LS slope. Butterfly valves at pump on the LS toe. This crossing replaces 20-inch pipe (see DSID 25371). (20-inch pipe replacement authorized under Permit No. 6306, 1968 - William P. Wilson). [Additional Reference(s): DWR Levee Log, 2004 (HLM 1.85). USACE Sacramento O&M Manual, Unit 127, June 1953, Revised 23 November 2021, (STA 92+31.5), listed as 20-inch steel pipe]. FS Date: 2/24/2022 3:22:03 PM

Top of Levee: View of levee crown looking downstream

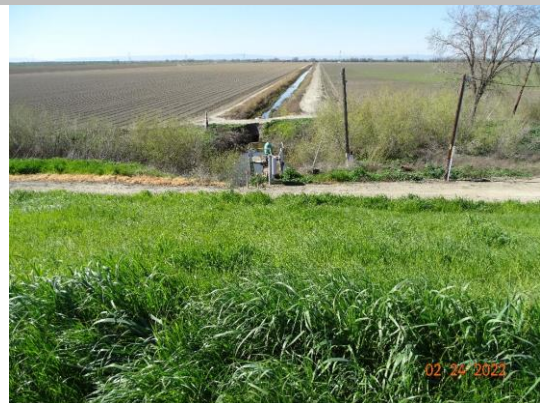
Photo 2 of 3 : UCIP\_FA\_2024\_72852\_109329.jpg

Land-Side: View of levee slope looking from crown crown. Drainage ditch off levee toe

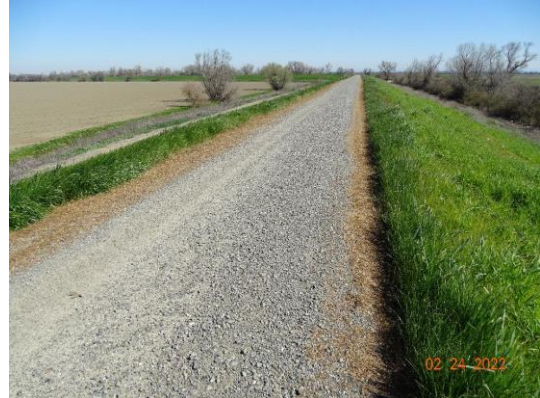
Photo 1 of 3 : UCIP\_FA\_2024\_72854\_109335.jpg

Comment Code						
Inspector Comment						
DS_ID:17742 FS_ID:72854 EP_NO: 10284 Repair Type: Non-Urgent EVAL Issue: Crossing Status: Found UCIP Comments: 02/24/2022 Record updated from No Action Needed to Non-Urgent. Crossing appears grouted. Grout filler tube on the top of pipe at concrete distribution box on landside. Marks of concrete around pipe. Unable to find a permit and confirm that pipe was properly abandoned. No signs of pipe on waterside. (O.Yakimov - DWR UCIP) 11/16/2018 Pipe is Grouted. (T. Skidgel - DWR Sacramento Yard)04/10/2014 Screw gates where removed and pipe was abanded by farmer, How pipe was abanded is unknown. (T. Skidgel - DWR Sacramento Yard)10/17/2012 Slide gate not found. (P. Amatya - DWR UCIP) FIELD_STRUCT_DESC: 1 of 2: 42-inch corrugated metal gravity drainage pipe through the levee, 23.6 feet below the crown. Slide gate on the waterside (WS) slope. Concrete distribution box at the landside (LS) toe. (42-inch pipe [HLM 2.63] authorized under Automatic Board Order (ABO) issued as Permit No. 10284, 1974 - La Borde and Hoover). [Additional Reference(s): DWR Levee Log, 2004 (HLM 2.63). USACE Sacramento O&M Manual, Unit 127, June 1953, Revised 23 November 2021, (STA 133+82), listed as two 42-inch CMP. USACE As-Built Drawing No. 50-04-1548, July 1936, Sheet 1, STA 18+90, listed as two 42-inch pipes]. FS Date: 2/24/2022 3:30:41 PM

Top of Levee: View of levee crown looking upstream

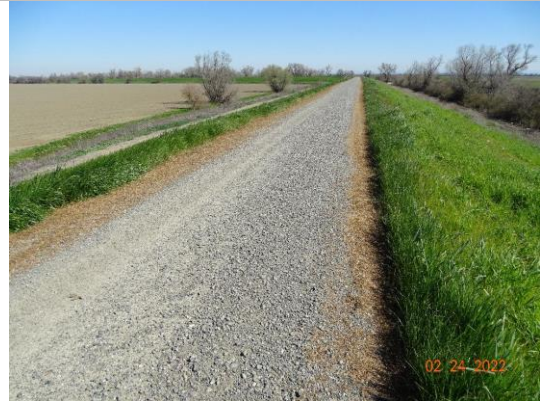
Photo 1 of 3 : UCIP\_FA\_2024\_72858\_109337.jpg

Comment Code						
Inspector Comment						
DS_ID:17747 FS_ID:72858 EP_NO: 10284 Repair Type: Non-Urgent EVAL Issue: Crossing Status: Found UCIP Comments: 02/24/2022 Record updated from No Action Needed to Non-Urgent. Crossing appears grouted. Grout filler tube on the top of pipe at concrete distribution box on landside. Marks of concrete around pipe. Unable to find a permit and confirm that pipe was properly abandoned. No signs of pipe on waterside. Geophysical results did not confirm presence of pipe through levee. Record will remain in UCIP's inspection records until future Levee Improvement Project can confirm no crossing was found through the levee. (O.Yakimov - DWR UCIP) 10/14/2014 Screw gate removed and pipe abandon by farmer, How pipe was abandoned is unknown. (T. Skidgel - DWR Sacramento Yard)10/17/2012 No slide gate found. (P. Amatya - DWR UCIP) FIELD_STRUCT_DESC: 2 of 2: 42-inch corrugated metal gravity drainage pipe through the levee, 23.6 feet below the crown. Slide gate on the waterside (WS) slope. Concrete distribution box at the landside (LS) toe. (42-inch pipe [HLM 2.63] authorized under Automatic Board Order (ABO) issued as Permit No. 10284, 1974 - La Borde and Hoover). [Additional Reference(s): DWR Levee Log, 2004 (HLM 2.63). USACE Sacramento O&M Manual, Unit 127, June 1953, Revised 23 November 2021, (STA 133+82), listed as two 42-inch CMP. USACE As-Built Drawing No. 50-04-1548, July 1936, Sheet 1, STA 18+90, listed as two 42-inch pipes]. FS Date: 2/24/2022 3:41:05 PM

Top of Levee: View of levee crown looking upstream

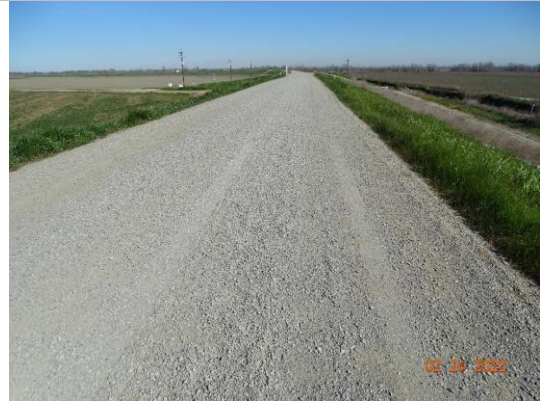
Photo 1 of 3 : UCIP\_FA\_2024\_72994\_109365.jpg

Comment Code					
Inspector Comment					
DS_ID:17750 FS_ID:72994 EP_NO: 10288 Repair Type: Non-Urgent EVAL Issue: Crossing Status: Indicator Found UCIP Comments: 02/24/2022 Record is Non-Urgent. Crossing appears abandoned. Previous inspection comment indicates that pipe was filled with grout. Unable to confirm proper abandonment. Crossing not found in the field. Geophysical study indicates possible presence of pipe through levee. Owner needs to coordinate with the CVFPB to remove or abandon crossing according to Title 23 requirements. (O.Yakimov - DWR UCIP) 05/29/2013 This pipe has been abandoned and filled with grout. (T. Skidgel - DWR Sacramento Yard) FIELD_STRUCT_DESC: 24-inch corrugated metal pipe drainage pipe through the levee, 23 feet below the crown. Flap gate on the waterside (WS) end. (24-inch pipe [HLM 0.33] authorized under Automatic Board Order (ABO) issued as Permit No. 10288, 1974 - Cache Creek Ranch Company). [Additional Reference(s): DWR Levee Log, 2004 (HLM 0.33), listed as abandoned 24-inch pipe). USACE As-Built Drawing No. 50-04-1548, July 1936, Sheet 1, approximate STA 60+30. USACE As-Built Drawing No. 50-04-2185, October 1943, Sheet 1, approximate STA 201+00, listed as 24-inch CMP]. FS Date: 2/24/2022 9:04:33 AM

Top of Levee: View of levee crown looking upstream

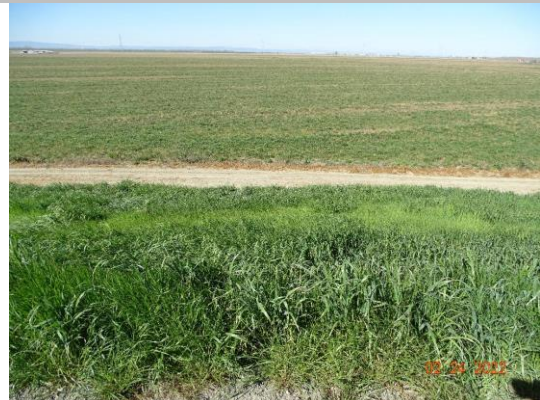
Photo 2 of 3 : UCIP\_FA\_2024\_72994\_109364.jpg

Land-Side: View of levee slope looking from crown

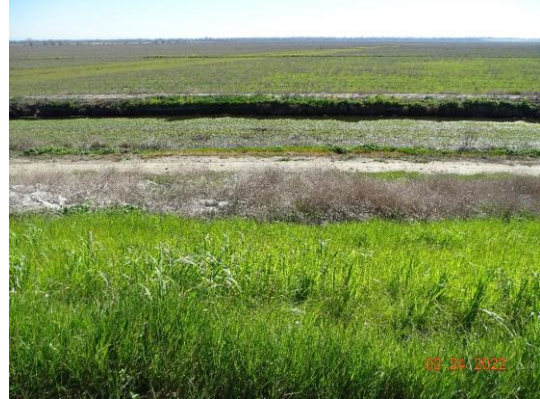
Photo 3 of 3 : UCIP\_FA\_2024\_72994\_109366.jpg

Water-Side: View of levee slope looking from crown

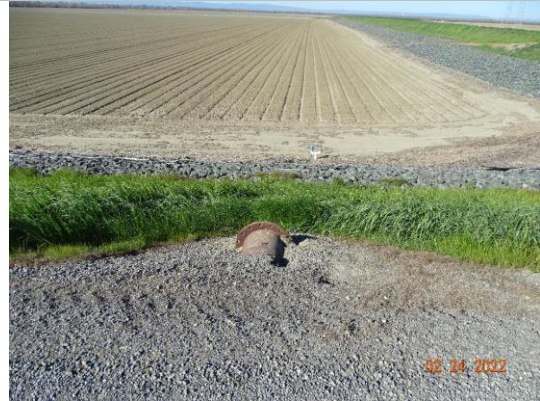
Photo 1 of 3 : UCIP\_FA\_2024\_73243\_109714.jpg

Comment Code						
Inspector Comment						
DS_ID:17756 FS_ID:73243 EP_NO: N/A Repair Type: Non-Urgent EVAL Issue: 11, Maintenance Compliance Issue Crossing Status: Found UCIP Comments: 02/24/2022 Record remains Non-Urgent. Pipe is open on waterside. Recommend capping the pipe. Sediment buildup inside the pipe. Permit associated with this pipe was administratively closed, no other permits authorizing pipe installation were identified. (O.Yakimov - DWR UCIP) 08/20/2020 Need to obtain a copy of USACE Drawing As-Built listed under additional references. Drawing information was listed by previous inspector. (O. Magana - DWR UCIP) 10/17/2012 Pipe not properly abandoned. (P. Amatya - DWR UCIP) FIELD_STRUCT_DESC: 18-inch steel irrigation or drainage pipe through the levee, 1.5 feet below the crown. (24-inch steel irrigation pipes at 5 locations authorized under Permit No. 12705, 1979 - Layton Knaggs. Permit was administratively closed). [Additional Reference(s): USACE As-Built Drawing No. CC5-04-0070, Revised 27 January 1994, Sheet 15, STA 74+00]. FS Date: 2/24/2022 10:58:56 AM

Water-Side: View of levee slope looking from crown

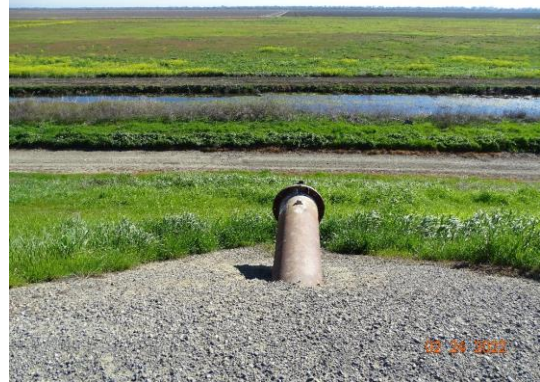
Photo 3 of 3 : UCIP\_FA\_2024\_73243\_109709.jpg

Land-Side: View of levee slope looking from crown

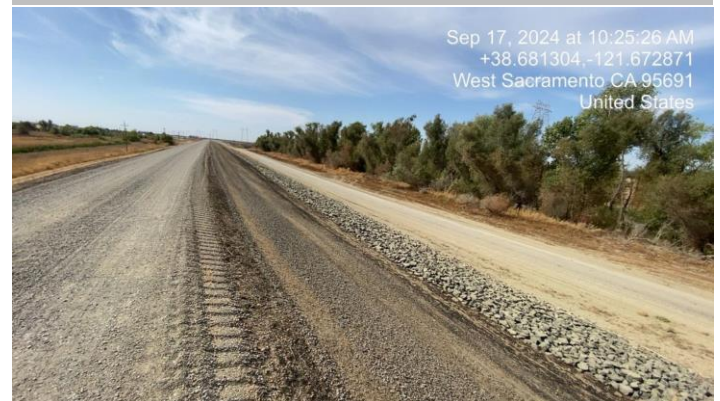
Photo 1 of 1 : FA\_2024\_ST0011\_293\_3\_20240917\_00004.jpg

LM Start	1.20	Rating **	A	Issue No.	3
LM End	1.20	Issue Type +	Ma	Location *	LS
Category	Earthen Levee			GPS Latitude/Longitude	
				Start	End
Item	Vegetation			38.681292°	38.681292°
				-121.672940°	-121.672940°
DWR ID	DWR_ST0011_03_f_2024_3				
Comment Code					
V1 : Control annual grass and weeds on the levee slopes and easements.					
Inspector Comment

View of good vegetation management on the landside slope (Fall 2024).

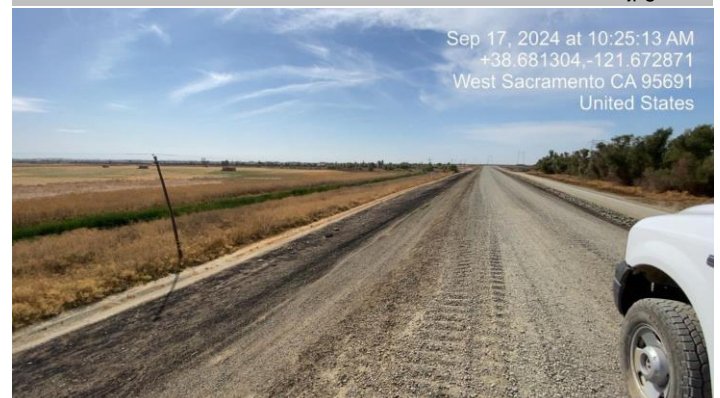
Photo 1 of 1 : FA\_2024\_ST0011\_293\_2\_20240917\_00005.jpg

LM Start	1.20	Rating **	A	Issue No.	2
LM End	1.20	Issue Type +	Ma	Location *	WS
Category	Earthen Levee			GPS Latitude/Longitude	
				Start	End
Item	Vegetation			38.681289°	38.681289°
				-121.672931°	-121.672931°
DWR ID	DWR_ST0011_03_f_2024_2				
Comment Code					
V1 : Control annual grass and weeds on the levee slopes and easements.					
Inspector Comment

View of good vegetation management on the waterside slope (Fall 2024).

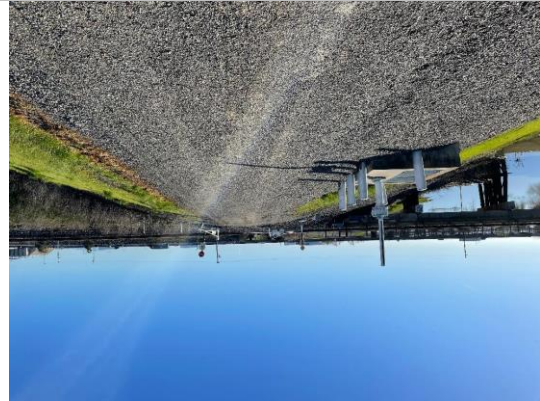
Photo 1 of 3 : UCIP\_FA\_2024\_82492\_119538.jpg

Comment Code					
Inspector Comment					
DS_ID:569 FS_ID:82492 EP_NO: 16096 Repair Type: Urgent EVAL Issue: 3a, Flood Risk Crossing Status: Found UCIP Comments: 02/28/2024 WS headwall was submerged in water and not visible during inspection. Could not verify if flap gate repairs completed since previous inspections. (J. Singh - DWR UCIP)11/07/2019 Flap gate at WS headwall not closing completely. A wooden stick on the top prevents flap gate closing leaving space for backflow. Provide maintenance on flap gate. About 20-foot long surface cracking observed on levee crown closer to LS shoulder. Not sure if cracking is related to this crossing (potential levee damage concern). (O.Yakimov - DWR UCIP)10/18/2012 The culvert was constructed in 1993. (P. Amatya - DWR UCIP) FIELD_STRUCT_DESC: 60-inch by 60-inch reinforced concrete box gravity drainage culvert through the right bank (west) levee of the Yolo Bypass, 20 feet below the crown. Concrete headwall with flap gate on waterside (WS). Concrete control box with slide gate located on WS shoulder. Concrete headwall on landside(LS). 60-inch by 60-inch culvert replaced an existing 30-inch gravity drain pipeline. (60-inch by 60-inch culvert authorized under Permit No. 16096, 1993 - Yolo County Flood Control and Water Conservation District, square culvert installed about 28 feet south of existing 30-inch pipe). FS Date: 2/28/2024

View of levee crown looking downstream

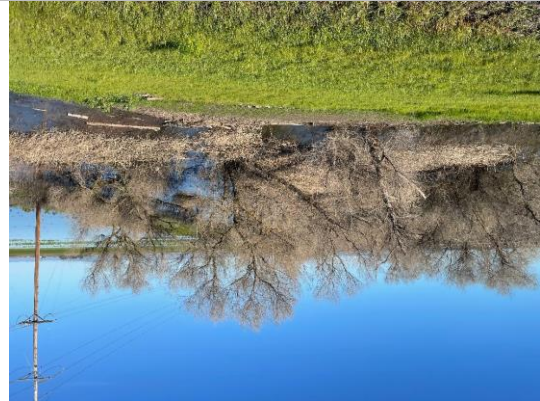
Photo 3 of 3 : UCIP\_FA\_2024\_82492\_119540.jpg

View of the landside slope

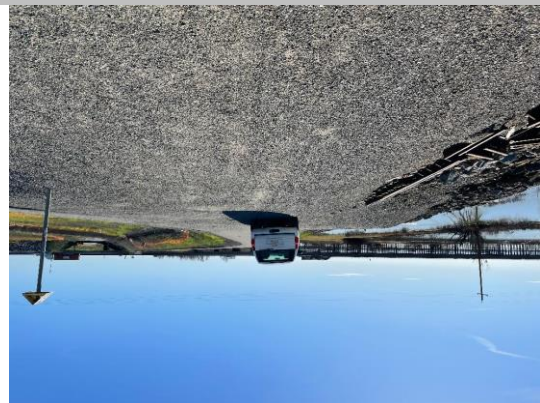
Photo 1 of 3 : UCIP\_FA\_2024\_82485\_119522.jpg

DS\_ID:528  
FS\_ID:82485  
EP\_NO: 10304  
Repair Type: No Action Needed  
EVAL Issue:  
Crossing Status: Found  
UCIP Comments: 02/28/2024 Flap gate on WS not visible during inspection due to high water. (J. Singh - DWR UCIP)09/20/2023 DMP internal video inspection has found none or minor pipe defects. Recommend next video inspection in 5 years. (J. Taylor - DWR UCIP)11/07/2019 Record updated from No Action Needed to Non-Urgent. Need to have CVFPB review ABO and determine current owner. (O.Yakimov - DWR UCIP)  
FIELD\_STRUCT\_DESC: 30-inch CIPP-lined corrugated metal gravity drainage pipe through the levee, 22 feet below the crown. Flap gate on the waterside (WS) end. Concrete headwall on the landside (LS) toe. 30-inch pipe authorized under Automatic Board Order (ABO) issued as Permit No. 10304, 1974 - Southern Pacific Transportation Company). [Additional Reference(s): DWR Levee Log, 2004, (HLM 0.63, listed as a 30-inch pipe). USACE Sacramento O&M Manual, Unit 120, June 1952, Revised 29 December 2016, (Station 446+08), listed as 30-inch CMP. USACE As-Built Drawing No. 50-04-2671, 25 January 1951, Sheet 5]. FS Date: 2/28/2024

View of levee crown looking downstream

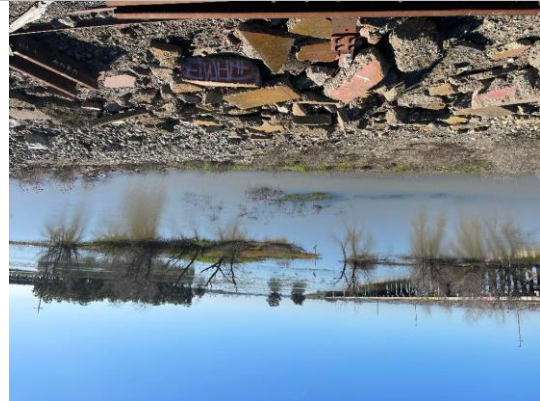
Photo 2 of 3 : UCIP\_FA\_2024\_82485\_119523.jpg

View of waterside slope

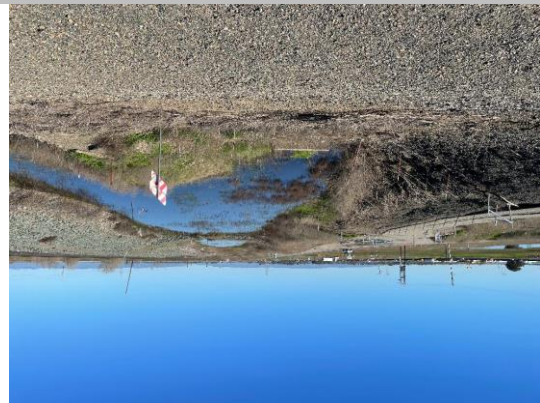
Photo 3 of 3 : UCIP\_FA\_2024\_82485\_119524.jpg

View of landside slope

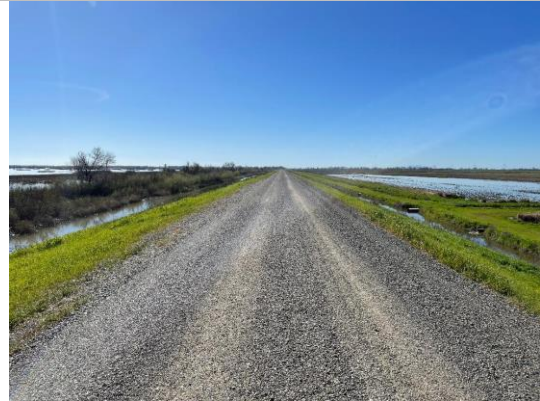
Photo 1 of 3 : UCIP\_FA\_2024\_84654\_119476.jpg

Comment Code						
Inspector Comment						
DS_ID:17736 FS_ID:84654 EP_NO: 10306 Repair Type: Urgent EVAL Issue: 1, Pipe Integrity Crossing Status: Found UCIP Comments: 08/20/2024 Code 12b removed since pipe is a system feature and LMA responsible. (J. Singh - DWR UCIP)02/28/2024 Only gate operator on WS was visible due to high water. DMP data shows no repairs done to the pipe at this time. Pipe remains urgent record. (J. Singh - DWR UCIP)11/07/2019 Record updated from No Action Needed to Non-Urgent. Need to have CVFPB review ABO and determine current owner. Permit authorizing crossing modifications to sleeve 42-inch pipe is not available. (O.Yakimov - DWR UCIP)06/20/2013 Farmer cleans this screw gate every year. (C. Lund - DWR Sacramento Yard)10/18/2012 Outlet pipe blocked half way by mud and debris on WS of the levee. (P. Amatya - DWR UCIP) FIELD_STRUCT_DESC: 48-inch corrugated metal gravity drainage pipe through the levee, 21.5 feet below the crown. 42-inch steel pipe inside the 48-inch pipe. Slide gate on the waterside (WS) with two cutoff walls, one headwall, and one saddle and apron. Pipe visible on landside (LS) toe. (48-inch pipe [HLM 2.12] authorized under Automatic Board Order (ABO) issued as Permit No. 10306, 1974 - Wells Fargo Bank, Trustees for Cowell Foundation). [Additional Reference(s): USACE Sacramento O&M Manual, Unit 119, December 1952, Revised 29 December 2016, (Station 80+00), listed as 48-inch CMP.USACE As-Built Drawing No. 50-04-2671, 25 January 1951, Sheet 1, 80+00]. FS Date: 2/28/2024

View of levee crown looking downstream

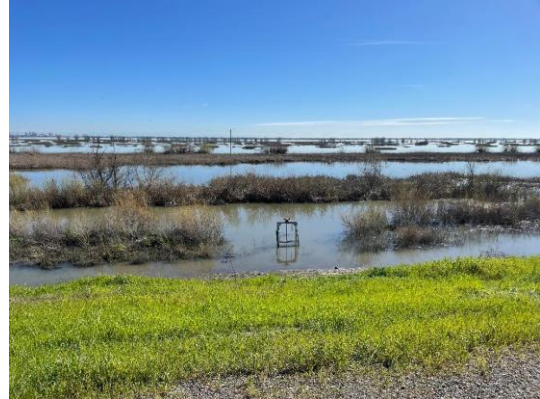
Photo 2 of 3 : UCIP\_FA\_2024\_84654\_119477.jpg

View of waterside slope from crown showing slide gate operator

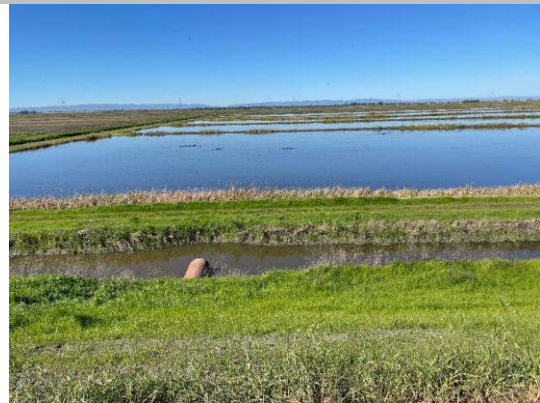
Photo 3 of 3 : UCIP\_FA\_2024\_84654\_119478.jpg

View of landside slope from crown
