**Flood Control Project Maintenance  
Levee Inspections**  
**LMA District Cover Sheet**  
**Spring 2016 Levee Inspection Results**

**Sutter Maintenance Yard East-West Interceptor**

**Levee Inspection Report By Mile - Spring 2016**

| Unit No. 01 West Levee | Right | 1.75 | 03/17/2016<br>03/17/2016 | Keith Millard |

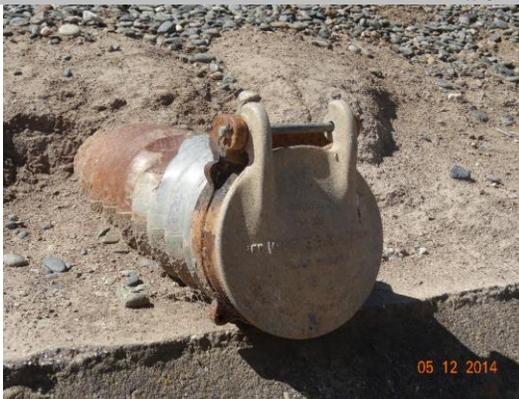
Photo 2 of 2 : UCIP\_SP\_2016\_48147\_64400.jpg

| FS_ID:48147<br>DS_ID:20115<br>EP_NO: N/A<br>Repair Type: Non-Urgent<br>Crossing Status: Found<br>UCIP Comments: 4/19/2016 Crossing appears to be in good condition.5/12/2015 Crossing appears in good condition. No noticeable issues to report.11/17/2014 Same as last inspection.5/12/2014 New flapgate installed on WS pipe end.11/4/2013 Same as last inspection.5/15/2013 Same as last inspection.10/16/2012 Pipe not permitted and has no flap gate.<br>FIELD_STRUCT_DESC: 8-inch corrugated metal drainage pipe through the levee, 1.5 feet below the crown. Outlet visible on waterside (WS). Unable to locate the inlet on landside (LS). No permit has been identified since crossing was field discovered in 2012.<br>FS Date: 5/2/2016 10:27:00 AM | | | | | |
