State of California
The Natural Resources Agency
Department of Water Resources
Division of Flood Management

2009
INSPECTION REPORT
OF THE
CENTRAL VALLEY STATE-FEDERAL
FLOOD PROTECTION SYSTEM

PUBLISHED IN JANUARY 2010

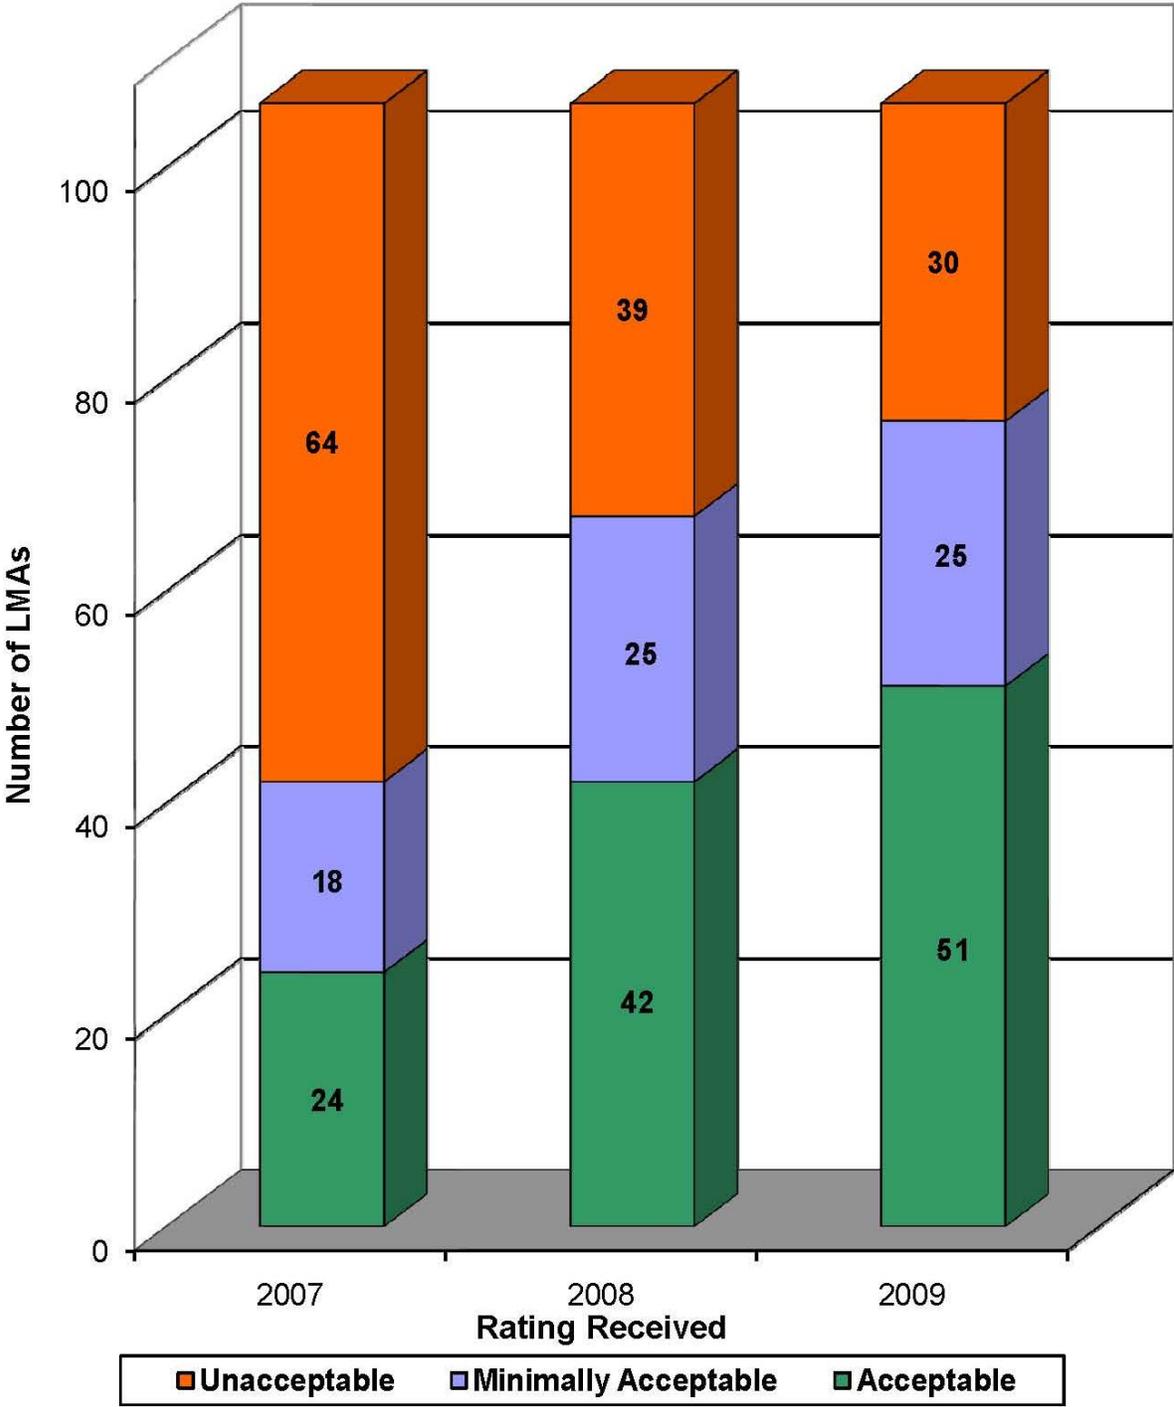
Appendix B describes the rating criteria and methodology used for levees. Table 2-1 and Figure 2-1 show the numbers of LMAs receiving each rating for the years 2007, 2008, and 2009. In general, the LMAs have significantly improved levee maintenance since 2007.

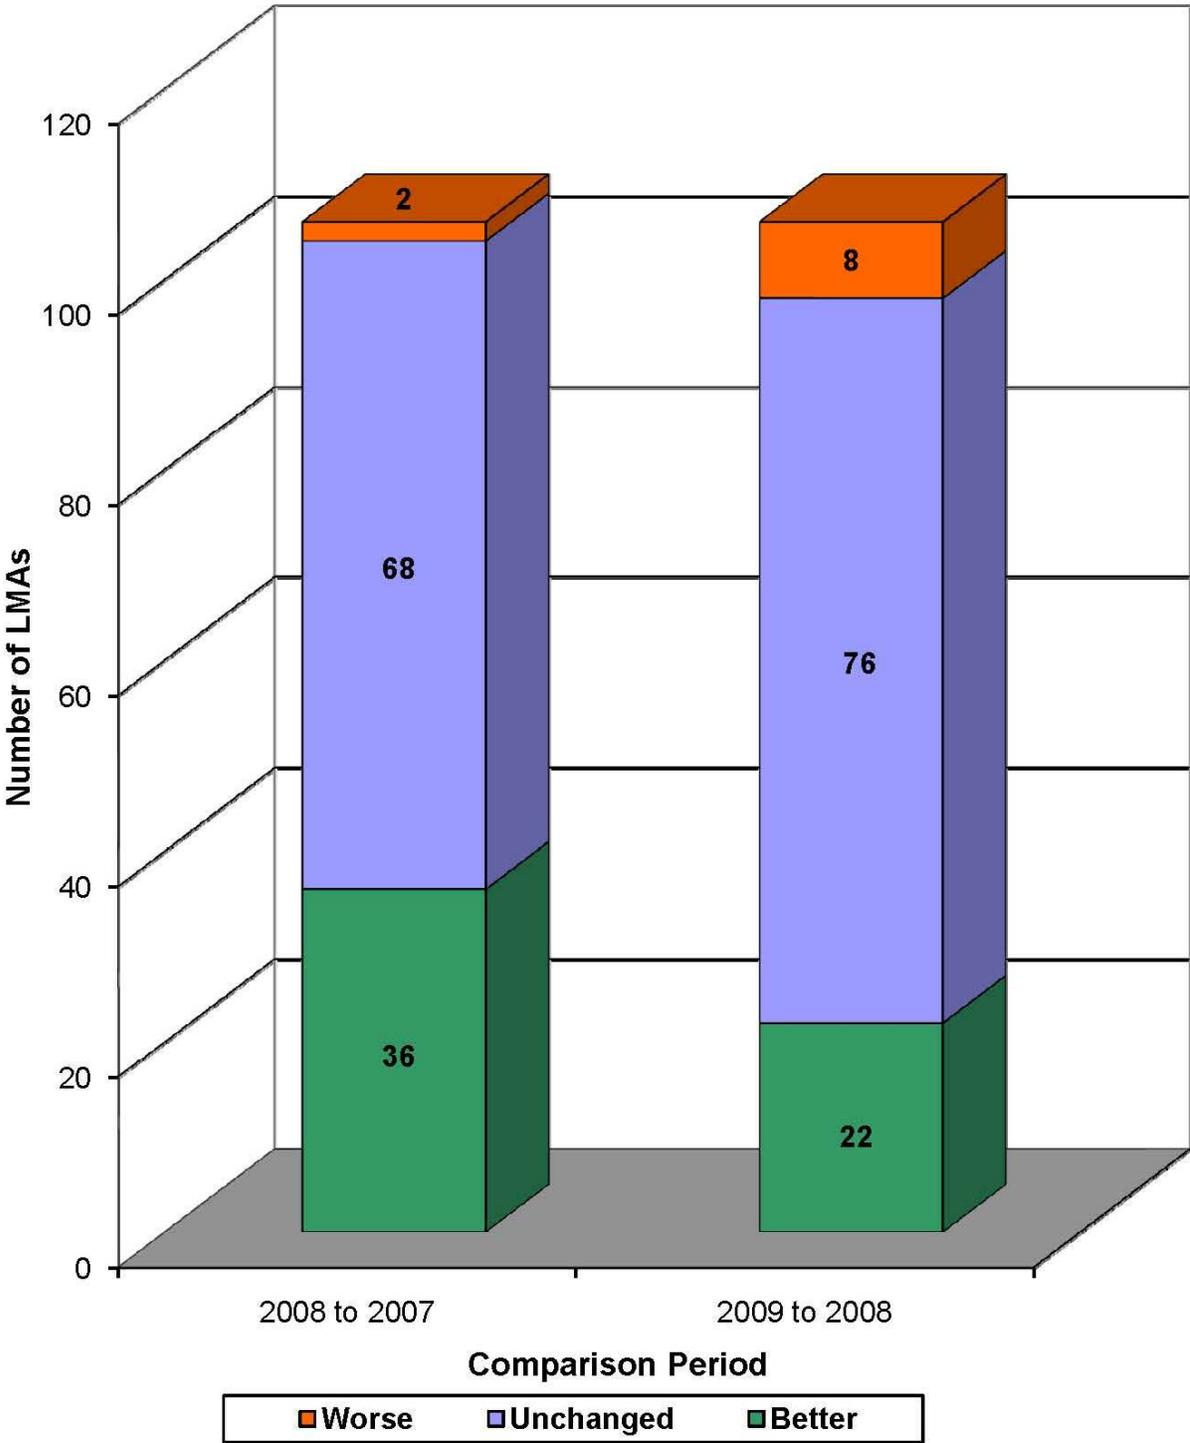
Figure 2-2 shows the number of agencies that received better, unchanged, or worse ratings in 2009 compared with 2008 and 2007. More LMAs had decreases or remained unchanged and less had increases in their ratings in 2009 than in 2008. However, more

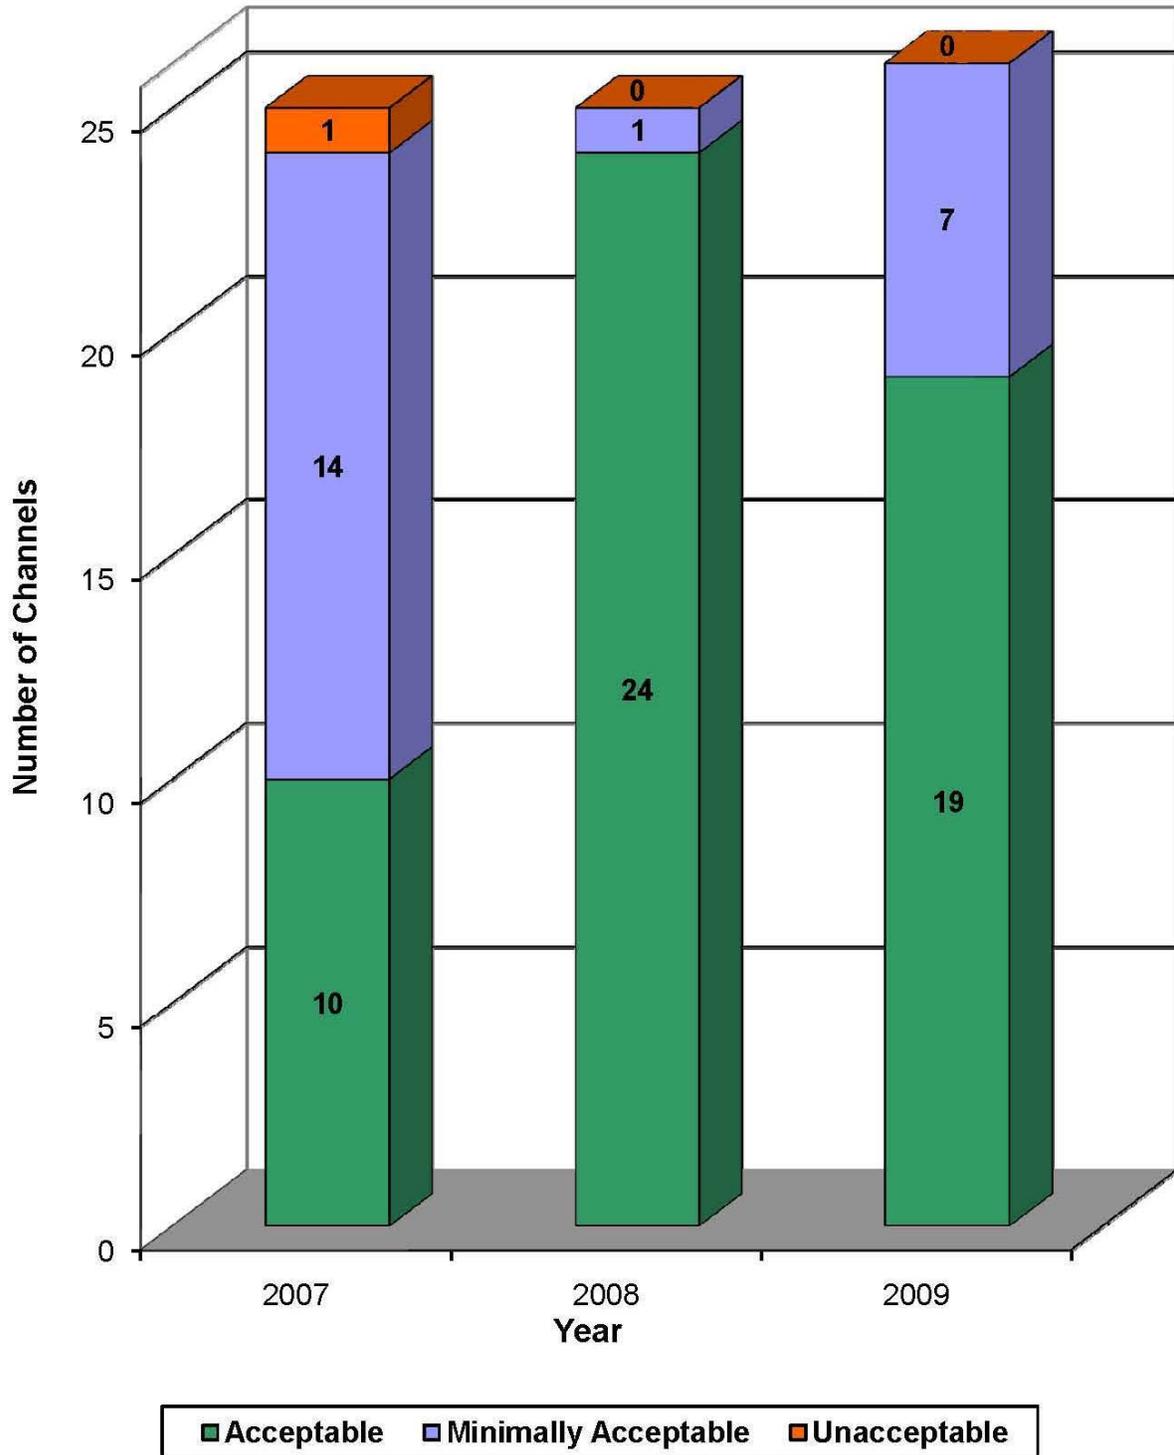
While the number of channels rated as Unacceptable was still zero in 2009, the number of Minimally Acceptable increased by six. This apparent decrease in the quality of maintenance practices is primarily due to continued enhancements to the inspection and rating processes and not due to a decrease in the maintenance efforts by the LMAs. The maintenance of the channels in 2009 was similar to what was seen in 2008 and was better in some cases. Figure 3-1 shows the progression of maintenance ratings from 2007 thru 2009.

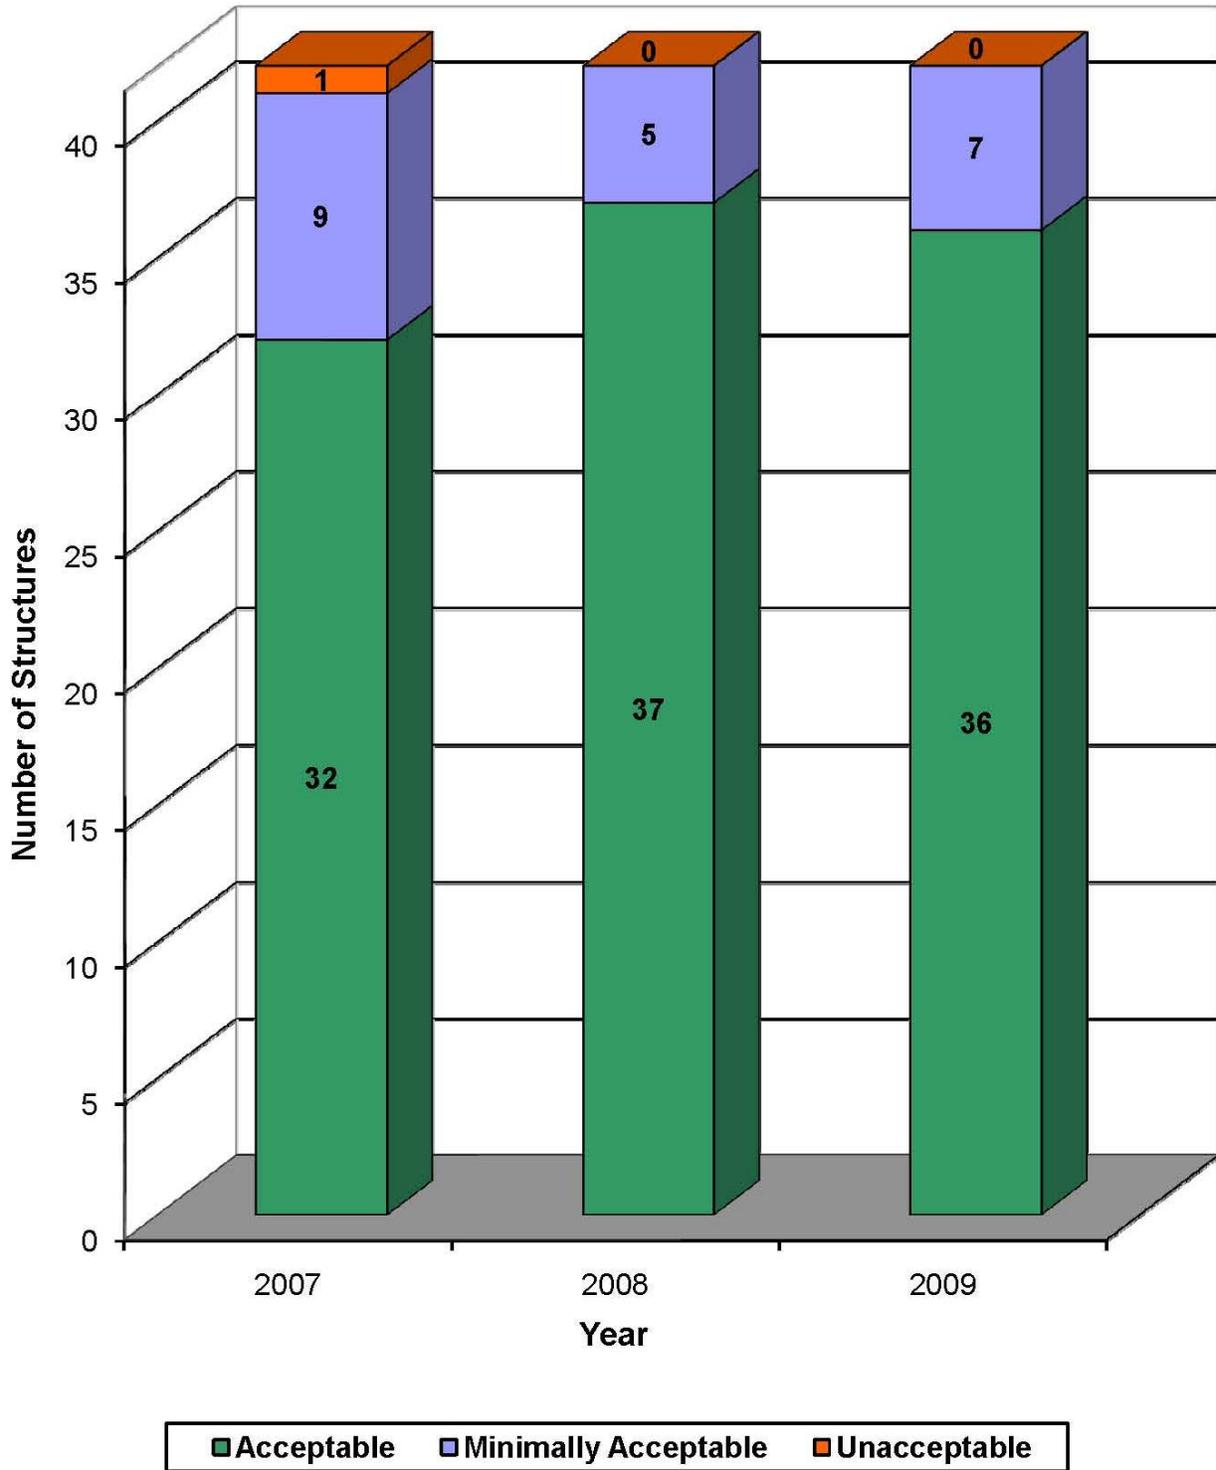
Figure 4-1

Most of the structures were found to be in a similar state of maintenance as in 2008 and the number of Acceptable and Minimally Acceptable ratings is similar to last year. Several pump plants were found to have some issues that caused them to receive worse ratings than previous years. The specific issues can be found in the detailed reports but generally include a lack of annual maintenance or components like backup power missing from the station. These issues are in the process of being addressed and are not expected to prevent the system from performing adequately during a high water event.

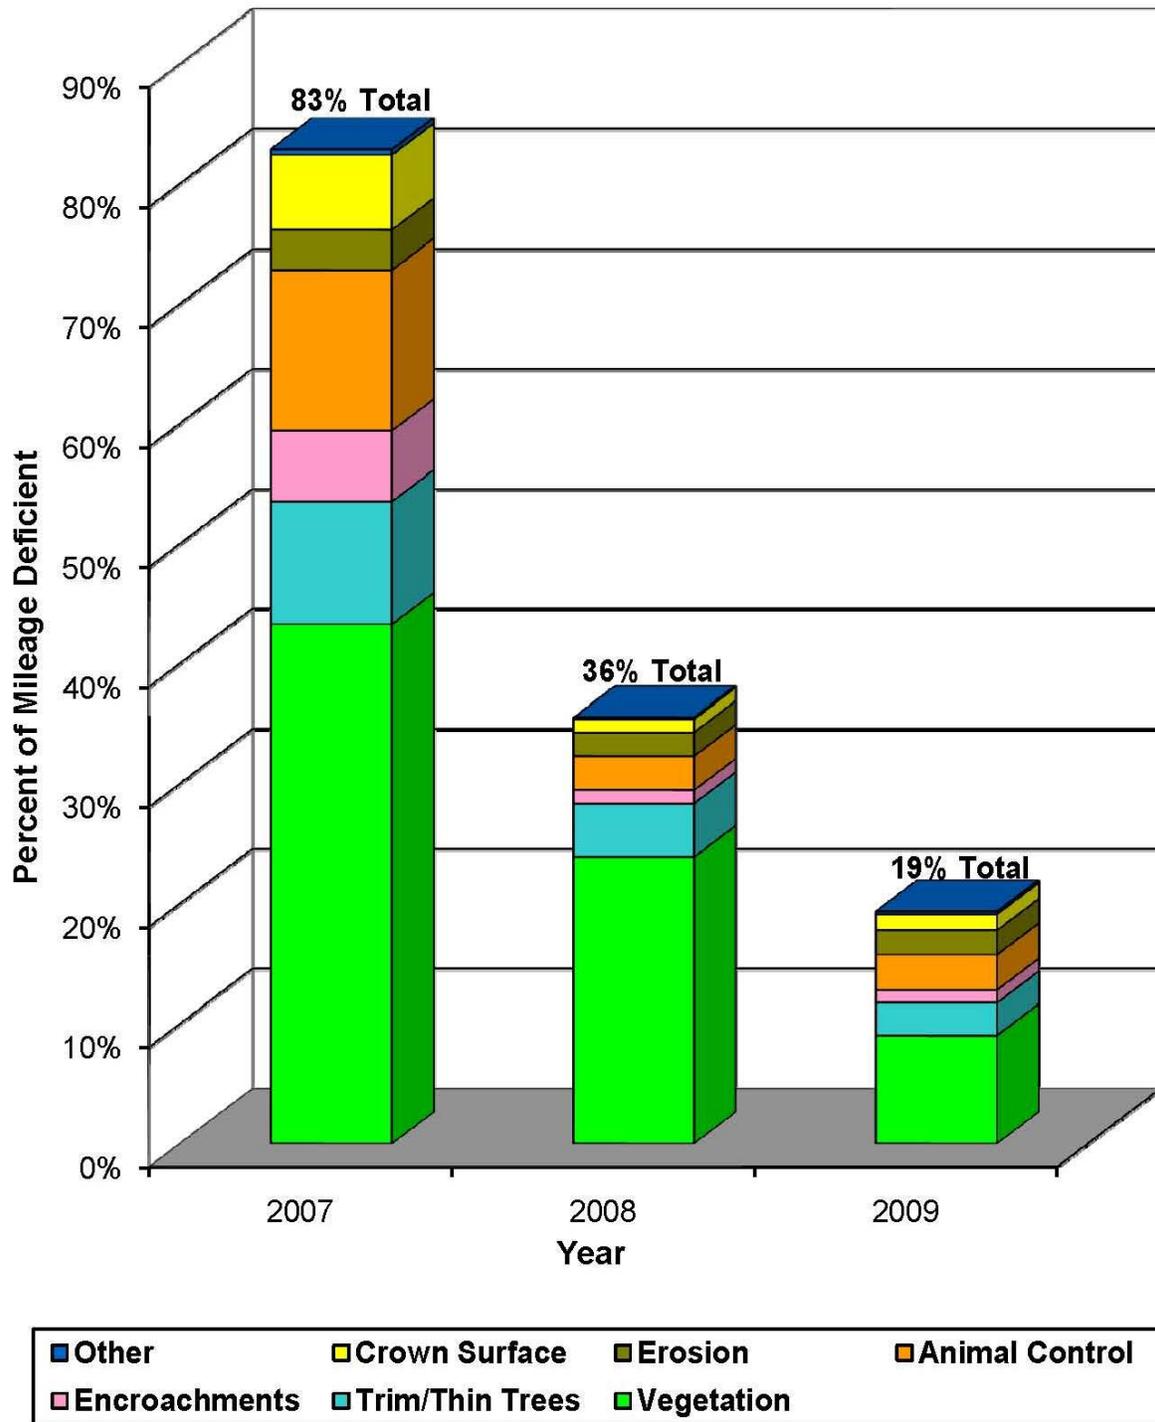
Figure H-3

Vegetation deficiencies make up the majority of deficient levee miles for 2009 followed by a significant amount of trim/thin trees and animal control. The remainder of deficient miles comes from encroachments, erosion, crown surface, and other items. Appendix H shows supplemental figures showing further analysis for the various basins and types of deficiencies.
