State of California
The Natural Resources Agency
Department of Water Resources
Division of Flood Management
Flood Project Integrity & Inspection Branch

2009
SUPPLEMENTAL
EROSION SURVEY
OF THE
SAN JOAQUIN RIVER
FLOOD CONTROL SYSTEM
April 2010

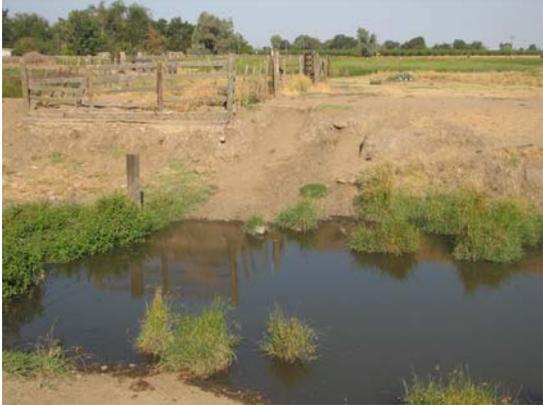
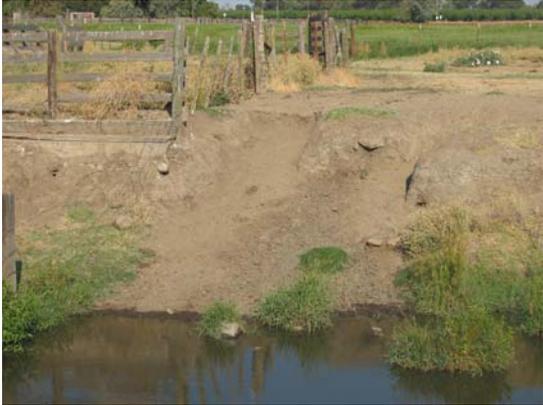
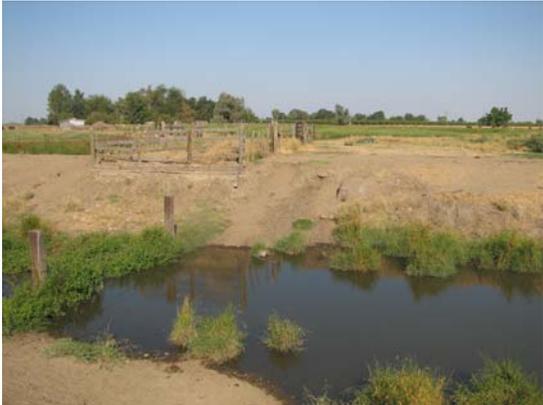
Most Recent:	2009: Site recommended as local maintenance issue, per CLRO CES Evaluation 2008 Report; previously rated "U"
Previous Comments:	2008: terracing; frequent livestock traversing slopes; 2007: GPS extended from opposite bank using Google Earth

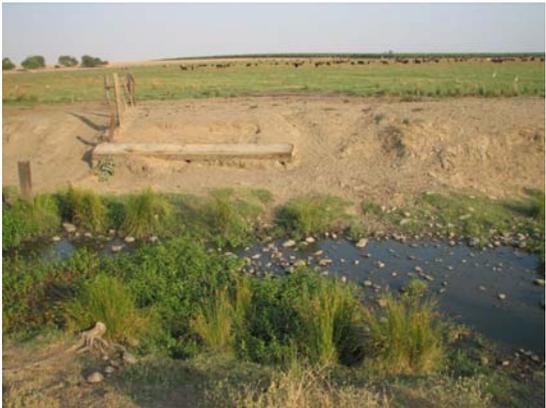
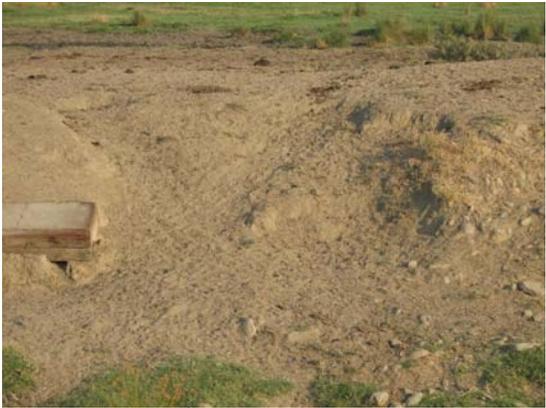
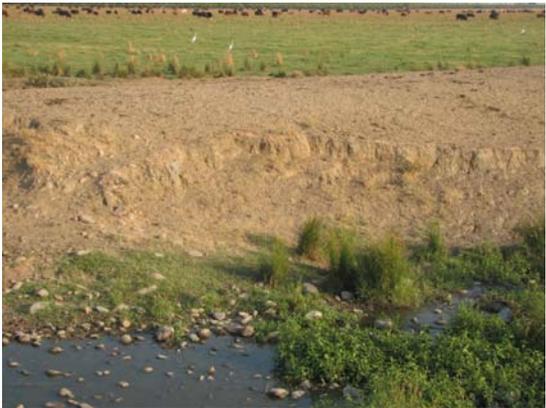
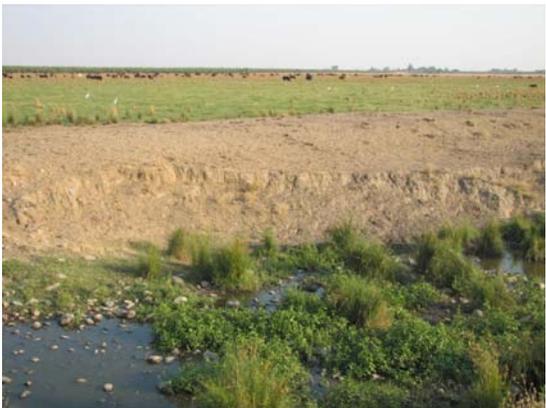
Most Recent:	2009: Site recommended as local maintenance issue, per CLRO CES Evaluation 2008 Report; terracetting damage from livestock traversing; there is a wooden platform installed on site; landside ground is same heights as levee crown; previously rated "M"
Previous Comments:	2007: GPS extended from opposite bank using Google Earth, GPS on file is correct

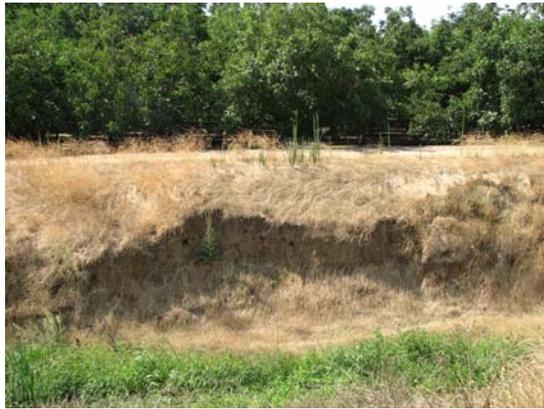
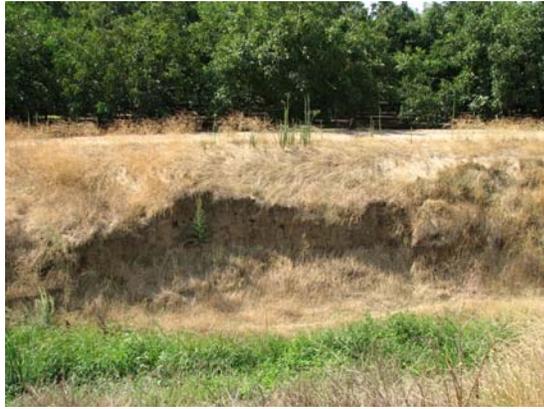
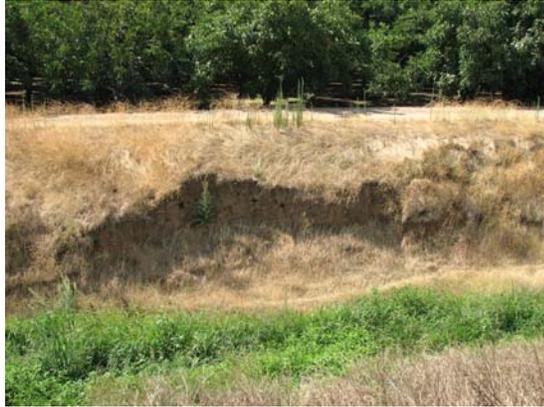
Site ID NA0017U15RM7.23

Most Recent:	2009: near-vertical scarp on the bank; levee is on high ground
Previous Comments:

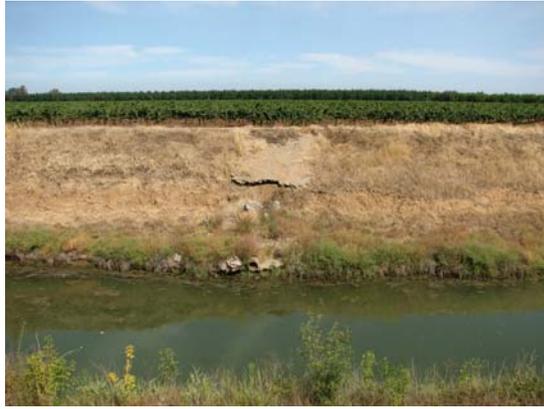
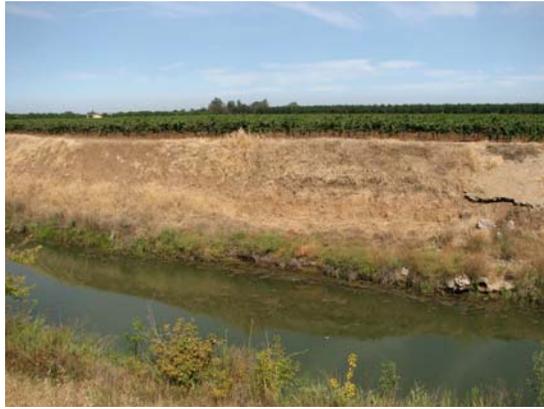
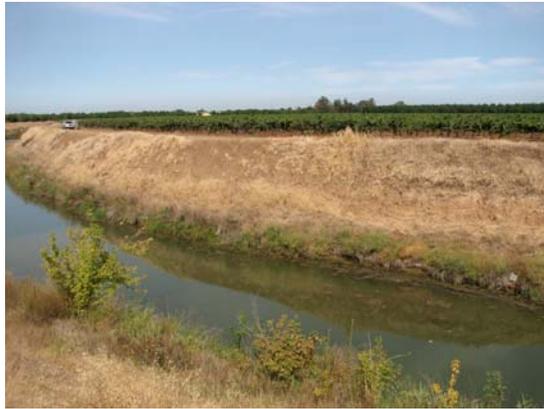
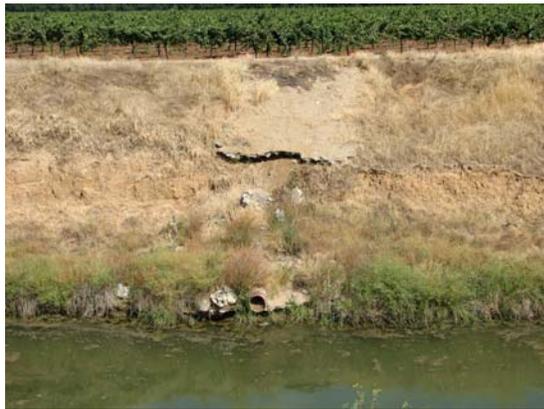
Most Recent:	2009: Erosion is incising into the levee; a pipe outlet is located at the levee toe; there are traces of concrete lining originally placed over the slope; levee is on high ground; inspect for potential pipe leak
Previous Comments:

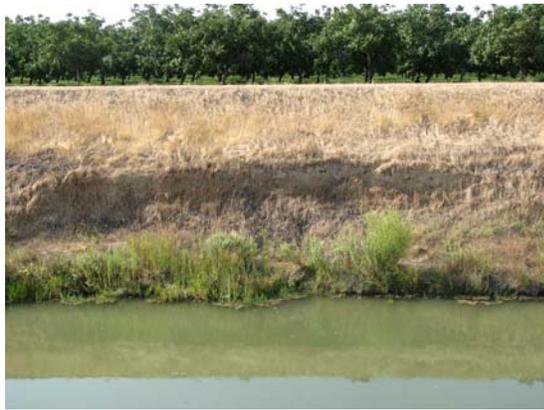
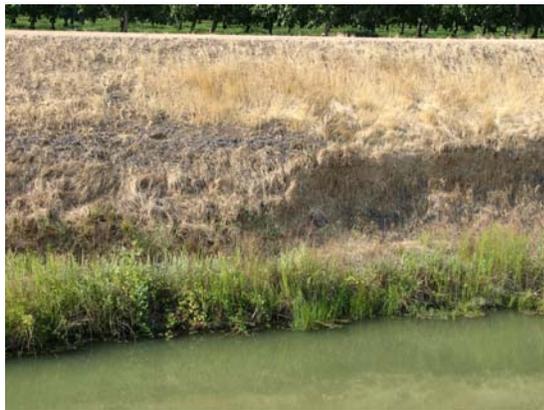
Site ID NA0017U15RM9.16

Most Recent:	2009: cut of 1-2 ft into the levee along lower 1/2 slope; cut is near-vertical; levee is on high ground
Previous Comments:

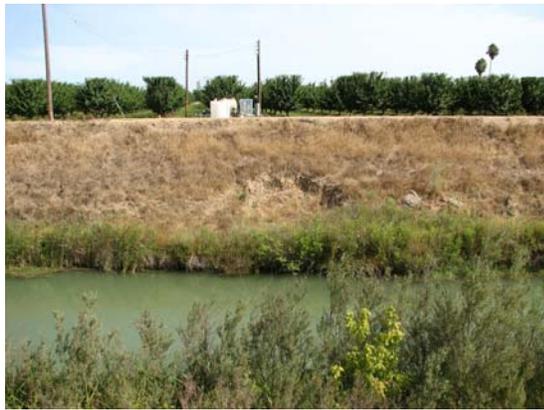
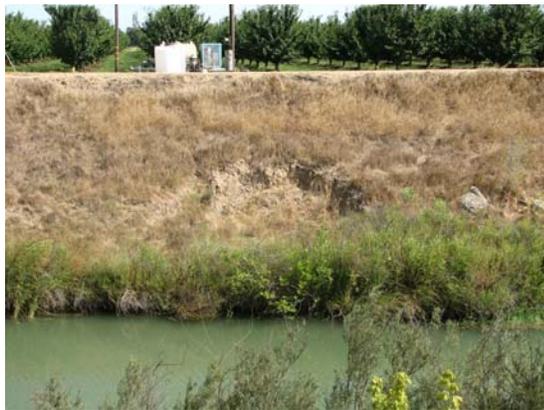
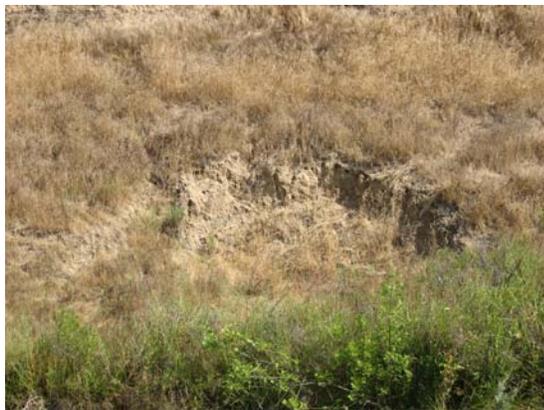
Site ID NA0017U15RM10.37

Most Recent:	2009: localized erosion; sloughing at the lower slope; small pocket erosion developing
Previous Comments:

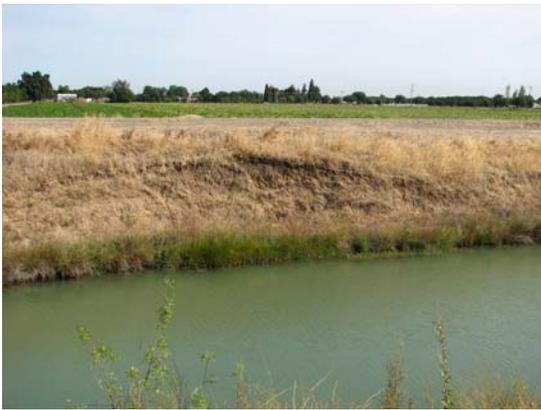
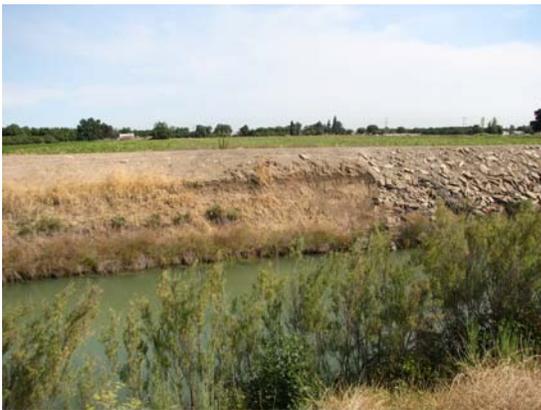
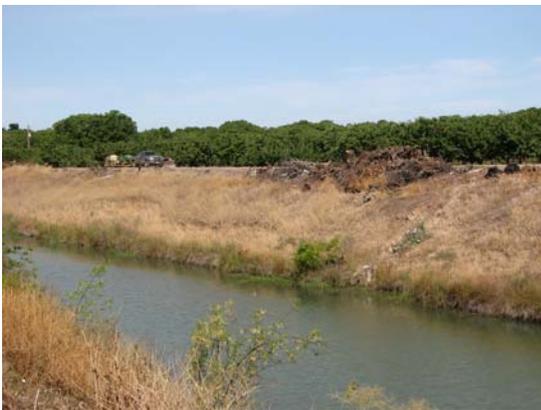
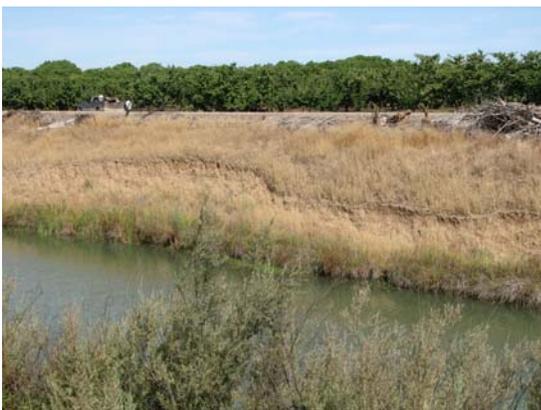
Most Recent:	2009: scarp with varying height of 1' - 5'; levee is on high ground; erosion occurs just downstream of rip rap placement; at the time of the survey, there were burn piles at various location along the waterside levee slope
Previous Comments:

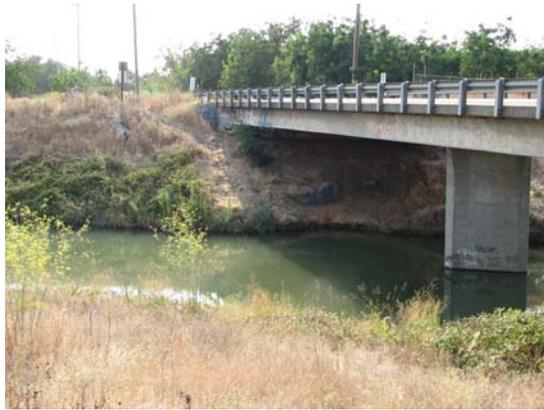
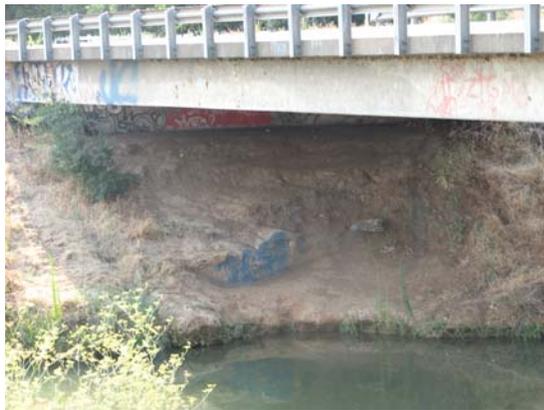
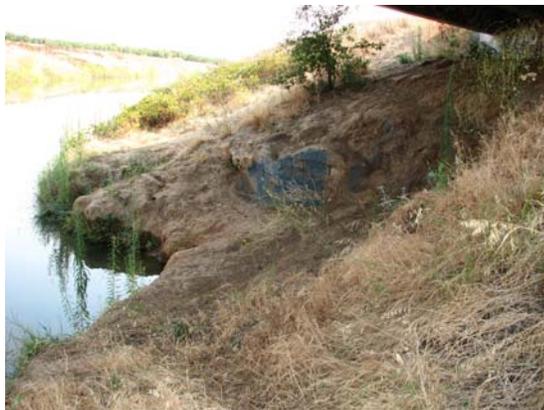
Site ID NA0017U16RM4.57

Most Recent:	2009: site is adjacent to abutment on Milton Road Bridge; pocket erosion has developed and will continue to expose the bridge foundation; this erosion appears to be critical as it may affect the bridge foundation
Previous Comments:

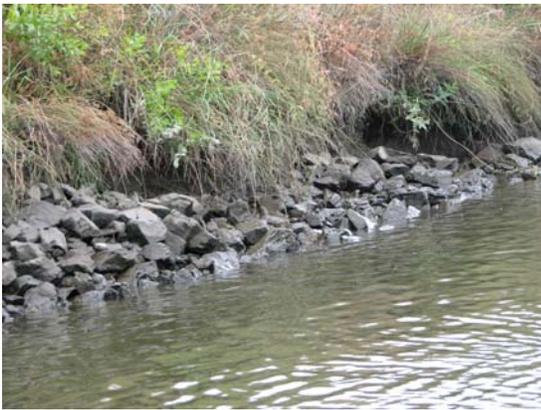
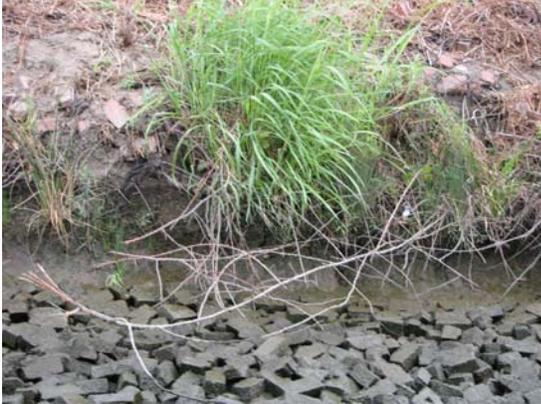
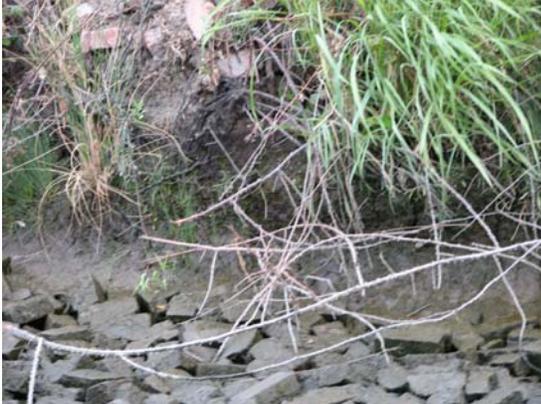
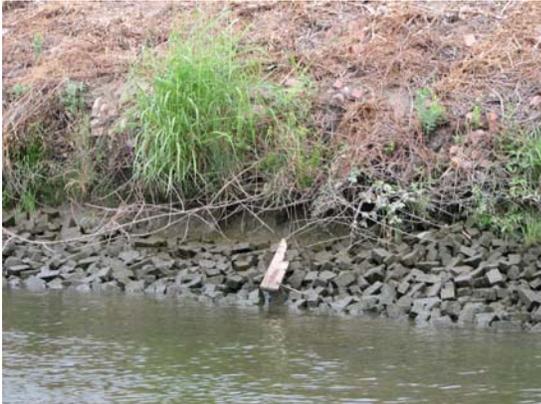
Most Recent:	2009: Undercutting of the toe just above the existing rip rap; note there is a housing development on the landside of the levee (refer to Aerial Atlas)
Previous Comments:

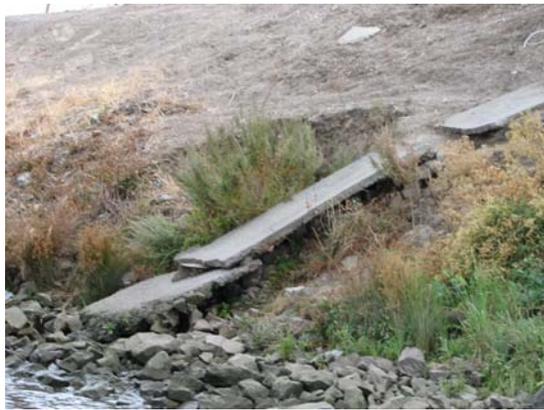
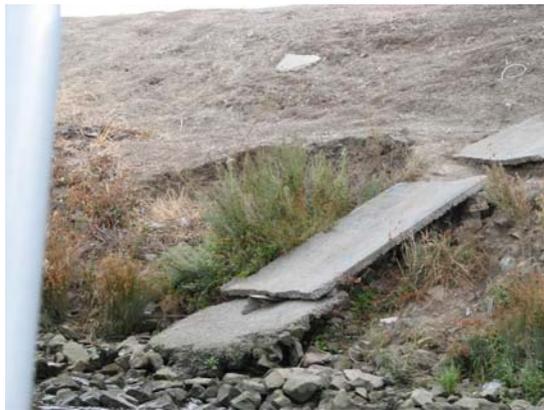
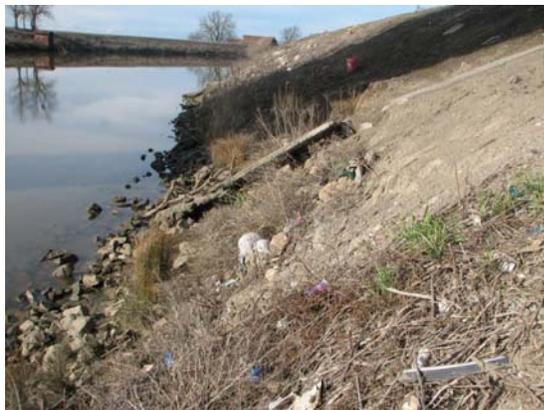
Most Recent:	2009: pocket erosion just below and across the abutment of Howard Road Bridge; existing toe rip rap and concrete slabs in place; erosion may develop into a larger pocket erosion if no corrective action is taken
Previous Comments:

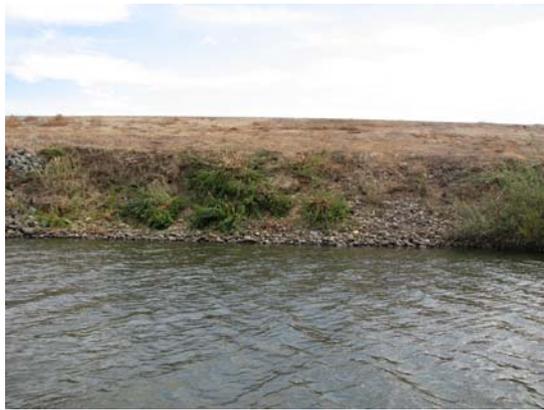
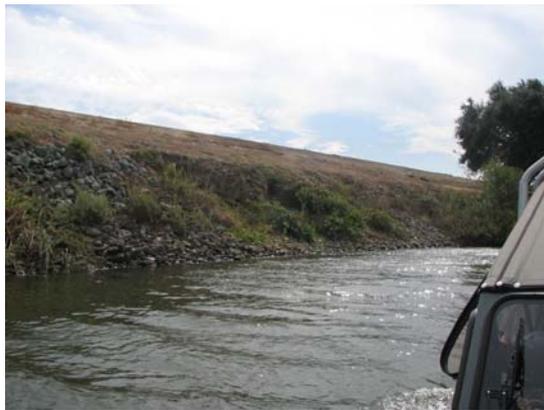
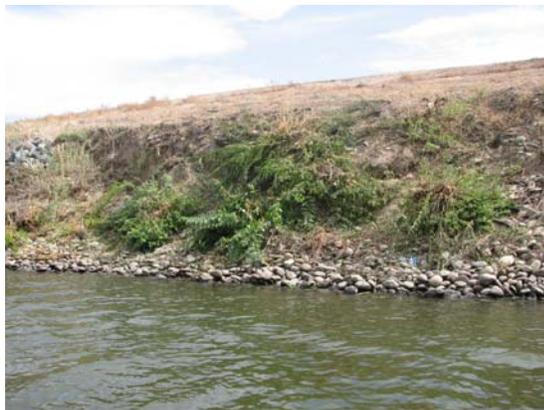
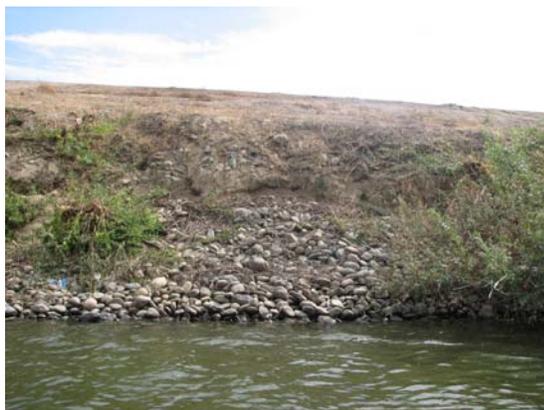
Most Recent:	2009: A 50-ft section of the lower slope has slumped just above the existing rip rap; there is also rip rap protection along the levee toe
Previous Comments:

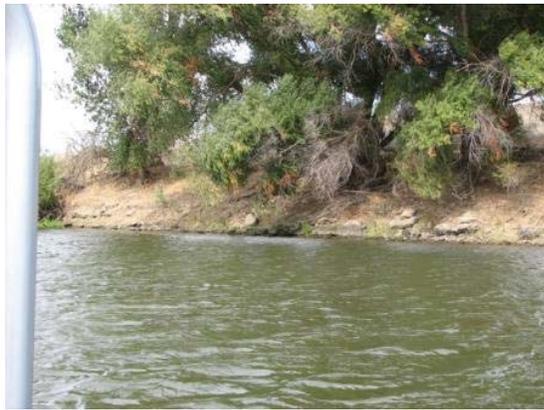
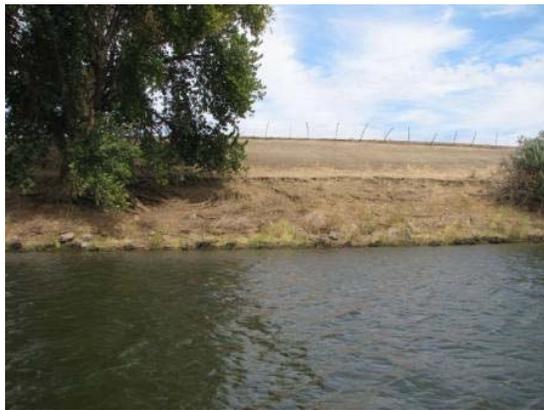
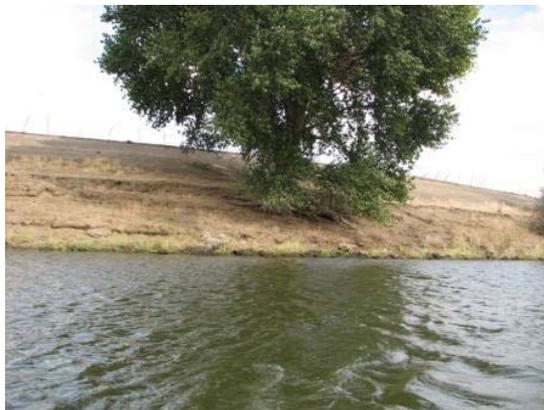
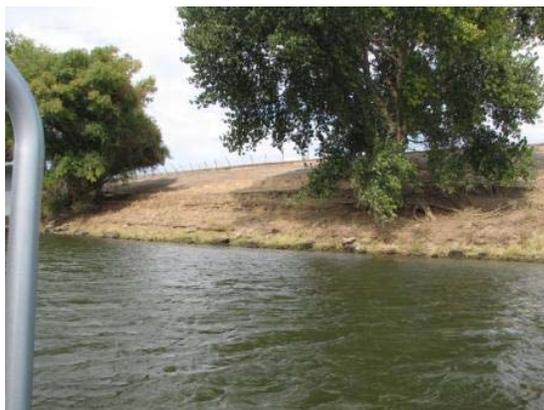
Site ID RD0017U2RM53.54

Most Recent:	2009: No major change observed; erosion site is immediately upstream of rehabilitation site ; recommend annual monitoring of site per Critical Erosion Sites Evaluation 2008 Report; note site # is the same as RM53.7, LM10.59; previously rated "U"
Previous Comments:	2008: Observed to be caused by wave-wash erosion; 2007: Visited site 6/7/07; site could be combined with Site 32

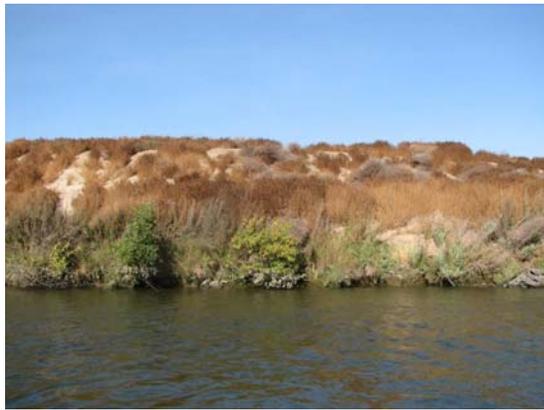
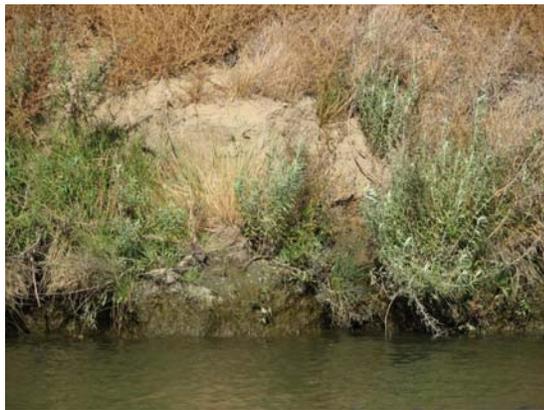
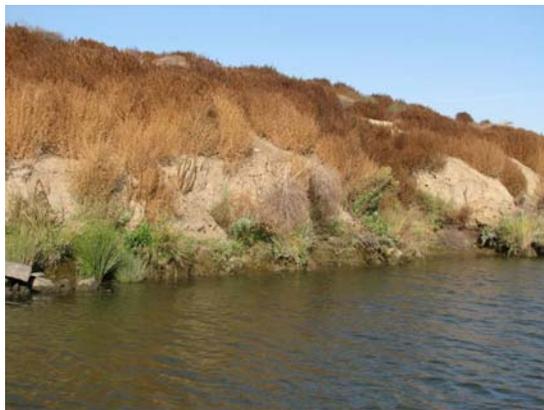
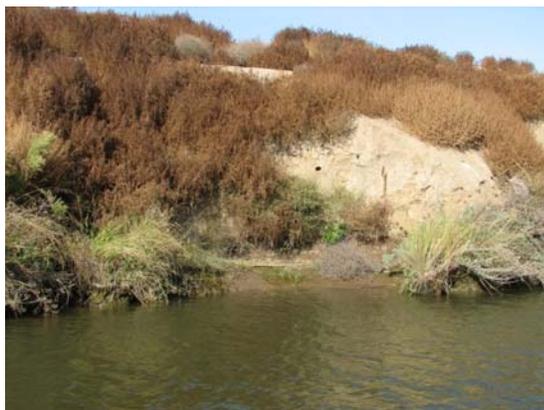
Site ID **RD0404U1RM40.86**

Most Recent:	2009: No major change observed; this site was combined with other existing sites at RMs 40.93, 40.98, and 41.14 as one site; several pocket erosion just above non-uniform toe rip rap; previously rated "U"; bare spots along the upper slope
Previous Comments:	2008: wave wash erosion; several pocket erosions along the lower slope; site is inside of a bend; 2006: visited site 9/12/06

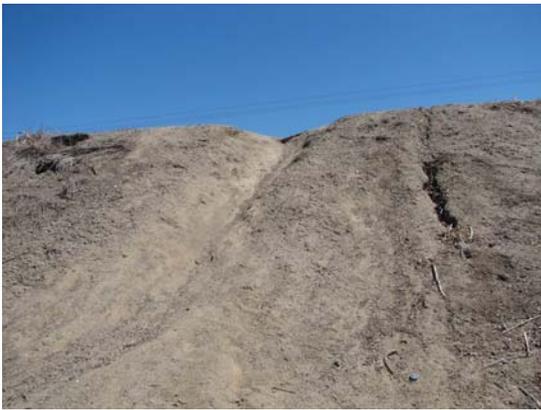
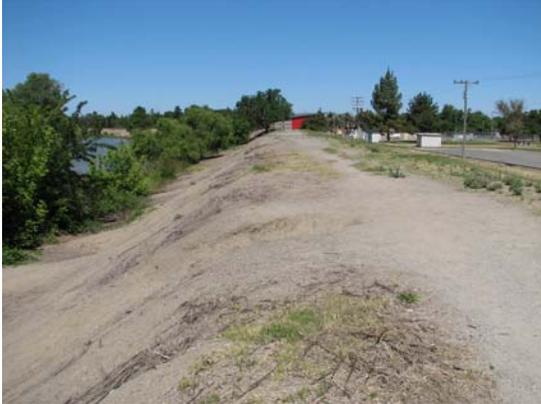
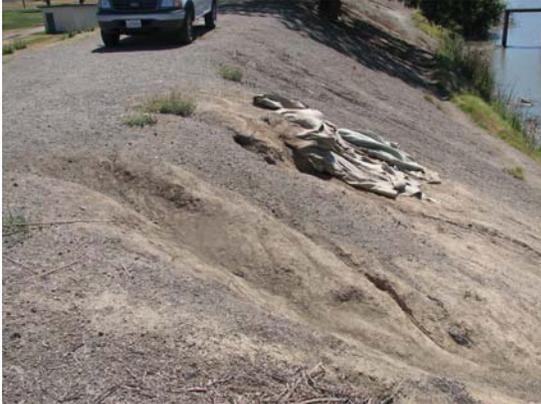
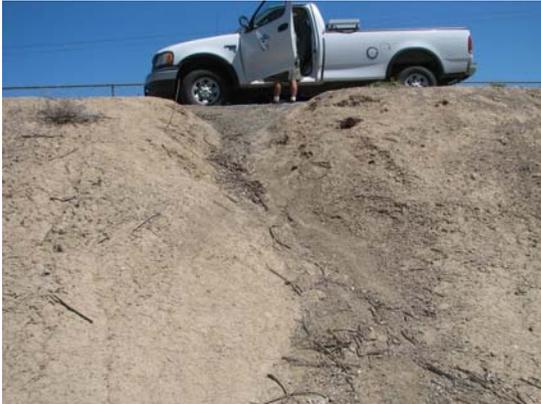
Site ID **RD0404U2RM1.56**

Most Recent:	2009: Erosion appears to be maintenance-related, and not cause by riverflow; recommend annual assessment and monitoring of erosion site, per Critical Erosion Sites Evaluation 2008 Report; previously rated "U"
Previous Comments:	2006: Headward erosion along the levee bank; erosion has created "notches" estimated to be about 12 ft in height; erosion appears to be maintenance related; DWR Inspector for the area says that the erosion has ben present for years

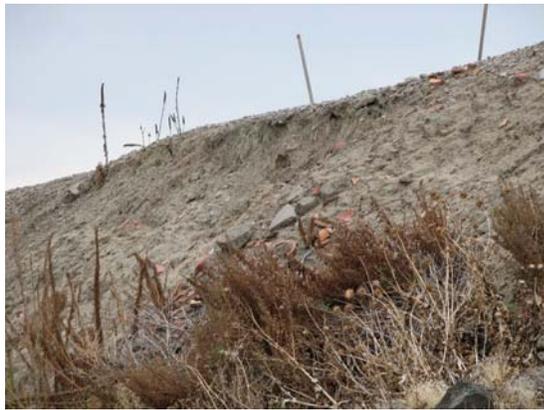
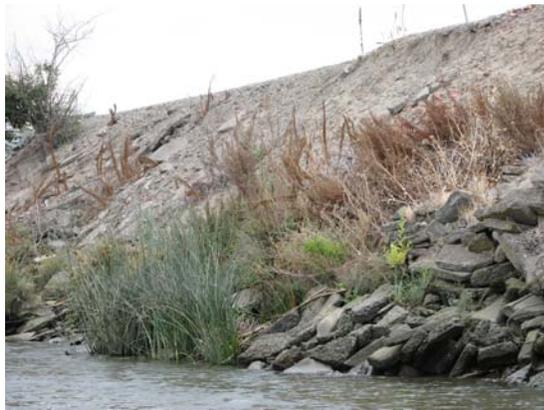
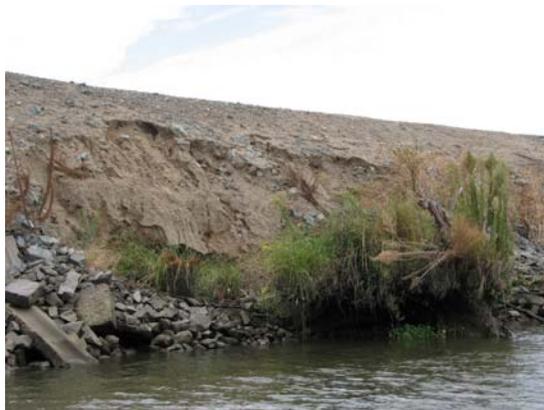
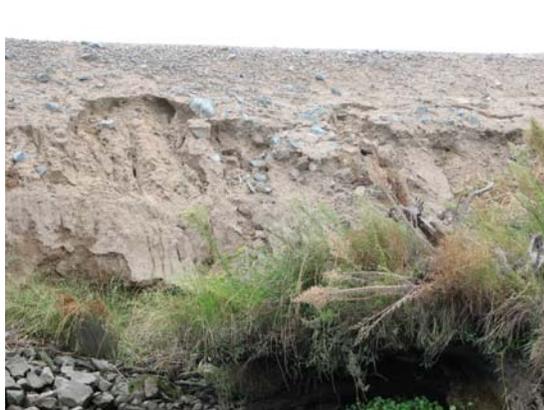
Site ID RD0524U1RM41.15

Most Recent:	2009: erosion site extends from RM 41.11 to 41.18; existing revetment is no longer adequately protecting the oversteepened slope
Previous Comments:	2008: Existing concrete slabs placed as temporary fix; sliding of revetment; 6' pocket erosion with near-vertical scarp; note a sewage treatment plant is located on landside of the levee

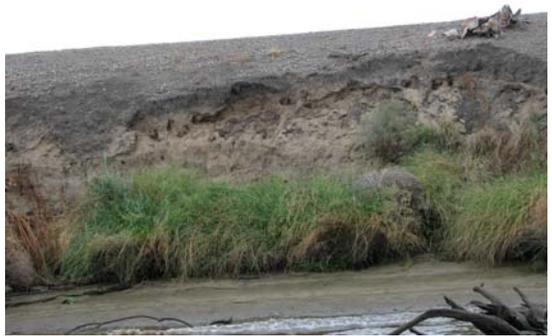
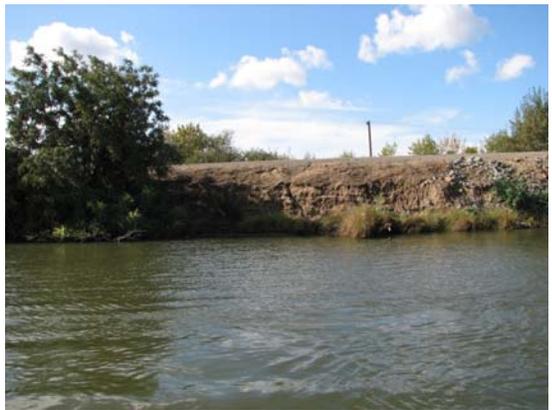
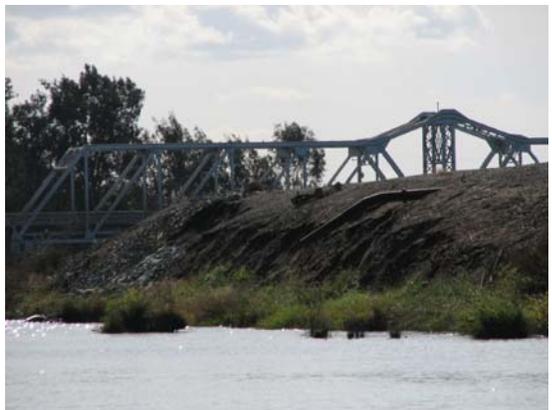
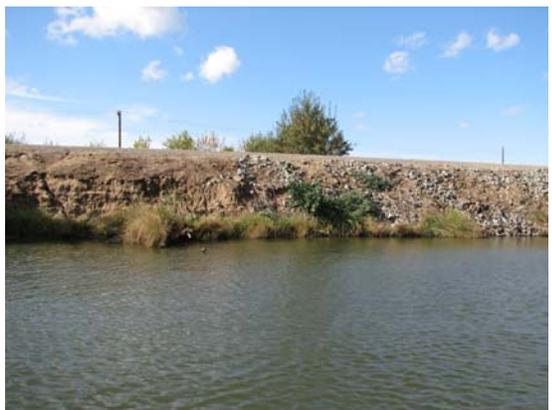
Site ID RD0524U1RM41.79

Most Recent:	2009: Site consists of an approximately 400 ft. eroding bank with minimal protection; the existing rip rap is sloughing; note there is an exposed section of a pipe
Previous Comments:	2006: There is extensive loss of rip rap on some sections; sewage disposal pond on land side; there is an exposed "hanging" pipe outlet from the upper slope

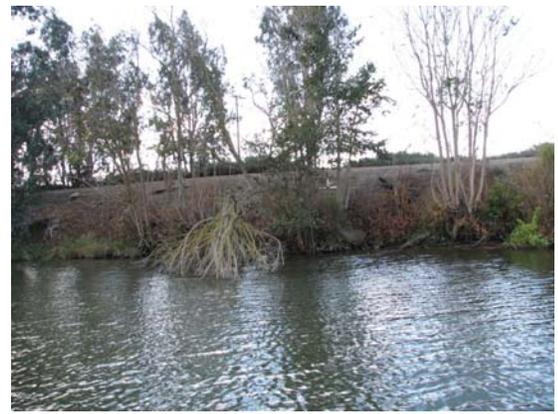
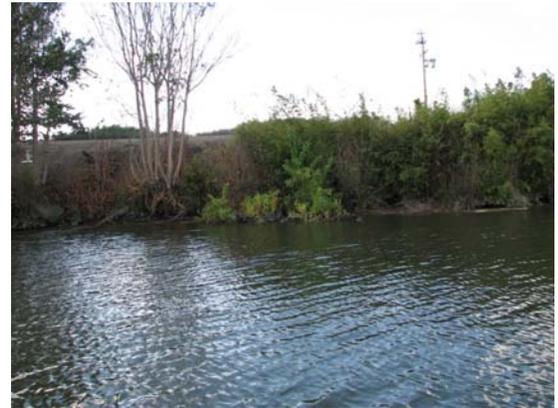
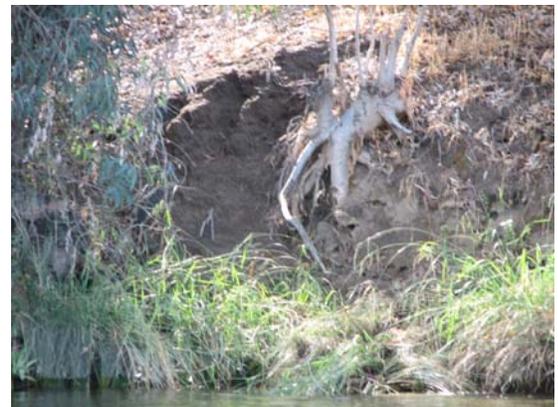
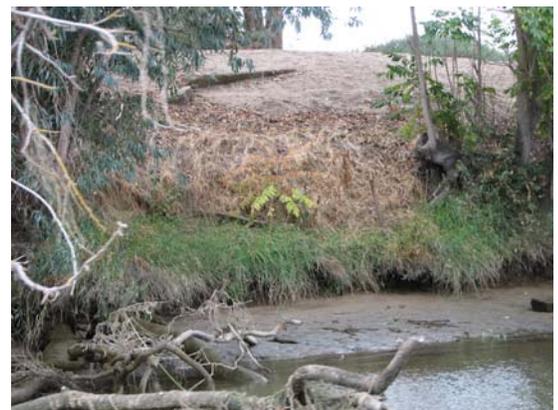
Site ID RD0524U1RM42.2

Most Recent:	2009: The lower slope is lined with some erosion pockets; some tree roots are exposed; there is visible undermining of the levee toe; site is immediately upstream of the Highway 4 Bridge; the bridge is possibly causing a scour to occur, eroding the bank
Previous Comments:

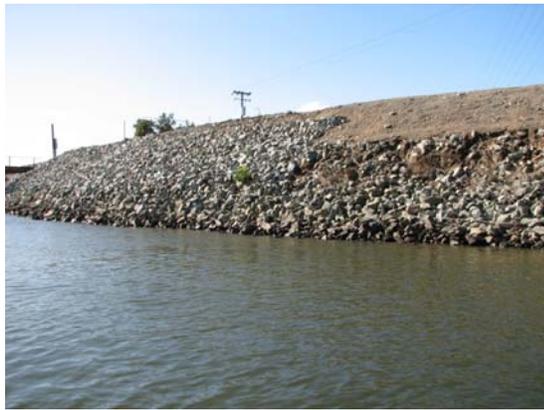
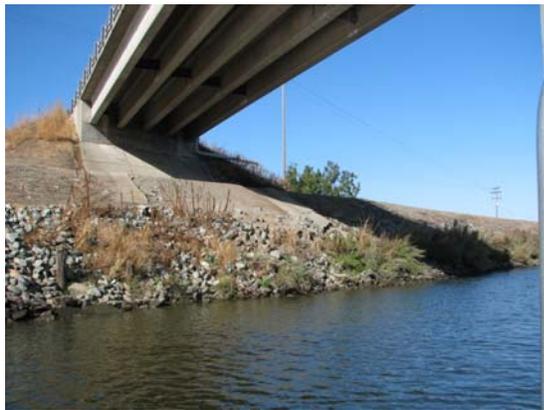
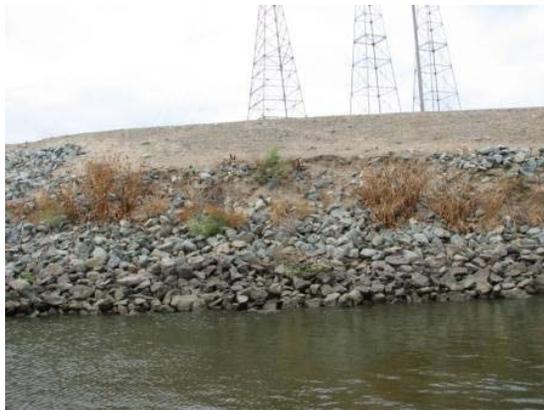
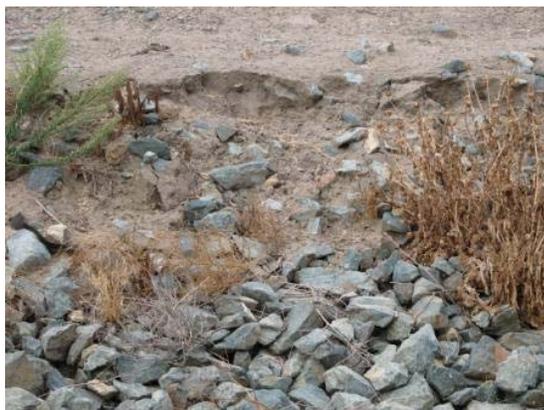
Site ID RD0524U1RM46.12

Most Recent:	2009: no major change observed; upper portion of the existing revetment has slipped, exposing the degraded bank; note the site # is same as RM 46.3, LM5.69 found in the CLRO CES Evaluation 2008 Report; ste was previously rated "M"
Previous Comments:	2008: Previously repaired using rock revetment; upper portion of the revetment is sliding, causing deformation on levee slope; upstream of Howards Road Bridge

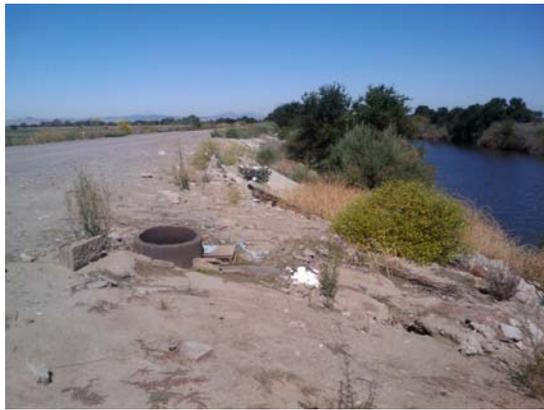
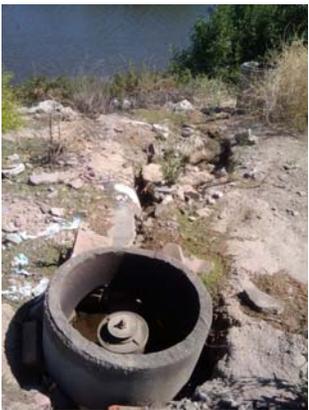
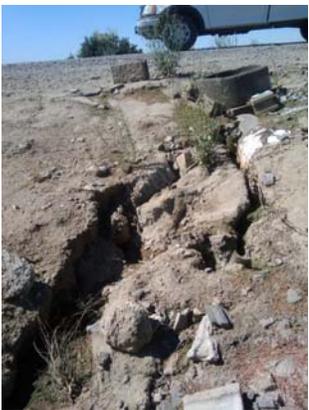
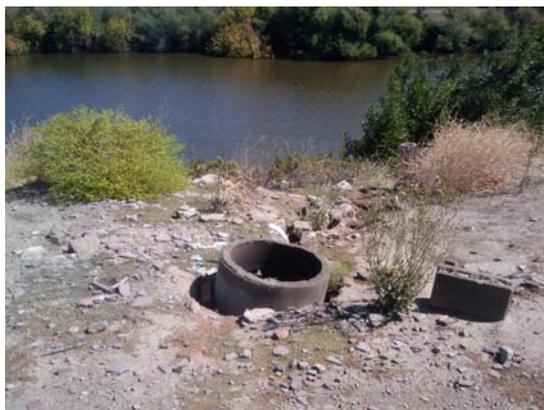
Most Recent:	2009: A possible leak or spill from a siphon breaker is eroding the slope and developing into a headward erosion; a portion of the buried pipe is exposed; the lower slope seems to be lined with chunks of concrete debris or other rock material
Previous Comments:

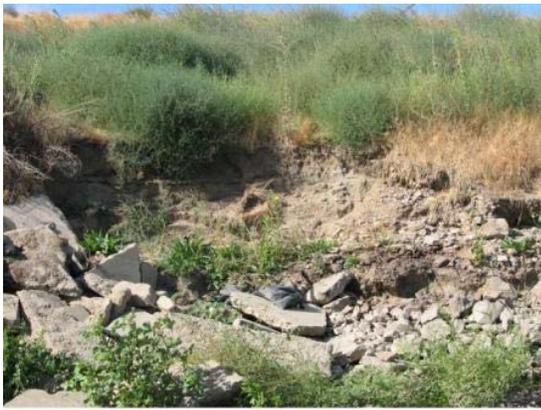
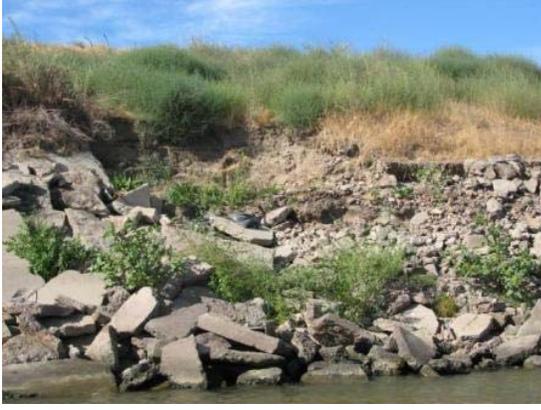
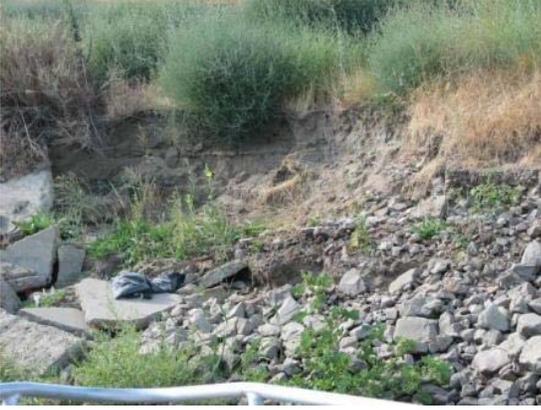
Most Recent:	2009: landside ground surface has been raised to the height of the levee crown; sloughing of the existing rip rap revetment on the lower slope, creating a pocket; site # is the same as RM54.34,LM1.08; previously rated "M"
Previous Comments:	2006: Previously marked with stake

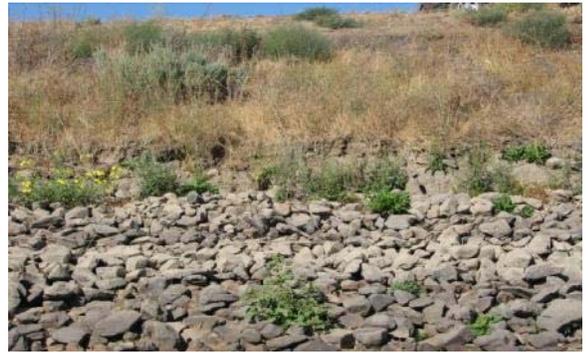
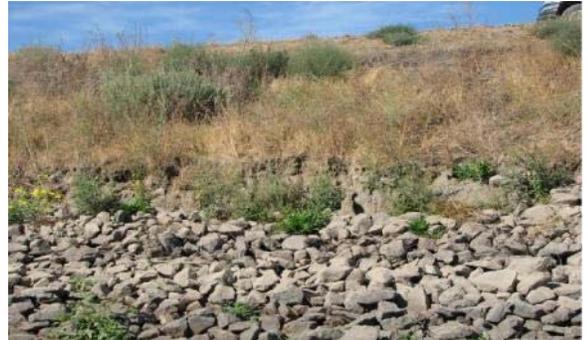
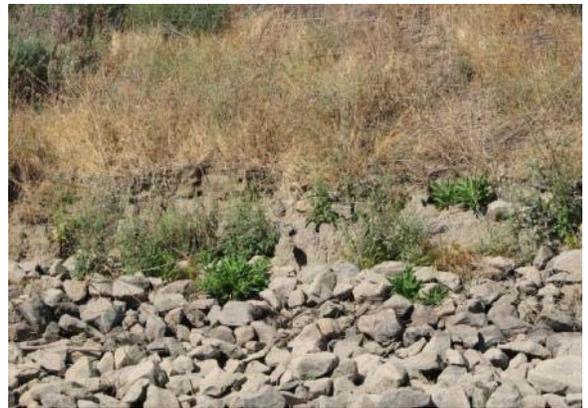
Most Recent:	2009: Portion of the rip rap has slipped, leaving an exposed section; there is dense vegetation surrounding site; landside ground surface has been raised to height of levee crown; site # same as RM55.75,LM2.25; previously rated "U"
Previous Comments:	2006: pocket erosion approximately .3-.4 miles downstream from SPRR bridge

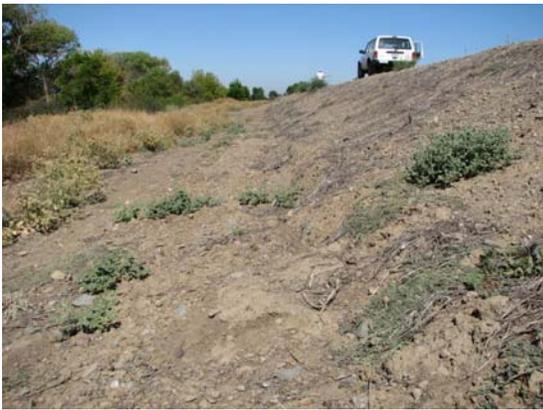
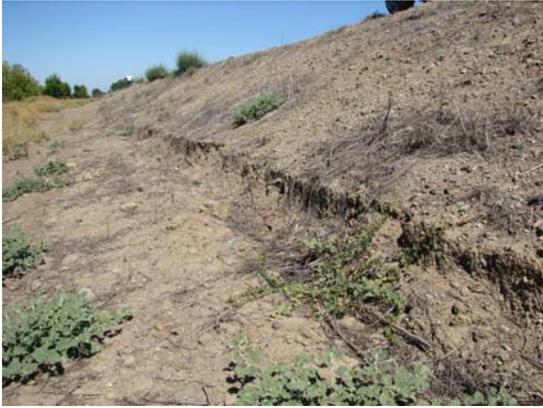
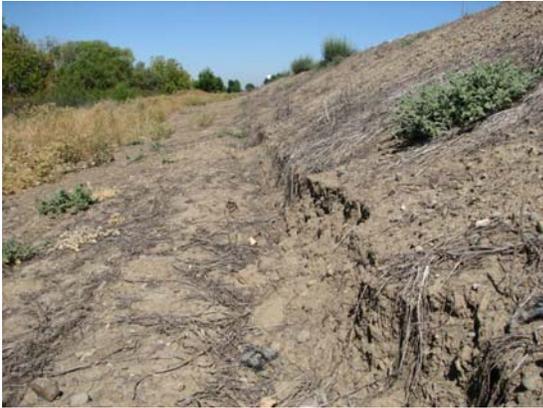
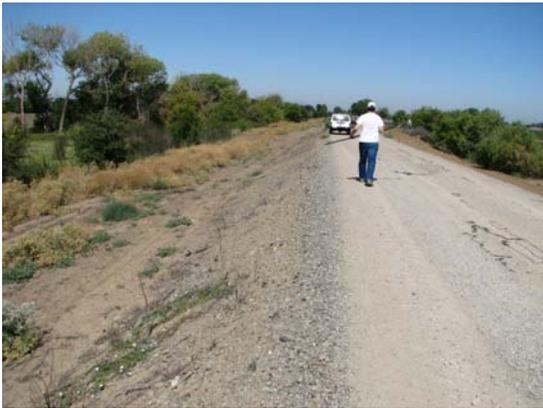
Most Recent:	2009: 1-2 ft. of vertical scarp on levee toe; damage was most likely caused by farming equipment during clearing operation;
Previous Comments:

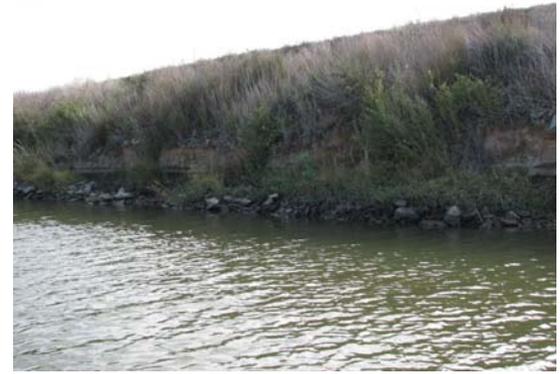
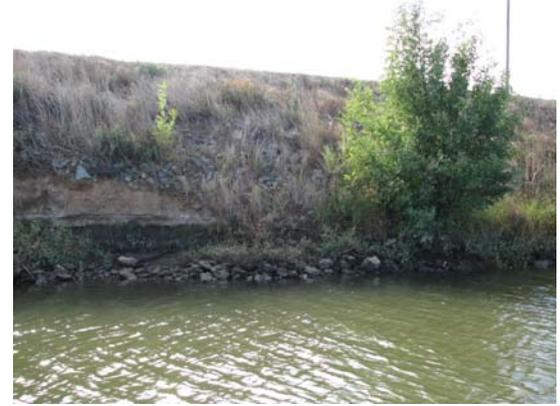
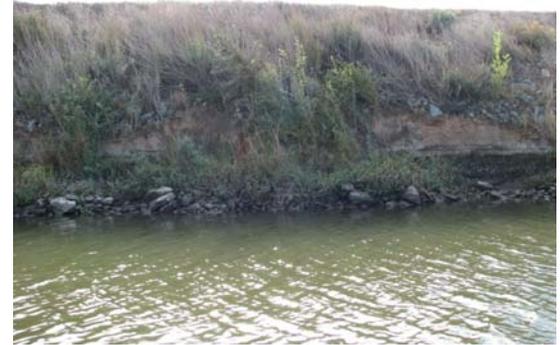
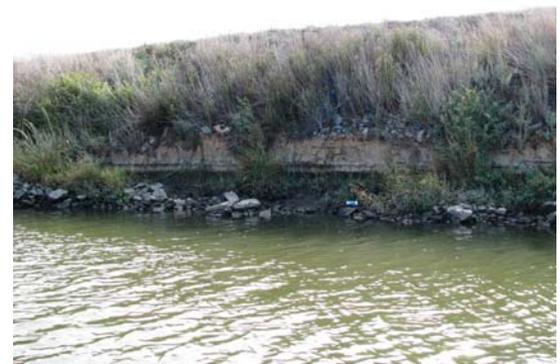
Most Recent:	2009: No major change observed; pocket erosion & vertical scarp; site was combined with RM 30.13 and 30.02 with total erosion length of 465 ft; recommend annual assessment & monitoring of site, per CLRO CES Evaluation 2008 Report; previously rated "M"
Previous Comments:	2008: Top of vertical scarp has rip rap that appears to be sliding; rodent holes; existing toe rip rap

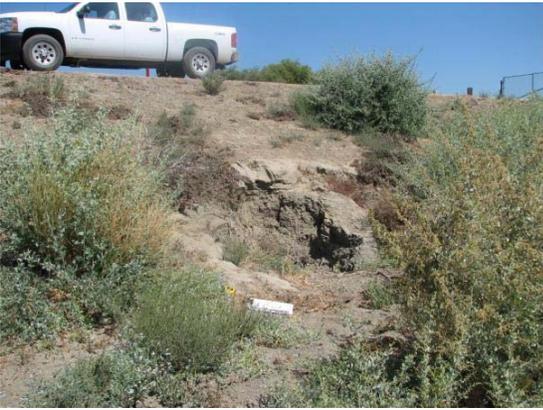
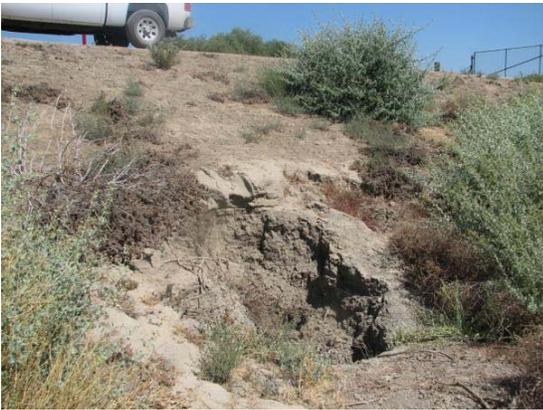
Most Recent:	2009: Note this site has not been reported to be repaired
Previous Comments:	2007: sinkhole approximately 7'x7'x2'; rated "M"

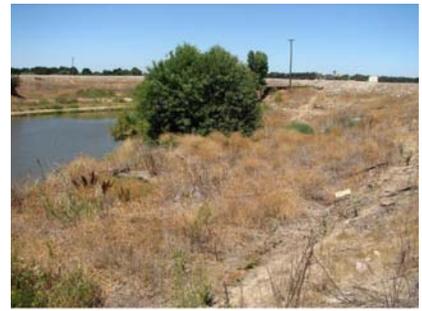
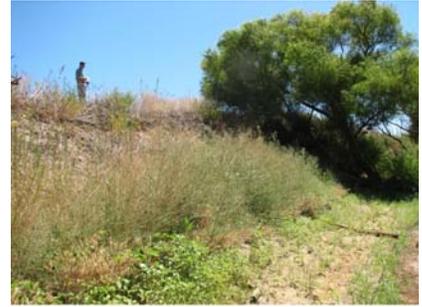
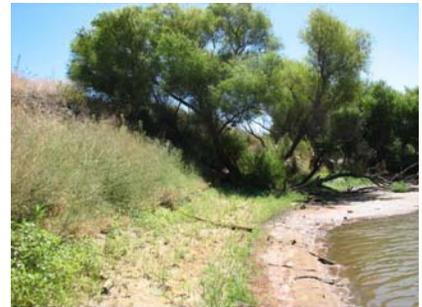
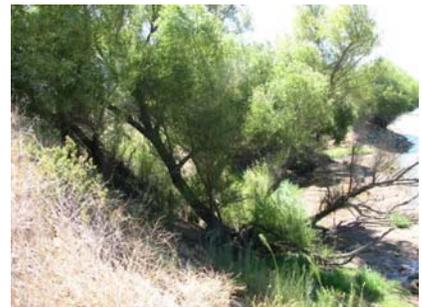
Most Recent:	2009: No major change; located in an oxbow; slope surface consist of very sandy material; exposed tree roots; recommend as a local maintenance issue, per CLRO CES Evaluation 2008 Report; Eddy Cordoza of RD 2075 is aware of the site; previously rated "U"
Previous Comments:	2007: Site is close to irrigation pump inlet

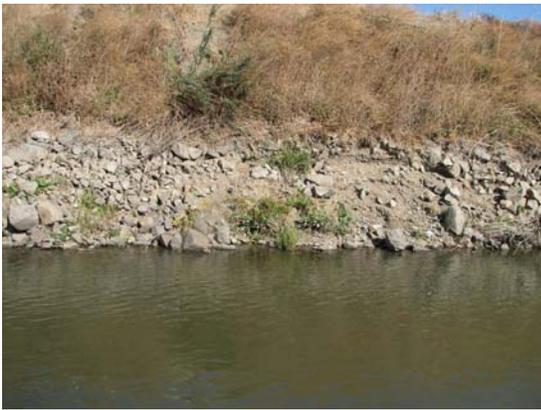
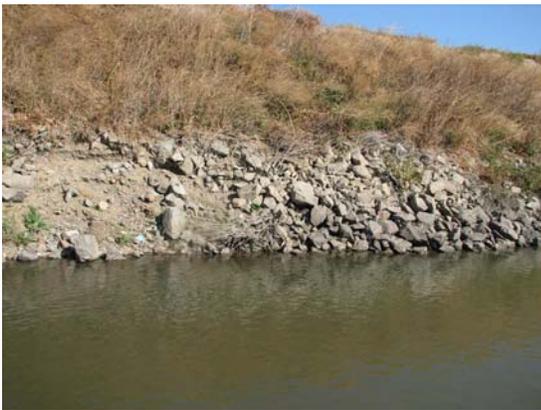
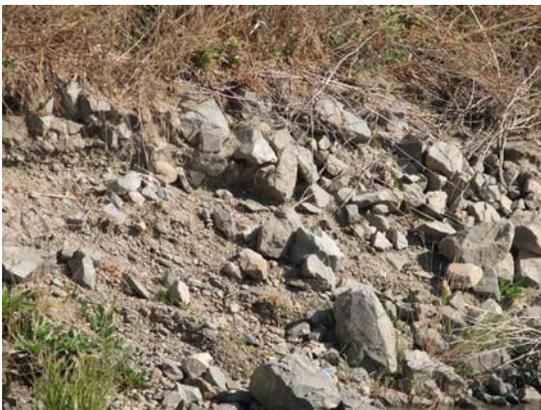
Most Recent:	2009: existing revetment just above the toe is sloughing; recommend as a local maintenance issue, per CLRO CES Evaluation 2008 Report; site # is same as RM29.1,LM1.10; previously rated "M"
Previous Comments:	2006: Toe slough; existing revetment

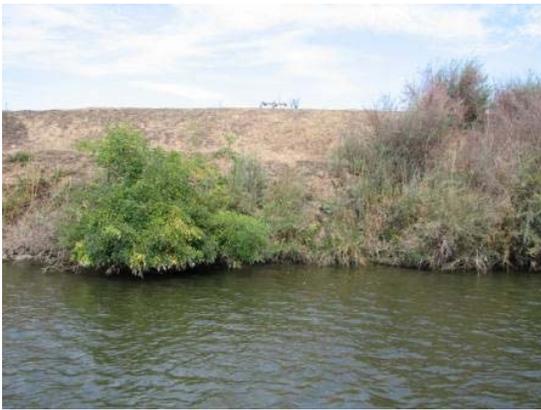
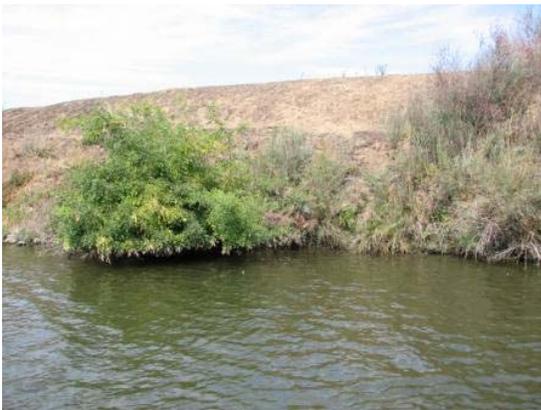
Most Recent:	2009: No major change observed; 5-ft vertical scarp is immediately downstream of where berm has tapered; recommend as local maintenance issue, per CLRO CES Evaluation 2008 Report; site is same as RM29.6,LM0.60; previously rated "U"
Previous Comments:	2008: No change observed; rodent holes on lower slope; wide levee crown
