State of California
The Natural Resources Agency
Department of Water Resources
Division of Flood Management
Flood Project Integrity & Inspection Branch

2009
SUPPLEMENTAL
EROSION SURVEY
OF THE
SAN JOAQUIN RIVER
FLOOD CONTROL SYSTEM
April 2010

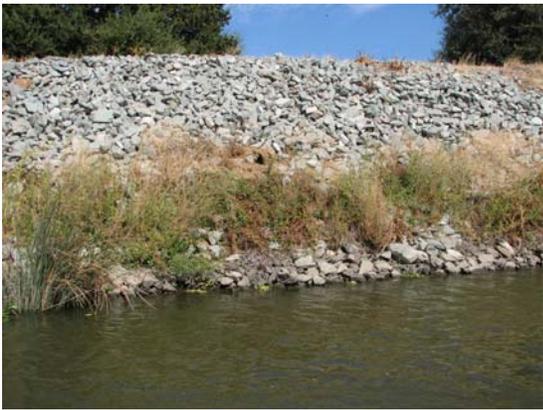
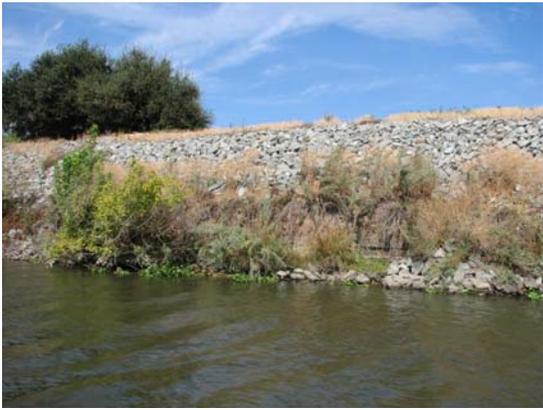
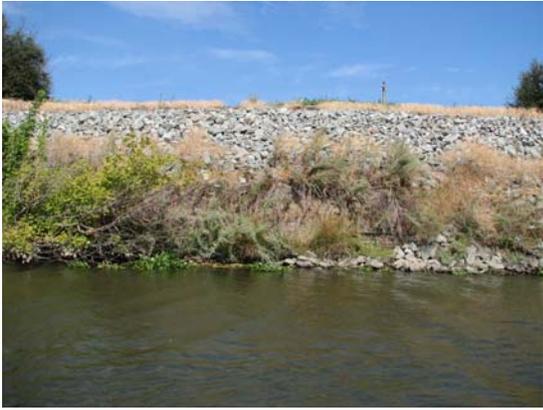
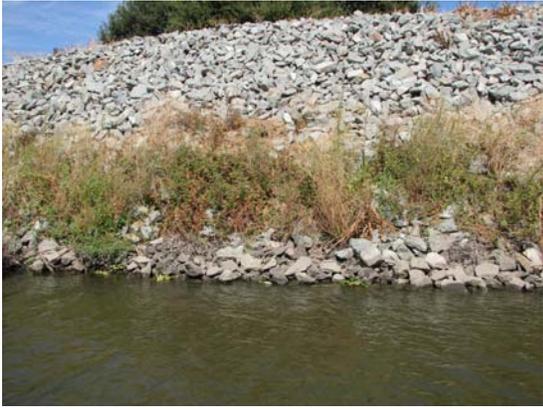
Most Recent:	2009: Rock revetment placed on the upper slope; however, vertical scarp is still present; recommend annual assessment and monitoring of erosion site, per CLRO CES Evaluation 2008 Report; site same as RM29.95,LM0.22; previously rated "M"
Previous Comments:	2008: pocket erosion with vertical scarp; loss of rip rap; mild vegetation growth since last survey

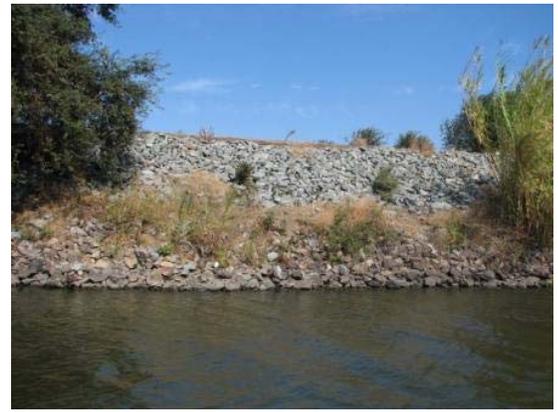
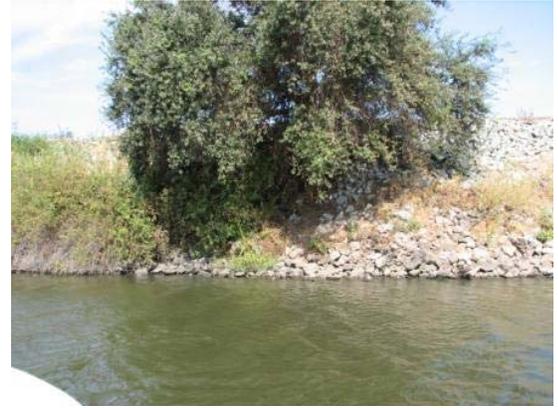
Most Recent:	2009: localized sloughing near the toe; rock protection has been added along the upper slope and along the toe; recommend annual assessment and monitoring of erosion site, per CLRO CES Evaluation 2008 Report; previously rated "M"
Previous Comments:	2008: Minor toe erosion

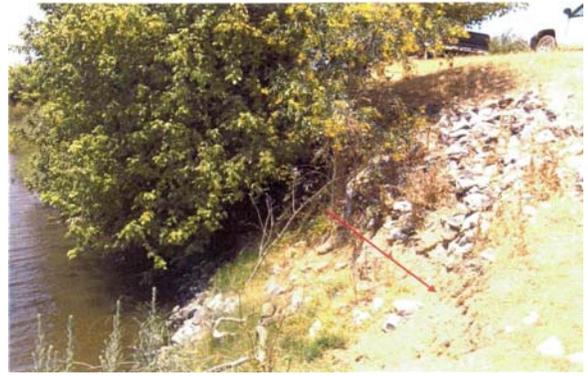
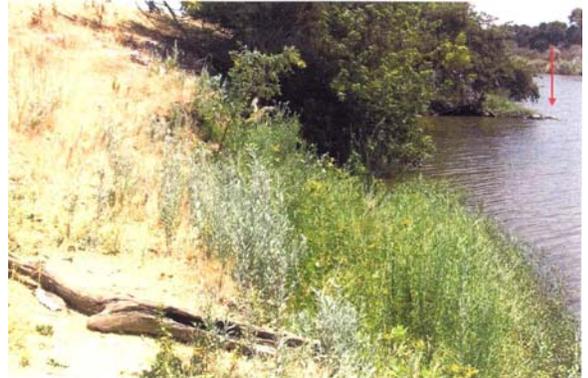
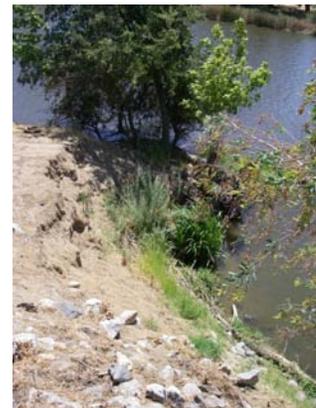
Most Recent:	2009: Pocket erosion on lower slope just above the toe rip rap; protruding rip rap upstream is creating an eddy, scouring the levee slope; site # is same as RM28.4,LM0.30; previously rated "U"; images are courtesy of the Levee Repair Office.
Previous Comments:	2008: Cut into levee profile; riprap slide; rodent holes; pictures do not match GPS and current condition

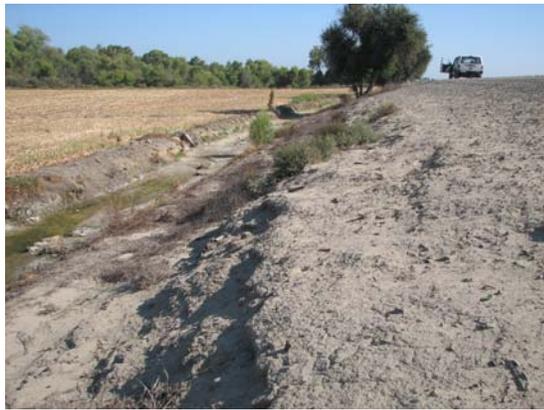
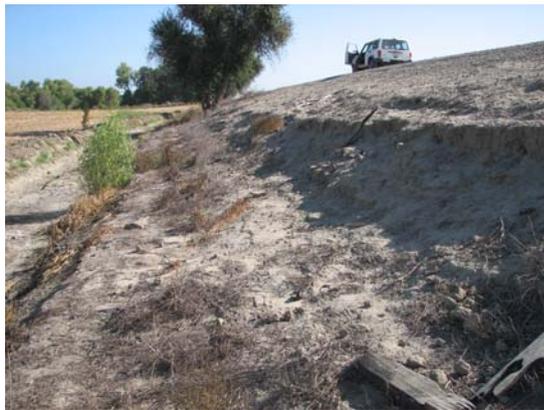
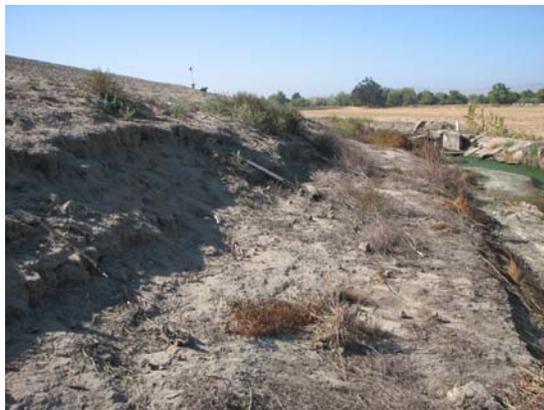
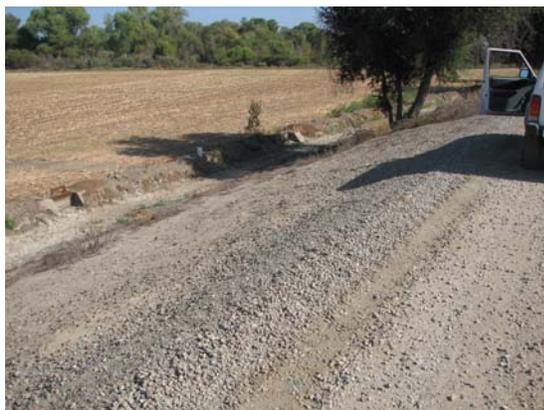
Length (ft):	50
Scarp Height (ft):	8
Location Relative to Levee:	On berm
Remaining Berm Width(ft):	15
Vegetation cover:	Ground surrounding site is fully covered
Burrow Holes (WS):	No Activity
Levee Slope (H:V):	2:1
Soil Type:	Silt (ML)
Condition of surrounding tree(s)	Tree(s) within affected area
Crown Width (ft):	
Site Relative to Bend:	Straight reach
Radius of Curvature:

Most Recent:	2009: No major change noticeable vegetation growth; erosion is on berm, but if left untreated, it will eventually erode into levee prism; recommend annual assessment/monitoring of site, per CES 2008 Report; site # same as RM6.8, LM0.73; previously rated "U"
Previous Comments:	2008: Downstream of WPRR near siphon pipe & pump; sandy levee; visited by Jeff Van Gilder and LRO in 2008 for repair assessment; scouring downstream of RR crossing, possibly caused by eddy effects

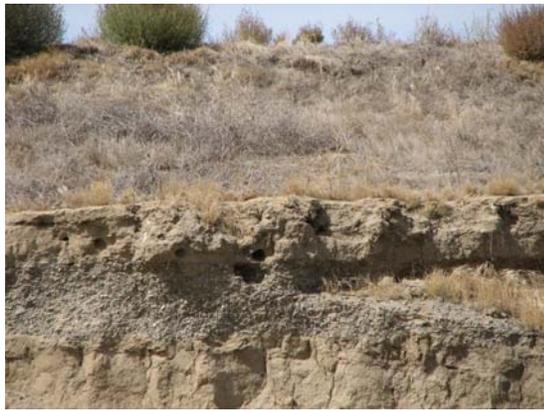
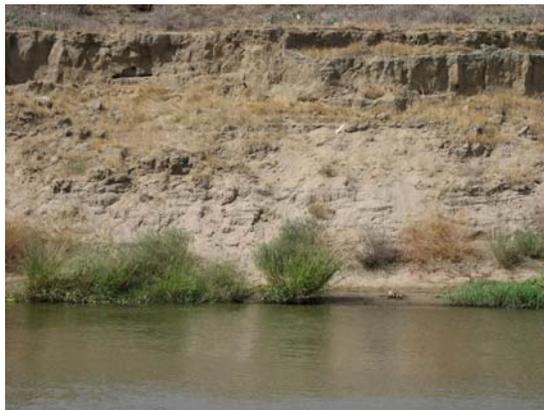
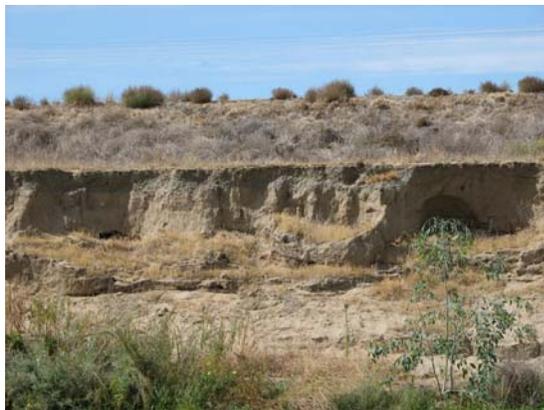
Length (ft):	<u>150</u>
Scarp Height (ft):	<u>10</u>
Location Relative to Levee:	<u>On berm</u>
Remaining Berm Width(ft):	<u>20</u>
Vegetation cover:	<u>1/3 of ground covered</u>
Burrow Holes (WS):	<u>Signs of Activity</u>
Levee Slope (H:V):	<u>3:1 or greater</u>
Soil Type:	<u>Silt (ML)</u>
Condition of surrounding tree(s)	<u>No tree(s) within affected area</u>
Crown Width (ft):	<u>16</u>
Site Relative to Bend:	<u>Outside of bend > 90 deg</u>
Radius of Curvature:	<u>5.7</u>

Most Recent:	2009: Site immediately downstream of existing rip rap; there is a 20-ft berm remaining; however, berm wil continue to erode, eventually erode into the levee profile; site # same as RM62.6,LM1.87; recommend annual assessment, per CES Evaluation 2008 Report
Previous Comments:	2006: Visited site 10/20/06

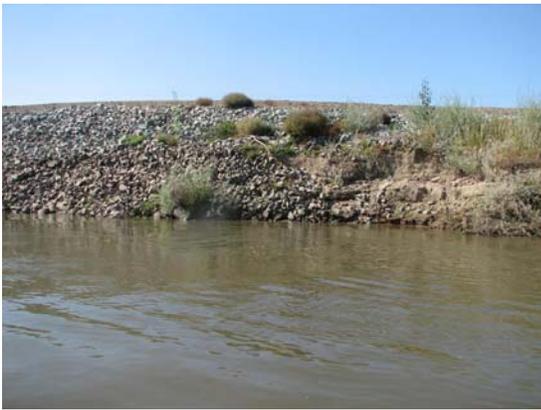
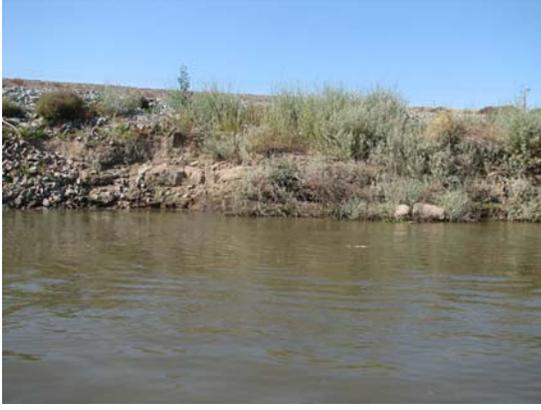
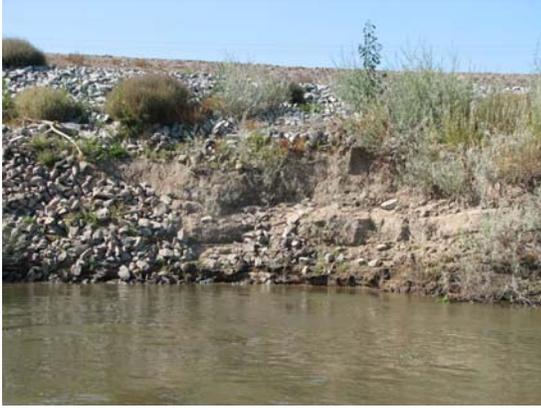
Length (ft):	<u>200</u>
Scarp Height (ft):	<u>5</u>
Location Relative to Levee:	<u>On berm</u>
Remaining Berm Width(ft):	<u>20</u>
Vegetation cover:	<u>2/3 of ground covered</u>
Burrow Holes (WS):	<u>No Activity</u>
Levee Slope (H:V):	<u>2:1</u>
Soil Type:	<u>Silt (ML)</u>
Condition of surrounding tree(s)	<u>No tree(s) within affected area</u>
Crown Width (ft):	
Site Relative to Bend:	<u>Outside of bend > 90 deg</u>
Radius of Curvature:	<u>5.7</u>

Most Recent:	2009: No major change observed; sloughing of the rip rap above toe; erosion begins immediately downstream of existing rip rap; roughly 15-ft berm remains; however, it will continue to erode and eventually intrude into the levee profile if left untreated
Previous Comments:	2006: Just upstream of where berm starts to widen

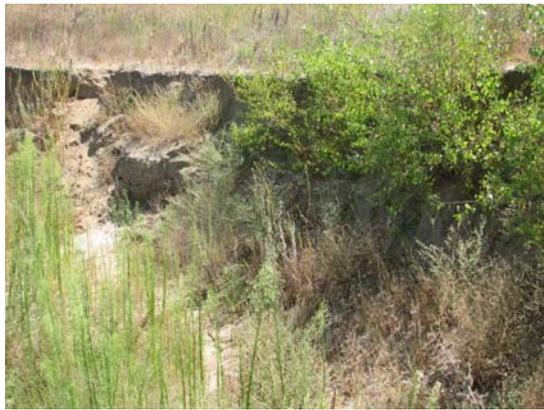
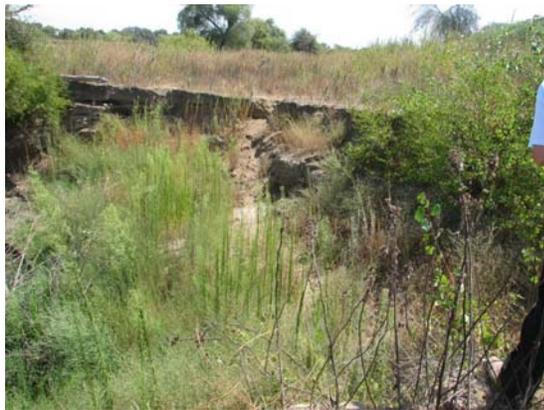
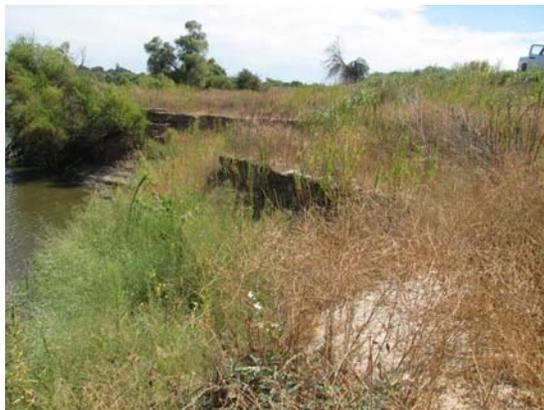
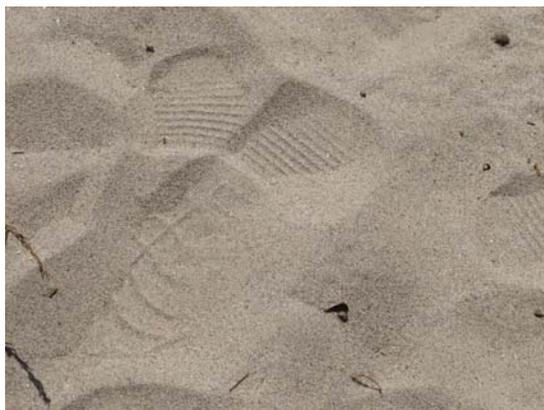
Site ID **RD2101U1RM73.92**

Length (ft):	500
Scarp Height (ft):	10
Location Relative to Levee:	Toe & beyond
Remaining Berm Width(ft):	0
Vegetation cover:	2/3 of ground covered
Burrow Holes (WS):	No Activity
Levee Slope (H:V):	2:1
Soil Type:	Sand (SP,SM and mixture)
Condition of surrounding tree(s)	No tree(s) within affected area
Crown Width (ft):	
Site Relative to Bend:	Immediately downstream of bend
Radius of Curvature:	7.9

Most Recent:	2009: recommend annual assessment and monitoring of critical erosion site, per CLRO CES Evaluation 2008 Report; an eddy has formed, eroding bank and intruding into the levee prism; site # same as RM76.3,LM1.89; previously rated "U"
Previous Comments:	2007: Recommended for short list of immediate repair sites; silty sand levee material
