**Flood Control Project Maintenance
Levee Inspections**

Maintenance Issue Types Only, Levee Inspection Report By Mile - Fall 2019

Levee District No. 0001 (Glenn County)

Waterway	Bank	Unit Miles	Inspection Start/End	Inspector
Unit No. 01 Sacramento River	Right	12.23	09/17/2019 09/17/2019	Makar Sokol

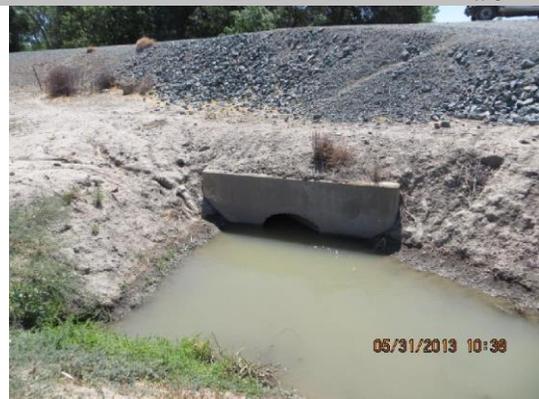
Photo 1 of 3 : UCIP_FA_2019_14559_23986.jpg

Comment Code					
Inspector Comment					
DS_ID:22922 FS_ID:14559 EP_NO: 9558 Repair Type: No Action Needed Crossing Status: Found UCIP Comments: FIELD_STRUCT_DESC: 24-inch corrugated metal drainage pipe through the levee, 11 feet below the crown. Flap gate located on the waterside (WS) end. Slide gate in 36-inch corrugated metal pipe riser unit on the WS slope. Two corrugated metal cutoff walls. Concrete headwalls on both ends. (24-inch pipe [HLM 10.08] authorized under Automatic Board Order (ABO) issued as Permit No. 9558, 1974 - Duard Geis). [Additional Reference(s): DWR Levee Log, 1992. USACE Sacramento O&M Manual 140, May 1960, (HLM 10.08)]. FS Date: 5/31/2013 8:43:01 AM

Pipe and headwall on LS toe.

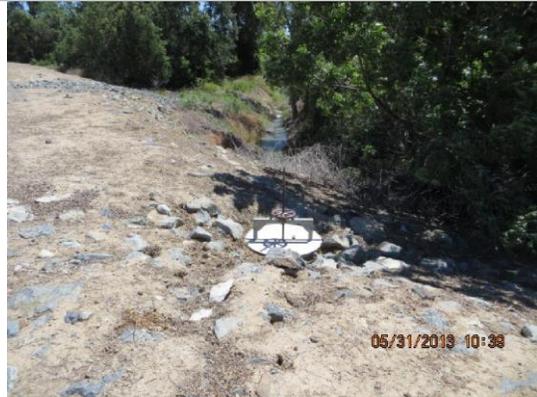
Photo 2 of 3 : UCIP_FA_2019_14559_23985.jpg

Comment Code					
Inspector Comment					
DS_ID:22922 FS_ID:14559 EP_NO: 9558 Repair Type: No Action Needed Crossing Status: Found UCIP Comments: FIELD_STRUCT_DESC: 24-inch corrugated metal drainage pipe through the levee, 11 feet below the crown. Flap gate located on the waterside (WS) end. Slide gate in 36-inch corrugated metal pipe riser unit on the WS slope. Two corrugated metal cutoff walls. Concrete headwalls on both ends. (24-inch pipe [HLM 10.08] authorized under Automatic Board Order (ABO) issued as Permit No. 9558, 1974 - Duard Geis. [Additional Reference(s): DWR Levee Log, 1992. USACE Sacramento O&M Manual 140, May 1960, (HLM 10.08)]. FS Date: 5/31/2013 8:43:01 AM

Slide gate in 36-inch CMP riser on WS slope.

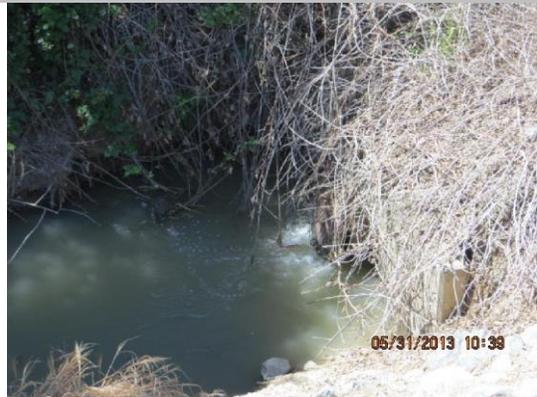
Photo 3 of 3 : UCIP_FA_2019_14559_23984.jpg

Pipe, flapgate, and headwall on WS toe.

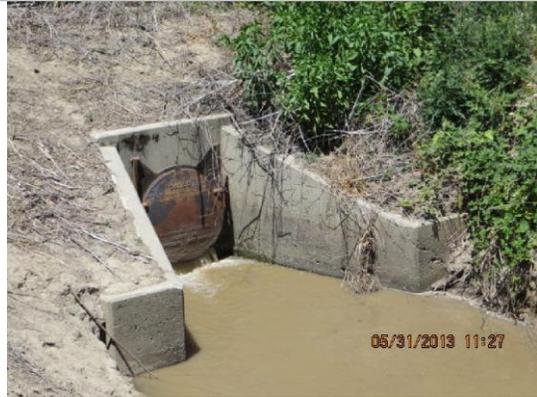
Photo 3 of 3 : UCIP_FA_2019_14565_24007.jpg

Comment Code					
Inspector Comment					
DS_ID:22925 FS_ID:14565 EP_NO: 9556 Repair Type: No Action Needed Crossing Status: Found UCIP Comments: FIELD_STRUCT_DESC: 48-inch corrugated metal drainage pipe through the levee, 11 feet below the crown. Flap gate on the waterside (WS) end. Concrete headwall on both ends. Slide gate in 60-inch diameter corrugated metal riser unit on the WS slope (48-inch pipe [HLM 11.17] authorized under Automatic Board Order (ABO) issued as Permit No. 9556, 1974 - Earl R. and Merrit R. Cooper). [Additional Reference(s): DWR Levee Log, 1992. USACE Sacramento O&M Manual 140, May 1960, (HLM 11.17)]. FS Date: 5/31/2013

Flap gate and concrete headwall on WS toe.

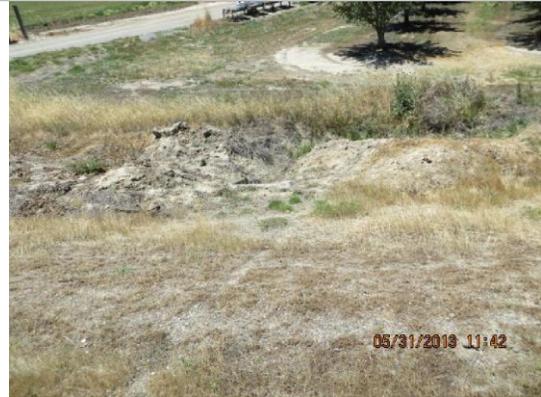
Photo 1 of 3 : UCIP_FA_2019_14566_24013.jpg

LM Start	11.64	Rating **	A/W	Issue No.	420
LM End	11.64	Issue Type +	Ma	Location *	
Category	Supplemental		GPS Latitude/Longitude		
			Start	End	
Item	DRAFT DWR UCIP LMA Responsibility		39.623874 °	39.623874 °	
			-121.999813 °	-121.999813 °	
DWR ID	22926				
Comment Code					
Inspector Comment					
DS_ID:22926 FS_ID:14566 EP_NO: 9555 Repair Type: No Action Needed Crossing Status: Found UCIP Comments: FIELD_STRUCT_DESC: 24-inch corrugated metal drainage pipe through the levee, 8.5 feet below the crown. Flap gate on the waterside (WS) slope. Concrete U-shaped headwalls on both ends. Two corrugated metal cutoff walls. (24-inch pipe [HLM 11.81] authorized under Automatic Board Order (ABO) issued as Permit No. 9555, 1974 - F. S. Reager). [Additional Reference(s): DWR Levee Log, 1992. USACE Sacramento O&M Manual 140, May 1960, (HLM 11.81)]. FS Date: 5/31/2013

Concrete headwall on LS toe.

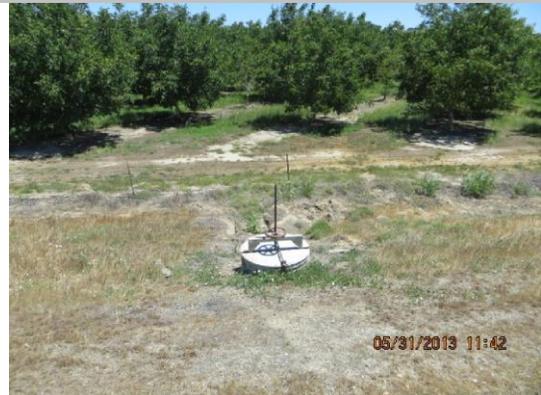
Photo 2 of 3 : UCIP_FA_2019_14566_24012.jpg

Slide gate in 36-inch CMP riser on WS slope.

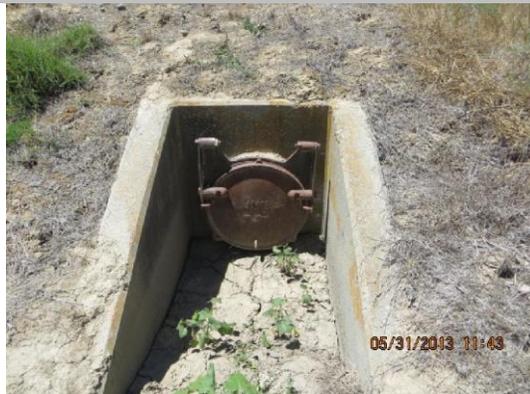
Photo 3 of 3 : UCIP_FA_2019_14566_24011.jpg

LM Start	11.64	Rating **	A/W	Issue No.	420 (cont)
LM End	11.64	Issue Type +	Ma	Location *	
Category	Supplemental			GPS Latitude/Longitude	
				Start	End
Item	DRAFT DWR UCIP LMA Responsibility			39.623874 °	39.623874 °
				-121.999813 °	-121.999813 °
DWR ID	22926				
Comment Code					
Inspector Comment					
DS_ID:22926 FS_ID:14566 EP_NO: 9555 Repair Type: No Action Needed Crossing Status: Found UCIP Comments: FIELD_STRUCT_DESC: 24-inch corrugated metal drainage pipe through the levee, 8.5 feet below the crown. Flap gate on the waterside (WS) slope. Concrete U-shaped headwalls on both ends. Two corrugated metal cutoff walls. (24-inch pipe [HLM 11.81] authorized under Automatic Board Order (ABO) issued as Permit No. 9555, 1974 - F. S. Reager). [Additional Reference(s): DWR Levee Log, 1992. USACE Sacramento O&M Manual 140, May 1960, (HLM 11.81)]. FS Date: 5/31/2013

Concrete headwall and flapgate on WS toe

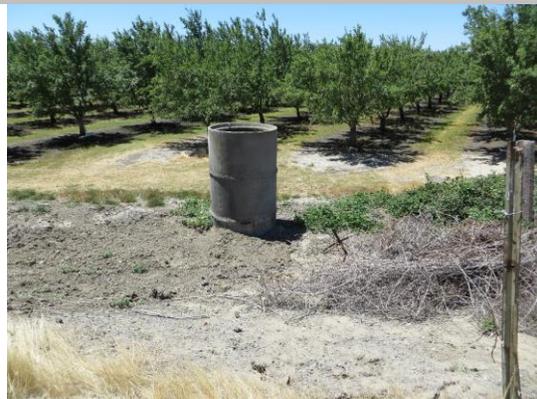
Photo 1 of 3 : UCIP_FA_2019_14567_24017.jpg

Comment Code					
Inspector Comment					
DS_ID:22927 FS_ID:14567 EP_NO: 9554 Repair Type: Non-Urgent Crossing Status: Found UCIP Comments: Erosion and sloughing on LS slope possibly due to rodent activity in area. FIELD_STRUCT_DESC: 24-inch corrugated metal drainage pipe through the levee, 11 feet below the crown. Slide gate in 36-inch corrugated metal riser unit on the waterside (WS) slope. 48-inch concrete standpipe on the landside (LS) toe. Two corrugated metal cutoff walls. (24-inch pipe [HLM 11.93] authorized under Automatic Board Order (ABO) issued as Permit No. 9554, 1974 - Thomas H. Reed). [Additional Reference(s): DWR Levee Log, 1992. USACE Sacramento O&M Manual 140, May 1960, (HLM 11.93)]. FS Date: 5/31/2013

Concrete standpipe on LS toe.

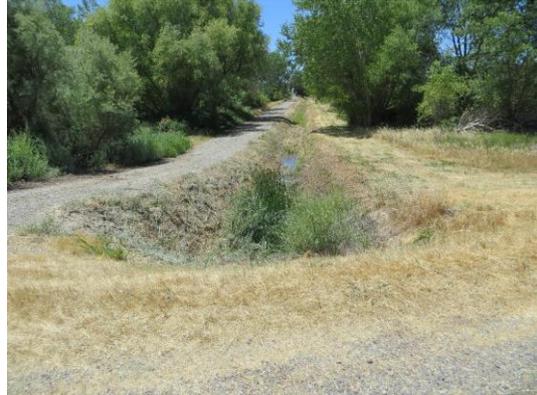
Photo 2 of 3 : UCIP_FA_2019_14569_24025.jpg

Comment Code					
Inspector Comment					
DS_ID:22928 FS_ID:14569 EP_NO: 9554 Repair Type: Non-Urgent Crossing Status: Found UCIP Comments: Flap gate heavily corroded. Good candidate for video inspection. Vegetation interfering with inlet. FIELD_STRUCT_DESC: 24-inch corrugated metal drainage pipe through the levee, 7 feet below the crown. Flap gate on the waterside (WS) end. Slide gate in 36-inch corrugated metal pipe riser unit on the WS slope. Concrete headwalls on both ends. Two corrugated metal cutoff walls. (24-inch pipe [12.04] authorized under Automatic Board Order (ABO) issued as Permit No. 9554, 1974 - Thomas H. Reed). [Additional Reference(s): DWR Levee Log, 1992. USACE Sacramento O&M Manual 140, May 1960, (HLM 12.04)]. FS Date: 5/31/2013

Drainage channel on LS toe.

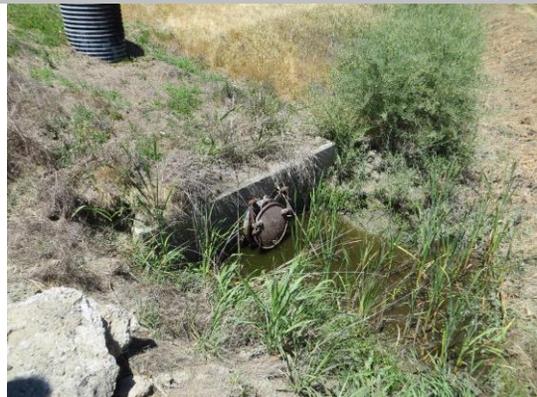
Photo 3 of 3 : UCIP_FA_2019_14569_24024.jpg

Headwall and flapgate on WS toe.

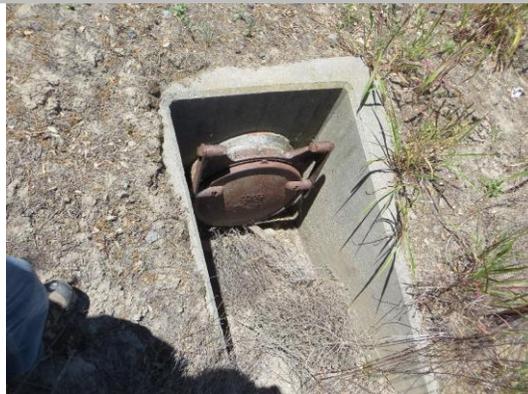
Photo 1 of 3 : UCIP_FA_2019_14570_24029.jpg

LM Start	12.13	Rating **	A/W	Issue No.	423
LM End	12.13	Issue Type +	Ma	Location *	
Category	Supplemental			GPS Latitude/Longitude	
				Start	End
Item	DRAFT DWR UCIP LMA Responsibility			39.630451°	39.630451°
				-122.002737°	-122.002737°
DWR ID	22929				
Comment Code					
Inspector Comment					
DS_ID:22929 FS_ID:14570 EP_NO: 9554 Repair Type: No Action Needed Crossing Status: Found UCIP Comments: FIELD_STRUCT_DESC: 24-inch corrugated metal drainage pipe through the levee, 7 feet below the crown. Flap gate on the waterside (WS) end. Slide gate in 36-inch corrugated metal riser unit on the WS slope. Concrete U-shaped headwalls on both ends. (24-inch pipe [HLM 12.29] authorized under Automatic Board Order (ABO) issued as Permit No. 9554, 1974 - Thomas H. Reed). [Additional Reference(s): DWR Levee Log, 1992. USACE Sacramento O&M Manual 140, May 1960, (HLM 12.29)]. FS Date: 5/31/2013

Flapgate and U-shaped concrete headwall on WS toe.

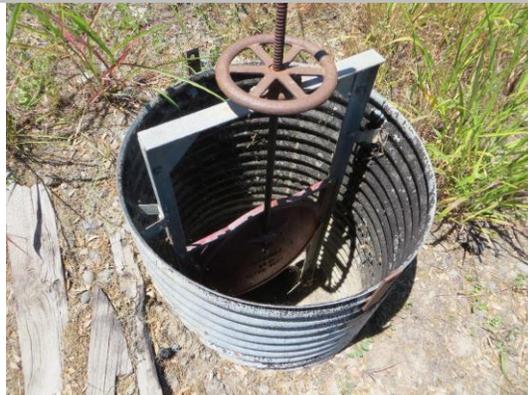
Photo 2 of 3 : UCIP_FA_2019_14570_24028.jpg

Slidegate in 36-inch CMP riser on WS slope.

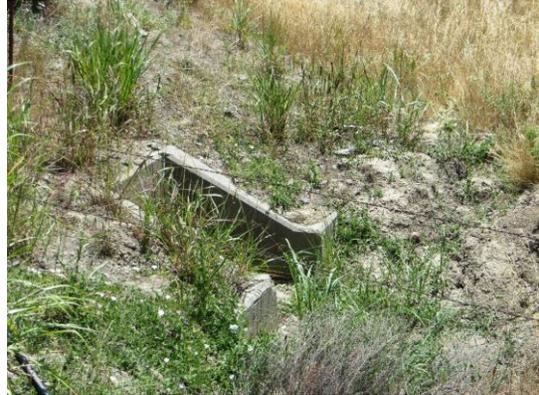
Photo 3 of 3 : UCIP_FA_2019_14570_24027.jpg

Comment Code					
Inspector Comment					
DS_ID:22929 FS_ID:14570 EP_NO: 9554 Repair Type: No Action Needed Crossing Status: Found UCIP Comments: FIELD_STRUCT_DESC: 24-inch corrugated metal drainage pipe through the levee, 7 feet below the crown. Flap gate on the waterside (WS) end. Slide gate in 36-inch corrugated metal riser unit on the WS slope. Concrete U-shaped headwalls on both ends. (24-inch pipe [HLM 12.29] authorized under Automatic Board Order (ABO) issued as Permit No. 9554, 1974 - Thomas H. Reed). [Additional Reference(s): DWR Levee Log, 1992. USACE Sacramento O&M Manual 140, May 1960, (HLM 12.29)]. FS Date: 5/31/2013

U-shaped concrete headwall on LS toe.
