**Flood Control Project Maintenance  
Levee Inspections**

**Fall 2019 Levee Maintenance Deficiency Summary Report**

**Sutter Maintenance Yard Maintenance Area 0001**

Waterway		Bank	Unit Miles	
Unit No. 01 Sacramento River		Right	16.76	
	Spring (March - May)	Summer (June - August)	(September - November) Fall	Winter (December - February)
Unit Maintenance Rating (Fall Only)			<b>A</b>	
Date of Inspection	4/17/2019 - 4/17/2019		10/15/2019 - 10/15/2019	
DWR Inspector	Makar Sokol		Makar Sokol	
Accompanied By	Bryan Reniff Sutter Maintenance Yard		Lincoln Carey Sutter Maintenance Yard

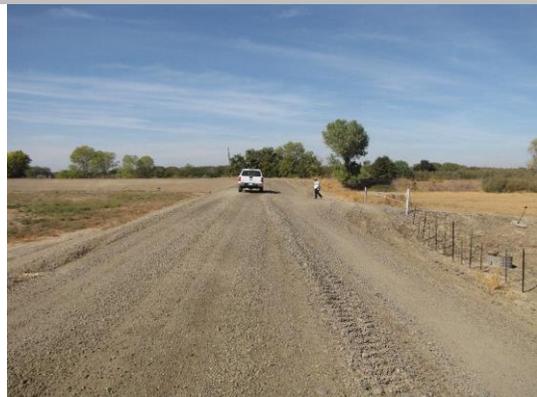
Photo 1 of 3 : UCIP\_FA\_2019\_51865\_70144.jpg

Item	DRAFT DWR UCIP Field Study			39.266435 °	39.266435 °
				-122.010943 °	-122.010943 °
DWR ID	16421				
Comment Code					
Inspector Comment					
DS_ID:16421 FS_ID:51865 EP_NO: 9475 Repair Type: Non-Urgent Crossing Status: Found UCIP Comments: 5/3/2017 Abandoned- only WS standpipe visible. (DWR Sutter Yard- AFreitag)10/24/2016 Appears to be abandoned.(DWR Sutter Yard- AFreitag)4/25/2016 Abandoned crossing. Only WS standpipe is visible.4/20/2015 Same as last inspection.6/18/2014 Same as last inspection.12/17/2013 Same as last inspection.7/18/2013 Same as last inspection.10/19/2012 Burrow activity; limited visibility of this crossing only on WS riser. This crossing was listed in the USACE Periodic Inspection as ID# USACE_CESPK_MA1C_2010_p_0207 the wheel to operate sluice gate missing. Issue addressed wheel to slide gate has been installed. FIELD_STRUCT_DESC: *ABANDONED* 30-inch corrugated metal irrigation pipe through the levee, 16.1 feet below the crown. Slide gate inside corrugated metal pipe (CMP) riser located on the waterside (WS) end. Line buried on the WS and landside (LS). (Automatic Board Order (ABO) issued as Permit No. 9475, 1974 - Mattie B. Zumwalt Co.) [Additional Reference(s): DWR Levee Log, 1992. USACE Sacramento O&M Manual 137, August 1955, (Station 247+86)]. FS Date: 5/23/2017 9:39:55 AM

Overview of levee crown looking upstream at crossing.

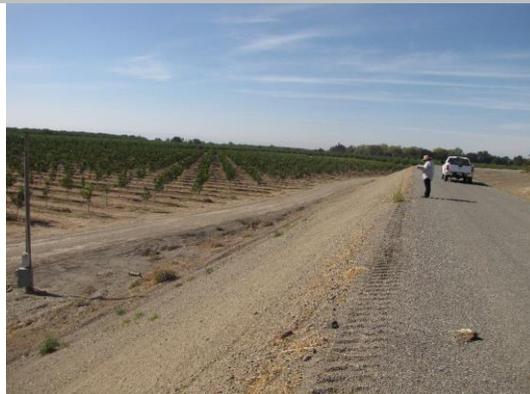
Photo 2 of 3 : UCIP\_FA\_2019\_51868\_70149.jpg

Item	DRAFT DWR UCIP Field Study			39.264924 °	39.264924 °
				-122.015887 °	-122.015887 °
DWR ID	16420				
Comment Code					
Inspector Comment					
<p>DS_ID:16420                  FS_ID:51868                  EP_NO: 4903                  Repair Type: Non-Urgent                  Crossing Status: Indicator Found                  UCIP Comments: 5/3/2017 Appears abandoned- if so needs to be done properly. (DWR Sutter Yard- AFreitag)10/24/2016 appears to be abandoned.(DWR Sutter Yard- AFreitag)4/25/2016 Appears to be an abandoned crossing.4/20/2015 Suspect that pump on LS is a well pump and has nothing to do with this crossing.6/18/2014 Same as last inspection.12/17/2013 Same as last inspection.7/18/2013 Same as last inspection.10/19/2012 Unable to locate siphon breaker, pump on LS; unable to tell if pump system is part of appurtenances. This crossing was listed in the USACE Periodic Inspection as ID# USACE_CESPK_MA1C_2010_p_0233 for utility pole and 8 inch steel riser located on landward toe.                  FIELD_STRUCT_DESC: 12-inch asphalt coated steel irrigation pipe through the levee, approximately 18-20 feet below the crown. Siphon breaker in 24-inch corrugated metal pipe (CMP) riser on the landside (LS) shoulder--not found. 3-inch electrical conduit through the levee--not found. Utility pole visible on the LS. Well station visible on the LS. No appurtenances visible on the waterside (WS). (Permit No. 4903, 4903-A, 1966 - Mattie B. Zumwalt Company, Inc.) [Additional Reference(s): DWR Levee Log, 1992].                  FS Date: 5/23/2017 9:41:40 AM</p>

View of levee crown looking upstream at crossing.

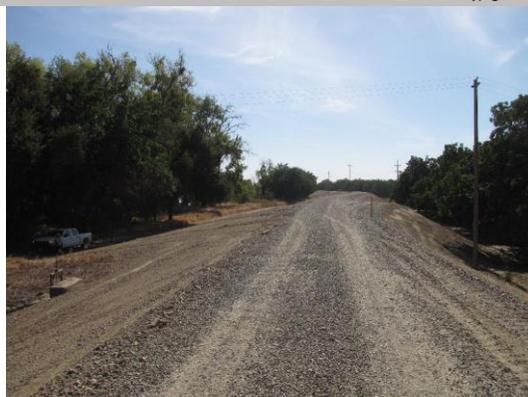
Photo 1 of 3 : UCIP\_FA\_2019\_51869\_70154.jpg

Item	DRAFT DWR UCIP Field Study			39.272069°	39.272069°
				-122.023240°	-122.023240°
DWR ID	16419				
Comment Code					
Inspector Comment					
DS_ID:16419 FS_ID:51869 EP_NO: 9476 Repair Type: Non-Urgent Crossing Status: Found UCIP Comments: 5/3/2017 Culvert has sediment build up in it- needs to be cleaned out. (DWR Sutter Yard- AFreitag)10/24/2016 LS outlets becoming over grown with vegetation in the ditch.(DWR Sutter Yard- AFreitag)4/25/2016 WS entry still blocked and wingwalls still cracked.4/20/2015 WS entry still blocked and wingwalls still cracked.6/18/2014 Same as last inspection.12/17/2013 Same as last inspection.7/18/2013 Same as last inspection.10/19/2012 blocked, no entry on WS. This crossing was listed in the USACE Periodic Inspection as ID# USACE_CESPK_MA1C_2010_p_0247 for u/s and d/s wing wall shows some cracking and tilting. FIELD_STRUCT_DESC: 1 of 2: 36-inch corrugated metal irrigation pipe and concrete box culvert through the levee at an unknown depth below the crown. Concrete headwall visible on the landside (LS) toe. (Automatic Board Order (ABO) issued as Permit No. 9476, 1974 - Ohliger) [Additional Reference(s): DWR Levee Log, 1992]. FS Date: 5/23/2017 9:51:10 AM

Overview of levee crown looking downstream at crossing.

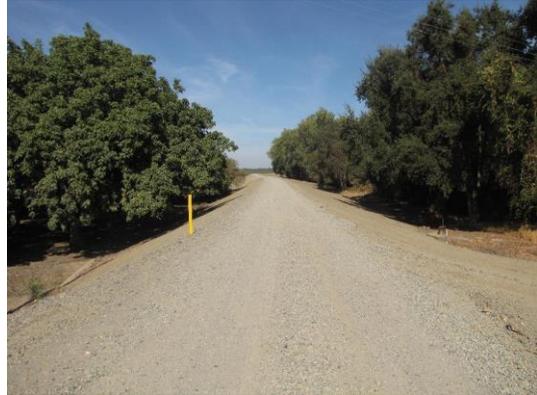
Photo 2 of 3 : UCIP\_FA\_2019\_51869\_70152.jpg

Item	DRAFT DWR UCIP Field Study			39.272069 °	39.272069 °
				-122.023240 °	-122.023240 °
DWR ID	16419				
Comment Code					
Inspector Comment					
DS_ID:16419 FS_ID:51869 EP_NO: 9476 Repair Type: Non-Urgent Crossing Status: Found UCIP Comments: 5/3/2017 Culvert has sediment build up in it- needs to be cleaned out. (DWR Sutter Yard- AFreitag)10/24/2016 LS outlets becoming over grown with vegetation in the ditch.(DWR Sutter Yard- AFreitag)4/25/2016 WS entry still blocked and wingwalls still cracked.4/20/2015 WS entry still blocked and wingwalls still cracked.6/18/2014 Same as last inspection.12/17/2013 Same as last inspection.7/18/2013 Same as last inspection.10/19/2012 blocked, no entry on WS. This crossing was listed in the USACE Periodic Inspection as ID# USACE_CESPK_MA1C_2010_p_0247 for u/s and d/s wing wall shows some cracking and tilting. FIELD_STRUCT_DESC: 1 of 2: 36-inch corrugated metal irrigation pipe and concrete box culvert through the levee at an unknown depth below the crown. Concrete headwall visible on the landside (LS) toe. (Automatic Board Order (ABO) issued as Permit No. 9476, 1974 - Ohliger) [Additional Reference(s): DWR Levee Log, 1992]. FS Date: 5/23/2017 9:51:10 AM

View of crossing looking upstream at crossing.

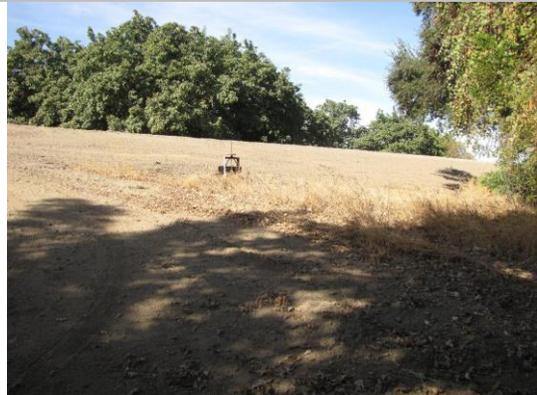
Photo 3 of 3 : UCIP\_FA\_2019\_51869\_70156.jpg

View of WS slope and access road. Slide gate is second crossing at this location.

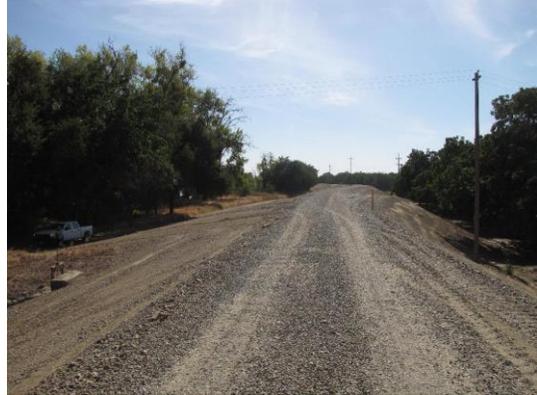
Photo 1 of 3 : UCIP\_FA\_2019\_51870\_70162.jpg

Item	DRAFT DWR UCIP Field Study			39.272069 °	39.272069 °
				-122.023240 °	-122.023240 °
DWR ID	17569				
Comment Code					
Inspector Comment					
DS_ID:17569 FS_ID:51870 EP_NO: 9476 Repair Type: Non-Urgent Crossing Status: Found UCIP Comments: 5/3/2107 Culvert has sediment build up in it- needs to be cleaned out. (DWR Sutter Yard- AFreitag)10/24/2016 LS outlets becoming overgrown with vegetation in the dtch.(DWR Sutter Yard- AFreitag)4/25/2016 WS entry still blocked and wingwalls still cracked.4/20/2015 WS entry still blocked and wingwalls still cracked.6/18/2014 Same as last inspection.12/17/2013 Same as last inspection.7/18/2013 Same as last inspection.10/19/2012 blocked, no entry on WS. This crossing was listed in the USACE Periodic Inspection as ID# USACE_CESPK_MA1C_2010_p_0247 for u/s and d/s wing wall shows some cracking and tilting. FIELD_STRUCT_DESC: 2 of 2: 36-inch corrugated metal irrigation pipe (15 feet long) and concrete box culvert through the levee at an unknown depth below the crown. Slide gate located on the waterside (WS). Concrete headwall visible on the landside (LS) toe. (Automatic Board Order (ABO) issued as Permit No. 9476-1974, Howard C. & Nadine M. Ohliger) [Additional Reference(s): DWR Levee Log, 1992]. FS Date: 5/23/2017 9:56:33 AM

View of levee crown looking downstream at crossing.

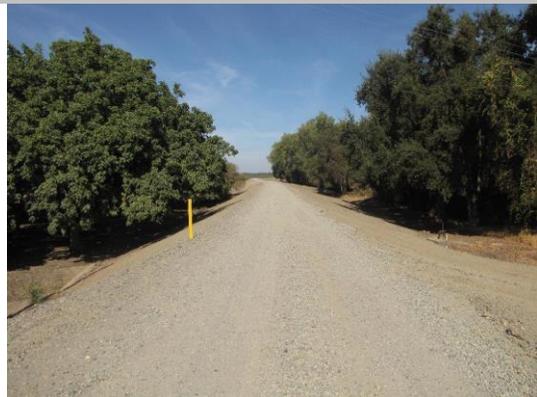
Photo 2 of 3 : UCIP\_FA\_2019\_51870\_70161.jpg

View of levee crown looking upstream at crossing.

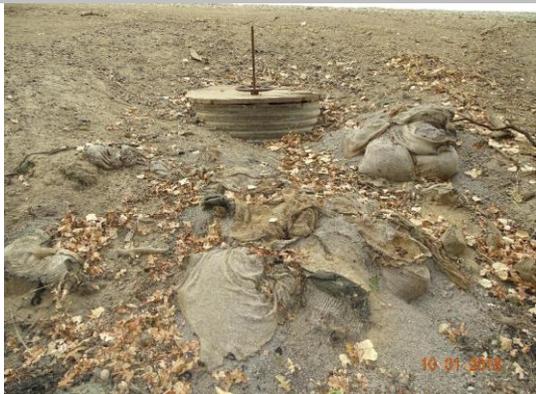
Photo 2 of 3 : UCIP\_FA\_2019\_53049\_78243.jpg

DS\_ID:16446  
 FS\_ID:53049  
 EP\_NO: N/A  
 Repair Type: Urgent  
 Crossing Status: Found  
 UCIP Comments: 10/1/2018 PVC pipe underneath the slide gate that is located inside CMP riser on WS shoulder was restored and blocks gate from closing. Sediment built up at the bottom of CMP riser. PVC pipe needs to be removed in order to properly close slide gate. (O.Yakimov - DWR UCIP)5/3/2017 Pipe leaked during the Jan/Feb 2017 high water event. Sand bags were placed at both the LS and WS outlets as well as down inside the standpipe to slow the water flow. The 5inch pvc was cut away but the slide gate could still not close fully. Suspect sediment build up was in the bottom of the stand pipe was blocking the gate. Inside of pipe should be cleaned out. (DWR Sutter Yard - AFreitag)10/24/2016 Pvc was back running through the crossing and blocking the screwgate. photo attached(DWR Sutter Yard - AFreitag)9/28/2016 Crossing has been downgraded from Urgent to Non-Urgent 5-inch PVC pipe was cut to allow the slide gate to close. Need to contact owner to remove unauthorized pipe to comply with Title 23. (DWR UCIP - omagana)4/25/2016 5 inch pvc pipe running through crossing has been cut out to allow the slide gate to close. (DWR Sutter Yard - afreitag)4/20/2015 5inch pvc is still present blocking slide gate from closing. WS end of pipe has been exposed so there is no way to stop water from flowing through pipe during highwater times. (DWR Sutter Yard - afreitag)6/23/2014 Same as last inspection. There is no way to stop water from flowing though pipe during high water times. (DWR Sutter Yard - afreitag)12/17/2013 Same as last inspection. (DWR Sutter Yard - afreitag)7/18/2013 Same as last inspection. (DWR Sutter Yard - afreitag)10/19/2012 Unauthorized 5 inch PVC pipe running through 36 inch crossing. 5 inch PVC crossing prevents slide gate from closing during high water. Debris and sediment inside riser. This crossing was listed in the USACE Periodic Inspection as ID# USACE\_CESPK\_MA1C\_2010\_p\_0258 for 5 inch PVC pipe running through culvert. (DWR UCIP - omagana) FIELD\_STRUCT\_DESC: 36-inch steel (not corrugated metal, as referenced in O&M manual) drainage pipe through the levee, approximately 14-16 feet below levee crown. Slide gate in corrugated metal pipe (CMP) riser on the waterside (WS) slope. Pipe also visible on the landside (LS). [Additional Reference(s): DWR Levee Log, 1992. USACE Sacramento O&M Manual 137, August 1955, (Station 331+31)]. FS Date: 10/1/2018 2:59:44 PM

View of CMP riser at WS shoulder.

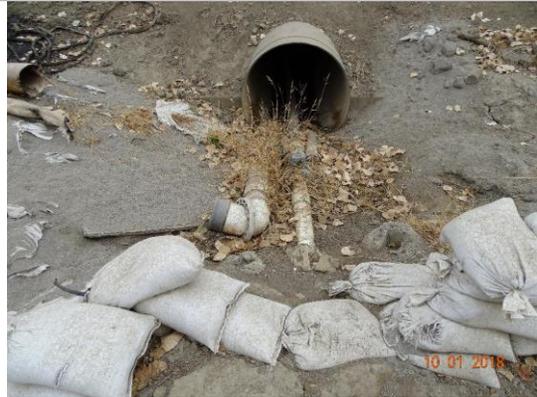
Photo 3 of 3 : UCIP\_FA\_2019\_53049\_78244.jpg

DS\_ID:16446  
 FS\_ID:53049  
 EP\_NO: N/A  
 Repair Type: Urgent  
 Crossing Status: Found  
 UCIP Comments: 10/1/2018 PVC pipe underneath the slide gate that is located inside CMP riser on WS shoulder was restored and blocks gate from closing. Sediment built up at the bottom of CMP riser. PVC pipe needs to be removed in order to properly close slide gate. (O.Yakimov - DWR UCIP)5/3/2017 Pipe leaked during the Jan/Feb 2017 high water event. Sand bags were placed at both the LS and WS outlets as well as down inside the standpipe to slow the water flow. The 5inch pvc was cut away but the slide gate could still not close fully. Suspect sediment build up was in the bottom of the stand pipe was blocking the gate. Inside of pipe should be cleaned out. (DWR Sutter Yard - AFreitag)10/24/2016 Pvc was back running through the crossing and blocking the screwgate. photo attached(DWR Sutter Yard - AFreitag)9/28/2016 Crossing has been downgraded from Urgent to Non-Urgent 5-inch PVC pipe was cut to allow the slide gate to close. Need to contact owner to remove unauthorized pipe to comply with Title 23. (DWR UCIP - omagana)4/25/2016 5 inch pvc pipe running through crossing has been cut out to allow the slide gate to close. (DWR Sutter Yard - afreitag)4/20/2015 5inch pvc is still present blocking slide gate from closing. WS end of pipe has been exposed so there is no way to stop water from flowing through pipe during highwater times. (DWR Sutter Yard - afreitag)6/23/2014 Same as last inspection. There is no way to stop water from flowing though pipe during high water times. (DWR Sutter Yard - afreitag)12/17/2013 Same as last inspection. (DWR Sutter Yard - afreitag)7/18/2013 Same as last inspection. (DWR Sutter Yard - afreitag)10/19/2012 Unauthorized 5 inch PVC pipe running through 36 inch crossing. 5 inch PVC crossing prevents slide gate from closing during high water. Debris and sediment inside riser. This crossing was listed in the USACE Periodic Inspection as ID# USACE\_CESPK\_MA1C\_2010\_p\_0258 for 5 inch PVC pipe running through culvert. (DWR UCIP - omagana) FIELD\_STRUCT\_DESC: 36-inch steel (not corrugated metal, as referenced in O&M manual) drainage pipe through the levee, approximately 14-16 feet below levee crown. Slide gate in corrugated metal pipe (CMP) riser on the waterside (WS) slope. Pipe also visible on the landside (LS). [Additional Reference(s): DWR Levee Log, 1992. USACE Sacramento O&M Manual 137, August 1955, (Station 331+31)]. FS Date: 10/1/2018 2:59:44 PM

Pipe at LS toe.

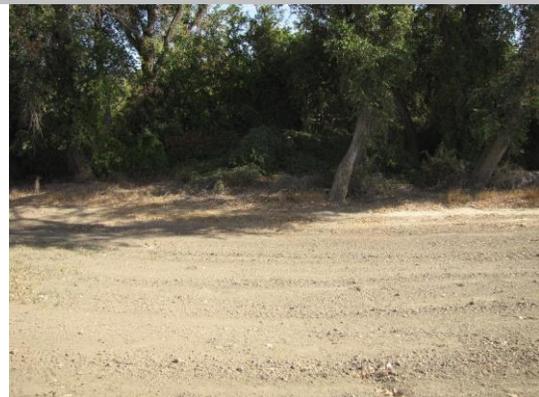
Photo 1 of 3 : UCIP\_FA\_2019\_51874\_70181.jpg

Item	DRAFT DWR UCIP LMA Responsibility			39.281721 °	39.281721 °
				-122.021894 °	-122.021894 °
DWR ID	16425				
Comment Code					
Inspector Comment					
DS_ID:16425 FS_ID:51874 EP_NO: N/A Repair Type: Non-Urgent Crossing Status: Found UCIP Comments: 5/3/2017 Abandoned- needs to be done properly. (DWR Sutter Yard- AFreitag)10/24/2016 Abandoned(DWR Sutter Yard- AFreitag)4/25/2016 Abandoned crossing.4/20/2015 Same as last inspection.6/23/2014 Same as last inspection.12/17/2013 Same as last inspection.7/18/2013 Same as last inspection.10/19/2012 Need to be properly abandoned concrete structure; plate covers concrete box; Concrete headwall damaged. This crossing was listed in the USACE Periodic Inspection as ID# USACE_CESPK_MA1C_2010_p_0262 for damage to concrete structure (vertical 2 inch wide cracks and spalling visible). FIELD_STRUCT_DESC: *ABANDONED* 72-inch corrugated metal (precast concrete) drainage pipe through the levee at an unknown depth below the crown. Structure is blocked on the waterside (WS) end with 3-foot concrete plug installed in 1980. Slide gate in concrete well on the landside (LS) shoulder. Concrete headwall at both toes. WS headwall not found. [Additional Reference(s): DWR Levee Log, 1992. USACE Sacramento O&M Manual 137, August 1955, (Station 339+74)]. FS Date: 5/23/2017 10:13:24 AM

View of WS no structure features visible.

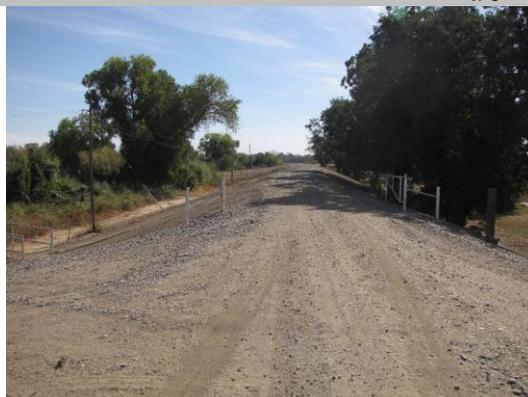
Photo 1 of 3 : UCIP\_FA\_2019\_51875\_70188.jpg

Item	DRAFT DWR UCIP Field Study			39.290147 °	39.290147 °
				-122.021525 °	-122.021525 °
DWR ID	16427				
Comment Code					
Inspector Comment					
DS_ID:16427 FS_ID:51875 EP_NO: 9482 Repair Type: Non-Urgent Crossing Status: Found UCIP Comments: 5/3/2017 Abandoned- Needs to be done properly. (DWR Sutter Yard- AFreitag)10/24/2016 Abandoned.(DWR Sutter Yard- AFreitag)4/25/2016 Abandoned pipe. Needs to be properly plugged if it never gets used.4/20/2015 Same as last inspection. Structure is still buried.6/23/2014 Same as last inspection.12/17/2013 Same as last inspection.7/18/2013 Same as last inspection.10/19/2012 Structure is buried and non-operational. This crossing was listed in the USACE Periodic Inspection as ID# USACE_CESPK_MA1C_2010_p_0288 for sluice gate closed and backfilled on WS and full of sediment with wingwall cracked on LS. FIELD_STRUCT_DESC: *ABANDONED* 1 of 2: 36-inch reinforced concrete irrigation pipe through the levee at approximately 18 feet below the crown. Wooden slide gates on the waterside (WS) end. Sliding metal gate noted in O&M manual. Concrete headwalls located on both WS and landside (LS). O&M manual structure reference is 4'-9" x 9'-6" concrete box culvert. (Automatic Board Order (ABO) issued as Permit No. 9482, 1974 - Elizabeth M. Farnsworth) [Additional Reference(s): DWR Levee Log, 1992. USACE Sacramento O&M Manual 137, August 1955, (Station 370+90)]. FS Date: 5/23/2017 10:14:12 AM

Overview of levee crown looking downstream at crossing.

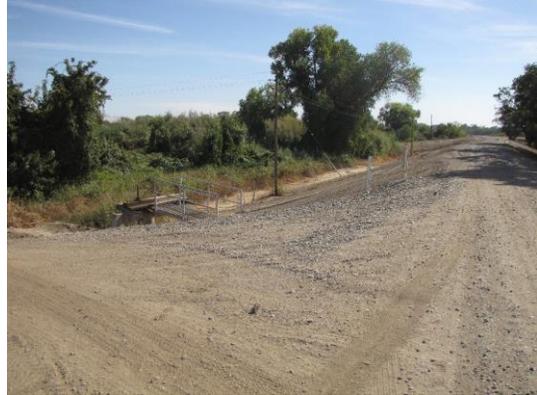
Photo 2 of 3 : UCIP\_FA\_2019\_51875\_70187.jpg

Item	DRAFT DWR UCIP Field Study			39.290147°	39.290147°
				-122.021525°	-122.021525°
DWR ID	16427				
Comment Code					
Inspector Comment					
<p>DS_ID:16427                  FS_ID:51875                  EP_NO: 9482                  Repair Type: Non-Urgent                  Crossing Status: Found                  UCIP Comments: 5/3/2017 Abandoned- Needs to be done properly. (DWR Sutter Yard- AFreitag)10/24/2016 Abandoned.(DWR Sutter Yard- AFreitag)4/25/2016 Abandoned pipe. Needs to be properly plugged if it never gets used.4/20/2015 Same as last inspection. Structure is still buried.6/23/2014 Same as last inspection.12/17/2013 Same as last inspection.7/18/2013 Same as last inspection.10/19/2012 Structure is buried and non-operational. This crossing was listed in the USACE Periodic Inspection as ID# USACE_CESPK_MA1C_2010_p_0288 for sluice gate closed and backfilled on WS and full of sediment with wingwall cracked on LS. FIELD_STRUCT_DESC: *ABANDONED* 1 of 2: 36-inch reinforced concrete irrigation pipe through the levee at approximately 18 feet below the crown. Wooden slide gates on the waterside (WS) end. Sliding metal gate noted in O&amp;M manual. Concrete headwalls located on both WS and landside (LS). O&amp;M manual structure reference is 4'-9" x 9'-6" concrete box culvert. (Automatic Board Order (ABO) issued as Permit No. 9482, 1974 - Elizabeth M. Farnsworth) [Additional Reference(s): DWR Levee Log, 1992. USACE Sacramento O&amp;M Manual 137, August 1955, (Station 370+90)].                  FS Date: 5/23/2017 10:14:12 AM</p>

WS-walkway and concrete headwall.

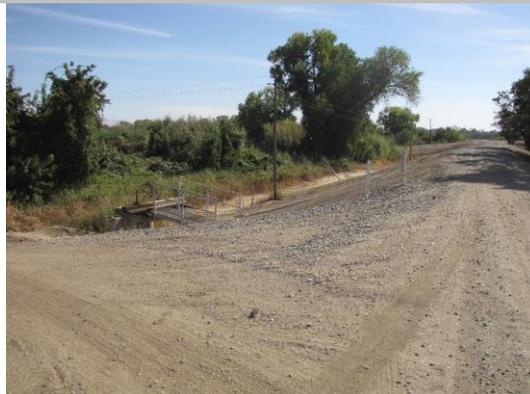
Photo 2 of 3 : UCIP\_FA\_2019\_51876\_70193.jpg

Item	DRAFT DWR UCIP Field Study			39.290169°	39.290169°
				-122.021532°	-122.021532°
DWR ID	17570				
Comment Code					
Inspector Comment					
<p>DS_ID:17570                  FS_ID:51876                  EP_NO: 9482                  Repair Type: Non-Urgent                  Crossing Status: Found                  UCIP Comments: 5/3/2017 WS slide gate was unburied and crossing was being used for irrigaton during site visit.(DWR Sutter Yard- AFreitag)10/24/2016 WS slide gate was unbruied and opened.(DWR Sutter Yard- AFreitag)4/25/2016 WS slide gate was unburied and opened allowing water to flow through to LS fields.4/20/2015 Structure is operational. WS slide gate was unburied allowing water to irrigate the fields. It gets reburied during highwater season.</p> <p>6/23/2014 Same as last inspection. Soli dug out again and water flowing through crossing.12/17/2013 WS screw gate was closed and buried by soil again.7/18/2013 WS screw gate has been cleared of dirt and is open to irrigate LS fields. LS outlet is still mostly blocked by sediment.10/19/2012 Structure is buried and non-operational. This crossing was listed in the USACE Periodic Inspection as ID# USACE_CESPK_MA1C_2010_p_0288 for sluice gate closed and backfilled on WS and full of sediment with wingwall cracked on LS. FIELD_STRUCT_DESC: 2 of 2: 36-inch reinforced concrete irrigation pipe through the levee, approximately 18 feet below the crown. Wooden slide gates on the waterside (WS) end. Sliding metal gate noted in O&amp;M manual. Concrete structure located on both WS and landside (LS). Inspector noticed that during 2015-2016 that this crossing is used in the spring and summer, and buried in the winter. O&amp;M manual structure reference is 4'-9" x 9'-6" concrete box culvert. (Automatic Board Order (ABO) issued as Permit No. 9482-1974, Elizabeth M. Farnsworth [Additional Reference(s): DWR Levee Log, 1992. USACE Sacramento O&amp;M Manual 137, August 1955, (Station 370+90)].                  FS Date: 5/23/2017 10:15:43 AM</p>

WS-walkway and concrete headwall.

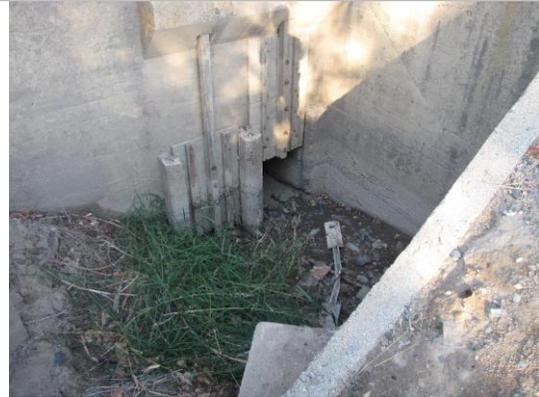
Photo 3 of 3 : UCIP\_FA\_2019\_51877\_70203.jpg

Item	DRAFT DWR UCIP Field Study			39.294074 °	39.294074 °
				-122.021435 °	-122.021435 °
DWR ID	16456				
Comment Code					
Inspector Comment					
<p>DS_ID:16456                  FS_ID:51877                  EP_NO: N/A                  Repair Type: Non-Urgent                  Crossing Status: Found                  UCIP Comments: 5/3/2017 Culvert was flowing water during site visit. Appears to be in good condition. Some sediment build up in the bottom of WS box. (DWR Sutter Yard- AFreitag)10/24/2016 Notes mentioned needing to confirm size of the culvert but was unable to access the ends at this inspection.(DWR Sutter Yard- AFreitag)4/25/2016 Second slide gate was held open to allow water to flow through to the LS ditch.4/20/2015 Same as last inspection. Rebar pin was still inplace holding the gate opened.6/23/2014 Same as last inspection.12/17/2013 Same as last inspection.7/18/2013 Same as last inspection.10/30/2012 Sediment and debris on waterward and landward side. This crossing was listed in the USACE Periodic Inspection as ID# USACE_CESPK_MA1C_2010_p_0293 for wooden slide gate held open by a piece of rebar acting as a pin.                  FIELD_STRUCT_DESC: 60-inches by 72-inches (5-foot by 6-foot) reinforced concrete box irrigation culvert (O&amp;M manual references 3-foot and 10-inch by 6-foot culvert) through the levee, approximately 12-15 feet below the crown. Two wooden slide gates on the waterside (WS) end. Concrete v-ditch along landside (LS) toe. [Additional Reference(s): DWR Levee Log, 1992. USACE Sacramento O&amp;M Manual 137, August 1955, (Station 385+33.5)].                  FS Date: 5/23/2017 10:27:11 AM</p>

View of wooden sluice gates located on WS.

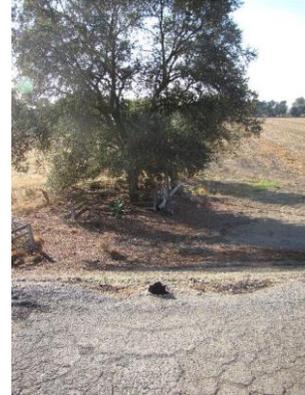
Photo 3 of 3 : UCIP\_FA\_2019\_51878\_70211.jpg

Item	DRAFT DWR UCIP Field Study			39.297384 °	39.297384 °
				-122.022989 °	-122.022989 °
DWR ID	16455				
Comment Code					
Inspector Comment					
<p>DS_ID:16455                  FS_ID:51878                  EP_NO: 12334                  Repair Type: Non-Urgent                  Crossing Status: Found                  UCIP Comments: 5/3/2017 No LS inlet found and no pump on WS- appears to have been abandoned. If so needs to be done properly. (DWR Sutter Yard- AFreitag)10/24/2016 Pump removed from WS pipe. Pipe end left open and should be capped.(DWR Sutter Yard- AFreitag)4/25/2016 No LS inlet found4/20/2015 Same as last inspection.6/23/2014 Same as last inspection.12/17/2013 Same as last inspection.7/18/2013 Same as last inspection.10/30/2012 Siphon breaker housing unit is bent and has debris inside. LS outlet not found.                  FIELD_STRUCT_DESC: 10-inch asphalt coated steel irrigation pipe through the levee, 3 feet below the crown. Centrifugal pump on the waterside (WS) bank. Siphon breaker on the landside (LS) shoulder of the levee. (Permit No. 12334, 1978 - Jean James) [Additional Reference(s): DWR Levee Log, 1992].                  FS Date: 5/23/2017 10:29:58 AM</p>

View of LS with appurtances present on levee shoulder.

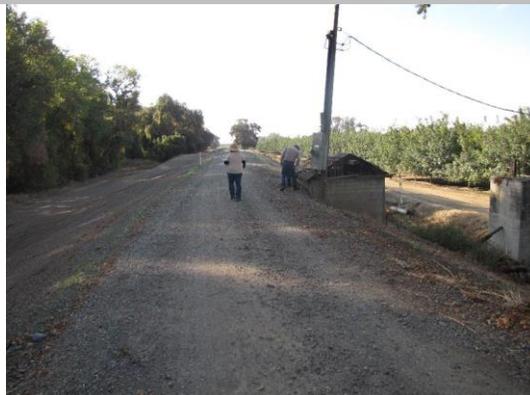
Photo 1 of 3 : UCIP\_FA\_2019\_51879\_70219.jpg

Item	DRAFT DWR UCIP Field Study			39.311103 °	39.311103 °
				-122.030541 °	-122.030541 °
DWR ID	16454				
Comment Code					
Inspector Comment					
<p>DS_ID:16454                      FS_ID:51879                      EP_NO: 9466                      Repair Type: Non-Urgent                      Crossing Status: Found                      UCIP Comments: 5/3/2017 Abandoned- needs to be done properly.                      (DWR Sutter Yard- AFreitag)10/24/2016 Abandoned.(DWR Sutter Yard- AFreitag)4/25/2016 Crossing appears to be abandoned. Power lines cut from the panels inside the concrete structure on LS.4/20/2015 Same as last inspection.6/23/2014 Same as last inspection.12/17/2013 Same as last inspection.7/18/2013 Same as last inspection.10/30/2012 No access to inspect slide gate on LS. Roof of pumping house deteriorating and debris scattered on LS. WS crossing not found. This crossing was listed in the USACE Periodic Inspection as ID# USACE_CESPK_MA1C_2010_p_345 no issues recorded.                      FIELD_STRUCT_DESC: *ABANDONED* 24-inch steel irrigation pipe through the levee, approximately 8-10 feet below the crown. Slide gate in concrete riser on the landside (LS) slope. Pump house encroaches into the LS slope. Two service poles on the LS shoulder. No visible appurtenances found on the waterside (WS) toe. Power source cut on the LS. (Automatic Board Order (ABO) issued as Permit No. 9466, 1974 - Roman Catholic Bishop of Sacramento). [Additional Reference(s): DWR Levee Log, 1992].                      FS Date: 5/23/2017 10:31:07 AM</p>

Overview of levee crown looking downstream at crossing.

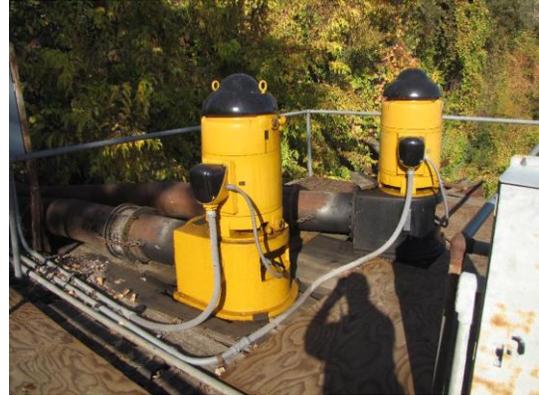
Photo 2 of 3 : UCIP\_FA\_2019\_53050\_70239.jpg

Item	DRAFT DWR UCIP Field Study			39.329750 °	39.329750 °
				-122.029602 °	-122.029602 °
DWR ID	16452				
Comment Code					
Inspector Comment					
<p>DS_ID:16452                  FS_ID:53050                  EP_NO: 1800                  Repair Type: Non-Urgent                  Crossing Status: Found                  UCIP Comments: 10/1/2018 Runoff erosion near pipe on WS is present. Pipe is in good condition. Need to verify new permit for the pipe. (O.Yakimov - DWR UCIP)5/3/2017 Rain run off erosion still present near pipe on WS shoulder. (DWR Sutter Yard- AFreitag)10/24/2016 Ws erosion still present. Looks to be just from rain run off.(DWR Sutter Yard- AFreitag)4/25/2016 Erosion still present by the WS pipes. (DWR Sutter Yard - afreitag)4/20/2015 Erosion happening near WS shoulder where the pipes enter the levee. May just be caused by rain runoff. (DWR Sutter Yard - afreitag)6/23/2014 Same as last inspection. (DWR Sutter Yard - afreitag)12/17/2013 Same as last inspection. (DWR Sutter Yard - afreitag)7/18/2013 Same as last inspection. (DWR Sutter Yard - afreitag)10/30/2012 This crossing has been completely modified-- need recent permit issued to allow work on levee and levee toe. Was levee compacted to CVFPB standards? This crossing was listed in the USACE Periodic Inspection as ID# USACE_CESPK_MA1C_2010_p_0371 unable to determine why this crossing was assigned "U". (DWR UCIP - omagana)                  FIELD_STRUCT_DESC: 1 of 2: 14-inch steel irrigation pipe through the levee, approximately 3-4 feet below the crown. Siphon breakers on the waterside (WS) end. (Permit No. 1800, 1959 - Jimeno Rancho) New pipe visible on the landside (LS). [Additional Reference(s): DWR Levee Log, 1992].                  FS Date: 10/1/2018 3:15:38 PM</p>

Pumps corresponding to 2-14 inch pipes.

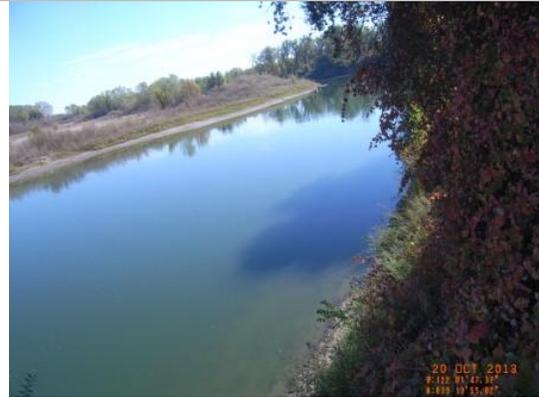
Photo 1 of 1 : FA\_2019\_MA0001\_297\_6\_20190822\_00003.jpg

LM Start	<b>10.32</b>	Rating **	A/W	Issue No.	<b>6</b>
LM End	<b>10.41</b>	Issue Type +	Ma	Location *	WS
Category	Supplemental		GPS Latitude/Longitude		
			Start	End	
Item	2017 USACE Erosion Survey		39.331447°	39.332716°	
			-122.029440°	-122.029953°	
DWR ID	DWR_ST0003_01_f_2018_1				
Comment Code					
Inspector Comment					
2017 Site ID: SAC 157.7 R Status: Eroding 2017 Field Notes: Vertical face of clay sand bank, new tree popout. Bank continues to erode. Site History: 2004 - Slowly eroding but near vertical with no vegetation to hold it. 2005 - Erosion is close to levee toe but not into the levee section yet. 2010 - Some new toe scour.

USACE 2013 Photo #1

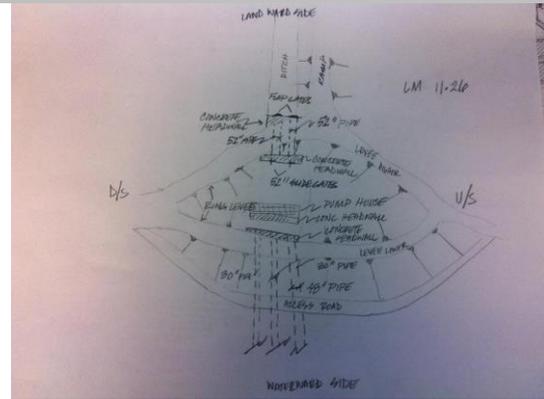
Photo 1 of 3 : UCIP\_FA\_2019\_53053\_70267.jpg

DS\_ID:16449  
 FS\_ID:53053  
 EP\_NO: 187  
 Repair Type: Non-Urgent  
 Crossing Status: Found  
 UCIP Comments: 10/1/2018 Pipe closed by steel plate at LS end. Plate is bolted to concrete headwall. CVFPB is working with owner to address issue. (O.Yakimov - DWR UCIP)5/3/2017 No changes have been made to this crossing since the NOV was sent out in January 2017. (DWR Sutter Yard- AFreitag)01/31/2017 Informal Notice of Violation (NOV) was sent out January 31, 2017 by DWR Flood Maintenance Office--owner will need to coordinate with CVFPB to remove, replace, or abandon pipe in-place. Owner has until Monday February 27th, 2017 to report to DWR contact: Bryan Reniff. (refer to Official Notice for details). (DWR UCIP - O. Magana)10/24/2016 Appears abandoned. Slide gate needs to be dug out and fully closed to prevent water flow during high water.(DWR Sutter Yard- AFreitag)4/25/2016 Crossing appears to be abandoned.4/21/2015 Same as last inspection.6/23/2014 Same as last inspection.12/17/2013 Same as last inspection.7/18/2013 Same as last inspection.10/30/2012 Need to determine if structure is still in use--contact owner. If abandoned structure--structure needs to be properly abandoned. This crossing was listed in the USACE Periodic Inspections as ID# USACE\_CESPK\_MA1C\_2010\_p\_0393 missing gate.

FIELD\_STRUCT\_DESC: 1 of 2: 52-inch corrugated metal irrigation pipe, 48-inch measured, through the levee, approximately 15 feet below the crown. Slide gate on the waterside (WS) and flap gate on the landside (LS). Concrete headwalls at both WS and LS. This structure is associated with another abandoned structure located on the WS. Abandoned structure includes pump house, multiple concrete walls, and 3 additional crossings (two 30-inch pipes and one 48-inch pipe). (Original structure installed under Permit No. 187, 1921 - Compton-Delevan Irrigation District-Maxwell I.D., new pump and platform installed and old pump house removed under Permit No. 9183-1973, Maxwell Irrigation District) [Additional Reference(s): DWR Levee Log, 1992].  
 FS Date: 10/1/2018 3:42:41 PM

Sketch of structure located at levee mile 11.26.

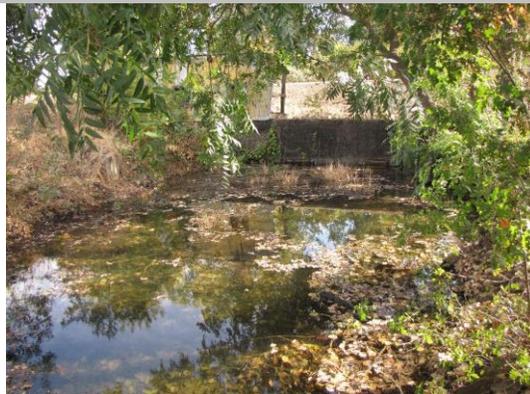
Photo 3 of 3 : UCIP\_FA\_2019\_53053\_70260.jpg

Item	DRAFT DWR UCIP Field Study			39.340867°	39.340867°
				-122.032932°	-122.032932°
DWR ID	16449				
Comment Code					
Inspector Comment					
<p>DS_ID:16449                  FS_ID:53053                  EP_NO: 187                  Repair Type: Non-Urgent                  Crossing Status: Found                  UCIP Comments: 10/1/2018 Pipe closed by steel plate at LS end. Plate is bolted to concrete headwall. CVFPB is working with owner to address issue. (O.Yakimov - DWR UCIP)5/3/2017 No changes have been made to this crossing since the NOV was sent out in January 2017. (DWR Sutter Yard- AFreitag)01/31/2017 Informal Notice of Violation (NOV) was sent out January 31, 2017 by DWR Flood Maintenance Office--owner will need to coordinate with CVFPB to remove, replace, or abandon pipe in-place. Owner has until Monday February 27th, 2017 to report to DWR contact: Bryan Reniff. (refer to Official Notice for details). (DWR UCIP - O. Magana)10/24/2016 Appears abandoned. Slide gate needs to be dug out and fully closed to prevent water flow during high water.(DWR Sutter Yard- AFreitag)4/25/2016 Crossing appears to be abandoned.4/21/2015 Same as last inspection.6/23/2014 Same as last inspection.12/17/2013 Same as last inspection.7/18/2013 Same as last inspection.10/30/2012 Need to determine if structure is still in use--contact owner. If abandoned structure--structure needs to be properly abandoned. This crossing was listed in the USACE Periodic Inspections as ID# USACE_CESPK_MA1C_2010_p_0393 missing gate. FIELD_STRUCT_DESC: 1 of 2: 52-inch corrugated metal irrigation pipe, 48-inch measured, through the levee, approximately 15 feet below the crown. Slide gate on the waterside (WS) and flap gate on the landside (LS). Concrete headwalls at both WS and LS. This structure is associated with another abandoned structure located on the WS. Abandoned structure includes pump house, multiple concrete walls, and 3 additional crossings (two 30-inch pipes and one 48-inch pipe). (Original structure installed under Permit No. 187, 1921 - Compton-Delevan Irrigation District-Maxwell I.D., new pump and platform installed and old pump house removed under Permit No. 9183-1973, Maxwell Irrigation District) [Additional Reference(s): DWR Levee Log, 1992]. FS Date: 10/1/2018 3:42:41 PM</p>

Drain channel inside ring levee.

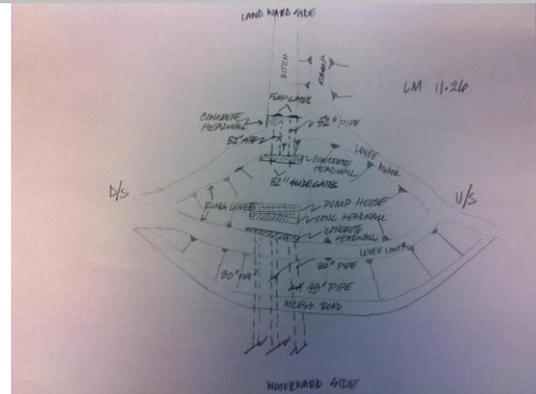
Photo 1 of 3 : UCIP\_FA\_2019\_53052\_70272.jpg

DS\_ID:17572  
 FS\_ID:53052  
 EP\_NO: 187  
 Repair Type: Urgent  
 Crossing Status: Found  
 UCIP Comments: 10/1/2018 Pipe closed by steel plate at LS end. Plate is bolted to concrete headwall. CVFPB is working with owner to address issue. Crossing remains "Urgent" because of missing slide gate on WS. (O.Yakimov - DWR UCIP)5/3/2017 No changes have been made at this crossing since the NOV was sent out in January 2017. (DWR Sutter Yard- AFreitag)01/31/2017 Informal Notice of Violation (NOV) was sent out January 31, 2017 by DWR Flood Maintenance Office--owner will need to coordinate with CVFPB to remove, replace, or abandon pipe in-place. Owner has until Monday February 27th, 2017 to respond to DWR contact: Bryan Reniff. (refer to Official Notice for details). (DWR UCIP - O. Magana)10/24/2016 Appears abandoned. Slide gate needs to be replaced or pipe end capped to prevent water flow during high water. (DWR Sutter Yard- AFreitag)4/25/2016 Crossing appears to be abandoned. Slide gate needs to be replaced or pipe needs to be plugged to prevent water flow during high water season. (DWR Sutter Yard - afreitag)4/21/2015 Same as last inspection. (DWR Sutter Yard - afreitag)6/23/2014 Same as last inspection. (DWR Sutter Yard - afreitag)12/17/2013 Same as last inspection. (DWR Sutter Yard - afreitag)7/18/2013 Same as last inspection. (DWR Sutter Yard - afreitag)10/30/2012 Missing positive closure device. Need to determine if structure is still in use--contact owner. If abandoned structure--structure needs to be abandoned properly. This crossing was listed in the USACE Periodic Inspections as ID# USACE\_CESPK\_MA1C\_2010\_p\_0393 missing gate. (DWR UCIP - omagana)

FIELD\_STRUCT\_DESC: 2 of 2: 52-inch corrugated metal irrigation pipe, 48-inch measured (2012), through the levee, approximately 15 feet below the crown. Slide gate on the waterside (WS) and flap gate on the landside (LS). Concrete headwalls at both ends. This structure is associated with another abandoned structure located on the WS. Abandoned structure includes pump house, multiple concrete walls, and 3 additional crossings (two 30-inch pipes and one 48-inch pipe). (Original structure installed under Permit No. 187, 1921 - Compton-Delevan Irrigation District-Maxwell I.D., new pump and platform installed and old pump house removed under Permit No. 9183-1973, Maxwell Irrigation District) [Additional Reference(s): DWR Levee Log, 1992].  
 FS Date: 10/1/2018 3:35:20 PM

Sketch of structure through levee ring located at levee mile 11.26.

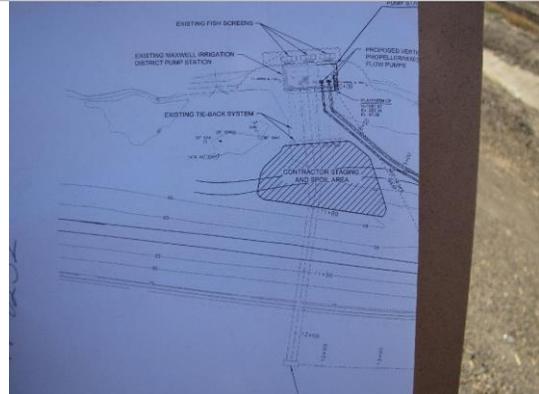
Photo 1 of 3 : UCIP\_FA\_2019\_51900\_70342.jpg

Item	DRAFT DWR UCIP Field Study		39.344400 °	39.344400 °	
			-122.031785 °	-122.031785 °	
DWR ID	20584				
Comment Code					
Inspector Comment					
DS_ID:20584 FS_ID:51900 EP_NO: N/A Repair Type: Non-Urgent Crossing Status: Found UCIP Comments: 5/3/2017 Crossing appears to be in good condition. (DWR Sutter Yard- AFreitag)10/24/2016 appears to be in good condition. (DWR Sutter Yard- AFreitag)4/25/2016 Crossing appears to be in good condition. 4/21/2015 Same as last inspection.6/23/2014 Same as last inspection. 12/17/2013 Same as last inspection.7/22/2013 Same as last inspection. 10/30/2012 Need to determine encroachment permit for this crossing. FIELD_STRUCT_DESC: [Maxwell Irrigation District] 3 of 3: 24-inch steel irrigation pipe through the levee at an unknown depth below the crown. Crossing is tied to existing Maxwell Irrigation District Pump Station located on the waterside (WS). Siphon breaker inside corrugated metal pipe (CMP) riser located on the landside (LS) shoulder. No permit has been identified since crossing was field discovered in 2012. FS Date: 5/23/2017 11:47:50 AM

Drawing of existing Maxwell Irrigation District Conveyance Pipeline (DWG available through Permit No. 17471 for work located at LM 11.51).

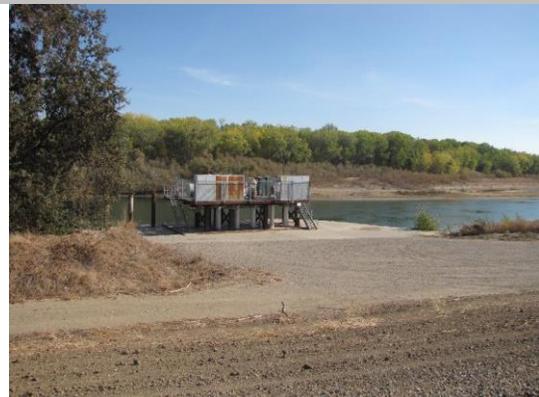
Photo 2 of 3 : UCIP\_FA\_2019\_51900\_70343.jpg

Maxwell Irrigation District Pump Station located on WS.

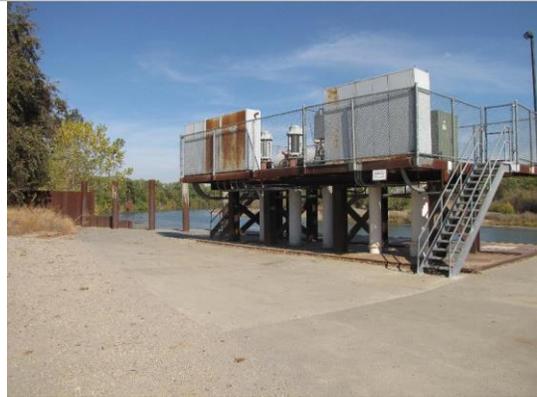
Photo 3 of 3 : UCIP\_FA\_2019\_51900\_70345.jpg

Item	DRAFT DWR UCIP Field Study			39.344400 °	39.344400 °
				-122.031785 °	-122.031785 °
DWR ID	20584				
Comment Code					
Inspector Comment					
DS_ID:20584 FS_ID:51900 EP_NO: N/A Repair Type: Non-Urgent Crossing Status: Found UCIP Comments: 5/3/2017 Crossing appears to be in good condition. (DWR Sutter Yard- AFreitag)10/24/2016 appears to be in good condition. (DWR Sutter Yard- AFreitag)4/25/2016 Crossing appears to be in good condition. 4/21/2015 Same as last inspection.6/23/2014 Same as last inspection. 12/17/2013 Same as last inspection.7/22/2013 Same as last inspection. 10/30/2012 Need to determine encroachment permit for this crossing. FIELD_STRUCT_DESC: [Maxwell Irrigation District] 3 of 3: 24-inch steel irrigation pipe through the levee at an unknown depth below the crown. Crossing is tied to existing Maxwell Irrigation District Pump Station located on the waterside (WS). Siphon breaker inside corrugated metal pipe (CMP) riser located on the landside (LS) shoulder. No permit has been identified since crossing was field discovered in 2012. FS Date: 5/23/2017 11:47:50 AM

Maxwell Irrigation District Pump Station located on WS.

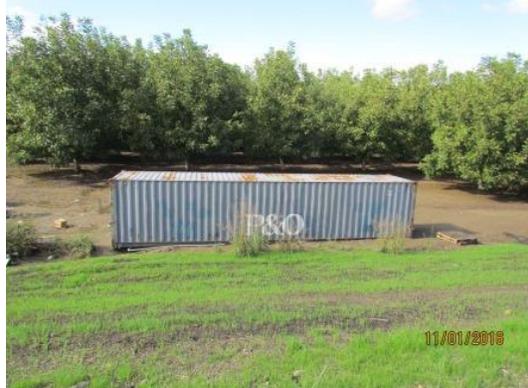
Photo 1 of 1 : FA\_2019\_MA0001\_297\_126\_20190822\_00034.jpg

LM Start	<b>13.48</b>	Rating **	M	Issue No.	<b>126</b>
LM End	<b>13.48</b>	Issue Type +	En	Location *	LS
Category	Earthen Levee		GPS Latitude/Longitude		
			Start	End	
Item	Encroachments		39.367832 °	39.367832 °	
			-122.015130 °	-122.015130 °	
DWR ID	DWR_MA0001_01_f_2016_126				
Comment Code					
EQ : Equipment					
Inspector Comment					
Shipping container should be moved 10 feet away from the landside toe.

View of a shipping container along the landside toe.

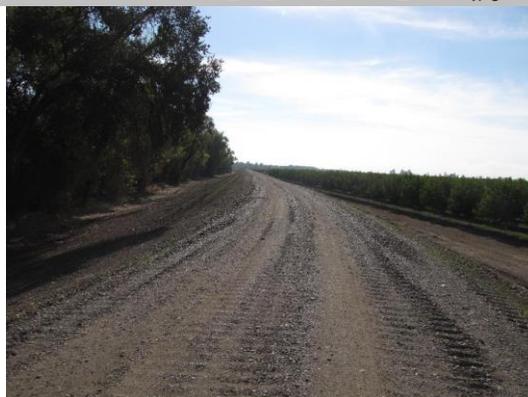
Photo 1 of 2 : UCIP\_FA\_2019\_51910\_70379.jpg

Item	DRAFT DWR UCIP Field Study		39.371934 °	39.371934 °	
			-122.012945 °	-122.012945 °	
DWR ID	16442				
Comment Code					
Inspector Comment					
DS_ID:16442 FS_ID:51910 EP_NO: N/A Repair Type: Non-Urgent Crossing Status: Found UCIP Comments: 5/3/2017 Abandoned- needs to be done so properly. (DWR Sutter Yard- AFreitag)10/24/2016 Abandoned.(DWR Sutter Yard- AFreitag)4/25/2016 Abandoned crossing4/21/2015 Slide gate is still buried.6/23/2014 Same as last inspection.12/17/2013 Same as last inspection.7/22/2013 Same as last inspection.10/30/2012 Slide gate is buried-non-fuctional. This crossing was listed in the USACE Periodic Inspections as ID# USACE_CESPK_MA1C_2010_p_0457 for buried slide gate. FIELD_STRUCT_DESC: *ABANDONED* 36-inch corrugated metal drainage pipe through the levee at approximately 15-18 feet below the crown. Slide gate on the waterside (WS) end. (Davis Ranches) [Additional Reference(s): DWR Levee Log, 1992]. FS Date: 5/23/2017 12:02:52 PM

Overview of levee crown looking downstream at crossing.

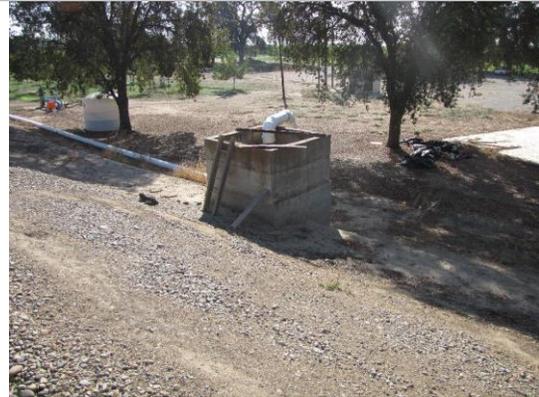
Photo 2 of 3 : UCIP\_FA\_2019\_53059\_70382.jpg

Item	DRAFT DWR UCIP Field Study		39.378568 °	39.378568 °	
			-122.013262 °	-122.013262 °	
DWR ID	16441				
Comment Code					
Inspector Comment					
<p>DS_ID:16441                  FS_ID:53059                  EP_NO: 9460                  Repair Type: Urgent                  Crossing Status: Found                  UCIP Comments: 10/1/2018 A gap visible between pipe end in concrete box on LS and flap gate. Pipe might be partially silted that blocks flap gate from closing properly. Needs proper abandonment if not in use. Open conduit allows for flooding during high water events. (O.Yakimov - DWR UCIP)5/3/2017 Water leaked through this crossing during the Jan/Feb 2017 high water event. A concrete pipe of unknown diameter exits the LS distribution box and follows the levee alignment downstream about 120ft and uncontrolled water flowed from that pipe end. If crossing is abandoned then it needs to be done so properly. (DWR Sutter Yard- AFreitag)10/24/2016 This entire crossing now appears to be abandoned. The pvc pipe that was previously connected to the LS well pump is no longer connected and used to fill the box.(DWR Sutter Yard- AFreitag)4/25/2016 WS concrete box appears to be abandoned. LS box appears to get filled by a well pump on LS.4/21/2015 Same as last inspection.6/23/2014 Same as last inspection.12/17/2013 Same as last inspection.7/22/2013 Same as last inspection.10/30/2012 Need to determine if crossing is still being used there are some abandoned features that remain at this crossing-- crossing has been modified. This crossing was listed in the USACE Periodic Inspections as ID# USACE_CESPK_MA1C_2010_p_0464 for abandoned pump station.                  FIELD_STRUCT_DESC: *ABANDONED* 18-inch steel irrigation pipe through the levee, at an unknown depth below the crown. Gate valve on the waterside (WS) end. Pump house on the WS berm. Concrete distribution box and flap gate at the landside (LS) toe. Inspector noted in 2016 that this structure appears to be partially abandoned concrete box appears to be in use. LS box appears to get filled by a well pump located on the LS and water distributed. (Automatic Board Order (ABO) issued as Permit No. 9460, 1974 - Morici Corporation) [Additional Reference(s): DWR Levee Log, 1992].                  FS Date: 10/1/2018 4:13:44 PM</p>

Concrete distribution box located on LS toe.

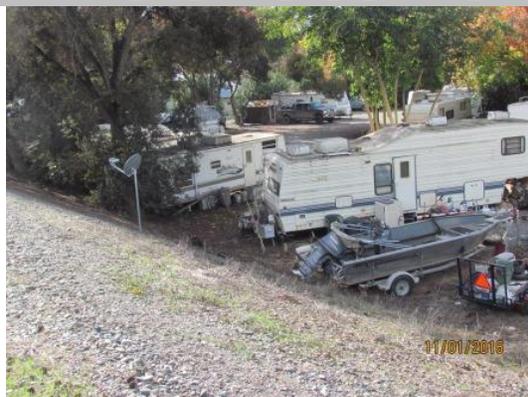
Photo 1 of 1 : FA\_2019\_MA0001\_297\_86\_20190822\_00021.jpg

LM Start	<b>15.84</b>	Rating **	U	Issue No.	<b>86</b>
LM End	<b>15.90</b>	Issue Type +	En	Location *	LS
Category	Earthen Levee			GPS Latitude/Longitude	
				Start	End
Item	Encroachments			39.400601°	39.401365°
				-122.009889°	-122.009374°
DWR ID	DWR_MA0001_01_s_2016_86				
Comment Code					
BU : Building					
Inspector Comment					
Mobile homes and trailers are within the landside toe easement.

View of the mobile homes and trailers along the landside toe.

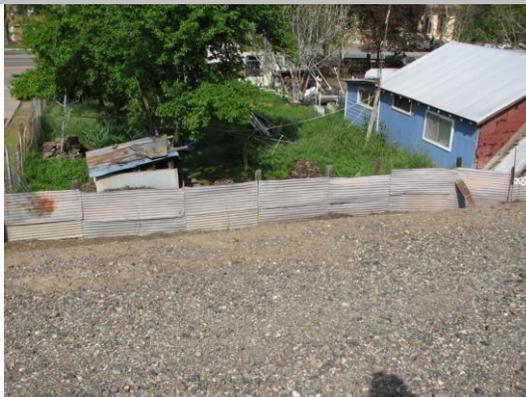
Photo 1 of 1 : FA\_2019\_MA0001\_297\_89\_20190822\_00023.jpg

LM Start	<b>16.00</b>	Rating **	U	Issue No.	<b>89</b>
LM End	<b>16.02</b>	Issue Type +	En	Location *	LS
Category	Earthen Levee			GPS Latitude/Longitude	
				Start	End
Item	Encroachments			39.402756 °	39.403040 °
				-122.009261 °	-122.009186 °
DWR ID	DWR_MA0001_01_s_2016_89				
Comment Code					
BU : Building					
Inspector Comment					
Red house and metal fence runs along the landside toe.

Corrugated metal fence obstructing visibility and access

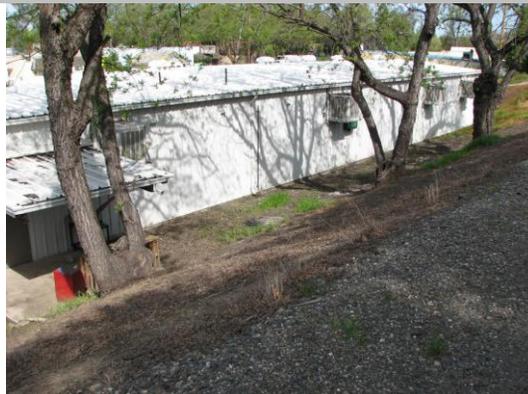
Photo 1 of 1 : FA\_2019\_MA0001\_297\_91\_20190822\_00025.jpg

LM Start	<b>16.06</b>	Rating **	U	Issue No.	<b>91</b>
LM End	<b>16.06</b>	Issue Type +	En	Location *	LS
Category	Earthen Levee		GPS Latitude/Longitude		
			Start	End	
Item	Encroachments		39.403565 °	39.403565 °	
			-122.009039 °	-122.009039 °	
DWR ID	DWR_MA0001_01_s_2016_91				
Comment Code					
BU : Building					
Inspector Comment					
Long, white metal building with several AC units is at the landside toe.

View of a building obstructing access.

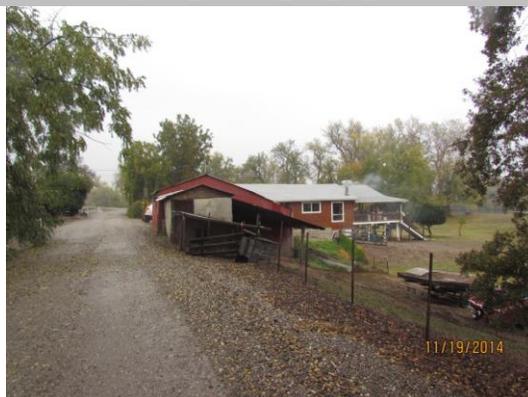
Photo 1 of 1 : FA\_2019\_MA0001\_297\_14\_20190822\_00007.jpg

LM Start	<b>16.08</b>	Rating **	U	Issue No.	<b>14</b>
LM End	<b>16.08</b>	Issue Type +	En	Location *	WS
Category	Earthen Levee		GPS Latitude/Longitude		
			Start	End	
Item	Encroachments		39.403930 °	39.403930 °	
			-122.008925 °	-122.008925 °	
DWR ID	DWR_MA0001_01_s_2012_14				
Comment Code					
BU : Building					
Inspector Comment

View of the building on the waterside slope.

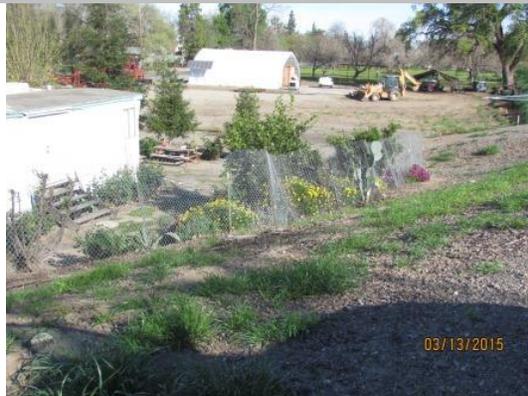
Photo 1 of 1 : FA\_2019\_MA0001\_297\_74\_20190822\_00016.jpg

LM Start	<b>16.10</b>	Rating **	M	Issue No.	<b>74</b>
LM End	<b>16.10</b>	Issue Type +	En	Location *	LS
Category	Earthen Levee			GPS Latitude/Longitude	
				Start	End
Item	Vegetation			39.404255 °	39.404255 °
				-122.008842 °	-122.008842 °
DWR ID	DWR_MA0001_01_s_2015_74				
Comment Code					
V6 : Landscaping					
Inspector Comment					
Remove the landscape from the landside slope and toe.

View of the landscape along the landside slope and toe.

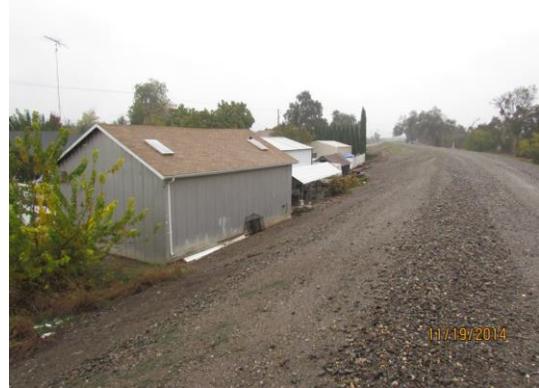
Photo 1 of 1 : FA\_2019\_MA0001\_297\_46\_20190822\_00011.jpg

LM Start	<b>16.31</b>	Rating **	U	Issue No.	<b>46</b>
LM End	<b>16.33</b>	Issue Type +	En	Location *	LS
Category	Earthen Levee			GPS Latitude/Longitude	
				Start	End
Item	Encroachments			39.407225°	39.407545°
				-122.008570°	-122.008640°
DWR ID	DWR_MA0001_01_s_2012_46				
Comment Code					
BU : Building					
Inspector Comment

View of the building along the landside toe.

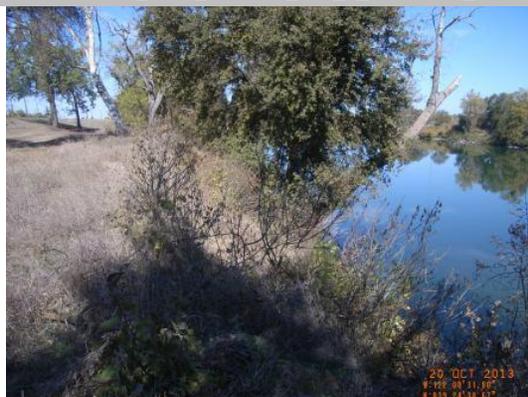
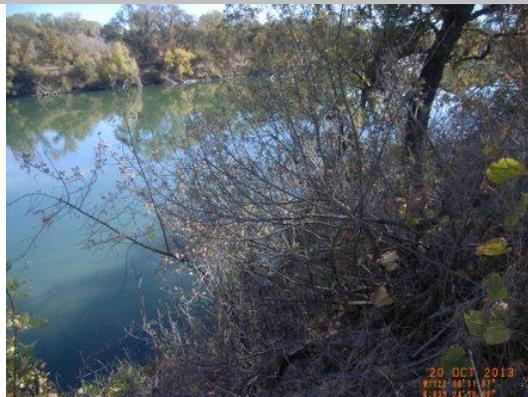
Photo 1 of 2 : FA\_2019\_MA0001\_297\_9\_20190822\_00005.jpg

LM Start	<b>16.35</b>	Rating **	A/W	Issue No.	<b>9</b>
LM End	<b>16.58</b>	Issue Type +	Ma	Location *	WS
Category	Supplemental			GPS Latitude/Longitude	
				Start	End
Item	2017 USACE Erosion Survey			39.407837°	39.411111°
				-122.008763°	-122.009238°
DWR ID	DWR_ST0010_02_f_2022_7				
Comment Code					
Inspector Comment					
2017 Site ID: SAC 164.3 R Status: Eroding 2017 Field Notes: New erosion along entire site. Site History: Erosion site added in 1997 and removed in 2005. 2009 - Site added back in, hard toe with slow moving erosion. Potential geotechnical failure. 2011 - Site extended downstream.

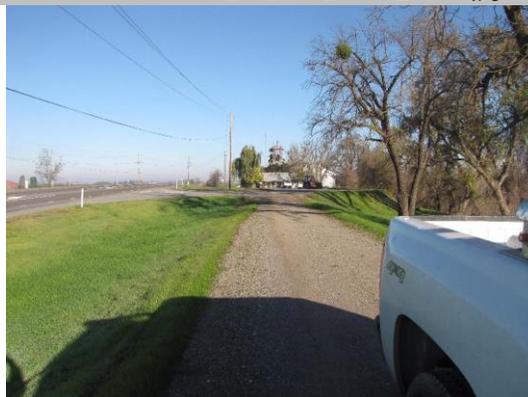
Photo 1 of 3 : UCIP\_FA\_2019\_51916\_70391.jpg

Item	DRAFT DWR UCIP Field Study		39.410645°	39.410645°	
			-122.009705°	-122.009705°	
DWR ID	16448				
Comment Code					
Inspector Comment					
<p>DS_ID:16448                  FS_ID:51916                  EP_NO: 14424                  Repair Type: Non-Urgent                  Crossing Status: Found                  UCIP Comments: 5/3/2017 WS sign still knocked over- needs to be replaced. (DWR Sutter Yard- AFreitag)10/24/2016 WS marker sign still knocked over.(DWR Sutter Yard- AFreitag)4/25/2016 WS marker sign is still knocked over.4/21/2015 Same as last inspection.11/3/2014 (DWR-Olivia) Need to contact owner to determine when markers will be placed. 6/23/2014 Same as last inspection.12/17/2013 Same as last inspection7/22/2013 Same as last inspection.12/2012 Waiting for information regarding crossing from PG&amp;E. Regarding damage warning sign--PG&amp;E has initiated a project to replace pipeline crossing sign and utility markers, as required by DOT codes/regulations.11/2012 Utility warning sign damaged. Olivia (UCIP team) is coordinating with PG&amp;E to determine more info on crossing.                  FIELD_STRUCT_DESC: 12-inch gas pipe through the levee, 30-inches below the crown. This 12-inch replacement pipe was installed by horizontally directionally drilling under the State HWY. Crossing is cathodically protected against external corrosion. Line was bored with a minimum cover of 48 feet under the right bank levee, 60 feet under the right bank, 25 feet under the channel and 52 feet under the left bank. Emergency contact: Monte Penland, Gas Maintenance Supervisor, 15871 Central Street, Meridian, CA 95957; Office No. 530-634-6520 or Mobile No. 530-356-7396. Utility crossing coordinates are approximate. This pipe is under pressure and cathodic protection (CP) readings are taken on a regular schedule. (Permit No. 14424, 1988 - Pacific Gas &amp; Electric [PG&amp;E]) [Additional Reference(s): DWR Levee Log, 1992].                  FS Date: 5/23/2017 1:50:01 PM</p>

View just upstream of utility crossing.

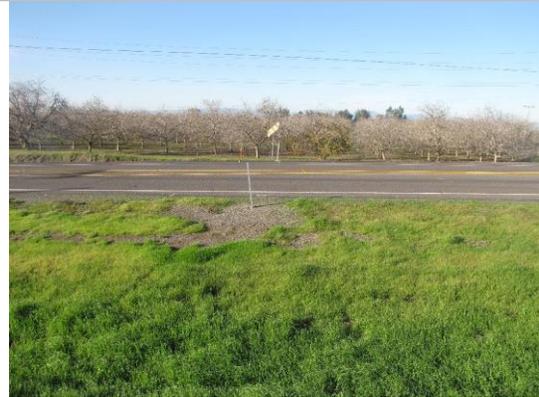
Photo 2 of 3 : UCIP\_FA\_2019\_51916\_70390.jpg

Item	DRAFT DWR UCIP Field Study			39.410645°	39.410645°
				-122.009705°	-122.009705°
DWR ID	16448				
Comment Code					
Inspector Comment					
<p>DS_ID:16448                  FS_ID:51916                  EP_NO: 14424                  Repair Type: Non-Urgent                  Crossing Status: Found                  UCIP Comments: 5/3/2017 WS sign still knocked over- needs to be replaced. (DWR Sutter Yard- AFreitag)10/24/2016 WS marker sign still knocked over.(DWR Sutter Yard- AFreitag)4/25/2016 WS marker sign is still knocked over.4/21/2015 Same as last inspection.11/3/2014 (DWR-Olivia) Need to contact owner to determine when markers will be placed. 6/23/2014 Same as last inspection.12/17/2013 Same as last inspection7/22/2013 Same as last inspection.12/2012 Waiting for information regarding crossing from PG&amp;E. Regarding damage warning sign--PG&amp;E has initiated a project to replace pipeline crossing sign and utility markers, as required by DOT codes/regulations.11/2012 Utility warning sign damaged. Olivia (UCIP team) is coordinating with PG&amp;E to determine more info on crossing.                  FIELD_STRUCT_DESC: 12-inch gas pipe through the levee, 30-inches below the crown. This 12-inch replacement pipe was installed by horizontally directionally drilling under the State HWY. Crossing is cathodically protected against external corrosion. Line was bored with a minimum cover of 48 feet under the right bank levee, 60 feet under the right bank, 25 feet under the channel and 52 feet under the left bank. Emergency contact: Monte Penland, Gas Maintenance Supervisor, 15871 Central Street, Meridian, CA 95957; Office No. 530-634-6520 or Mobile No. 530-356-7396. Utility crossing coordinates are approximate. This pipe is under pressure and cathodic protection (CP) readings are taken on a regular schedule. (Permit No. 14424, 1988 - Pacific Gas &amp; Electric [PG&amp;E]) [Additional Reference(s): DWR Levee Log, 1992].                  FS Date: 5/23/2017 1:50:01 PM</p>

View of utility marker located on LS across hwy.
