**Flood Control Project Maintenance  
Levee Inspections**

**Fall 2019 Levee Maintenance Deficiency Summary Report**

**Sutter Maintenance Yard Maintenance Area 0001**

Waterway		Bank	Unit Miles	
Unit No. 01 Sacramento River		Right	16.76	
	Spring (March - May)	Summer (June - August)	(September - November) Fall	Winter (December - February)
Unit Maintenance Rating (Fall Only)			<b>A</b>	
Date of Inspection	4/17/2019 - 4/17/2019		10/15/2019 - 10/15/2019	
DWR Inspector	Makar Sokol		Makar Sokol	
Accompanied By	Bryan Reniff Sutter Maintenance Yard		Lincoln Carey Sutter Maintenance Yard

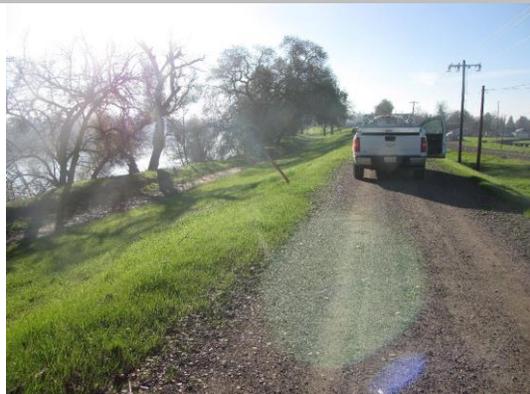
Photo 3 of 3 : UCIP\_FA\_2019\_51916\_70395.jpg

Item	DRAFT DWR UCIP Field Study			39.410645°	39.410645°
				-122.009705°	-122.009705°
DWR ID	16448				
Comment Code					
Inspector Comment					
<p>DS_ID:16448                  FS_ID:51916                  EP_NO: 14424                  Repair Type: Non-Urgent                  Crossing Status: Found                  UCIP Comments: 5/3/2017 WS sign still knocked over- needs to be replaced. (DWR Sutter Yard- AFreitag)10/24/2016 WS marker sign still knocked over.(DWR Sutter Yard- AFreitag)4/25/2016 WS marker sign is still knocked over.4/21/2015 Same as last inspection.11/3/2014 (DWR-Olivia) Need to contact owner to determine when markers will be placed. 6/23/2014 Same as last inspection.12/17/2013 Same as last inspection7/22/2013 Same as last inspection.12/2012 Waiting for information regarding crossing from PG&amp;E. Regarding damage warning sign--PG&amp;E has initiated a project to replace pipeline crossing sign and utility markers, as required by DOT codes/regulations.11/2012 Utility warning sign damaged. Olivia (UCIP team) is coordinating with PG&amp;E to determine more info on crossing.                  FIELD_STRUCT_DESC: 12-inch gas pipe through the levee, 30-inches below the crown. This 12-inch replacement pipe was installed by horizontally directionally drilling under the State HWY. Crossing is cathodically protected against external corrosion. Line was bored with a minimum cover of 48 feet under the right bank levee, 60 feet under the right bank, 25 feet under the channel and 52 feet under the left bank. Emergency contact: Monte Penland, Gas Maintenance Supervisor, 15871 Central Street, Meridian, CA 95957; Office No. 530-634-6520 or Mobile No. 530-356-7396. Utility crossing coordinates are approximate. This pipe is under pressure and cathodic protection (CP) readings are taken on a regular schedule. (Permit No. 14424, 1988 - Pacific Gas &amp; Electric [PG&amp;E]) [Additional Reference(s): DWR Levee Log, 1992].                  FS Date: 5/23/2017 1:50:01 PM</p>

View of levee looking downstream at crossing.
