**Flood Control Project Maintenance
Levee Inspections**

Fall 2019 Levee Maintenance Deficiency Summary Report

**Flood Control Project Maintenance
Levee Inspections
LMA District Cover Sheet
Fall 2019 Levee Inspection Results**

Sutter Maintenance Yard Maintenance Area 0005

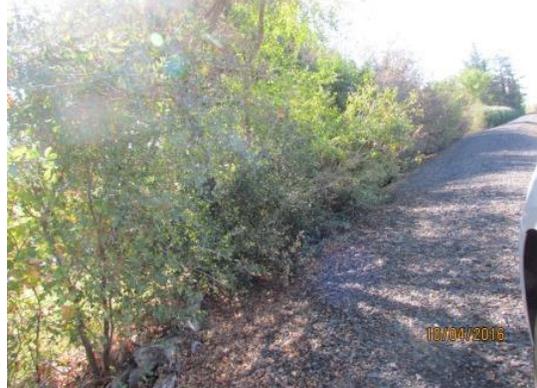
Photo 1 of 1 : FA_2019_MA0005_196_32_20190822_00012.jpg

LM Start	0.58	Rating **	M	Issue No.	32
LM End	0.68	Issue Type +	Ma	Location *	LS
Category	Earthen Levee			GPS Latitude/Longitude	
				Start	End
Item	Trim / Thin Trees			39.690496°	39.689137°
				-121.777109°	-121.776938°
DWR ID	DWR_MA0005_01_s_2014_32				
Comment Code					
T2 : Thin trees to allow visibility of the ground and room to flood fight.					
Inspector Comment					
Trees smaller than 4-inches in diameter at chest height shall be removed from the landside slope and within ten feet of the landside toe.

View of the trees along the landside toe blocking visibility.

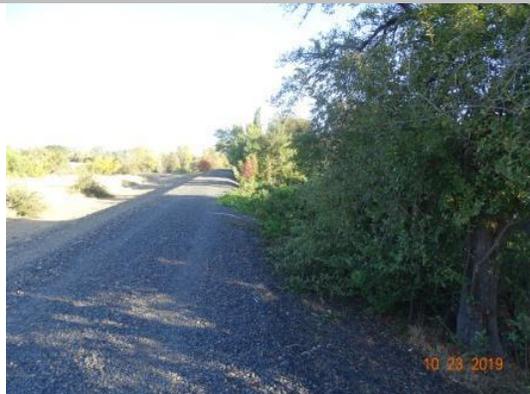
Photo 1 of 1 : FA_2019_MA0005_196_47_20191028_00086.jpg

LM Start	0.79	Rating **	M	Issue No.	47
LM End	0.82	Issue Type +	Ma	Location *	LS
Category	Earthen Levee			GPS Latitude/Longitude	
				Start	End
Item	Trim / Thin Trees			39.687676 °	39.687193 °
				-121.777419 °	-121.777461 °
DWR ID	DWR_MA0005_01_f_2019_47				
Comment Code					
T1 : Trim trees to at least five feet above ground level.					
Inspector Comment

View of trees that require trimming along the landside slope. Fall 2019.

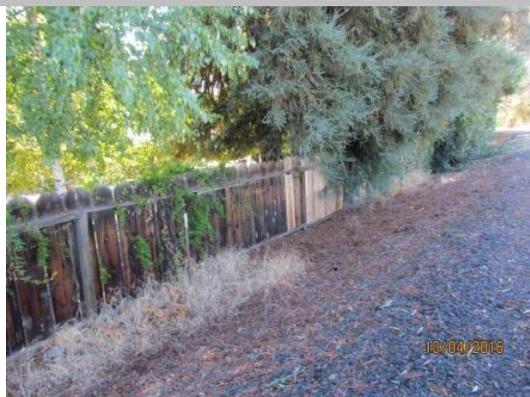
Photo 1 of 1 : FA_2019_MA0005_196_49_20190822_00023.jpg

LM Start	0.90	Rating **	U	Issue No.	49
LM End	0.92	Issue Type +	En	Location *	LS
Category	Earthen Levee			GPS Latitude/Longitude	
				Start	End
Item	Encroachments			39.686087 °	39.685756 °
				-121.777555 °	-121.777540 °
DWR ID	DWR_MA0005_01_f_2016_49				
Comment Code					
FE : Fence					
Inspector Comment

View of the wood plank fence at the landside toe.

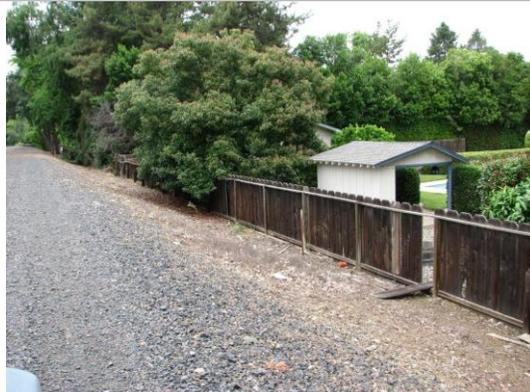
Photo 1 of 1 : FA_2019_MA0005_196_42_20190822_00018.jpg

LM Start	1.24	Rating **	U	Issue No.	42
LM End	1.26	Issue Type +	En	Location *	LS
Category	Earthen Levee			GPS Latitude/Longitude	
				Start	End
Item	Encroachments			39.681305°	39.681044°
				-121.776533°	-121.776547°
DWR ID	DWR_MA0005_01_s_2016_42				
Comment Code					
FE : Fence					
Inspector Comment

View of the wood plank fence at the landside toe.

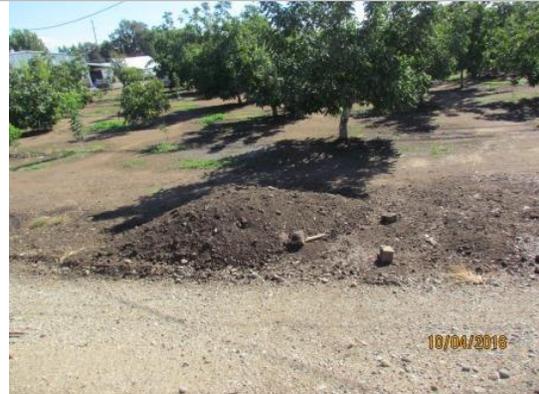
Photo 1 of 1 : FA_2019_MA0005_196_53_20190822_00025.jpg

LM Start	1.52	Rating **	M	Issue No.	53
LM End	1.52	Issue Type +	En	Location *	LS
Category	Earthen Levee			GPS Latitude/Longitude	
				Start	End
Item	Encroachments			39.677240°	39.677240°
				-121.777521°	-121.777521°
DWR ID	DWR_MA0005_01_f_2016_53				
Comment Code					
DE : Debris					
Inspector Comment					
Remove the pile of soil and rocks on the landside toe.

View of the soil and rock pile on the landside toe.

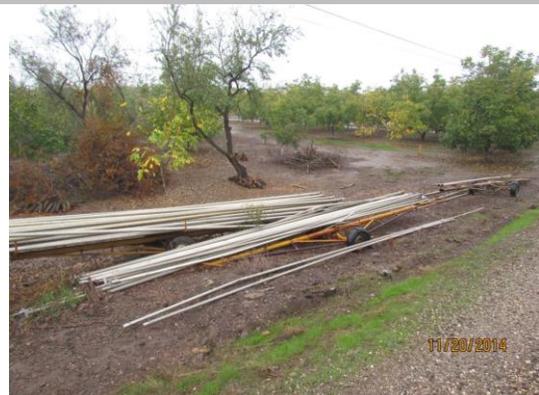
Photo 1 of 1 : FA_2019_MA0005_196_30_20190822_00010.jpg

LM Start	1.53	Rating **	M	Issue No.	30
LM End	1.53	Issue Type +	En	Location *	LS
Category	Earthen Levee			GPS Latitude/Longitude	
				Start	End
Item	Encroachments			39.677130°	39.677130°
				-121.777583°	-121.777583°
DWR ID	DWR_MA0005_01_f_2014_30				
Comment Code					
EQ : Equipment					
Inspector Comment

View of the sprinkler pipe and equipment along the landside toe.

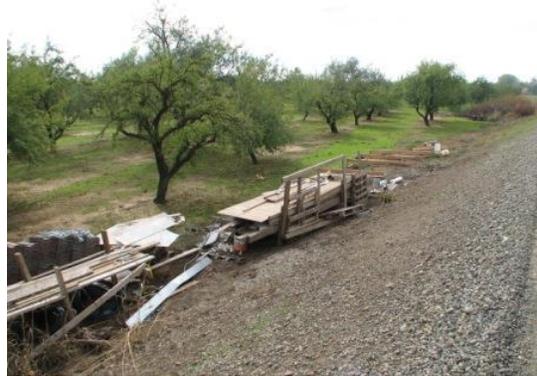
Photo 1 of 1 : FA_2019_MA0005_196_1_20190822_00001.jpg

LM Start	1.66	Rating **	M	Issue No.	1
LM End	1.66	Issue Type +	En	Location *	LS
Category	Earthen Levee			GPS Latitude/Longitude	
				Start	End
Item	Encroachments			39.675528°	39.675528°
				-121.778642°	-121.778642°
DWR ID	DWR_MA0005_01_s_2012_1				
Comment Code					
MA : Material					
Inspector Comment					
The materials and equipment should be moved ten feet away from the landside toe.

View of the construction supply on pallets.

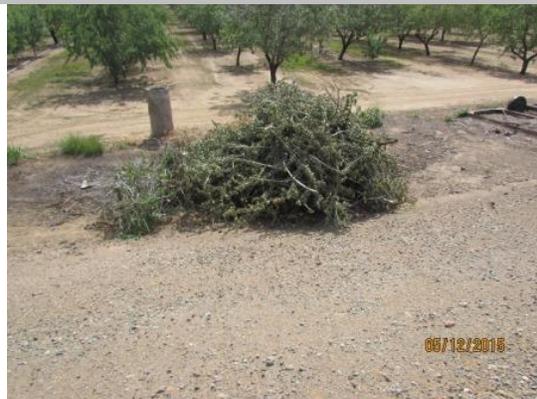
Photo 1 of 1 : FA_2019_MA0005_196_28_20190822_00009.jpg

LM Start	1.82	Rating **	M	Issue No.	28
LM End	1.82	Issue Type +	En	Location *	LS
Category	Earthen Levee			GPS Latitude/Longitude	
				Start	End
Item	Encroachments			39.673390°	39.673390°
				-121.779830°	-121.779830°
DWR ID	DWR_MA0005_01_s_2015_28				
Comment Code					
PR : Prunings					
Inspector Comment					
Remove the prunings from the landside toe.

View of the prunings along the landside toe.

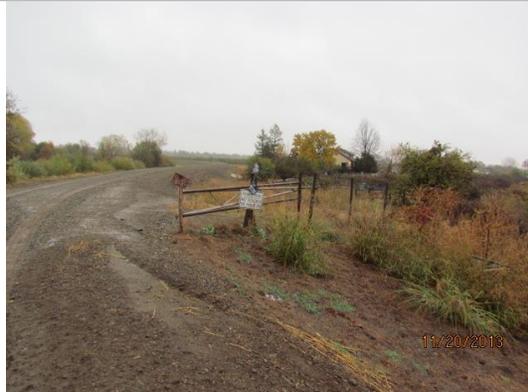
Photo 1 of 1 : FA_2019_MA0005_196_10_20190822_00005.jpg

LM Start	2.09	Rating **	M	Issue No.	10
LM End	2.09	Issue Type +	En	Location *	LS
Category	Earthen Levee		GPS Latitude/Longitude		
			Start	End	
Item	Encroachments		39.670112°	39.670112°	
			-121.782012°	-121.782012°	
DWR ID	DWR_MA0005_01_s_2016_10				
Comment Code					
FE : Fence					
Inspector Comment					
No permit was found for the gate.

View of the unpermitted gate.

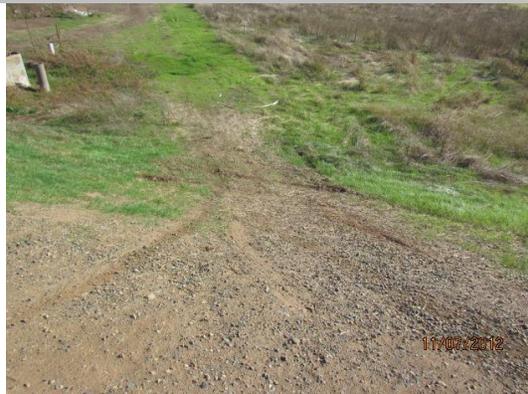
Photo 1 of 1 : FA_2019_MA0005_196_9_20190822_00004.jpg

LM Start	2.54	Rating **	M	Issue No.	9
LM End	2.54	Issue Type +	Ma	Location *	LS
Category	Earthen Levee			GPS Latitude/Longitude	
				Start	End
Item	Slope Stability			39.663876 °	39.663876 °
				-121.784014 °	-121.784014 °
DWR ID	DWR_MA0005_01_f_2012_9				
Comment Code					
S3 : Repair the levee slope damaged by vehicle traffic and prevent access where possible.					
Inspector Comment

View of the vehicle erosion along the landside slope.

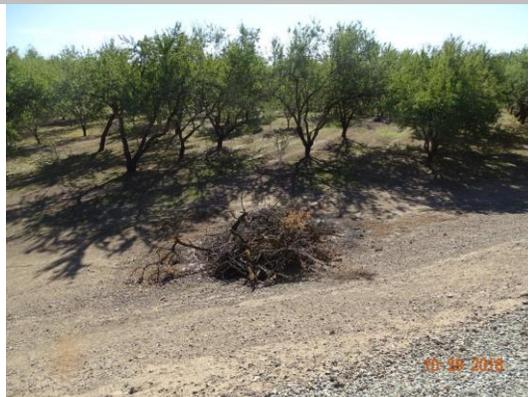
Photo 1 of 1 : FA_2019_MA0005_196_65_20190822_00029.jpg

LM Start	2.82	Rating **	M	Issue No.	65
LM End	2.82	Issue Type +	En	Location *	LS
Category	Earthen Levee			GPS Latitude/Longitude	
				Start	End
Item	Encroachments			39.660153 °	39.660153 °
				-121.785137 °	-121.785137 °
DWR ID	DWR_MA0005_01_f_2018_65				
Comment Code					
PR : Prunings					
Inspector Comment					
Remove the pruning from the landside toe.

View of the prunings along the landside toe.

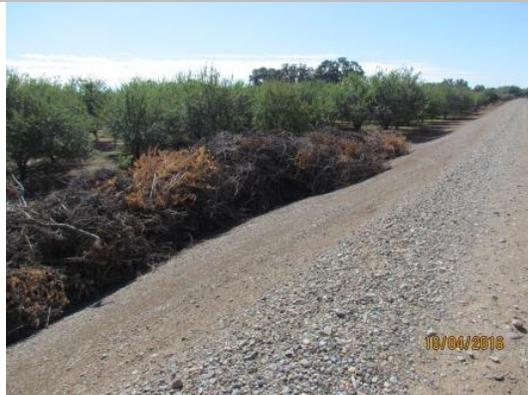
Photo 1 of 1 : FA_2019_MA0005_196_37_20190822_00014.jpg

LM Start	3.06	Rating **	M	Issue No.	37
LM End	3.06	Issue Type +	En	Location *	LS
Category	Earthen Levee			GPS Latitude/Longitude	
				Start	End
Item	Encroachments			39.656911 °	39.656911 °
				-121.787097 °	-121.787097 °
DWR ID	DWR_MA0005_01_f_2015_37				
Comment Code					
PR : Prunings					
Inspector Comment					
Remove the prunings from the landside toe.

View of the prunings along the landside toe.

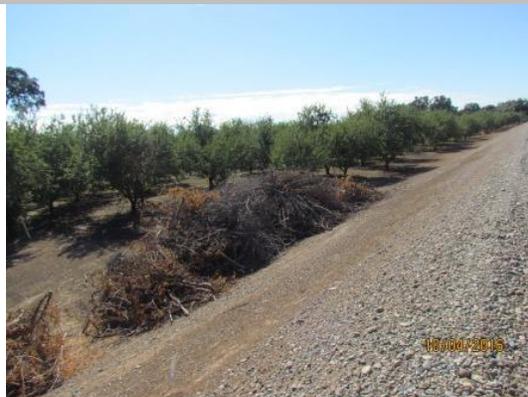
Photo 1 of 1 : FA_2019_MA0005_196_38_20190822_00015.jpg

LM Start	3.21	Rating **	M	Issue No.	38
LM End	3.21	Issue Type +	En	Location *	LS
Category	Earthen Levee			GPS Latitude/Longitude	
				Start	End
Item	Encroachments			39.654938 °	39.654938 °
				-121.787892 °	-121.787892 °
DWR ID	DWR_MA0005_01_f_2015_38				
Comment Code					
PR : Prunings					
Inspector Comment					
Remove the prunings from the landside toe.

View of the prunings along the landside toe.

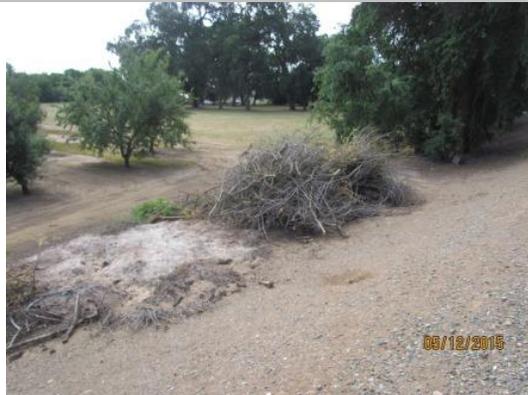
Photo 1 of 1 : FA_2019_MA0005_196_31_20190822_00011.jpg

LM Start	3.42	Rating **	M	Issue No.	31
LM End	3.42	Issue Type +	En	Location *	LS
Category	Earthen Levee			GPS Latitude/Longitude	
				Start	End
Item	Encroachments			39.652028 °	39.652028 °
				-121.789090 °	-121.789090 °
DWR ID	DWR_MA0005_01_s_2015_31				
Comment Code					
PR : Prunings					
Inspector Comment					
Remove the prunings from the landside toe.

View of the prunings along the landside toe.

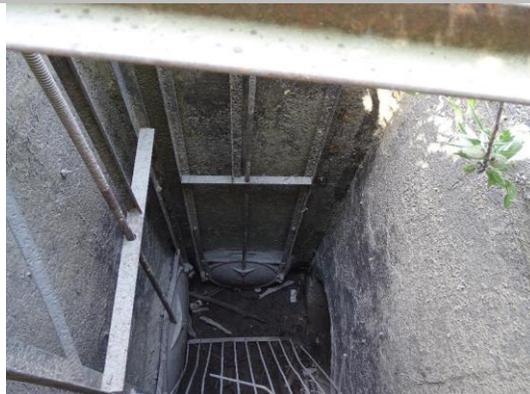
Photo 2 of 3 : UCIP_FA_2019_54141_79696.jpg

DS_ID:1616
 FS_ID:54141
 EP_NO: N/A
 Repair Type: Non-Urgent
 Crossing Status: Found
 UCIP Comments: 06/05/2019 No issues recorded during inspection. (O.Yakimov - DWR UCIP)
 05/15/2017 Crossing appears to be in good condition. LS inlet is located in the Distribution box on the LS toe. This is an overflow pipe used to regulate water levels in side the box. Pipe has been selected to be internally cleaned and inspected as part fo the DMP project. (DWR Sutter Yard- AFreitag)11/15/2016 Crossing appears to be in good condition. (DWR Sutter Yard- AFreitag)5/9/2016 Crossing appears to be in good condition.8/5/2015 WS pipe end is being overgrown by trees and other vegetation. Needs to be cleared back.12/8/2014 Same as last inspection.6/11/2014 Same as last inspection.11/20/2013 Same as last inspection.5/29/2013 Same as last inspection.
 FIELD_STRUCT_DESC: 24-inch corrugated metal drainage pipe through the levee, 12.0 feet below the crown. Slide gate in a corrugated metal riser on the waterside (WS) slope. Flap gate on the WS toe. Inlet on the landside (LS) toe. [Additional Reference(s): DWR Levee Log, 1990 (HLM 3.95). USACE Sacramento O&M Manual, Unit 516 - Upper Butte Creek - Part No. 2, April 1960, (Station 381+36)].

View inside of concrete distribution box on LS

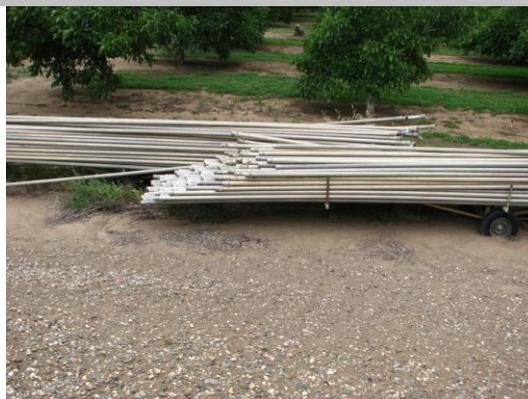
Photo 1 of 1 : FA_2019_MA0005_196_27_20190822_00008.jpg

LM Start	4.13	Rating **	M	Issue No.	27
LM End	4.13	Issue Type +	En	Location *	LS
Category	Earthen Levee			GPS Latitude/Longitude	
				Start	End
Item	Encroachments			39.643100°	39.643100°
				-121.782827°	-121.782827°
DWR ID	DWR_MA0005_01_s_2017_27				
Comment Code					
EQ : Equipment					
Inspector Comment					
Agricultural piping on trailer.

5/5/2016: Remove equipment from LS toe.

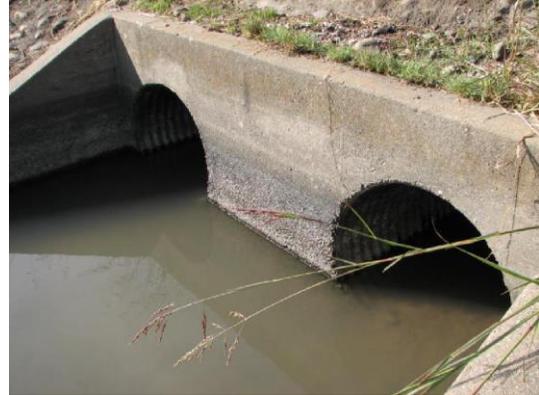
Photo 1 of 2 : UCIP_FA_2019_54040_67941.jpg

Comment Code					
Inspector Comment					
DS_ID:1620 FS_ID:54040 EP_NO: N/A Repair Type: Non-Urgent Crossing Status: Found UCIP Comments: 05/23/2019 (O. Magana - DWR UCIP)05/15/2017 Abandoned and needs to be done properly. A sink hole formed in the WS toe road and revealed the location of the WS pipe end. Sink hole will need to be repaired before the next high water season but the pipe has been selected to be internally cleaned and camera inspected as part of the DMP project so it will have needed to be excavated along the WS end anyways. (DWR Sutter Yard- AFreitag)11/15/2016 Abandoned. Needs cover for the standpipe. (DWR Sutter Yard- AFreitag)05/09/2016 Abandoned pipe. Needs a cover for the standpipe.08/05/2015 Abandoned crossing. Covers need to be made for tops of standpipes to prevent falls.12/08/2014 Same as last inspection.06/11/2014 Same as last inspection.11/19/2013 Same as last inspection.05/29/2013 Same as last inspection. Land owner said pipes are abandoned and no longer used. Covers should be made for top of standpipe to prevent falls. Pipes should be properly abandoned.10/30/2012 Pipe 1/2 filled with soil at slide gate end. FIELD_STRUCT_DESC: *ABANDONED* 1 of 2: 36-inch drainage pipe through the levee, 11 feet below the crown. Slide gate in a 54-inch corrugated metal riser on the waterside (WS) slope. Concrete "U" headwall on the landside (LS). [Additional Reference(s): DWR Levee Log, 1990 (HLM 5.66). Sacramento O&M Manual, Unit 516 - Upper Butte Creek - Part No. 2, April 1960 (Station 470+00)]. FS Date: 5/23/2019 5:10:38 PM

Headwall at LS toe.

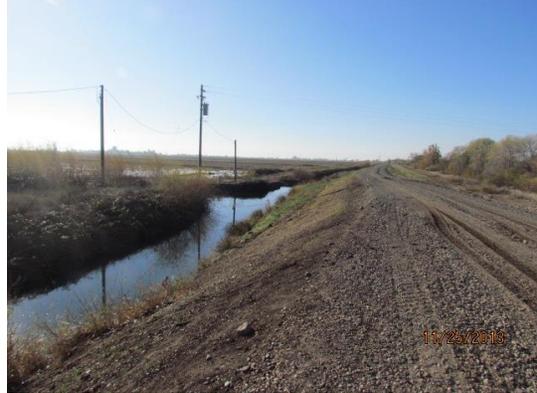
Photo 1 of 1 : FA_2019_MA0005_196_55_20190822_00026.jpg

LM Start	5.69	Rating **	M	Issue No.	55
LM End	6.23	Issue Type +	En	Location *	LS
Category	Earthen Levee		GPS Latitude/Longitude		
			Start	End	
Item	Encroachments		39.622766°	39.615666°	
			-121.773159°	-121.777353°	
DWR ID	DWR_MA0005_01_s_2015_55				
Comment Code					
DT : Ditch					
Inspector Comment

View of the irrigation ditch along the landside toe.

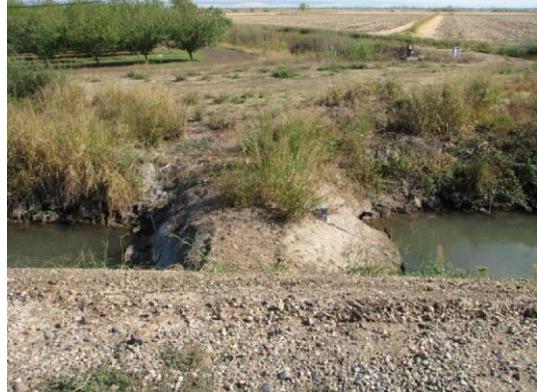
Photo 1 of 1 : UCIP_FA_2019_51958_11616.jpg

Comment Code					
Inspector Comment					
<p>DS_ID:1622 FS_ID:51958 EP_NO: N/A Repair Type: Non-Urgent Crossing Status: Indicator Found UCIP Comments: 5/15/2017 Unable to locate. (DWR Sutter Yard-AFreitag)11/15/2016 Unable to locate. The concrete fill in the LS toe channel appears to just be erosion protection. (DWR Sutter Yard-AFreitag)8/5/2015 Unable to locate.12/8/2014 Same as last inspection.6/11/2014 Same as last inspection.11/19/2013 Same as last inspection.5/29/2013 Same as last inspection. FIELD_STRUCT_DESC: 18-inch corrugated metal drainage pipe through the levee, 15 feet below the crown, indicator found. Concrete headwall and flap gate on the waterside (WS). Concrete fill in channel on the landside (LS) toe is a good indicator of the pipe location. [Additional Reference(s): DWR Levee Log, 1990 (HLM 5.85). Sacramento O&M Manual, Unit 516 - Upper Butte Creek - Part No. 2, April 1960, 18-inch pipe referenced only in USACE As-Built Drawing No. 50-4-3367, Exhibit B, Sheet 8, April 1957, (Station 480+25)]. FS Date: 5/31/2017 1:06:21 PM</p>

Concrete fill on LS toe a good indicator for location of pipe.

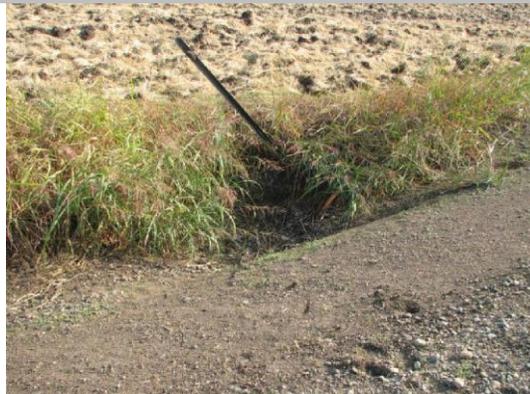
Photo 1 of 2 : UCIP_FA_2019_51970_67970.jpg

Headwall at LS toe.

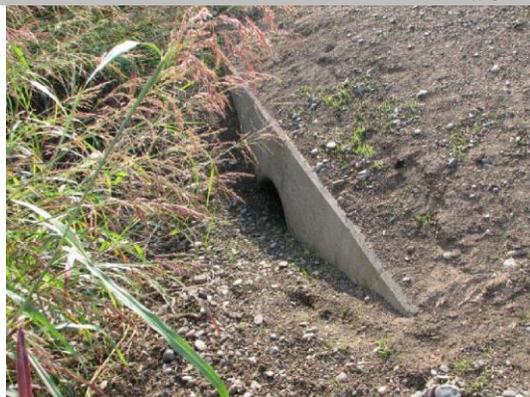
Photo 2 of 2 : UCIP_FA_2019_51970_67969.jpg

Headwall at LS toe.

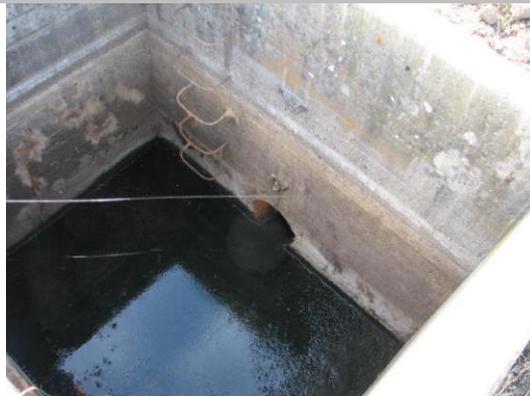
Photo 3 of 3 : UCIP_FA_2019_51975_67974.jpg

Comment Code					
Inspector Comment					
<p>DS_ID:1631 FS_ID:51975 EP_NO: N/A Repair Type: Non-Urgent Crossing Status: Found UCIP Comments: 5/16/2017 Abandoned and needs to be done so properly. (DWR Sutter Yard- A Freitag)11/15/2016 Abandoned. (DWR Sutter Yard- A Freitag)5/11/2016 Abandoned pipe.8/4/2015 Abandoned pipe. Casey Wilder has started the steps to have the pipe properly abandoned and removed from the levee.12/8/2014 Same as last inspection.6/11/2014 Same as last inspection.11/19/2013 Same as last inspection.5/29/2013 Same as last inspection.10/30/2012 Need to confirm proper abandonment of pipe. Pipe should be plugged on LS. FIELD_STRUCT_DESC: 16-inch steel irrigation pipe through the levee, 11.5 feet below the crown. Pump located on the waterside (WS). Distribution box at the landside (LS) toe. [Additional Reference(s): DWR Levee Log, 1990 (HLM 9.21). USACE Sacramento O&M Manual, Unit 515 - Upper Butte Creek - Part No. 1, April 1955, (Station 655+68). USACE As-Built Drawing No. 50-4-2637, Exhibit B, Sheet 3, April 1950, (Station 655+68.2)]. FS Date: 5/31/2017 2:09:46 PM</p>

Pipe at bottom of concrete distribution box.

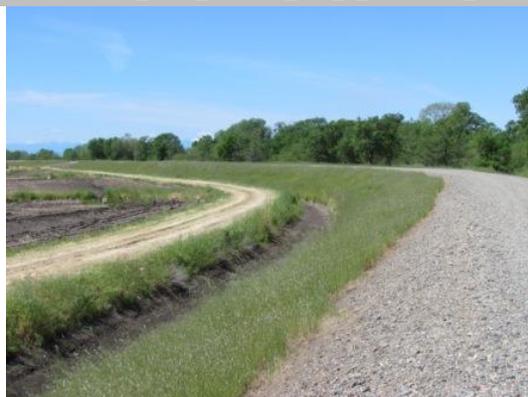
Photo 1 of 1 : FA_2019_MA0005_196_5_20190822_00002.jpg

LM Start	9.54	Rating **	M	Issue No.	5
LM End	10.33	Issue Type +	En	Location *	LS
Category	Earthen Levee		GPS Latitude/Longitude		
			Start	End	
Item	Encroachments		39.574837°	39.567892°	
			-121.807913°	-121.819283°	
DWR ID	DWR_MA0005_01_s_2012_5				
Comment Code					
DT : Ditch					
Inspector Comment

View of the agricultural ditch along the landside toe.

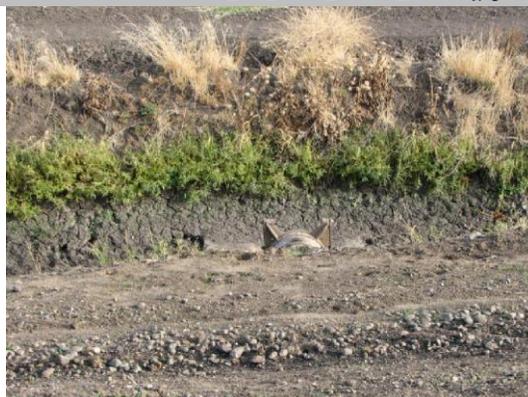
Photo 1 of 1 : UCIP_FA_2019_51980_67986.jpg

LM Start	10.04	Rating **	M	Issue No.	918
LM End	10.04	Issue Type +	En	Location *	
Category	Supplemental		GPS Latitude/Longitude		
			Start	End	
Item	DRAFT DWR UCIP Field Study		39.570596°	39.570596°	
			-121.815215°	-121.815215°	
DWR ID	1633

Comment Code					
Inspector Comment					
<p>DS_ID:1633 FS_ID:51980 EP_NO: N/A Repair Type: Non-Urgent Crossing Status: Found UCIP Comments: 5/16/2017 Abandoned crossing and needs to be done so properly. Pipe has been selected to be internally cleaned and inspected as part of the DMP project. (DWR Sutter Yard-AFreitag)11/15/2016 Abandoned. (DWR Sutter Yard-AFreitag)5/11/2016 Abandoned crossing.8/4/2015 Abandoned pipe. Casey Wilder has started the steps to have the pipe properly abandoned and removed from the levee.12/8/2014 Same as last inspection.6/11/2014 Same as last inspection.11/19/2013 Same as last inspection.5/29/2013 Same as last inspection.10/30/2012 Pipe and headwall buried on WS, no access to slide gate. FIELD_STRUCT_DESC: 24-inch corrugated metal irrigation pipe through the levee, 12.5 feet below the crown. Slide gate on the waterside (WS). Flap gate and headwall on the landside (LS). Concrete headwall at the WS toe. [Additional Reference(s): DWR Levee Log, 1990 (HLM 10.19). USACE Sacramento O&M Manual, Unit 515 - Upper Butte Creek - Part No. 1, April 1955, (Station 706+00). USACE As-Built Drawing No. 50-4-2637, Exhibit B, Sheet 3, April 1950]. FS Date: 5/31/2017 2:15:33 PM</p>

Flap gate and headwall at LS toe in irrigation or drainage ditch.

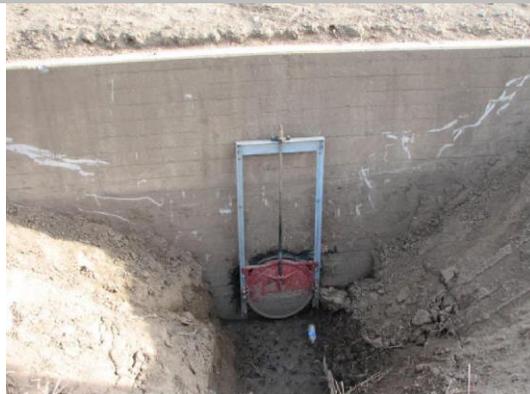
Photo 3 of 3 : UCIP_FA_2019_51981_67987.jpg

Comment Code					
Inspector Comment					
DS_ID:1634 FS_ID:51981 EP_NO: N/A Repair Type: Non-Urgent Crossing Status: Found UCIP Comments: 5/16/2017 Abandoned- needs to be done so properly. Pipe has been selected to be internally cleaned and inspected as part of the DMP project. (DWR Sutter Yard- AFreitag)11/15/2016 Abandoned. (DWR Sutter Yard- AFreitag)5/11/2016 Abandoned crossing.8/4/2015 Abandoned pipe. Casey Wilder has started the steps to have the pipe properly abandoned and removed from the levee.12/8/2014 Same as last inspection.6/11/2014 Same as last inspection.11/19/2013 Same as last inspection.5/29/2013 Same as last inspection. FIELD_STRUCT_DESC: 24-inch corrugated metal irrigation pipe through the levee, 14.5 feet below the crown. Slide gate on the waterside (WS) on concrete headwall. Flap gate on the landside (LS). [Additional Reference(s): DWR Levee Log, 1990 (HLM 10.41). USACE Sacramento O&M Manual, Unit 515 - Upper Butte Creek - Part No. 1, April 1955, (Station 717+50). USACE As-Built Drawing No. 50-4-2637, Exhibit B, Sheet 3, April 1950]. FS Date: 5/31/2017 2:16:48 PM

Headwall and slide gate on WS toe.

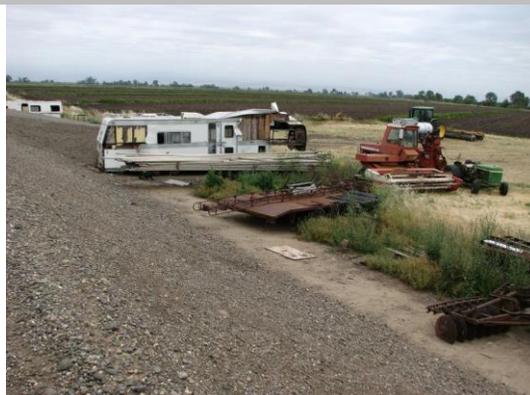
Photo 1 of 1 : FA_2019_MA0005_196_26_20190822_00007.jpg

LM Start	10.37	Rating **	M	Issue No.	26
LM End	10.37	Issue Type +	En	Location *	LS
Category	Earthen Levee			GPS Latitude/Longitude	
				Start	End
Item	Encroachments			39.567541 °	39.567541 °
				-121.819786 °	-121.819786 °
DWR ID	DWR_MA0005_01_s_2016_26				
Comment Code					
EQ : Equipment					
Inspector Comment					
Abandoned motorhomes and farm equipment should be removed from the landside toe.

5/5/2016: Remove abandoned motorhome and equipment from LS toe.

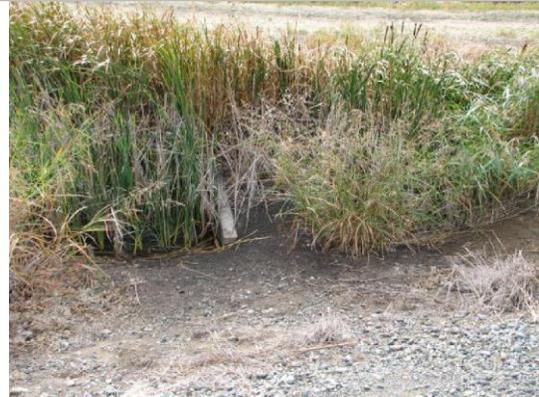
Photo 1 of 1 : UCIP_FA_2019_51996_68025.jpg

Comment Code					
Inspector Comment					
<p>DS_ID:1747 FS_ID:51996 EP_NO: N/A Repair Type: Non-Urgent Crossing Status: Indicator Found UCIP Comments: 5/16/2017 Pipe is buried on both sides of the levee. Unable to locate. (DWR Sutter Yard- AFreitag)11/15/2016 Buried on both sides of Levee. (DWR Sutter Yard - AFreitag)5/11/2016 Buried pipe.8/4/2015 Pipe is buried on both ends.6/11/2014 Same as last inspection.11/19/2013 Same as last inspection.5/29/2013 Same as last inspection.10/31/2012 Pipe burried on both LS and WS. FIELD_STRUCT_DESC: 48-inch corrugated metal irrigation pipe through the levee, at an unknown depth, indicator found. 48-inch corrugated metal riser and a sparring water meter/irrigation structure on the landside (LS). 4-foot by 6-foot concrete distribution box at the LS toe. [Additional Reference(s): USACE Sacramento O&M Manual, Unit 515 - Upper Butte Creek - Part No. 1, April 1955, (Station 836+86). USACE As-Built Drawing No. 50-4-2637, Exhibit B, Sheet 4, April 1950, (Station 836+85.70)]. FS Date: 5/31/2017 2:34:41 PM</p>

Buried pipe at concrete box, LS toe.

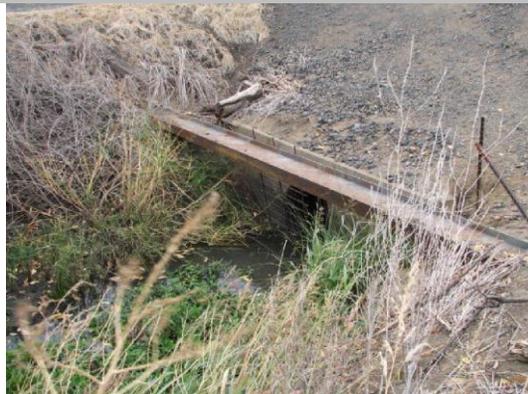
Photo 1 of 3 : UCIP_FA_2019_51999_68033.jpg

Comment Code					
Inspector Comment					
DS_ID:1639 FS_ID:51999 EP_NO: N/A Repair Type: Non-Urgent Crossing Status: Found UCIP Comments: 5/16/2017 Soil still eroded away from the WS wing walls. Pipe has been selected to be internally cleaned and inspected as part of the DMP project. (DWR Sutter Yard- AFreitag)11/15/2016 No soil supporting the WS wing walls. (DWR Sutter Yard- AFreitag)5/11/2016 Still no soil supporting the WS wing walls and apron. WS vegetation was thinner and not a problem this time.8/4/2015 No soil supporting the WS wing walls at the WS pipe end. WS pipe end is also being overgrown with vegetation and should be cleared back.6/11/2014 Same as last inspection.11/19/2013 Same as last inspection.5/29/2013 Same as last inspection.10/31/2012 Soil under Concrete wing walls on WS toe has been eroded. No soil supporting wing walls. FIELD_STRUCT_DESC: 36-inch corrugated metal drainage pipe through the levee, 13 feet below the crown. Flap gate on the waterside (WS). Concrete headwalls on the landside (LS) and the WS ends. [Additional Reference(s): DWR Levee Log, 1990 (HLM 14.66). USACE Sacramento O&M Manual 515, April 1955, (Station 978+25). USACE As-Built Drawing No. 50-4-2637, Exhibit B, Sheet 5, April 1950, (Station 978+24.95)]. FS Date: 5/31/2017 2:39:05 PM

Headwall at inlet on LS toe.

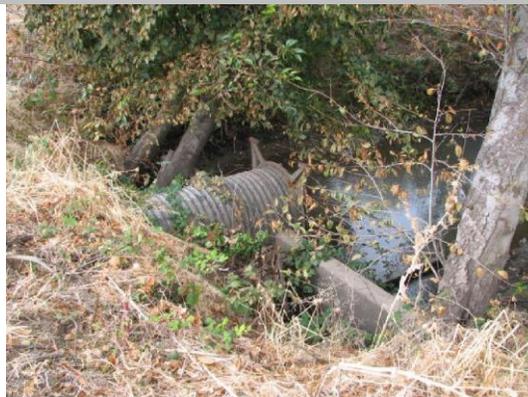
Photo 2 of 3 : UCIP_FA_2019_51999_68032.jpg

LM Start	14.46	Rating **	M	Issue No.	927 (cont)
LM End	14.46	Issue Type +	Ma	Location *

CMP pipe, flap gate, and headwall on WS toe.

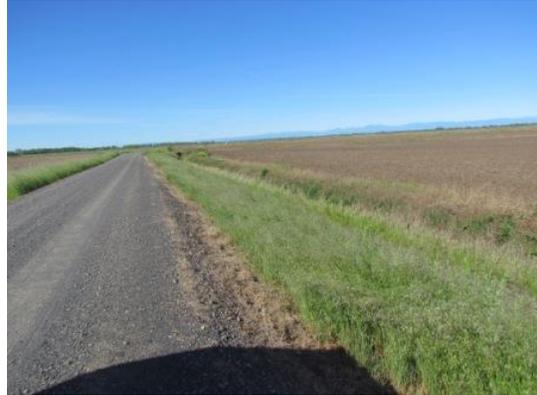
Photo 1 of 1 : FA_2019_MA0005_197_1_20190822_00001.jpg

LM Start	1.21	Rating **	M	Issue No.	1
LM End	1.59	Issue Type +	En	Location *	LS
Category	Earthen Levee			GPS Latitude/Longitude	
				Start	End
Item	Encroachments			39.529933 °	39.534102 °
				-121.861563 °	-121.856947 °
DWR ID	DWR_MA0005_02_s_2012_1				
Comment Code					
DT : Ditch					
Inspector Comment

View of the agricultural ditch along the landside toe.

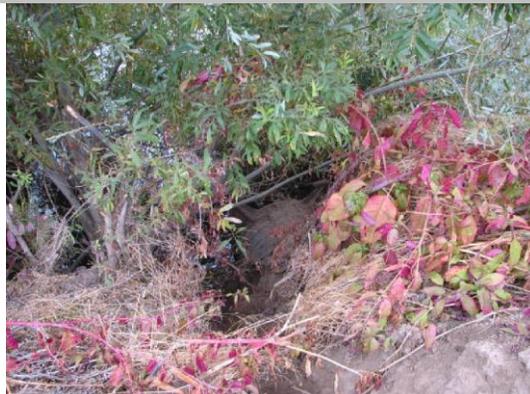
Photo 1 of 3 : UCIP_FA_2019_53009_68497.jpg

Comment Code					
Inspector Comment					
<p>DS_ID:1645 FS_ID:53009 EP_NO: N/A Repair Type: Urgent Crossing Status: Found UCIP Comments: 10/5/2018 Unable to see pipe on waterside due to high water level in the creek. Erosion is present around headwall on LS. Screw gate on LS blocked with silt approximately halfway in height. (O.Yakimov - DWR UCIP) 5/18/2017 LS erosion still present. Ws flap gate has been completely buried by sediment after the high water flows through the area. Pipe has been selected to be internally cleaned and inspected as part of the DMP project. (DWR Sutter Yard- AFreitag)11/14/2016 LS erosion still present and is into the prism of the levee. WS flap gate was still mostly buried and non-operational. (DWR Sutter Yard- AFreitag)5/23/2016 The tree that was overgrowing the WS flapgate has been removed. Flap gate was half buried and unable to open. Erosion on the LS is still present. (DWR Sutter Yard - afreitag)7/28/2015 LS inlet is underwater but there appears to be erosion behind the LS headwall. WS pipe end and flap gate are completely overgrown and inaccessible for inspection. (DWR Sutter Yard - afreitag)11/25/2014 Tree is overgrowing the WS pipe outlet.. Needs to be trimmed back. (DWR Sutter Yard - afreitag)6/4/2014 Same as last inspection. (DWR Sutter Yard - afreitag)11/12/2013 Same as last inspection. (DWR Sutter Yard - afreitag)6/6/2013 Same as last inspection. (DWR Sutter Yard - afreitag)10/31/2012 Vegetation needs to be cleared from outlet. (DWR UCIP - wwylie) FIELD_STRUCT_DESC: 36-inch corrugated metal drainage pipe through the levee, 17 feet below the crown. Flap gate on the waterside (WS). Slide gate on the landside (LS) toe. Concrete headwalls at both the LS and the WS toes. [Additional Reference(s): DWR Levee Log, 1990 (HLM 1.92). USACE Sacramento O&M Manual, Unit 515 - Upper Butte Creek - Part No. 1, (Station 902+50). USACE As-Built Drawing No. 50-4-2637, Exhibit B, Sheet 5, April 1950]. FS Date: 10/5/2018 11:20:19 AM</p>

Flap gate on WS slope.

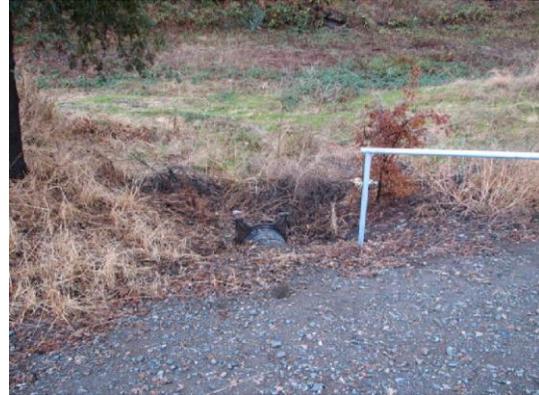
Photo 1 of 3 : UCIP_FA_2019_52049_68122.jpg

Comment Code					
Inspector Comment					
<p>DS_ID:1654 FS_ID:52049 EP_NO: N/A Repair Type: No Action Needed Crossing Status: Found UCIP Comments: 5/18/2017 Crossing appears to be in good condition. Pipe has been selected to be internally cleaned and inspected as part of the DMP project. (DWR Sutter Yard- AFreitag)11/14/2016 Crossing appears to be in good condition. (DWR Sutter Yard- AFreitag)5/23/2016 Crossing appears to be in good condition. 7/28/2015 Crossing appears in good condition. No noticeable issues to report. 11/24/2014 Same as last inspection. 6/04/2014 Same as last inspection. 11/12/2013 Same as last inspection. 6/6/2013 Same as last inspection. FIELD_STRUCT_DESC: 24-inch corrugated metal drainage pipe through the levee, 9.4 feet below the crown. Flap gate on the waterside (WS). Concrete headwalls at both the landside (LS) and the WS toes. [Additional Reference(s): DWR Levee Log, 1990 (HLM 6.56). USACE Sacramento O&M Manual, Unit 515 - Upper Butte Creek - Part No. 1, April 1955, (Station 627+00). USACE As-Built Drawing No. 50-4-2637, Exhibit B, Sheet 3, April 1950]. FS Date: 6/1/2017 1:10:07 PM</p>

Flap gate on WS toe.

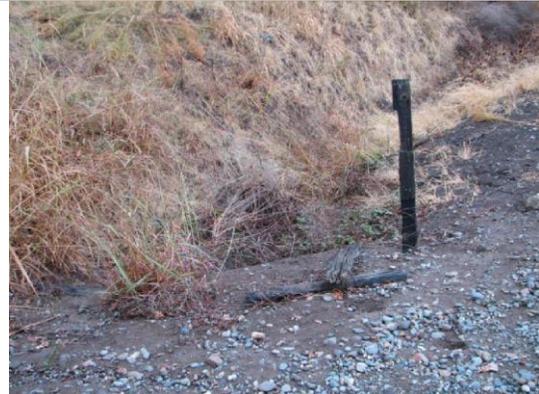
Photo 2 of 3 : UCIP_FA_2019_52049_68121.jpg

LM Start	6.47	Rating **	A/W	Issue No.	87 (cont)
LM End	6.47	Issue Type +	Ma	Location *

Headwall on LS toe.

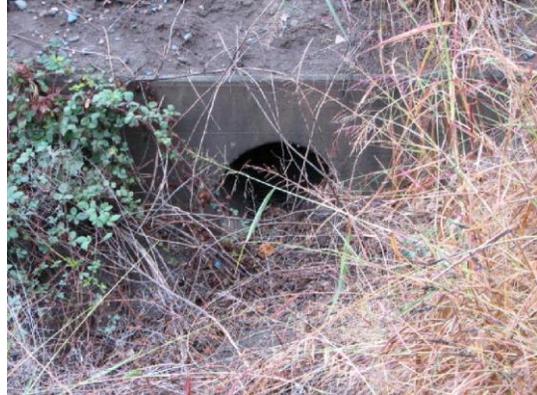
Photo 3 of 3 : UCIP_FA_2019_52049_68120.jpg

Comment Code					
Inspector Comment					
<p>DS_ID:1654 FS_ID:52049 EP_NO: N/A Repair Type: No Action Needed Crossing Status: Found UCIP Comments: 5/18/2017 Crossing appears to be in good condition. Pipe has been selected to be internally cleaned and inspected as part of the DMP project. (DWR Sutter Yard- A Freitag)11/14/2016 Crossing appears to be in good condition. (DWR Sutter Yard- A Freitag)5/23/2016 Crossing appears to be in good condition. 7/28/2015 Crossing appears in good condition. No noticeable issues to report. 11/24/2014 Same as last inspection. 6/04/2014 Same as last inspection. 11/12/2013 Same as last inspection. 6/6/2013 Same as last inspection. FIELD_STRUCT_DESC: 24-inch corrugated metal drainage pipe through the levee, 9.4 feet below the crown. Flap gate on the waterside (WS). Concrete headwalls at both the landside (LS) and the WS toes. [Additional Reference(s): DWR Levee Log, 1990 (HLM 6.56). USACE Sacramento O&M Manual, Unit 515 - Upper Butte Creek - Part No. 1, April 1955, (Station 627+00). USACE As-Built Drawing No. 50-4-2637, Exhibit B, Sheet 3, April 1950]. FS Date: 6/1/2017 1:10:07 PM</p>

Headwall on LS toe.

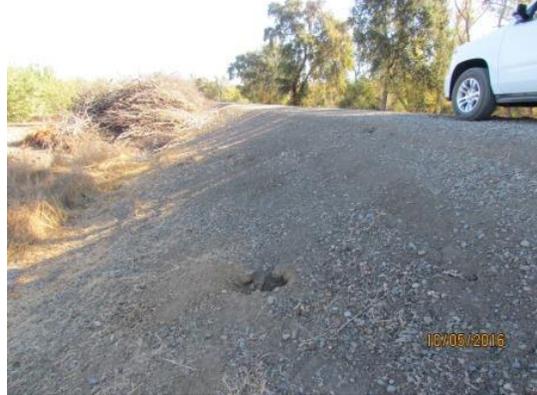
Photo 1 of 2 : FA_2019_MA0005_197_53_20190822_00025.jpg

LM Start	7.74	Rating **	U	Issue No.	53
LM End	7.74	Issue Type +	Ma	Location *	LS
Category	Earthen Levee			GPS Latitude/Longitude	
				Start	End
Item	Animal Control			39.605088°	39.605088°
				-121.788569°	-121.788569°
DWR ID	DWR_MA0005_02_f_2016_53				
Comment Code					
A3 : No rodents visible, but rodent burrows visible; need to backfill and compact or grout burrows.					
Inspector Comment

View of the rodent holes along the landside slope.

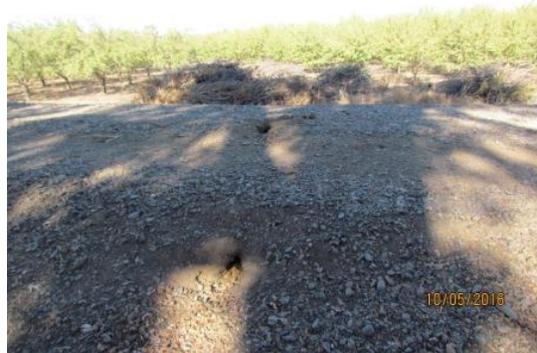
Photo 2 of 2 : FA_2019_MA0005_197_53_20190822_00026.jpg

LM Start	7.74	Rating **	U	Issue No.	53 (cont)
LM End	7.74	Issue Type +	Ma	Location *	LS

View of the rodent holes along the crown and waterside slope.

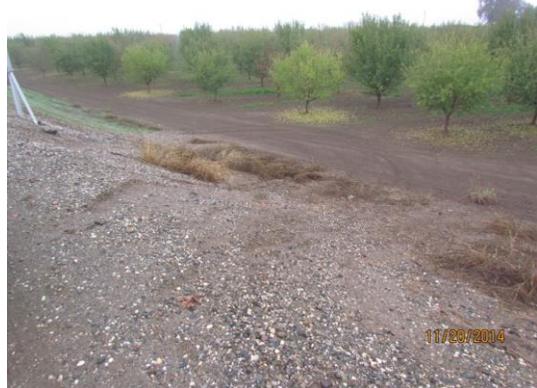
Photo 2 of 2 : FA_2019_MA0005_197_13_20190822_00007.jpg

LM Start	7.98	Rating **	M	Issue No.	13 (cont)
LM End	7.98	Issue Type +	Ma	Location *	LS
Category	Earthen Levee			GPS Latitude/Longitude	
				Start	End
Item	Slope Stability			39.607710°	39.607710°
				-121.785868°	-121.785868°
DWR ID	DWR_MA0005_02_s_2012_13				
Comment Code					
S3 : Repair the levee slope damaged by vehicle traffic and prevent access where possible.					
Inspector Comment

View of the vehicle erosion along the landside slope.

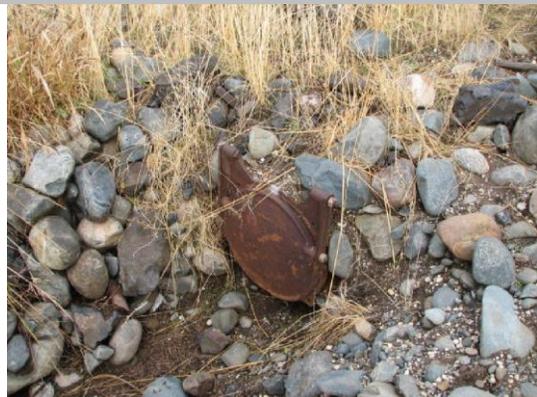
Photo 1 of 2 : UCIP_FA_2019_52052_68129.jpg

Comment Code					
Inspector Comment					
DS_ID:1656 FS_ID:52052 EP_NO: N/A Repair Type: Non-Urgent Crossing Status: Found UCIP Comments: 5/18/2017 LS inlet is almost completely full of soil. Pipe has been selected to be internally cleaned and inspected as part of the DMP project. (DWR Sutter Yard- AFreitag)11/14/2016 LS inlet almost completely full of soil. (DWR Sutter Yard- AFreitag)5/23/2016 LS end is almost completel full of soil.7/28/2015 Pipe is still over 3/4 full of soil. 11/24/2014 Same as last inspection.6/04/2014 Same as last inspection.11/12/2013 Same as last inspection.6/6/2013 Same as last inspection.10/31/2012 Pipe 3/4 full with soil on LS. FIELD_STRUCT_DESC: 18-inch corrugated metal drainage pipe through the levee at an unknown depth below the crown. Concrete headwall at the landside (LS) toe. Flap gate on the waterside (WS). [Additional Reference(s): USACE Sacramento O&M Manual, Unit 515 - Upper Butte Creek - Part No. 1, April 1955, pipe referenced only in USACE As-Built Drawing No. 50-4-2637, Exhibit B, Sheet 2, April 1950, (Station 550+42)]. FS Date: 6/1/2017 1:15:55 PM

Flap gate at WS toe.

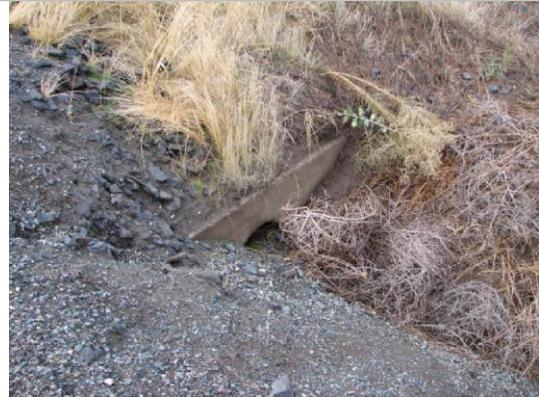
Photo 2 of 2 : UCIP_FA_2019_52052_68128.jpg

Comment Code					
Inspector Comment					
<p>DS_ID:1656 FS_ID:52052 EP_NO: N/A Repair Type: Non-Urgent Crossing Status: Found UCIP Comments: 5/18/2017 LS inlet is almost completely full of soil. Pipe has been selected to be internally cleaned and inspected as part of the DMP project. (DWR Sutter Yard- AFreitag)11/14/2016 LS inlet almost completely full of soil. (DWR Sutter Yard- AFreitag)5/23/2016 LS end is almost completel full of soil.7/28/2015 Pipe is still over 3/4 full of soil. 11/24/2014 Same as last inspection.6/04/2014 Same as last inspection.11/12/2013 Same as last inspection.6/6/2013 Same as last inspection.10/31/2012 Pipe 3/4 full with soil on LS. FIELD_STRUCT_DESC: 18-inch corrugated metal drainage pipe through the levee at an unknown depth below the crown. Concrete headwall at the landside (LS) toe. Flap gate on the waterside (WS). [Additional Reference(s): USACE Sacramento O&M Manual, Unit 515 - Upper Butte Creek - Part No. 1, April 1955, pipe referenced only in USACE As-Built Drawing No. 50-4-2637, Exhibit B, Sheet 2, April 1950, (Station 550+42)]. FS Date: 6/1/2017 1:15:55 PM</p>

Concrete headwall on LS toe.

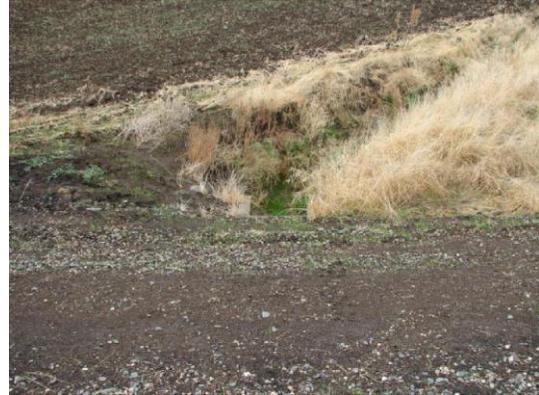
Photo 1 of 3 : UCIP_FA_2019_52059_68394.jpg

Comment Code					
Inspector Comment					
DS_ID:1662 FS_ID:52059 EP_NO: N/A Repair Type: No Action Needed Crossing Status: Found UCIP Comments: 5/18/2017 Crossing appears to be in good condition. Pipe has been selected to be internally cleaned and inspected as part of the DMP project. (DWR Sutter Yard- AFreitag)11/14/2016 Crossing appears to be in good condition. (DWR Sutter Yard- AFreitag)5/12/2016 Crossing appears to be in good condition.7/30/2015 Crossing is in good condition. No noticeable issues to report.11/24/2014 Same as last inspection.6/4/2014 Same as last inspection.11/13/2013 Same as last inspection..6/6/2013 Same as last inspection. FIELD_STRUCT_DESC: 30-inch corrugated metal drainage pipe through the levee, 16.3 feet below the crown. Flap gate on the waterside (WS). Concrete "U" shaped headwalls on both the landside (LS) and the WS. [Additional Reference(s): DWR Levee Log, 1990 (HLM 8.21). USACE Sacramento O&M Manual, Unit 516 - Upper Butte Creek - Part No. 2, April 1960, (Station 374+90). USACE As-Built Drawing No. 50-4-3367, Exhibit B, Sheet 13, April 1957]. FS Date: 6/1/2017 1:25:58 PM

Concrete inlet on LS toe.

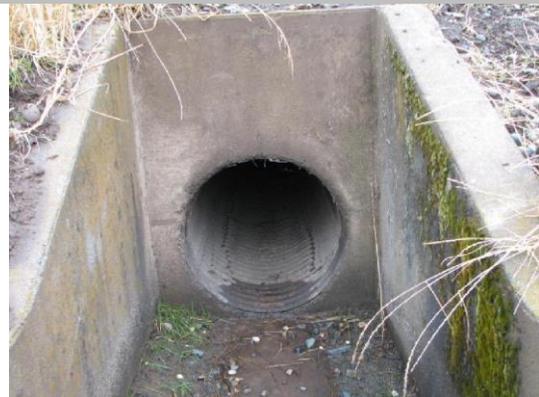
Photo 2 of 3 : UCIP_FA_2019_52059_68393.jpg

LM Start	8.11	Rating **	A/W	Issue No.	89 (cont)
LM End	8.11	Issue Type +	Ma	Location *

Concrete inlet on LS toe.

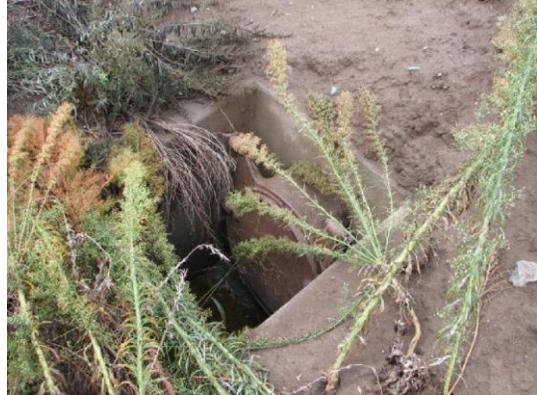
Photo 3 of 3 : UCIP_FA_2019_52059_68392.jpg

Comment Code					
Inspector Comment					
DS_ID:1662 FS_ID:52059 EP_NO: N/A Repair Type: No Action Needed Crossing Status: Found UCIP Comments: 5/18/2017 Crossing appears to be in good condition. Pipe has been selected to be internally cleaned and inspected as part of the DMP project. (DWR Sutter Yard- AFreitag)11/14/2016 Crossing appears to be in good condition. (DWR Sutter Yard- AFreitag)5/12/2016 Crossing appears to be in good condition.7/30/2015 Crossing is in good condition. No noticeable issues to report.11/24/2014 Same as last inspection.6/4/2014 Same as last inspection.11/13/2013 Same as last inspection..6/6/2013 Same as last inspection. FIELD_STRUCT_DESC: 30-inch corrugated metal drainage pipe through the levee, 16.3 feet below the crown. Flap gate on the waterside (WS). Concrete "U" shaped headwalls on both the landside (LS) and the WS. [Additional Reference(s): DWR Levee Log, 1990 (HLM 8.21). USACE Sacramento O&M Manual, Unit 516 - Upper Butte Creek - Part No. 2, April 1960, (Station 374+90). USACE As-Built Drawing No. 50-4-3367, Exhibit B, Sheet 13, April 1957]. FS Date: 6/1/2017 1:25:58 PM

Concrete outlet and flap gate on WS toe.

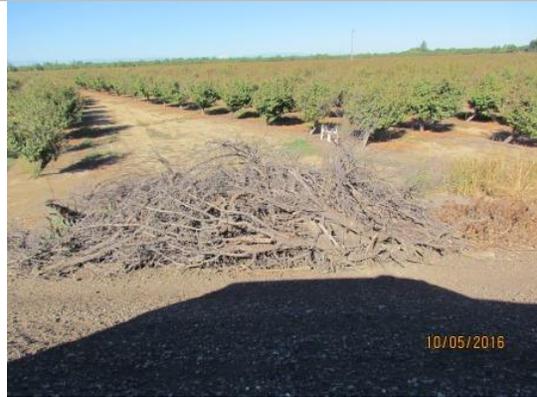
Photo 1 of 1 : FA_2019_MA0005_197_47_20190822_00022.jpg

LM Start	8.67	Rating **	M	Issue No.	47
LM End	8.67	Issue Type +	En	Location *	LS
Category	Earthen Levee		GPS Latitude/Longitude		
			Start	End	
Item	Encroachments		39.616370°	39.616370°	
			-121.779779°	-121.779779°	
DWR ID	DWR_MA0005_02_s_2016_47				
Comment Code					
PR : Prunings					
Inspector Comment					
Remove the prunings from the landside slope.

View of the prunings along the landside toe.

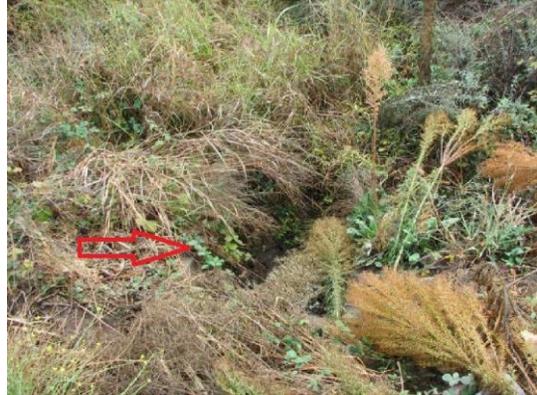
Photo 3 of 3 : UCIP_FA_2019_52061_68395.jpg

Comment Code					
Inspector Comment					
<p>DS_ID:1663 FS_ID:52061 EP_NO: N/A Repair Type: No Action Needed Crossing Status: Found UCIP Comments: 5/18/2017 Crossing appears to be in good condition. Pipe has been selected to be internally cleaned and inspected as part of the DMP project. (DWR Sutter Yard- AFreitag)11/14/2016 Crossing appears to be in good condition. (DWR Sutter Yard- AFreitag)5/12/2016 Crossing appears to be in good condition. 7/30/2015 Crossing appears in good condition. No noticeable issues to report. 11/24/2014 Same as last inspection. 6/4/2014 Same as last inspection. 11/13/2013 Damaged pipe section was dug up and replaced. New WS flapgates with u-shaped wingwall installed on end of pipe. 6/6/2013 Same as last inspection. Plans have been made to repair during summer of 2013 before high water season. 11/01/2012 Pipe rusted through along bottom at WS outlet. Sink hole over pipe on WS berm. WS headwall eroded eternally around backside of headwall. FIELD_STRUCT_DESC: 24-inch corrugated metal drainage pipe through the levee, 15 feet below the crown. Flap gate on the waterside (WS). Concrete headwalls on both the landside (LS) and the WS. [Additional Reference(s): DWR Levee Log, 1990 (HLM 8.89). USACE Sacramento O&M Manual, Unit 516 - Upper Butte Creek - Part No. 2, April 1960, pipe is only referenced in USACE As-Built Drawing No. 50-4-3367, Exhibit B, Sheet 11, (Station 340+04)]. FS Date: 6/1/2017 1:27:46 PM</p>

Concrete U shaped outlet and flap gate at WS of Berm.

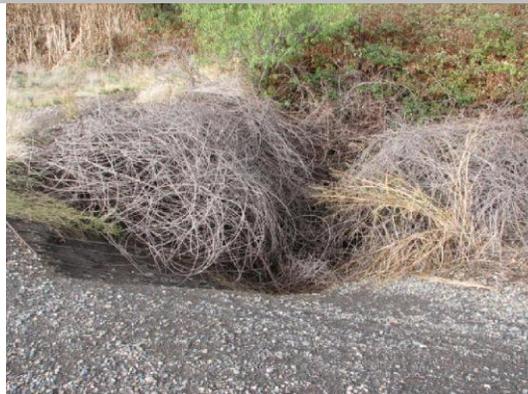
Photo 2 of 3 : UCIP_FA_2019_52062_68404.jpg

Comment Code					
Inspector Comment					
<p>DS_ID:1664 FS_ID:52062 EP_NO: N/A Repair Type: Non-Urgent Crossing Status: Found UCIP Comments: 5/18/2017 No LS slide gate but not sure its even needed. Pipe has been selected to be internally cleaned and inspected as part of the DMP project. (DWR Sutter Yard- AFreitag)11/14/2016 LS slide gate still missing. Rest of crossing appears in good condition. (DWR Sutter Yard- AFreitag)5/12/2016 LS inlet was unburied. Slide gate still missing7/30/2015 LS inlet is still buried.11/24/2014 Same as last inspection.6/4/2014 Same as last inspection.11/13/2013 Same as last inspection.6/6/2013 Same as last inspection.11/01/2012 LS inlet is buried under soil and covered with brambles. Slide gate missing from LS. FIELD_STRUCT_DESC: 24-inch corrugated metal drainage pipe through the levee, 12 feet below the crown. Flap gate on the waterside (WS). Concrete headwall on the WS. Concrete headwall on the landside (LS), not found. [Additional Reference(s): DWR Levee Log, 1990 (HLM 8.93). USACE Sacramento O&M Manual, Unit 516 - Upper Butte Creek - Part No. 2, April 1960, (Station 338+04). USACE As-Built Drawing No. 50-4-3367, Exhibit B, Sheet 11, April 1957]. FS Date: 6/1/2017 1:29:34 PM</p>

Brambles and soil over pipe at inlet.

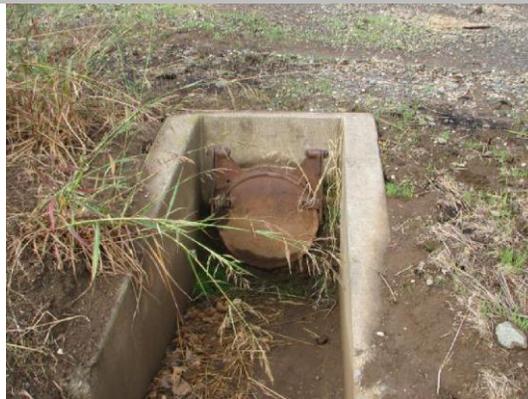
Photo 3 of 3 : UCIP_FA_2019_52062_68403.jpg

LM Start	8.80	Rating **	M	Issue No.	91 (cont)
LM End	8.80	Issue Type +	Ma	Location *

Concrete U shaped headwall and flap gate at WS toe.

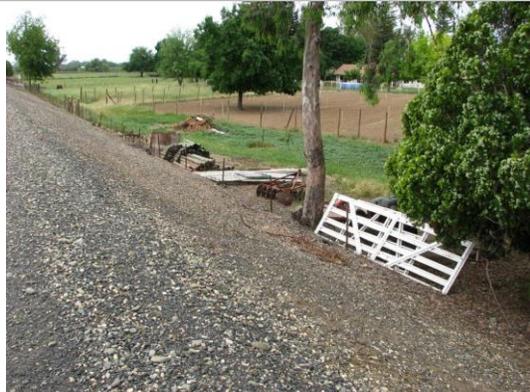
Photo 1 of 1 : FA_2019_MA0005_197_45_20190822_00020.jpg

LM Start	9.09	Rating **	M	Issue No.	45
LM End	9.09	Issue Type +	En	Location *	LS
Category	Earthen Levee			GPS Latitude/Longitude	
				Start	End
Item	Encroachments			39.622017°	39.622017°
				-121.776552°	-121.776552°
DWR ID	DWR_MA0005_02_s_2016_45				
Comment Code					
EQ : Equipment					
Inspector Comment					
Materials and equipment should be removed from the landside toe.

View of equipment and materials from the landside toe.

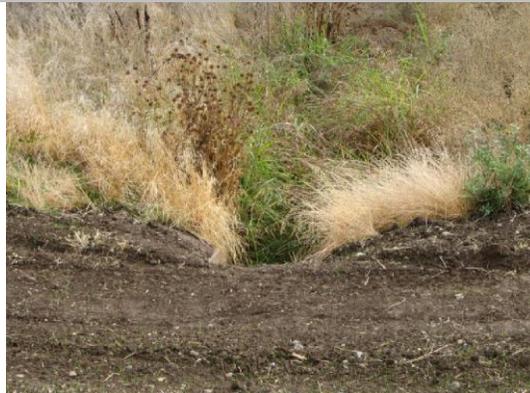
Photo 1 of 3 : UCIP_FA_2019_52063_68413.jpg

LM Start	9.12	Rating **	A/W	Issue No.	92
LM End	9.12	Issue Type +	Ma	Location *	
Category	Supplemental			GPS Latitude/Longitude	
				Start	End
Item	DRAFT DWR UCIP LMA Responsibility			39.622377°	39.622377°
				-121.776327°	-121.776327°
DWR ID	1665

Comment Code					
Inspector Comment					
<p>DS_ID:1665 FS_ID:52063 EP_NO: N/A Repair Type: No Action Needed Crossing Status: Found UCIP Comments: 5/18/2017 Crossing appears to be in good condition. Pipe has been selected to be internally cleaned and inspected as part of the DMP project. (DWR Sutter Yard- AFreitag)11/14/2016 Crossing appears to be in good condition. (DWR Sutter Yard- AFreitag)5/12/2016 Crossing appears to be in good condition.7/30/2015 Crossing appears in good condition. No noticeable issues to report.11/24/2014 Same as last inspection.6/4/2014 Same as last inspection.11/13/2013 Same as last inspection.6/6/2013 Same as last inspection. FIELD_STRUCT_DESC: 24-inch corrugated metal drainage pipe through the levee, 11.3 feet below the crown. Flap gate on the waterside (WS). Concrete headwalls on both the landside (LS) and the WS. [Additional Reference(s): DWR Levee Log, 1990 (HLM 9.25). USACE Sacramento O&M Manual, Unit 516 - Upper Butte Creek - Part No. 2, April 1960, (Station 321+20)]. FS Date: 6/1/2017 1:32:51 PM</p>

Concrete U shaped headwall and flap gate on WS toe.

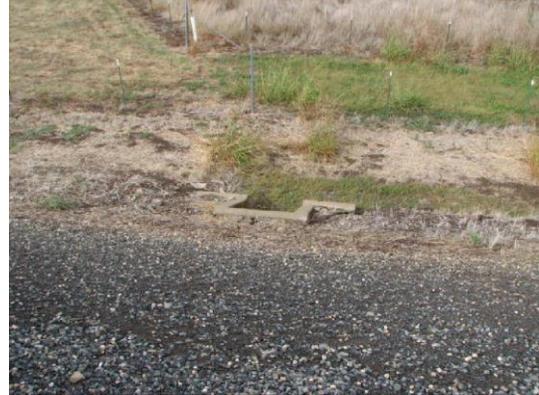
Photo 2 of 3 : UCIP_FA_2019_52063_68412.jpg

Comment Code					
Inspector Comment					
<p>DS_ID:1665 FS_ID:52063 EP_NO: N/A Repair Type: No Action Needed Crossing Status: Found UCIP Comments: 5/18/2017 Crossing appears to be in good condition. Pipe has been selected to be internally cleaned and inspected as part of the DMP project. (DWR Sutter Yard- AFreitag)11/14/2016 Crossing appears to be in good condition. (DWR Sutter Yard- AFreitag)5/12/2016 Crossing appears to be in good condition.7/30/2015 Crossing appears in good condition. No noticeable issues to report.11/24/2014 Same as last inspection.6/4/2014 Same as last inspection.11/13/2013 Same as last inspection.6/6/2013 Same as last inspection. FIELD_STRUCT_DESC: 24-inch corrugated metal drainage pipe through the levee, 11.3 feet below the crown. Flap gate on the waterside (WS). Concrete headwalls on both the landside (LS) and the WS. [Additional Reference(s): DWR Levee Log, 1990 (HLM 9.25). USACE Sacramento O&M Manual, Unit 516 - Upper Butte Creek - Part No. 2, April 1960, (Station 321+20)]. FS Date: 6/1/2017 1:32:51 PM</p>

Concrete U shaped headwall on LS toe.

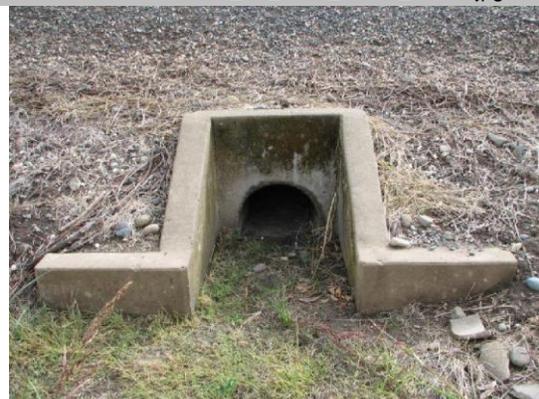
Photo 3 of 3 : UCIP_FA_2019_52063_68411.jpg

LM Start	9.12	Rating **	A/W	Issue No.	92 (cont)
LM End	9.12	Issue Type +	Ma	Location *

Concrete U shaped headwall on LS toe.

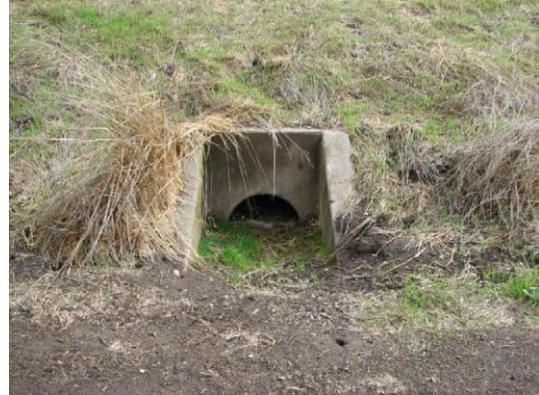
Photo 3 of 3 : UCIP_FA_2019_52064_68415.jpg

Comment Code					
Inspector Comment					
<p>DS_ID:1666 FS_ID:52064 EP_NO: N/A Repair Type: Non-Urgent Crossing Status: Found UCIP Comments: 5/18/2017 LS inlet half full of soil and WS flap gate half buried by sediment. Pipe has been selected to be internally cleaned and inspected as part of the DMP project. (DWR Sutter Yard-AFreitag)11/14/2016 LS pipe inlet is half full of soil. WS flap gate shut but half buried by sediment. (DWR Sutter Yard-AFreitag)5/12/2016 Pipe is half full of soil.7/30/2015 Pipe is 1/4 to 1/2 full of soil still.11/24/2014 Same as last inspection.6/4/2014 Same as last inspection.11/13/2013 Same as last inspection.6/6/2013 Same as last inspection.11/01/2012 Pipe 1/2 filled with soil. FIELD_STRUCT_DESC: 24-inch corrugated metal drainage pipe through the levee, 11.2 feet below the crown. Flap gate on the waterside (WS). Concrete "U" shaped headwalls on both the landside (LS) and the WS. [Additional Reference(s): DWR Levee Log, 1990 (HLM 9.57). USACE Sacramento O&M Manual, Unit 516 - Upper Butte Creek - Part No. 2, April 1960, (Station 304+10). USACE As-Built Drawing No. 50-4-3367, Exhibit B, Sheet 3, April 1957]. FS Date: 6/1/2017 1:34:12 PM</p>

Concrete U-shaped headwall on LS toe.

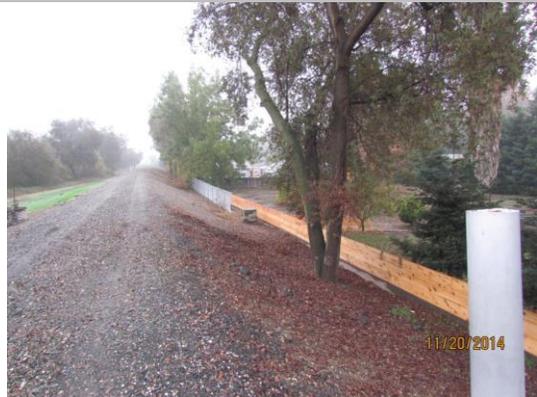
Photo 1 of 1 : FA_2019_MA0005_197_41_20190822_00017.jpg

LM Start	10.90	Rating **	U	Issue No.	41
LM End	10.93	Issue Type +	En	Location *	LS
Category	Earthen Levee		GPS Latitude/Longitude		
			Start	End	
Item	Encroachments		39.645508°	39.645508°	
			-121.786515°	-121.786742°	
DWR ID	DWR_MA0005_02_f_2014_41				
Comment Code					
FE : Fence					
Inspector Comment					
Remove or apply for permit for the fence along landside toe

View of the new fence along the landside toe.
