**Flood Control Project Maintenance
Levee Inspections**

Fall 2019 Levee Maintenance Deficiency Summary Report

**Flood Control Project Maintenance
Levee Inspections
LMA District Cover Sheet
Fall 2019 Levee Inspection Results**

Sutter Maintenance Yard Maintenance Area 0005

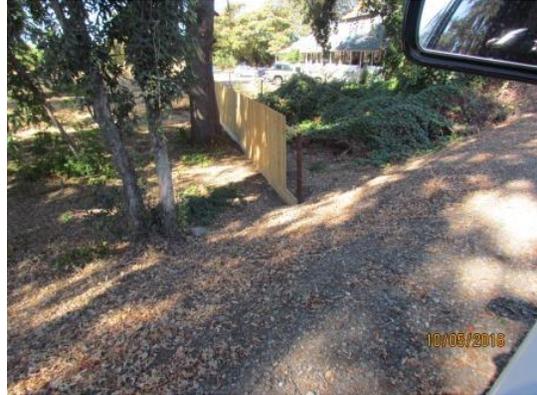
Photo 1 of 1 : FA_2019_MA0005_197_60_20190822_00029.jpg

LM Start	10.98	Rating **	U	Issue No.	60
LM End	11.04	Issue Type +	En	Location *	LS
Category	Earthen Levee		GPS Latitude/Longitude		
			Start	End	
Item	Encroachments		39.646523°	39.647238°	
			-121.787310°	-121.787866°	
DWR ID	DWR_MA0005_02_f_2016_60				
Comment Code					
FE : Fence					
Inspector Comment					
Apply for permit or remove the fence from the landside toe.

Fence now extends along LS toe, parallel to the levee.

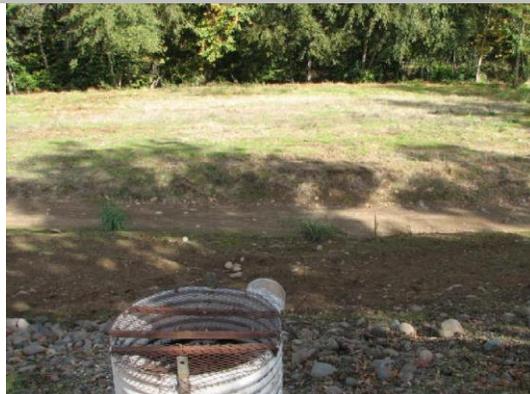
Photo 1 of 3 : UCIP_FA_2019_52069_68429.jpg

Comment Code					
Inspector Comment					
DS_ID:1670 FS_ID:52069 EP_NO: N/A Repair Type: Non-Urgent Crossing Status: Found UCIP Comments: 5/18/2017 Appears abandoned- Slide gates in WS riser and LS distribution box missing. Pipe has been selected to be internally cleaned and inspected as part of the DMP project. (DWR Sutter Yard- AFreitag)11/14/2016 Appears abandoned- Slide gates in WS riser and LS distribution box missing. (DWR Sutter Yard- AFreitag)5/11/2016 Crossing appears to be in good condition.7/30/2015 Crossing appears in good condition. No noticeable issues to report.11/24/2014 Same as last inspection.6/4/2014 Same as last inspection.11/13/2013 Same as last inspection.6/6/2013 New flap gate installed on WS end of pipe. FIELD_STRUCT_DESC: 24-inch corrugated metal irrigation pipe through the levee, 9.7 feet below the crown. Slide gate in corrugated metal riser on the waterside (WS) slope. Flap gate on the WS toe. Slide gate in concrete distribution box on the landside (LS). [Additional Reference(s): DWR Levee Log, 1990 (HLM 11.27). USACE Sacramento O&M Manual, Unit 516 - Upper Butte Creek - Part No. 2, April 1960, (Station 215+65), 20-inch pipe referenced. USACE As-Built Drawing No. 50-4-3367, Exhibit B, Sheet 2, April 1957, drawing shows 18-inch pipe]. FS Date: 6/1/2017 1:43:12 PM

CM riser on WS shoulder-missing slide gate.

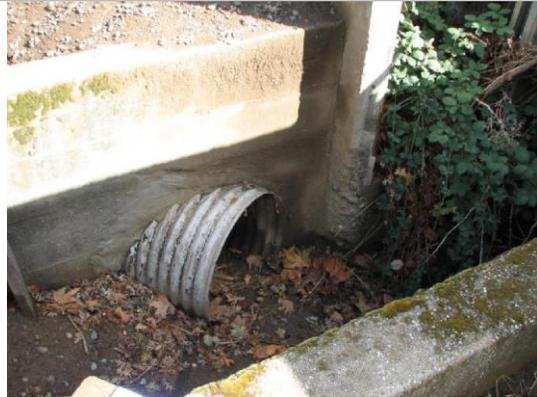
Photo 1 of 3 : UCIP_FA_2019_52070_68436.jpg

Comment Code					
Inspector Comment					
<p>DS_ID:1671 FS_ID:52070 EP_NO: N/A Repair Type: Non-Urgent Crossing Status: Found UCIP Comments: 5/18/2017 Abandoned- WS end still buried. (DWR Sutter Yard- AFreitag)11/14/2016 Appears abandoned. (DWR Sutter Yard- AFreitag)5/11/2016 Abandoned crossing7/30/2015 Abandoned crossing. Unable to locate the WS end of pipe.11/24/2014 Same as last inspection.6/4/2014 Same as last inspection.11/13/2013 Same as last inspection.6/6/2013 Same as last inspection.11/01/2012 Pipe appears abandoned. It needs to be abandoned properly. FIELD_STRUCT_DESC: 30-inch corrugated metal irrigation pipe through the levee, 9.4 feet below the crown. Slide gate in a 42-inch corrugated metal riser on the waterside (WS) slope. Concrete distribution box on the landside (LS). [Additional Reference(s): DWR Levee Log, 1990 (HLM 11.27). USACE Sacramento O&M Manual, Unit 516 - Upper Butte Creek - Part No. 2, April 1960, (Station 215+46)]. FS Date: 6/1/2017 1:45:09 PM</p>

Pipe at concrete distribution box on LS toe.

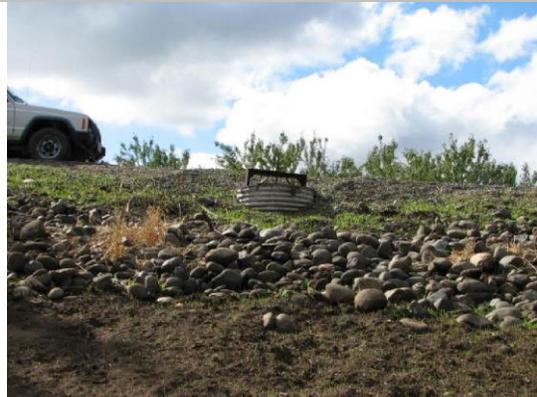
Photo 2 of 3 : UCIP_FA_2019_52070_68435.jpg

LM Start	11.12	Rating **	M	Issue No.	95 (cont)
LM End	11.12	Issue Type +	En	Location *

CM riser with slide gate on WS shoulder.

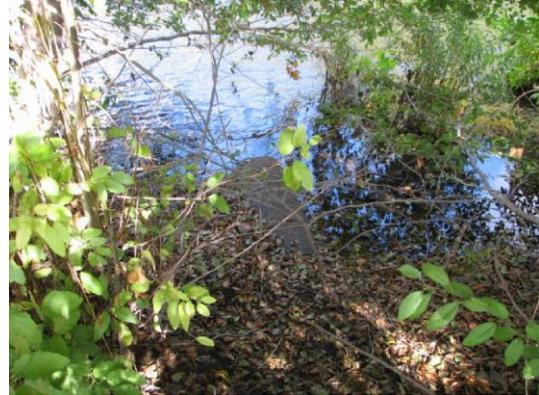
Photo 3 of 3 : UCIP_FA_2019_52070_68434.jpg

Comment Code					
Inspector Comment					
<p>DS_ID:1671 FS_ID:52070 EP_NO: N/A Repair Type: Non-Urgent Crossing Status: Found UCIP Comments: 5/18/2017 Abandoned- WS end still buried. (DWR Sutter Yard- AFreitag)11/14/2016 Appears abandoned. (DWR Sutter Yard- AFreitag)5/11/2016 Abandoned crossing7/30/2015 Abandoned crossing. Unable to locate the WS end of pipe.11/24/2014 Same as last inspection.6/4/2014 Same as last inspection.11/13/2013 Same as last inspection.6/6/2013 Same as last inspection.11/01/2012 Pipe appears abandoned. It needs to be abandoned properly. FIELD_STRUCT_DESC: 30-inch corrugated metal irrigation pipe through the levee, 9.4 feet below the crown. Slide gate in a 42-inch corrugated metal riser on the waterside (WS) slope. Concrete distribution box on the landside (LS). [Additional Reference(s): DWR Levee Log, 1990 (HLM 11.27). USACE Sacramento O&M Manual, Unit 516 - Upper Butte Creek - Part No. 2, April 1960, (Station 215+46)]. FS Date: 6/1/2017 1:45:09 PM</p>

Concrete pipe at edge of creek on WS.

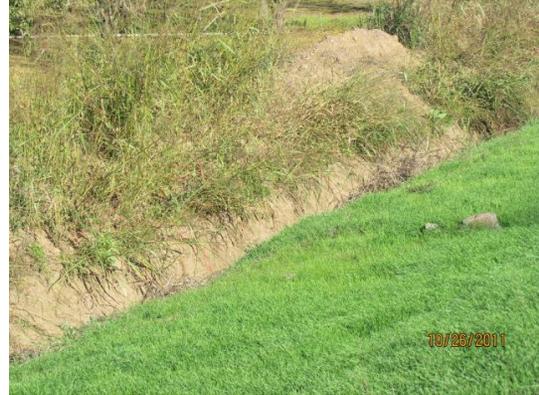
Photo 1 of 1 : FA_2019_MA0005_197_6_20190822_00003.jpg

LM Start	11.77	Rating **	M	Issue No.	6
LM End	11.77	Issue Type +	En	Location *	LS
Category	Earthen Levee			GPS Latitude/Longitude	
				Start	End
Item	Encroachments			39.650046°	39.657142°
				-121.789945°	-121.788690°
DWR ID	DWR_MA0005_02_s_2012_6				
Comment Code					
DT : Ditch					
Inspector Comment

View of the ditch along the landside toe.

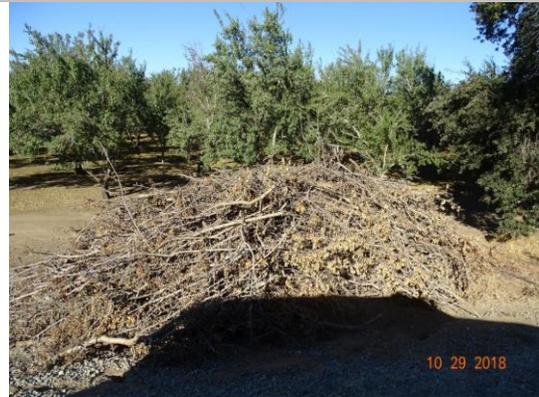
Photo 1 of 1 : FA_2019_MA0005_197_70_20190822_00035.jpg

LM Start	11.77	Rating **	M	Issue No.	70
LM End	11.77	Issue Type +	En	Location *	LS
Category	Earthen Levee			GPS Latitude/Longitude	
				Start	End
Item	Encroachments			39.657115°	39.657115°
				-121.788703°	-121.788703°
DWR ID	DWR_MA0005_02_f_2018_70				
Comment Code					
PR : Prunings					
Inspector Comment					
Remove the prunings from the landside toe.

View of the prunings along the landside toe.

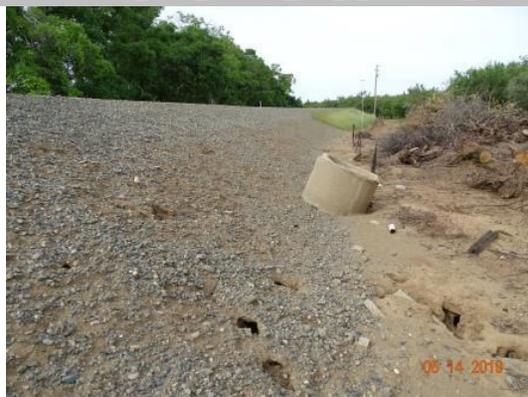
Photo 1 of 1 : FA_2019_MA0005_197_9_20190822_00005.jpg

LM Start	12.84	Rating **	M	Issue No.	9
LM End	12.84	Issue Type +	Ma	Location *	LS
Category	Earthen Levee			GPS Latitude/Longitude	
				Start	End
Item	Animal Control			39.671281°	39.671281°
				-121.782390°	-121.782389°
DWR ID	DWR_MA0005_02_s_2019_9				
Comment Code					
A3 : No rodents visible, but rodent burrows visible; need to backfill and compact or grout burrows.					
Inspector Comment

View of the animal burrows on the landside slope. Spring 2019.

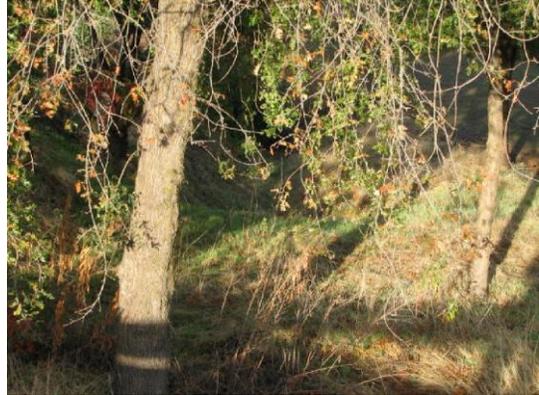
Photo 1 of 3 : UCIP_FA_2019_52083_68531.jpg

Comment Code					
Inspector Comment					
DS_ID:1679 FS_ID:52083 EP_NO: N/A Repair Type: No Action Needed Crossing Status: Found UCIP Comments: 5/18/2017 Crossing appears to be in good condition. Pipe has been selected to be internally cleaned and inspected as part of the DMP project. (DWR Sutter Yard- AFreitag)11/14/2016 Crossing appears to be in good condition. (DWR Sutter Yard- AFreitag)5/11/2016 Crossing appears to be in good condition. 8/3/2015 Crossing appears in good condition. No noticeable issues to report. 11/25/2014 Same as last inspection. 6/4/2014 Same as last inspection. 11/13/2013 Same as last inspection. 6/6/2013 Same as last inspection. FIELD_STRUCT_DESC: 24-inch corrugated metal drainage pipe through the levee, 14.5 feet below the crown. Concrete "U" shaped headwall on the waterside (WS). Flap gate on the WS. [Additional Reference(s): DWR Levee Log, 1990 (HLM 13.61). USACE Sacramento O&M Manual, Unit 516 - Upper Butte Creek - Part No. 2, April 1960, (Station 93+78)]. FS Date: 6/1/2017 2:09:55 PM

Inlet relocated after bridge replacement away from LS toe.

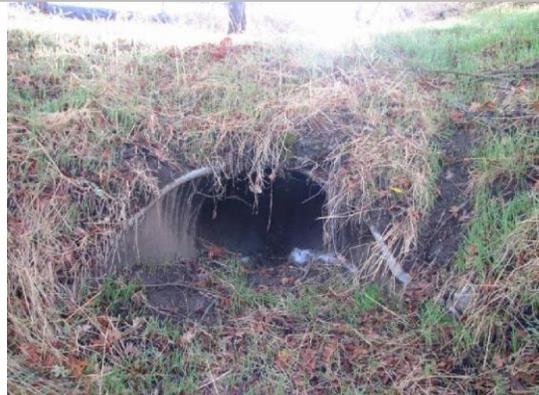
Photo 2 of 3 : UCIP_FA_2019_52083_68530.jpg

LM Start	13.40	Rating **	A/W	Issue No.	99 (cont)
LM End	13.40	Issue Type +	Ma	Location *

Inlet 50-feet NW of levee crown.

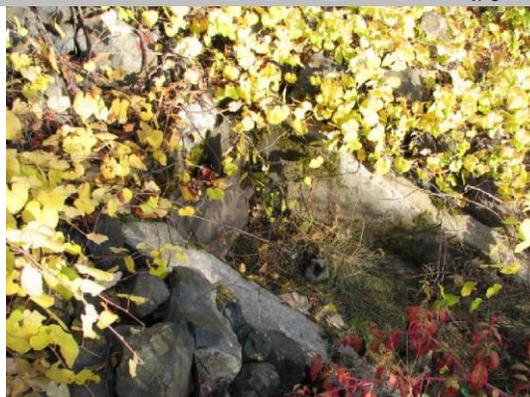
Photo 3 of 3 : UCIP_FA_2019_52083_68533.jpg

Comment Code					
Inspector Comment					
DS_ID:1679 FS_ID:52083 EP_NO: N/A Repair Type: No Action Needed Crossing Status: Found UCIP Comments: 5/18/2017 Crossing appears to be in good condition. Pipe has been selected to be internally cleaned and inspected as part of the DMP project. (DWR Sutter Yard- AFreitag)11/14/2016 Crossing appears to be in good condition. (DWR Sutter Yard- AFreitag)5/11/2016 Crossing appears to be in good condition.8/3/2015 Crossing appears in good condition. No noticeable issues to report.11/25/2014 Same as last inspection.6/4/2014 Same as last inspection.11/13/2013 Same as last inspection.6/6/2013 Same as last inspection. FIELD_STRUCT_DESC: 24-inch corrugated metal drainage pipe through the levee, 14.5 feet below the crown. Concrete "U" shaped headwall on the waterside (WS). Flap gate on the WS. [Additional Reference(s): DWR Levee Log, 1990 (HLM 13.61). USACE Sacramento O&M Manual, Unit 516 - Upper Butte Creek - Part No. 2, April 1960, (Station 93+78)]. FS Date: 6/1/2017 2:09:55 PM

Concrete U-shaped headwall and flap gate at WS slope.

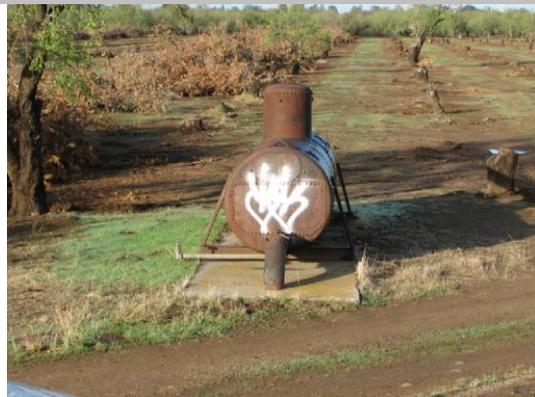
Photo 1 of 1 : UCIP_FA_2019_52084_68534.jpg

Comment Code					
Inspector Comment					
DS_ID:1680 FS_ID:52084 EP_NO: N/A Repair Type: Non-Urgent Crossing Status: Found UCIP Comments: 5/18/2017 Unable to locate. (DWR Sutter Yard-AFreitag)11/14/2016 Unable to locate. (DWR Sutter Yard-AFreitag)5/11/2016 Unable to locate.8/3/2015 Unable to locate.11/25/2014 Unable to locate.6/4/2014 Same as last inspection. Unable to locate.11/13/2013 Unable to locate.6/6/2013 Boiler has been removed and pipe buried on LS. Unable to locate.11/01/2012 Pipe appears to be abandoned. FIELD_STRUCT_DESC: 8-inch steel irrigation pipe through the levee, 6.5 feet below the crown. Boiler attached to the landside (LS). [Additional Reference(s): DWR Levee Log, 1990 (HLM 13.99). USACE Sacramento O&M Manual, Unit 516 - Upper Butte Creek - Part No. 2, April 1960, (Station 73+27)]. FS Date: 6/1/2017 2:11:21 PM

Pipe attached at boiler on LS toe.

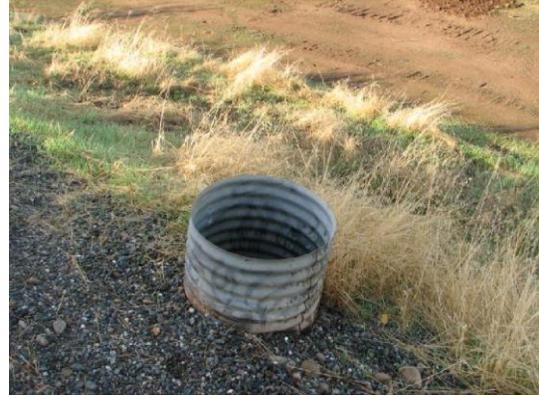
Photo 1 of 1 : UCIP_FA_2019_52085_68535.jpg

Comment Code					
Inspector Comment					
DS_ID:1681 FS_ID:52085 EP_NO: N/A Repair Type: Non-Urgent Crossing Status: Found UCIP Comments: 5/18/2017 Appears abandoned- if so needs to be done so properly. (DWR Sutter Yard- AFreitag)11/14/2016 Appears abandoned (DWR Sutter Yard- AFreitag)5/11/216 Abandoned crossing8/3/2015 Pipe still appears abandoned.11/25/2014 Same as last inspection.6/4/2014 Same as last inspection.11/13/2013 Same as last inspection.6/6/2013 Same as last inspection.11/01/2012 Pipe appears to be abandoned. FIELD_STRUCT_DESC: *ABANDONED* 6-inch steel irrigation pipe through the levee, 7.1 feet below the crown. Siphon breaker in a corrugated metal riser on the landside (LS) slope. One corrugated metal cutoff wall. Pipe is open on both ends. [Additional Reference(s): DWR Levee Log, 1990 (HLM 14.15). USACE Sacramento O&M Manual, Unit 516 - Upper Butte Creek - Part No. 2, April 1960, (Station 65+52)]. FS Date: 6/1/2017 2:12:13 PM

CM riser with siphon breaker on LS shoulder.

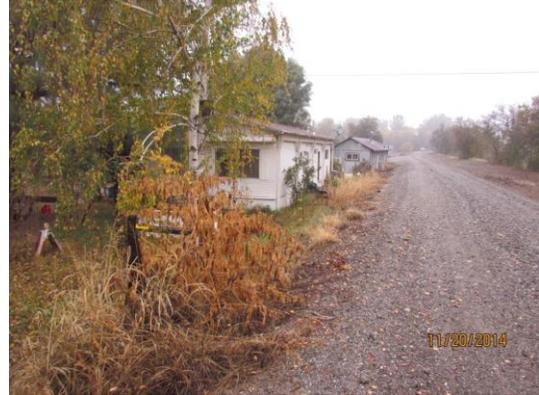
Photo 1 of 1 : FA_2019_MA0005_197_25_20190822_00011.jpg

LM Start	14.33	Rating **	U	Issue No.	25
LM End	14.33	Issue Type +	En	Location *	LS
Category	Earthen Levee		GPS Latitude/Longitude		
			Start	End	
Item	Encroachments		39.691580°	39.691580°	
			-121.779254°	-121.779254°	
DWR ID	DWR_MA0005_02_s_2012_25				
Comment Code					
BU : Building					
Inspector Comment					
Unpermitted structure.

View of the buildings at the landside toe.

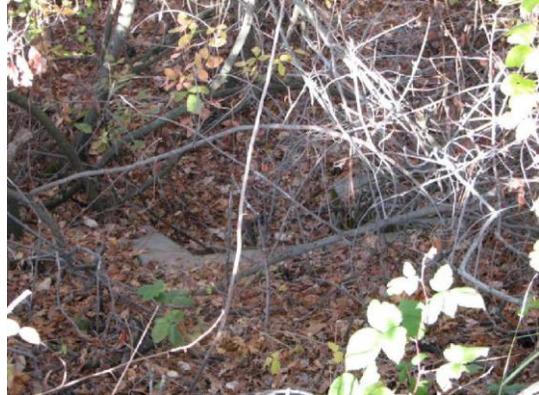
Photo 1 of 2 : UCIP_FA_2019_52087_68541.jpg

Comment Code					
Inspector Comment					
<p>DS_ID:1683 FS_ID:52087 EP_NO: N/A Repair Type: Non-Urgent Crossing Status: Found UCIP Comments: 5/18/2017 WS appears to be in good condition. LS inlet is across a ditch and inaccessible for inspection due to dense vegetation and being down a very steep slope. Pipe has been selected to be internally cleaned and inspected as part of the DMP project. (DWR Sutter Yard- AFreitag)11/14/2016 Crossing appears to be in good condition. (DWR Sutter Yard- AFreitag)5/11/2016 Crossing appears to be in good condition.8/3/2015 Crossing appears in good condition. No noticeable issues to report.6/6/2013 Same as last inspection.11/13/2013 Same as last inspection.6/4/2014 Same as last inspection.11/25/2014 Same as last inspection. FIELD_STRUCT_DESC: 24-inch corrugated metal drainage pipe through the levee, 14.3 feet below the crown. Concrete "U" headwalls on both the landside (LS) and the waterside (WS). Flap gate on the WS. Inlet downhill from a concrete lined channel at the low point on the LS toe. [Additional Reference(s): DWR Levee Log, 1990 (HLM 14.69). USACE Sacramento O&M Manual, Unit 516 - Upper Butte Creek - Part No. 2, April 1960, (Station 36+85)]. FS Date: 6/1/2017 2:14:24 PM</p>

Inlet at LS toe.

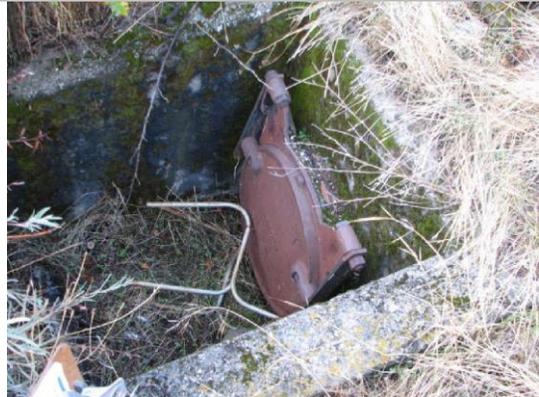
Photo 2 of 2 : UCIP_FA_2019_52087_68540.jpg

Outlet at WS toe with flap gate and concrete U-shaped headwall.

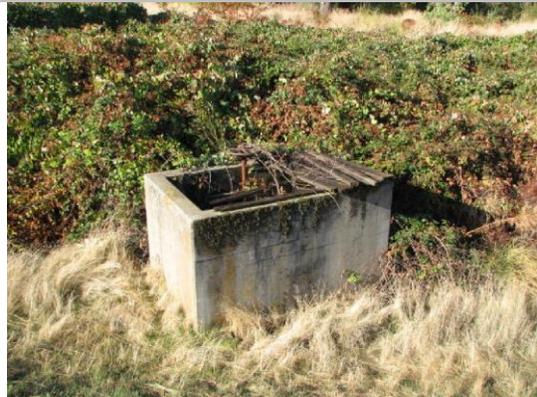
Photo 1 of 2 : UCIP_FA_2019_52090_68570.jpg

Comment Code					
Inspector Comment					
DS_ID:1685 FS_ID:52090 EP_NO: N/A Repair Type: Non-Urgent Crossing Status: Found UCIP Comments: 5/18/2017 Crossing appears to be in good condition. WS riser needs a cover. (DWR Sutter Yard- AFreitag)11/14/2016 Good condition- needs a cover for the riser. (DWR Sutter Yard- AFreitag)5/11/2016 Needs a cover for riser. The rest of the crossing appears to be in good condition.8/3/2015 Crossing appears in good condition but needs a cover made for the riser.11/25/2014 Same as last inspection.6/4/2014 Same as last inspection.11/13/2013 Same as last inspection.6/6/2013 Same as last inspection. FIELD_STRUCT_DESC: 42-inch steel irrigation pipe (siphon) through the levee, 10 feet below the crown. Slide gate in a 54-inch corrugated metal riser on the waterside (WS) slope. 5-foot by 8-foot concrete distribution box on the landside (LS). Two corrugated metal cutoff walls installed within the levee. [Additional Reference(s): DWR Levee Log, 1990 (HLM 15.22). USACE Sacramento O&M Manual, Unit 516 - Upper Butte Creek - Part No. 2, April 1960, (Station 8+30)]. FS Date: 6/1/2017 2:21:26 PM

Concrete distribution box with slide gate on LS toe.

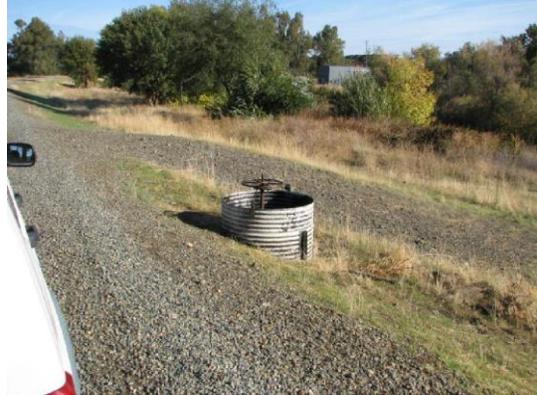
Photo 2 of 2 : UCIP_FA_2019_52090_68569.jpg

Comment Code					
Inspector Comment					
DS_ID:1685 FS_ID:52090 EP_NO: N/A Repair Type: Non-Urgent Crossing Status: Found UCIP Comments: 5/18/2017 Crossing appears to be in good condition. WS riser needs a cover. (DWR Sutter Yard- AFreitag)11/14/2016 Good condition- needs a cover for the riser. (DWR Sutter Yard- AFreitag)5/11/2016 Needs a cover for riser. The rest of the crossing appears to be in good condition.8/3/2015 Crossing appears in good condition but needs a cover made for the riser.11/25/2014 Same as last inspection.6/4/2014 Same as last inspection.11/13/2013 Same as last inspection.6/6/2013 Same as last inspection. FIELD_STRUCT_DESC: 42-inch steel irrigation pipe (siphon) through the levee, 10 feet below the crown. Slide gate in a 54-inch corrugated metal riser on the waterside (WS) slope. 5-foot by 8-foot concrete distribution box on the landside (LS). Two corrugated metal cutoff walls installed within the levee. [Additional Reference(s): DWR Levee Log, 1990 (HLM 15.22). USACE Sacramento O&M Manual, Unit 516 - Upper Butte Creek - Part No. 2, April 1960, (Station 8+30)]. FS Date: 6/1/2017 2:21:26 PM

CMP riser on WS shoulder with slide gate.

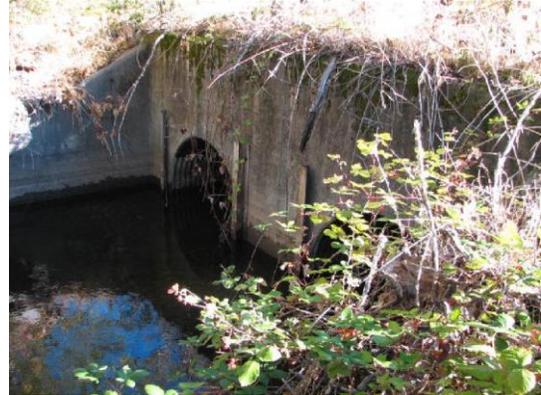
Photo 1 of 3 : UCIP_FA_2019_52093_68579.jpg

Comment Code					
Inspector Comment					
<p>DS_ID:16316 FS_ID:52093 EP_NO: N/A Repair Type: Non-Urgent Crossing Status: Found UCIP Comments: 5/18/2017 Crossing appears to be in good condition. WS riser needs a cover. (DWR Sutter Yard- AFreitag)11/14/2016 Good condition- needs a cover for standpipe. (DWR Sutter Yard- AFreitag)5/11/2016 Needs a lcover for riser. The rest of the crossing appears in good condition.8/3/2015 Crossing appears in good condition but needs a cover made for the riser.11/25/2014 Same as last inspection.6/4/2014 Same as last inspection.11/13/2013 Same as last inspection.6/6/2013 Same as last inspection. Need to construct cover for top of standpipe.11/01/2012 Good candidate for video inspection. FIELD_STRUCT_DESC: 2 of 2: 54-inch corrugated metal irrigation pipe (siphon) through the levee, 17.8 feet below the crown. Slide gate in a 66-inch corrugated metal riser on the waterside (WS). Concrete headwall and irrigation ditch at the landside (LS) toe. Edgar Slough riser units in the floodway. [Additional Reference(s): DWR Levee Log, 1990 (HLM 15.71). USACE Sacramento O&M Manual, Unit 516 - Upper Butte Creek - Part No. 2, April 1960, (Station 132+00)]. FS Date: 6/1/2017 2:24:17 PM</p>

Concrete headwall at LS toe.

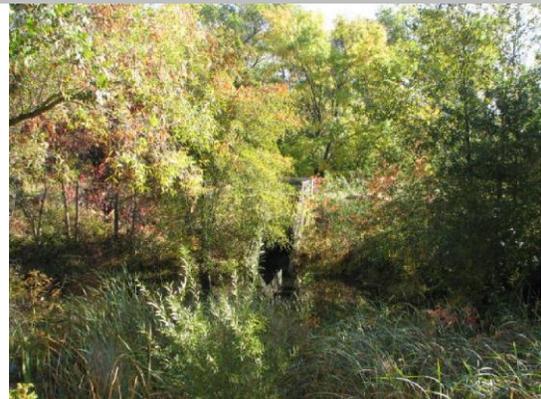
Photo 2 of 3 : UCIP_FA_2019_52093_68578.jpg

Related structure out in floodway.

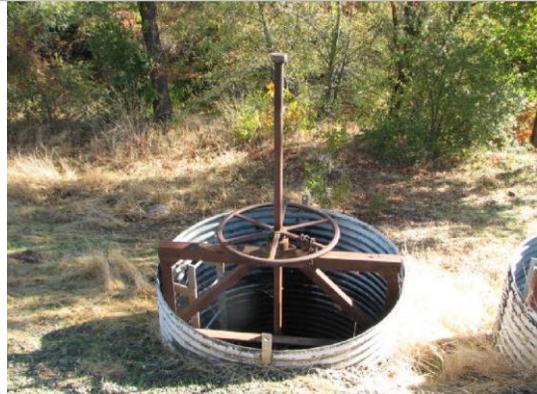
Photo 3 of 3 : UCIP_FA_2019_52093_68577.jpg

Comment Code					
Inspector Comment					
<p>DS_ID:16316 FS_ID:52093 EP_NO: N/A Repair Type: Non-Urgent Crossing Status: Found UCIP Comments: 5/18/2017 Crossing appears to be in good condition. WS riser needs a cover. (DWR Sutter Yard- AFreitag)11/14/2016 Good condition- needs a cover for standpipe. (DWR Sutter Yard- AFreitag)5/11/2016 Needs a lcover for riser. The rest of the crossing appears in good condition.8/3/2015 Crossing appears in good condition but needs a cover made for the riser.11/25/2014 Same as last inspection.6/4/2014 Same as last inspection.11/13/2013 Same as last inspection.6/6/2013 Same as last inspection. Need to construct cover for top of standpipe.11/01/2012 Good candidate for video inspection. FIELD_STRUCT_DESC: 2 of 2: 54-inch corrugated metal irrigation pipe (siphon) through the levee, 17.8 feet below the crown. Slide gate in a 66-inch corrugated metal riser on the waterside (WS). Concrete headwall and irrigation ditch at the landside (LS) toe. Edgar Slough riser units in the floodway. [Additional Reference(s): DWR Levee Log, 1990 (HLM 15.71). USACE Sacramento O&M Manual, Unit 516 - Upper Butte Creek - Part No. 2, April 1960, (Station 132+00)]. FS Date: 6/1/2017 2:24:17 PM</p>

66-inch CMP riser on WS shoulder.

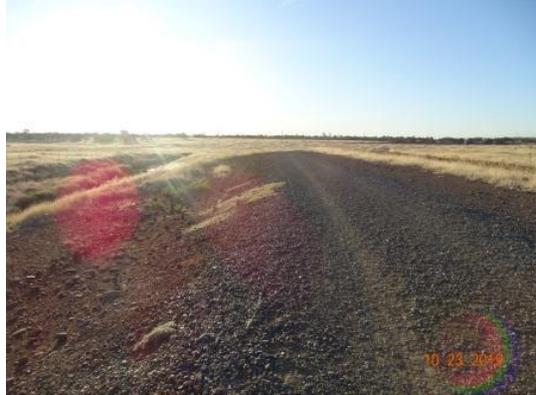
Photo 1 of 1 : FA_2019_MA0005_198_1_20191028_00001.jpg

LM Start	0.55	Rating **	A	Issue No.	1
LM End	0.55	Issue Type +	Ma	Location *	WS
Category	Earthen Levee		GPS Latitude/Longitude		
			Start	End	
Item	Vegetation		39.724271°	39.724271°	
			-121.781058°	-121.781058°	
DWR ID	DWR_MA0005_03_f_2019_1				
Comment Code					
V1 : Control annual grass and weeds on the levee slopes and easements.					
Inspector Comment					
Vegetation is well maintained on both landside and waterside slopes.

View of well-maintained waterside slope, free of vegetation. Fall 2019.
