**Flood Control Project Maintenance
Levee Inspections**

Fall 2019 Levee Maintenance Deficiency Summary Report

Sacramento River Basin

Sutter Maintenance Yard Maintenance Area 0007

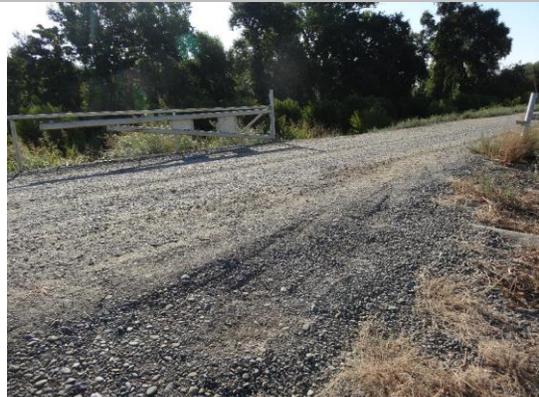
Photo 2 of 3 : UCIP_FA_2019_56069_77331.jpg

DS_ID:20816
 FS_ID:56069
 EP_NO: 11987
 Repair Type: Non-Urgent
 Crossing Status: Found
 UCIP Comments: 05/07/2019 Crossing has been modified. Need to contact owner to determine permit authorizing new modifications on both WS and LS. (O. Magana - DWR UCIP)12/07/2018 New encroachment owner information: Sukhraj Singh Pamma, 9850 Sheldon Avenue, Live Oak, CA 95953-9784, 1-530-695-2490. Information obtained from the Levee_Encroachment_listing_11288.pdf received from SBFCA. The permit listed in the pdf file is 11987. This permit was issued to the Cox Brothers in 1977. Need to have new owner apply for Permit Name Change with the CVFPB. (O. Magana - DWR UCIP) 08/09/2017 It appears that this pipe is used to water the orchard located on the WS. Dense vegetation present along the WS slope, recommend clearing vegetation to allow for proper inspection of levee slope. No permit has been identified since 2012. (DWR UCIP - O. Magana)08/02/2017 After reviewing record drawings it appears this crossing has remained. This pipe was not part of the Feather River West Levee Improvements, Project D. Pipe is located outside the project limits. Project Improvements began at Station (Sta) 1765+00 (MA0007 about LM 1.73) to Sta 2303+50 (ST0005 about LM 1.23), refer to record drawings for the Feather River West Levee Improvement Plans Station 1765+00 to 2368+26, Project D details. (DWR UCIP - O. Magana)

Overview of levee crown at crossing looking downstream.

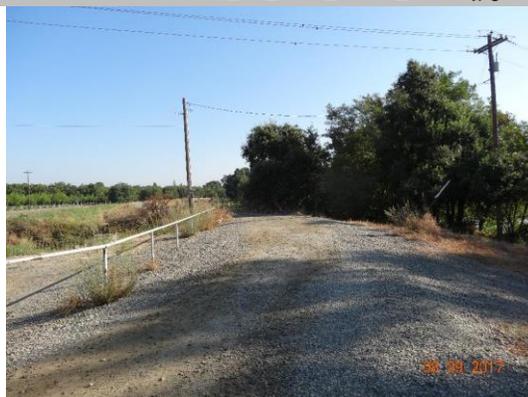
Photo 1 of 3 : UCIP_FA_2019_55067_77346.jpg

DS_ID:16926
 FS_ID:55067
 EP_NO: N/A
 Repair Type: Non-Urgent
 Crossing Status: Found
 UCIP Comments: 05/07/2019 Record remains Non-Urgent, no permit has been identified for the structure. Recommend adding covers to the CMP risers located on the WS as a safety measure. DMP internal inspection is still pending. It is unclear who the owner and maintainer is for this structure. LMA will need to coordinate with CVFPB to determine true owner. (O. Magana - DWR UCIP)12/07/2018 Encroachment Owner is Butte Water District c/o Mark Orme, District Manager, 735 Virginia Street, Gridley, CA 95948, 1-530-846-3100. Information obtained from the Levee_Encroachment_listing_11288.pdf obtained from SBFCA which also indicates CVFPB Permit Process - New Permit. Need to coordinate with CVFPB to determine status of permit. (O. Magana - DWR UCIP)
 08/09/2017 Dual 60-inch pipes are still present--no modifications appear to have been made to this structure. No permit or owner has been identified. Need to contact owner to notify of safety issue regarding the missing covers for CMP riser. (DWR UCIP - O. Magana)08/02/2017 After reviewing record drawings it appears this crossing has remained. Project Improvements begin at Station (Sta) 1765+00 (MA0007 about LM 1.73) to Sta 2303+50 (ST0005 about LM 1.23), refer to record drawings for the Feather River West Levee Improvement Plans Station 1765+00 to 2368+26, Project D details. MA0007 project details include NO CUTOFF WALL from Sta 1765+00 (MA0007 about LM 1.73) to 1815+00 (MA0007 about LM 2.64) and LEVEE DEGRADE AND RECONSTRUCTION WITH CUT OFF WALL from Sta 1817+00 (MA0007 about LM 2.69) to Sta 2289+00, Sta 2287+00 to Sta 2290+00 (MA0007 about LM 11.60). (DWR UCIP - O. Magana)

05/16/2016 Feather River West Levee Improvement Project--Levee currently under construction.06/10/2015 Debris still present in risers and pipes were not replaced with the SBFCA project.12/29/2014 Same as last inspection.05/19/2014 Same as last inspection.11/06/2013 Same as last inspection.05/13/2013 SBFCA project recommends replacing in accordance with title 23.05/07/2013 Same debris issue as last inspection. Recommend repairing top cover to prevent falls. Wheel to open gate chained and locked so could not verify gate operation.10/31/2012 Debris inside riser could prevent slide gate from closing. This crossing was listed in the USACE Periodic Inspections as ID# USACE_CESPK_MA07_2010_a_0060 however, no issues noted. (DWR UCIP - O. Magana)
 FIELD_STRUCT_DESC: 1 of 2: 60-inch corrugated metal gravity drainage pipe through the levee, 12.5 feet below the crown. Slide gate in a 78-inch corrugated metal pipe (CMP) well on the waterside (WS)

Overview of levee crown looking upstream towards crossings.

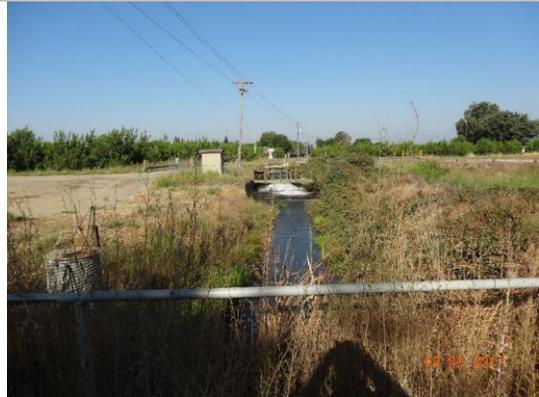
Photo 3 of 3 : UCIP_FA_2019_55067_77342.jpg

LS view: view of canal looking west from crossing.

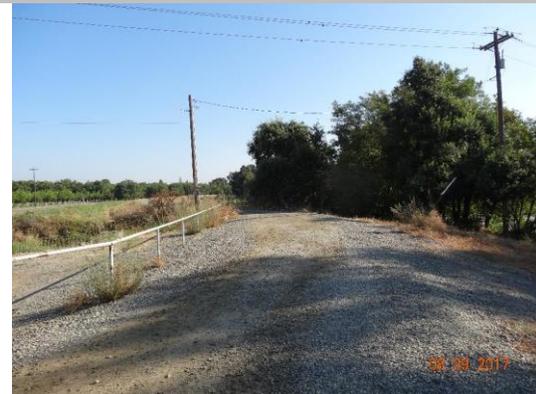
Photo 1 of 3 : UCIP_FA_2019_55066_77352.jpg

DS_ID:17011
 FS_ID:55066
 EP_NO: N/A
 Repair Type: Non-Urgent
 Crossing Status: Found
 UCIP Comments: 05/07/2019 Record remains Non-Urgent, no permit has been identified for the structure. Recommend adding covers to the CMP risers located on the WS as a safety measure. DMP internal inspection is still pending. It is unclear who the owner and maintainer is for this structure. LMA will need to coordinate with CVFPB to determine true owner. (O. Magana - DWR UCIP)12/07/2018 Encroachment Owner is Butte Water District c/o Mark Orme, District Manager, 735 Virginia Street, Gridley, CA 95948, 1-530-846-3100. Information obtained from the Levee_Encroachment_listing_11288.pdf obtained from SBFCa which also indicates CVFPB Permit Process - New Permit. Need to coordinate with CVFPB to determine status of permit. (O. Magana - DWR UCIP)
 08/09/2017 Dual 60-inch pipes are still present--no modifications appear to have been made to this structure. No permit or owner has been identified. Need to contact owner to notify of safety issue regarding the missing covers for CMP riser. (DWR UCIP - O. Magana)08/02/2017 After reviewing record drawings it appears this crossing has remained. Project Improvements begin at Station (Sta) 1765+00 (MA0007 about LM 1.73) to Sta 2303+50 (ST0005 about LM 1.23), refer to record drawings for the Feather River West Levee Improvement Plans Station 1765+00 to 2368+26, Project D details. MA0007 project details include NO CUTOFF WALL from Sta 1765+00 (MA0007 about LM 1.73) to 1815+00 (MA0007 about LM 2.64) and LEVEE DEGRADE AND RECONSTRUCTION WITH CUT OFF WALL from Sta 1817+00 (MA0007 about LM 2.69) to Sta 2289+00, Sta 2287+00 to Sta 2290+00 (MA0007 about LM 11.60). (DWR UCIP - O. Magana)

05/16/2016 Feather River West Levee Improvement Project--Levee currently under construction.06/10/2015 Debris still present inside riser and pipe was not replaced with the SBFCa project.12/29/2014 Same as last inspection.05/19/2014 Same as last inspection.11/06/2013 Same as last inspection.05/13/2013 SBFCa project recommends replacing in accordance with title 23.05/07/2013 Same as last inspection. Recommend constructing cover to prevent falls. Wheel to operate gate chained and locked so gate operation could not be verified.10/31/2012 no cover; debris inside riser could prevent slide gate from closing. This crossing was listed in the USACE Periodic Inspections as ID# USACE_CESPK_MA07_2010_a_0060 however, no issues noted. (DWR UCIP - O. Magana)
 FIELD_STRUCT_DESC: 2 of 2: 60-inch corrugated metal gravity drainage pipe through the levee, 12.5 feet below the crown. Slide gate in a 78-inch corrugated metal pipe (CMP) well on the waterside (WS)

Overview of levee crown looking upstream towards crossings.

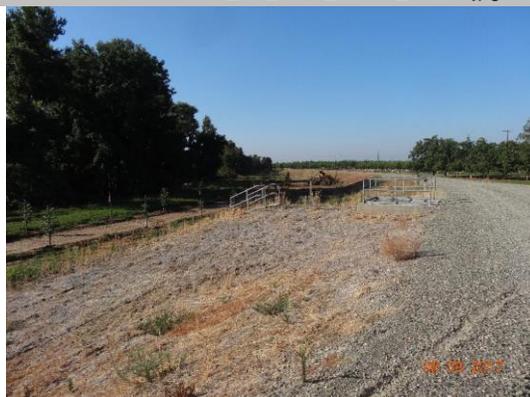
Photo 1 of 3 : UCIP_FA_2019_55068_77116.jpg

Comment Code					
Inspector Comment					
<p>DS_ID:25499 FS_ID:55068 EP_NO: N/A Repair Type: Non-Urgent Crossing Status: Found UCIP Comments: 05/07/2019 Record has been updated from No Action Needed to Non-Urgent, no permit has been issued by the CVFPB for this pipe. Second paddle marker located along the LS slope is down. No other issues were observed during inspection. (O. Magana - DWR UCIP)08/09/2017 Crossing field verified, photos added to record, and coordinates updated. No permit has been issued however, markers show owner as WAL (or Waller Family Revocable Trust c/o Sandra A. Waller. Will need to update permit information when the CVFPB issues permit for this crossing. (DWR UCIP - O. Magana)08/08/2017 Crossing was installed under the Feather River West Levee Improvements, Project D. Project Improvements begin at Station (Sta) 1765+00 (MA0007 about LM 1.73) to Sta 2303+50 (ST0005 about LM 1.23), refer to record drawings for the Feather River West Levee Improvement Plans Station 1765+00 to 2368+26, Project D details. MA0007 project details include NO CUTOFF WALL from Sta 1765+00 (MA0007 about LM 1.73) to 1815+00 (MA0007 about LM 2.64) and LEVEE DEGRADE AND RECONSTRUCTION WITH CUT OFF WALL from Sta 1817+00 (MA0007 about LM 2.69) to Sta 2289+00, Sta 2287+00 to Sta 2290+00 (MA0007 about LM 11.60). (DWR UCIP - O. Magana) FIELD_STRUCT_DESC: 24-inch inside diameter gravity drainage pipe of an unknown material through the levee, 4.5 feet below the crown. 18-inch drainage layer at the pipe inlet at the landside (LS) toe. Existing ground regraded to provide a smooth transition to inlet structure on the landside (LS) end. Access control grate inside the inlet structure. Gate riser structure with positive shutoff valve on the waterside (WS) shoulder. Flap gate and outfall structure with riprap on the waterside (WS) end. Existing ground regraded to provide a smooth transition at the outlet. (Existing 24-inch gravity drainage pipe crossing removed [refer to DSID 16925] and replaced portion within construction limit with a new 24-inch gravity drainage pipe crossing during the Feather River West Levee Improvements, Project D). [Additional Reference(s): Sutter Butte Flood Control Agency (SBFCA) Feather River West Levee Project, Volume 4 of 6 (Project D) Feather River West Levee Improvement Plans Sta 1765+00 to 2368+26, Volume 4-SBFCA_Record_Drawings_Project D_2017.05.16.pdf, Drawing No. C-509]. FS Date: 5/7/2019 12:44:00 PM</p>

Overview of WS at crossing.

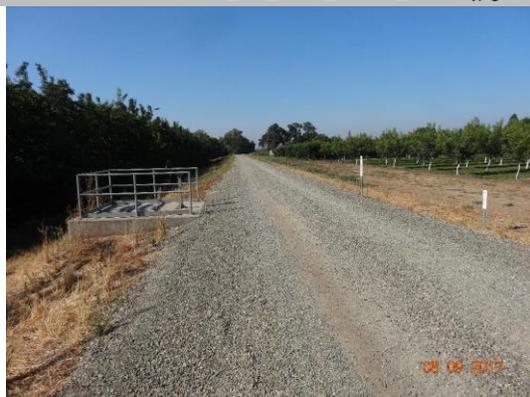
Photo 3 of 3 : UCIP_FA_2019_55070_77128.jpg

Comment Code					
Inspector Comment					
<p>DS_ID:25501 FS_ID:55070 EP_NO: N/A Repair Type: Non-Urgent Crossing Status: Found UCIP Comments: 05/07/2019 Record has been updated from No Action Needed to Non-Urgent, no permit has been issued yet by the CVFPB. Second paddle marker is down on the LS slope. (O. Magana - DWR UCIP)08/09/2017 Crossing was field verified and photographed. Photos added. No permit shown but pipe marker shows owner as WAL (Waller family Revocable Trust c/o Sandra A Waller). Permit will be updated when CVFPB issues one. (DWR Sutter-AFreitag)08/08/2017 Crossing was installed under the Feather River West Levee Improvements, Project D. Project Improvements begin at Station (Sta) 1765+00 (MA0007 about LM 1.73) to Sta 2303+50 (ST0005 about LM 1.23), refer to record drawings for the Feather River West Levee Improvement Plans Station 1765+00 to 2368+26, Project D details. MA0007 project details include NO CUTOFF WALL from Sta 1765+00 (MA0007 about LM 1.73) to 1815+00 (MA0007 about LM 2.64) and LEVEE DEGRADE AND RECONSTRUCTION WITH CUT OFF WALL from Sta 1817+00 (MA0007 about LM 2.69) to Sta 2289+00, Sta 2287+00 to Sta 2290+00 (MA0007 about LM 11.60). (DWR UCIP - O. Magana) FIELD_STRUCT_DESC: 36-inch inside diameter gravity drainage pipe of an unknown material through the levee, 9.7 feet below the crown. 18-inch drainage layer at the pipe inlet at the landside (LS) toe. Connection manhole with existing 24-inch gravity pipe near the landside (LS) toe. Gate riser structure with positive shutoff valve on the waterside (WS) shoulder. Plug and cap on WS end of pipe. Temporary 4-inch by 4-inch marker post above WS end of pipe. (Existing 24-inch corrugated metal irrigation pipe crossing removed and replaced portion within construction limit with a new 36-inch through pipe crossing within construction limits during the Feather River West Levee Improvements, Project D). [Additional Reference(s): Sutter Butte Flood Control Agency (SBFCA) Feather River West Levee Project, Volume 4 of 6 (Project D) Feather River West Levee Improvement Plans Sta 1765+00 to 2368+26, 2016, Volume 4-SBFCA_Record_Drawings_Project D_2017.05.16.pdf, Drawing No. C-513]. FS Date: 5/7/2019 12:45:00 PM</p>

Overview of levee crown looking downstream

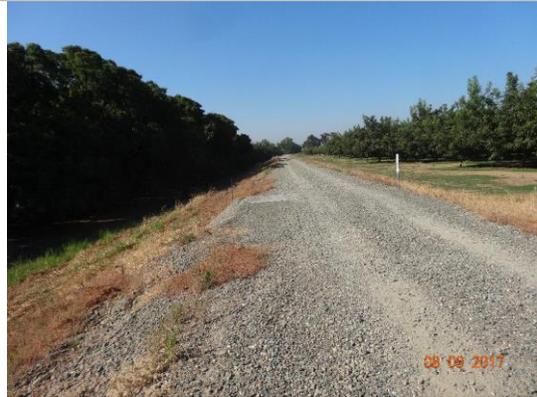
Photo 1 of 3 : UCIP_FA_2019_55857_77133.jpg

DS_ID:20817
 FS_ID:55857
 EP_NO: N/A
 Repair Type: Non-Urgent
 Crossing Status: Found
 UCIP Comments: 05/07/2019 Record has been updated from No Action Needed to Non-Urgent, no permit has been issued for new pipe. Permit 17213 does not account for improvements made in 2016. Paddle marker is down on the LS slope. (O. Magana - DWR UCIP)08/09/2017 Crossing was field verified and photographed. Photos updated. Permit number and ownership added to description. Owners address Sandra A Waller, 585 Cowee Avenue, Gridley, CA 95948. 08/02/2017 Crossing was rehabilitated under the Feather River West Levee Improvements, Project D. Project Improvements begin at Station (Sta) 1765+00 (MA0007 about LM 1.73) to Sta 2303+50 (ST0005 about LM 1.23), refer to record drawings for the Feather River West Levee Improvement Plans Station 1765+00 to 2368+26, Project D details. MA0007 project details include NO CUTOFF WALL from Sta 1765+00 (MA0007 about LM 1.73) to 1815+00 (MA0007 about LM 2.64) and LEVEE DEGRADE AND RECONSTRUCTION WITH CUT OFF WALL from Sta 1817+00 (MA0007 about LM 2.69) to Sta 2289+00, Sta 2287+00 to Sta 2290+00 (MA0007 about LM 11.60). (DWR UCIP - O. Magana)

Overview of levee crown looking downstream

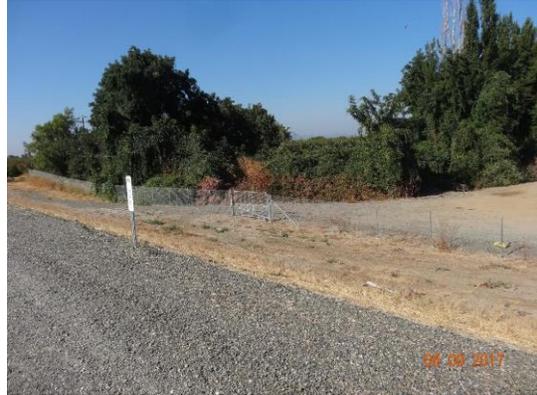
Photo 3 of 3 : UCIP_FA_2019_55073_77189.jpg

Comment Code					
Inspector Comment					
<p>DS_ID:25503 FS_ID:55073 EP_NO: N/A Repair Type: Non-Urgent Crossing Status: Found UCIP Comments: 05/07/2019 Record has been updated from No Action Needed to Non-Urgent, no permit has been issued for this crossing. Second paddle marker located at LS toe has been bent. No other issues were recorded during inspection. (O. Magana - DWR UCIP)08/09/2017 Crossing was field verified and photographed. Photos added. No known permit for crossing but alignment markers show owner as GSD (City of Gridley c/o Bruce Nash, 685 Kentucky Street, Gridley, CA 95948.) Permit will be updated when CVFPB issues one. (DWR Sutter- AFreitag)08/08/2017 Crossing was installed under the Feather River West Levee Improvements, Project D. Project Improvements begin at Station (Sta) 1765+00 (MA0007 about LM 1.73) to Sta 2303+50 (ST0005 about LM 1.23), refer to record drawings for the Feather River West Levee Improvement Plans Station 1765+00 to 2368+26, Project D details. MA0007 project details include NO CUTOFF WALL from Sta 1765+00 (MA0007 about LM 1.73) to 1815+00 (MA0007 about LM 2.64) and LEVEE DEGRADE AND RECONSTRUCTION WITH CUT OFF WALL from Sta 1817+00 (MA0007 about LM 2.69) to Sta 2289+00, Sta 2287+00 to Sta 2290+00 (MA0007 about LM 11.60). (DWR UCIP - O. Magana) FIELD_STRUCT_DESC: 36-inch inside diameter gravity drainage pipe of an unknown material through the levee, 24.1 feet below the crown. 18-inch drainage layer at the pipe inlet at the landside (LS) toe. Two connection manholes, one off the landside (LS) toe, the other off the waterside (WS) toe, where the 36-inch gravity drainage pipe connects to the existing 24-inch gravity drainage pipe near the construction limits. Gate riser structure with positive shutoff valve on the waterside (WS) shoulder. (Existing 24-inch corrugated metal gravity drainage pipe crossing removed and replaced portion within construction limit with a new 36-inch gravity drainage pipe crossing during the Feather River West Levee Improvements, Project D). [Additional Reference(s): Sutter Butte Flood Control Agency (SBFCA) Feather River West Levee Project, Volume 4 of 6 (Project D) Feather River West Levee Improvement Plans Sta 1765+00 to 2368+26, 2016, Volume 4-SBFCA_Record_Drawings_Project D_2017.05.16.pdf, Drawing No. C-519]. FS Date: 5/7/2019 12:45:00 PM</p>

Overview of LS

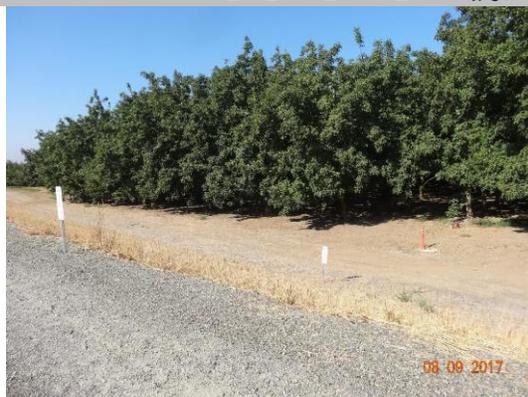
Photo 3 of 3 : UCIP_FA_2019_55074_77180.jpg

Comment Code					
Inspector Comment					
<p>DS_ID:25504 FS_ID:55074 EP_NO: N/A Repair Type: Non-Urgent Crossing Status: Found UCIP Comments: 05/07/2019 Record has been updated from No Action Needed to Non-Urgent, no permit has been issued by the CVFPB. Second LS marker has been bent. No other issues were identified during inspection. (O. Magana - DWR UCIP)08/08/2017 Crossing was installed under the Feather River West Levee Improvements, Project D. Project Improvements begin at Station (Sta) 1765+00 (MA0007 about LM 1.73) to Sta 2303+50 (ST0005 about LM 1.23), refer to record drawings for the Feather River West Levee Improvement Plans Station 1765+00 to 2368+26, Project D details. MA0007 project details include NO CUTOFF WALL from Sta 1765+00 (MA0007 about LM 1.73) to 1815+00 (MA0007 about LM 2.64) and LEVEE DEGRADE AND RECONSTRUCTION WITH CUT OFF WALL from Sta 1817+00 (MA0007 about LM 2.69) to Sta 2289+00, Sta 2287+00 to Sta 2290+00 (MA0007 about LM 11.60). (DWR UCIP - O. Magana) FIELD_STRUCT_DESC: 36-inch inside diameter irrigation pipe of an unknown material through the levee, 14.1 feet below the crown. 18-inch drainage layer at the pipe inlet at the landside (LS) toe. Gate riser structure with positive shutoff valve on the waterside (WS) shoulder. Ends of new and existing pipes plugged and capped. Marker post at the WS end of the new pipe. C-900 riser with 8-inch Waterman Type 1 sunshine alfalfa valve, or approved equal, with 6-inch-thick by 12-inch-wide concrete collar near the landside (LS) end of the new pipe. (Existing 24-inch corrugated metal pipe [CMP], 18-inch gravity drainage pipe [indicated in record drawings], and 12-inch steel gravity drainage pipe crossing removed and replaced portion within construction limit with a new 36-inch irrigation pipe crossing during the Feather River West Levee Improvements, Project D). [Additional Reference(s): Sutter Butte Flood Control Agency (SBFCA) Feather River West Levee Project, Volume 4 of 6 (Project D) Feather River West Levee Improvement Plans Sta 1765+00 to 2368+26, 2016, Volume 4-SBFCA_Record_Drawings_Project D_2017.05.16.pdf, Drawing No. C-521]. FS Date: 5/7/2019 12:46:00 PM</p>

Overview of LS looking downstream at crossing.

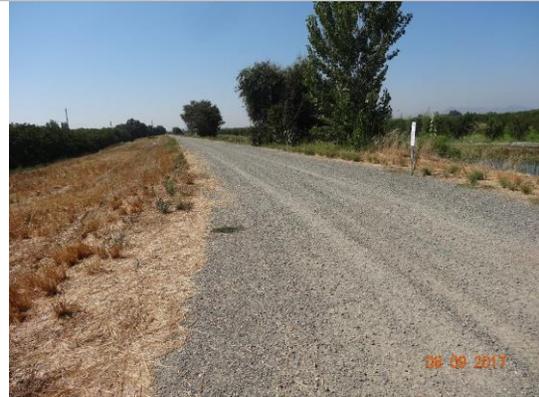
Photo 2 of 3 : UCIP_FA_2019_55077_77166.jpg

Comment Code					
Inspector Comment					
<p>DS_ID:25511 FS_ID:55077 EP_NO: N/A Repair Type: Non-Urgent Crossing Status: Found UCIP Comments: 05/07/2019 Record has been updated from No Action Needed to Non-Urgent, no permit has been issued by the CVFPB. No other issues were recorded during inspection. (O. Magana - DWR UCIP)08/09/2017 Crossing field verified, photos added to record, and coordinates updated. No permit has been issued will need to update permit information when the CVFPB issues permit for this crossing. (DWR UCIP - O. Magana)08/08/2017 Crossing was installed under the Feather River West Levee Improvements, Project D. Project Improvements begin at Station (Sta) 1765+00 (MA0007 about LM 1.73) to Sta 2303+50 (ST0005 about LM 1.23), refer to record drawings for the Feather River West Levee Improvement Plans Station 1765+00 to 2368+26, Project D details. MA0007 project details include NO CUTOFF WALL from Sta 1765+00 (MA0007 about LM 1.73) to 1815+00 (MA0007 about LM 2.64) and LEVEE DEGRADE AND RECONSTRUCTION WITH CUT OFF WALL from Sta 1817+00 (MA0007 about LM 2.69) to Sta 2289+00, Sta 2287+00 to Sta 2290+00 (MA0007 about LM 11.60). (DWR UCIP - O. Magana) FIELD_STRUCT_DESC: 36-inch inside diameter gravity irrigation pipe of an unknown material through the levee, 10 feet below the crown. 18-inch drainage layer at the pipe inlet at the landside (LS) toe. Inlet structure with riprap and sheet pile on the landside (LS) end at the Sutter-Butte Main Canal. Gate riser structure with positive shutoff valve on the waterside (WS) shoulder. Connected to existing 24-inch gravity irrigation pipe at the WS toe, 107 feet from the center of the crown, within 5 feet of the construction limit. Marker post at the same location on the WS toe. There may also be a marker post on the WS or LS shoulder. (Existing 24-inch corrugated metal gravity irrigation pipe crossing removed and replaced within construction limits with a new 36-inch gravity irrigation pipe crossing during the Feather River West Levee Improvements, Project D). [Additional Reference(s): Sutter Butte Flood Control Agency (SBFCA) Feather River West Levee Project, Volume 4 of 6 (Project D) Feather River West Levee Improvement Plans Sta 1765+00 to 2368+26, 2016, Volume 4-SBFCA_Record_Drawings_Project D_2017.05.16.pdf, Drawing No. C-529]. FS Date: 5/7/2019 12:46:00 PM</p>

Overview of levee crown looking downstream at crossing.

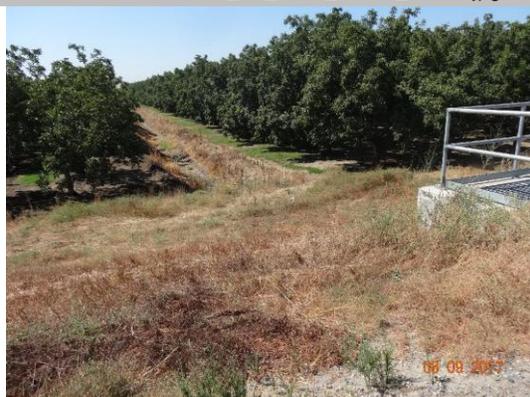
Photo 2 of 3 : UCIP_FA_2019_55078_77219.jpg

Comment Code					
Inspector Comment					
<p>DS_ID:25512 FS_ID:55078 EP_NO: N/A Repair Type: Non-Urgent Crossing Status: Found UCIP Comments: 05/07/2019 Record has been updated from No Action Needed to Non-Urgent, no permit has been issued by the CVFPB. No other issues were recorded during inspection. (O. Magana - DWR UCIP)08/09/2017 Crossing was field verified and photographed. Photos added. Current levee is incorrect and needs to be CLM 5.417. GPS coordinates were updated. No permit on record but it will be added when the CVFPB issues one. (DWR Sutter-AFreitag)08/08/2017 Crossing was installed under the Feather River West Levee Improvements, Project D. Project Improvements begin at Station (Sta) 1765+00 (MA0007 about LM 1.73) to Sta 2303+50 (ST0005 about LM 1.23), refer to record drawings for the Feather River West Levee Improvement Plans Station 1765+00 to 2368+26, Project D details. MA0007 project details include NO CUTOFF WALL from Sta 1765+00 (MA0007 about LM 1.73) to 1815+00 (MA0007 about LM 2.64) and LEVEE DEGRADE AND RECONSTRUCTION WITH CUT OFF WALL from Sta 1817+00 (MA0007 about LM 2.69) to Sta 2289+00, Sta 2287+00 to Sta 2290+00 (MA0007 about LM 11.60). (DWR UCIP - O. Magana) FIELD_STRUCT_DESC: 36-inch inside diameter gravity drainage pipe of an unknown material, 18.9 feet below the crown. 18-inch drainage layer at the pipe inlet at the landside (LS) toe. Inlet structure on the landside (LS) end. Gate riser structure with positive shutoff valve on the waterside (WS) shoulder. Flap gate, outfall structure, and riprap at outlet on the waterside (WS) end. Drainage channel regraded as required to provide a smooth transition at the inlet and the outlet. (Two existing 60-inch corrugated metal gravity drainage pipe crossings removed and replaced portion within construction limit with a new 36-inch gravity drainage pipe crossing during the Feather River West Levee Improvements, Project D). [Additional Reference(s): Sutter Butte Flood Control Agency (SBFCA) Feather River West Levee Project, Volume 4 of 6 (Project D) Feather River West Levee Improvement Plans Sta 1765+00 to 2368+26, 2016, Volume 4-SBFCA_Record_Drawings_Project D_2017.05.16.pdf, Drawing No. C-531]. FS Date: 5/7/2019 12:39:00 PM</p>

Overview of WS

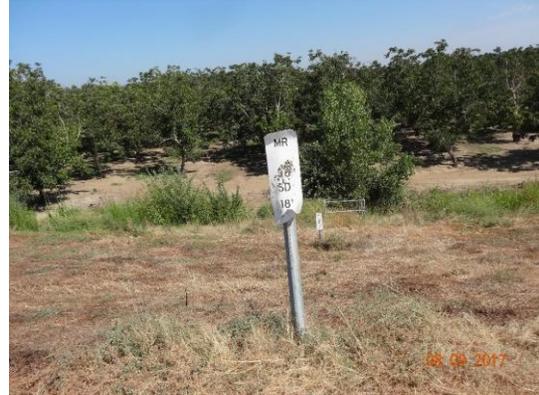
Photo 3 of 3 : UCIP_FA_2019_55078_77220.jpg

Comment Code					
Inspector Comment					
<p>DS_ID:25512 FS_ID:55078 EP_NO: N/A Repair Type: Non-Urgent Crossing Status: Found UCIP Comments: 05/07/2019 Record has been updated from No Action Needed to Non-Urgent, no permit has been issued by the CVFPB. No other issues were recorded during inspection. (O. Magana - DWR UCIP)08/09/2017 Crossing was field verified and photographed. Photos added. Current levee is incorrect and needs to be CLM 5.417. GPS coordinates were updated. No permit on record but it will be added when the CVFPB issues one. (DWR Sutter-AFreitag)08/08/2017 Crossing was installed under the Feather River West Levee Improvements, Project D. Project Improvements begin at Station (Sta) 1765+00 (MA0007 about LM 1.73) to Sta 2303+50 (ST0005 about LM 1.23), refer to record drawings for the Feather River West Levee Improvement Plans Station 1765+00 to 2368+26, Project D details. MA0007 project details include NO CUTOFF WALL from Sta 1765+00 (MA0007 about LM 1.73) to 1815+00 (MA0007 about LM 2.64) and LEVEE DEGRADE AND RECONSTRUCTION WITH CUT OFF WALL from Sta 1817+00 (MA0007 about LM 2.69) to Sta 2289+00, Sta 2287+00 to Sta 2290+00 (MA0007 about LM 11.60). (DWR UCIP - O. Magana) FIELD_STRUCT_DESC: 36-inch inside diameter gravity drainage pipe of an unknown material, 18.9 feet below the crown. 18-inch drainage layer at the pipe inlet at the landside (LS) toe. Inlet structure on the landside (LS) end. Gate riser structure with positive shutoff valve on the waterside (WS) shoulder. Flap gate, outfall structure, and riprap at outlet on the waterside (WS) end. Drainage channel regraded as required to provide a smooth transition at the inlet and the outlet. (Two existing 60-inch corrugated metal gravity drainage pipe crossings removed and replaced portion within construction limit with a new 36-inch gravity drainage pipe crossing during the Feather River West Levee Improvements, Project D). [Additional Reference(s): Sutter Butte Flood Control Agency (SBFCA) Feather River West Levee Project, Volume 4 of 6 (Project D) Feather River West Levee Improvement Plans Sta 1765+00 to 2368+26, 2016, Volume 4-SBFCA_Record_Drawings_Project D_2017.05.16.pdf, Drawing No. C-531]. FS Date: 5/7/2019 12:39:00 PM</p>

Overview of LS

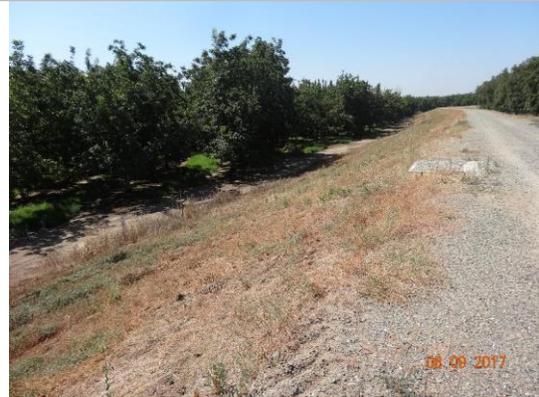
Photo 1 of 3 : UCIP_FA_2019_55859_77246.jpg

DS_ID:25513
 FS_ID:55859
 EP_NO: 4591
 Repair Type: Non-Urgent
 Crossing Status: Found
 UCIP Comments: 05/07/2019 Record has been updated from No Action Needed to Non-Urgent, no permit has been issued by the CVFPB. Recommend auditing Permit No. 4591 to determine if modifications made under the levee improvement project are assumed under current permit or if new permit will be issued. No other issues were recorded during inspection. (O. Magana - DWR UCIP)08/09/2017 Crossing was visited and field verified. Coordinates updated to show pipes new location (39.38342, -121.63595). CLM will need to be updated also. Photos added. (DWR Sutter- AFreitag)08/08/2017 Crossing was installed under the Feather River West Levee Improvements, Project D. Project Improvements begin at Station (Sta) 1765+00 (MA0007 about LM 1.73) to Sta 2303+50 (ST0005 about LM 1.23), refer to record drawings for the Feather River West Levee Improvement Plans Station 1765+00 to 2368+26, Project D details. MA0007 project details include NO CUTOFF WALL from Sta 1765+00 (MA0007 about LM 1.73) to 1815+00 (MA0007 about LM 2.64) and LEVEE DEGRADE AND RECONSTRUCTION WITH CUT OFF WALL from Sta 1817+00 (MA0007 about LM 2.69) to Sta 2289+00, Sta 2287+00 to Sta 2290+00 (MA0007 about LM 11.60). (DWR UCIP - O. Magana)

Overview of WS

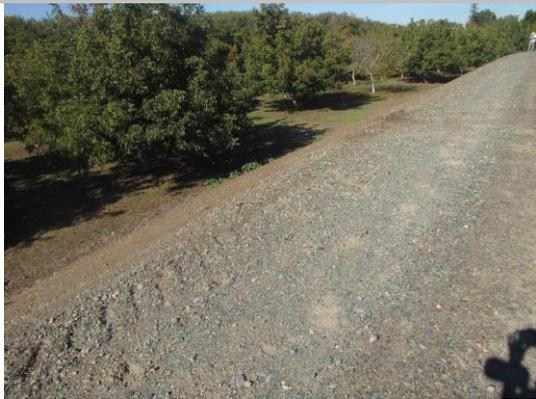
Photo 1 of 3 : UCIP_FA_2019_55082_65923.jpg

DS_ID:16960
 FS_ID:55082
 EP_NO: 17895
 Repair Type: Non-Urgent
 Crossing Status: Not Found
 UCIP Comments: 05/07/2019 Record has been updated from No Action Needed to Non-Urgent, no pipe was found during inspection. Photos taken to show that there is no evidence of 5-inch line. Need to coordinate with CVFPB to find out if pipe permit was withdrawn. (O. Magana - DWR UCIP)08/09/2017 Field confirmed no signs of crossing at this location, levee section removed and rebuilt with slurry wall. No photos were taken at this location. Recommend taking photos of current condition at this site and append to this record. (DWR UCIP - O. Magana)08/08/2017 Pre-construction drawings, for construction drawings, show this crossing removed and replaced, however record drawings (post-construction) do not reference this crossing. Need to follow up with consultants responsible for record drawings to determine status of this crossing -- conflicting information between pre- and post-construction drawings. Project Improvements begin at Station (Sta) 1765+00 (MA0007 about LM 1.73) to Sta 2303+50 (ST0005 about LM 1.23), refer to record drawings for the Feather River West Levee Improvement Plans Station 1765+00 to 2368+26, Project D details. MA0007 project details include NO CUTOFF WALL from Sta 1765+00 (MA0007 about LM 1.73) to 1815+00 (MA0007 about LM 2.64) and LEVEE DEGRADE AND RECONSTRUCTION WITH CUT OFF WALL from Sta 1817+00 (MA0007 about LM 2.69) to Sta 2289+00, Sta 2287+00 to Sta 2290+00 (MA0007 about LM 11.60). (DWR UCIP - O. Magana)

View of LS and levee crown looking upstream towards crossing.

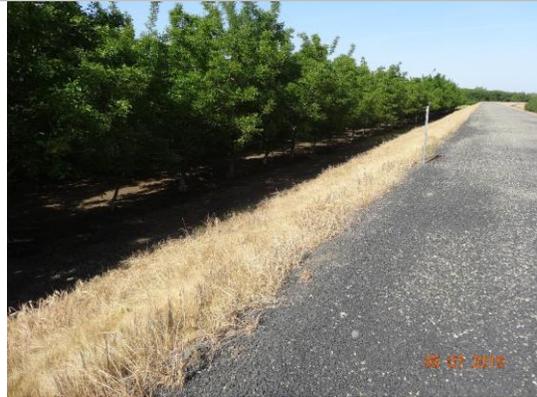
Photo 1 of 3 : UCIP_FA_2019_55089_80707.jpg

Comment Code					
Inspector Comment					
DS_ID:25527 FS_ID:55089 EP_NO: N/A Repair Type: Non-Urgent Crossing Status: Found UCIP Comments: 05/07/2019 Record has been updated from No Action Needed to Non-Urgent, no permit has been issued by the CVFPB authorizing pipe. No other issues were recorded during inspection. (O. Magana - DWR UCIP) FIELD_STRUCT_DESC: 2-inch pressurized pipe of an unknown material or purpose through the levee, 3 feet below the crown. [AdditionalReference(s): Sutter Butte Flood Control Agency (SBFCA) Feather River West Levee Project, Volume 4 of 6 (Project D) Feather River West Levee Improvement Plans Sta 1765+00 to 2368+26, 2016, Volume 4-SBFCA_Record_Drawings_Project D_2017.05.16.pdf, Drawing No. C-137 and C-543]. FS Date: 5/7/2019

LS view: overview of LS.

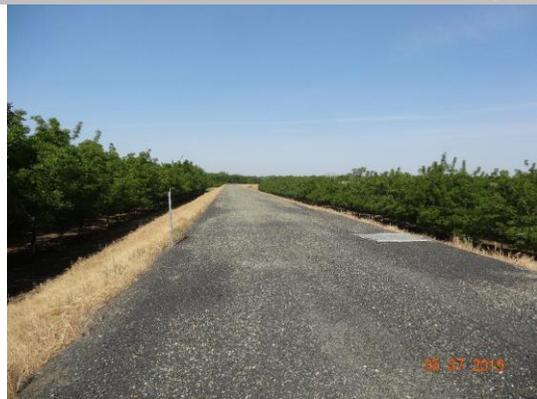
Photo 2 of 3 : UCIP_FA_2019_55089_80708.jpg

Overview of levee crown looking u/s towards pipe crossing.

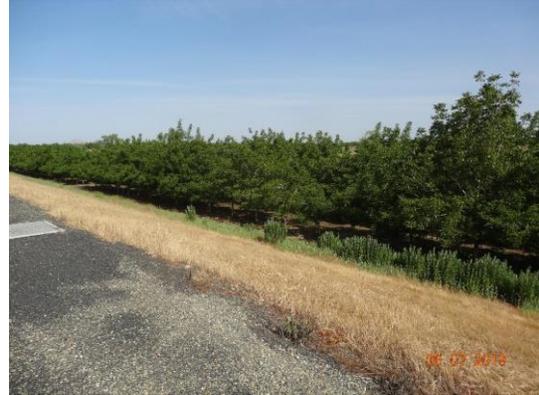
Photo 3 of 3 : UCIP_FA_2019_55089_80709.jpg

Comment Code						
Inspector Comment						
DS_ID:25527 FS_ID:55089 EP_NO: N/A Repair Type: Non-Urgent Crossing Status: Found UCIP Comments: 05/07/2019 Record has been updated from No Action Needed to Non-Urgent, no permit has been issued by the CVFPB authorizing pipe. No other issues were recorded during inspection. (O. Magana - DWR UCIP) FIELD_STRUCT_DESC: 2-inch pressurized pipe of an unknown material or purpose through the levee, 3 feet below the crown. [AdditionalReference(s): Sutter Butte Flood Control Agency (SBFCA) Feather River West Levee Project, Volume 4 of 6 (Project D) Feather River West Levee Improvement Plans Sta 1765+00 to 2368+26, 2016, Volume 4-SBFCA_Record_Drawings_Project D_2017.05.16.pdf, Drawing No. C-137 and C-543]. FS Date: 5/7/2019

WS view: overview of WS.

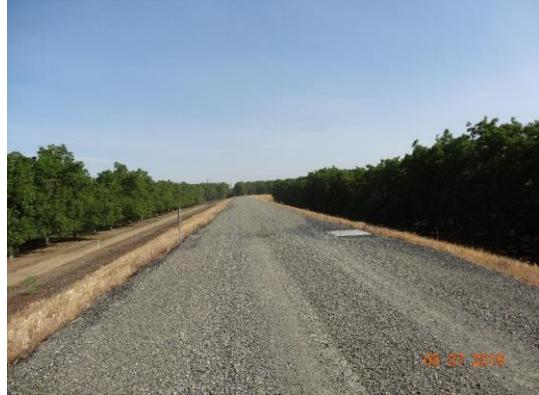
Photo 1 of 3 : UCIP_FA_2019_55084_80715.jpg

Comment Code					
Inspector Comment					
DS_ID:25528 FS_ID:55084 EP_NO: N/A Repair Type: Non-Urgent Crossing Status: Found UCIP Comments: 05/07/2019 Record has been updated from No Action Needed to Non-Urgent, no permit has been issued by the CVFPB authorizing pipe. No other issues were recorded during inspection. (O. Magana - DWR UCIP) FIELD_STRUCT_DESC: 2-inch steel irrigation pipe through the levee, 3 feet below the levee crown. Concrete vault located at the waterside (WS) shoulder. (2-inch irrigation line installed under the Feather River Levee Improvement Project; Existing 2-inch irrigation pipe crossing removed and disposed portion within construction limit during the Feather River West Levee Improvements, Project D authorized under Permit No. 18793-3, 2014 - Sutter Butte Flood Control Agency). [Additional Reference(s): Sutter Butte Flood Control Agency (SBFCA) Feather River West Levee Project, Volume 4 of 6 (Project D) Feather River West Levee Improvement Plans Sta 1765+00 to 2368+26, 2016, Volume 4-SBFCA_Record_Drawings_Project_D_2017.05.16.pdf, Drawing No. C-545]. FS Date: 5/7/2019

Overview of levee crown looking u/s towards pipe crossing.

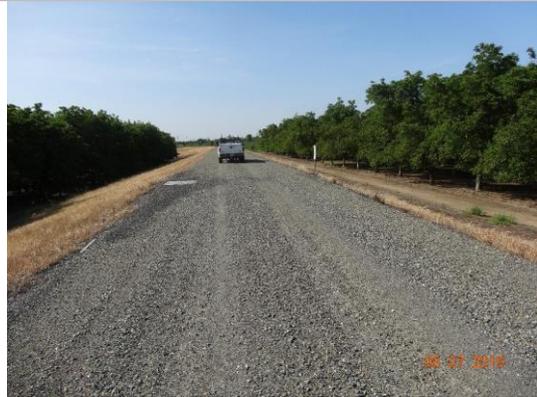
Photo 3 of 3 : UCIP_FA_2019_55084_80717.jpg

Comment Code					
Inspector Comment					
DS_ID:25528 FS_ID:55084 EP_NO: N/A Repair Type: Non-Urgent Crossing Status: Found UCIP Comments: 05/07/2019 Record has been updated from No Action Needed to Non-Urgent, no permit has been issued by the CVFPB authorizing pipe. No other issues were recorded during inspection. (O. Magana - DWR UCIP) FIELD_STRUCT_DESC: 2-inch steel irrigation pipe through the levee, 3 feet below the levee crown. Concrete vault located at the waterside (WS) shoulder. (2-inch irrigation line installed under the Feather River Levee Improvement Project; Existing 2-inch irrigation pipe crossing removed and disposed portion within construction limit during the Feather River West Levee Improvements, Project D authorized under Permit No. 18793-3, 2014 - Sutter Butte Flood Control Agency). [Additional Reference(s): Sutter Butte Flood Control Agency (SBFCA) Feather River West Levee Project, Volume 4 of 6 (Project D) Feather River West Levee Improvement Plans Sta 1765+00 to 2368+26, 2016, Volume 4-SBFCA_Record_Drawings_Project_D_2017.05.16.pdf, Drawing No. C-545]. FS Date: 5/7/2019

Overview of levee crown looking d/s towards pipe crossing.

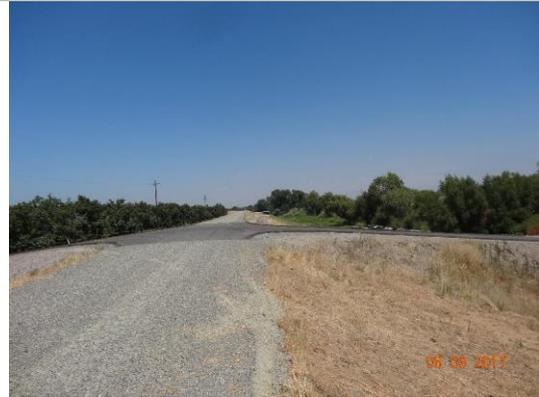
Photo 1 of 3 : UCIP_FA_2019_55086_77233.jpg

DS_ID:25516
 FS_ID:55086
 EP_NO: N/A
 Repair Type: Non-Urgent
 Crossing Status: Found
 UCIP Comments: 05/07/2019 Record has been updated from No Action Needed to Non-Urgent, no permit has been issued by the CVFPB authorizing pipe. Paddle marker located on LS shoulder has been bent. No other issues were recorded during inspection. (O. Magana - DWR UCIP)08/08/2017 Crossing was installed under the Feather River West Levee Improvements, Project D. Project Improvements begin at Station (Sta) 1765+00 (MA0007 about LM 1.73) to Sta 2303+50 (ST0005 about LM 1.23), refer to record drawings for the Feather River West Levee Improvement Plans Station 1765+00 to 2368+26, Project D details. MA0007 project details include NO CUTOFF WALL from Sta 1765+00 (MA0007 about LM 1.73) to 1815+00 (MA0007 about LM 2.64) and LEVEE DEGRADE AND RECONSTRUCTION WITH CUT OFF WALL from Sta 1817+00 (MA0007 about LM 2.69) to Sta 2289+00, Sta 2287+00 to Sta 2290+00 (MA0007 about LM 11.60). (DWR UCIP - O. Magana)

Overview of levee crown looking upstream toward crossing.

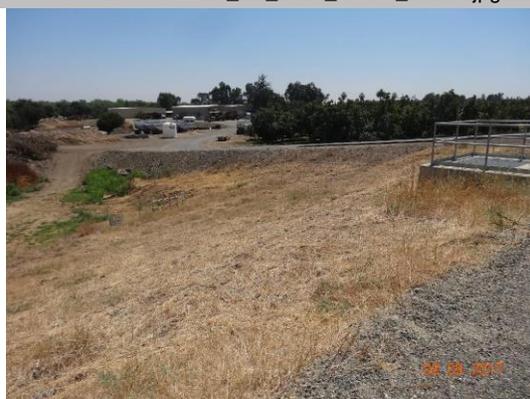
Photo 2 of 3 : UCIP_FA_2019_55086_77243.jpg

DS_ID:25516
 FS_ID:55086
 EP_NO: N/A
 Repair Type: Non-Urgent
 Crossing Status: Found
 UCIP Comments: 05/07/2019 Record has been updated from No Action Needed to Non-Urgent, no permit has been issued by the CVFPB authorizing pipe. Paddle marker located on LS shoulder has been bent. No other issues were recorded during inspection. (O. Magana - DWR UCIP)08/08/2017 Crossing was installed under the Feather River West Levee Improvements, Project D. Project Improvements begin at Station (Sta) 1765+00 (MA0007 about LM 1.73) to Sta 2303+50 (ST0005 about LM 1.23), refer to record drawings for the Feather River West Levee Improvement Plans Station 1765+00 to 2368+26, Project D details. MA0007 project details include NO CUTOFF WALL from Sta 1765+00 (MA0007 about LM 1.73) to 1815+00 (MA0007 about LM 2.64) and LEVEE DEGRADE AND RECONSTRUCTION WITH CUT OFF WALL from Sta 1817+00 (MA0007 about LM 2.69) to Sta 2289+00, Sta 2287+00 to Sta 2290+00 (MA0007 about LM 11.60). (DWR UCIP - O. Magana)

Overview of WS slope at crossing.

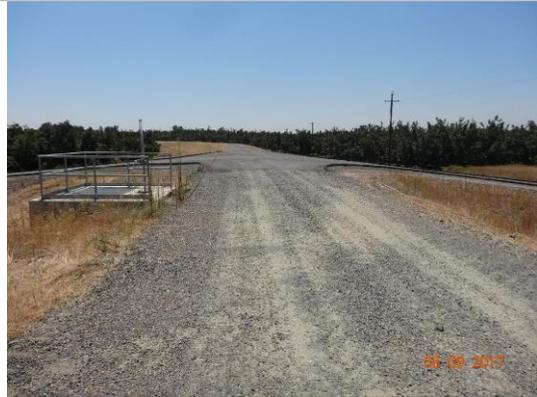
Photo 3 of 3 : UCIP_FA_2019_55086_77234.jpg

Comment Code					
Inspector Comment					
<p>DS_ID:25516 FS_ID:55086 EP_NO: N/A Repair Type: Non-Urgent Crossing Status: Found UCIP Comments: 05/07/2019 Record has been updated from No Action Needed to Non-Urgent, no permit has been issued by the CVFPB authorizing pipe. Paddle marker located on LS shoulder has been bent. No other issues were recorded during inspection. (O. Magana - DWR UCIP)08/08/2017 Crossing was installed under the Feather River West Levee Improvements, Project D. Project Improvements begin at Station (Sta) 1765+00 (MA0007 about LM 1.73) to Sta 2303+50 (ST0005 about LM 1.23), refer to record drawings for the Feather River West Levee Improvement Plans Station 1765+00 to 2368+26, Project D details. MA0007 project details include NO CUTOFF WALL from Sta 1765+00 (MA0007 about LM 1.73) to 1815+00 (MA0007 about LM 2.64) and LEVEE DEGRADE AND RECONSTRUCTION WITH CUT OFF WALL from Sta 1817+00 (MA0007 about LM 2.69) to Sta 2289+00, Sta 2287+00 to Sta 2290+00 (MA0007 about LM 11.60). (DWR UCIP - O. Magana) FIELD_STRUCT_DESC: 36-inch inside diameter gravity drainage pipe of an unknown material through the levee, 17 feet below the crown. 18-inch drainage layer at the pipe inlet at the landside (LS) toe. Existing ground regraded off the LS toe to provide a smooth transition to the pipe inlet. Gate riser structure with positive shutoff valve on the waterside (WS) shoulder. 36-inch flap gate, outfall structure, and riprap R90 at the pipe outlet at the WS toe. Existing ground regraded off the WS toe to provide a smooth transition to the pipe outlet. (Existing 24-inch corrugated metal gravity drainage pipe crossing removed and replaced portion within construction limit with a new 36-inch gravity drainage pipe crossing during the Feather River West Levee Improvements, Project D). [Additional Reference(s): Sutter Butte Flood Control Agency (SBFCA) Feather River West Levee Project, Volume 4 of 6 (Project D) Feather River West Levee Improvement Plans Sta 1765+00 to 2368+26, 2016, Volume 4-SBFCA_Record_Drawings_Project D_2017.05.16.pdf, Drawing No. C-553]. FS Date: 5/7/2019 12:48:00 PM</p>

Overview of levee crown looking downstream at crossing.
