**Flood Control Project Maintenance
Levee Inspections**
LMA District Cover Sheet
Spring 2020 Levee Inspection Results

Butte County Department of Public Works

**Flood Control Project Maintenance
Levee Inspections**

Waterway	Bank	Unit Miles
Unit No. 01 Mud Creek	Right	6.80

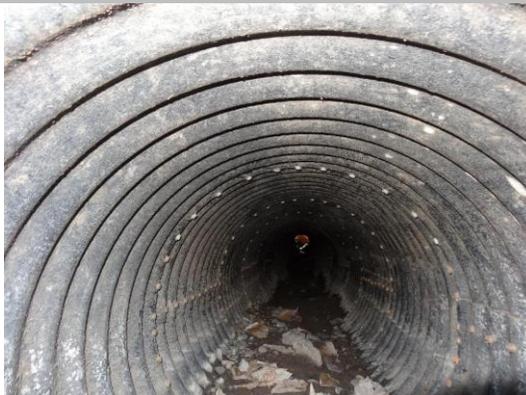
Photo 3 of 3 : UCIP_SP_2020_50142_55884.jpg

LM Start	1.90	Rating **	A/W	Issue No.	66 (cont)
LM End	1.90	Issue Type +	Ma	Location *	
Category	Supplemental			GPS Latitude/Longitude	
				Start	End
Item	DWR UCIP LMA Responsibility			39.747563 °	39.747563 °
				-121.920170 °	-121.920170 °
DWR ID	19212

LS view: inside view of CMP on levee slope. Needs cleaning and clearing.

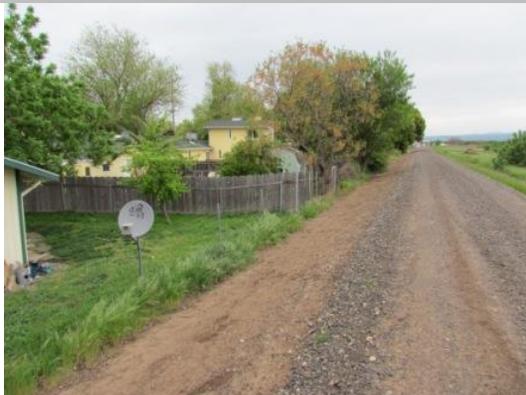
Photo 1 of 1 : SP_2020_NA0003_64_3_20200226_00001.jpg

LM Start	2.00	Rating **	M	Issue No.	3
LM End	2.04	Issue Type +	En	Location *	LS
Category	Earthen Levee			GPS Latitude/Longitude	
				Start	End
Item	Encroachments			39.748330 °	39.748867 °
				-121.918685 °	-121.918533 °
DWR ID	DWR_NA0003_01_s_2012_3				
Comment Code					
FE : Fence					
Inspector Comment

View of the fences along the landside toe.

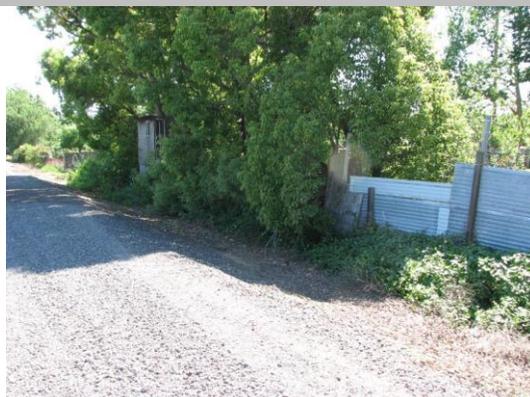
Photo 1 of 1 : SP_2020_NA0003_64_40_20200226_00013.jpg

LM Start	2.06	Rating **	U	Issue No.	40
LM End	2.08	Issue Type +	En	Location *	LS
Category	Earthen Levee		GPS Latitude/Longitude		
			Start	End	
Item	Encroachments		39.749145 °	39.749461 °	
			-121.918506 °	-121.918425 °	
DWR ID	DWR_NA0003_01_s_2016_40				
Comment Code					
FE : Fence					
Inspector Comment					
The corrugated fencing with vegetation is completely obscuring landside toe.

View of a metal fence and treehouse obstructing visibility and access.

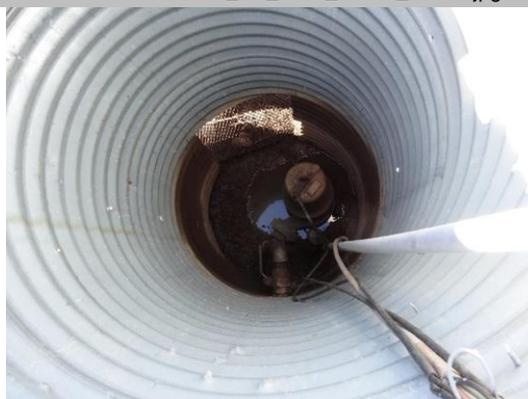
Photo 3 of 3 : UCIP_SP_2020_30291_55698.jpg

LM Start	2.71	Rating **	M	Issue No.	67 (cont)
LM End	2.71	Issue Type +	En	Location *	
Category	Supplemental			GPS Latitude/Longitude	
				Start	End
Item	DWR UCIP Field Study			39.757445 °	39.757445 °
				-121.913654 °	-121.913654 °
DWR ID	19230

LS view: inside view of CMP riser. Pipe, gate valve, air vent, and submersible pump in the riser.

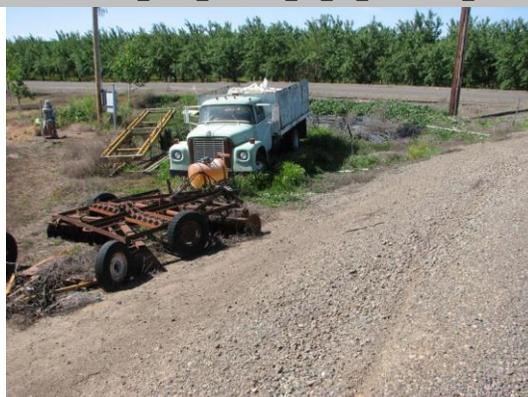
Photo 1 of 1 : SP_2020_NA0003_64_39_20200226_00012.jpg

LM Start	2.98	Rating **	M	Issue No.	39
LM End	2.98	Issue Type +	En	Location *	LS
Category	Earthen Levee			GPS Latitude/Longitude	
				Start	End
Item	Encroachments			39.760539 °	39.760539 °
				-121.911376 °	-121.911376 °
DWR ID	DWR_NA0003_01_s_2016_39				
Comment Code					
AV : Abandoned vehicles					
Inspector Comment					
Truck and farm equipment are blocking the landside toe.

View of equipment and vehicles along the landside toe.

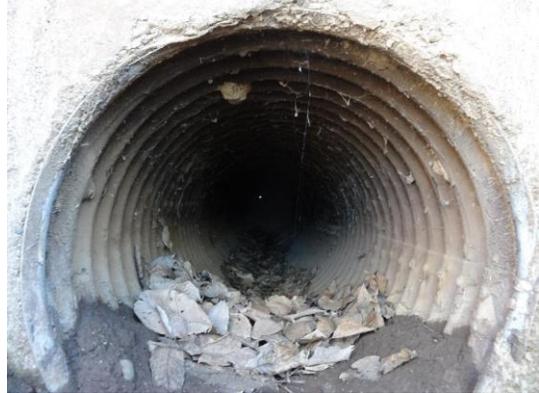
Photo 3 of 3 : UCIP_SP_2020_30310_55739.jpg

LM Start	3.39	Rating **	M	Issue No.	70 (cont)
LM End	3.39	Issue Type +	Ma	Location *	
Category	Supplemental			GPS Latitude/Longitude	
				Start	End
Item	DWR UCIP LMA Responsibility			39.765440 °	39.765440 °
				-121.907261 °	-121.907261 °
DWR ID	19218

LS view: inside view of CMP on levee slope. Needs cleaning and clearing.

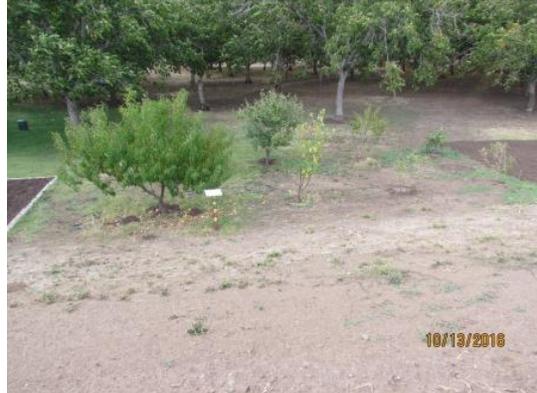
Photo 1 of 1 : SP_2020_NA0003_64_29_20200226_00008.jpg

LM Start	4.01	Rating **	U	Issue No.	29
LM End	4.01	Issue Type +	En	Location *	LS
Category	Earthen Levee		GPS Latitude/Longitude		
			Start	End	
Item	Encroachments		39.771732 °	39.771732 °	
			-121.899699 °	-121.899699 °	
DWR ID	DWR_NA0003_01_f_2014_29				
Comment Code					
CR : Crops					
Inspector Comment					
Fruit trees are present at the toe of the levee.

View of the fruit trees within 10' of landside levee toe.

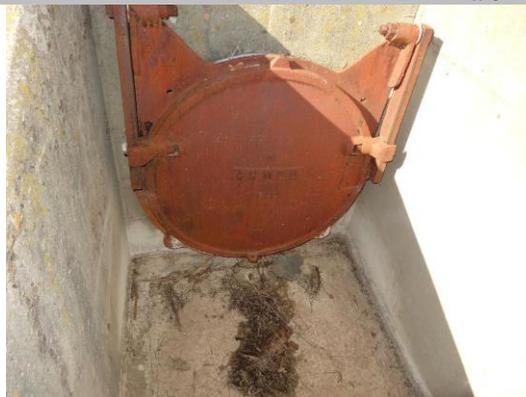
Photo 1 of 3 : UCIP_SP_2020_30327_55768.jpg

Comment Code					
Inspector Comment					
DS_ID:19222 FS_ID:30327 EP_NO: N/A Repair Type: No Action Needed Crossing Status: Found UCIP Comments: Slide gate in CM stadipe on waterside levee slope. FIELD_STRUCT_DESC: 36-inch corrugated metal gravity drainage pipe through the levee, 17 feet below the crown. Slide gate in a corrugated metal standpipe on the waterside (WS) slope. Flap gate on the WS end. Concrete U-shaped headwall on each end. Grouted riprap apron on the landside (LS) end. Grouted riprap spillway on the WS end. [Additional Reference(s): DWR Levee Log, 1992. USACE Sacramento O&M Manual 504, May 1965, (HLM 5.22)]. FS Date: 2/20/2014

WS view: U type concrete headwall, pipe, and flapgate on levee slope.

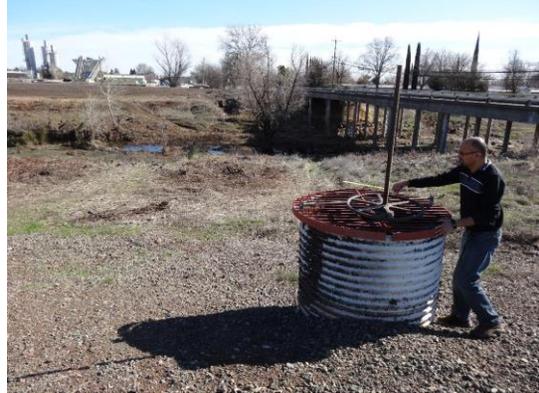
Photo 2 of 3 : UCIP_SP_2020_30327_55767.jpg

LM Start	5.09	Rating **	A/W	Issue No.	75 (cont)
LM End	5.09	Issue Type +	Ma	Location *	
Category	Supplemental			GPS Latitude/Longitude	
				Start	End
Item	DWR UCIP LMA Responsibility			39.783636 °	39.783636 °
				-121.888463 °	-121.888463 °
DWR ID	19222

WS view: CM standpipe with slide gate on levee slope.

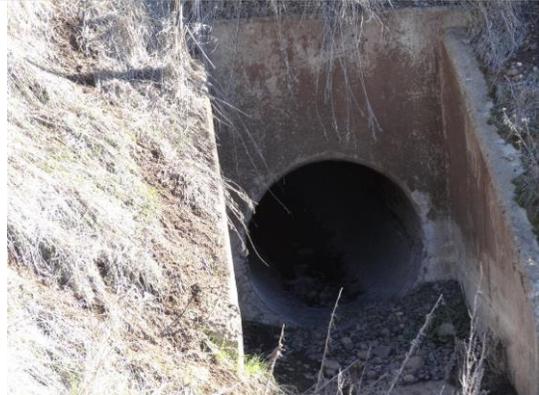
Photo 3 of 3 : UCIP_SP_2020_30327_55766.jpg

LM Start	5.20	Rating **	A/W	Issue No.	75 (cont)
LM End	5.09	Issue Type +	Ma	Location *

LS view: U type concrete headwall and CMP on levee slope.

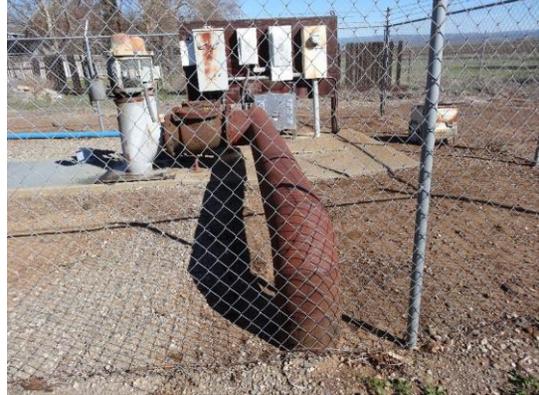
Photo 3 of 3 : UCIP_SP_2020_30368_55859.jpg

LM Start	5.30	Rating **	M	Issue No.	76 (cont)
LM End	5.30	Issue Type +	En	Location *	
Category	Supplemental			GPS Latitude/Longitude	
				Start	End
Item	DWR UCIP Field Study			39.784739 °	39.784739 °
				-121.884860 °	-121.884860 °
DWR ID	19223

LS view: pipe, pumps, power boxes, concrete vault on landside.

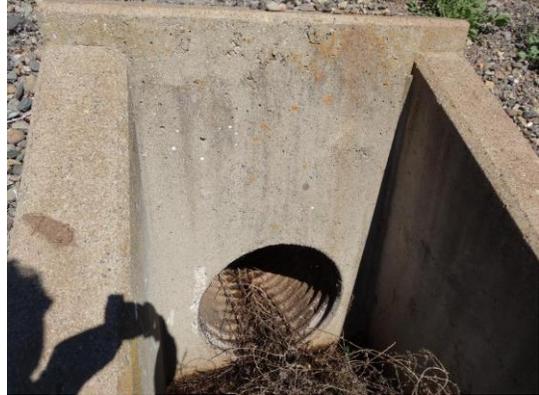
Photo 3 of 3 : UCIP_SP_2020_31667_57966.jpg

LM Start	0.23	Rating **	M	Issue No.	47 (cont)
LM End	0.23	Issue Type +	Ma	Location *	
Category	Supplemental			GPS Latitude/Longitude	
				Start	End
Item	DWR UCIP LMA Responsibility			39.797416 °	39.797416 °
				-121.881675 °	-121.881675 °
DWR ID	19234

LS view: U type concrete headwall and CMP on levee slope. Vegetation debris on inlet box.

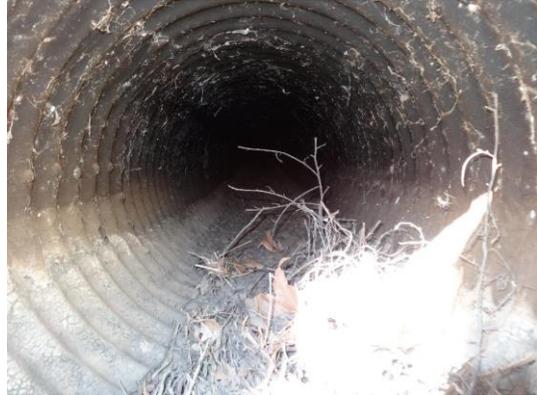
Photo 3 of 3 : UCIP_SP_2020_30403_55920.jpg

LM Start	1.26	Rating **	M	Issue No.	48 (cont)
LM End	1.26	Issue Type +	Ma	Location *	
Category	Supplemental			GPS Latitude/Longitude	
				Start	End
Item	DWR UCIP LMA Responsibility			39.784062 °	39.784062 °
				-121.884344 °	-121.884344 °
DWR ID	19235

LS view: inside view of CMP on levee slope. Needs cleaning and clearing.

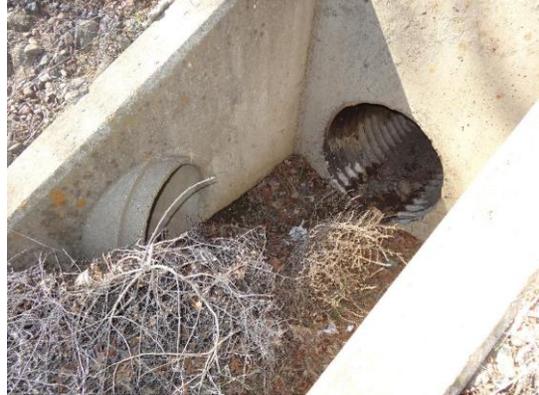
Photo 2 of 2 : UCIP_SP_2020_30743_56640.jpg

DS_ID:19237
 FS_ID:30743
 EP_NO: N/A
 Repair Type: Non-Urgent
 Crossing Status: Found
 UCIP Comments: Needs cleaning and clearing of debris.
 FIELD_STRUCT_DESC: 24-inch corrugated metal gravity drainage pipe through the levee, 11 feet below the crown. Flap gate on the waterside (WS) end. Concrete U-shaped headwall on each end. Grouted riprap apron on the landside (LS) end. Grouted riprap spillway on the WS end. [Additional Reference(s): DWR Levee Log, 1992. USACE Sacramento O&M Manual 504, May 1965, (HLM 1.55)].
 FS Date: 2/24/2014

LM Start	1.46	Rating **	M	Issue No.	49 (cont)
LM End	1.46	Issue Type +	Ma	Location *	
Category	Supplemental		GPS Latitude/Longitude		
			Start	End	
Item	DWR UCIP LMA Responsibility		39.782980 °	39.782980 °	
			-121.887834 °	-121.887834 °	
DWR ID	19237

LS view: U type concrete headwall and CMP on levee slope. Vegetation debris and soil in inlet area.

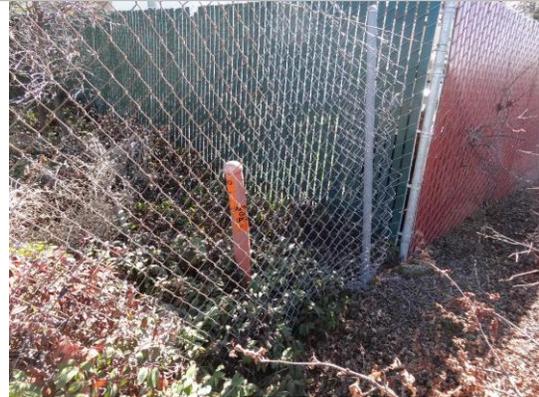
Photo 1 of 1 : UCIP_SP_2020_41873_56643.jpg

LM Start	1.49	Rating **	M	Issue No.	50
LM End	1.49	Issue Type +	En	Location *	
Category	Supplemental		GPS Latitude/Longitude		
			Start	End	
Item	DWR UCIP Field Study		39.782766 °	39.782766 °	
			-121.888187 °	-121.888187 °	
DWR ID	24803				
Comment Code					
Inspector Comment					
DS_ID:24803 FS_ID:41873 EP_NO: 9874 Repair Type: Non-Urgent Crossing Status: Indicator Found UCIP Comments: May need to contact owner to determine status of crossing and install markers as appropriate. FIELD_STRUCT_DESC: 6-inch natural gas main of an unknown material through both levees and under Mud Creek, downstream from the Esplanade, at an unknown depth. Indicator on the landside (LS) toe. (Plans to install a 6-inch natural gas pipeline across Mud Creek and through adjacent levee authorized under Permit No. 9874, 1974 - Pacific Gas and Electric Company [PG&E]). FS Date: 2/24/2014

LS view: gasline marker on levee toe.

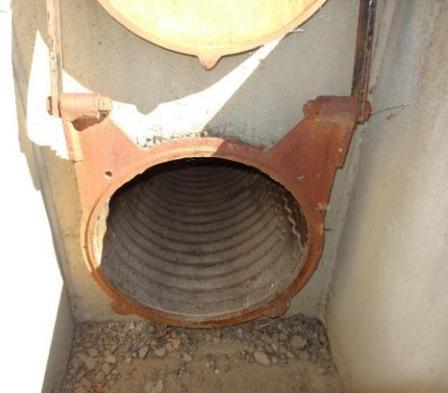
Photo 2 of 3 : UCIP_SP_2020_41375_56645.jpg

LM Start	2.03	Rating **	M	Issue No.	51 (cont)
LM End	2.03	Issue Type +	En	Location *	
Category	Supplemental			GPS Latitude/Longitude	
				Start	End
Item	DWR UCIP Field Study			39.776025 °	39.776025 °
				-121.892911 °	-121.892911 °
DWR ID	19238

WS view: U type concrete headwall, pipe, and flapgate on levee slope.

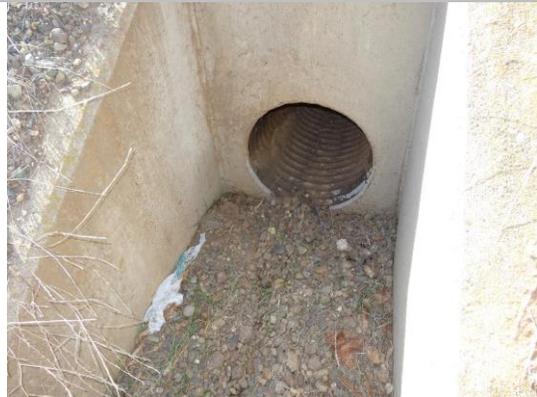
Photo 3 of 3 : UCIP_SP_2020_41375_56644.jpg

LM Start	2.03	Rating **	M	Issue No.	51 (cont)
LM End	2.03	Issue Type +	En	Location *

LS view: U type concrete headwall and CMP on levee slope.

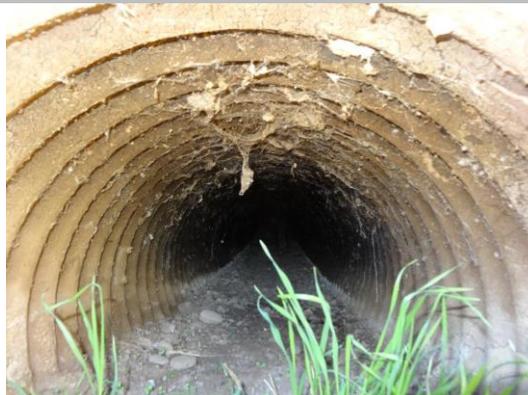
Photo 3 of 3 : UCIP_SP_2020_30763_56660.jpg

LM Start	2.34	Rating **	M	Issue No.	52 (cont)
LM End	2.34	Issue Type +	Ma	Location *	
Category	Supplemental			GPS Latitude/Longitude	
				Start	End
Item	DWR UCIP LMA Responsibility			39.772185 °	39.772185 °
				-121.895681 °	-121.895681 °
DWR ID	19239

LS view: inside view of CMP on levee slope. Needs cleaning and clearing.

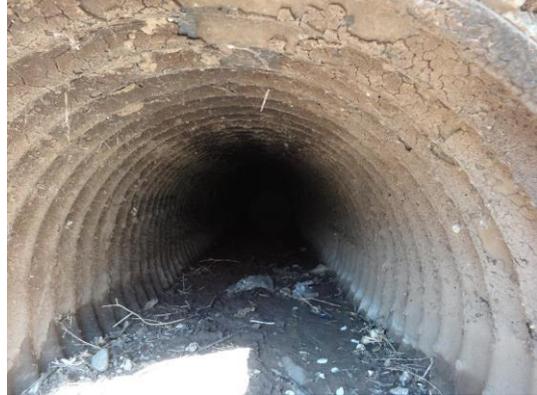
Photo 3 of 3 : UCIP_SP_2020_31031_56915.jpg

LM Start	5.64	Rating **	M	Issue No.	56 (cont)
LM End	5.64	Issue Type +	Ma	Location *	
Category	Supplemental			GPS Latitude/Longitude	
				Start	End
Item	DWR UCIP LMA Responsibility			39.738898 °	39.738898 °
				-121.930242 °	-121.930242 °
DWR ID	19247

LS view: inside view of CMP on levee slope. Needs cleaning and clearing.

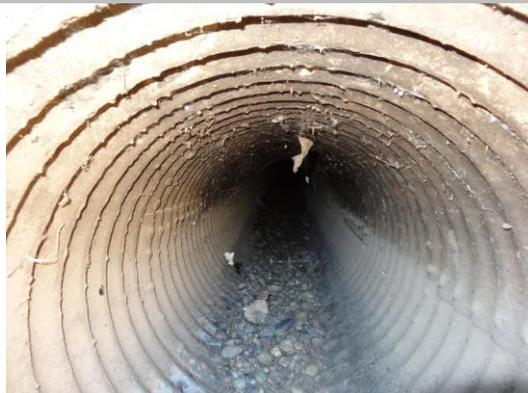
Photo 3 of 3 : UCIP_SP_2020_31034_56924.jpg

LM Start	6.15	Rating **	M	Issue No.	59 (cont)
LM End	6.15	Issue Type +	Ma	Location *	
Category	Supplemental			GPS Latitude/Longitude	
				Start	End
Item	DWR UCIP LMA Responsibility			39.732515 °	39.732515 °
				-121.930373 °	-121.930373 °
DWR ID	19249

LS view: inside view of CMP on levee slope. Needs cleaning and clearing.

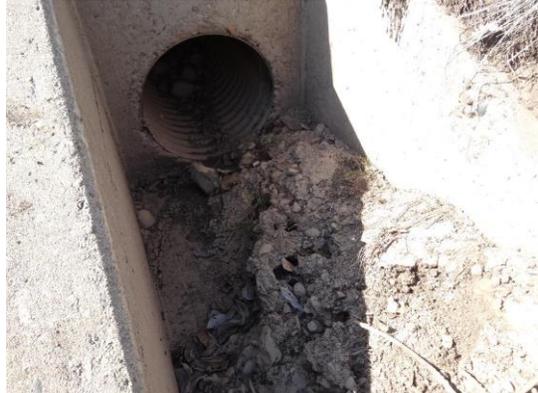
Photo 2 of 3 : UCIP_SP_2020_31085_56987.jpg

LM Start	6.43	Rating **	M	Issue No.	60 (cont)
LM End	6.43	Issue Type +	Ma	Location *	
Category	Supplemental			GPS Latitude/Longitude	
				Start	End
Item	DWR UCIP LMA Responsibility			39.728812 °	39.728812 °
				-121.932623 °	-121.932623 °
DWR ID	19251

LS view: U type concrete headwall and CMP on levee slope. Soil/mud on inlet box.

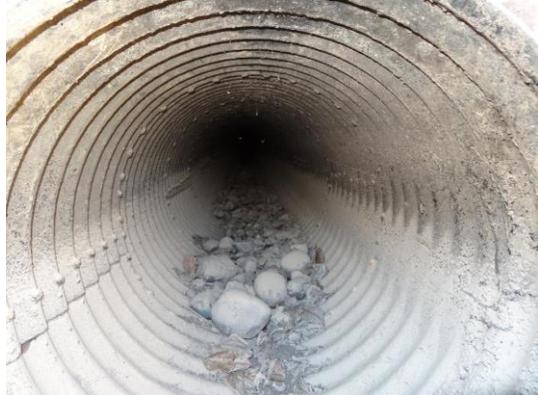
Photo 3 of 3 : UCIP_SP_2020_31085_56986.jpg

LS view: inside view of CMP on levee slope. Needs cleaning and clearing.

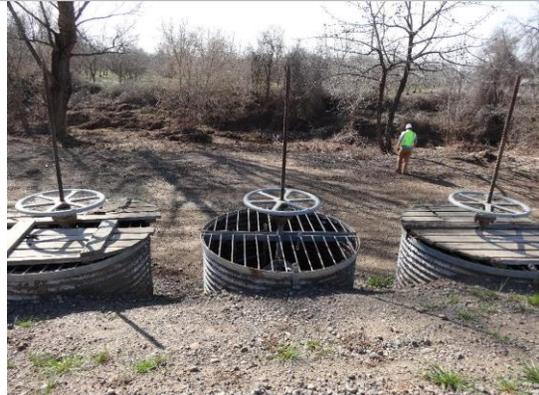
Photo 1 of 3 : UCIP_SP_2020_32085_58585.jpg

Comment Code					
Inspector Comment					
DS_ID:19253 FS_ID:32085 EP_NO: N/A Repair Type: Non-Urgent Crossing Status: Found UCIP Comments: Slide gates in CMP risers on waterside shoulder. Needs cleaning and clearing of debris. FIELD_STRUCT_DESC: 1 of 3: 48-inch corrugated metal gravity drainage pipe through the levee, 18 feet below the crown. Flap gate on the waterside (WS) end. Slide gate in a corrugated metal pipe (CMP) riser on the WS shoulder. Concrete U-shaped headwall on each end. Grouted riprap apron on the landside (LS) end. Grouted riprap spillway on the WS end. [Additional Reference(s): DWR Levee Log, 1992. USACE Sacramento O&M Manual 504, May 1965, (HLM 7.46)]. FS Date: 2/25/2014

WS view: slide gates in CMP risers on waterside shoulder.

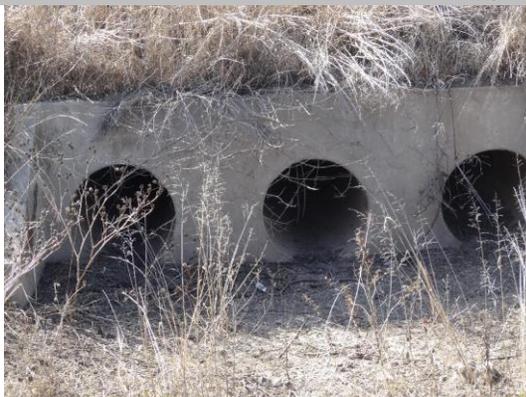
Photo 3 of 3 : UCIP_SP_2020_32085_58586.jpg

LS view: U type concrete headwall and CMPs on levee slope. Soil/mud on inlet box.

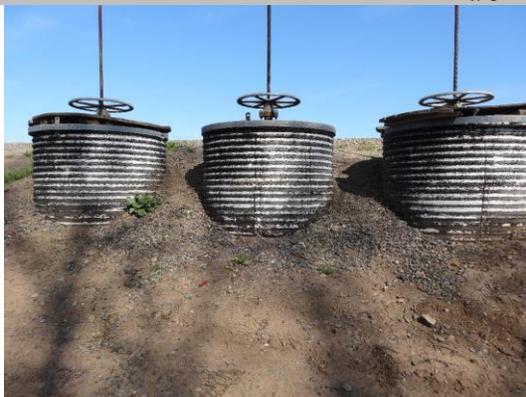
Photo 1 of 3 : UCIP_SP_2020_32087_58592.jpg

DS_ID:19261
 FS_ID:32087
 EP_NO: N/A
 Repair Type: Non-Urgent
 Crossing Status: Found
 UCIP Comments: Slide gates in CMP risers on waterside shoulder. Needs cleaning and clearing on both pipe ends.
 FIELD_STRUCT_DESC: 3 of 3: 48-inch corrugated metal gravity drainage pipe through the levee, 18 feet below the crown. Flap gate on the waterside (WS) end. Slide gate in a corrugated metal pipe (CMP) riser on the WS shoulder. Concrete U-shaped headwall on each end. Grouted riprap apron on the landside (LS) end. Grouted riprap spillway on the WS end. [Additional Reference(s): DWR Levee Log, 1992. USACE Sacramento O&M Manual 504, May 1965, (HLM 7.46)].
 FS Date: 2/25/2014

WS view: slide gates in CMP risers on waterside shoulder.

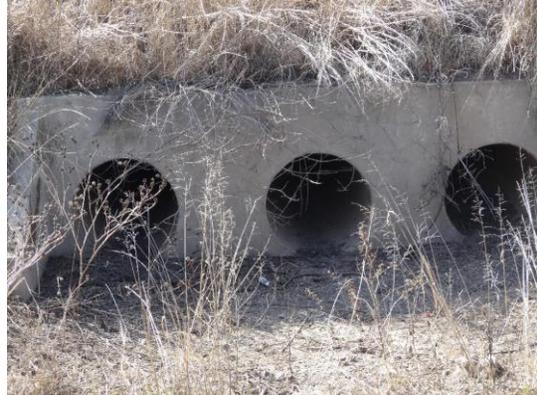
Photo 3 of 3 : UCIP_SP_2020_32086_58587.jpg

LS view: U type concrete headwall and CMPs on levee slope. Soil/mud on inlet box.

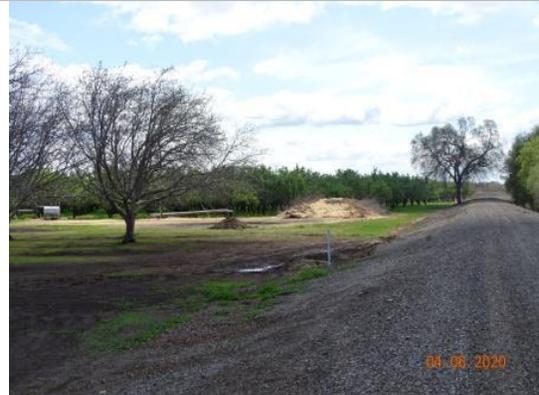
Photo 1 of 1 : SP_2020_NA0003_66_3_20200413_00002.jpg

LM Start	0.21	Rating **	A	Issue No.	3
LM End	0.21	Issue Type +	Ma	Location *	LS
Category	Earthen Levee		GPS Latitude/Longitude		
			Start	End	
Item	Vegetation		39.735707 °	39.735707 °	
			-121.928811 °	-121.928811 °	
DWR ID	DWR_NA0003_02A_s_2020_3				
Comment Code					
V1 : Control annual grass and weeds on the levee slopes and easements.					
Inspector Comment					
Good vegetation control on both landside and waterside slopes.

View of landside slope with good vegetation control. Spring 2020.

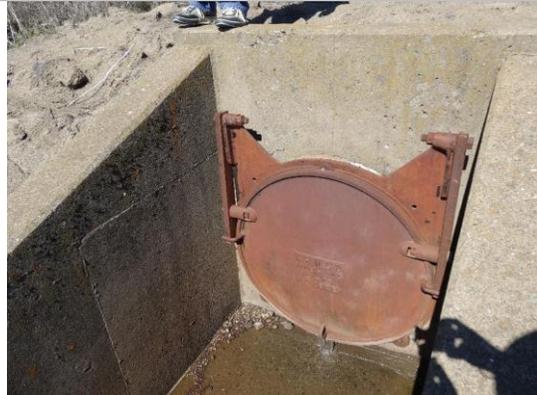
Photo 1 of 3 : UCIP_SP_2020_51844_58602.jpg

Comment Code					
Inspector Comment					
DS_ID:19262 FS_ID:51844 EP_NO: N/A Repair Type: No Action Needed Crossing Status: Found UCIP Comments: 05/16/2017 Crossing has been downgraded from Non-Urgent to No Action Needed. The flap gate appears to be in good working order based on the photos, and the small pile of debris not enough to warrant Non-Urgent rating. (K. Fazel - UCIP)03/11/2014:Slide gate in CMP riser on waterside.The culvert was working during field inspection. (P. Amatya - DWR) FIELD_STRUCT_DESC: 42-inch corrugated metal gravity drainage pipe through the levee, 14 feet below the crown. Flap gate on the waterside (WS) end. Slide gate in a corrugated metal pipe (CMP) riser on the WS slope. Concrete U-shaped headwall on each end. Grouted riprap apron on the landside (LS) end. Grouted riprap spillway on the WS end. [Additional Reference(s): DWR Levee Log, 1992. USACE Sacramento O&M Manual 504, May 1965, (HLM 0.09)]. FS Date: 3/11/2014

WS view: U type concrete headwall, pipe, and flapgate on levee slope.

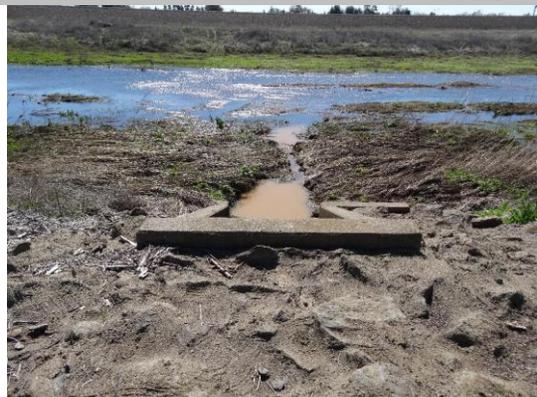
Photo 2 of 3 : UCIP_SP_2020_51844_58601.jpg

WS view: U type concrete headwall of CMP culvert on levee slope. Grouted riprap levee slope and spillway.

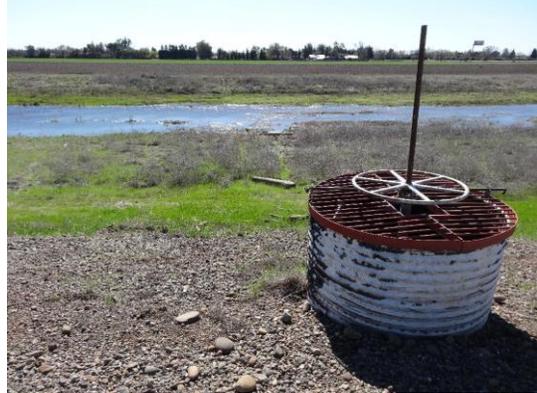
Photo 3 of 3 : UCIP_SP_2020_51844_58600.jpg

WS view: slide gate in CMP riser on waterside shoulder.

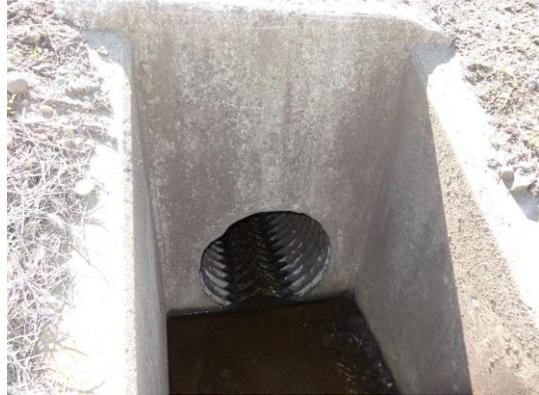
Photo 2 of 2 : UCIP_SP_2020_31899_58186.jpg

LS view: U type concrete headwall and CMP on levee slope. Looks clean and clear.

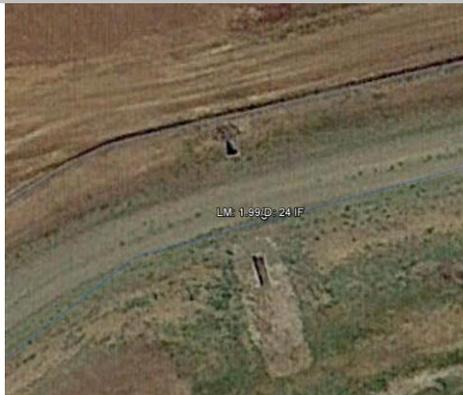
Photo 1 of 1 : UCIP_SP_2020_31900_58189.jpg

LM Start	1.96	Rating **	M	Issue No.	35
LM End	1.96	Issue Type +	En	Location *	
Category	Supplemental		GPS Latitude/Longitude		
			Start	End	
Item	DWR UCIP Field Study		39.781714 °	39.781714 °	
			-121.850868 °	-121.850868 °	
DWR ID	19266				
Comment Code					
Inspector Comment					
DS_ID:19266 FS_ID:31900 EP_NO: N/A Repair Type: Non-Urgent Crossing Status: Indicator Found UCIP Comments: Needs location confirmation, GPS reading has not taken due to access problem. FIELD_STRUCT_DESC: 24-inch corrugated metal gravity drainage pipe through the levee, 8 feet below the crown. Flap gate on the waterside (WS) end. Concrete U-shaped headwall on each end. Grouted riprap apron on the landside (LS) end. Grouted riprap spillway on the WS end. [Additional Reference(s): DWR Levee Log, 1992. USACE Sacramento O&M Manual 504, May 1965, (HLM 2.00)]. FS Date: 3/11/2014

Bird's eye view: concrete headwall visible on both sides of the levee. Grouted riprap spillway on waterside.

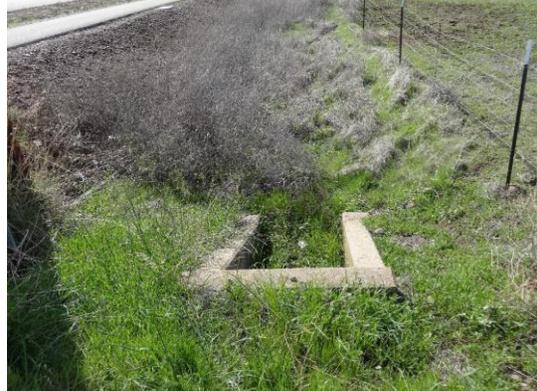
Photo 2 of 3 : UCIP_SP_2020_32124_58624.jpg

LS view: U type concrete headwall of CMP culvert on levee slope. Vegetation on inlet box.

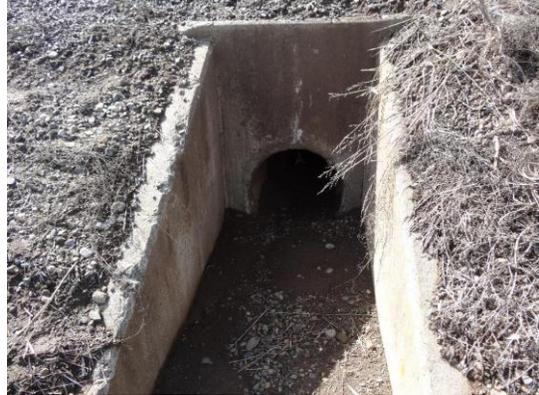
Photo 2 of 3 : UCIP_SP_2020_31901_58193.jpg

LS view: U type concrete headwall and CMP on levee slope. Soil/mud on inlet box.

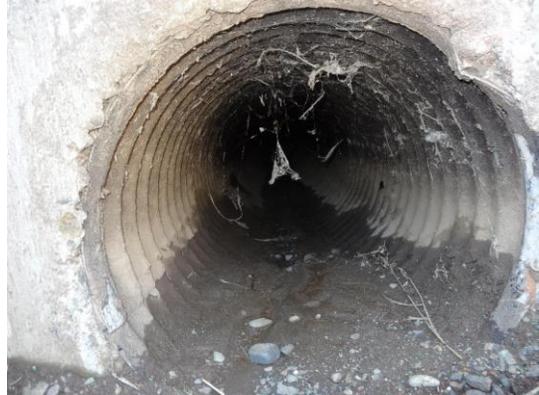
Photo 3 of 3 : UCIP_SP_2020_31901_58195.jpg

LS view: inside view of CMP on levee slope. Needs cleaning and clearing.

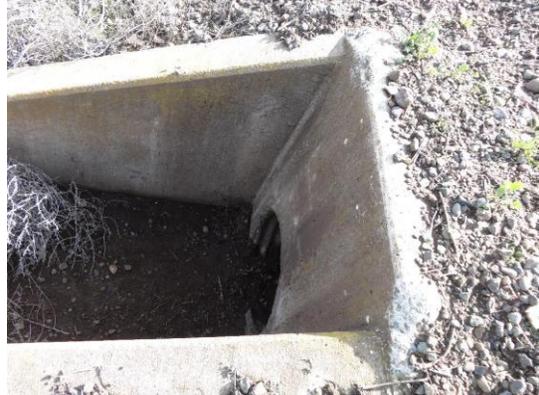
Photo 3 of 3 : UCIP_SP_2020_31902_58199.jpg

LS view: U type concrete headwall and CMP on levee slope. Soil/mud on inlet box.

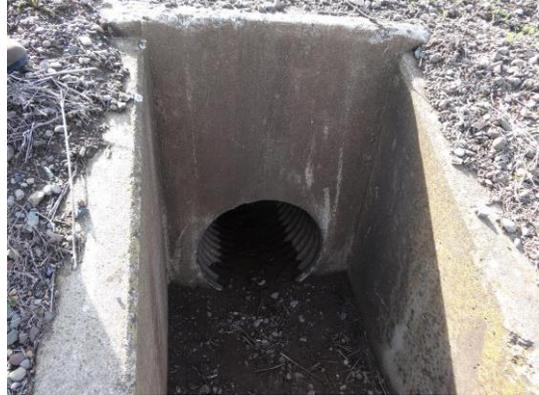
Photo 2 of 3 : UCIP_SP_2020_31864_58068.jpg

DS_ID:19271
 FS_ID:31864
 EP_NO: N/A
 Repair Type: Non-Urgent
 Crossing Status: Found
 UCIP Comments: Needs cleaning and clearing the culvert.
 FIELD_STRUCT_DESC: 24-inch corrugated metal gravity drainage pipe through the levee, 10.5 feet below the crown. Flap gate on the waterside (WS) end. Concrete U-shaped headwall on each end. Grouted riprap apron on the landside (LS) end. Grouted riprap spillway on the WS end. [Additional Reference(s): DWR Levee Log, 1992. USACE Sacramento O&M Manual 504, May 1965, (HLM 3.43)].
 FS Date: 3/7/2014

LS view: U type concrete headwall and CMP on levee slope. Soil/mud on inlet box.

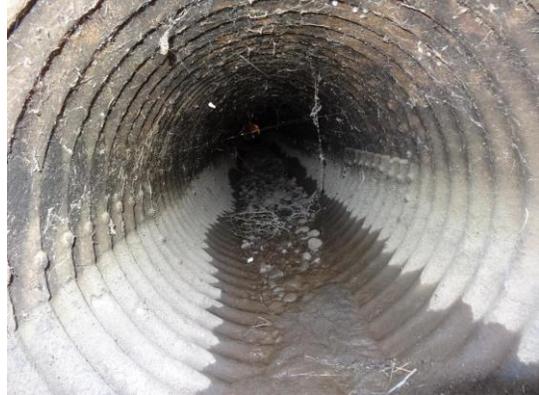
Photo 3 of 3 : UCIP_SP_2020_31864_58067.jpg

LS view: inside view of CMP on levee slope. Needs cleaning and clearing.

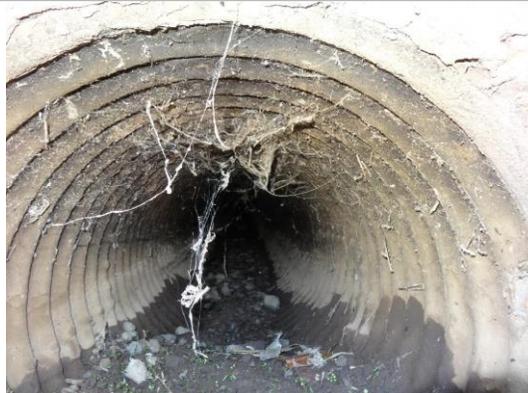
Photo 3 of 3 : UCIP_SP_2020_31856_58051.jpg

LS view: inside view of CMP on levee slope. Needs cleaning and clearing.

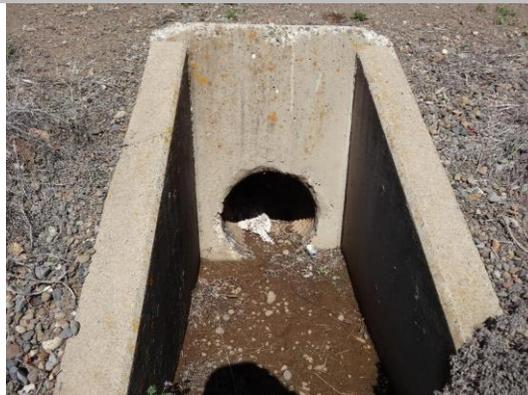
Photo 3 of 3 : UCIP_SP_2020_32026_58518.jpg

LS view: U type concrete headwall and CMP on levee slope. Mud and pebbles on inlet box.

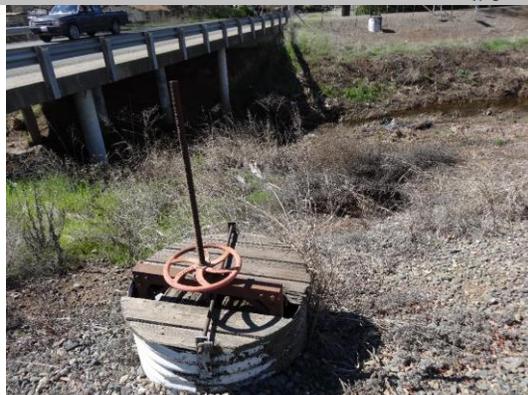
Photo 1 of 3 : UCIP_SP_2020_32025_58512.jpg

DS_ID:19280
 FS_ID:32025
 EP_NO: N/A
 Repair Type: Non-Urgent
 Crossing Status: Found
 UCIP Comments: Slide gate in a CMP riser. Vegetation debris and mud on inlet box. Needs cleaning and clearing the culvert.
 FIELD_STRUCT_DESC: 24-inch corrugated metal gravity drainage pipe through the levee and under the channel, 9.5 feet below the crown. Slide gate in a corrugated metal pipe (CMP) riser on the waterside (WS) slope. Concrete U-shaped headwall on the landside (LS) end.
 [Additional Reference(s): DWR Levee Log, 1992. USACE Sacramento O&M Manual 504, May 1965, (HLM 0.34)].
 FS Date: 3/7/2014

WS view: slide gate in CMP riser on waterside shoulder.

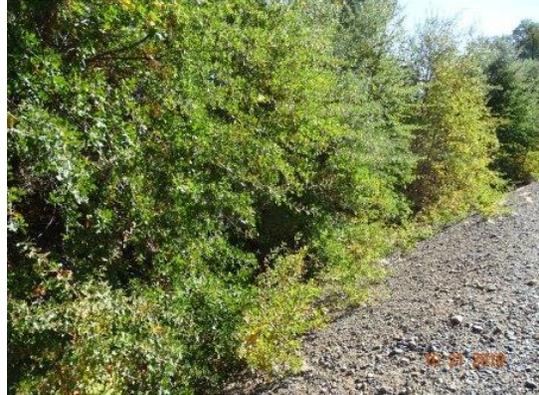
Photo 1 of 1 : SP_2020_NA0003_68_14_20200226_00004.jpg

LM Start	0.35	Rating **	U	Issue No.	14
LM End	0.38	Issue Type +	Ma	Location *	WS
Category	Earthen Levee		GPS Latitude/Longitude		
			Start	End	
Item	Trim / Thin Trees		39.775656 °	39.775289 °	
			-121.850308 °	-121.849907 °	
DWR ID	DWR_NA0003_04_f_2019_14				
Comment Code					
T1 : Trim trees to at least five feet above ground level.					
Inspector Comment

View of trees and wild growth along the waterside slope and toe. Fall 2019.

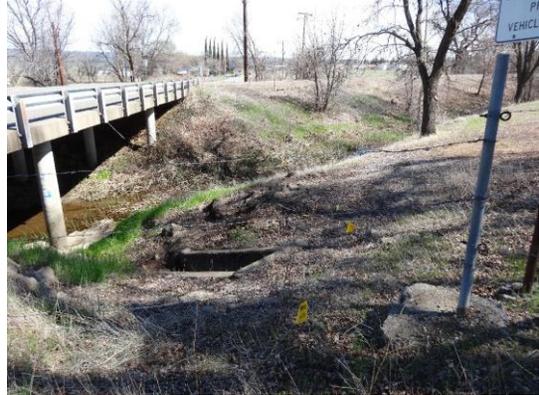
Photo 1 of 2 : UCIP_SP_2020_31946_58357.jpg

LM Start	0.92	Rating **	M	Issue No.	46
LM End	0.92	Issue Type +	En	Location *	
Category	Supplemental		GPS Latitude/Longitude		
			Start	End	
Item	DWR UCIP Field Study		39.775729 °	39.775729 °	
			-121.850950 °	-121.850950 °	
DWR ID	19293				
Comment Code					
Inspector Comment					
DS_ID:19293 FS_ID:31946 EP_NO: 15950 Repair Type: Non-Urgent Crossing Status: Indicator Found UCIP Comments: Only little gasline indicator flags found on both sides of the levee and across the creek. FIELD_STRUCT_DESC: 6-inch high-pressure natural gas main line of an unknown material through both levees and under Dry Creek, 2 feet below the crown. (Plans to place a 6-inch high-pressure gas main under both levees and creek bed to a depth of 5 feet across Dry Creek authorized under Permit No. 15950, 1992 - Pacific Gas and Electric Company [PG&E]). FS Date: 3/7/2014

WS view: little gasline indicator (yellow flags) on both sides of the levee.

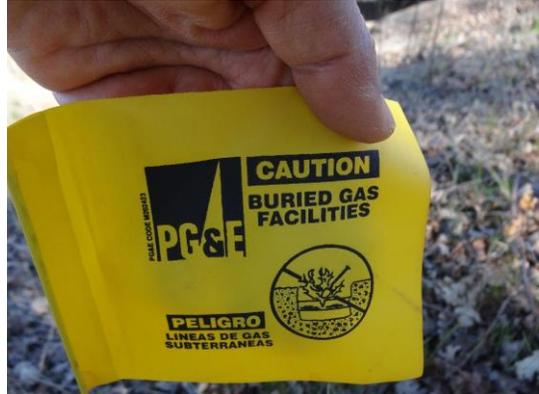
Photo 2 of 2 : UCIP_SP_2020_31946_58356.jpg

WS view: close up view of little gasline indicator.

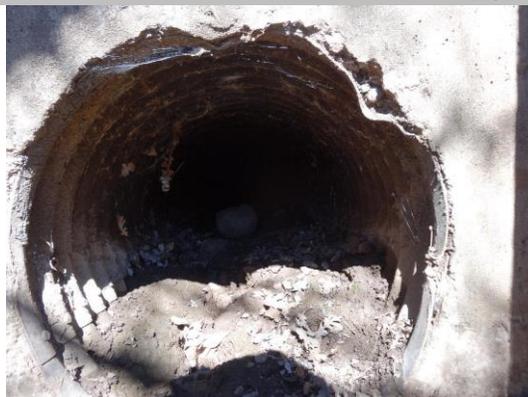
Photo 3 of 3 : UCIP_SP_2020_31963_58385.jpg

LM Start	1.11	Rating **	M	Issue No.	48 (cont)
LM End	1.11	Issue Type +	Ma	Location *	
Category	Supplemental			GPS Latitude/Longitude	
				Start	End
Item	DWR UCIP LMA Responsibility			39.776709 °	39.776709 °
				-121.853932 °	-121.853932 °
DWR ID	19289

LS view: inside view of CMP on levee slope. Needs cleaning and clearing.

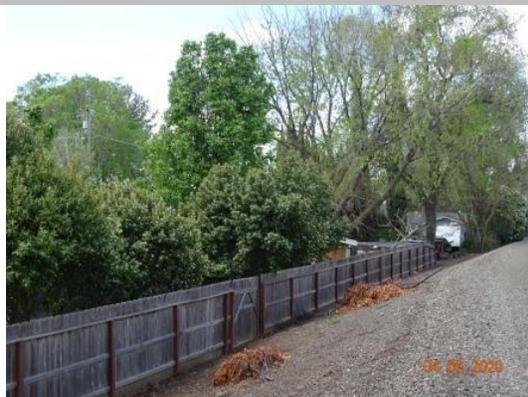
Photo 1 of 1 : SP_2020_NA0003_68_3_20200413_00036.jpg

LM Start	1.11	Rating **	U	Issue No.	3
LM End	1.22	Issue Type +	En	Location *	LS
Category	Earthen Levee			GPS Latitude/Longitude	
				Start	End
Item	Encroachments			39.776760 °	39.77650 °
				-121.854022 °	-121.855687 °
DWR ID	DWR_NA0003_04_s_2012_3				
Comment Code					
FE : Fence					
Inspector Comment

View of the fence along the landside toe. Spring 2020.

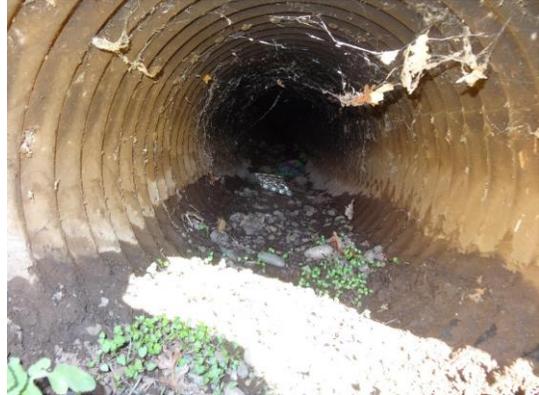
Photo 3 of 3 : UCIP_SP_2020_31965_58393.jpg

LM Start	2.15	Rating **	M	Issue No.	50 (cont)
LM End	2.15	Issue Type +	Ma	Location *	
Category	Supplemental			GPS Latitude/Longitude	
				Start	End
Item	DWR UCIP LMA Responsibility			39.782777 °	39.782777 °
				-121.871179 °	-121.871179 °
DWR ID	19291

LS view: inside view of CMP on levee slope. Needs cleaning and clearing.

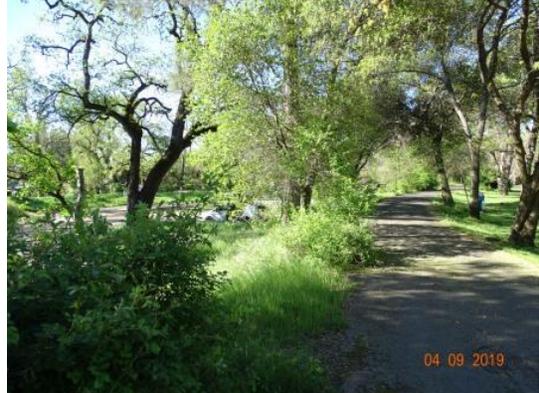
Photo 1 of 1 : SP_2020_NA0003_69_1_20200226_00001.jpg

LM Start	0.03	Rating **	M	Issue No.	1
LM End	0.20	Issue Type +	Ma	Location *	LS
Category	Earthen Levee		GPS Latitude/Longitude		
			Start	End	
Item	Vegetation		39.763164 °	39.761860 °	
			-121.790335 °	-121.792635 °	
DWR ID	DWR_NA0003_05_s_2012_1				
Comment Code					
V2 : Remove the wild growth other than native grasses from the levee slopes.					
Inspector Comment

View of the wild growth on the landside slope. Spring 2019.

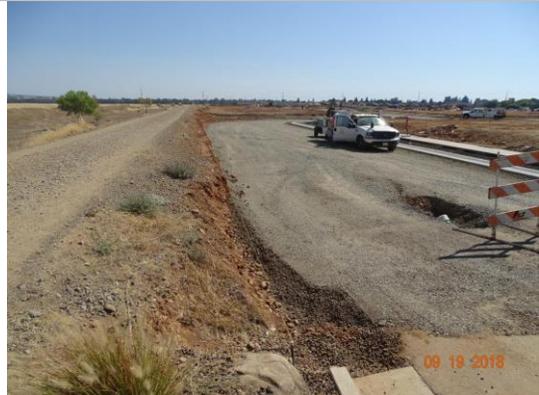
Photo 1 of 2 : SP_2020_NA0003_69_15_20200226_00005.jpg

LM Start	1.56	Rating **	U	Issue No.	15
LM End	1.56	Issue Type +	En	Location *	LS
Category	Earthen Levee		GPS Latitude/Longitude		
			Start	End	
Item	Encroachments		39.772190 °	39.772190 °	
			-121.810700 °	-121.810700 °	
DWR ID	DWR_NA0003_05_f_2017_15				
Comment Code					
RW : Retaining Wall					
Inspector Comment					
The developer cut a paved road, gutter and large rocks in slope/toe of the levee. The board is in the process of resolving the encroachment.

View of the housing track road cutting into the levee toe.
